## Building Inspection Report VR

Inspection Date: Wed, 14 Jan 2026

Property Address: 14 Base St, Victoria Point QLD 4165,  
Australia

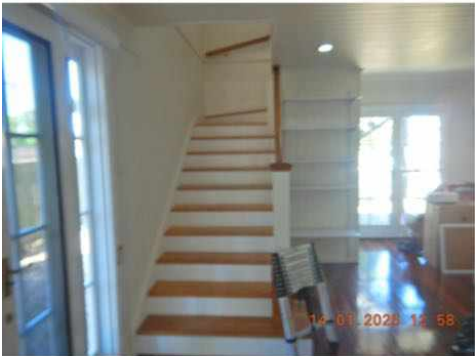
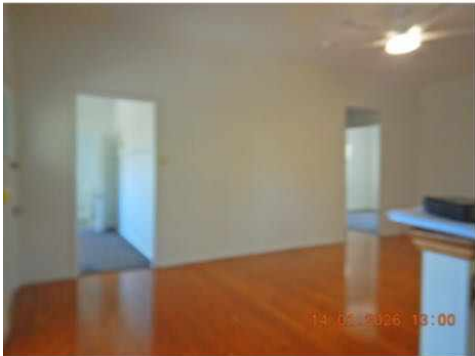
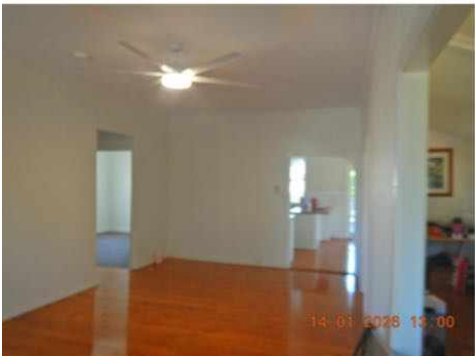
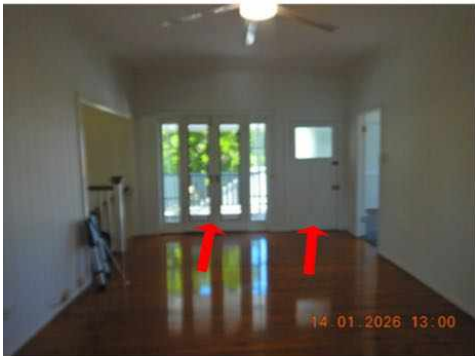
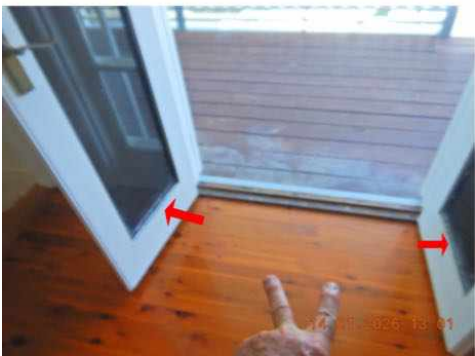
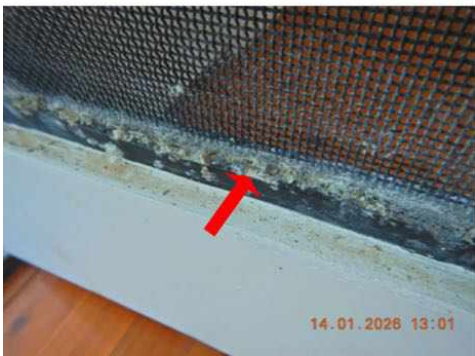
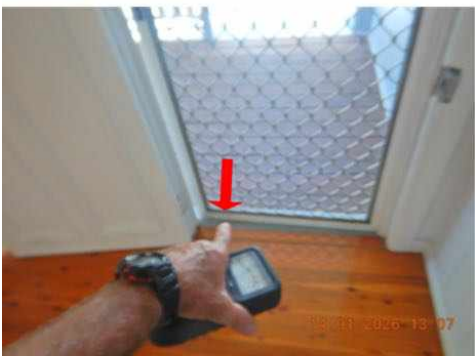
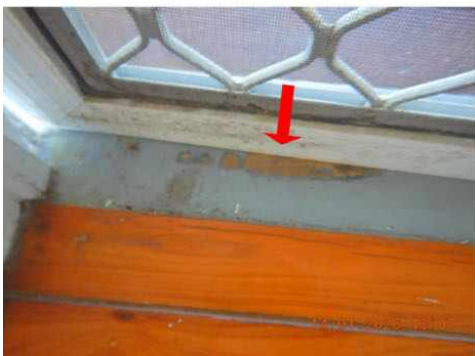
### Defects 3.21

Building: Main Building  
 Location: Family Room > Front  
 Finding: Door jamming/ binding  
 Information: The front upstairs balcony entry security door to this room was found to be jamming or binding at the bottom and will require adjustment to return this door to full operational capacity.

The twin French door security mesh was found to be in a minor corroded condition and will require repairs or replacement.

A carpenter contractor or handyman could complete the job.

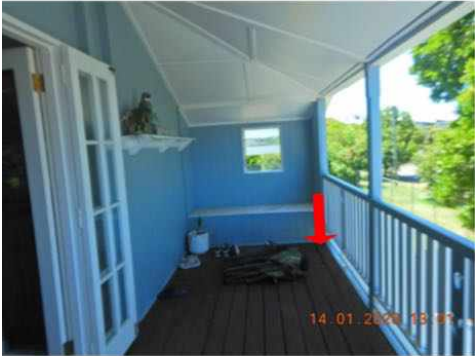
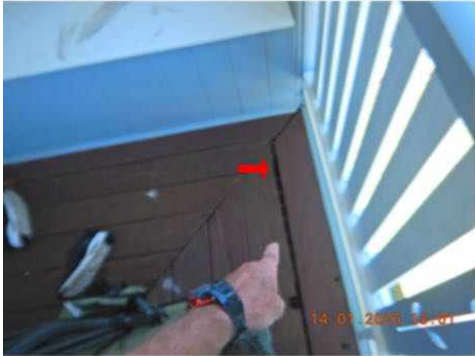
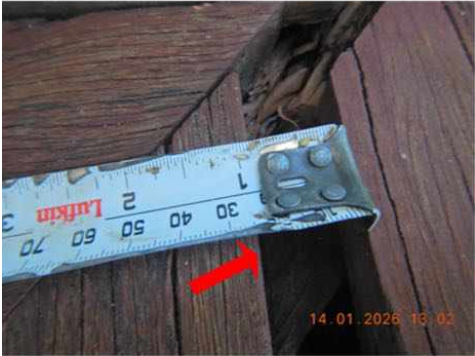
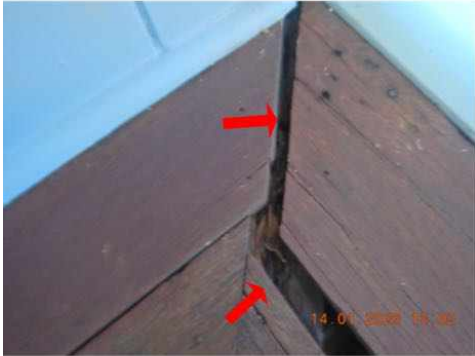
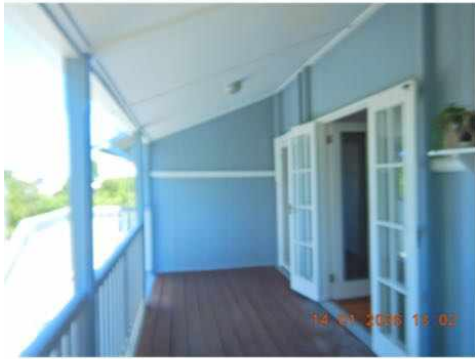
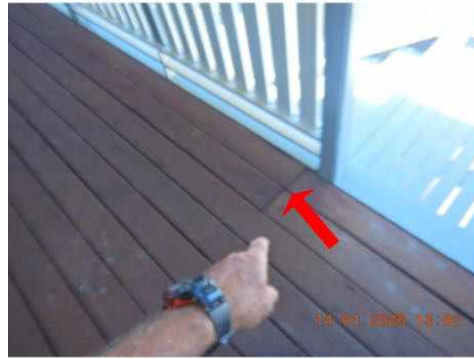
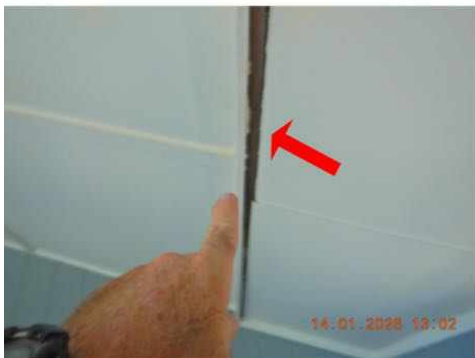
Defects 3.22

Building: Main Building  
Location: Balcony > Front Right  
Finding: Deck Gap  
Information: The front upstairs under cover deck area was found to have a significant 25 mm gap between decking boards that will require adjustment or repairs.

Areas of decking were found to be lifting, and decking nails protruding from the decking boards.

Eaves timber trims were found to be missing, and will require installation.

Repairs will be required.

A carpenter contractor or handyman could complete the job.

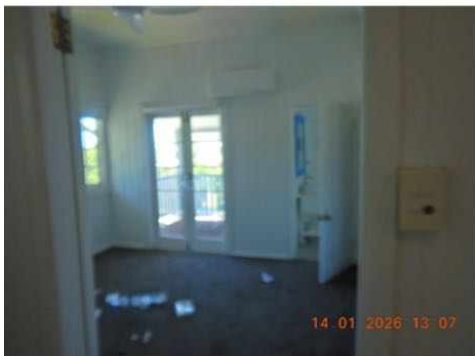
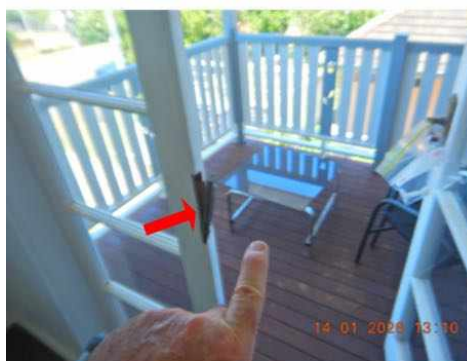
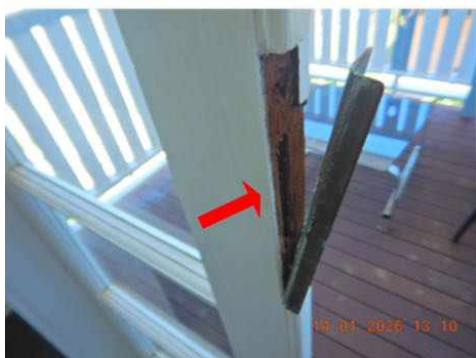
### Defects 3.23

Building: Main Building  
Location: Bedroom 4 > Rear  
Finding: Door striker plate Missing  
Information: The bedroom -4 French door jamb striker plate was found to be damaged or not secured adequately, at the time of this inspection.

This will require adjustment or repair to allow the door latch to secure the door closed as intended.

A carpenter contractor or handyman can complete this job.

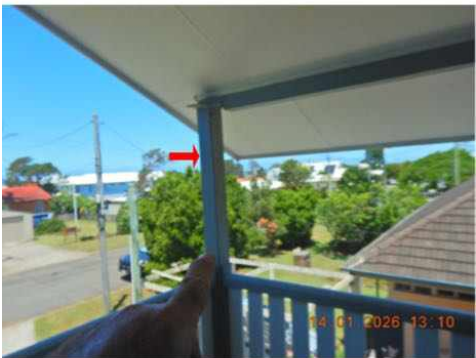
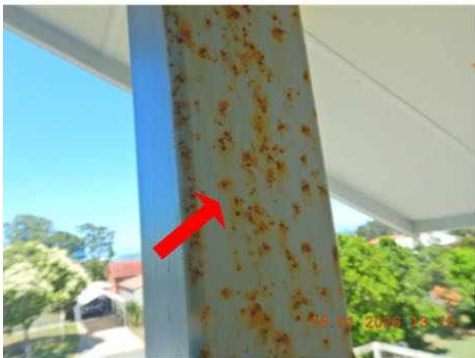
### Defects 3.24

Building:	Main Building
Location:	Bedroom -4/ Deck > Front
Finding:	Building element - Rusted or corroded
Information:	The upstairs bedroom-4 deck steel post shows evidence of minor surface rusting and corrosion, which is likely to have developed as a result of excessive exposure to moisture and or inadequate coatings.

As surface rust provides no protection to the underlying iron, the deteriorating condition is likely to worsen if not addressed in the short-term future.

Where possible, the use of galvanized (treated) metals or aluminium coated metals aid in rust prevention, as does regular general maintenance. Rust formation can be controlled with coatings, such as paint, that isolate the iron from the environment.

Rusting and corrosion should be managed by ideally removing or limiting the affected surface from exposure to moisture. A registered builder may be appointed to replace any building elements that have been severely affected by rust or water damage.

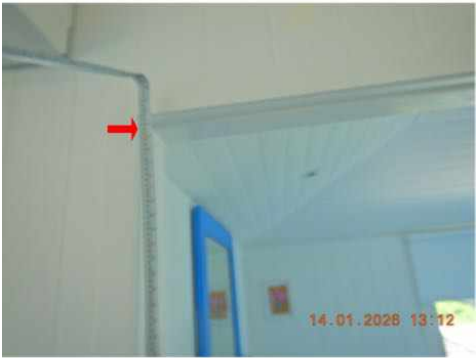
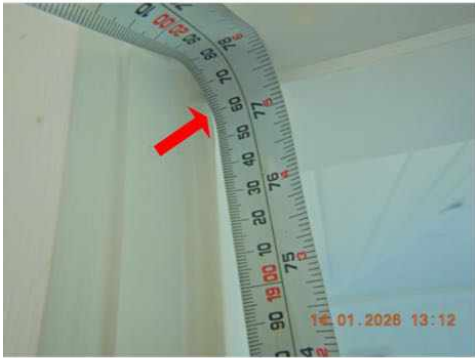
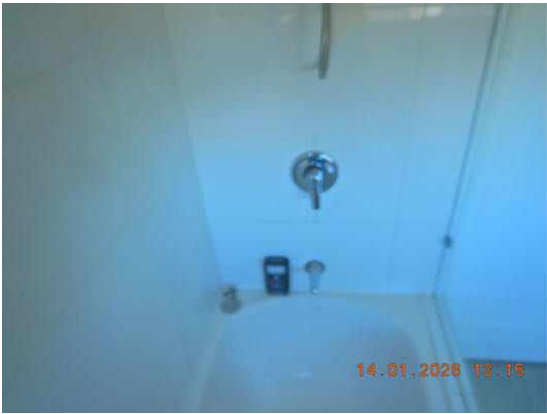
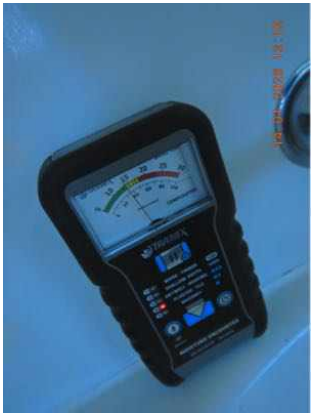
**Defects 3.25**

Building: Main Building  
Location: Bedroom 4/ Ensuite > Front  
Finding: Bathroom door head height.  
Information: The bedroom -4 ensuite door opening was found to only be 1960 mm in height from the floor to the underside of the door frame at the heights point.

Minimum legal height for an internal door opening is 2000 mm.

This opening does not comply with current Australian standards.

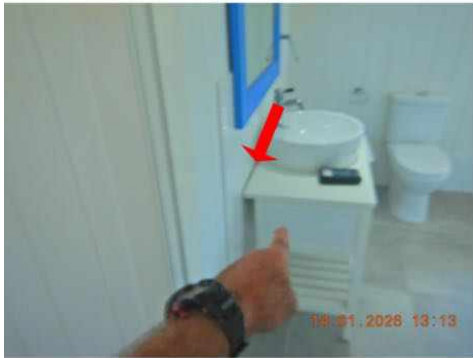
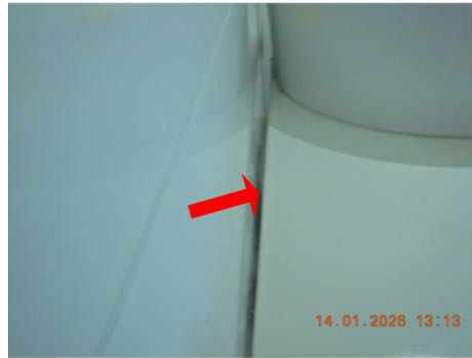
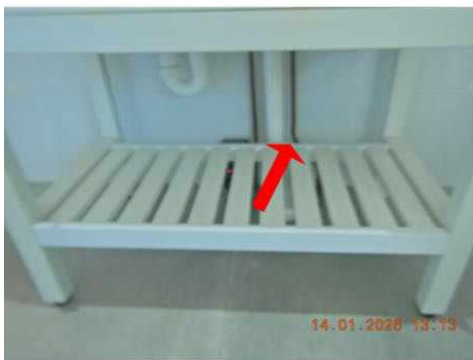
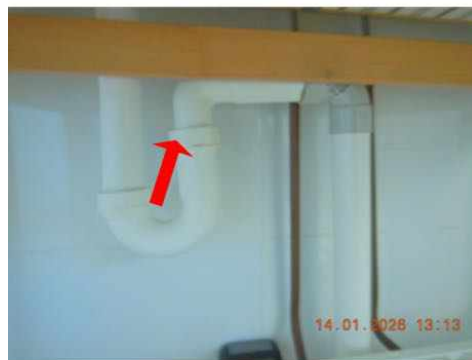
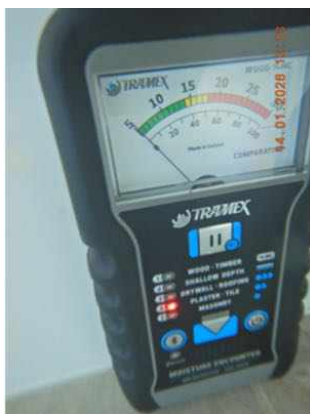
Defects 3.26

Building: Main Building  
Location: Bedroom 4/Ensuite > Front  
Finding: Vanity unit not secured.  
Information: The bedroom -4 ensuite vanity unit was found to not be secured to the wall, and easily moved . There appears to be no damage to the unit at this time ,but will require securing to the wall to reduce the risk of any future damage occurring to any of the plumbing connections . A plumbing contractor or handyman could complete the job.

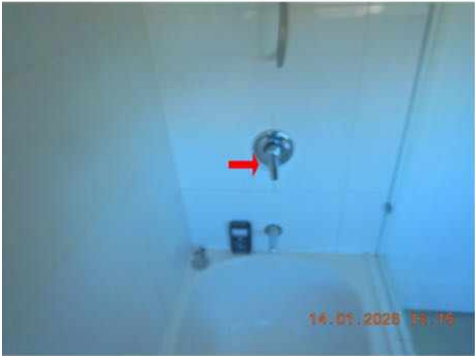
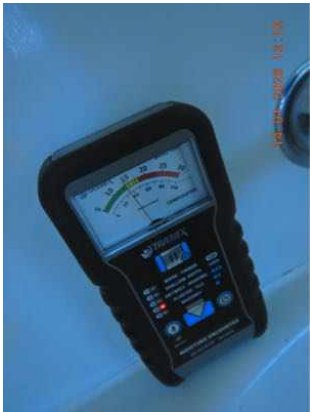
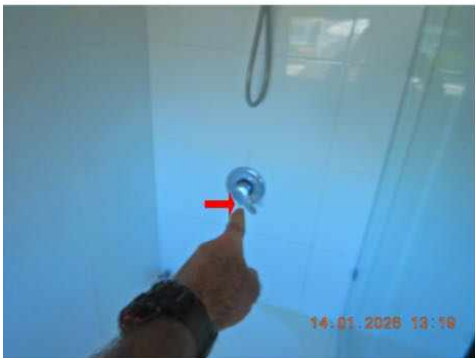
### Defects 3.27

Finding: Shower mixer/diverter  
Information: The bathroom shower/bath wall mixer diverter unit was found to be faulty, and was not allowing the shower bath wall spout to be operational at the time of this inspection .  
The mixer would not allow either outlet to be operated individually as intended for use.  
A plumbing contractor should inspect this unit for repair or replacement.

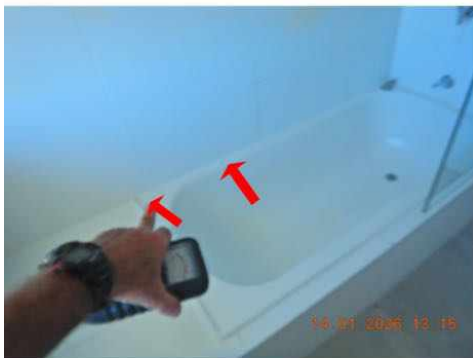
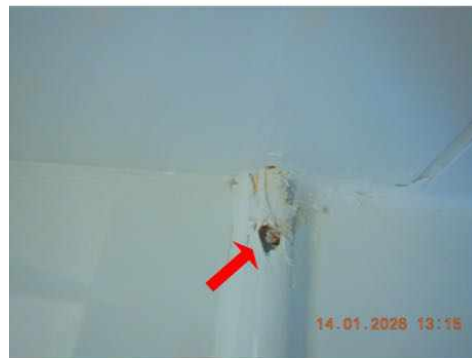
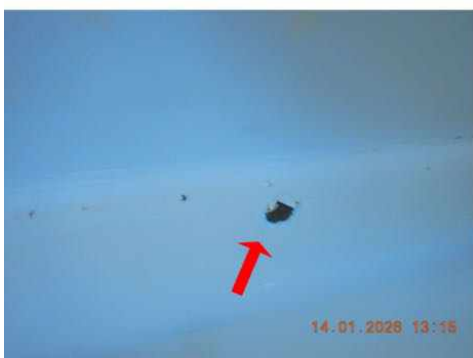
### Defects 3.28

Finding: Bath tub rusted

Information: The upstairs bedroom-4 bath tub was found to have sustained minor impact damaged and rusting to a couple of areas at the time of this inspection,

This will require repair to reduce the risk of further rusting and deterioration occurring.

A bath repair specialist should be engaged to carry out this task.

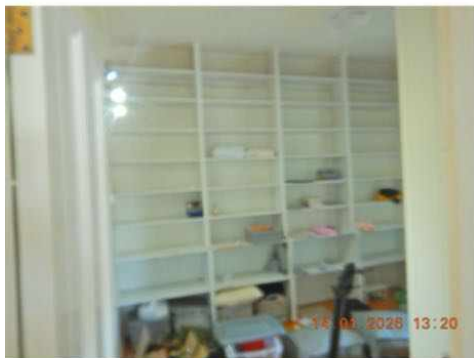
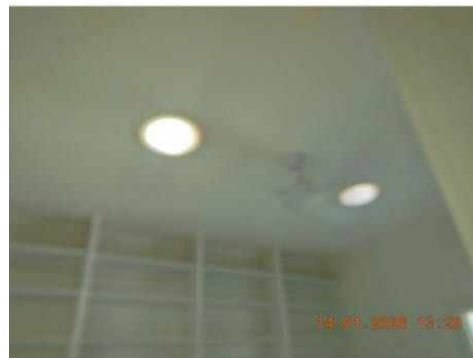
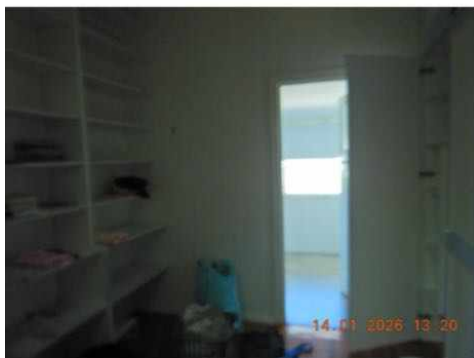
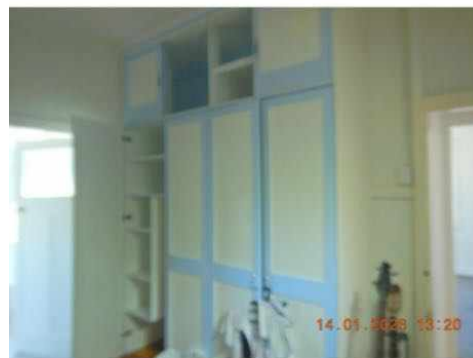
## Defects 3.29

Building: Main Building  
Location: Store Room > All Areas  
Finding: Mechanical ventilation not installed.  
Information: The upstairs internal storage room / bedroom was found to not have mechanical ventilation system installed in the ceiling and vented to the exterior of the building as required by the Australian building code standards ( As 1662.2 ) for bedrooms with no natural ventilation available.

Installation of an appropriate mechanical ventilation system will be required in this room to meet current standards requirements.

A licensed electrical contractor could complete the job.

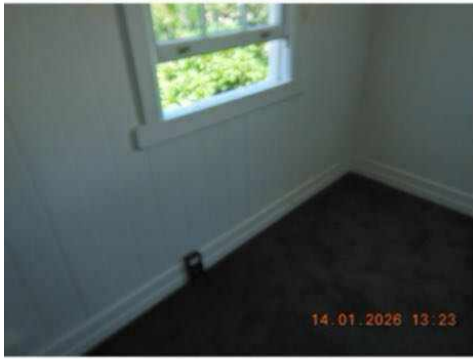
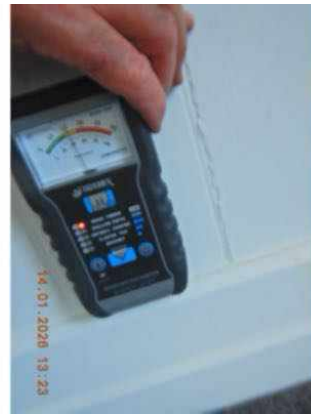
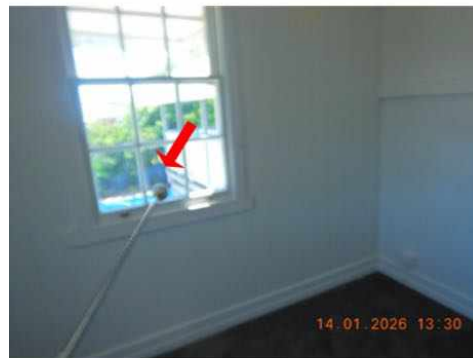
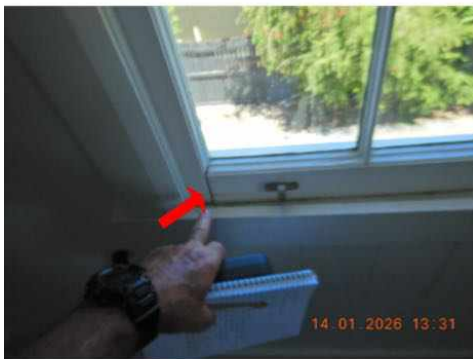
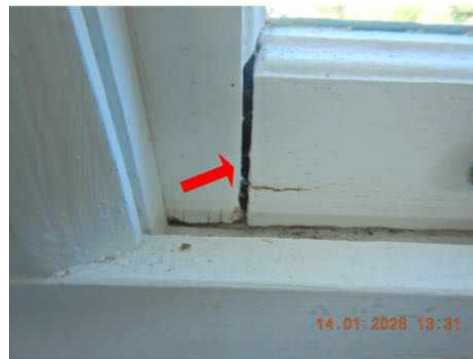
### Defects 3.30

Building:	Main Building
Location:	Bedroom 3 > Rear
Finding:	Window - Cracked
Information:	Cracks were identified in the bedroom -3 rear window and timber frame in this area. Cracking in windows is generally the result of impact damage, and is likely to develop further when left unmanaged.

The likelihood of this windowpane further cracking and shattering is increased exponentially, providing a safety hazard in the area. The cracked window also impairs the weather tightness of the building, creating potential for minor water leaks.

A qualified glazier is required to repair the window as soon as possible. Depending on the extent of the cracking, replacement of the window may be required. Please be advised that any persons coming into contact with the cracked window should do so with due caution to avoid any personal injury that may ensue.

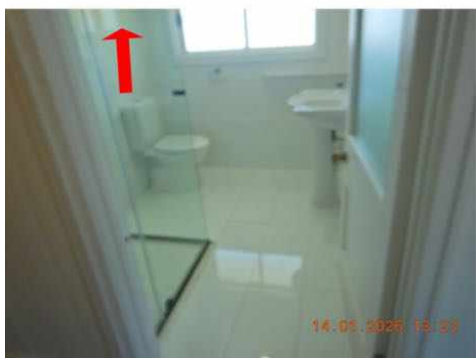
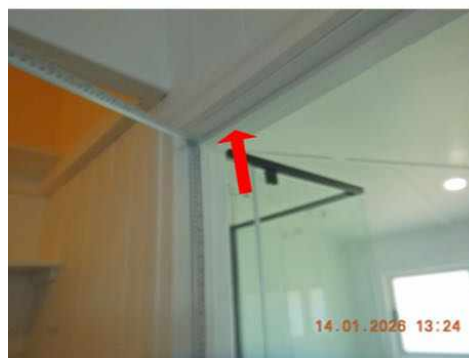
### Defects 3.31

Building:	Main Building
Location:	Bedroom 3/ Ensuite > Front
Finding:	Bathroom door head height.
Information:	<p>The bedroom - 3 ensuite door opening was found to only be 1930 mm in height from the floor to the underside of the door frame at the heights point.</p> <p>Minimum legal height for an internal door opening is 2000 mm.</p> <p>This opening does not comply with current Australian standards.</p>

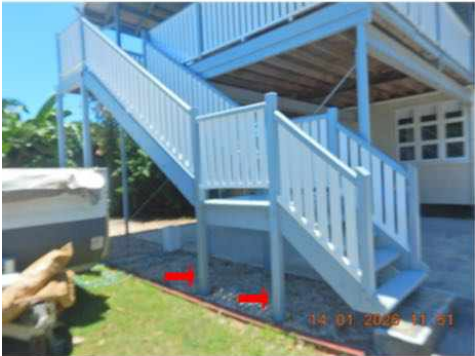
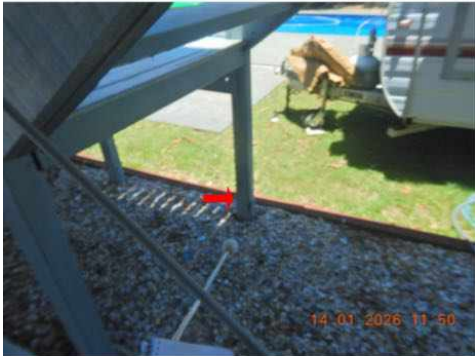
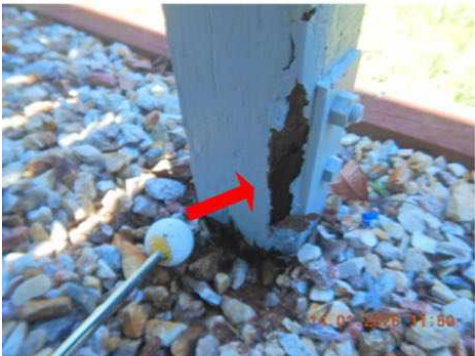
### Defects 3.32

Finding: Wood rot

Information: The rear stairs landing timber posts shows evidence of minor wood rot. Wood rot, also known as Fungal Decay, occurs when timbers and other cellulose building materials are exposed to damp conditions on an ongoing basis. This could be the result of exposure to weathering over a prolonged period of time, or the attraction of excessive moisture from other abutting building materials. Contributing factors also include poor air ventilation in the area.

Wood rot is often associated with general damp problems and is evidenced by a 'musty' smell or mould and mildew occurring on surfaces. If left unmanaged, damp conditions can lead to further health problems and the decay of timbers will continue.

Early intervention and regular maintenance, particularly of exterior timbers, will prolong the useful life of these building elements. Prior to any works being performed, the cause of the moisture that has created the visible wood rot should be identified and addressed in a suitable manner. Replacement of affected timbers may then be a necessary step in protecting surrounding building elements from such deterioration.

A qualified plumber may be appointed to assess the cause of excessive moisture and to provide advice on any remedial works as required. A qualified carpenter or

registered builder may also be required to replace affected building materials.
