# Building and Timber Pest Inspection Report

Inspection Date: Fri, 13 Feb 2026

Property Address: 16B Alfred St, Mascot NSW 2020,  
Australia

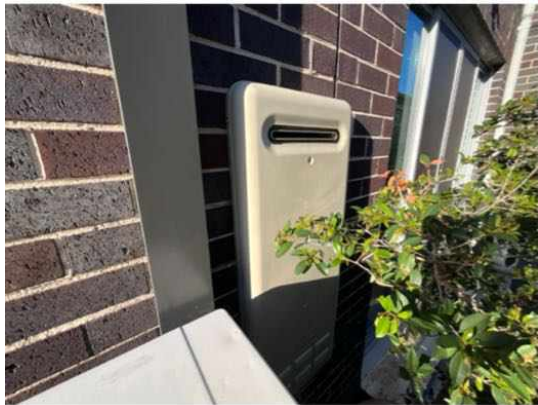
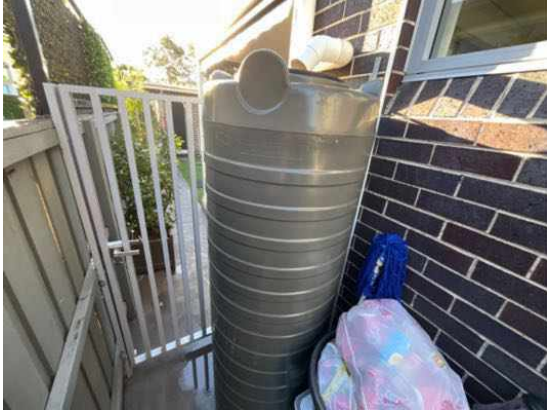
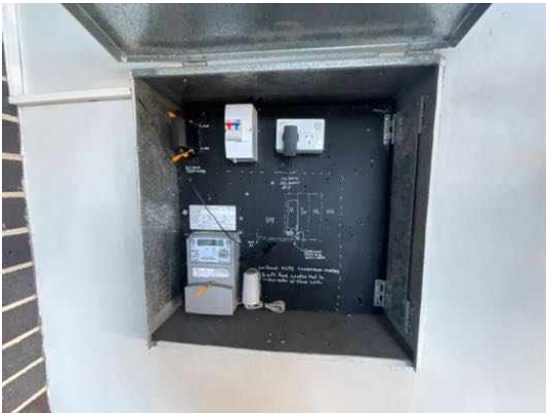
Building: Main Building  
Location: All Areas  
Finding: Photos Added  
Information: Additional photos are provided for your general reference.
