Building Inspection Report

Inspection Date: Thu, 5 Feb 2026

Property Address: 5/12-14 Purkis St, Camperdown NSW 2050,
Australia

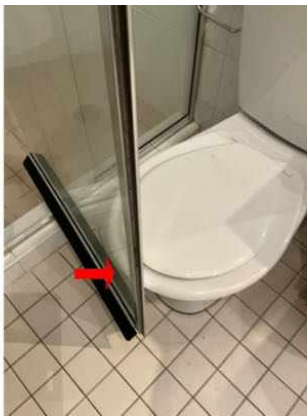
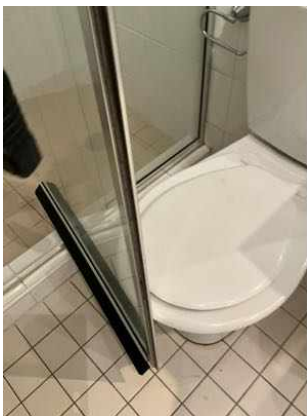
Defects 1.02

Location: Bathroom
Finding: Shower screen - Hitting toilet
Information: A safety hazard was identified in the bathroom of the property. The issue pertains to the shower screen, which, when fully opened, makes contact with the adjacent toilet. This situation poses an immediate risk to the safety and well-being of occupants due to the potential for accidents and injuries.

Collision between the shower screen and the toilet can cause injury to individuals using the bathroom, particularly if the shower screen shatters upon impact. The repeated contact between the shower screen and the toilet can also result in damage to both fixtures, leading to costly repairs or replacements.

This is to be addressed prior to handover.

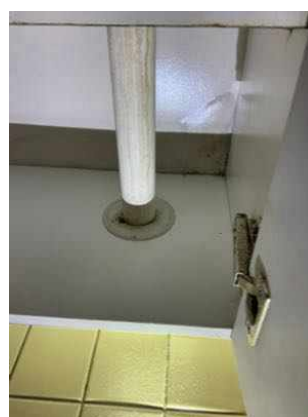
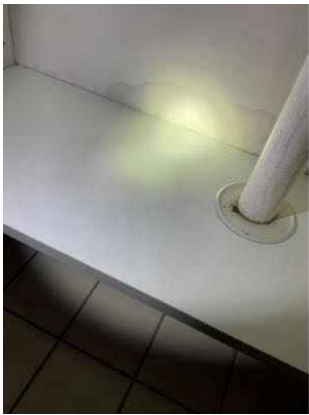
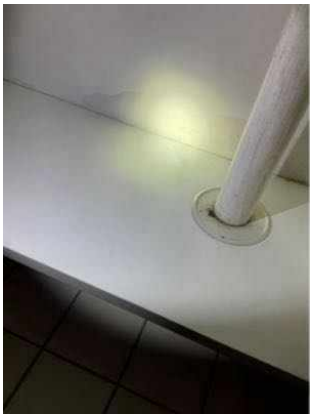
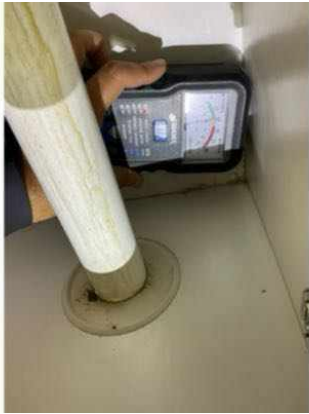
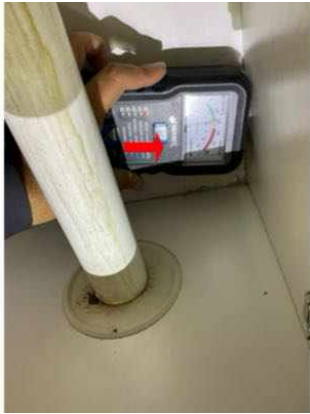
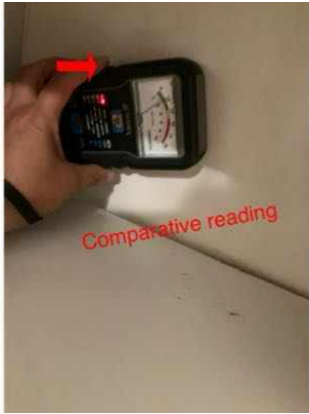
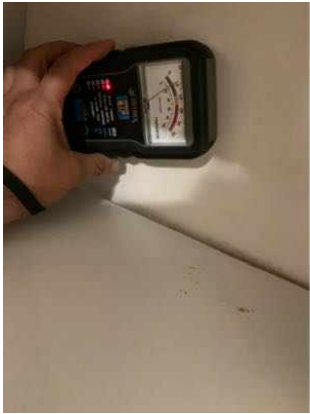
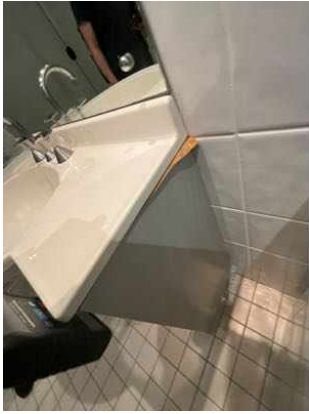
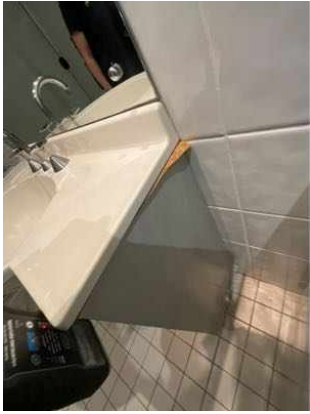
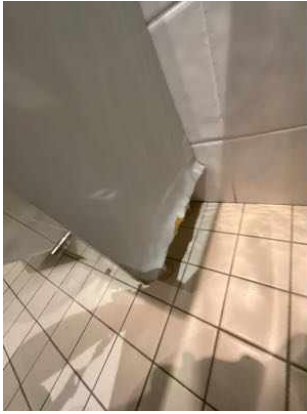
Defects 2.02

Building:	Main Building
Location:	Bathroom
Finding:	Water damage
Information:	The area has sustained water damage resulting in potential structural issues. This damage compromises both the aesthetic and functional aspects.

1 **Plumber:** If the water damage is due to plumbing issues, a plumber can fix leaks and ensure there are no further water-related problems.

2 **General Contractor:** If the damage is extensive and affects the surrounding area, a general contractor can coordinate the repair work, including any related structural or cosmetic repairs.

Make sure to obtain quotes from these professionals to determine the most cost-effective and efficient solution for your specific situation.

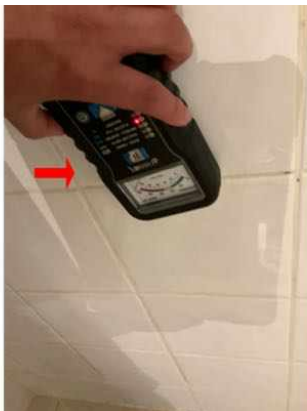
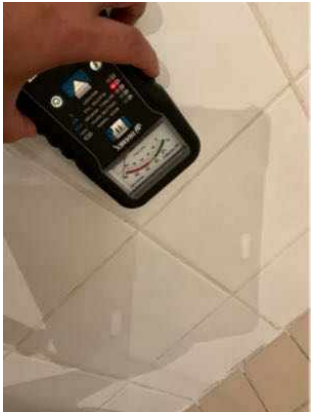
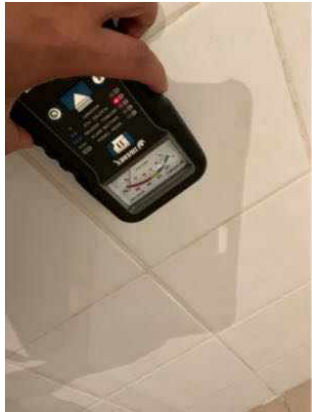
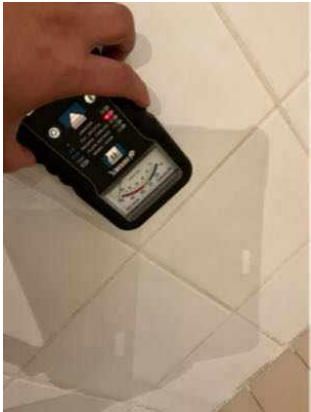
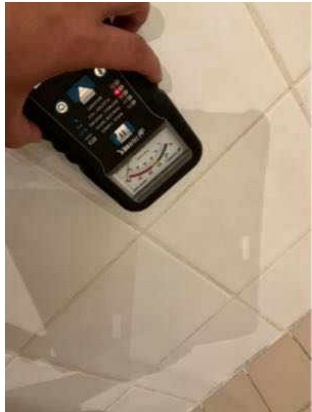
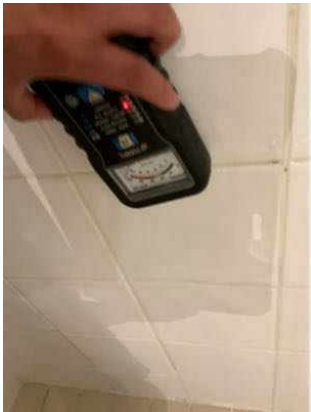
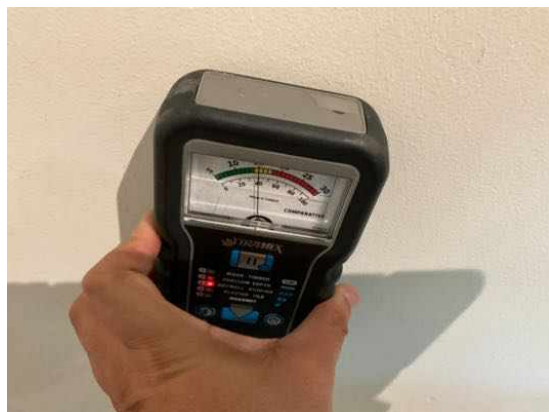
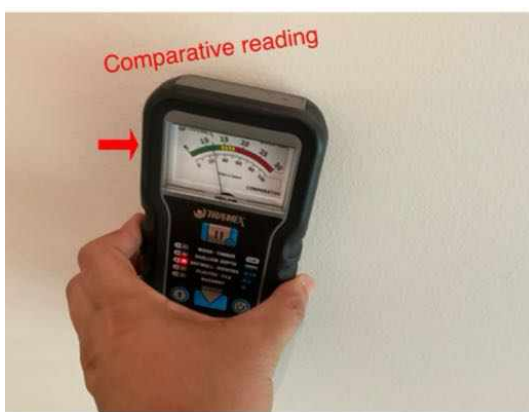
Defects 2.03

Building:	Main Building
Location:	Bathroom
Finding:	Evidence of excessive moisture was present at the time of inspection
Information:	Excessive moisture is present behind the bathroom tiles, indicating a potential water leakage issue within the wall.

The prolonged presence of moisture can lead to mold growth, deteriorate the structure, and create an environment conducive to health hazards. Additionally, it may compromise the adhesive holding the tiles, leading to their detachment.

A licensed plumber or a qualified contractor specializing in water damage remediation should investigate the source of the moisture, fix any leaks, and address the damage. Additionally, replacing affected tiles and ensuring proper waterproofing are crucial to preventing future issues.

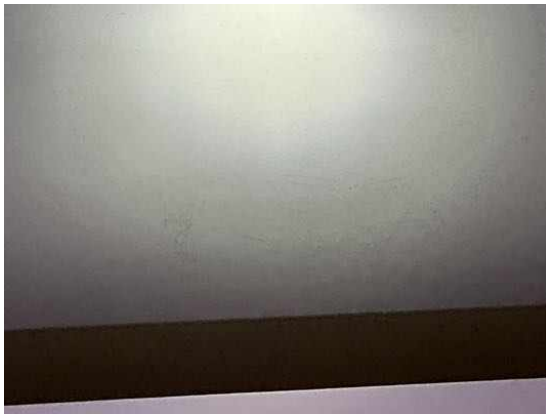
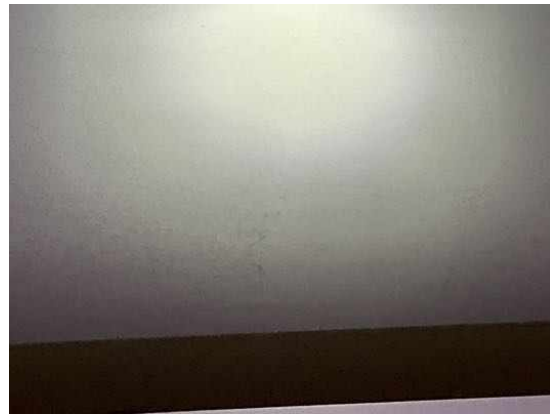
Defects 3.01

1. Aesthetic Degradation: Scratches mar the appearance of the painted surface, diminishing its visual appeal and potentially lowering property value.
2. Corrosion Vulnerability: Exposed areas of bare metal due to scratched paint are susceptible to corrosion, leading to structural damage and compromised durability.
3. Environmental Hazards: Scratched paint can release hazardous chemicals into the environment, posing risks to both human health and the ecosystem.

A qualified painter should address the issue promptly to repair the scratched paint. Depending on the severity of the scratches, repair options may include sanding, priming, and repainting the affected area to restore the integrity and appearance of the paint surface.

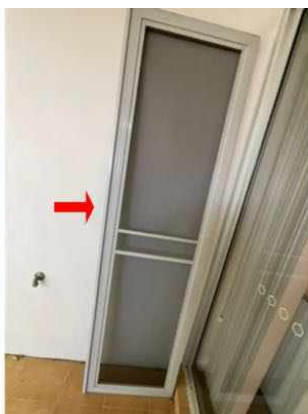
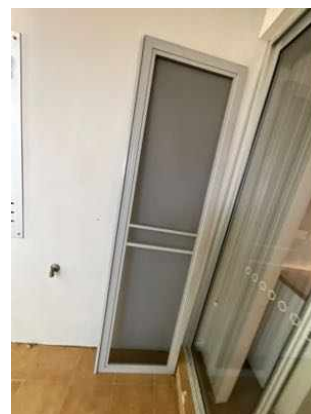
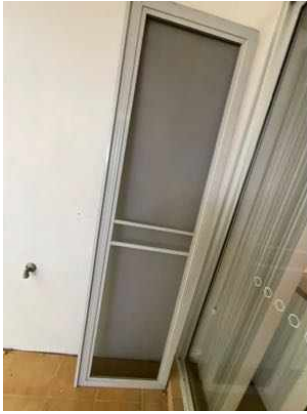
Defects 3.02

Finding: Damaged insect grill

Information: The insect grill is damaged , compromising its ability to prevent insects from entering the designated area.

Increased likelihood of insect infiltration, potentially leading to hygiene issues and discomfort for occupants.

A qualified maintenance technician or facilities management team should address the broken insect grill promptly to restore its functionality and prevent the associated risks.

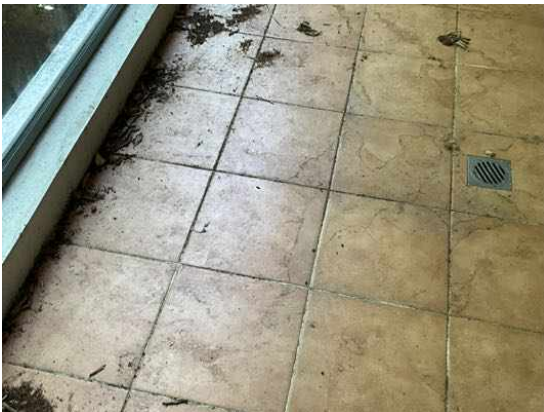
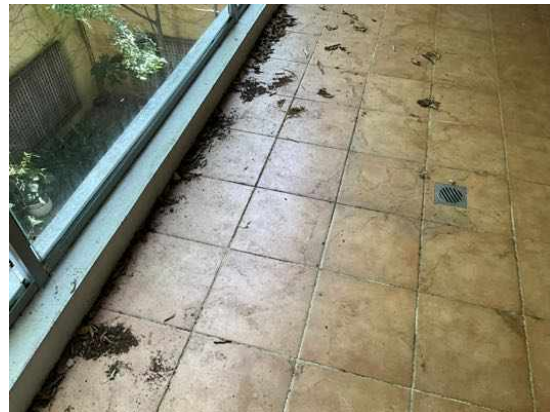
Defects 3.04

Finding: Water staining

Information: Water staining was evident in this area at the time of inspection. Water staining indicates that surfaces have been exposed to excessive moisture over time. The minerals and other elements in the water lead to staining, which may graduate to corrosion and deterioration if left unmanaged.

While mostly an appearance defect, water staining can be indicative of more serious defects, which may be currently concealed by other building elements.

Where water staining is active, a licensed plumber must be consulted to identify the cause of the staining and to provide advice on any reparation works that may be required. Replacement of any broken or damaged structures is advised.

Conversely, where water staining is old and inactive, affected building materials may be repaired or replaced at client discretion. A qualified carpenter or registered builder may be appointed to perform these works.

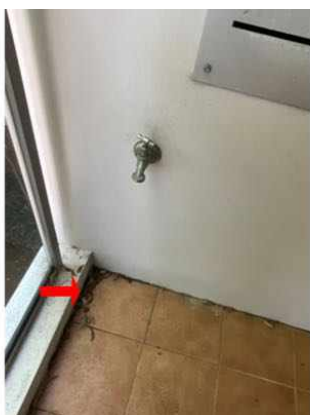
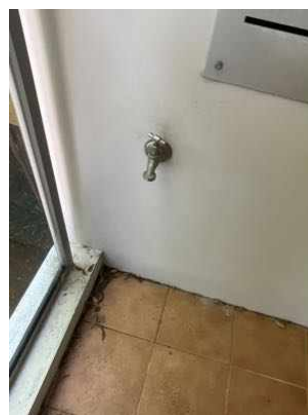
Defects 3.05

Building: Main Building
 Location: Balcony
 Finding: No Drain under tap
 Information: There is no drain installed under the tap, leading to water accumulation and creating conducive conditions for timber pests. This defect needs immediate attention to prevent potential damage and pest infestation.

2. Timber Pest Infestation: The damp environment created by standing water is highly conducive to timber pests, such as termites and wood borers, which thrive in moist conditions and can cause significant damage to wooden structures.

3. Structural Damage: Prolonged exposure to moisture can lead to wood rot and deterioration of structural timber, compromising the integrity of the building.

A licensed plumber or a qualified building contractor can address this defect by:

3. Repair and Prevention: Inspecting and repairing any existing water damage and implementing measures to prevent future water accumulation and pest infestations.

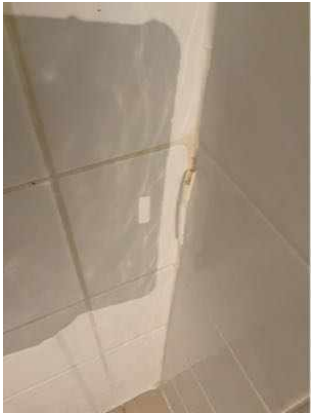
Defects 3.09

Building:	Main Building
Location:	Bathroom
Finding:	Sealant and grouting - Missing or damaged
Information:	It was noted on inspection that sealant or grout is degraded to the tiled shower alcove and or other areas of the bathroom.

Different materials and floor areas move at different rates, generally causing cracking to grout or sealant at this point. A flexible sealant is required to allow for expected expansion and contraction, while keeping the joint water tight and protective of all associated building materials.

There appears to be excessive mould to the sealant and grout which will likely require scraping out and replacement.

Flexible and mould resistant materials should be applied to affected areas to prevent any subsequent water damage that is likely to occur. Regular maintenance and replacement of damage or missing or damaged sealant and grout is highly recommended to the wet areas, as this is a regular wear and tear defect. Sealant and grouting in areas that come into regular contact with water should be maintained for the long term care of your property.

A sealant specialist or tiling contractor should be appointed to complete these works as soon as possible

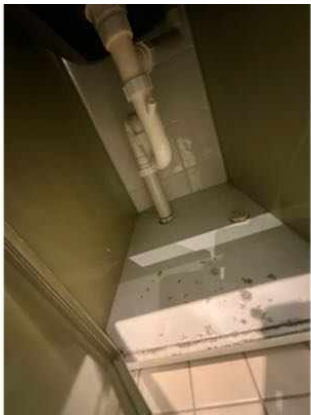
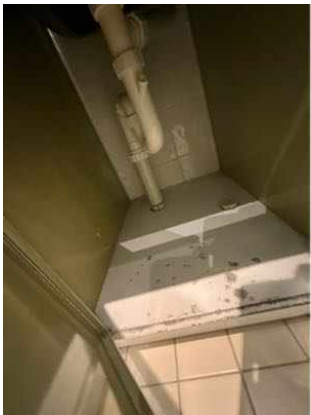
Building: Main Building
Location: All Areas
Finding: Additional Photos - Obstructions and Limitations
Information: These photographs are an indication of the obstructions and limitations which impeded full inspection of the property at the time of inspection. These obstructions can hide an array of defects and should be removed to allow full inspection to be carried out. A re-inspection is recommended once the areas are made accessible.
