# Building and Timber Pest Inspection Report

Inspection Date: Fri, 20 Feb 2026

Property Address: 2/46 Sadie St, Glenroy VIC 3046, Australia

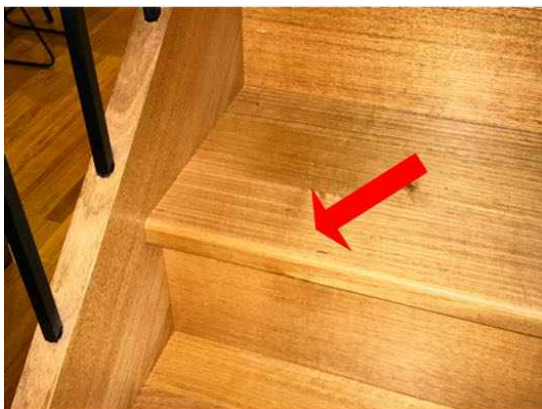
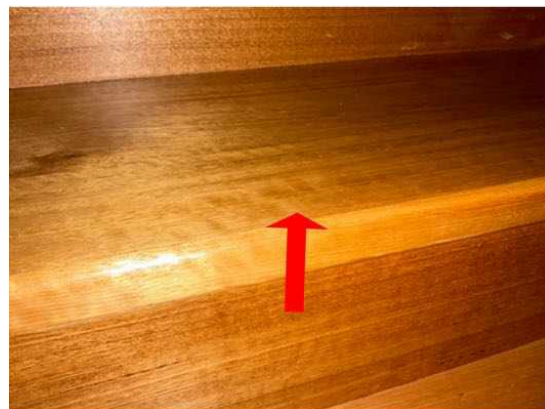
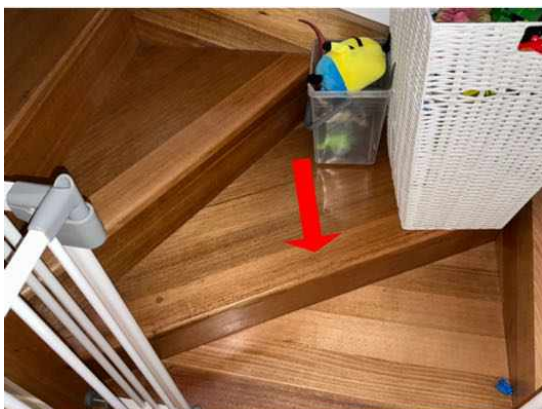
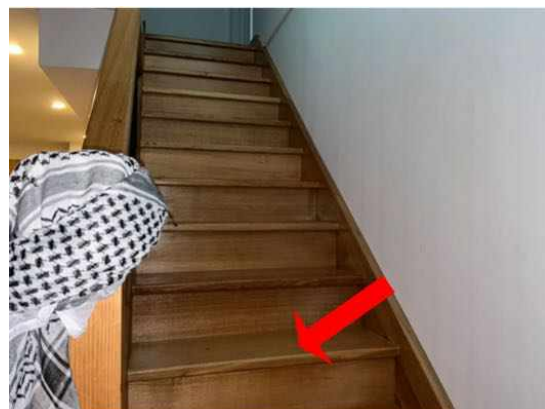
Building: Main Building  
Location: Stairs - Internal  
Finding: Stairs slippery finish  
Information: It was observed that the polished timber stairs were finished in a coating that has no slip index rating and appears to be quite smooth

Polished timber stairs should be finished in an appropriate non-nonslip coating with a rough surface finish. Alternatively the stairs should be fitted with nonslip nosing to the treads or a non-slip tape to the stair treads

A general handyman or specialist flooring/painting contractor should review as soon as possible.

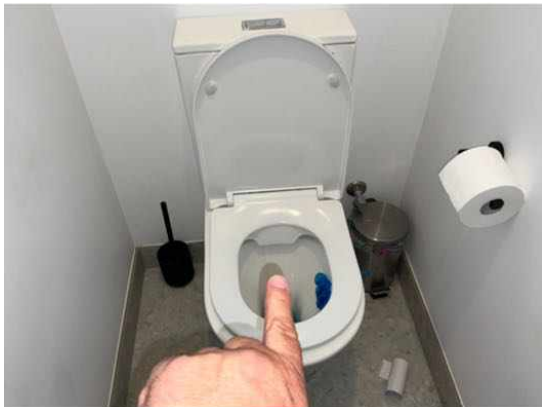
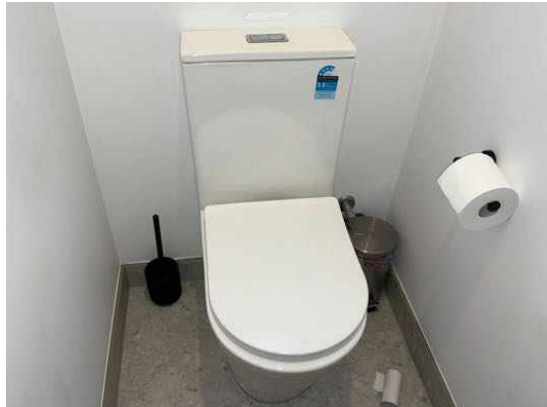
Finding: Toilet seat loose

Information: It was observed that the toilet seats throughout the building are loose and unstable.

Loose seats can cause fall injury to persons while in use and lead to serious injury

A licensed sanitary plumber should be engaged to review prior to use

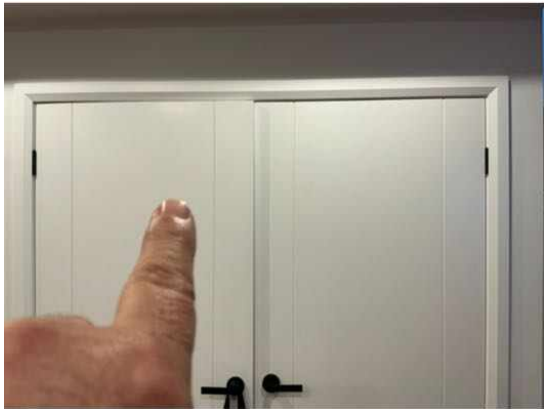
Building: Main Building  
 Location: Laundry  
 Finding: Door - Binding/jamming  
 Information: Binding and/or jamming of this laundry door is evident during standard operation. This defect inhibits the functionality of the affected door as well as creating potential for secondary defects to associated building elements, such as damage to the floor covering.

A door that binds to flooring or to the associated door frame may have several causes, ranging from minor defects, such as poor installation of the door or deteriorated hinges, through to major structural issues, such as damage to subfloor structures.

Where door binding/jamming appears to indicate major structural issues, a registered builder specialising in re-stumping should be appointed to provide an estimate on the cost of rectification.

For minor causes, a qualified carpenter or general handyperson should be appointed to perform minor rectification works at client discretion.

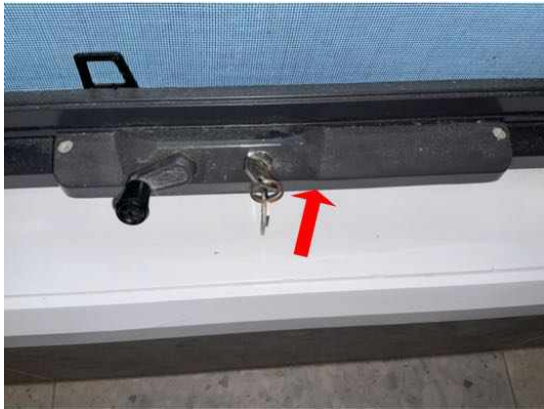
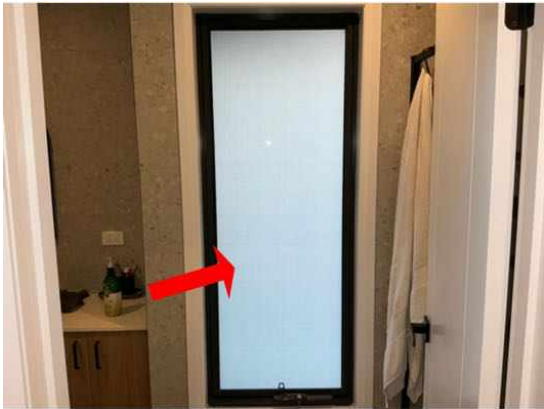
**Finding 3.02**

Building: Main Building  
 Location: All Areas  
 Finding: Locked windows  
 Information: It was noted at the time of the inspection that the operation of several windows was unable to be tested as they were locked or had damaged winders/locks

The windows should be re-inspected once they have been unlocked.

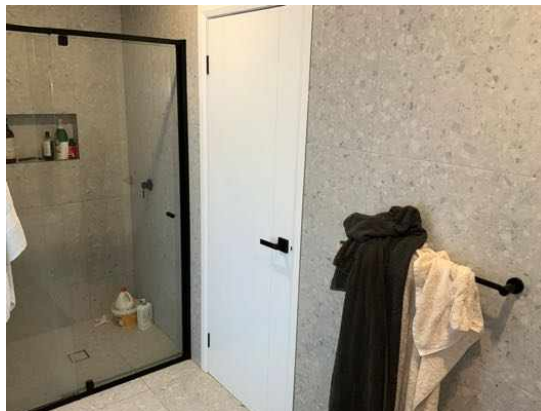
Building: Main Building  
 Location: Ensuite  
 Finding: Door binding  
 Information: It was noted at the time of the inspection that the door to bathroom ( master) was binding on the floor. The closing operation appears to have resistance when closing as the door is in operation.

A qualified carpenter should be engaged to review as the owners discretion.

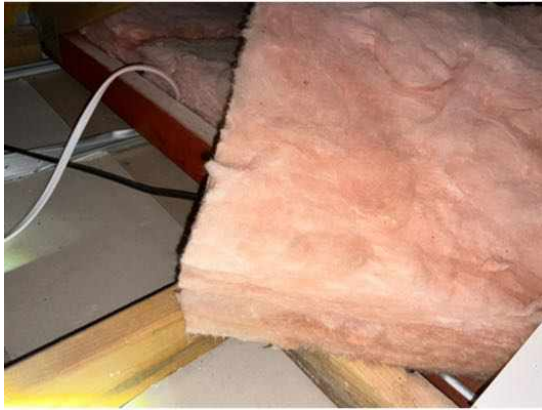
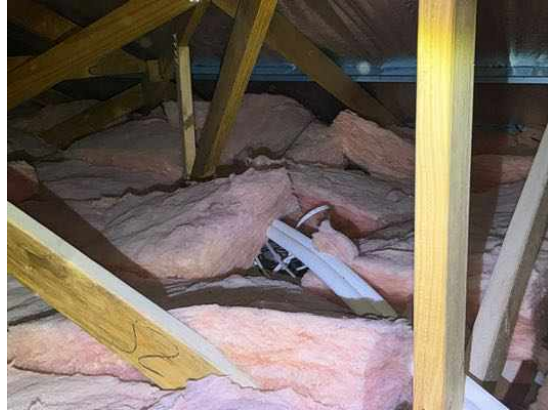
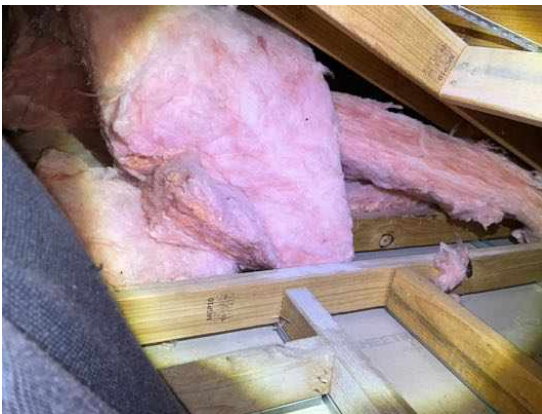
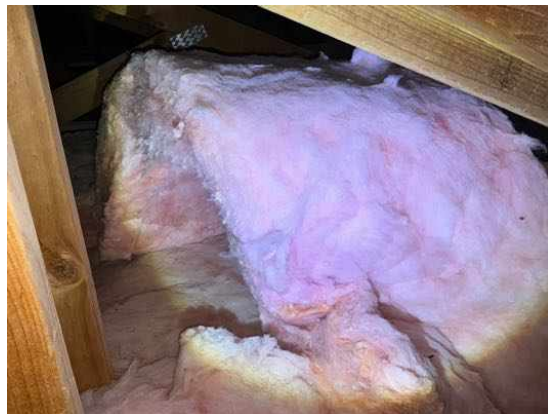
Building: Main Building  
 Location: Roof Void  
 Finding: Insulation - Missing-disturbed  
 Information: Upon inspection of the roof void it was noted that insulation is not present or disturbed.

Where insulation is absent, the area does not meet current Australian Standards. Installation of adequate insulation is required and should be conducted as soon as possible.

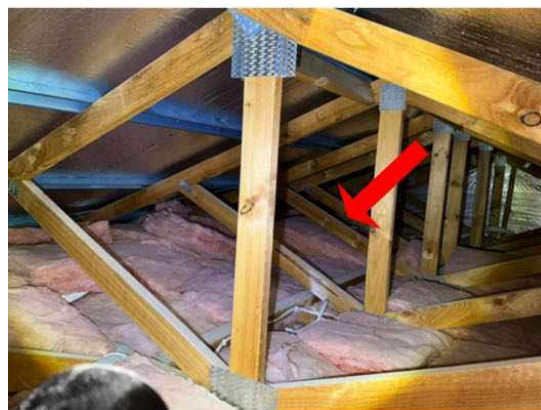
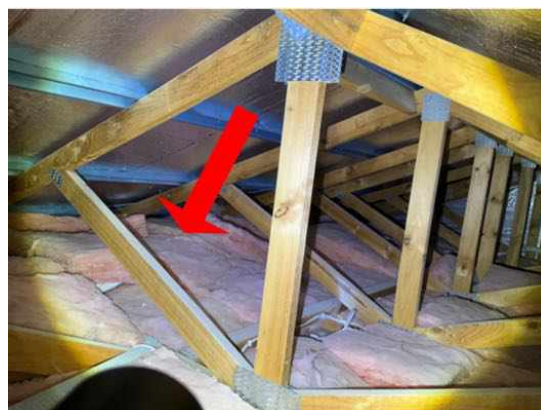
### Finding 3.08

| Information: | Exhaust fans should from the fan to the outside atmosphere. This is to prevent condensation, unwanted smells and the build up of moisture in the roof void. Roof insulation was also covering the fans. |

A licensed plumber or licensed electrician should review immediately

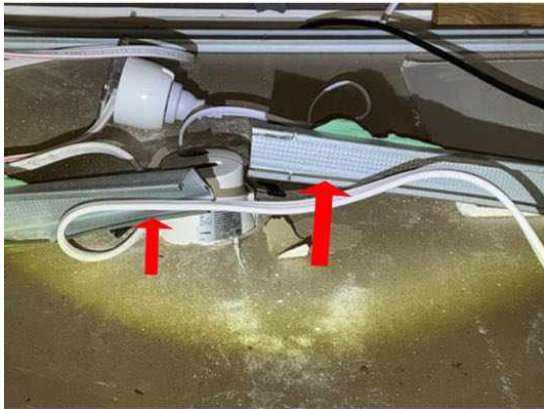
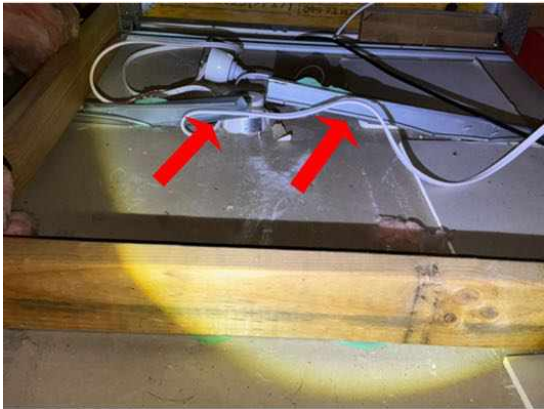
### Finding 3.09

Information: It was observed at the time of the inspection that a metal ceiling plaster batten had been cut to accommodate the installation of a downlight. The batten had not been repaired. This appears to have been damaged during construction.

It is noted that the batten at present has no support and this could lead to cracking and instability of the plaster to ceiling below.

A plaster contractor or general handyman should be engaged to review at their owners discretion

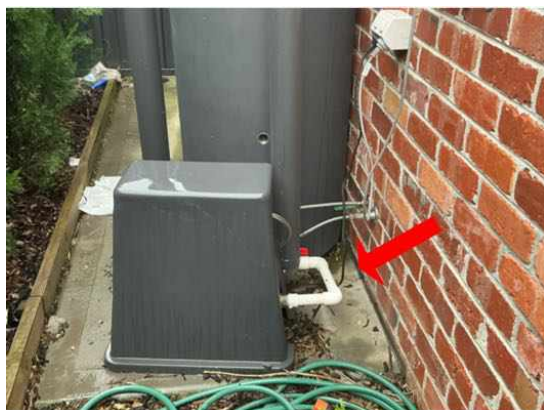
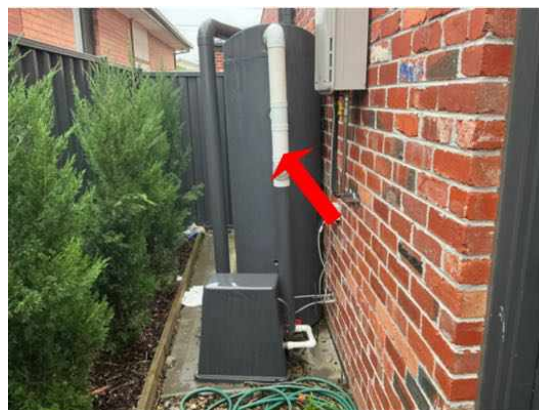
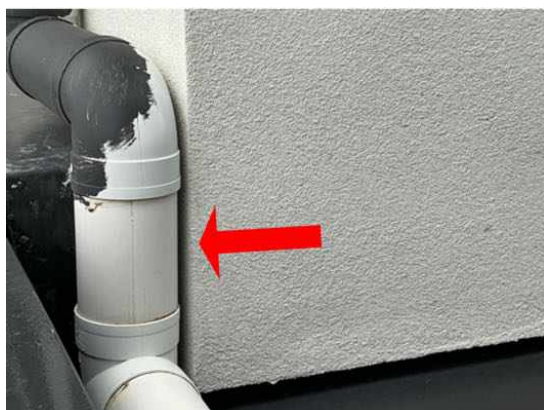
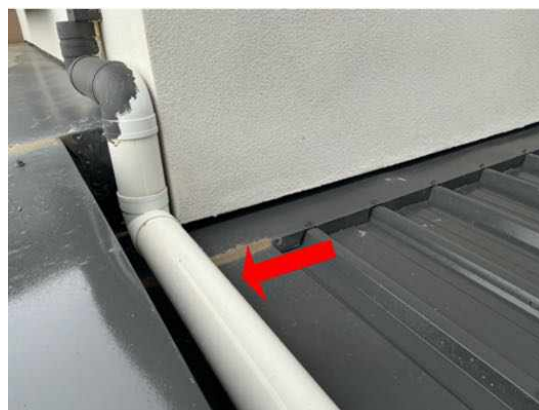
**Finding 3.10**

Building: Main Building  
Location: All External Areas  
Finding: Downpipes PVC not painted NH  
Information: It was observed that some PVC pipes were not UV protected with suitable paint.

UV damage will cause the downpipes to become brittle and prematurely deteriorate the PVC.

The downpipes should be painted with a suitable paint to protect against UV damage to protect against UV damage.

A general handyman should be engaged to review at the owners discretion.

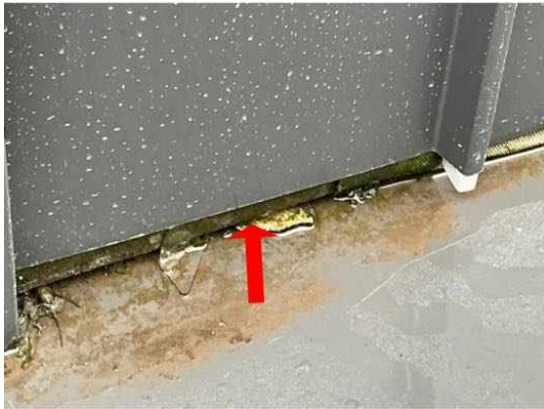
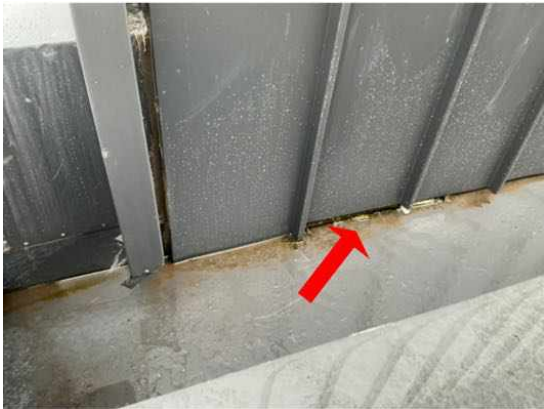
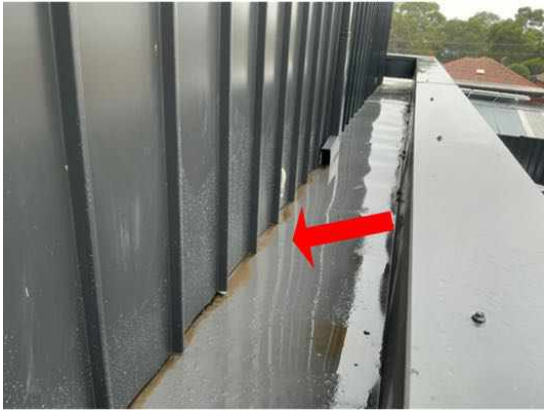
### Finding 3.11

| Finding: | Building not sealed against moisture ingress |
| Information: | It was observed that the metal cladding to the first floor was cut short of the horizontal roof decking and was demonstrating gaps and poor workmanship. Water and moisture can wick up underneath the cladding and allow a moisture ingress into the building. The substrate underneath was also visible. Unattended to, premature deterioration of other building elements could occur, which could cause mould growth and provide an environment for termite infestation and fungal attack of timbers. |

A licensed roof plumber should be engaged to review as soon as possible

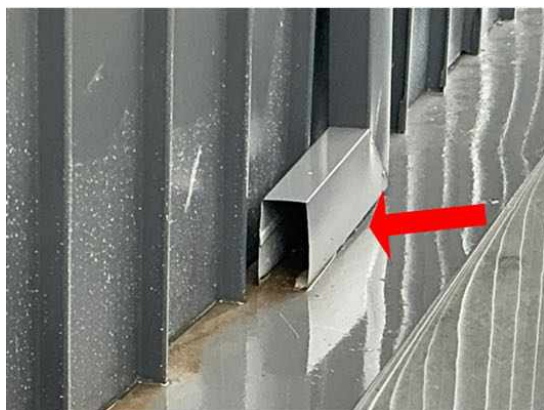
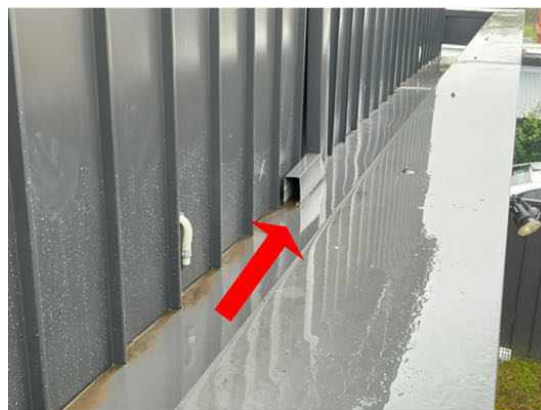
**Finding 3.12**

Building: Main Building  
Location: Exterior walls - left side  
Finding: Rainwater spreader  
Information: It was noted at the time of the inspection that the rainwater spreader was sitting on top of the metal roof flashing below. This could cause premature deterioration and corrode both the flashing and the roof spreader. This demonstrates poor workmanship.

A licensed roof plumber should be engaged to review as soon as possible

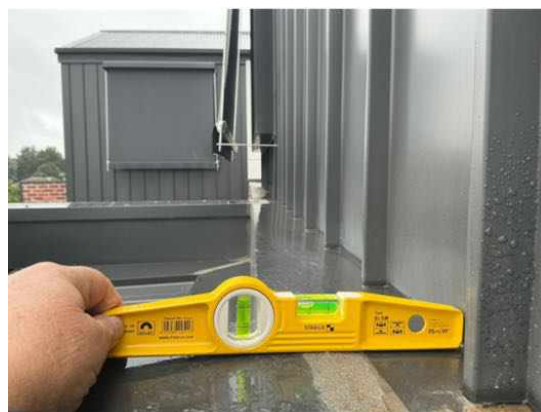
### Finding 3.13

| Information: | It was observed that the roof flashing was installed falling towards the building. |

Flashings falling in the wrong direction can cause water penetration into the building and pooling of water along the flashing reducing the durability of the flashing. This defect would be considered non-compliant to the current building regulations and standards.

Flashings and cappings are defective if a minimum fall of three degrees is not provided across the width of the flashing to divert water run off away from the building.

A licensed roof plumber should rework at the owners discretion.

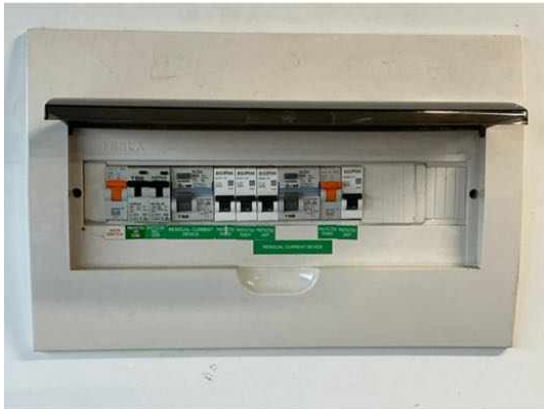
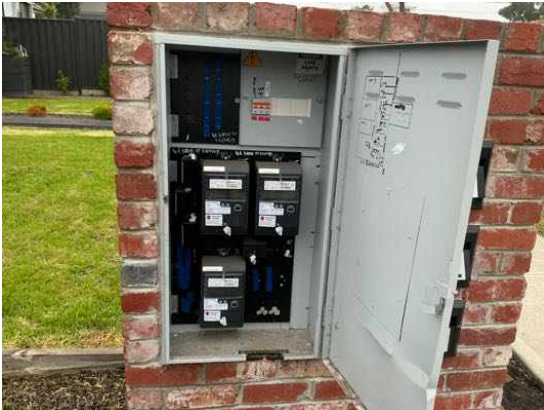
Building: Main Building  
 Location: Meter Box  
 Finding: Termite Management System - no evidence of a chemical installation  
 Information: The application of a post-construction chemical termite barrier is highly recommended for all properties, particularly if live termite activity has been found on the site previously. Such barriers are highly effective in preventing termite attack on any timber building elements throughout the property.

A durable notice should be placed in the switchboard unit to indicate current termite barriers. At the time of inspection, it appeared as though no termite management system has been installed, with no evidence to suggest preventative works taking place.

The client may consider gaining further advice from a pest controller as to the costs and procedures involved with this application. It is recommended that obtaining such advice be a short-term priority.

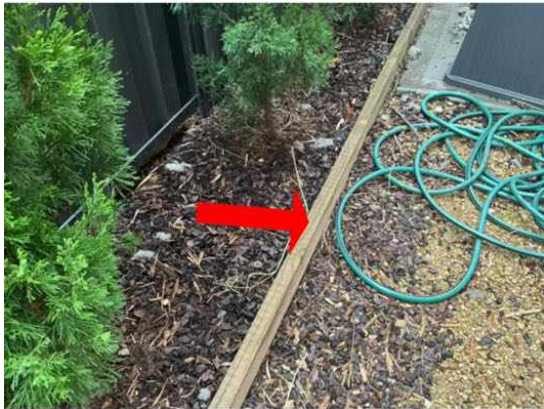
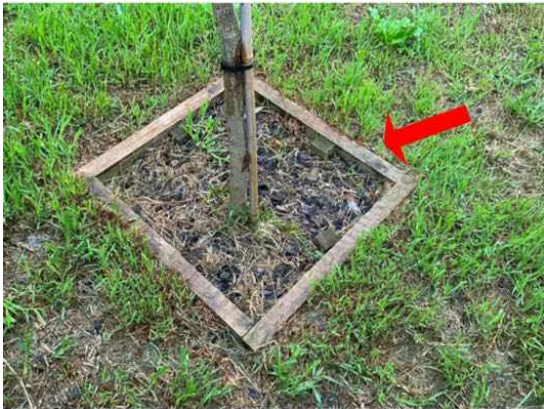
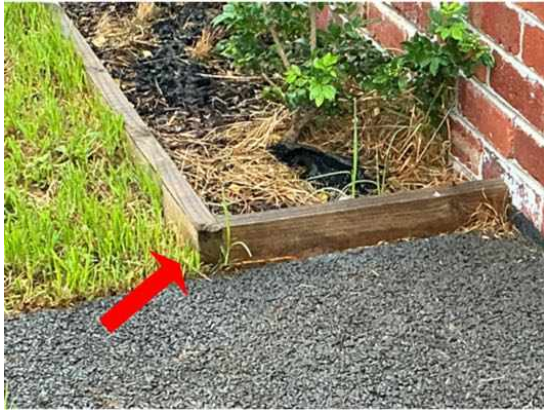
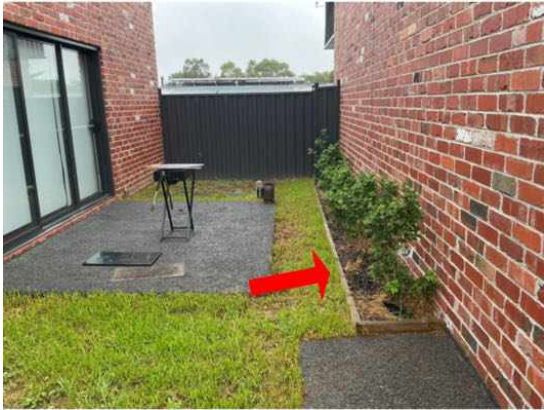
| Finding: | Untreated or non-durable timbers in a hazardous environment |
| Information: | To reduce the risk of timber pest attack it is essential that timber used in a hazardous environment (e.g. in direct contact with the ground or frequently exposed to damp conditions) is of sufficient durability and/or is adequately preservative treated. |

Untreated timbers in direct contact with the ground are likely to develop severe wood rot and/or fungal decay if left unattended creating attraction for subterranean termites to infest the timbers from surrounding areas.

If untreated or non-durable timbers are found to be in a hazardous environment it is highly advised that replacement of these building elements be performed as soon as possible to aid the protection of the property against termite / timber pest attack.

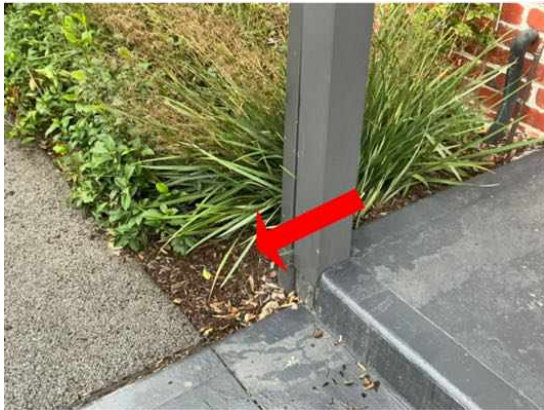
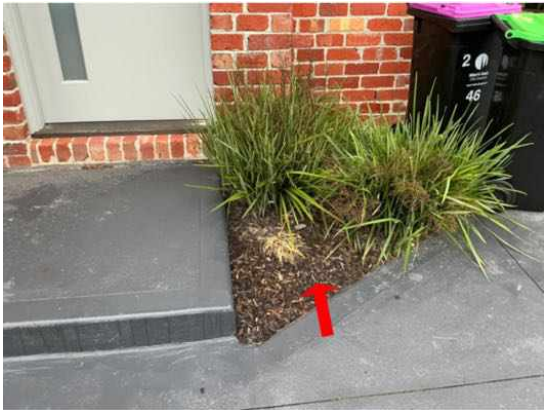
**Finding 6.04**

Building: Main Building  
 Location: All External Areas  
 Finding: Garden Beds - Conditions Conducive to Termites  
 Information: Garden beds were found to be evident in the garden area. These garden beds can include untreated timber, and with a combination of moisture from watering hosing can make conditions conducive to termite activity and termite ingress.

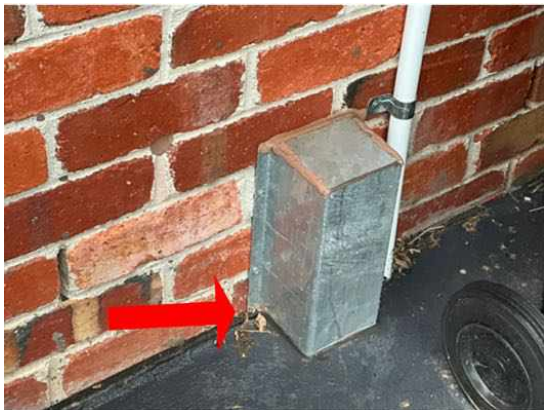
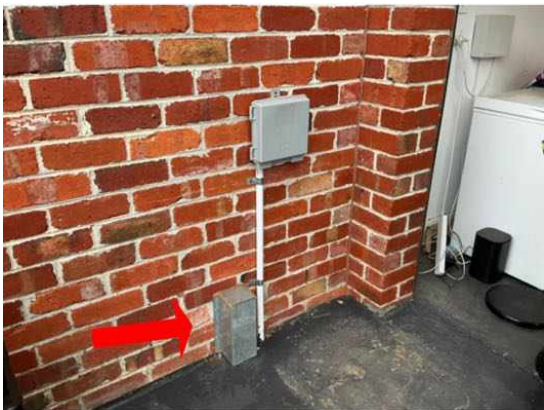
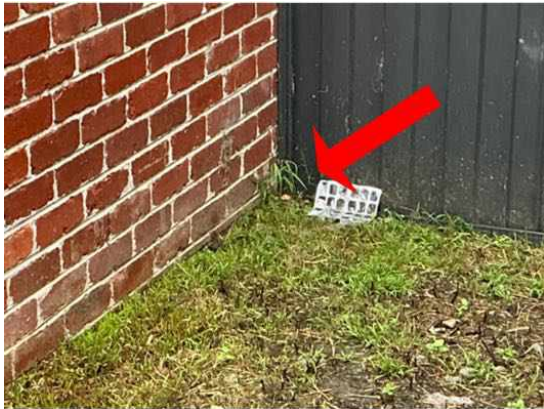
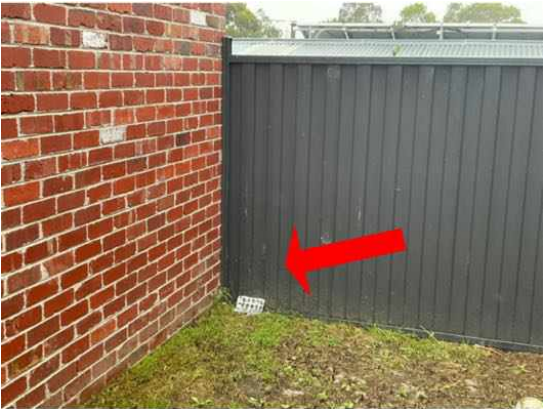
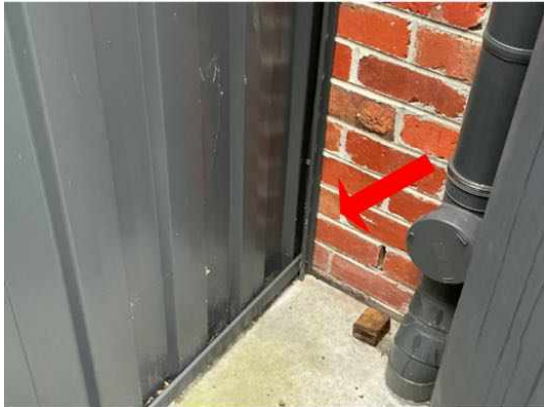
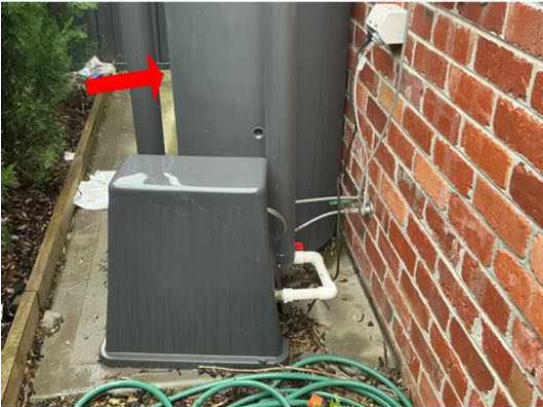
**Finding 6.05**

Building: Main Building  
Location: All External Areas  
Finding: Bridging of termite barrier  
Information: Bridging of termite barriers occurs when termites bridge (usually by building a mud tunnel) a termite barrier or inspection zone or where termites have a passage allowing them to bridge the barrier.

Generally this takes the form of finished ground levels external paving or concrete being retrospectively installed above the damp course level the adjacent internal floor level or weep and ventilation holes.

Where bridging has occurred full inspection is prevented and termites may enter a property in a concealed or undetectable manner.

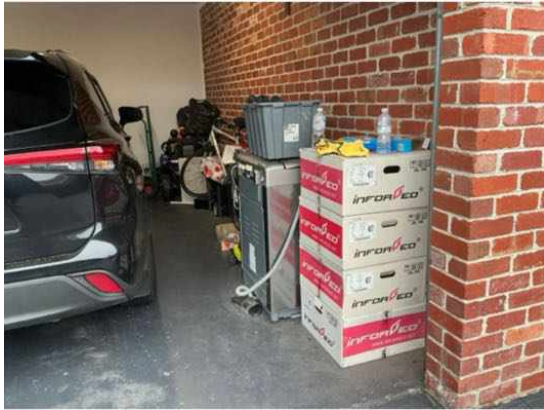
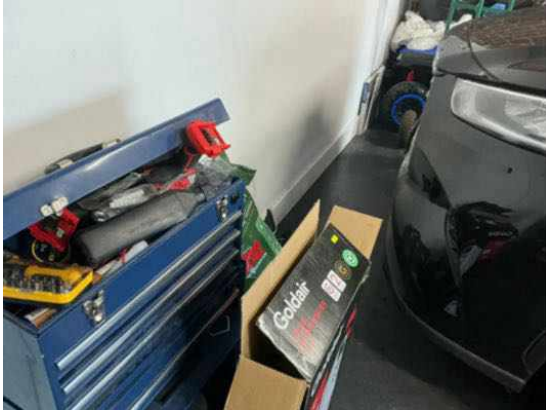
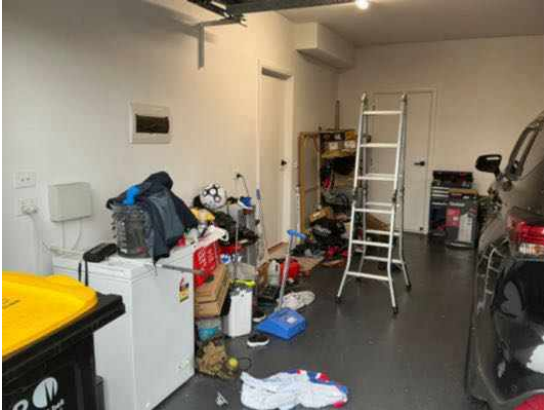
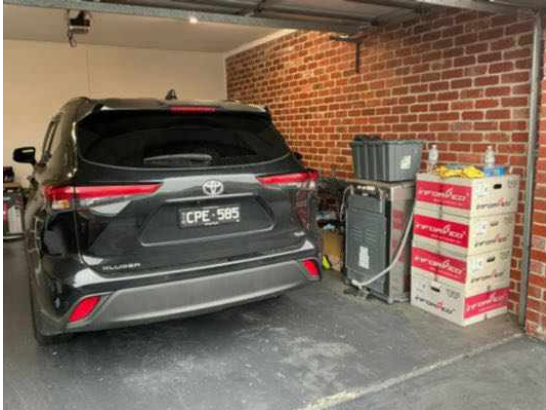
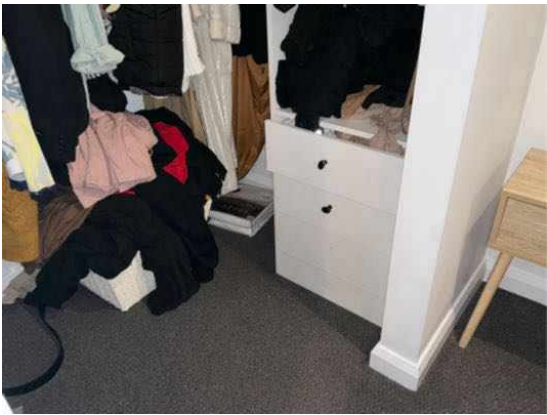
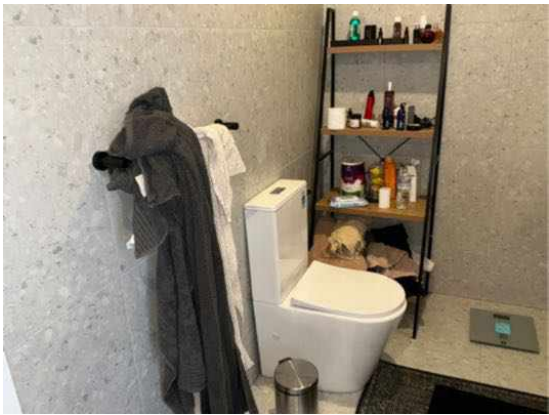
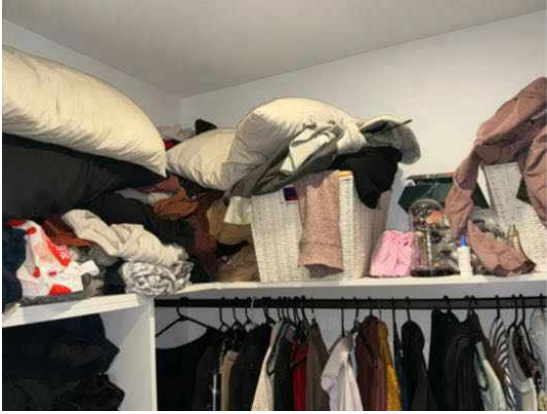
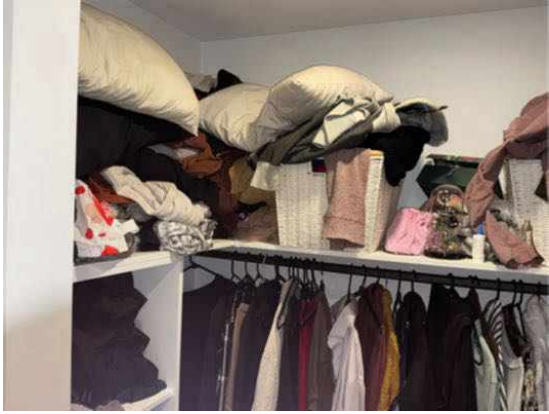
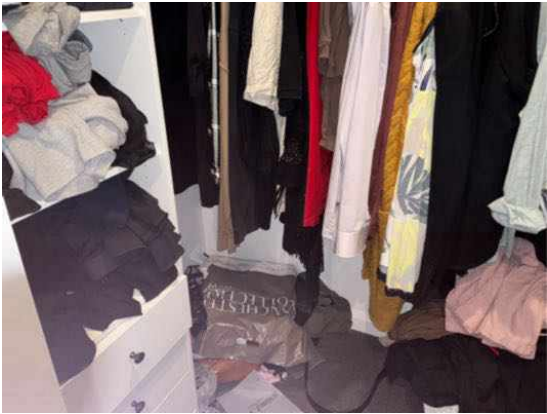
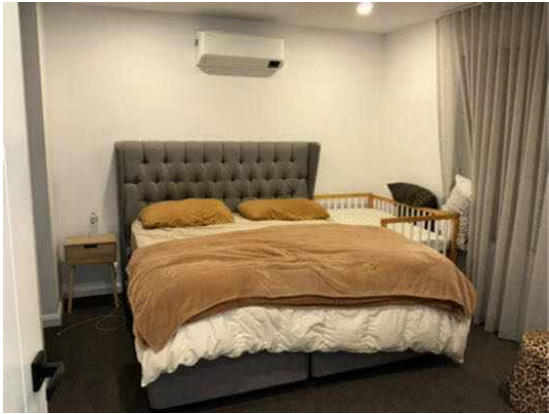
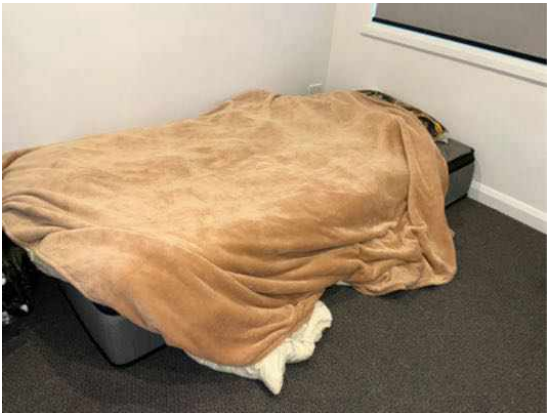
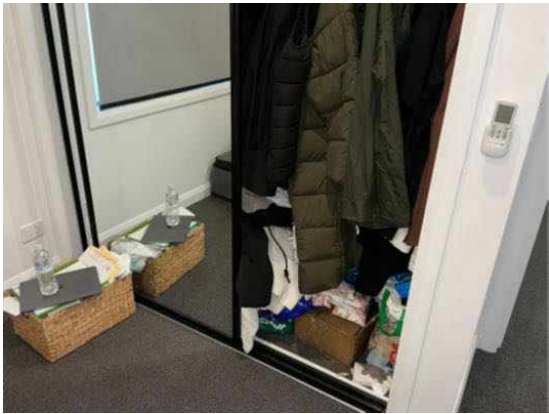
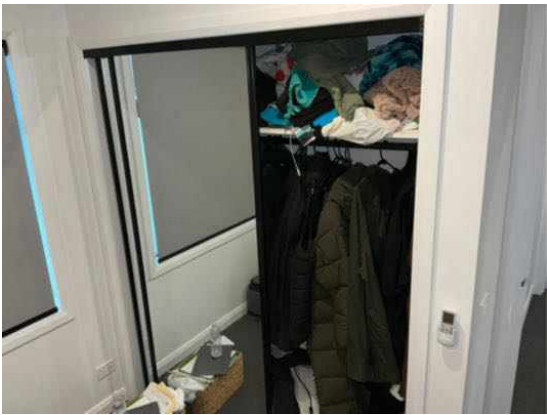
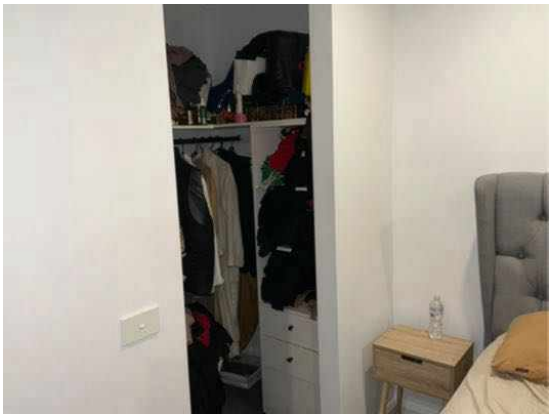
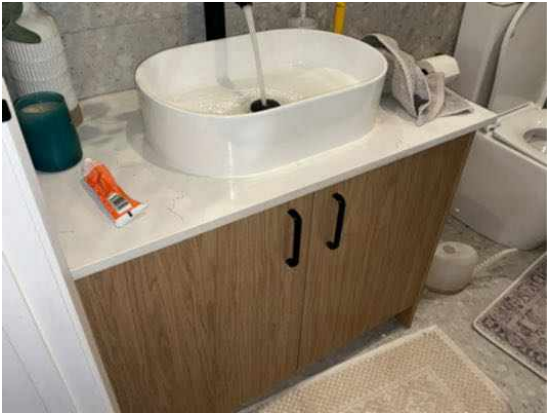
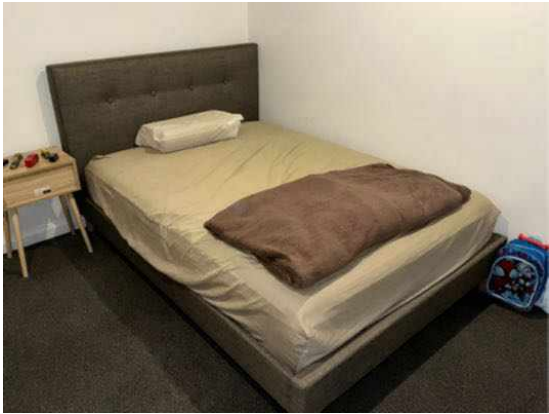
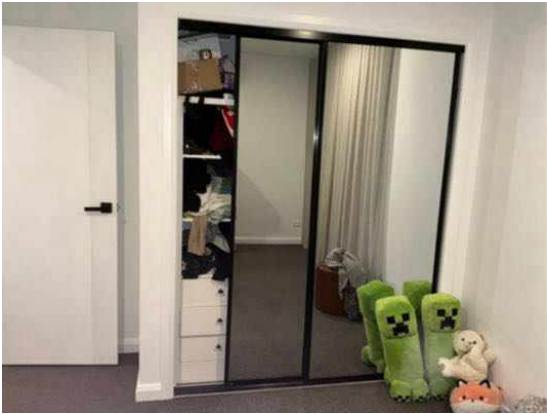
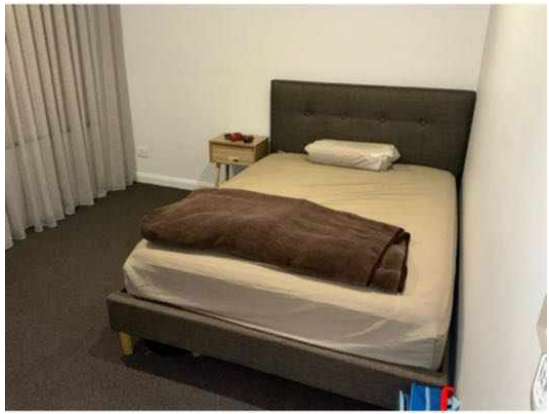
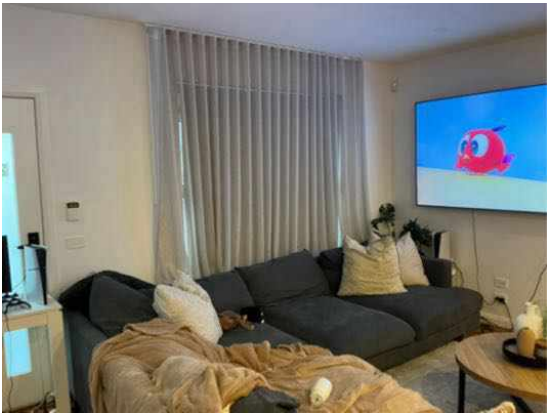
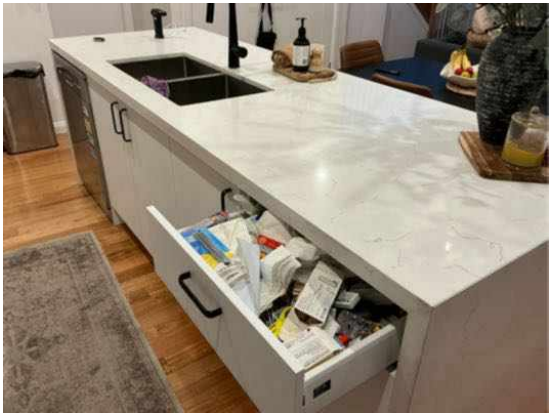
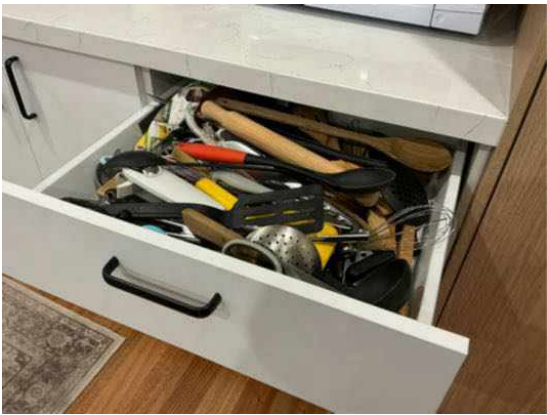
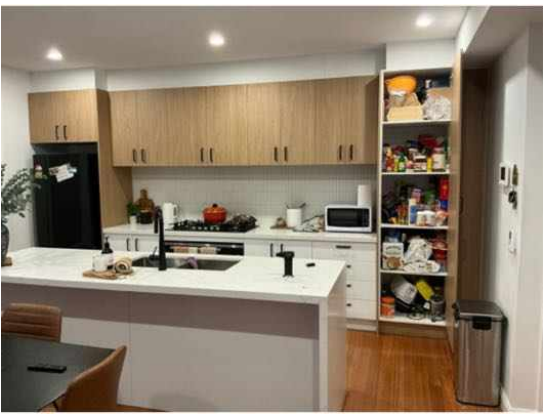
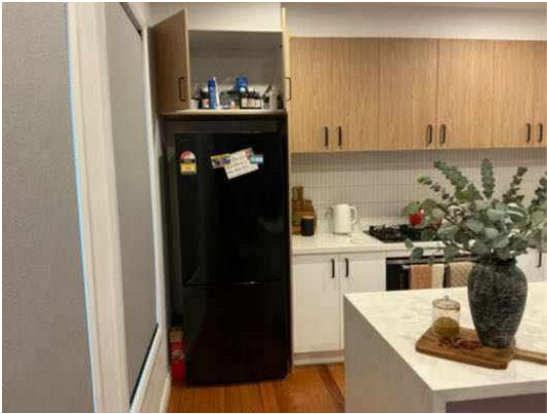
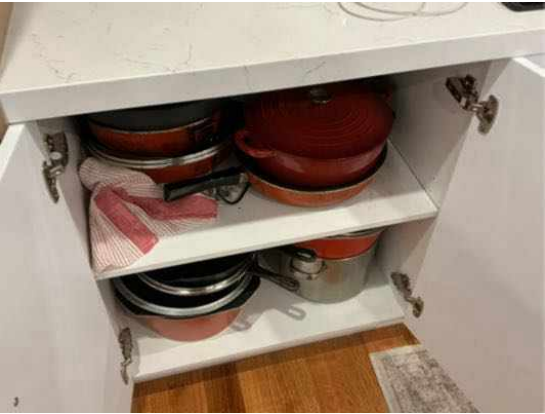
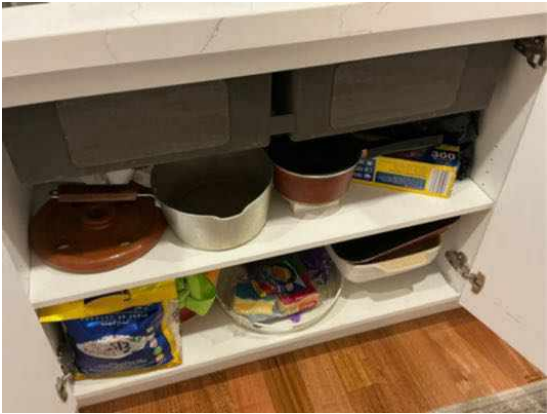
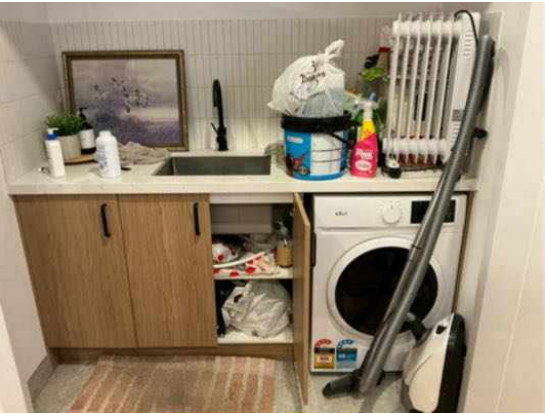
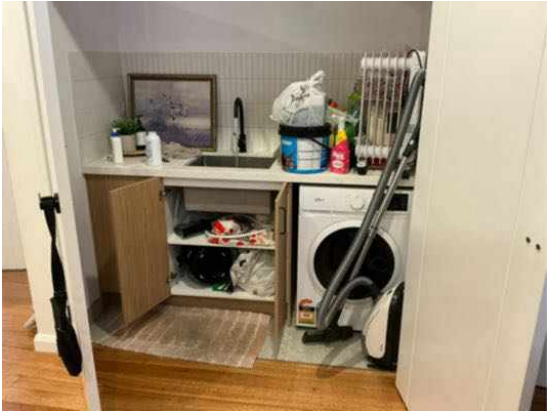
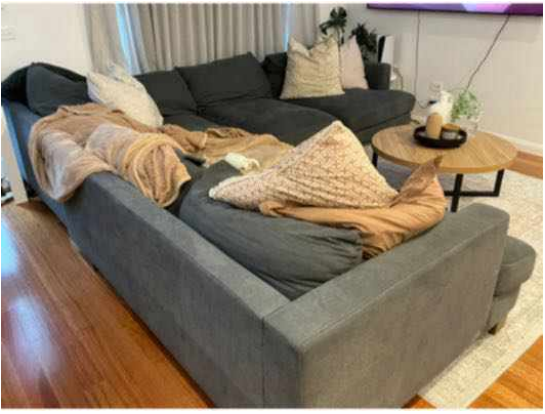
#### Noted Item

Building: Main Building  
Location: All Areas  
Finding: Additional Photos - Obstructions and Limitations  
Information: These photographs are an indication of the obstructions and limitations which impeded full inspection of the property at the time of inspection. These obstructions can hide an array of defects and should be removed to allow full inspection to be carried out. A re-inspection is recommended once the areas are made accessible.
