# Building and Timber Pest Inspection Report

Inspection Date: Tue, 17 Mar 2026

Property Address: 25 Jacob Cres, Glenroy NSW 2640,  
Australia

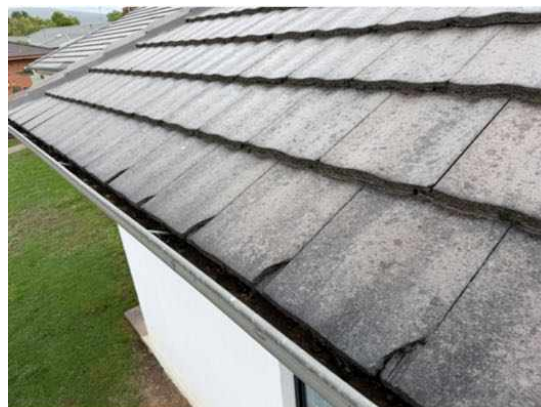
### Finding 3.03

Building:	Main Building
Location:	Guttering
Finding:	Gutters - Debris & Water pooling
Information:	Water pooling and debris were noted in sections of the guttering at the time of inspection, likely due to sagging of the gutters. A loose clip was also noted.

Recommend engaging a licensed roof plumber in the short term, to provide further advice & maintenance works to ensure adequate roof drainage is achieved. All debris and overhanging vegetation should be cleared to ensure proper drainage and prevent overflows.

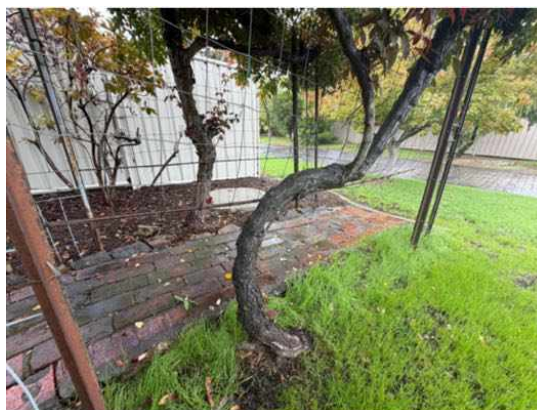
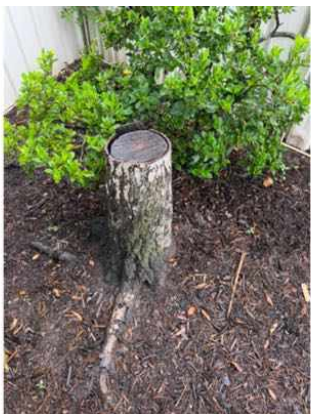
Building:	Main Building
Location:	All External Areas
Finding:	Timber in direct ground contact & trees - conducive to termites
Information:	Where timber materials are in direct contact with the ground and consequently moisture, they become conducive to termite activity. The tree stumps, landscaping timbers, and trees surrounding the building create an environment conducive to termite activity.

Where feasible, any timbers in direct contact with the ground should be removed and any trees in close proximity to the building should be removed or test drilled (inspected) at least annually to reduce the risk of termite infestation & detect any early signs of termite activity.

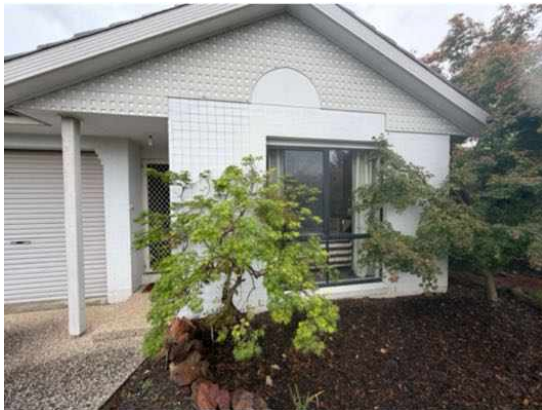
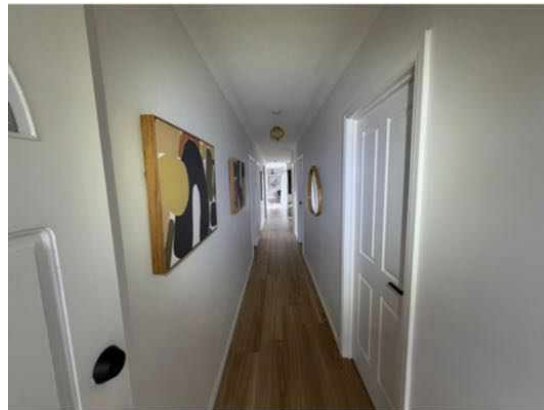
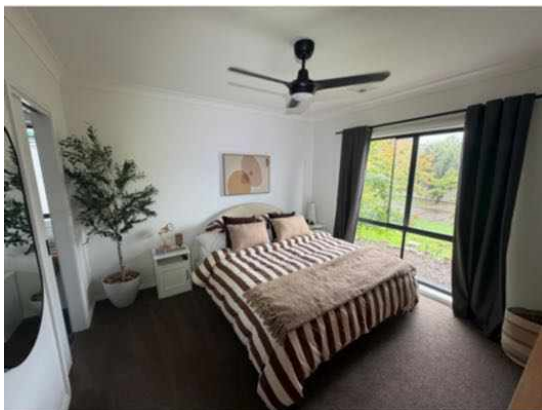
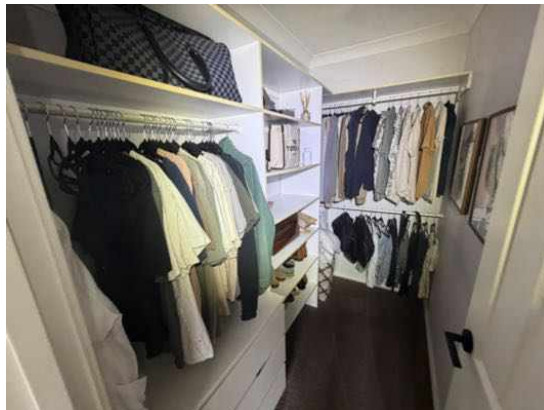
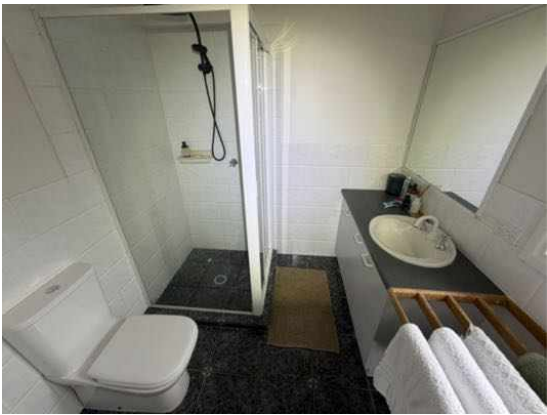
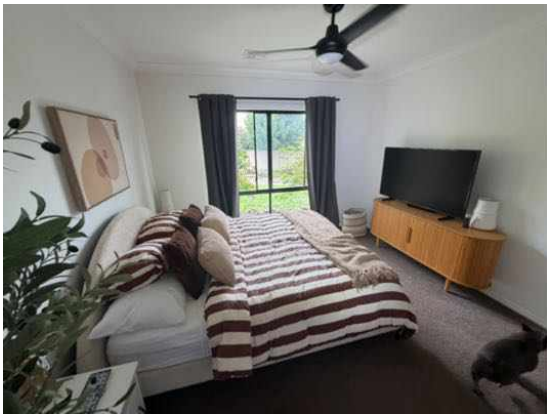
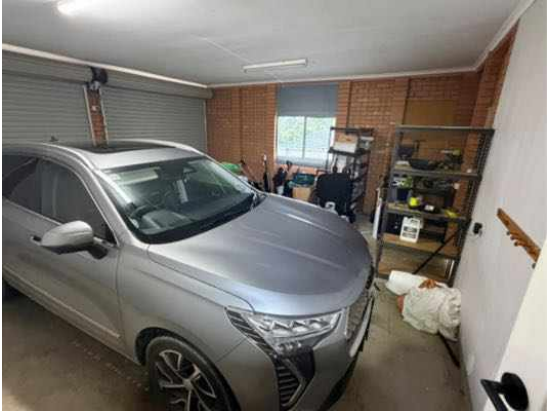
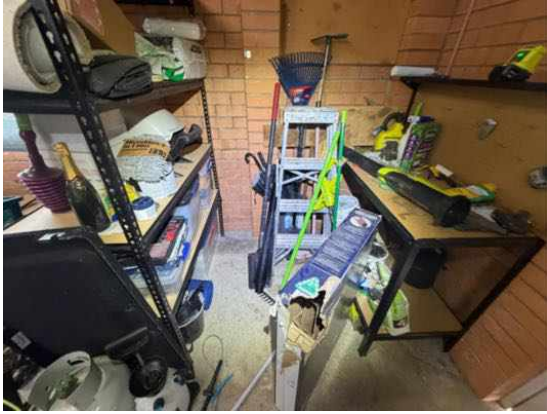
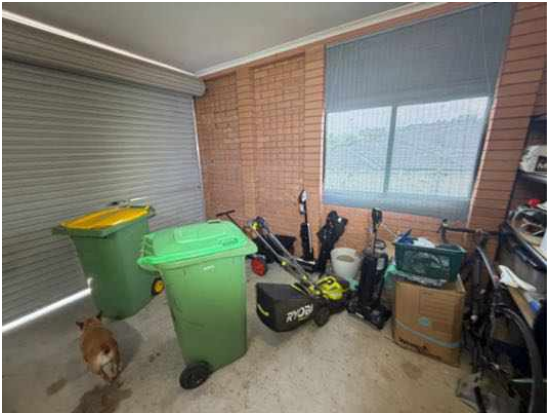
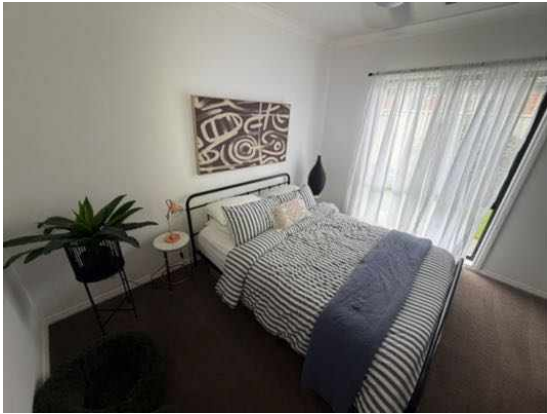
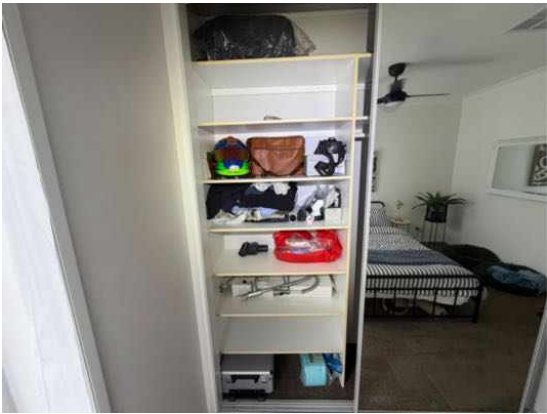
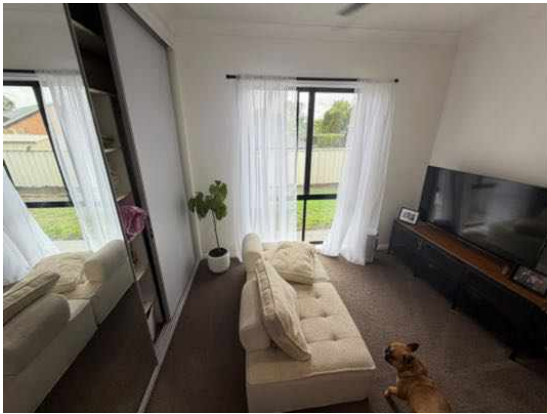
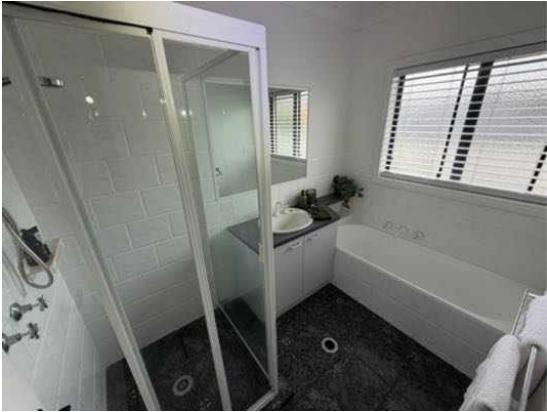
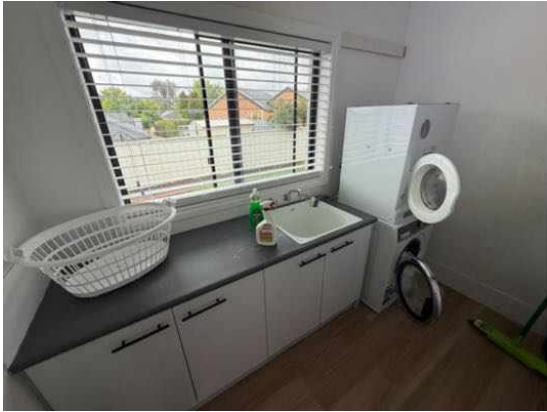
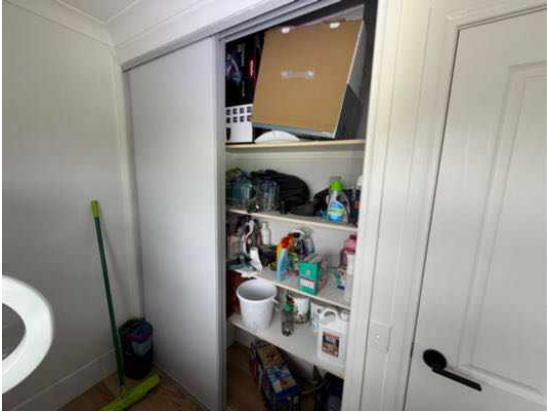
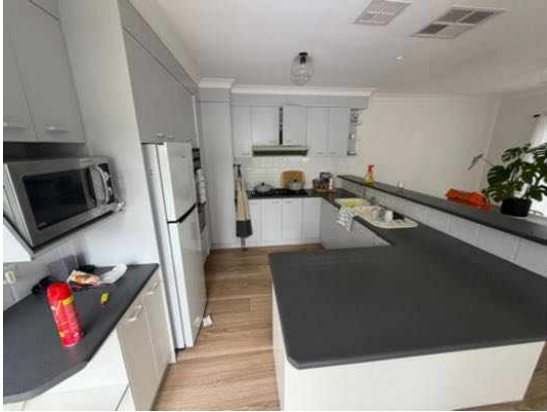
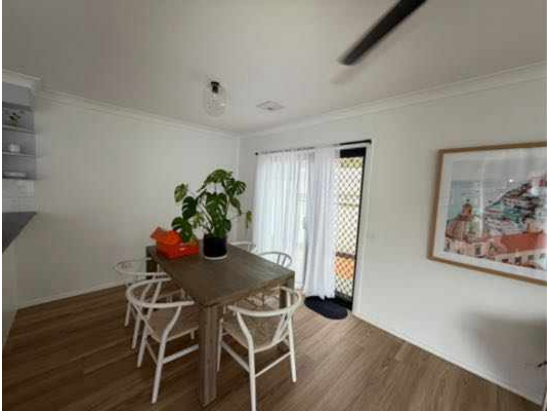
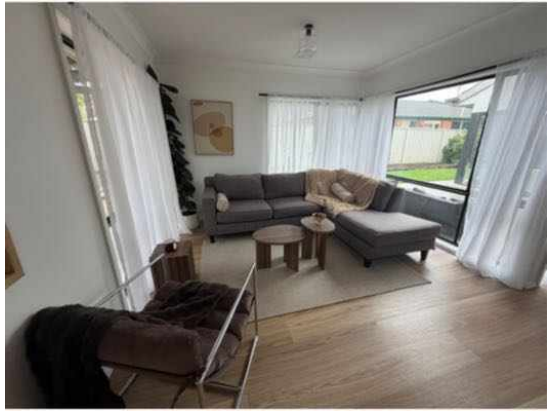
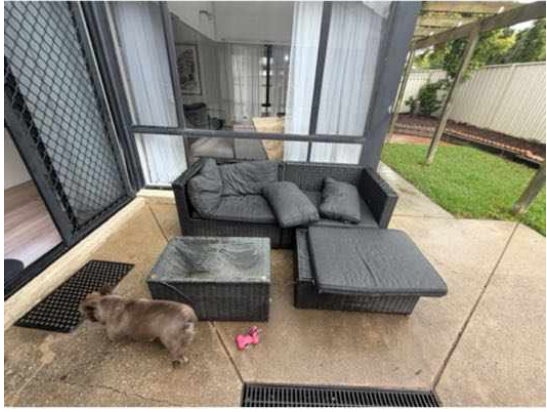
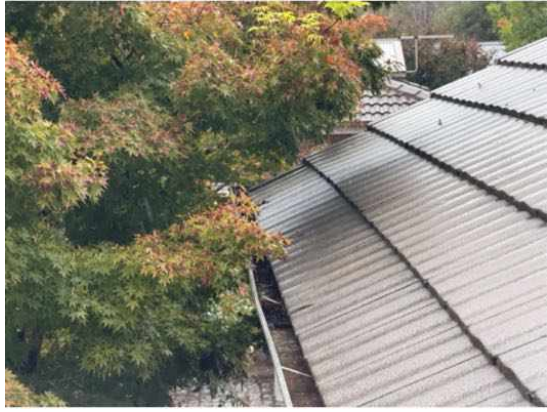
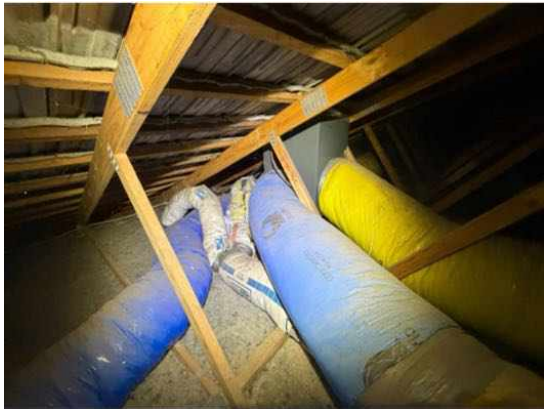
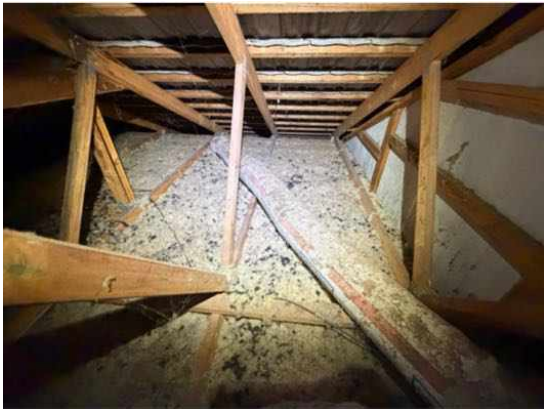
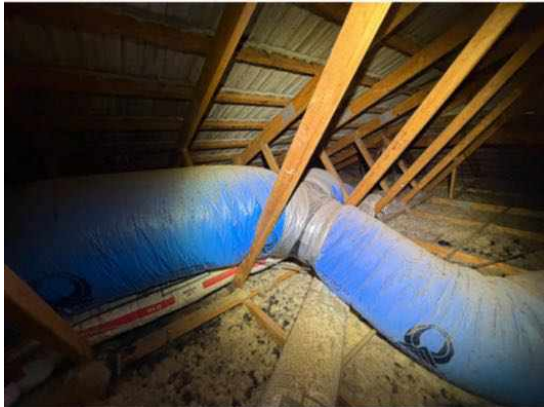
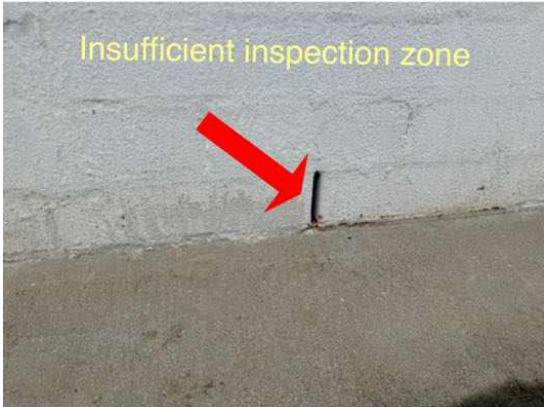
Building: Main Building  
Location: All Areas  
Finding: Additional Photos - Obstructions and Limitations  
Information: These photographs are an indication of the obstructions and limitations which impeded full inspection of the property at the time of inspection. These obstructions can hide an array of defects and should be removed to allow full inspection to be carried out. A re-inspection is recommended once the areas are made accessible.

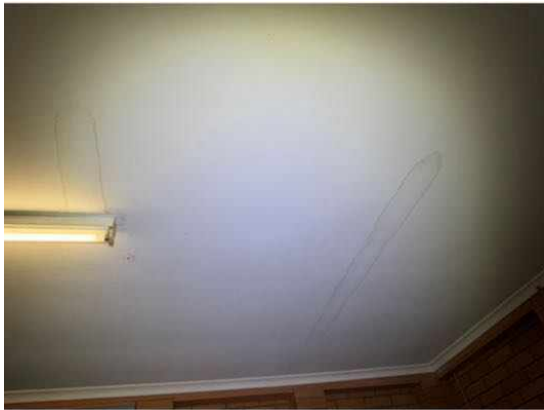
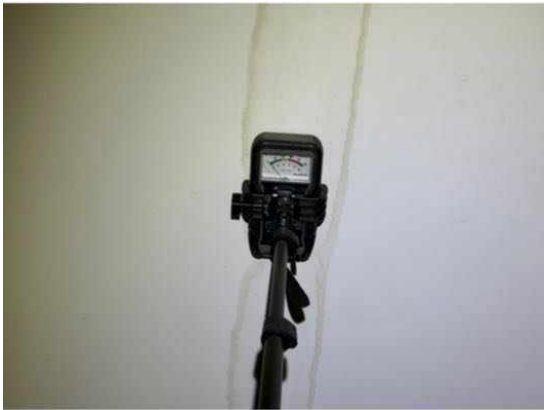
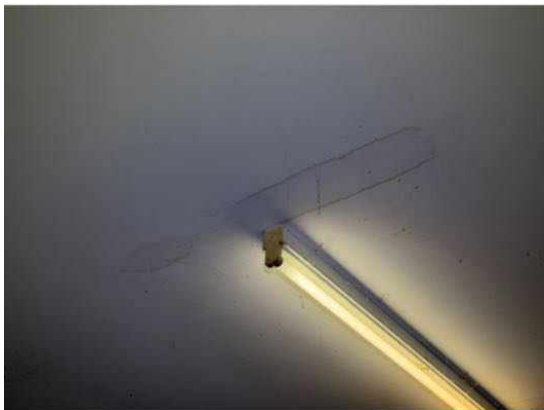
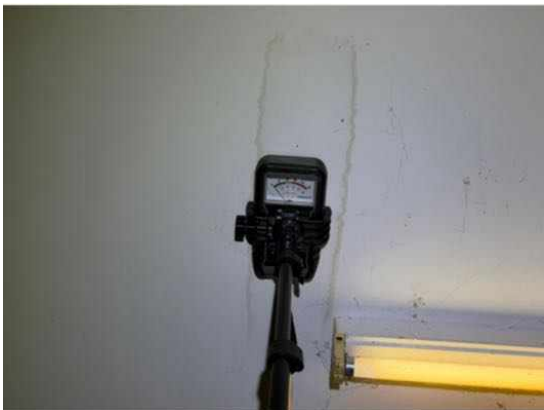
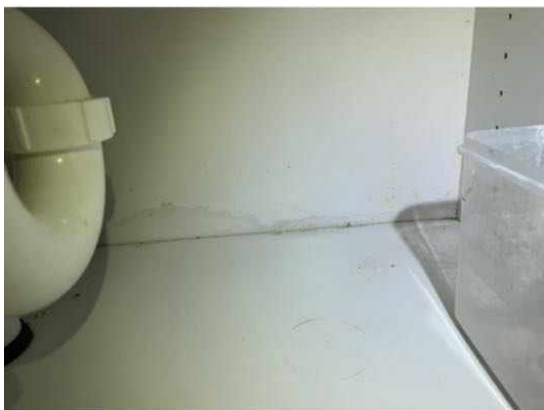
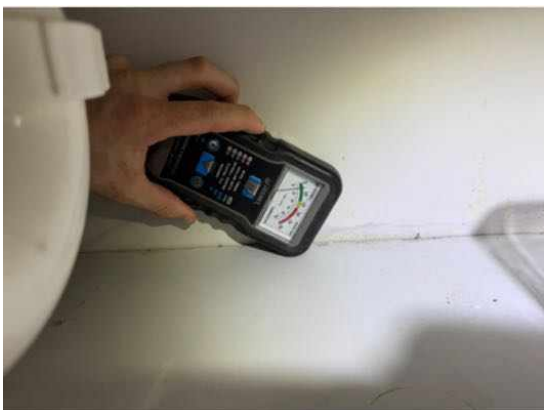
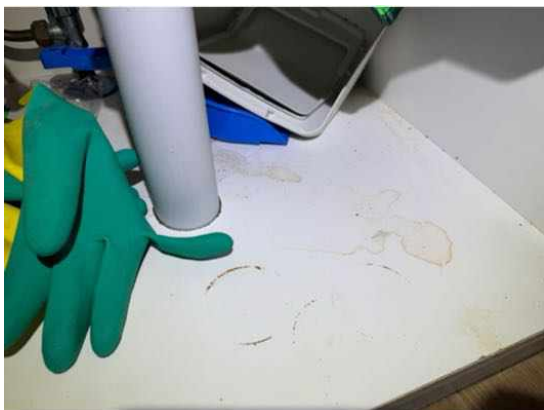
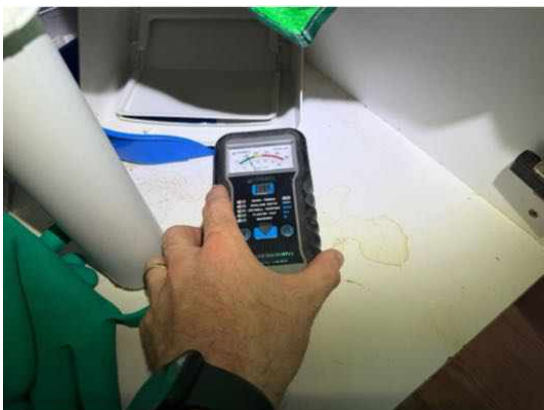
Building: Main Building  
 Location: Garage ceiling, beneath laundry & kitchen sink  
 Finding: Water Staining Present  
 Information: It appears that water staining was present at but not limited to, the garage ceiling and beneath the laundry & kitchen sink. Potential causes of leaking include deteriorated roof cladding or damaged plumbing fittings and fixtures.

No high moisture was evident in these areas at the time of inspection. Recommend that the client monitor these areas. Should leaking persist or return, a licensed plumber should be engaged promptly, to provide remedial works.

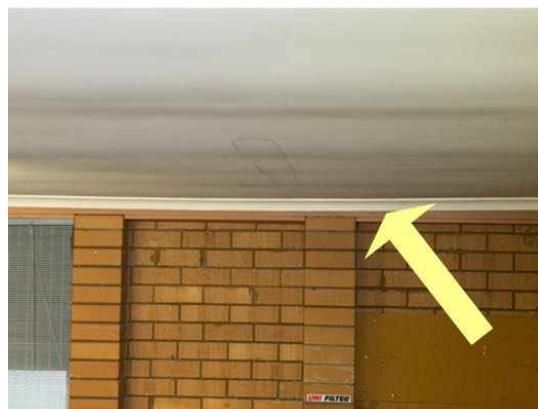
Building: Main Building  
 Location: Garage  
 Finding: Garage Ceiling - Sagging  
 Information: Sections of the garage ceiling appeared to be slightly sagging. Causes of ceiling sagging include fixings (e.g. nails or glue) that have become loose and require re-fixing. Recommend that the client monitor the sagging.

Should the sagging develop, a licensed plasterer should be engaged to provide maintenance works where necessary.
