Building and Timber Pest Inspection Report VR

Inspection Date: Fri, 13 Feb 2026

Property Address: 108 Bilga Cres, Malabar NSW 2036,
Australia

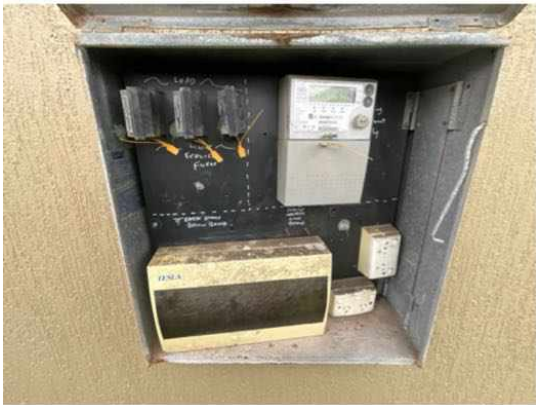
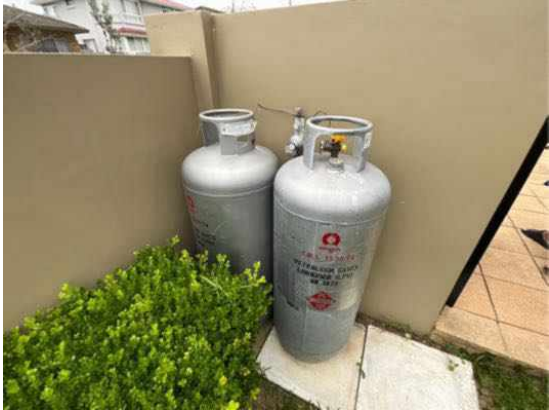
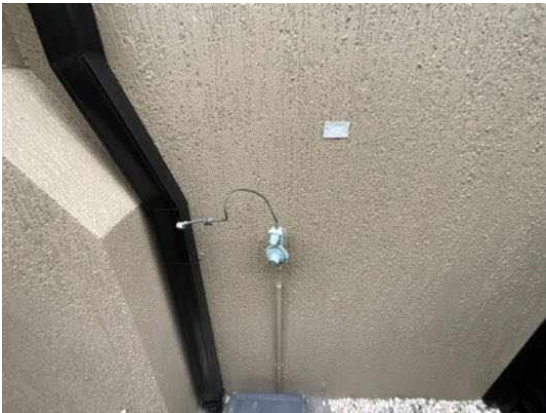
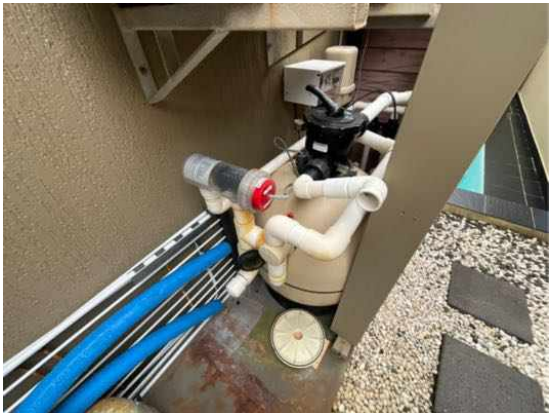
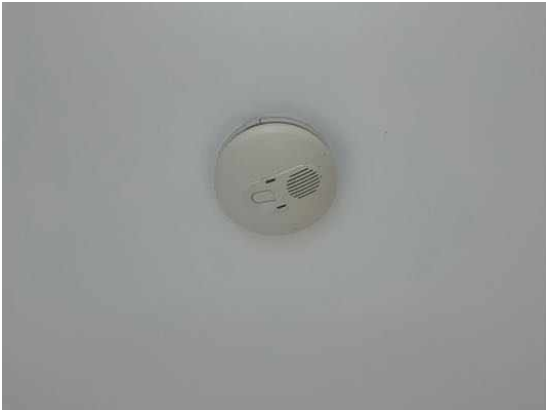
Building: Main Building
Location: All Areas
Finding: Photos Added
Information: Additional photos are provided for your general reference.
