## Building Inspection Report

Inspection Date: Wed, 25 Feb 2026

Property Address: a4409/1 Hamilton Cres, Ryde NSW 2112,  
Australia

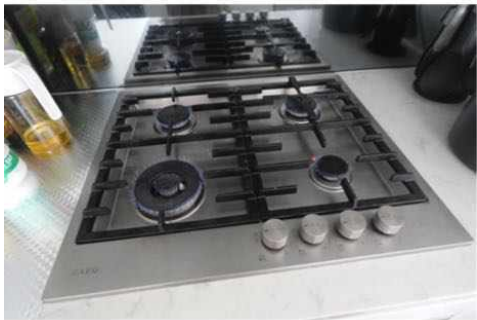
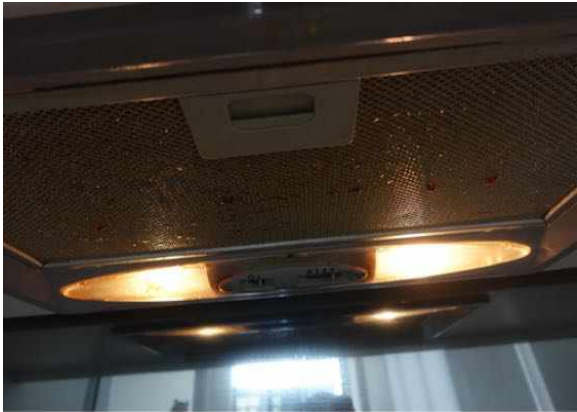
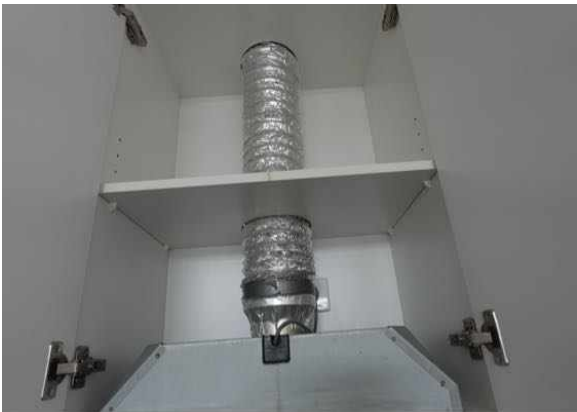
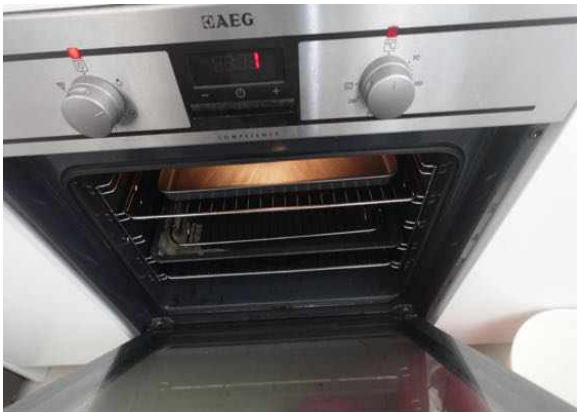
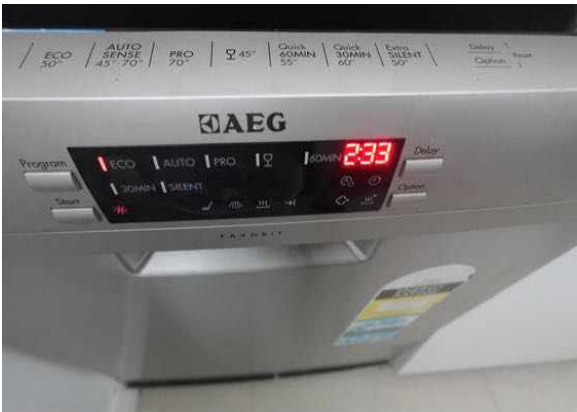
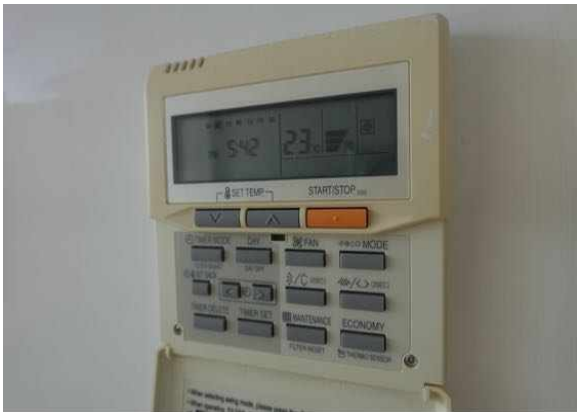
Building: Main Building  
Location: All Areas  
Finding: Additional Photos  
Information: Additional photos are provided for your general reference only.
