Building and Timber Pest Inspection Report

Inspection Date: Fri, 30 Jan 2026

Property Address: 1A Roland Rd, Rostrevor SA 5073, Australia

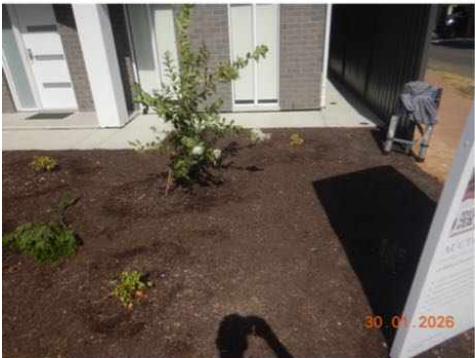
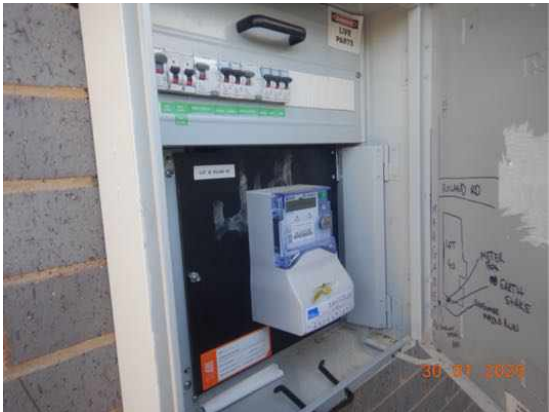
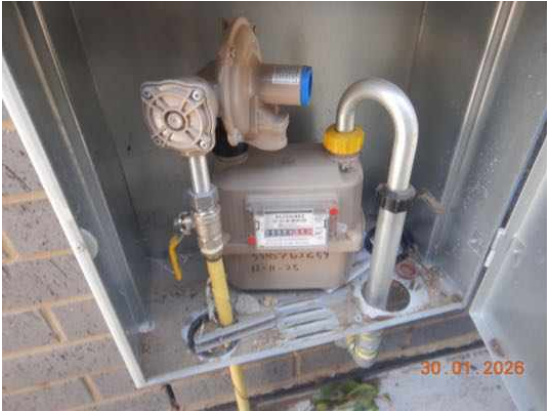
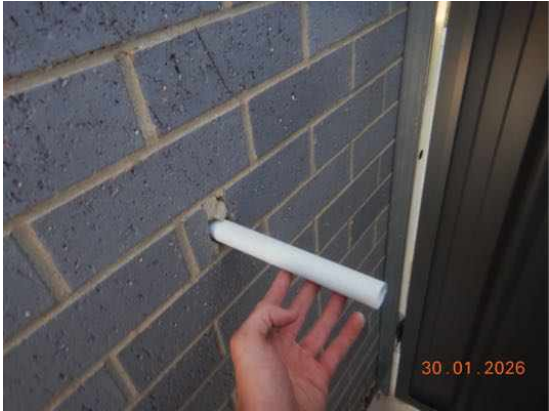
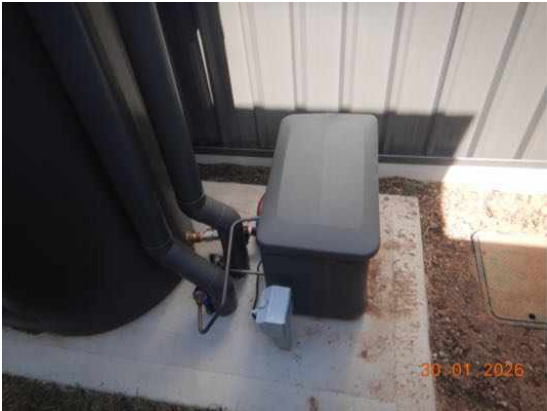
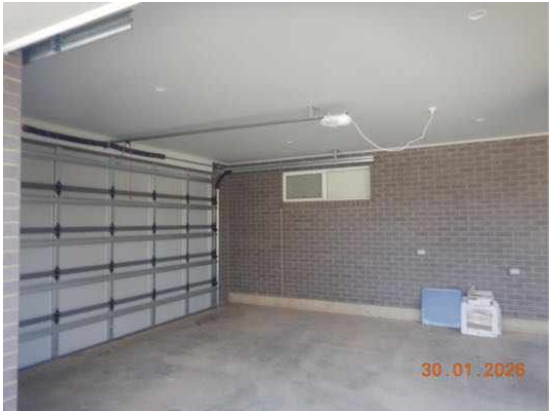
Building: Building 1
Location: All Areas
Finding: Additional Photos
Information:

Additional photos are provided for your general reference.

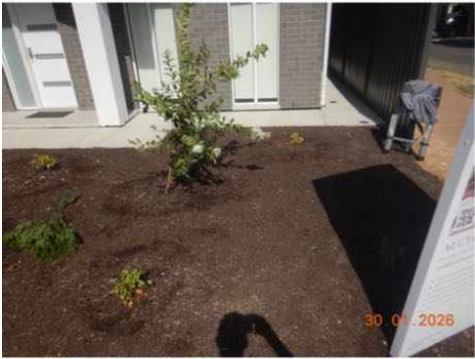
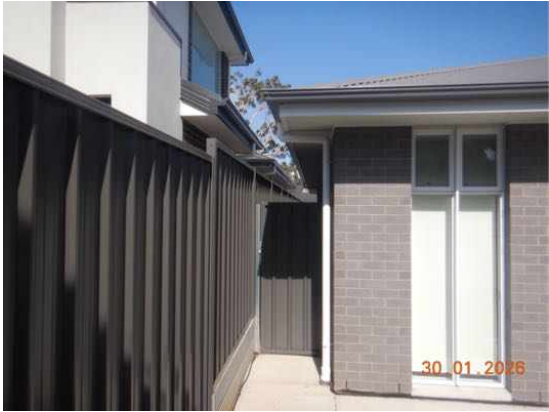
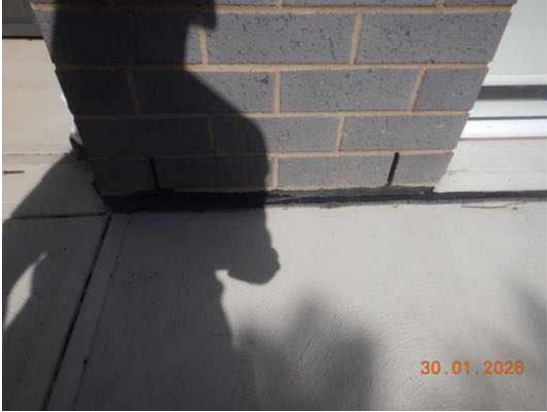
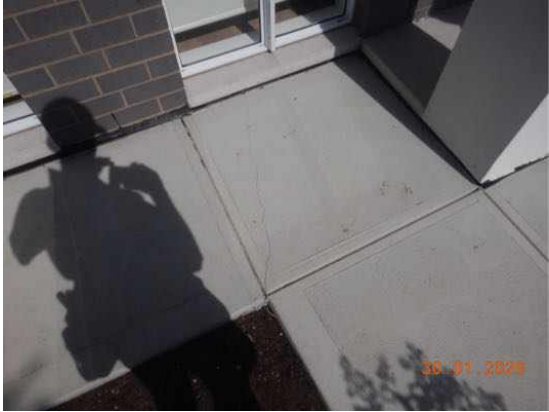
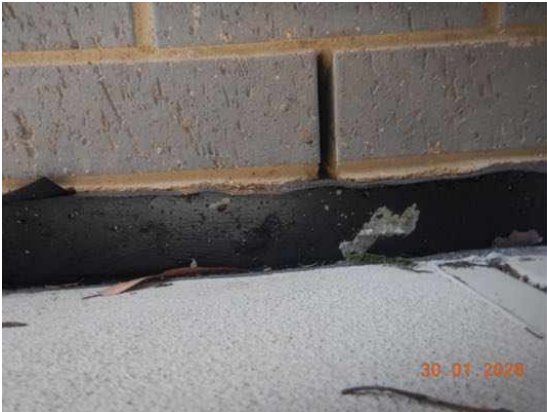
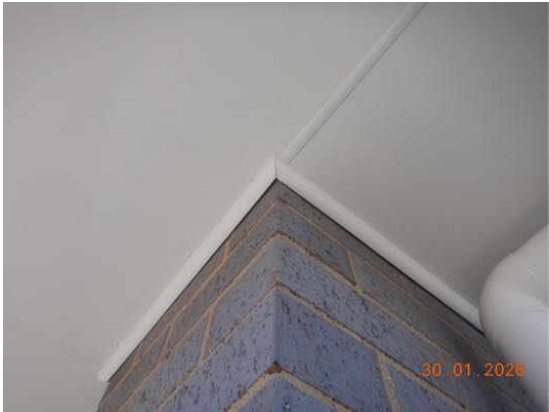
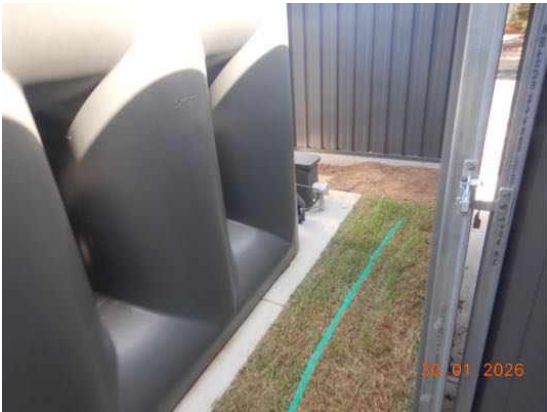
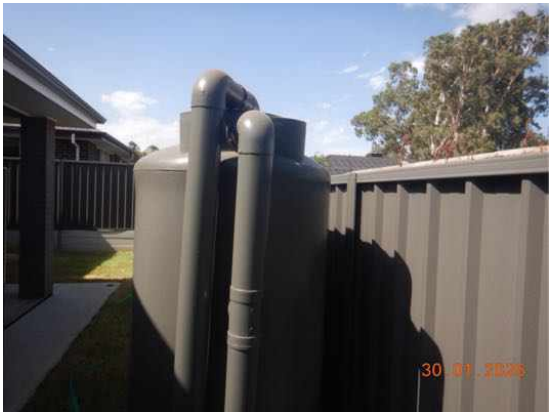
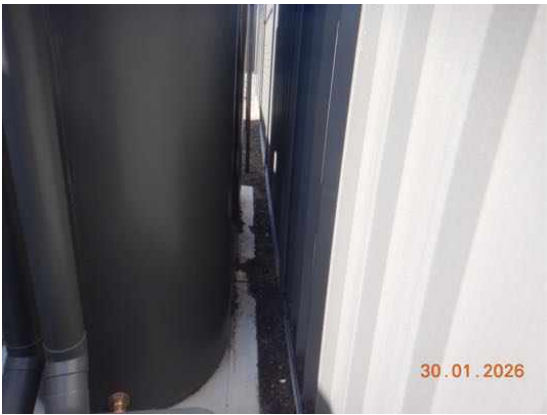
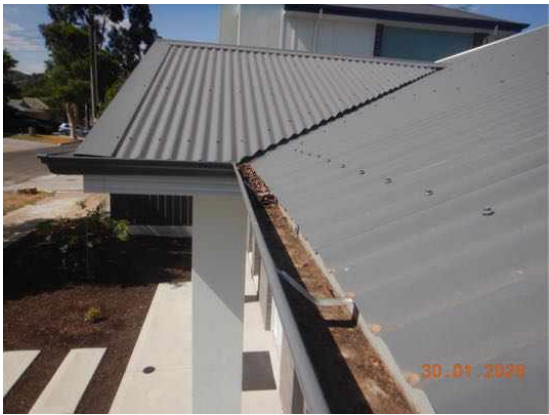
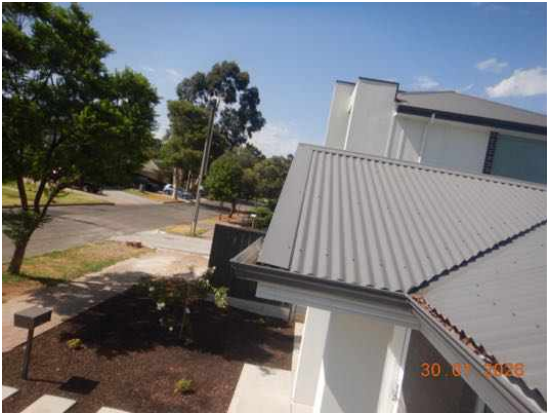
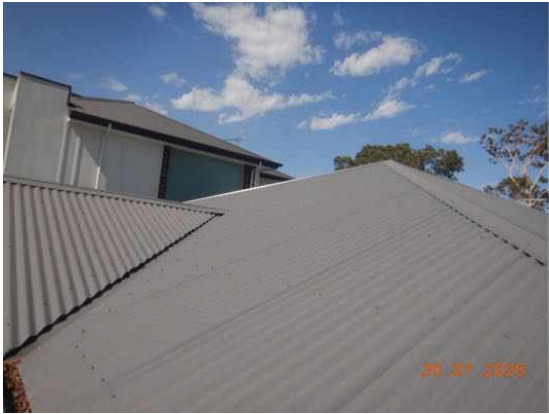
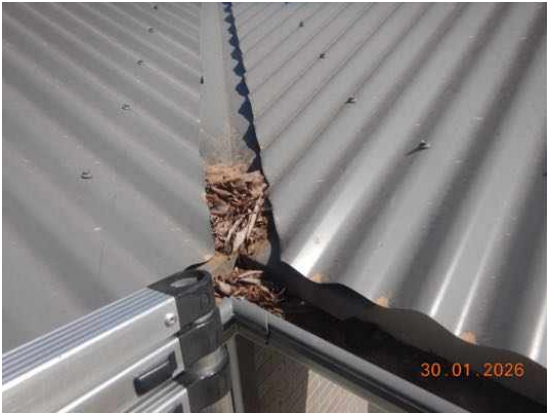
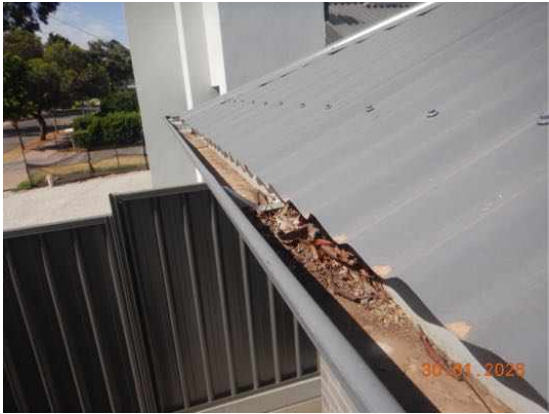
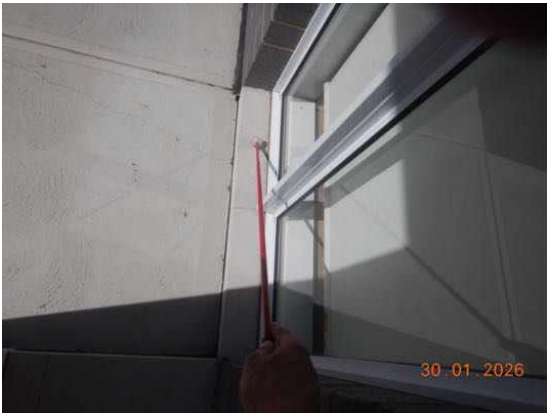
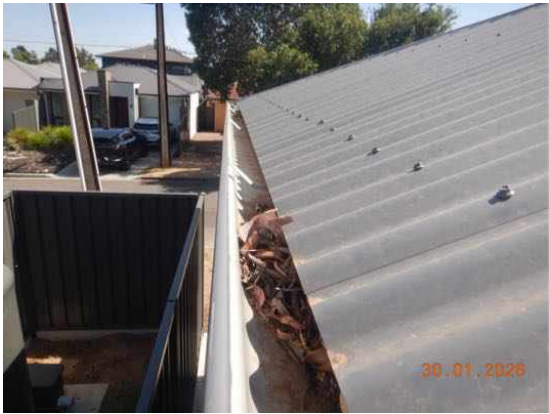
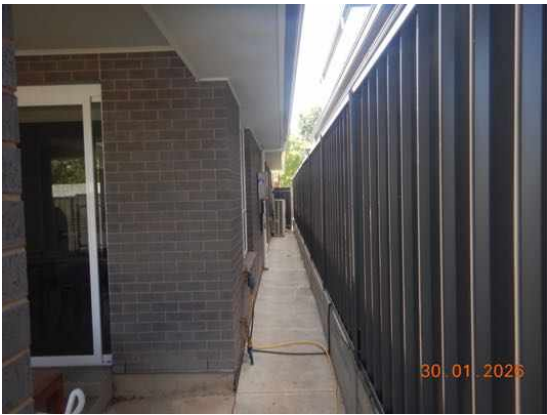
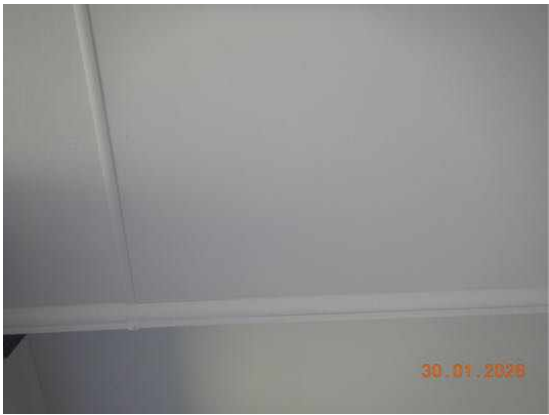
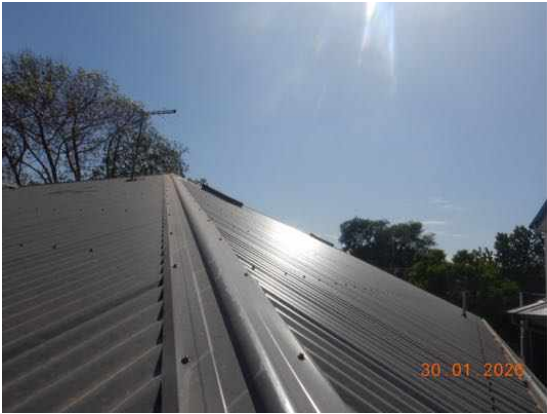
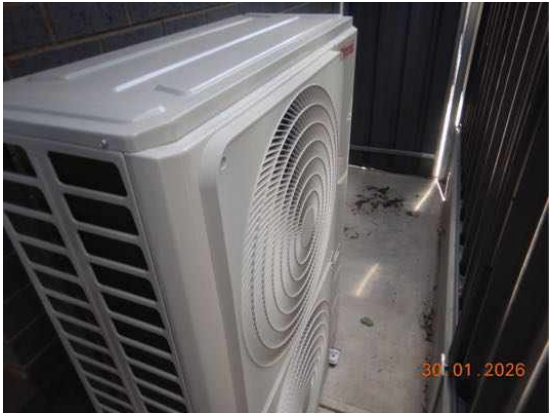
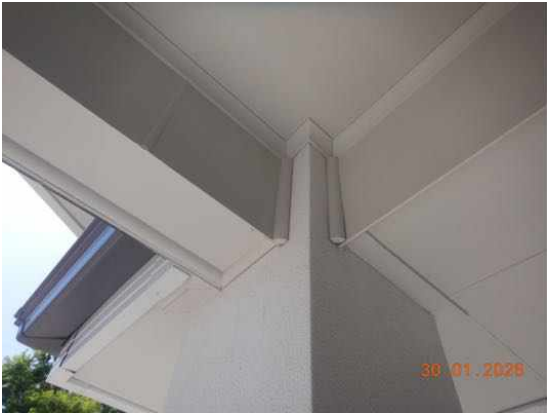
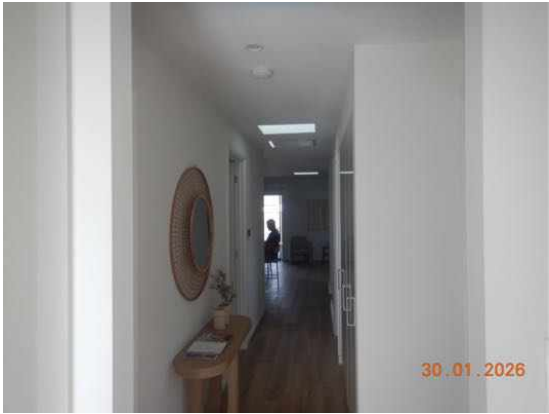
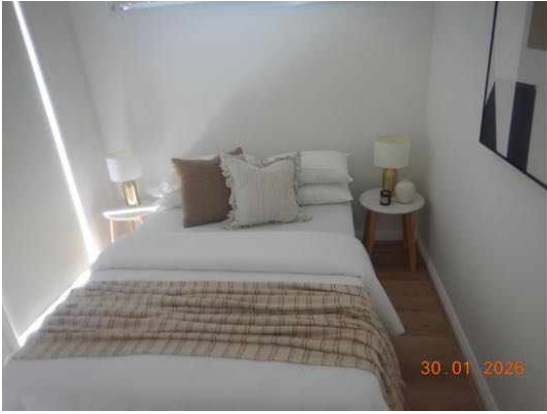
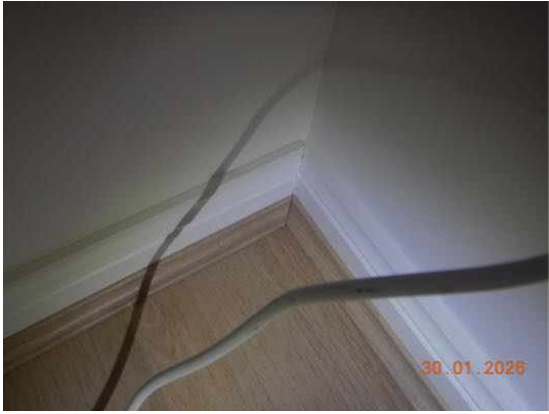
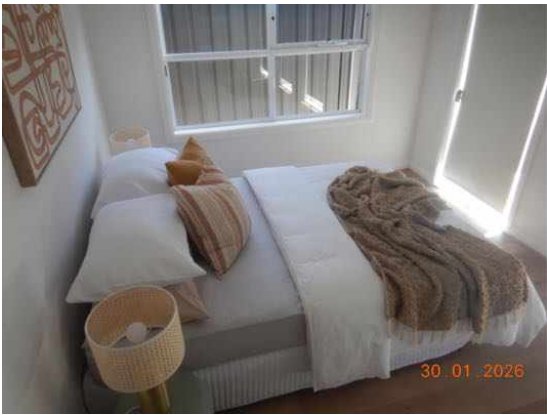
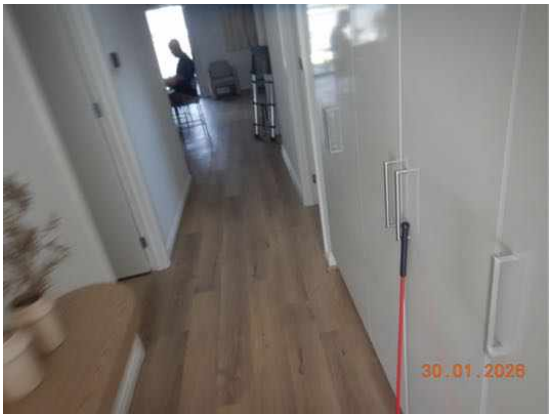
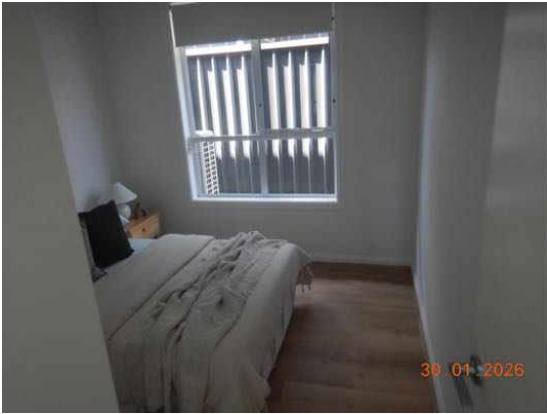
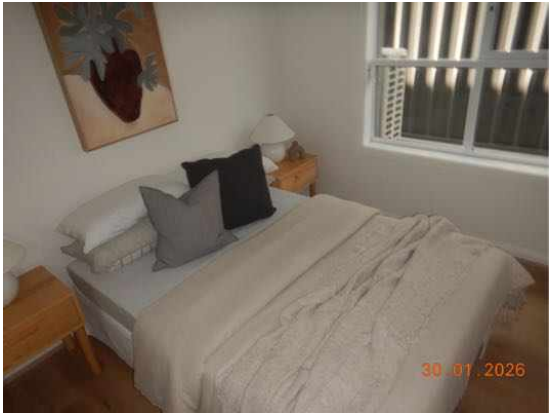
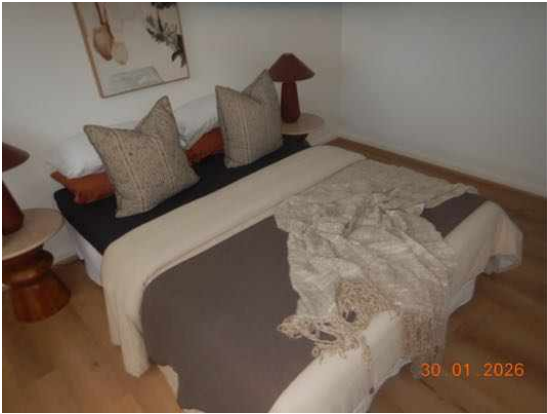
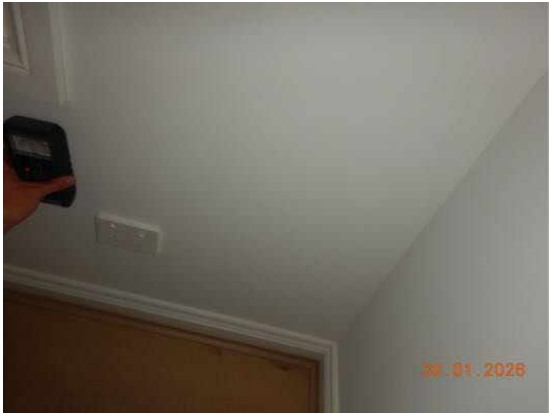
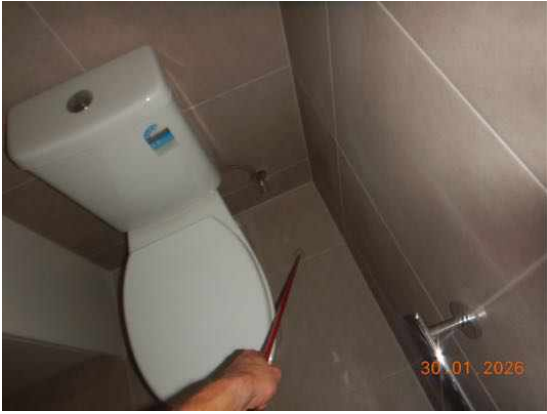
Noted Item

Building: Building 1
 Location: All Areas
 Finding: Additional Photos - Obstructions and Limitations
 Information:

These photographs are an indication of the obstructions and limitations which impeded full inspection of the property at the time of inspection. These obstructions can hide an array of defects and should be removed to allow full inspection to be carried out.
