## Building and Timber Pest Inspection Report

Inspection Date: Tue, 3 Feb 2026

Property Address: 34 Ursula St, Winston Hills NSW 2153,  
Australia

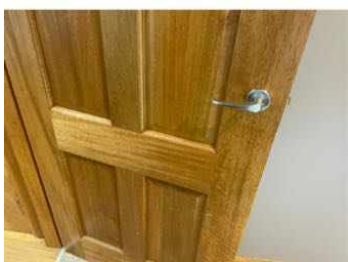
### Finding 3.09

If left unaddressed, the marks may become more noticeable over time, particularly in high-traffic areas, which could reduce the visual appeal of the interiors. The integrity of the paint and finishes is not compromised, but cosmetic touch-ups may be required to maintain a uniform presentation.

It is recommended that the affected surfaces be cleaned or repainted in the near future by a suitably qualified tradesperson to restore the appearance and uniformity of the internal finishes. Regular maintenance of painted surfaces, including walls, ceilings, and trims, can help prolong their life and visual quality.

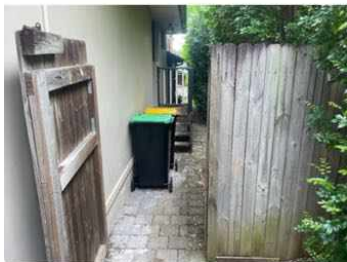
Information: Any timbers in direct ground contact provide opportunity for concealed termite entry and are likely to be subject to premature rot and decay as the soil retains moisture or damp conditions against the timbers.

Remove untreated timber that is in direct contact with external grounds. Consider replacement with more durable materials i.e. treated timber or non timber elements. Frequent pest inspections are advised to readily identify any termite activity in these areas.

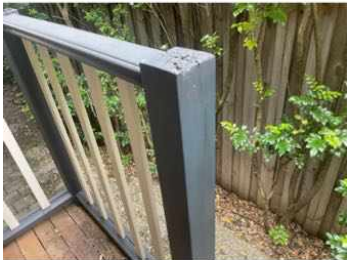
or absorbed moisture from other abutting building materials. It is advisable to remove these affected timbers to prevent any chance of attack in the future.

Wood decay is more susceptible to termite attack and these timbers should be replaced to limit termite attack.

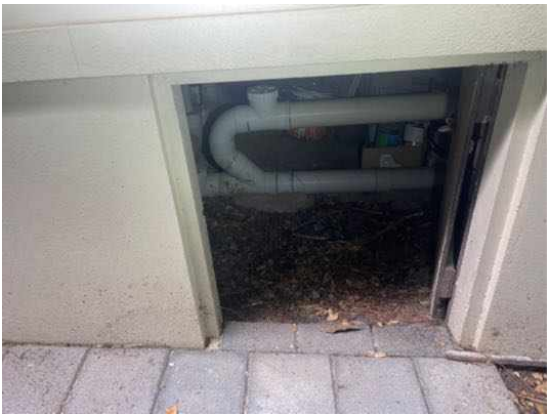
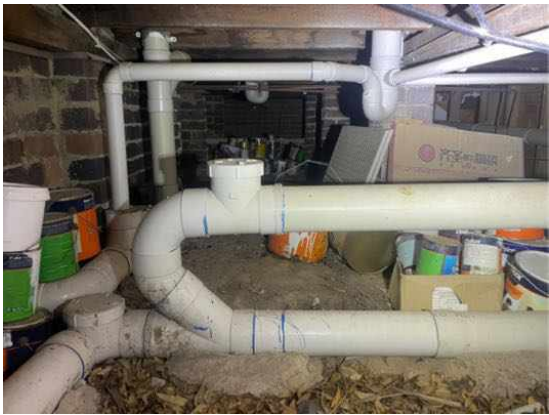
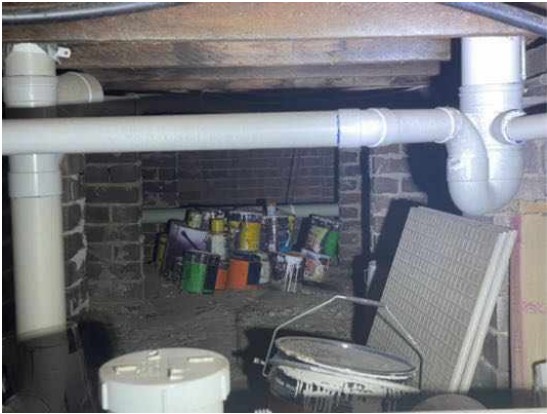
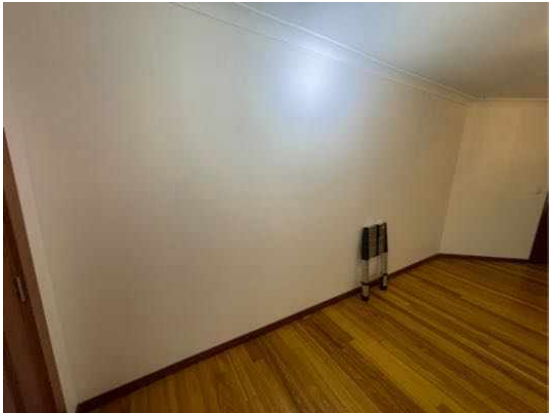
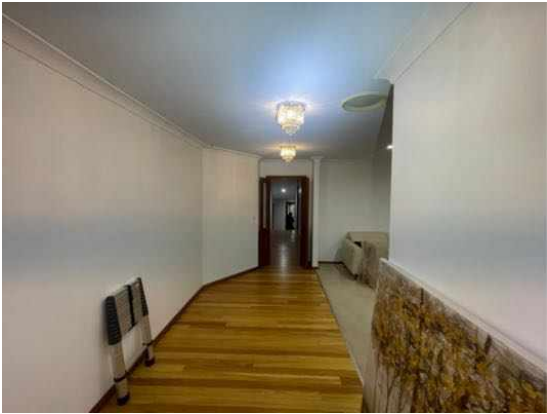
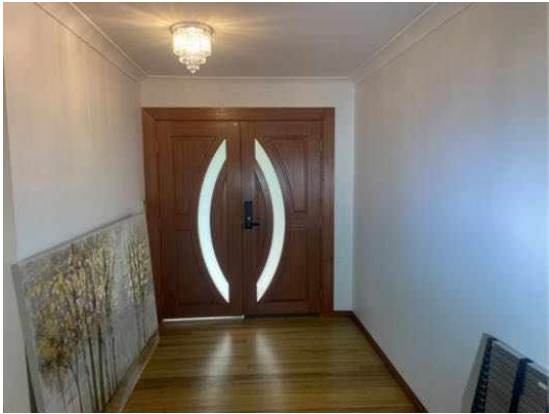
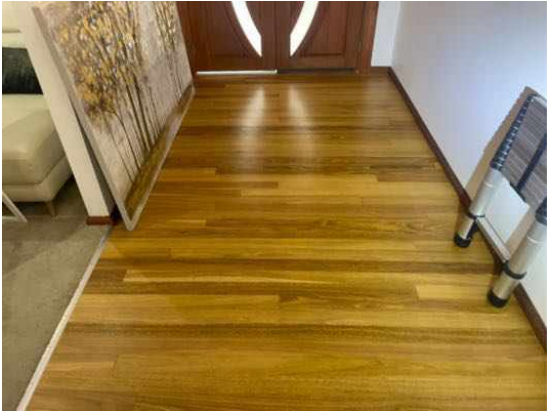
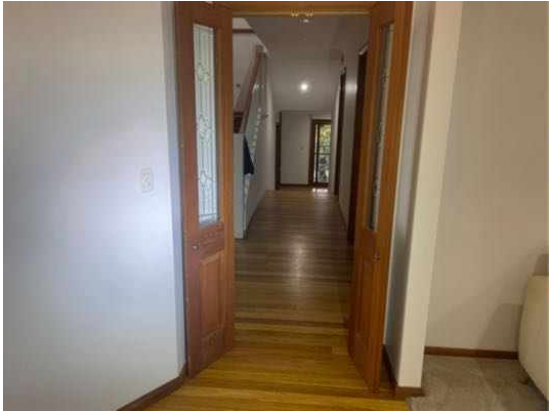
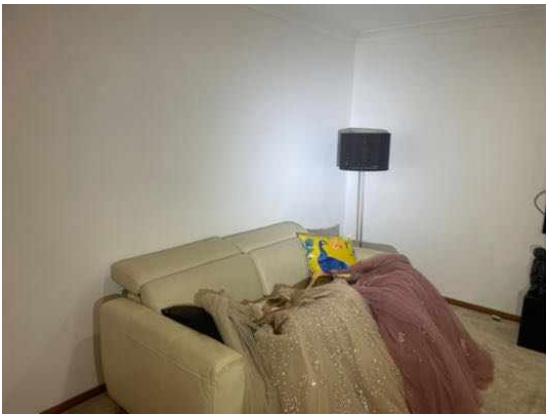
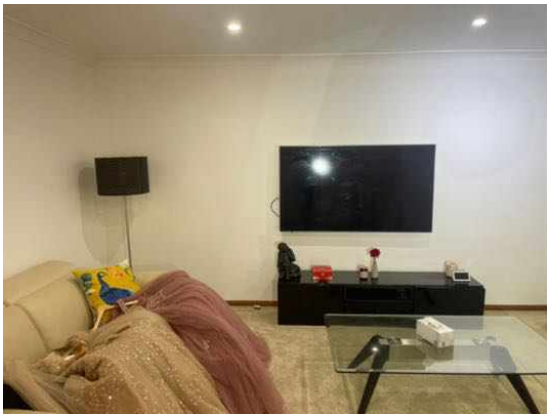
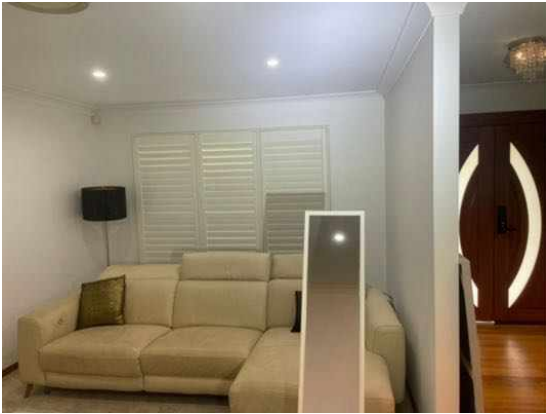
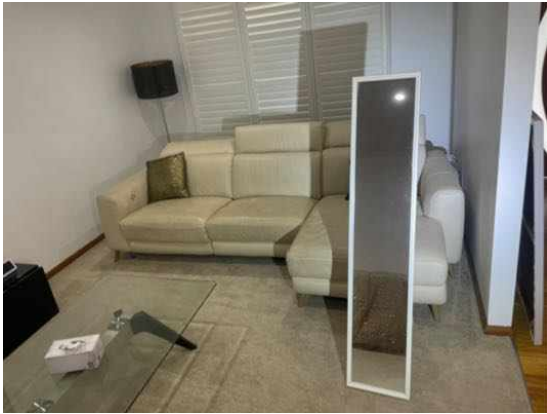
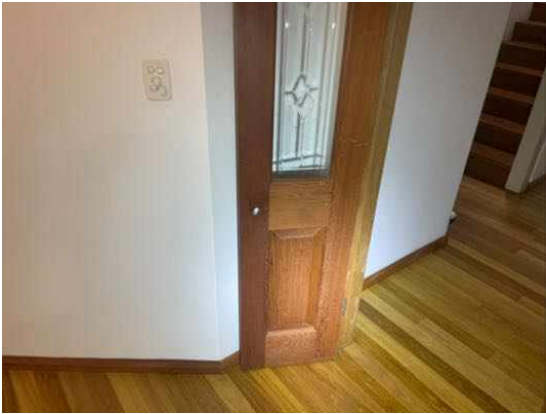
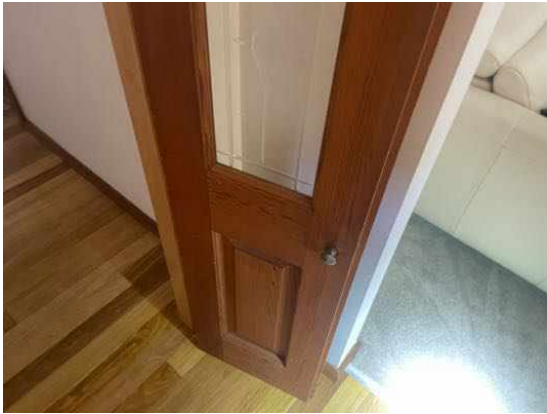
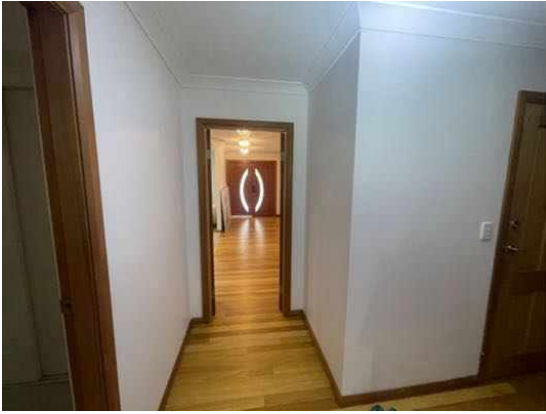
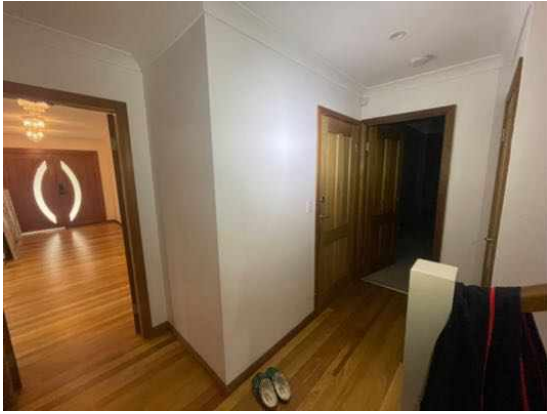
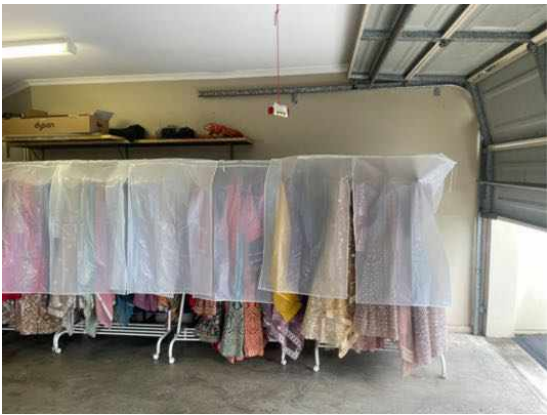
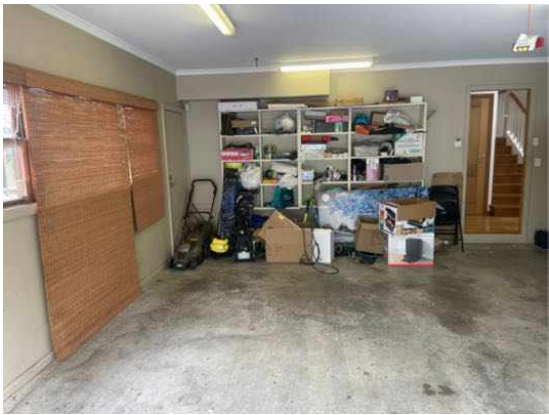
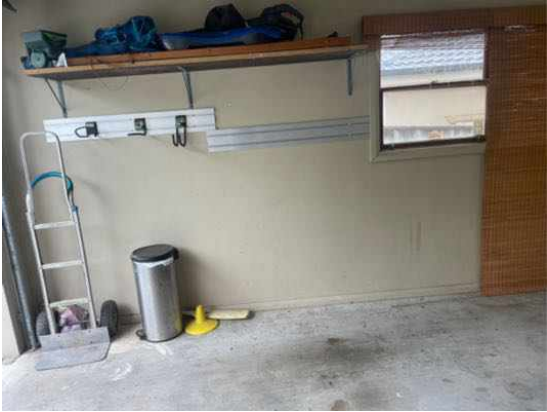
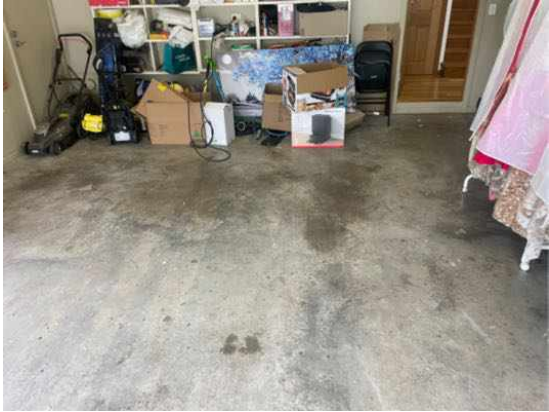
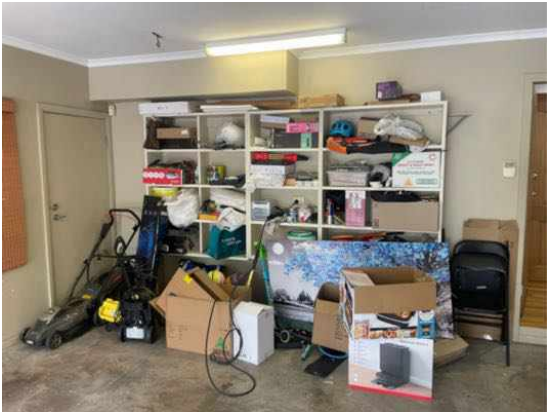
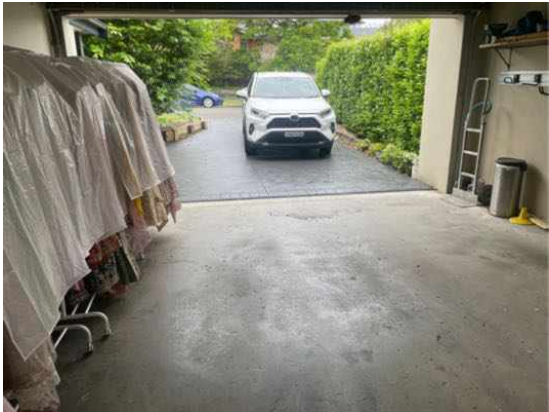
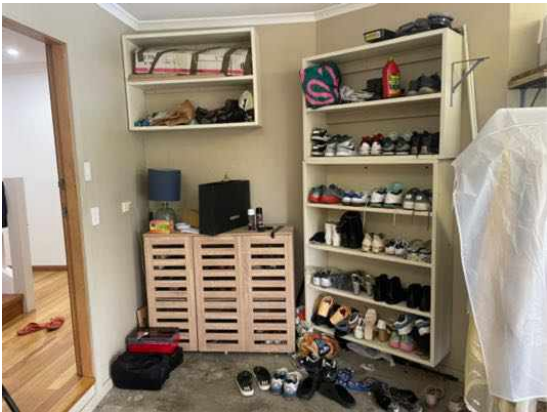
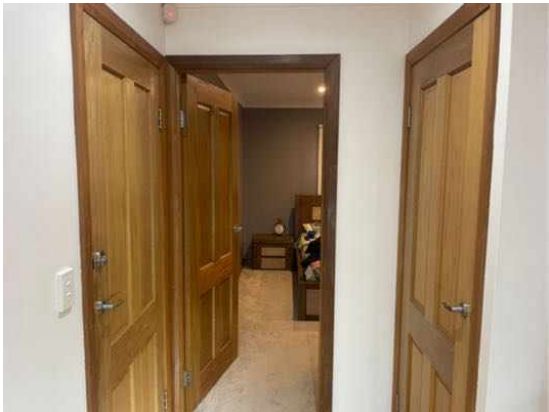
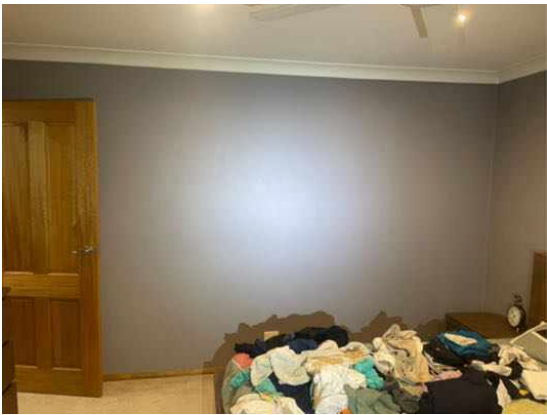
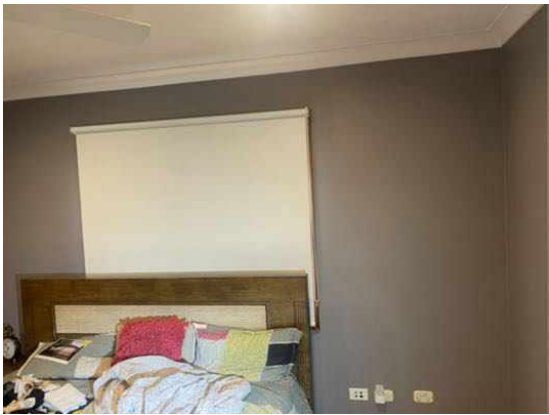
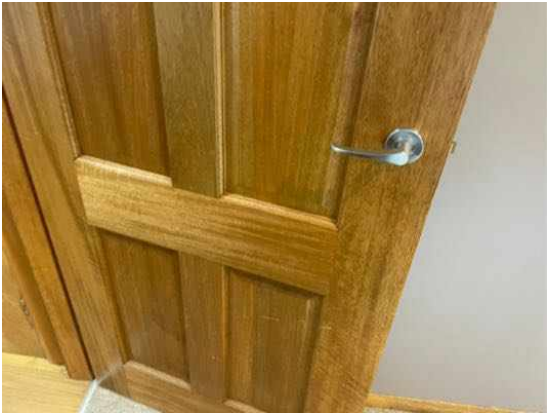
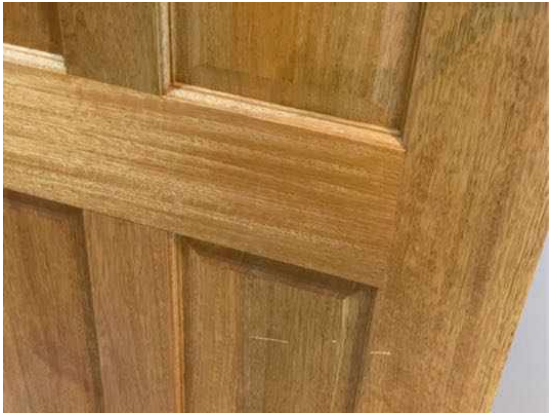
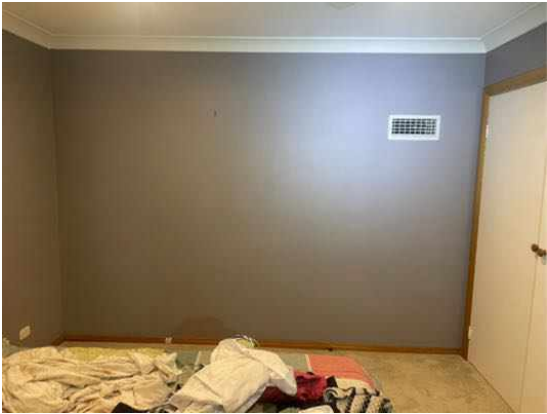
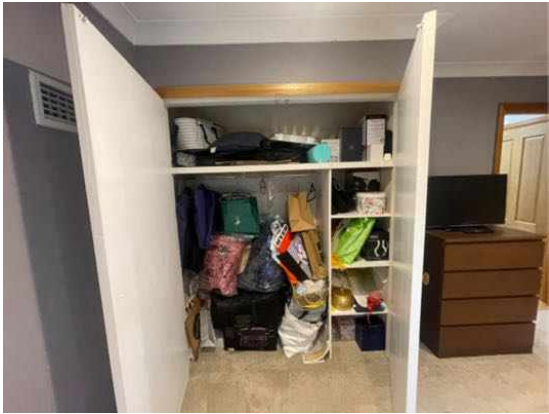
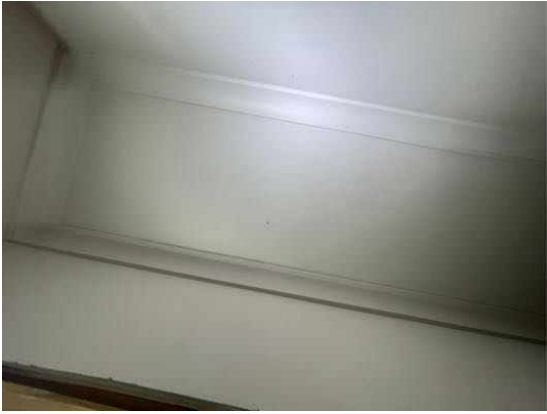
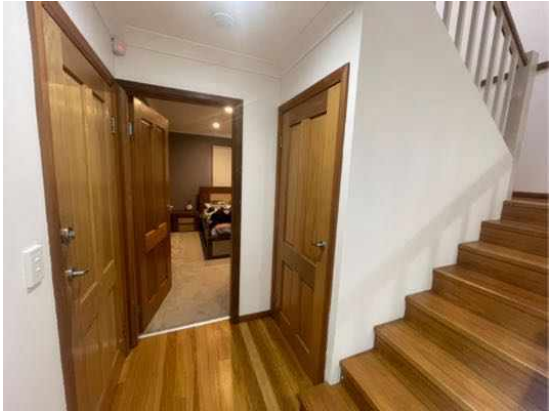
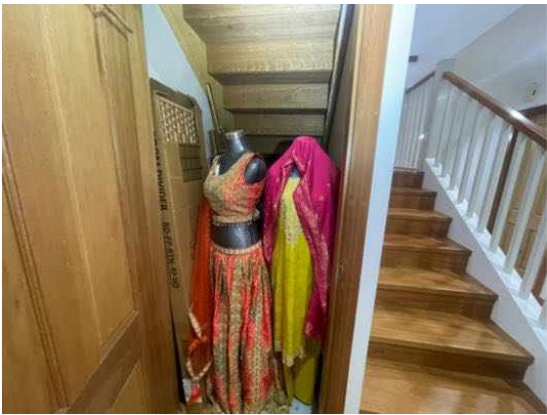
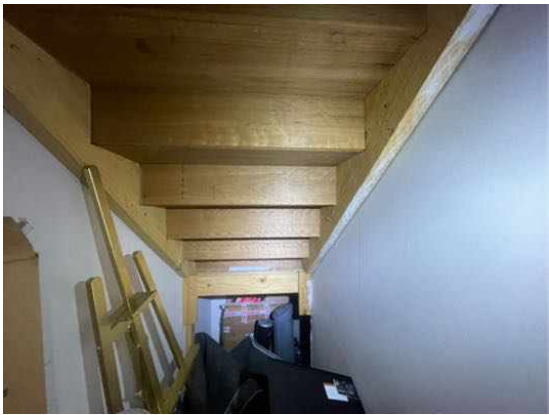
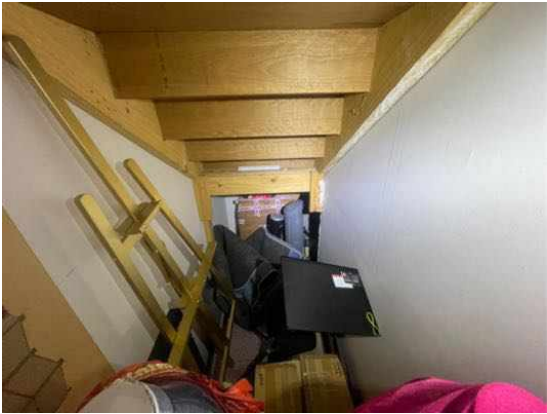
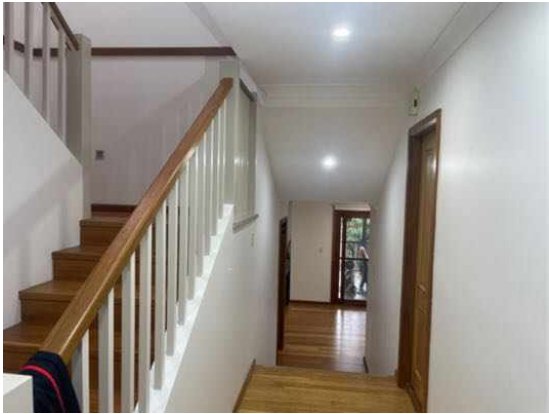
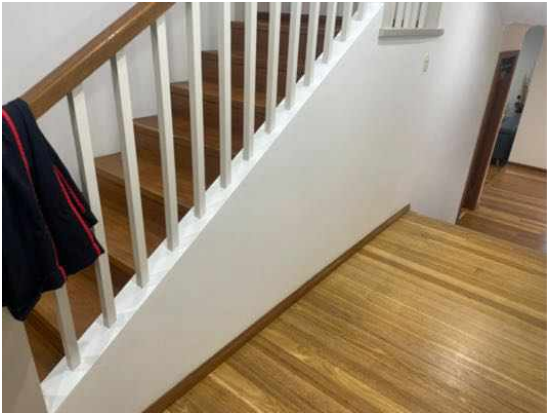
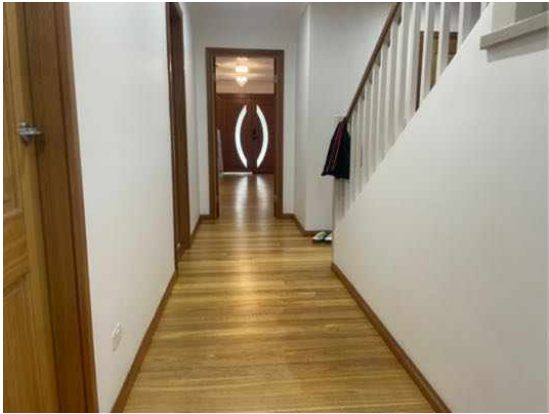
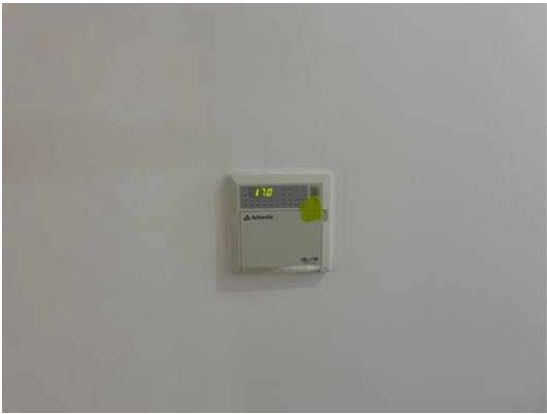
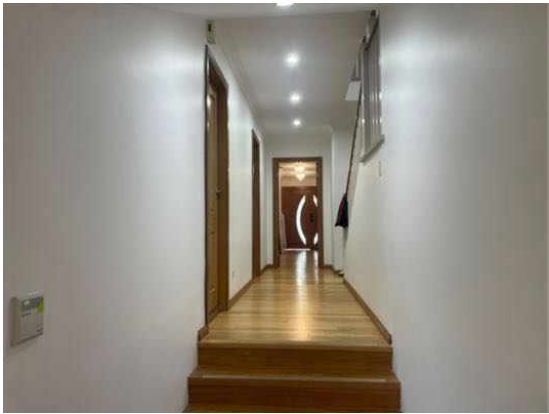
Building: Main Building  
Location: All Internal Areas  
Finding: Inspection Photographs and Access Limitations  
Information: Photographs taken at the time of inspection are attached to this report and form part of the inspection record. The photographs are provided to support and illustrate the observations made and reflect the condition of the property at the time of inspection only.

At the time of inspection, access and visibility were restricted in multiple areas of the property due to obstructions, site conditions, and physical constraints present on the day. Areas affected by restricted or obstructed access included the subfloor, interior areas, exterior areas, roof cavity, and roof exterior. As a result, these areas could not be fully inspected, and the inspection was limited to building elements that were reasonably accessible and visible at the time.
