Building and Timber Pest Inspection Report

Inspection Date: Tue, 10 Feb 2026

Property Address: 309/9-11 Arncliffe St, Wollri Creek NSW
2205, Australia

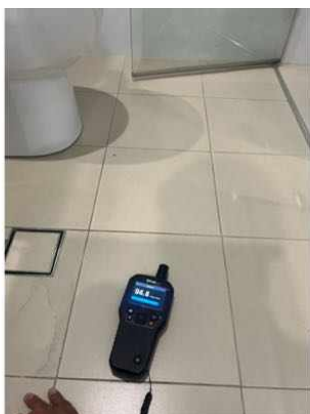
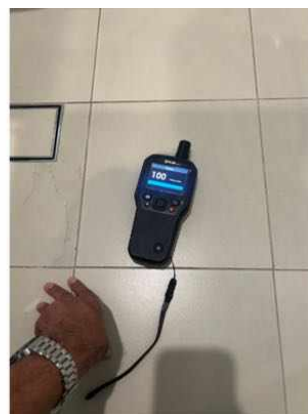
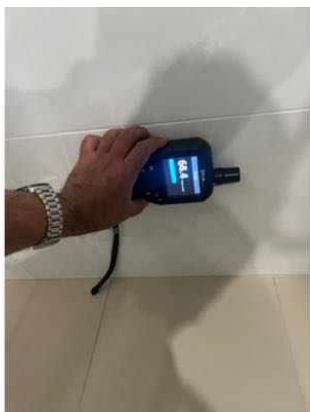
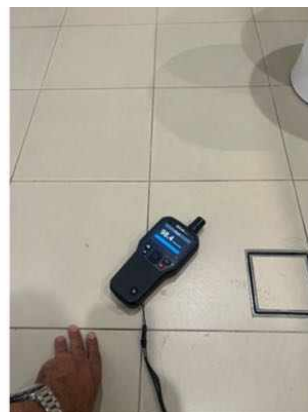
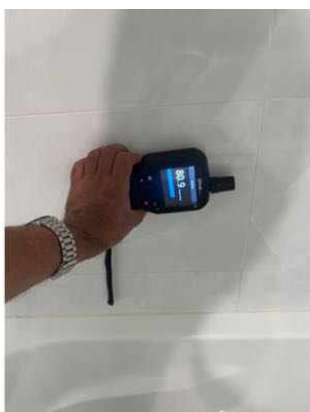
Finding 3.02

Building:	Main Building
Location:	Bathroom, Ensuite
Finding:	Elevated Moisture Bathroom (No visible deterioration noted)
Information:	Elevated moisture levels were detected to tiled surfaces in bathroom/shower areas. Persistent moisture ingress can lead to concealed damage, including timber rot and mould growth.

Elevated moisture readings in tiled wet areas can occur from normal shower use, age/deterioration of waterproofing membranes, plumbing leaks or moisture absorption through grout lines. While no damage was visible, elevated readings may indicate moisture retention behind tiles, which can be a conducive condition for future deterioration if not monitored.

No immediate action required. Monitor the area over time for signs of drumming, efflorescence, tile movement, or grout deterioration. If concerns arise, a licensed waterproofing specialist can perform further investigation (e.g., pressure testing, membrane assessment).

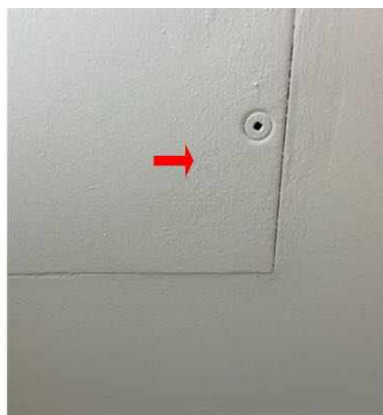
Finding 3.03

Building:	Main Building
Location:	Bathroom
Finding:	Water Staining - Humidity or Ventilation
Information:	The ceiling surface shows peeling paint and water staining on the walls faint commonly consistent with humidity-related staining, often found in bathroom or wet areas with insufficient ventilation. While there is no visible sagging or major water damage, the pattern suggests prolonged moisture exposure, possibly due to steam accumulation or minor condensation issues. According to AS 4349.1-2007 (Appendix C), this would be classified as a minor defect unless further deterioration or active leaks are found. Recommend improving mechanical or natural ventilation, cleaning the

surface with mould treatment, and monitoring for recurrence.

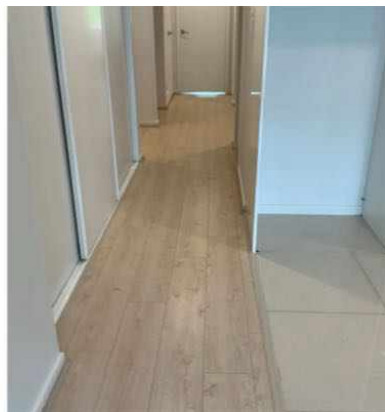
Finding 3.04

Building:	Main Building
Location:	All Areas
Finding:	Uneven Laminate Floor
Information:	unevenness was observed to sections of the laminate flooring. This condition is typically associated with installation tolerances, minor subfloor irregularities, or natural movement of a floating floor system. While not considered a major defect, the unevenness may present a minor trip hazard and lead to accelerated wear of the flooring if left unrectified. Monitoring and, if required, localised rectification by a flooring contractor is recommended.

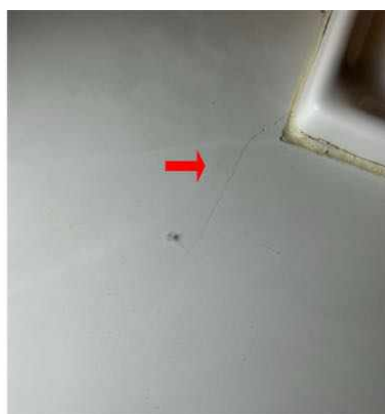
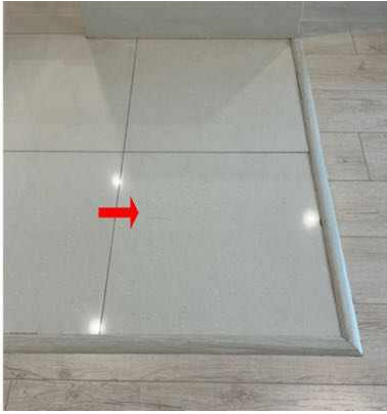
Finding 3.05

Finding: Tiles - Cracked or damaged

Information: Cracking was evident to the tiling in this area at the time of inspection. While the cracking appears to be minor, this area is frequently exposed to water, allowing potential for water penetration into adjoining sections of walls or flooring.

If left unmanaged, water penetration to these areas may lead to subsequent water damage, which is likely necessitate repair work to affected building elements.

A tiling contractor should be appointed to ensure that no further water damage occurs. The re-application of silicone and grouting throughout remaining tile work is also advised, to further protect the area against water penetration.

Where water penetration has led to water damage, appointment of a relevant tradesperson may be required to repair damaged building elements.

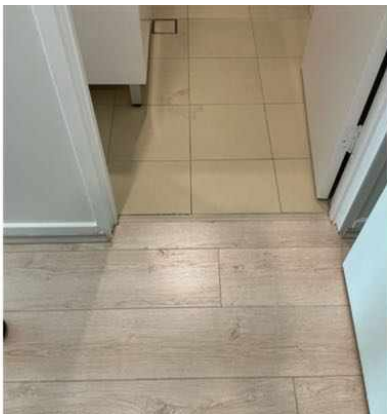
Finding 3.06

Information: The bathroom floor is at the same level as the adjoining timber flooring. This configuration is typical in modern apartments and is permitted where compliant waterproofing and floor falls are provided. No evidence of moisture damage was observed at the time of inspection; however, waterproofing performance cannot be confirmed without invasive inspection.

Care should be taken to avoid excessive water migration beyond the bathroom during use.

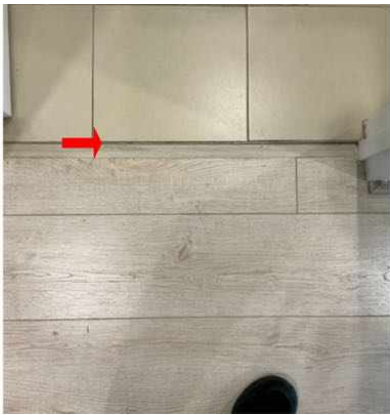
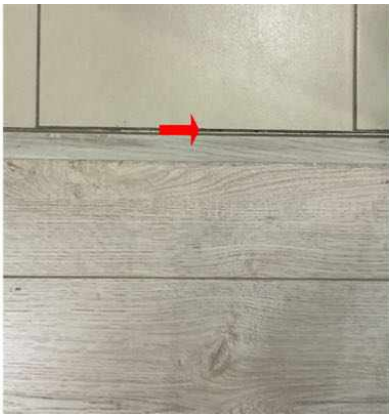
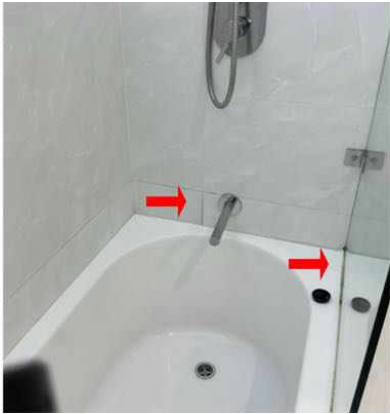
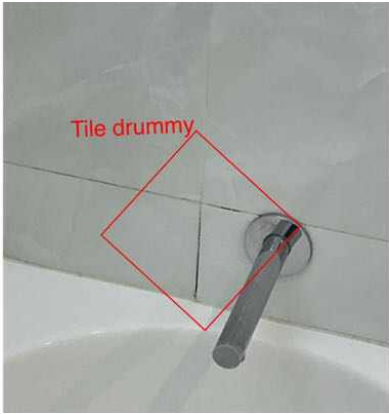
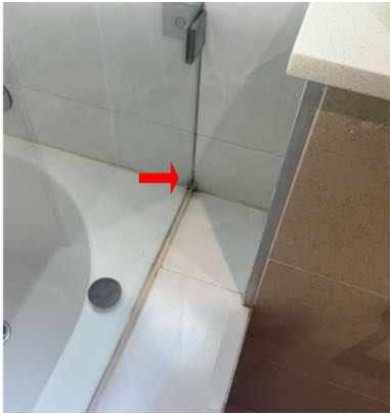
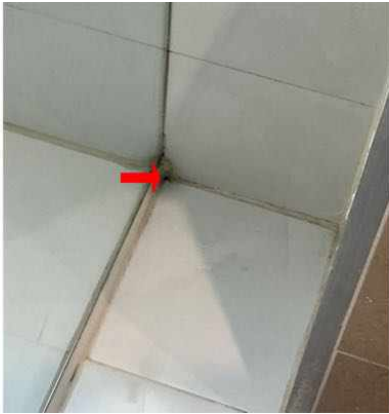
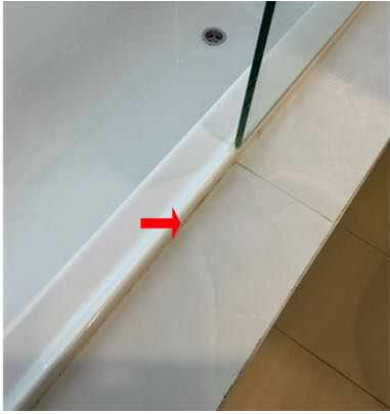
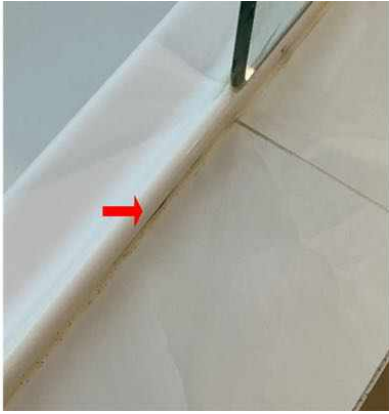
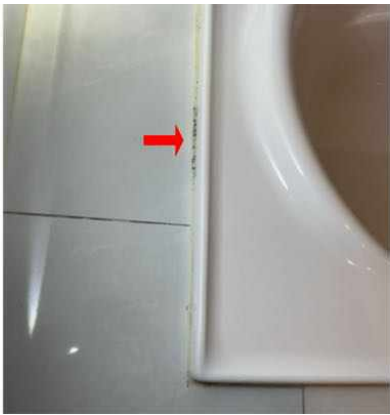
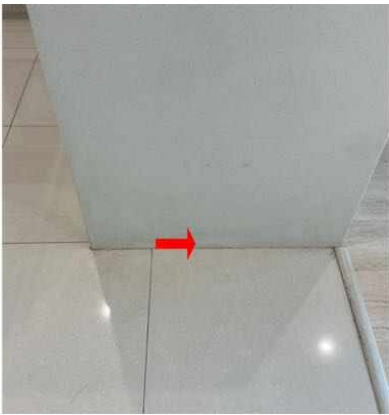
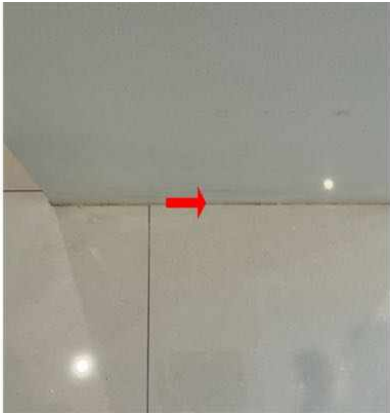
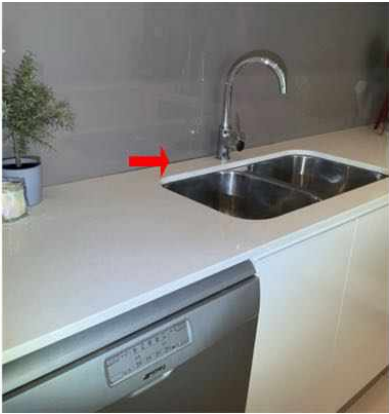
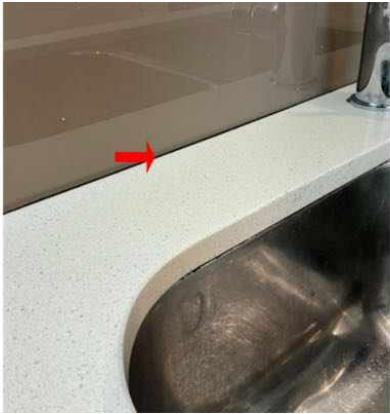
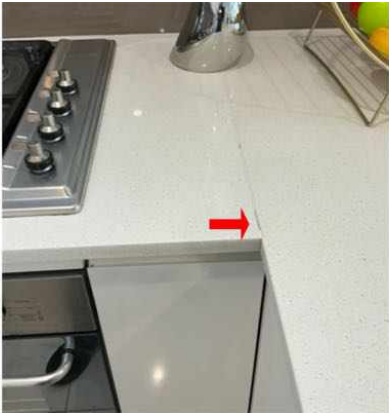
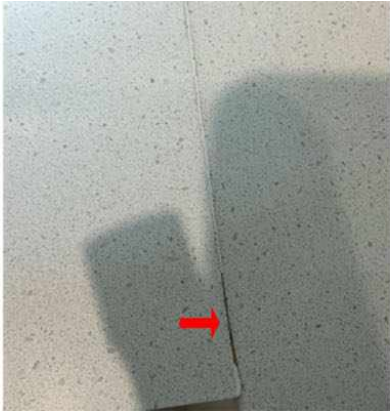
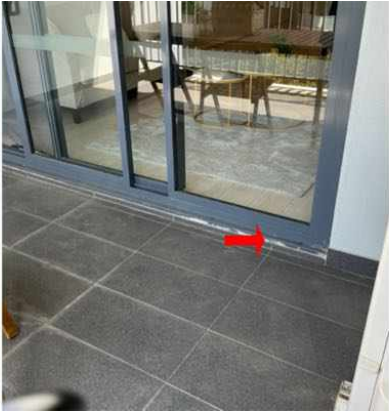
Building:	Main Building
Location:	All Internal Areas
Finding:	Sealant and grouting - Missing or degraded
Information:	It was noted on inspection that sealant or grout is degraded. There is also evidence of poor workmanship and excessive use of sealant. Silicone should never be used as a

first line of defence against waterproofing. Further inspection by a licensed waterproofing contractor is highly recommended.

Different materials and floor areas move at different rates, generally causing cracking to grout or sealant at this point. A flexible sealant is required to allow for expected expansion and contraction, while keeping the joint water tight and protective of all associated building materials.

A sealant specialist or tiling contractor should be appointed to complete these works as soon as possible.

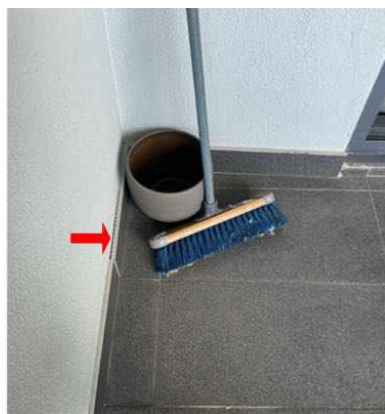
Finding 3.09

Building:	Main Building
Location:	All Internal Areas
Finding:	Paint finish and hairline cracking
Information:	The paint finish in this area was identified as being incomplete at the time of inspection including some hairline minor cracking.

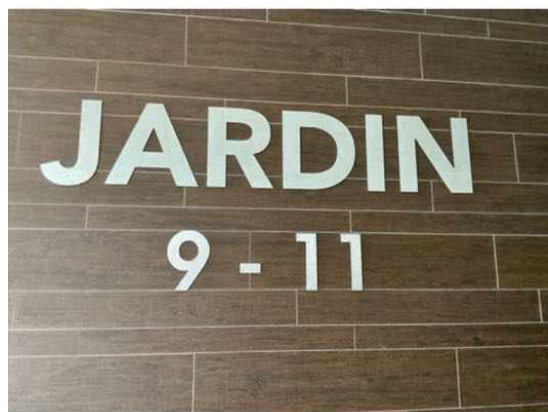
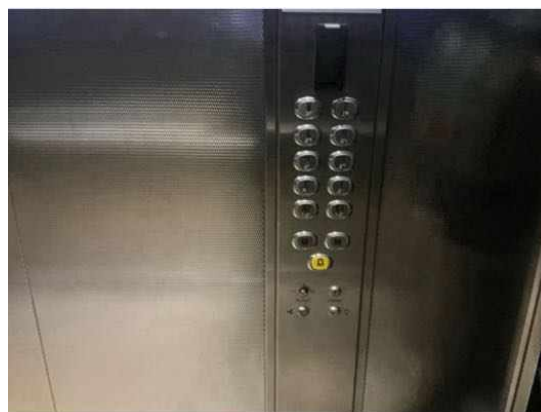
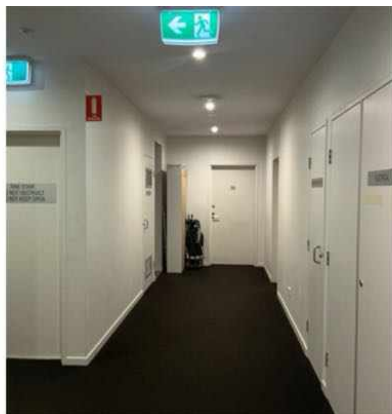
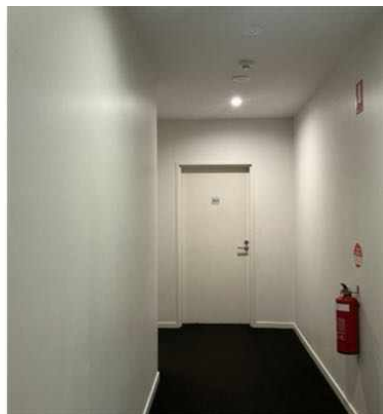
Noted Item

Building: Main Building
Location: All External Areas
Finding: Additional Photos - Obstructions and Limitations
Information: These photographs are an indication of the obstructions and limitations which impeded full inspection of the property at the time of inspection. These obstructions can hide an array of defects and should be removed to allow full inspection to be carried out. A re-inspection is recommended once the areas are made accessible.

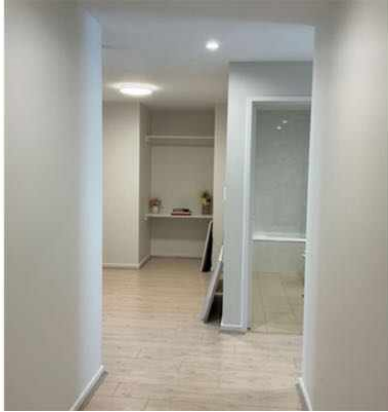
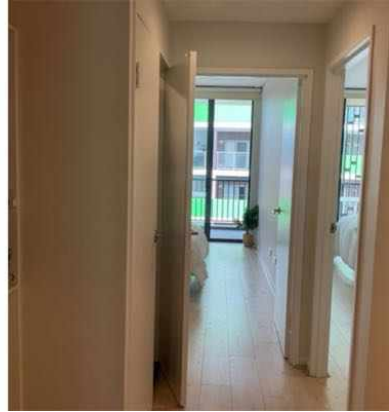
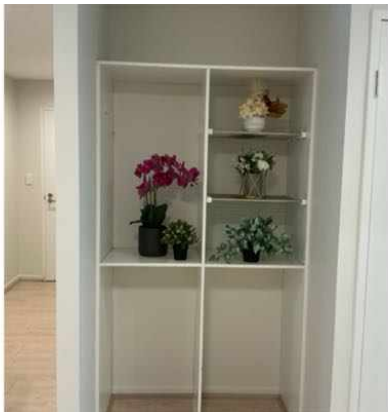
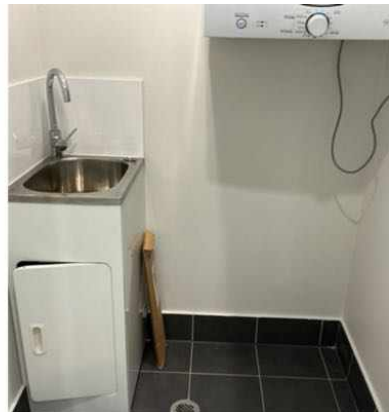
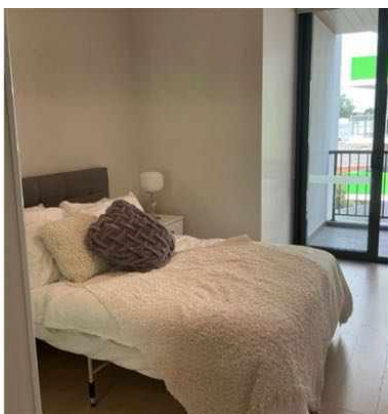
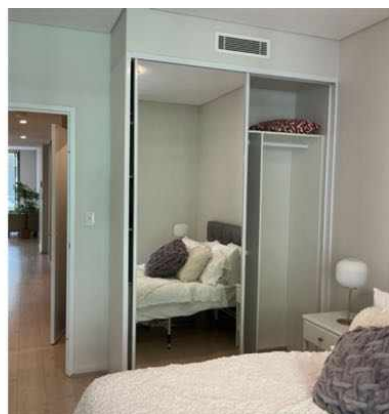
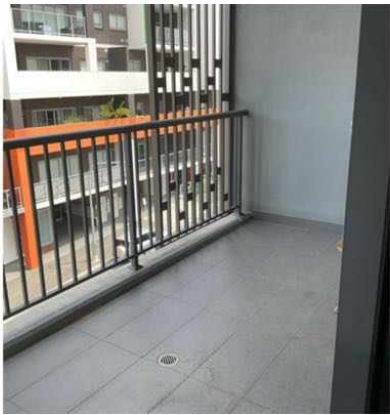
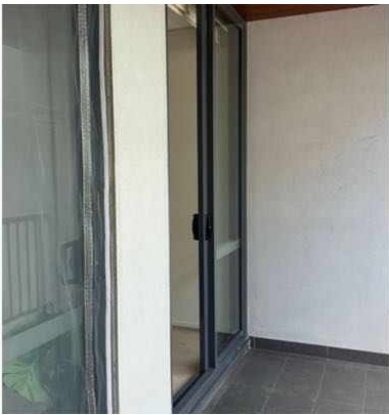
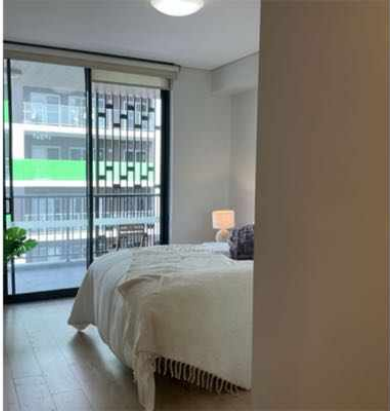
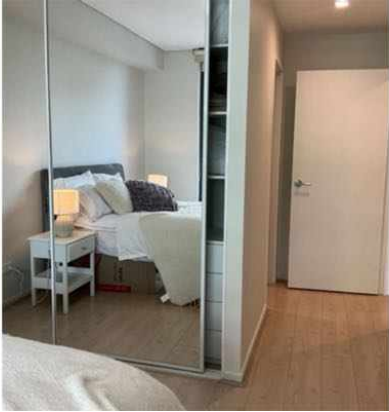
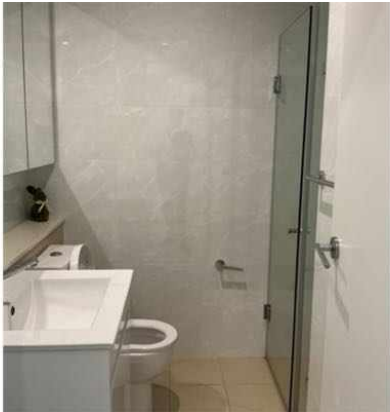
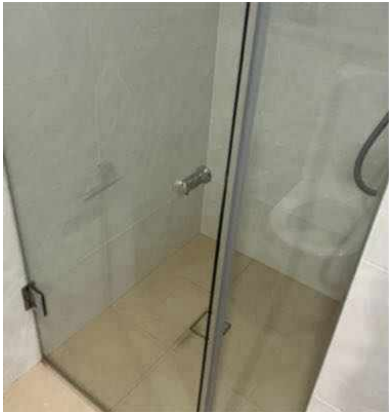
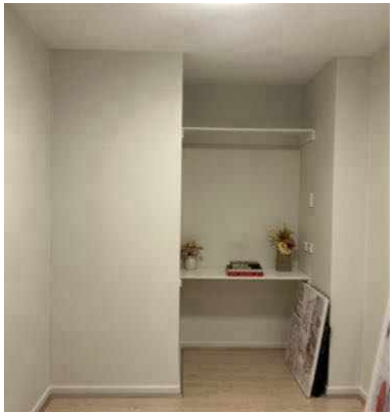
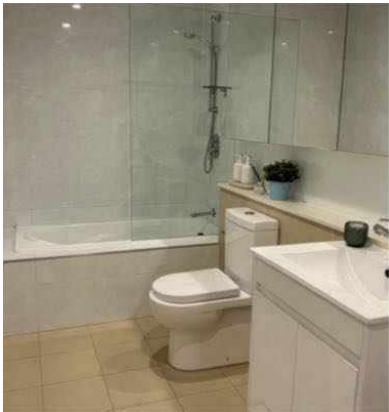
Building: Main Building
Location: All Internal Areas
Finding: Additional Photos - Obstructions and Limitations
Information: These photographs are an indication of the obstructions and limitations which impeded full inspection of the property at the time of inspection. These obstructions can hide an array of defects and should be removed to allow full inspection to be carried out. A re-inspection is recommended once the areas are made accessible.
