Building Inspection Report

Inspection Date: Thu, 2 Apr 2026

Property Address: 65 Highgate Dr, Flagstone QLD 4280,
Australia

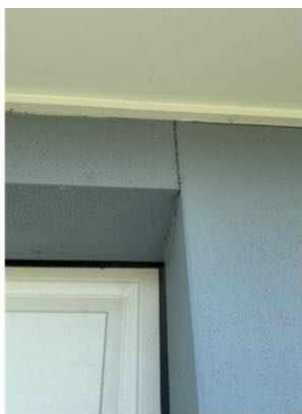
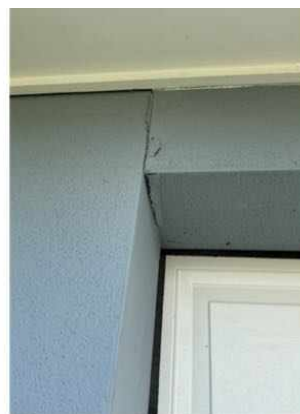
Defects 3.03

Building:	Main Building
Location:	Exterior walls - front garage > Front
Finding:	Cracks to external render - Category 2
Information:	It has been observed that cracking to external rendered surfaces has occurred. The degree of damage falls within Category 2, described as noticeable cracks which are easily filled. Cracking of this size are generally less than 5mm in width.

Category 2 damage is required to be monitored for a period of 12 months. After the monitoring period, a crack rated at Category 2 or above is considered a defect requiring rectification.

Always contact your building inspector should cracks widen, lengthen, or become more numerous.

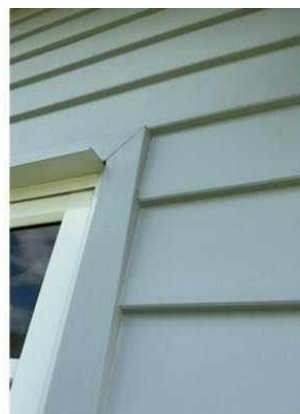
Defects 3.05

The sealant has deteriorated leaving openings at junctions, this may allow water ingress into the wall cavity which may cause moisture damage to framing and wall linings.

This may also result in premature deterioration of adjoining building elements.

A handyman or sealant technician may be required to rectify this condition.

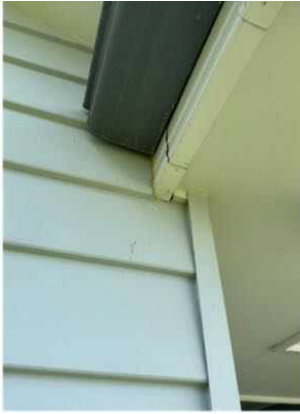
Defects 3.06

Building:	Main Building
Location:	Roof plumbing > Front
Finding:	Water staining
Information:	Water staining was evident in this area at the time of inspection. Water staining indicates that surfaces have been exposed to excessive moisture over time. The minerals and other elements in the water lead to staining, which may graduate to corrosion and deterioration if left unmanaged.

While mostly an appearance defect, water staining can be indicative of more serious defects, which may be currently concealed by other building elements.

Where water staining is active, a licensed plumber must be consulted to identify the cause of the staining and to provide advice on any reparation works that may be required. Replacement of any broken or damaged structures is advised.

Conversely, where water staining is old and inactive, affected building materials may be repaired or replaced at client discretion. A qualified carpenter or registered builder may be appointed to perform these works.

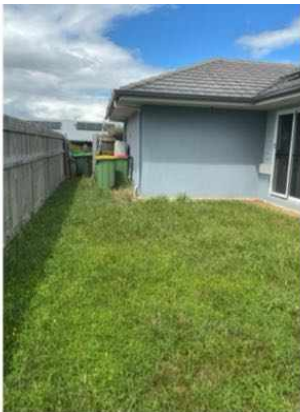
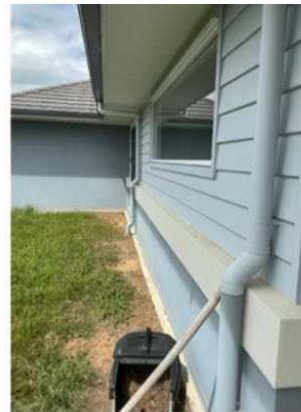
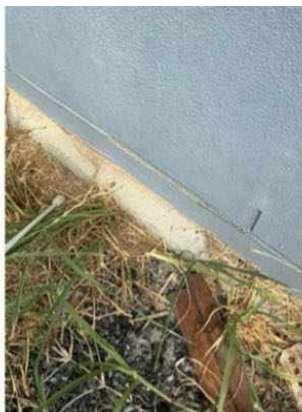
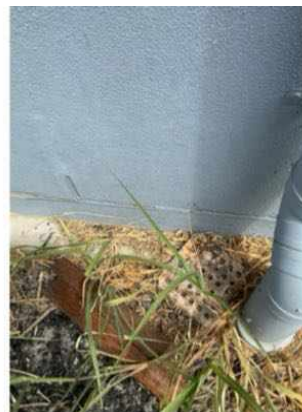
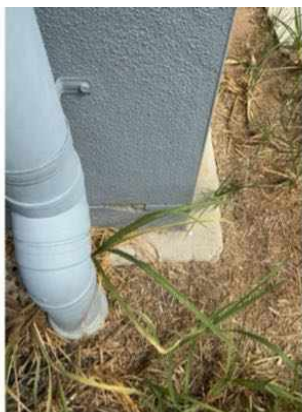
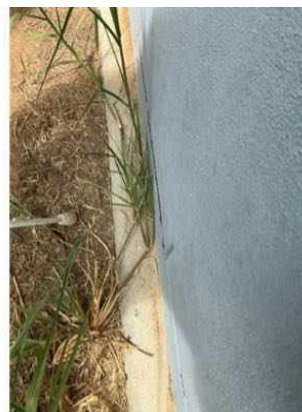
Defects 3.07

Building:	Main Building
Location:	Exterior walls - right side > Rear Right
Finding:	Cracks to external render - Category 2
Information:	It has been observed that cracking to external rendered surfaces has occurred. The degree of damage falls within Category 2, described as noticeable cracks which are easily filled. Cracking of this size are generally less than 5mm in width.

Category 2 damage is required to be monitored for a period of 12 months. After the monitoring period, a crack rated at Category 2 or above is considered a defect requiring rectification.

Always contact your building inspector should cracks widen, lengthen, or become more numerous.

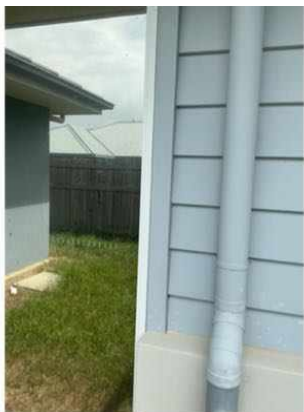
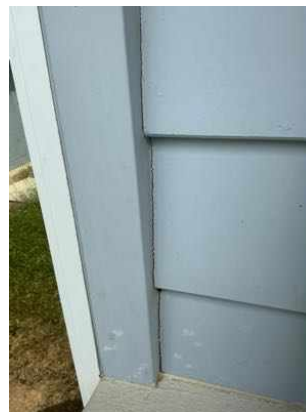
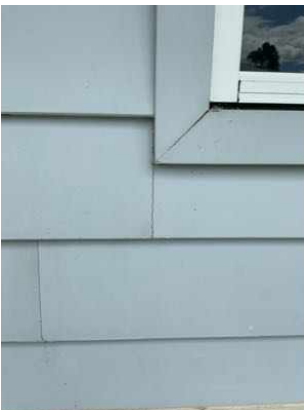
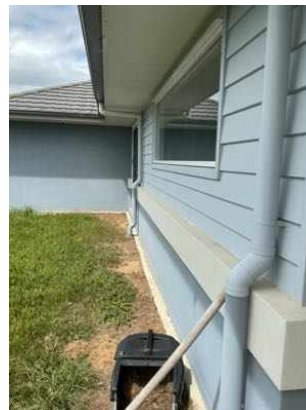
Defects 3.08

Building:	Main Building
Location:	Cladding > Rear Right
Finding:	Gaps - in external cladding gaps
Information:	Gaps are present in sealant to external cladding joints.

The sealant has deteriorated leaving openings at junctions, this may allow water ingress into the wall cavity which may cause moisture damage to framing and wall linings.

This may also result in premature deterioration of adjoining building elements.

A handyman or sealant technician may be required to rectify this condition.

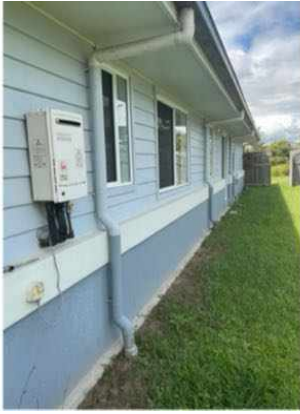
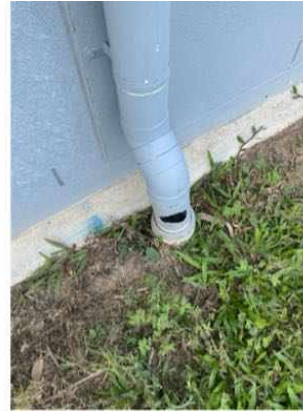
Defects 3.09

Building:	Main Building
Location:	Exterior walls - left side > Rear Left
Finding:	Exterior roof plumbing - Leaking
Information:	Active gutter leaks were evident at the time of inspection. Roof leaks can have a number of causes, including damage to gutter joints, deterioration of roof fixtures and fittings, or loosely associated materials (fascias etc.)

A roof plumber should be appointed as soon as possible to primarily identify the cause of the leak, and to provide subsequent repair works as necessary. Depending on the extent of the damage, replacement of sections of the roof gutter may be required, and may be performed by a roof plumber.

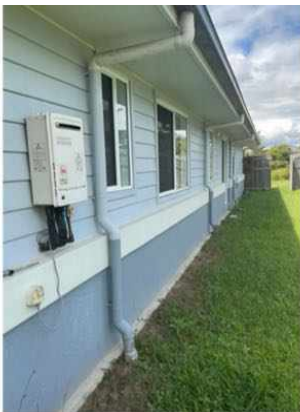
Defects 3.10

Building: Main Building
 Location: Cladding > Rear Left
 Finding: Gaps - in external cladding gaps
 Information: Gaps are present in sealant to external cladding joints.

The sealant has deteriorated leaving openings at junctions, this may allow water ingress into the wall cavity which may cause moisture damage to framing and wall linings.

This may also result in premature deterioration of adjoining building elements.

A handyman or sealant technician may be required to rectify this condition.

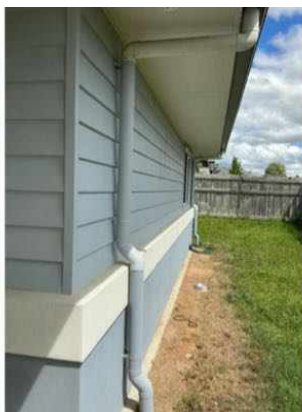
Defects 3.11

The gap comprises the weatherproofing of the opening and may allow water ingress moisture penetration or air leakage.

Re sealing and painting is required.

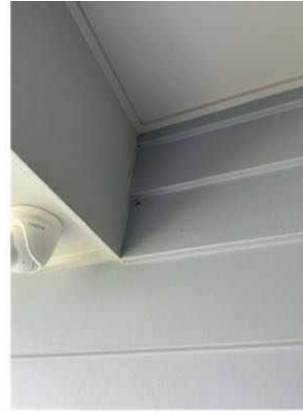
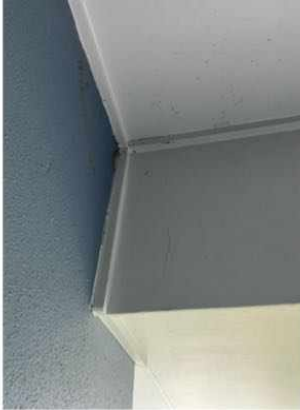
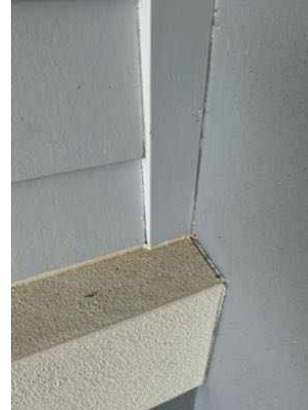
Defects 3.14

Building:	Main Building
Location:	Porch > Front
Finding:	Beading - gap
Information:	Beading acts (like cornice or skirtings) to cover the intersection or joins of building materials. It was noted at the time of inspection that beading in this area has minor gaps. This deterioration is suspected to have been caused by general ageing, which is expected in a building of this age and condition.

Beading is important in weatherproofing the surrounding building elements and preventing termite or pest ingress. Furthermore, beading works to protect the joins of building materials, which are more susceptible to deterioration and decay.

Repair or replacement of the beading is advised to ensure the protection and longevity of any associated building elements. Such works may be performed by a general handyperson or qualified carpenter.

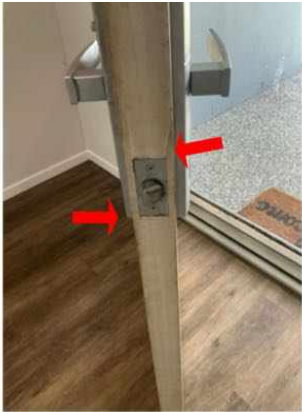
Defects 3.15

Building: Main Building
Location: Entry/hallway > Front
Finding: Door skin-split
Information: At time of inspection it was noted that the door skin was split.

This may be due to accidental damage or minor impact.

The door maybe required to be re paired by a qualified carpenter.

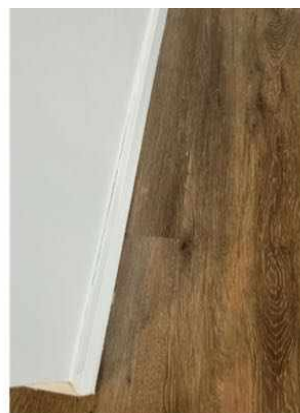
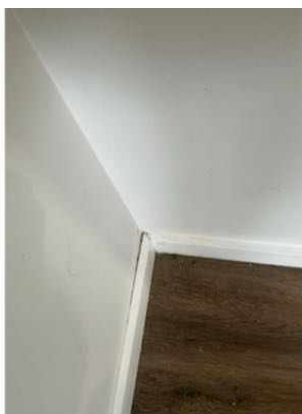
Defects 3.17

Building: Main Building
 Location: Theatre Room > Rear
 Finding: Beading - Missing
 Information: Where beading (also known as 'quad' or rubber seals) are missing from glazing, the area is more susceptible to deterioration and decay, and is more likely to allow water ingress.

If the lack of beading or rubber seals is not addressed, the structure will generally age more quickly. This deterioration may subsequently lead to secondary building defects in adjoining building materials, as well as reducing the insulation properties of the

window.

A general handyman or window specialist should be appointed as soon as possible to install adequate sealing to this area.

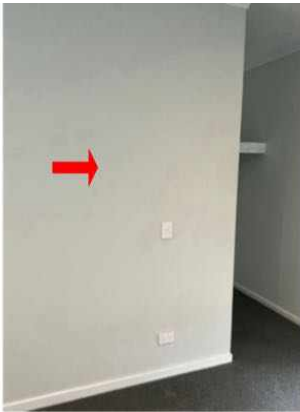
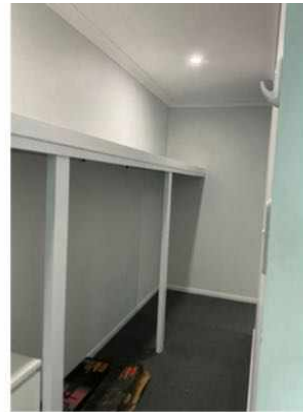
Defects 3.18

Building:	Main Building
Location:	Bedroom - Master > Centre
Finding:	Plaster - Drummy
Information:	Sections of plaster sheeting in this area appear to be drummy. The term 'drummy' is used to describe plaster which, whilst solid, has become detached from its original fixing.

The most common causes of plaster failure are physical damage and moisture damage. Moisture causes plaster to swell and shrink as the humidity of the air changes, or as a consequence of leaks, which can be enough to create drumminess or cracking.

Ensure that the general environment is free of moisture and humidity to aid in the prevention of drummy plaster and plaster damage. Appointment of a qualified

plasterer is advised in order to complete remedial works as necessary.

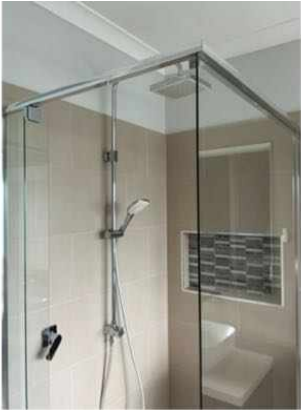
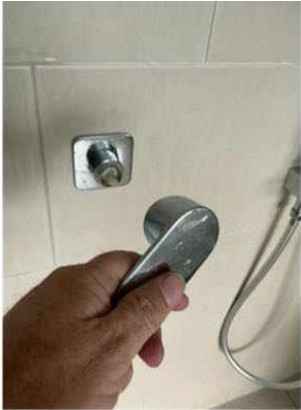
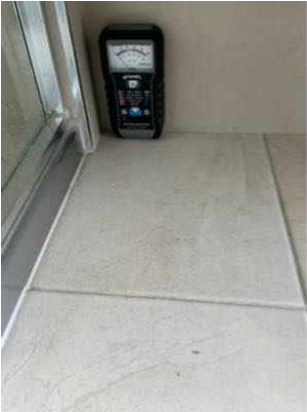
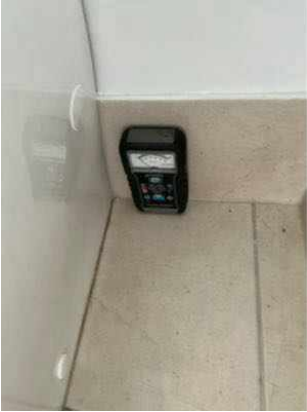
Defects 3.19

Building:	Main Building
Location:	Ensuite - Master > Existing
Finding:	Tap - Loose
Information:	The tap in this area has not been installed correctly, or has deteriorated with age, and is consequently loose. This tap being loose creates potential for water leaks and subsequent water damage to the surrounding area.

Where taps or spouts are loose, a qualified plumber should be appointed to re-fix the

plumbing fitting.

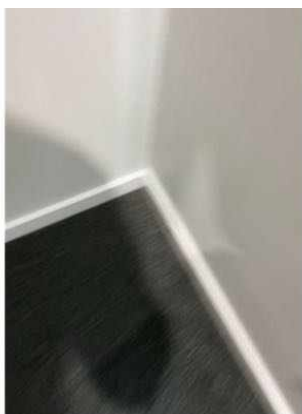
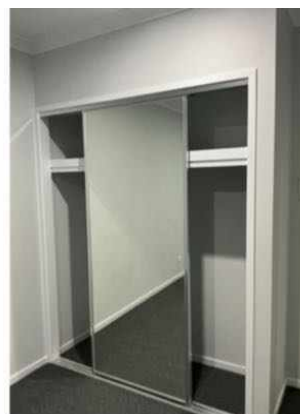
Defects 3.20

Building:	Main Building
Location:	Bedroom 3 > Rear Right
Finding:	Beading - gap
Information:	Beading acts (like cornice or skirtings) to cover the intersection or joins of building materials. It was noted at the time of inspection that beading in this area has minor gaps. This deterioration is suspected to have been caused by general ageing, which is expected in a building of this age and condition.

Beading is important in weatherproofing the surrounding building elements and preventing termite or pest ingress. Furthermore, beading works to protect the joins of building materials, which are more susceptible to deterioration and decay.

Repair or replacement of the beading is advised to ensure the protection and longevity of any associated building elements. Such works may be performed by a general handyperson or qualified carpenter.

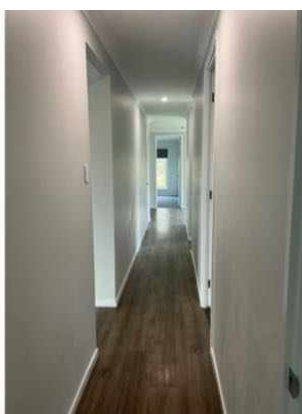
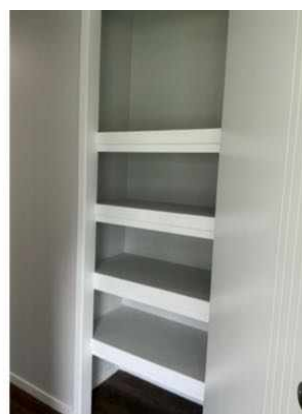
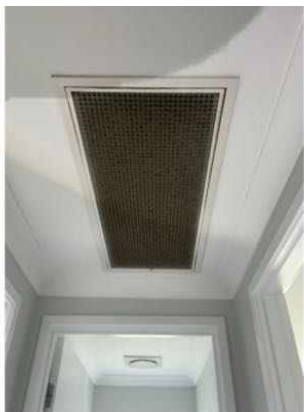
Defects 3.23

Building:	Main Building
Location:	Hallway > Centre
Finding:	Air vents - Blocked or inadequate
Information:	It was noted at the time of inspection that the subfloor area lacks adequate ventilation. The cause of this inadequate ventilation is the state of the air vents to the subfloor area. Where air vents are insufficient in number or are blocked, either fully or partially, subfloor ventilation is decreased.

A well ventilated subfloor aids in maintaining dry conditions, preventing secondary damage such as wood rot and pest activity, as well as preventing the development of mould/fungi and mildew (which can lead to major respiratory issues or safety hazards for occupants, particularly the elderly, the very young and those with existing illnesses).

All air vents should be cleared of blockages to promote adequate air flow to the area. Where ventilation is still insufficient, retrospective installation of air vents may be required. Appointment of a registered builder may be required to perform these works as necessary.

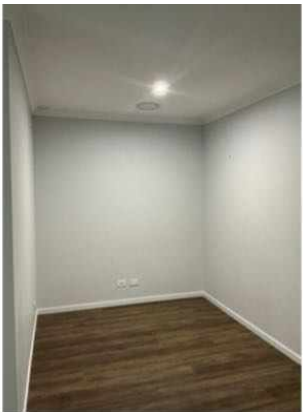
Defects 3.24

Building: Main Building
Location: Family Room > Existing
Finding: Walls - Scuffed
Information: Superficial scuff marks were noted to the internal walls in this area at the time of inspection. Marked and scuffed surfaces, while detracting from the overall appearance of the affected building element, do not indicate any operational or structural damage. This degree of surface damage is consistent with general wear and tear.

Marked surfaces may be left at client discretion, as no repair/replacement is necessarily required. Marked surfaces are unlikely to result in the development of secondary damage; however, the client may wish to seek quotations for the cost to refurbish or replace the affected wall linings.

A general handyman or cleaning contractor may be appointed to rectify marked or scuffed surfaces at the client's discretion.

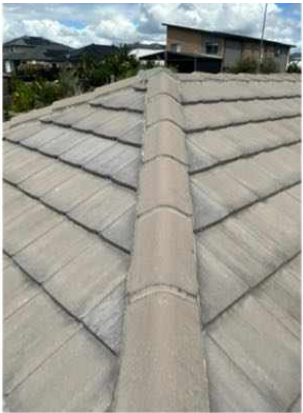
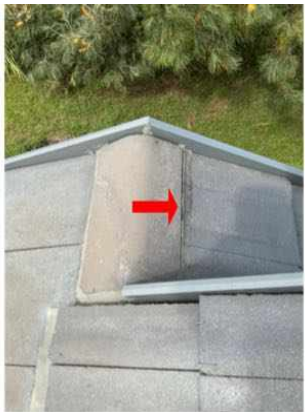
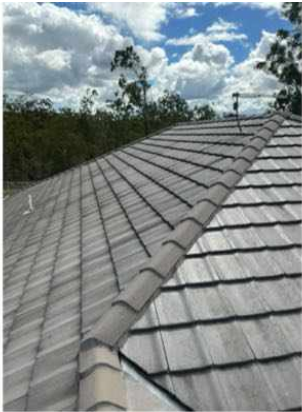
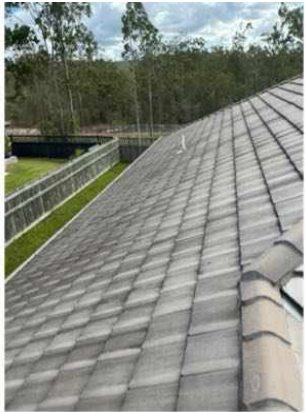
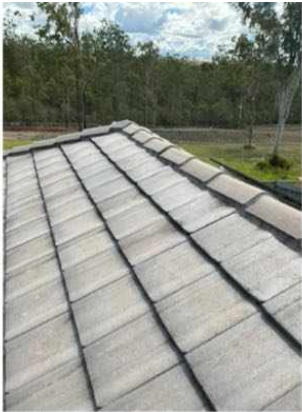
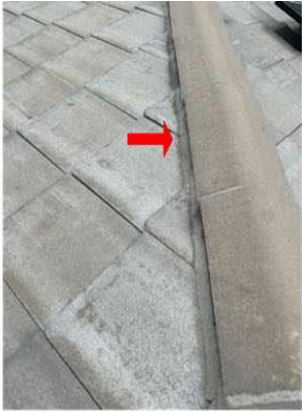
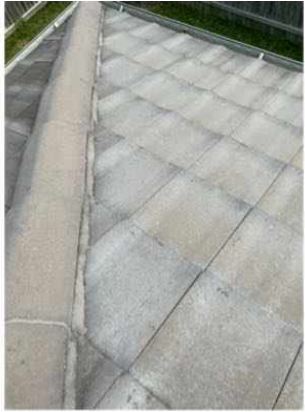
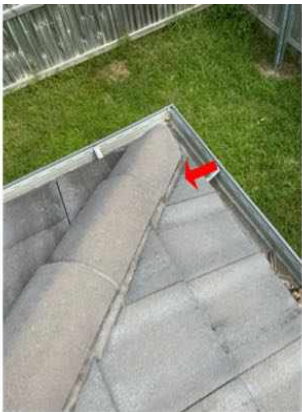
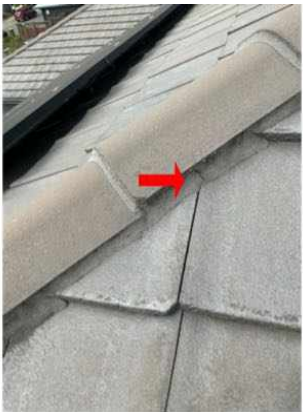
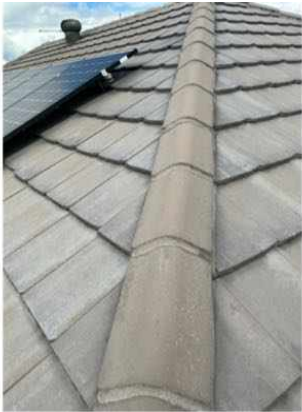
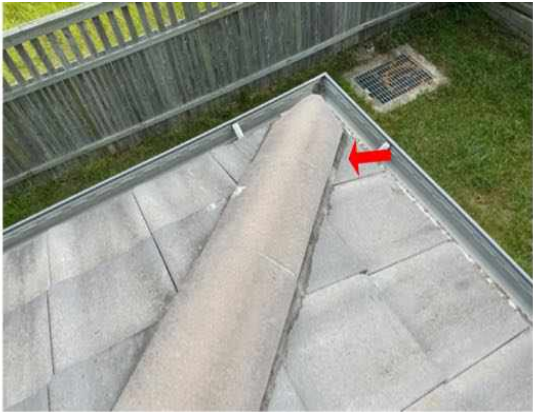
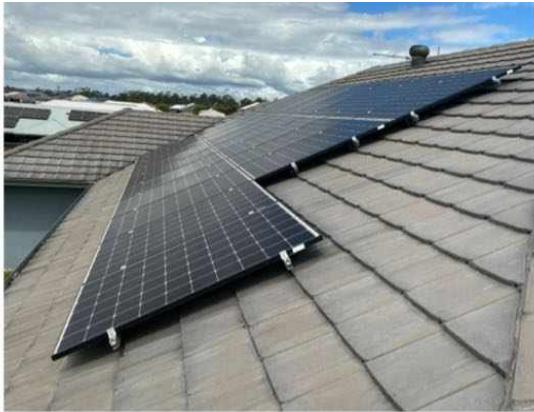
Defects 3.25

Building: Main Building
Location: Roof Exterior > Existing
Finding: Roof pointing- minor repairs
Information: At the time the of the inspection it was noted that the pointing in sections of the roof capping has deteriorated and minor repairs are required.

This due to age and uv damage which is common in properties of this age.

A roof tiler may be required to rectify this condition.

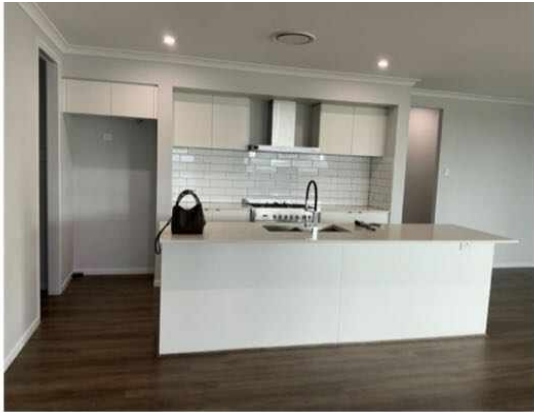
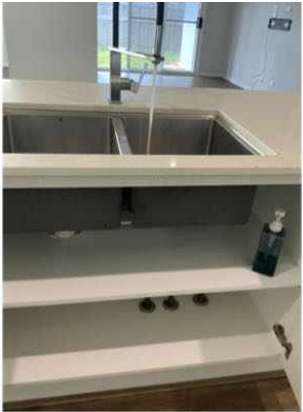
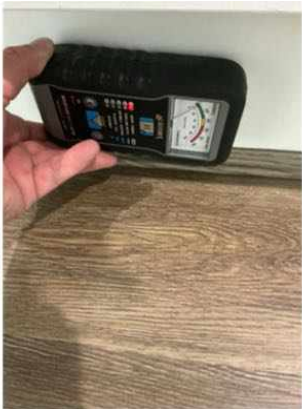
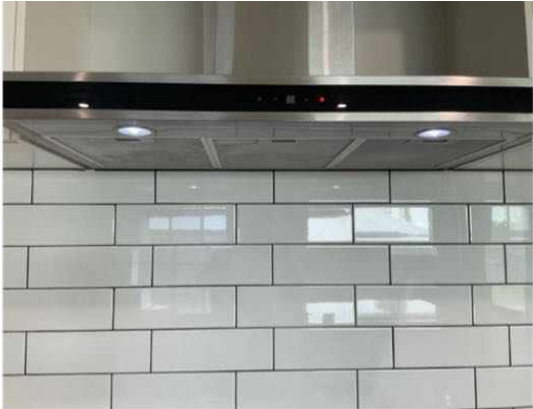
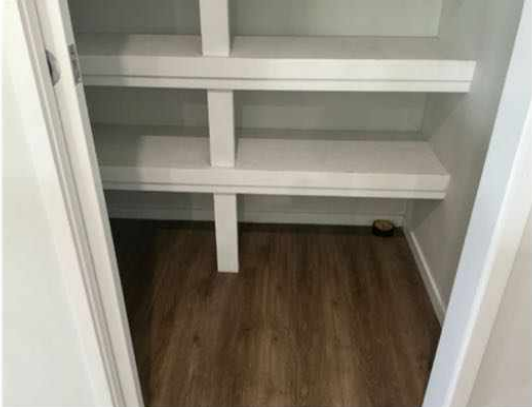
Building: Main Building
Location: Kitchen > Existing
Finding: Additional Photos
Information: Additional photos are provided for your general reference
