Building and Timber Pest Inspection Report

Inspection Date: Thu, 2 Apr 2026

Property Address: 49 Melba Rd, Lalor Park NSW 2147,
Australia

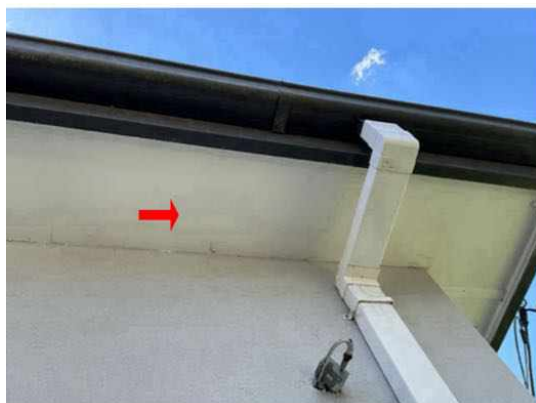
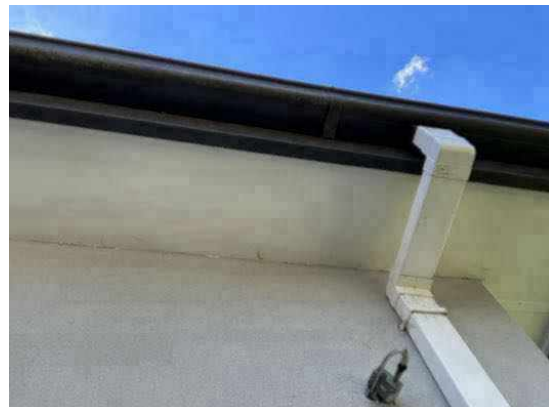
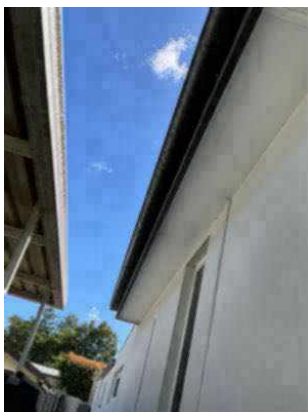
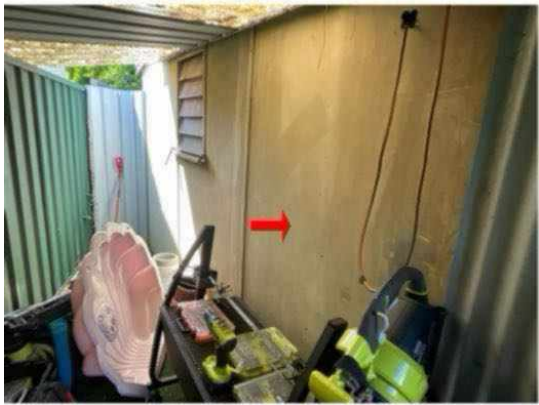
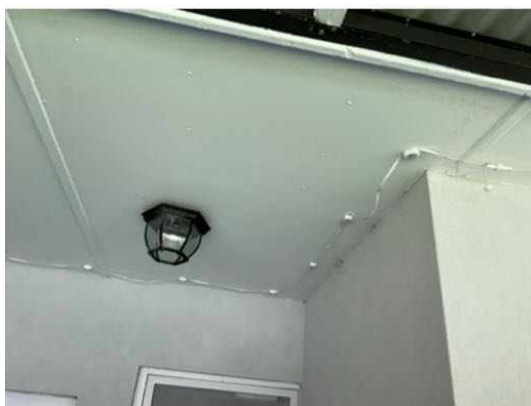
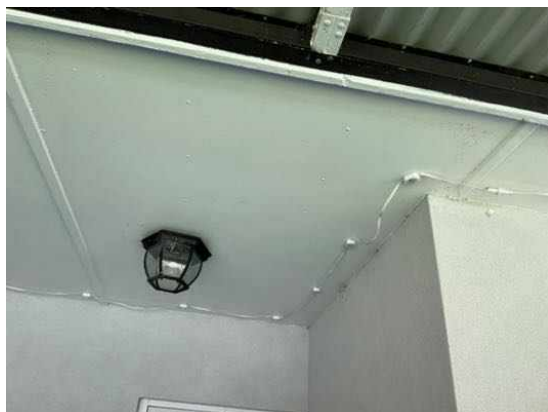
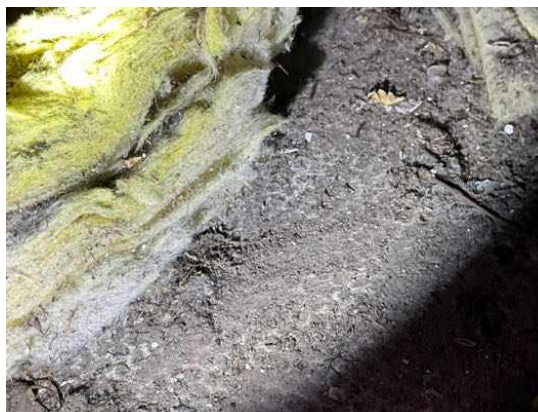
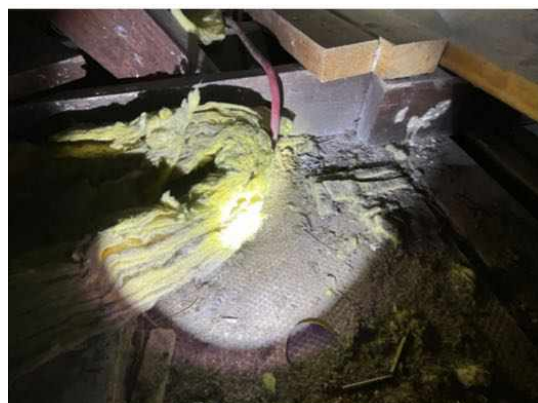
Information: Reporting on Asbestos is outside the Scope of this Report. This suspected defect is highlighted as a caution only. We suspect, based on our experience in the building industry, that there is a higher risk of the identified building element containing asbestos.

As Asbestos Reporting is outside the scope of this report, we advise that you consider a separate Asbestos Inspection and Condition Audit, which can include the taking of samples for definitive confirmation of the presence of Asbestos.

In the interim, the client is advised to act with caution, especially when considering any damage to building materials general wear and tear renovations extensions demolition and general maintenance activities due to the suspected presence of Asbestos.

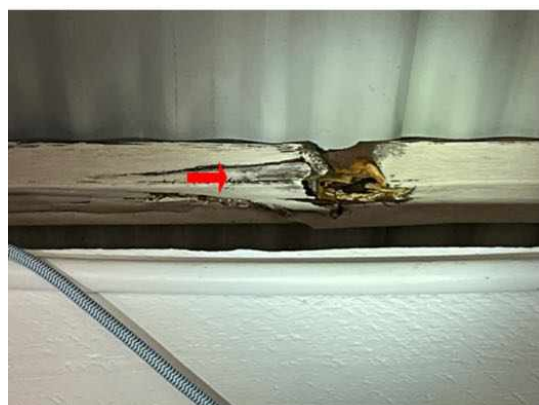
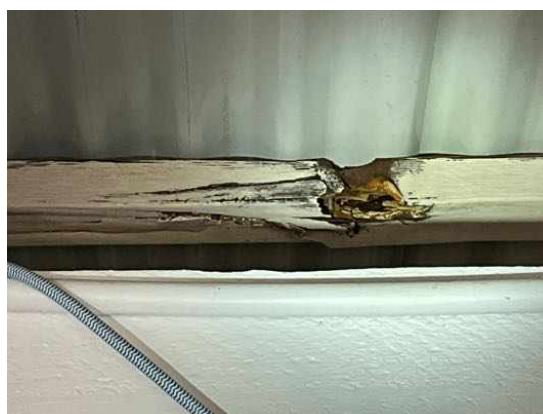
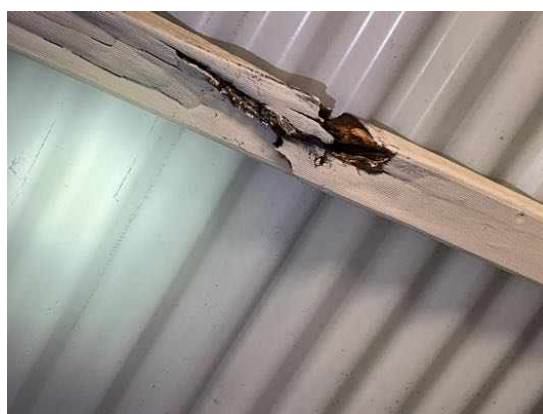
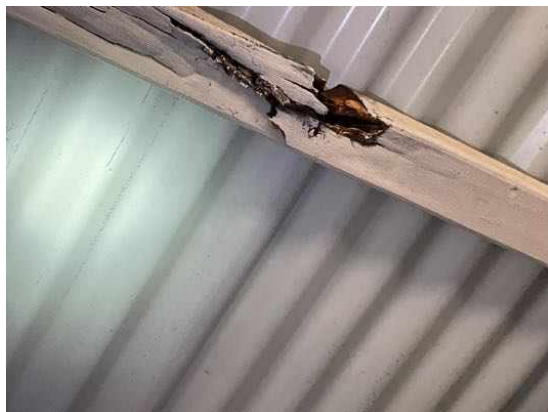
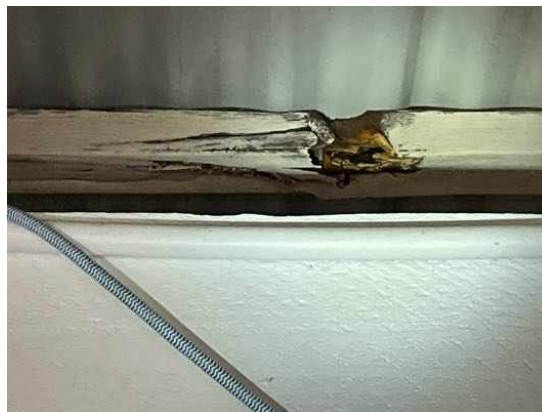
Finding 2.01

Building:	Main Building
Location:	Pergola
Finding:	Rot weakening the timber structure
Information:	Cracks and signs of wood rot have been observed, weakening the timber structure. The deterioration could be due to moisture exposure, aging, or insect infestation, compromising the structural integrity of the timber.

- ****Structural Instability:**** The cracks and wood rot can compromise the load-bearing capacity of the timber, potentially leading to structural failure or collapse, especially in load-bearing walls, beams, or frames.
- ****Safety Hazard:**** Weakening of the timber structure increases the risk of accidents, such as falling debris or collapse, posing a danger to occupants.
- ****Progressive Damage:**** If left unaddressed, wood rot can spread, further degrading the timber and accelerating the risk of structural failure.
- ****Pest Infestation:**** Wood rot can attract pests such as termites, which may cause additional damage.

A structural engineer or professional carpenter should be contacted to assess the extent of the damage. Depending on the severity, repairs may involve replacing the affected timber sections, treating the wood with preservatives, or reinforcing the structure. If there is extensive rot, a specialist in wood restoration or pest control may also be required to prevent further decay or infestation.

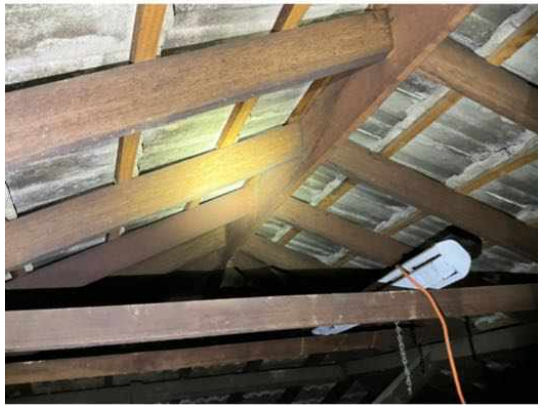
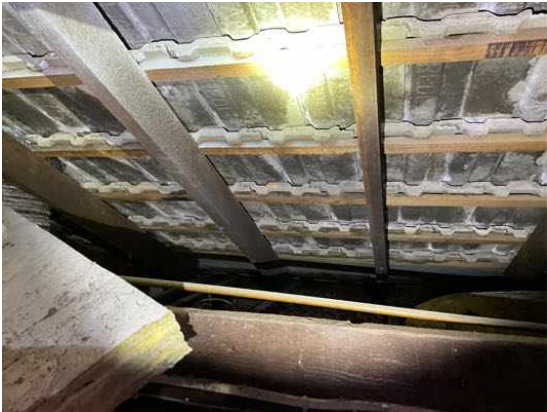
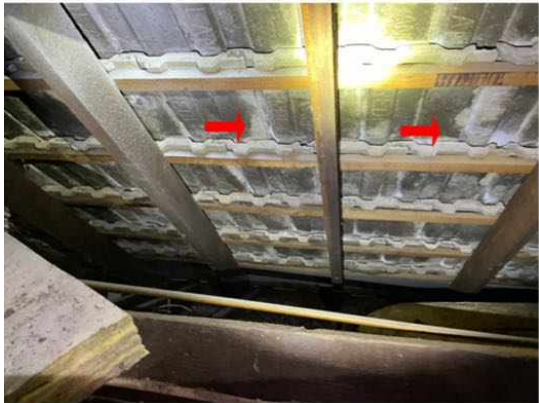
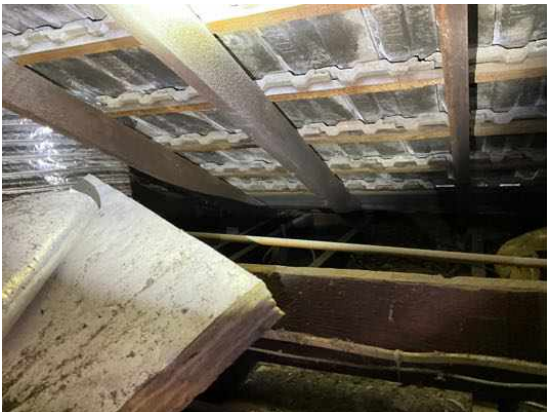
Finding 2.02

Building:	Main Building
Location:	Roof Void
Finding:	Roof void - Suspected water leak
Information:	Suspected water leak in the roof void, as evidenced by the presence of water stains indicating potential gaps or holes.

- **Structural Damage:** Continuous water leakage can weaken the structural integrity of the roof and ceiling, leading to potential collapse.
- **Mold and Mildew:** Persistent moisture can promote the growth of mold and mildew, posing health risks such as respiratory problems and allergic reactions.
- **Electrical Hazard:** Water intrusion near electrical wiring can create a risk of short circuits, fires, or electrical shocks.
- **Insulation Damage:** Prolonged exposure to moisture can damage insulation, reducing its effectiveness and increasing energy costs.

A licensed roofing contractor should be contacted immediately to inspect, diagnose, and repair the source of the leak to prevent further damage.

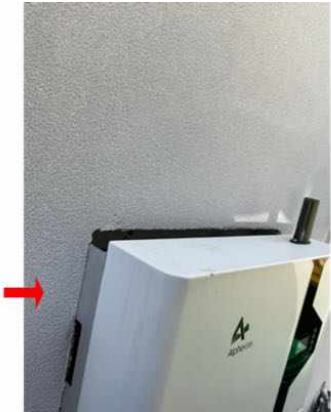
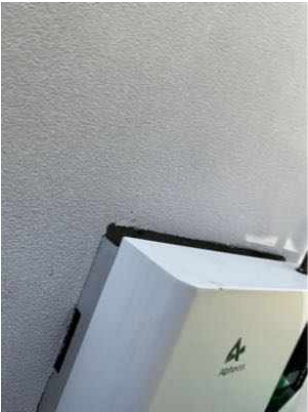
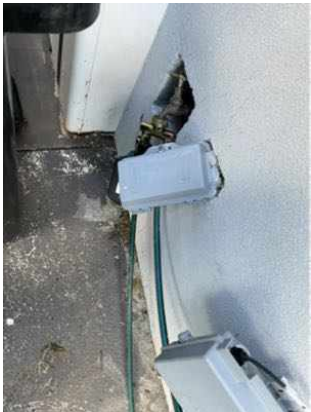
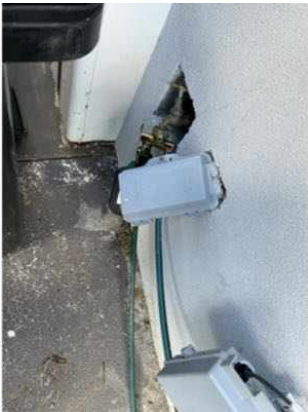
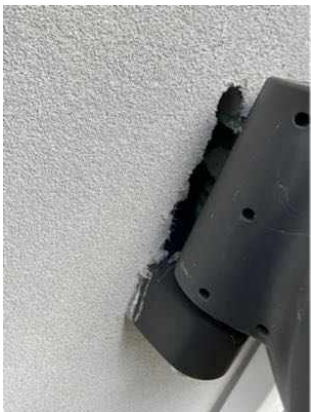
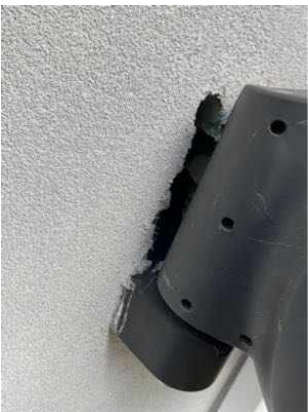
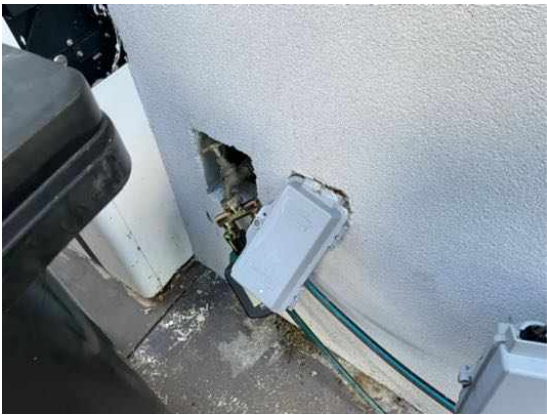
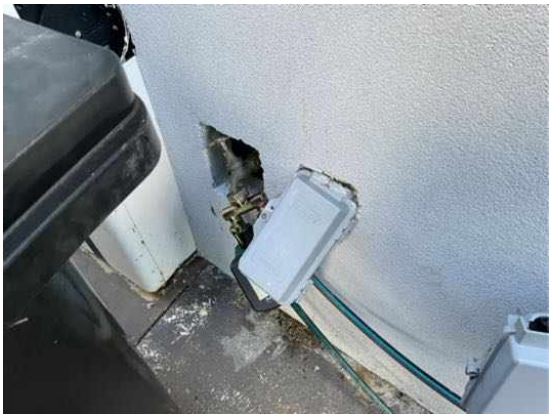
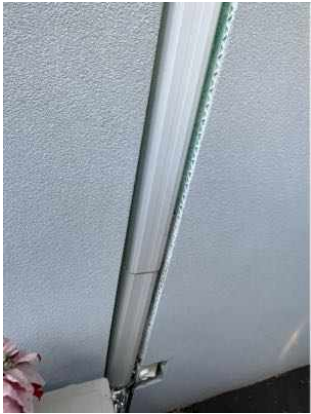
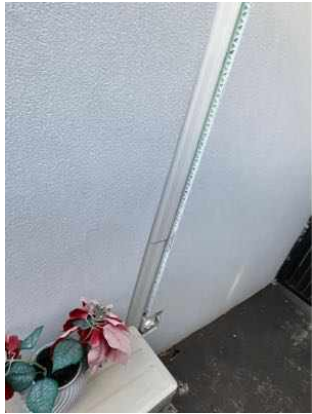
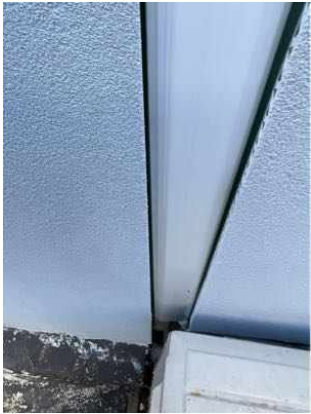
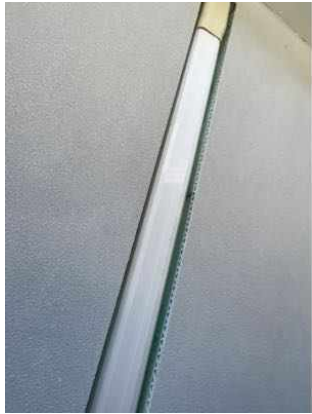
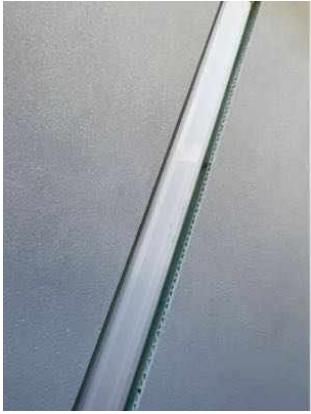
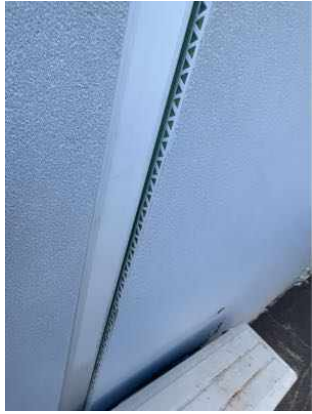
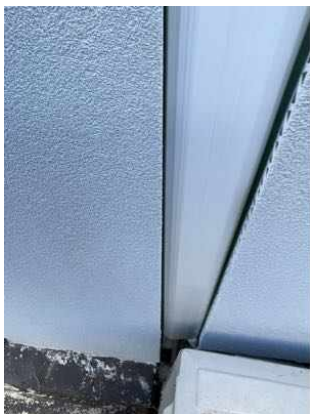
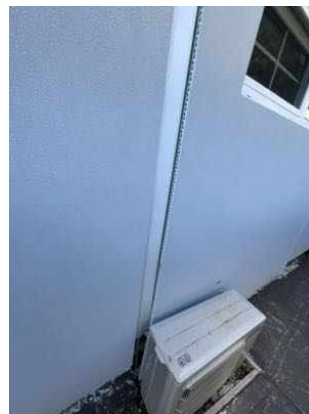
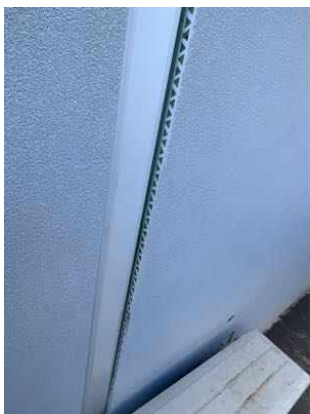
Finding 3.01

integrity, potential safety hazards, and a decreased lifespan of the structure. It may also lead to aesthetic and functional issues.

Resolution: A qualified contractor or construction professional should be consulted to assess and address the poor workmanship. They can implement corrective measures to ensure structural soundness, safety, and overall quality of the construction.

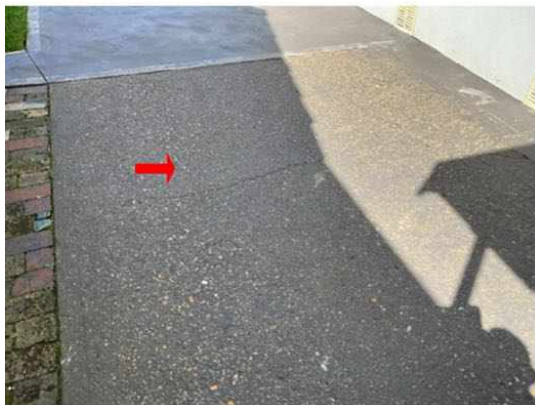
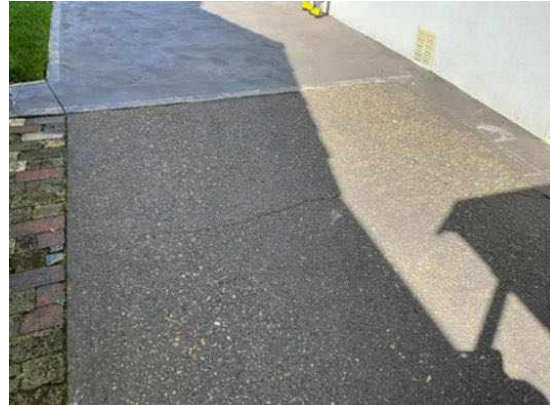
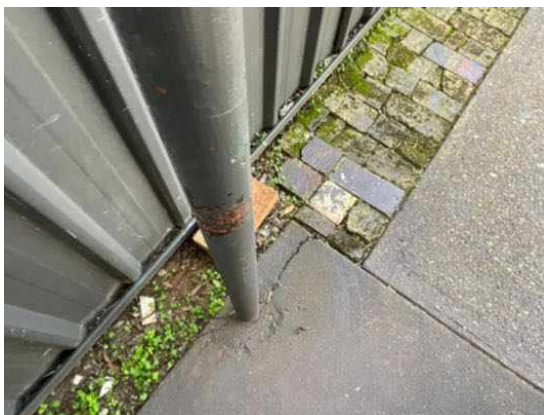
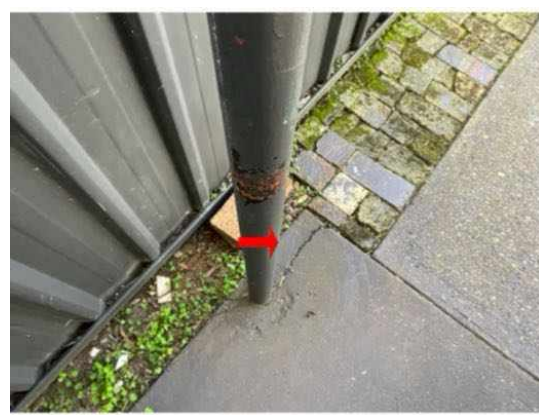
Finding 3.02

Building:	Main Building
Location:	All Areas
Finding:	Noticeable Cracking in Concrete Slab
Information:	Noticeable cracking has been observed in the concrete slab, failing to meet the required construction and quality standards.

- Cracks are visible on the surface and may extend through the depth of the slab.
- Evidence of improper curing or inadequate reinforcement leading to cracking.

- Compromised structural integrity of the slab, potentially leading to failure under load.
- Water ingress through cracks, causing corrosion of reinforcement and further weakening the structure.

- A structural engineer should be engaged to assess the extent of the cracking and recommend appropriate repair methods.

- A licensed contractor or concrete repair specialist should carry out the recommended repairs under the guidance of the structural engineer.

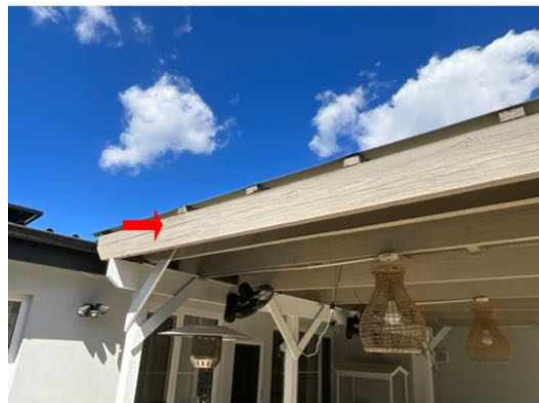
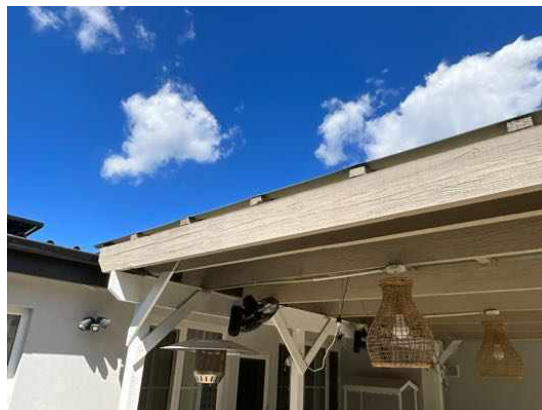
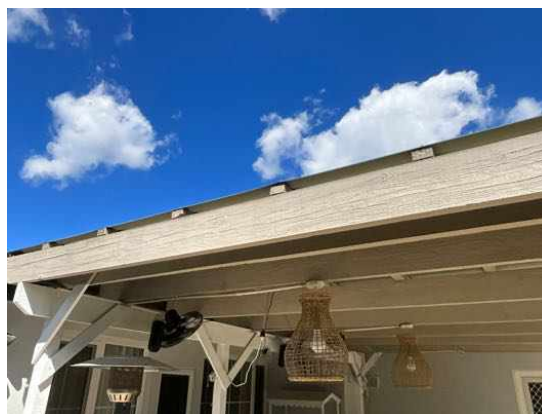
Finding 3.03

Building:	Main Building
Location:	All Areas
Finding:	Timber - exposed to weather
Information:	External timbers that are frequently exposed to harsh weather conditions require adequate protection in order to maintain their condition. Where timbers have not been painted or treated adequately, general deterioration is likely to occur at an accelerated rate.

If left unattended, replacement of these timbers is likely to be necessary in the short-term future. Adequate treatment of these timbers is required as soon as possible by a painting contractor or general handyman.

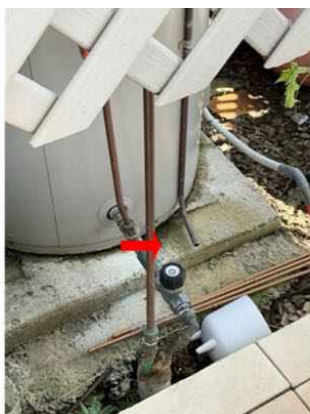
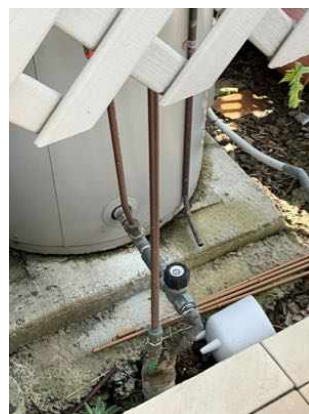
Finding 3.04

Building:	Main Building
Location:	Yard - Back
Finding:	HWS Overflow - Not Connected
Information:	The Hot Water System (HWS) overflow was found to be disconnected from storm water drainage and is creating excessive moisture in the surrounding area.

These damp conditions can lead to secondary defects such as rot, rust or corrosion of associated building elements, the formation of fungal decay, or even the creation of potential slip hazards. When coupled with poor site drainage, pooling of water may also attract termite activity to this area.

It is highly recommended that a licensed plumber be appointed to connect the HWS overflow in order to prevent such an environment from being created. These minor works should be carried out as soon as possible.

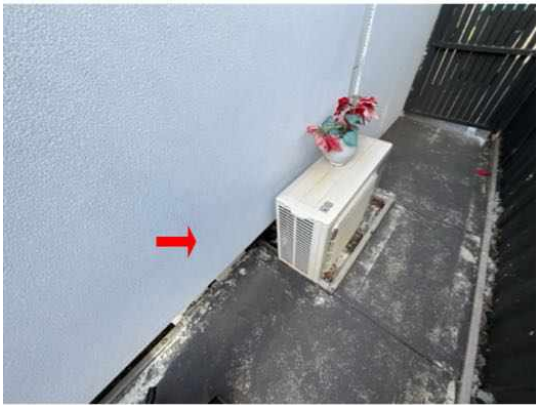
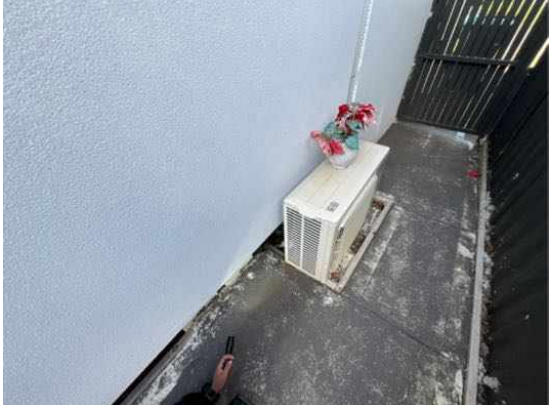
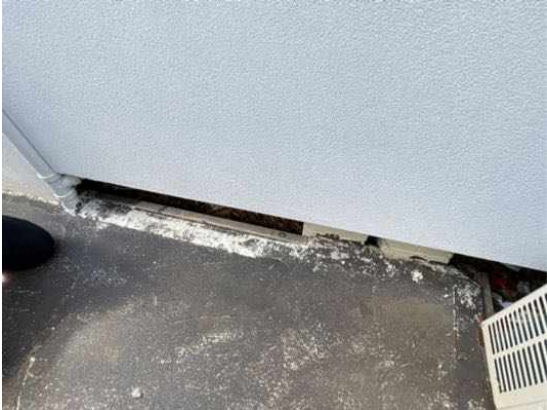
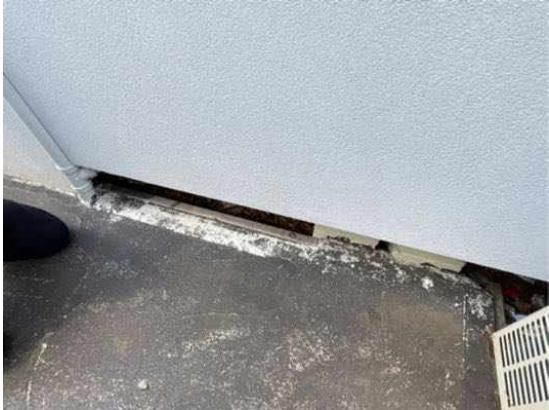
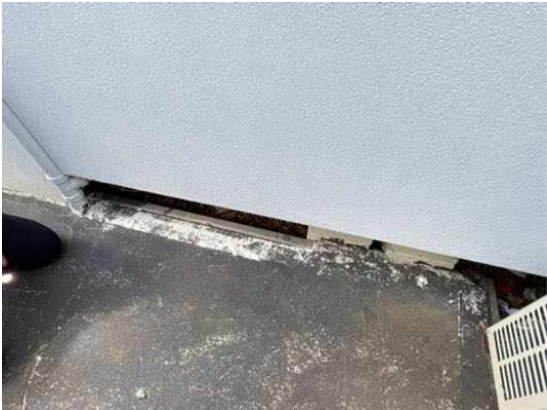
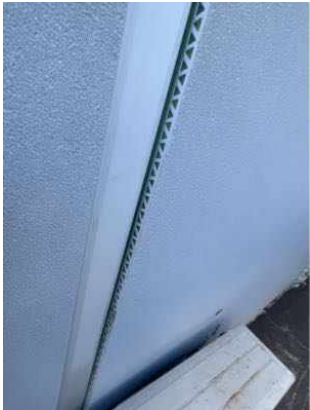
Finding 3.05

Building:	Main Building
Location:	Subfloor
Finding:	Subfloor ventilation - Inadequate - blocked airflow
Information:	The subfloor of the property has inadequate ventilation due to blocked airflow from all sides, preventing proper circulation of air beneath the building.

A licensed builder or ventilation specialist should be consulted to assess and install adequate subfloor ventilation. This may include installing vents, mechanical fans, or other solutions to improve airflow and prevent moisture buildup. Proper ventilation will ensure the longevity of the building's structural components and reduce health risks associated with dampness.

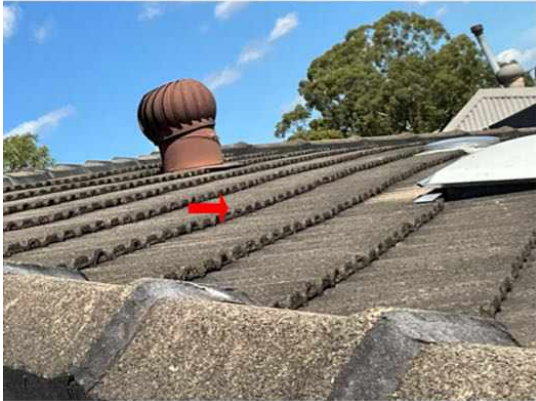
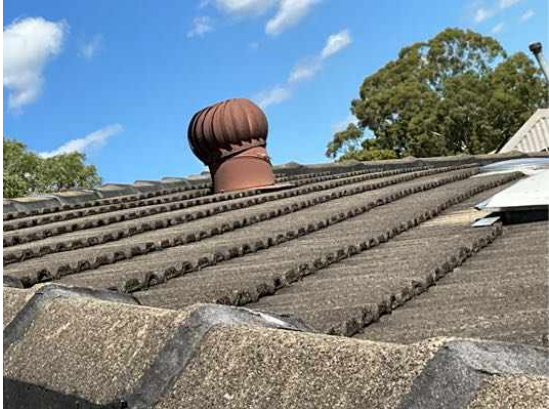
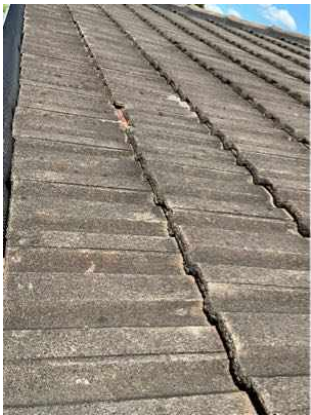
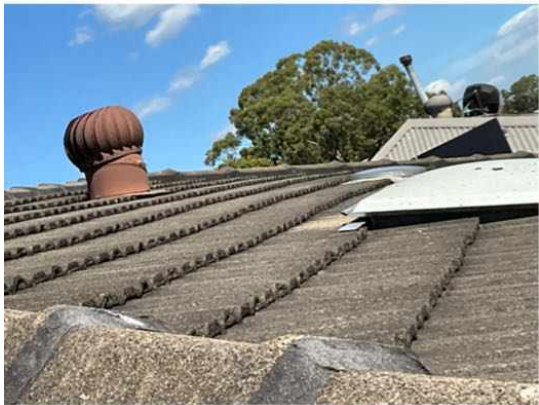
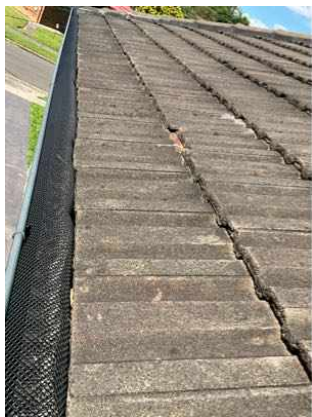
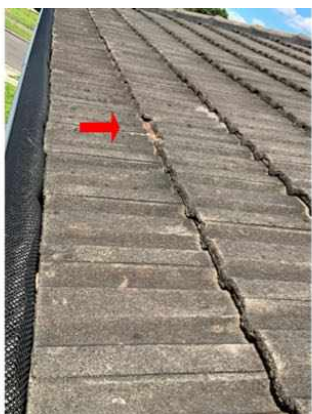
Finding 3.06

Building: Main Building
Location: Roof Exterior
Finding: Roof Weathered
Information: Upon inspection of the exterior roofing, the majority of roof was not in a fair condition. While weathering of the roof is consistent with the age of the property, maintenance works are required.

Isolated areas of mortar have come loose in the valleys and minor cracking is also present. Re-pointing and re-sealing the may be considered as an interim solution by the client to help preserve and extend the life span of the tiles.

Where left unmanaged, deteriorating roof are likely to lead to a number of secondary defects, including minor water leaks and weather exposure to internal roofing structures.

Consultation with a roofing contractor is highly advised to gain advice on cost of remedial works that may be required in the short to medium term. Remedial works are likely to increase the longevity of the exterior roofing structure.

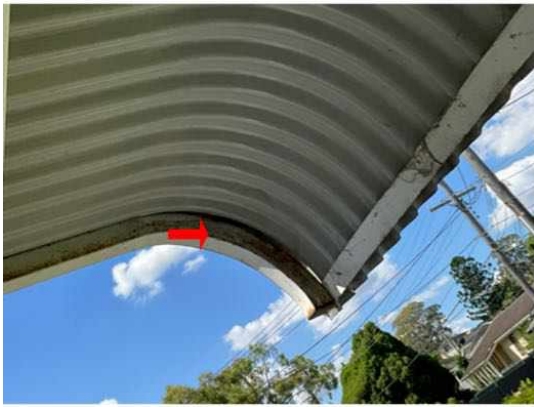
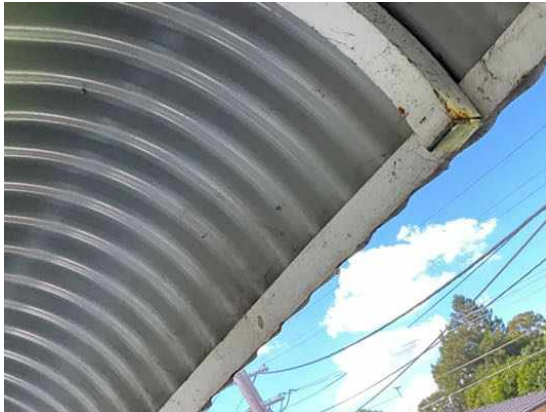
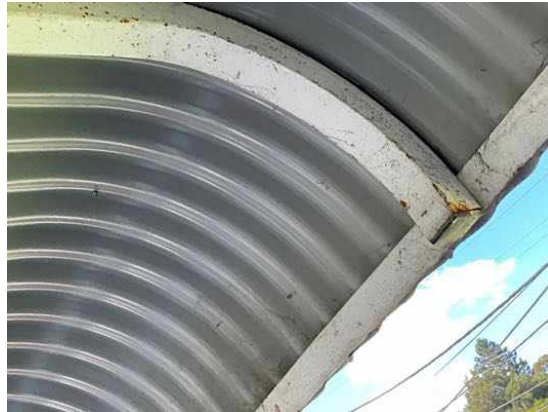
Finding 3.07

Building:	Main Building
Location:	Front porch
Finding:	Building element - Rusted or corroded
Information:	This building element shows evidence of rusting and corrosion, which is likely to have developed as a result of excessive exposure to moisture and or inadequate coatings.

As surface rust provides no protection to the underlying iron, the deteriorating condition is likely to worsen if not addressed in the short-term future.

Rusting and corrosion should be managed by ideally removing or limiting the affected surface from exposure to moisture. A registered builder may be appointed to replace any building elements that have been severely affected by rust or water damage.

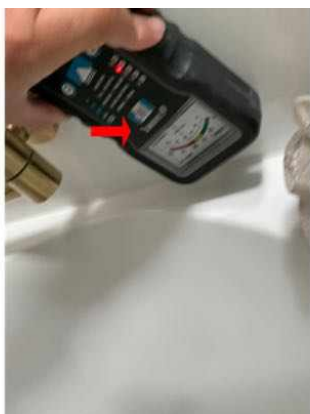
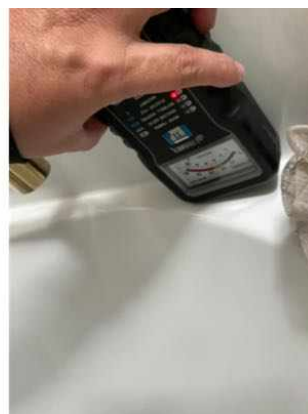
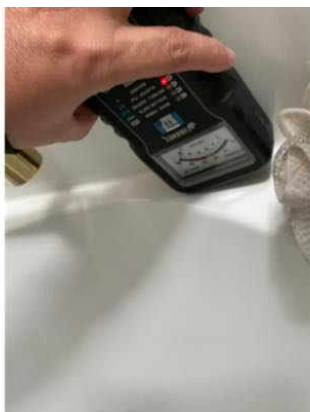
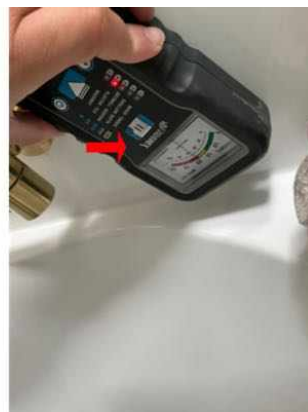
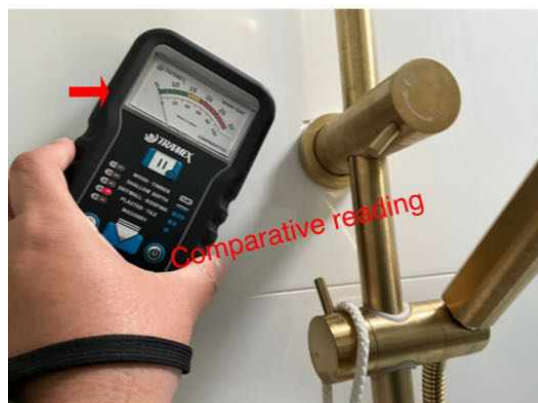
Finding 3.09

Building: Main Building
 Location: Ensuite
 Finding: Shower - Damp
 Information:

Damp is evident to the lower 300mm of wall to the shower alcove. This defect is quite common, and is suspected to have been caused by moisture permeating through the grouting in this area, which shows evidence of deterioration. Leaking pipes within the adjoining wall is also a possible cause.

Consultation with a qualified plumber or bathroom specialist is advised immediately to identify the cause of damp and to perform remedial works as required. Where excessive mould growth is present, further inspection by a specialist environmental health inspector should also be considered.

Always ensure that sealant and grout is in good condition to prevent any moisture issues occurring in the future.

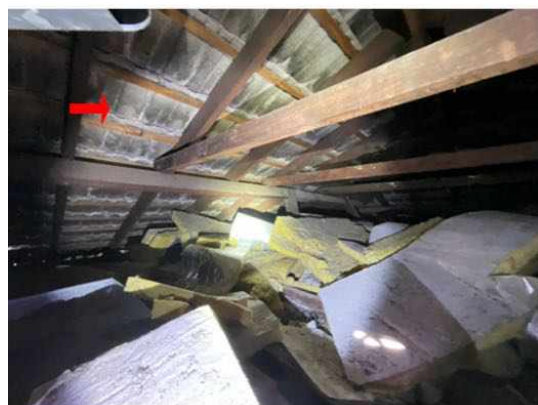
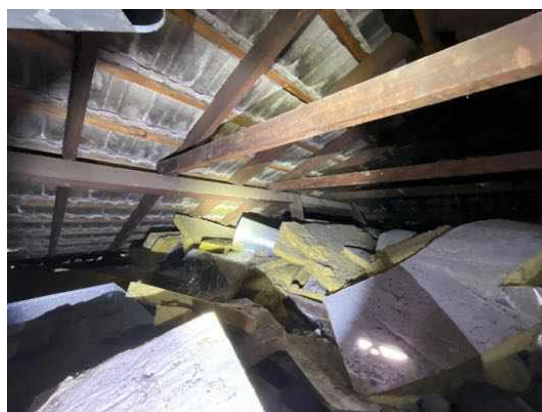
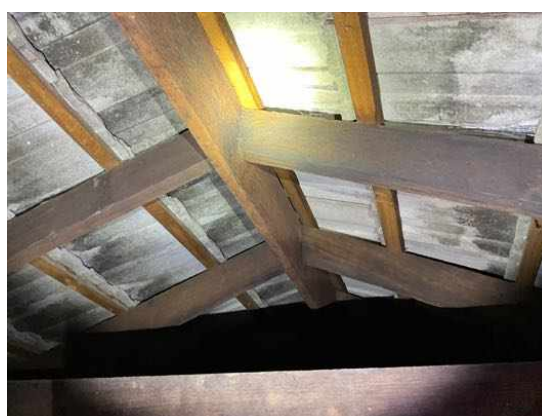
Finding 3.12

Building:	Main Building
Location:	Roof Void
Finding:	Insulation poorly placed
Information:	During the roof void inspection, it was observed that multiple insulation batts have

- Reduced Energy Efficiency: Exposed areas without insulation can lead to increased heating and cooling costs as they allow for thermal bridging.
- Increased Moisture Risk: Uneven insulation may lead to condensation issues, especially in colder climates, potentially affecting timber framing and ceiling materials.
-

- Qualified Insulation Installer – A licensed insulation contractor should be engaged to reposition or replace the insulation batts, ensuring consistent and complete coverage across the ceiling.

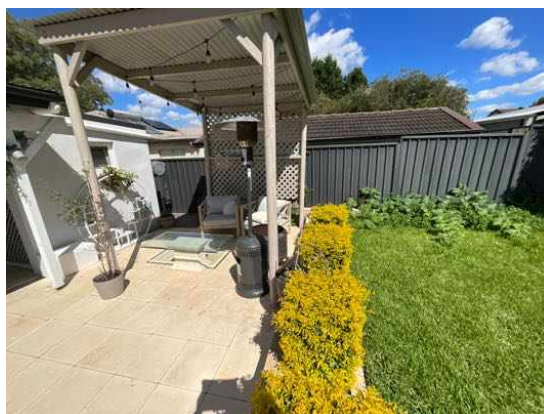
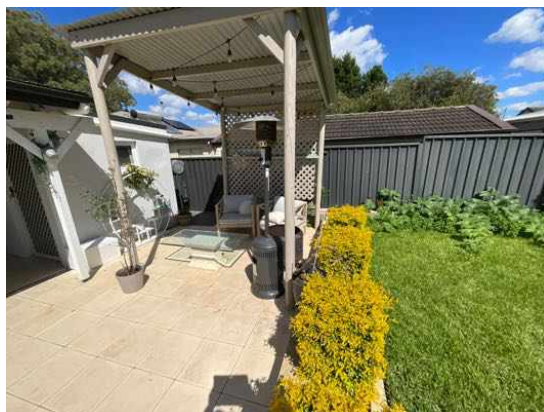
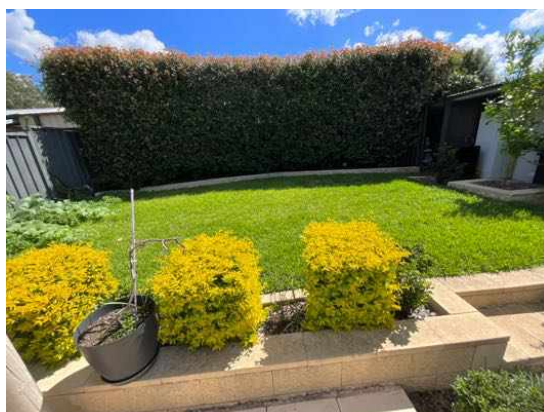
Finding 6.03

Building:	Main Building
Location:	All Areas
Finding:	Timber on ground / conducive conditions to termite damage
Information:	Timber on the ground is indeed conducive to termite damage. Termites are known to thrive in moist environments, and wood in contact with soil or moisture is more susceptible to infestation.

To prevent this, it's important to keep timber elevated and away from direct ground contact. Regular inspections and proper termite control measures are also essential to protect your wooden structures from termite damage.

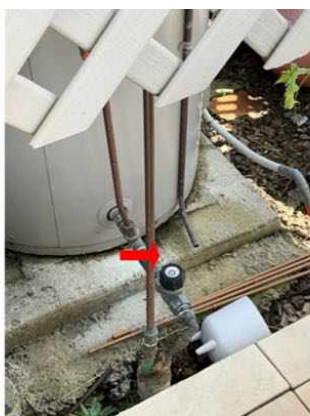
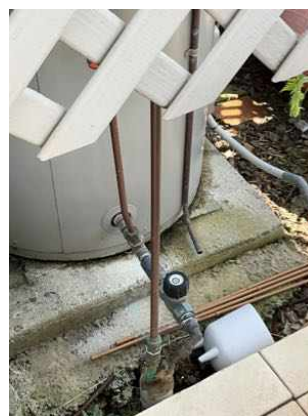
Finding 6.04

Building:	Main Building
Location:	Yard - Back
Finding:	HWS not connected - conducive conditions for timber pest attacks
Information:	The hot water system (HWS) is not connected, leaving exposed pipes and creating conducive conditions for timber pest attacks.

Risk of Timber Pest Attack: The risk of timber pest attack is heightened when the hot water system is not connected. Exposed pipes provide easy access points for timber pests like termites and ants to infiltrate the building structure. These pests are attracted to moisture, and the absence of flowing water through the system can lead to moisture buildup, creating an ideal environment for pests to thrive and cause damage to timber components within the building.

A licensed plumber or qualified plumbing technician should be engaged to reconnect the hot water system. They will assess the existing plumbing infrastructure, determine the appropriate connection points, and ensure proper installation and functionality of the HWS. Additionally, they may inspect for any signs of timber pest activity and recommend preventive measures, such as installing physical barriers or implementing moisture control measures, to deter pest infestations and protect the building from damage. Regular maintenance and inspections by homeowners or property managers are also essential to detect and address potential issues before they escalate.

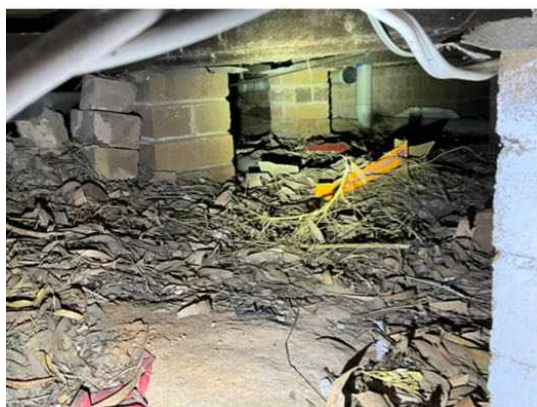
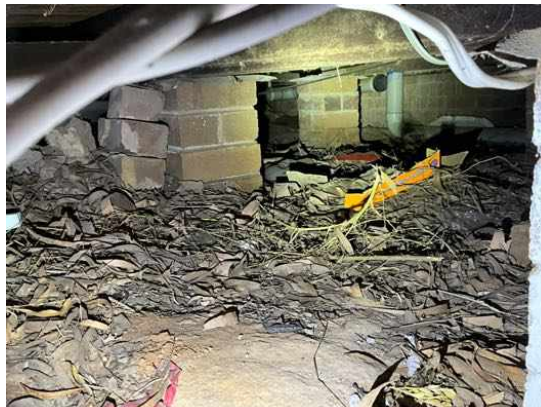
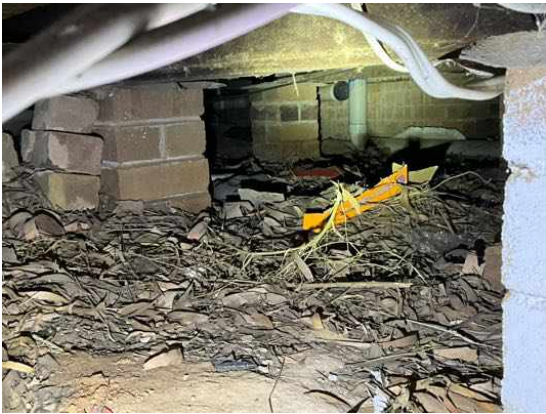
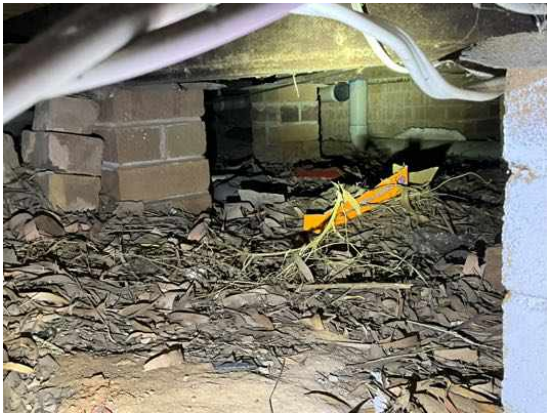
Finding 6.05

Building:	Main Building
Location:	Subfloor
Finding:	Subfloor - poor ventilation, inadequate site drainage, water stains
Information:	The subfloor lacks adequate ventilation, suffers from inadequate site drainage, exhibits water stains, creating conducive conditions for timber pests such as termites.

Risk: The combination of poor ventilation, inadequate drainage, water stains significantly increases the risk of timber pest infestations. Termites are attracted to moist environments and can thrive in subfloors with high humidity levels and water damage. The lack of proper ventilation and drainage exacerbates moisture retention, providing an ideal habitat for timber pests to establish colonies and cause extensive damage to the subfloor structure. Additionally, water stains indicate previous or ongoing moisture issues, which further attract timber pests and contribute to the deterioration of timber materials.

A licensed pest control professional specializing in timber pest management should be consulted to assess the extent of the infestation and develop a comprehensive treatment plan. They can implement strategies to eliminate existing timber pests, such as termites and prevent future infestations by addressing underlying moisture issues. Additionally, a qualified plumber or builder may be needed to improve subfloor ventilation, enhance site drainage, repair water-damaged areas. Regular inspections and maintenance are essential to ensure ongoing protection against timber pests and maintain the structural integrity of the subfloor.

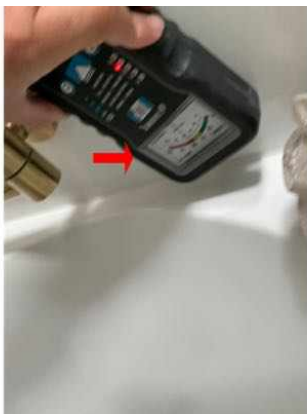
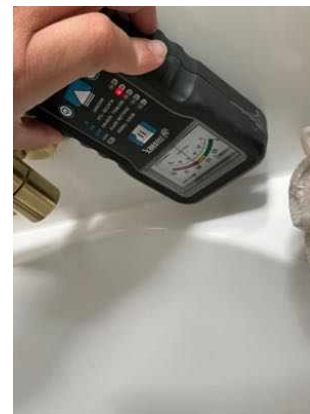
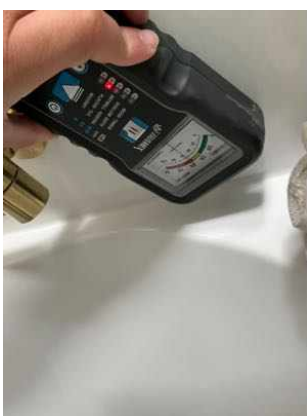
Finding 6.06

Building:	Main Building
Location:	Bathroom
Finding:	Excessive moisture - Conducive to Timber pest
Information:	Excessive moisture can attract termites and produce conditions that promote fungal growth and wood decay.

Excessive moisture is generally caused by deteriorated inadequate or missing roof drainage leaking plumbing pipes or fixtures poorly plumbed HWS overflows or condenser units and poor site drainage.

If mould growth has been found there may be environmental biological or health issues involved. In these cases an appropriately qualified inspector should also be contacted.

Prior to any remedial works being performed a qualified plumber should be appointed to further inspect the property and to identify the cause of the excessive moisture. Works to remove affected building elements may then be necessary and should be performed by an appropriate tradesperson.

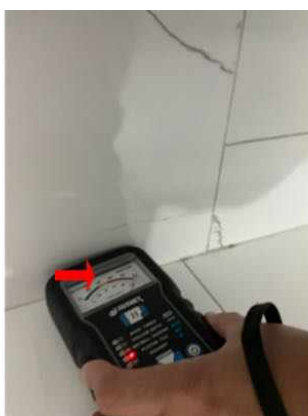
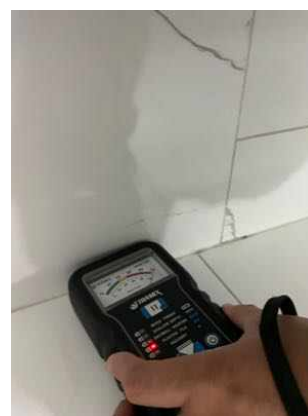
Finding 6.07

Building:	Main Building
Location:	Ensuite

Finding: Excessive moisture - Conducive to Timber pest
 Information: Excessive moisture can attract termites and produce conditions that promote fungal growth and wood decay.

Excessive moisture is generally caused by deteriorated inadequate or missing roof drainage leaking plumbing pipes or fixtures poorly plumbed HWS overflows or condenser units and poor site drainage.

If mould growth has been found there may be environmental biological or health issues involved. In these cases an appropriately qualified inspector should also be contacted.

Prior to any remedial works being performed a qualified plumber should be appointed to further inspect the property and to identify the cause of the excessive moisture. Works to remove affected building elements may then be necessary and should be performed by an appropriate tradesperson.

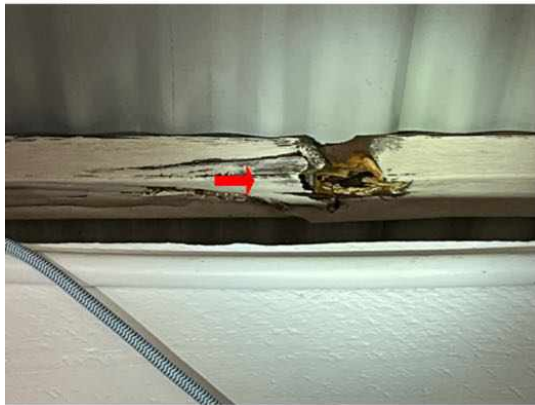
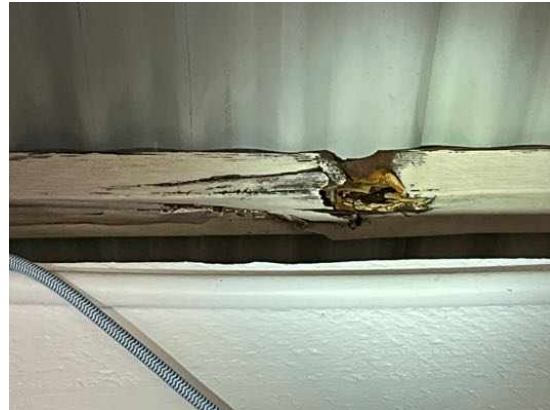
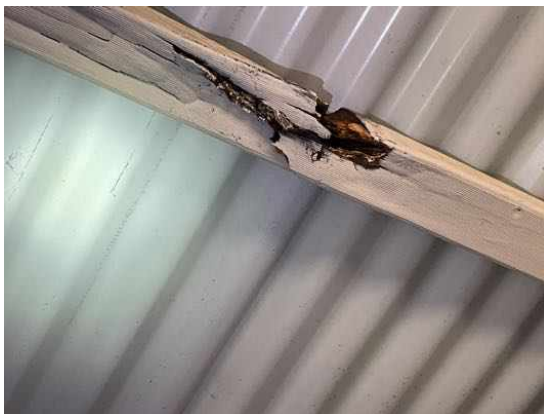
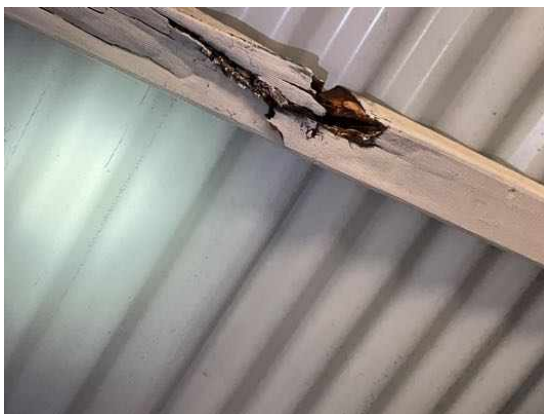
Finding 7.01

Building: Main Building
 Location: Pergola
 Finding: Wood rot
 Information: This building element shows evidence of wood rot. Wood rot, also known as Fungal Decay, occurs when timbers and other cellulose building materials are exposed to damp conditions on an ongoing basis. This could be the result of exposure to weathering over a prolonged period of time, or the attraction of excessive moisture from other abutting building materials. Contributing factors also include poor air ventilation in the area.

Wood rot is often associated with general damp problems and is evidenced by a 'musty' smell or mould and mildew occurring on surfaces. If left unmanaged, damp conditions can lead to further health problems and the decay of timbers will continue.

Early intervention and regular maintenance, particularly of exterior timbers, will prolong the useful life of these building elements. Prior to any works being performed, the cause of the moisture that has created the visible wood rot should be identified and addressed in a suitable manner. Replacement of affected timbers may then be a necessary step in protecting surrounding building elements from such deterioration.

A qualified plumber may be appointed to assess the cause of excessive moisture and to provide advice on any remedial works as required. A qualified carpenter or registered builder may also be required to replace affected building materials.

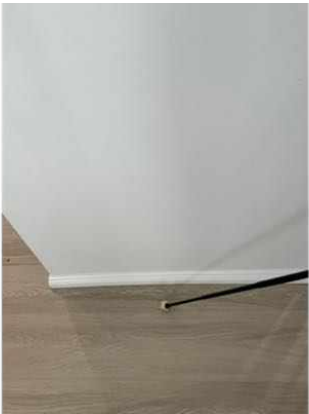
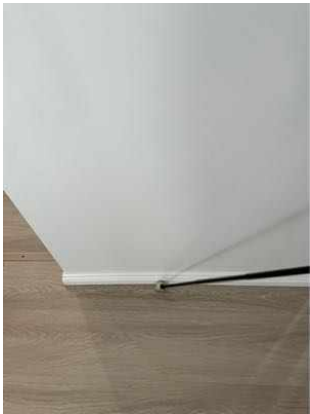
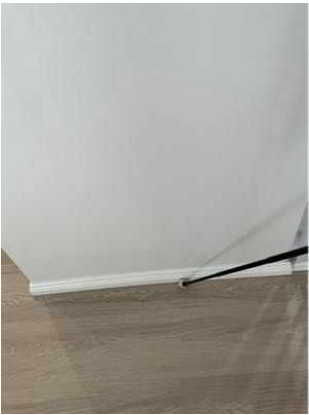
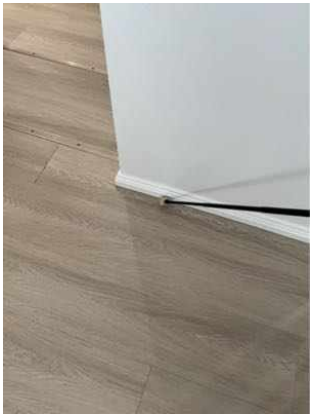
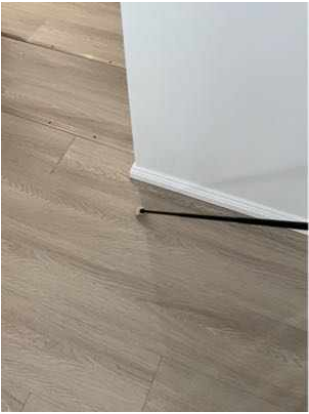
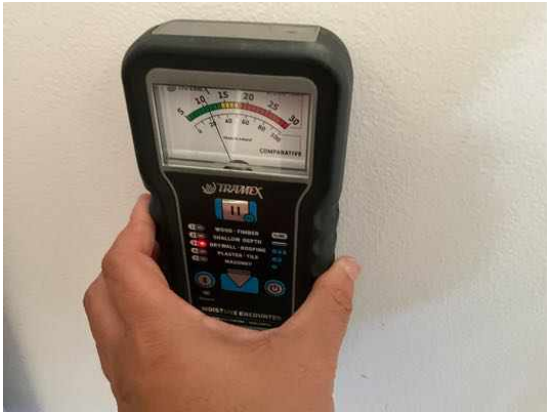
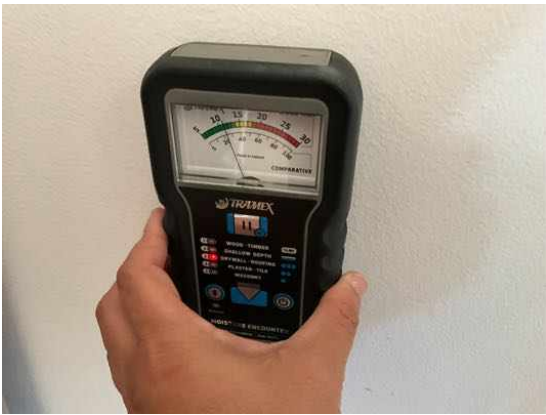
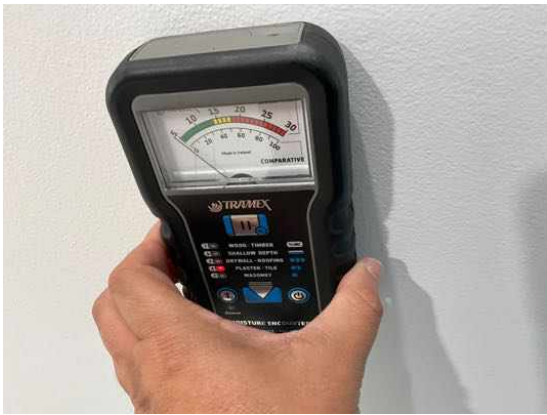
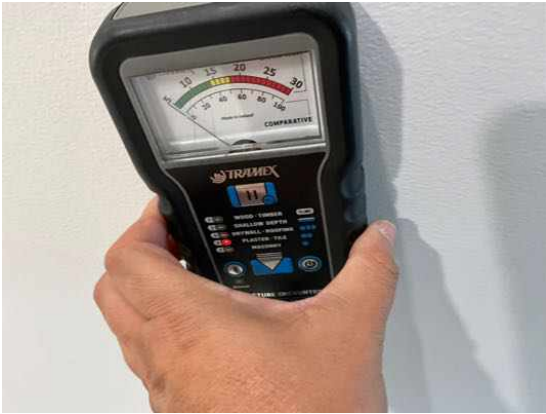
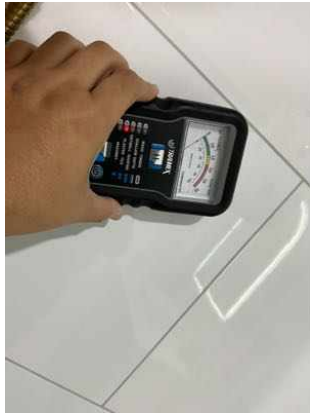
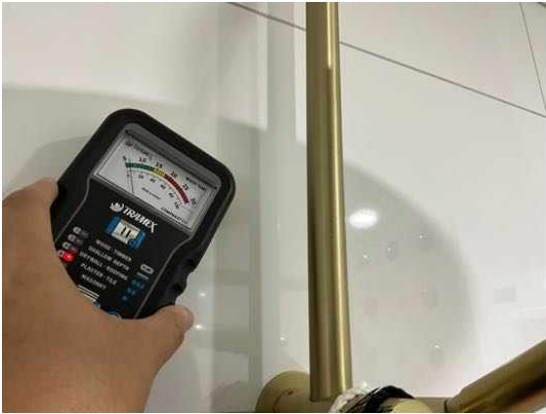
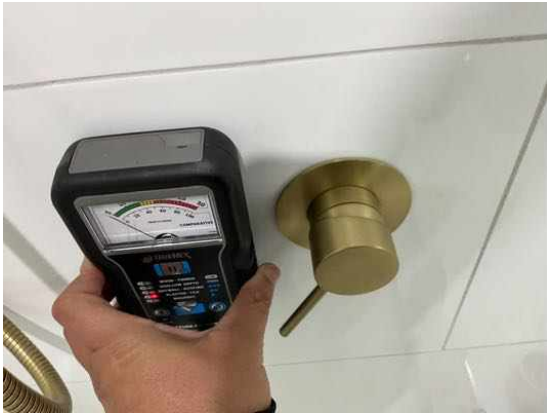
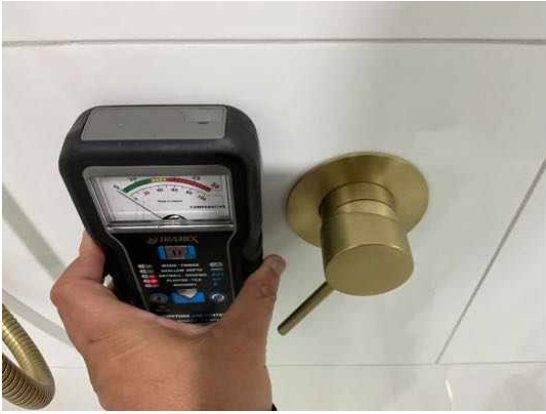
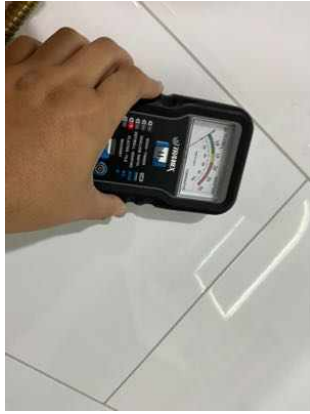
Building: Main Building
Location: All Areas
Finding: Additional Photos
Information: Additional photos are provided for your general reference
