Building and Timber Pest Inspection Report

Inspection Date: Thu, 2 Apr 2026

Property Address: 49 Melba Rd, Lalor Park NSW 2147,
Australia

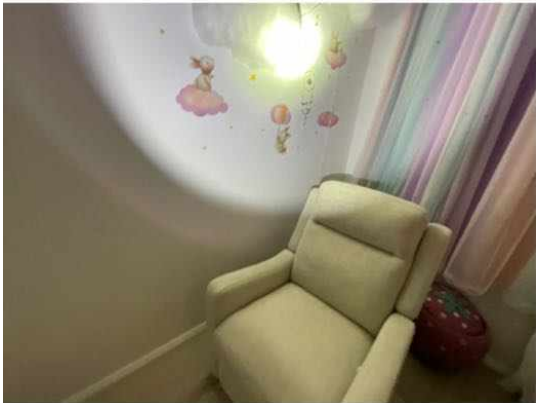
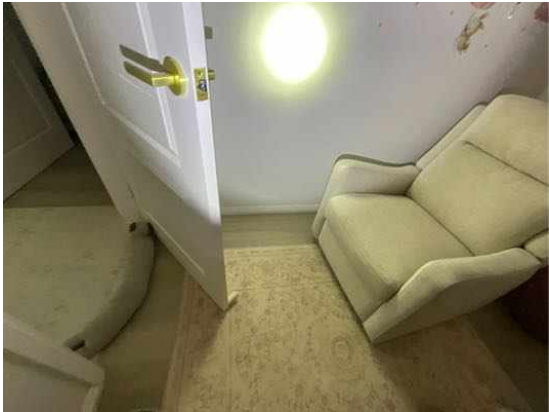
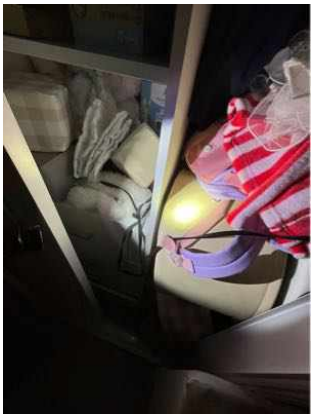
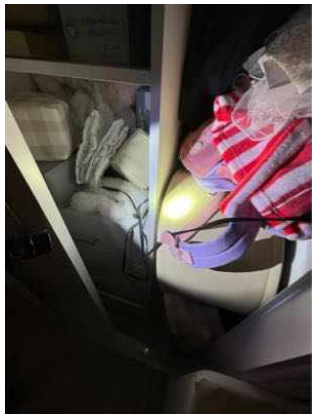
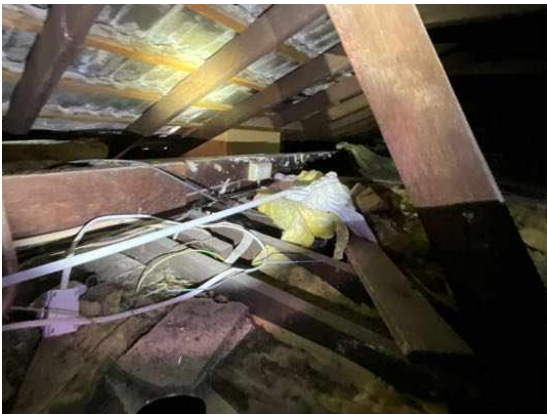
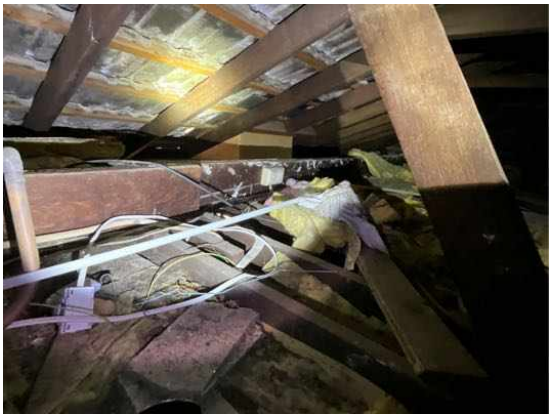
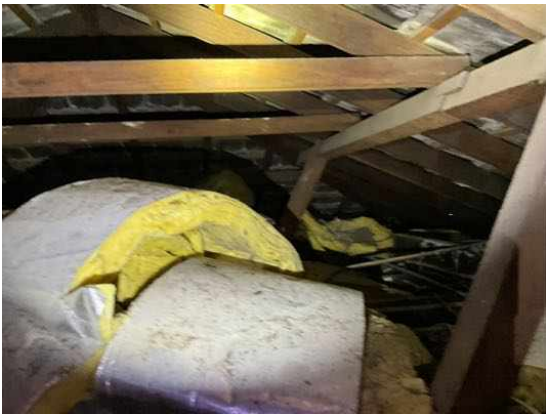
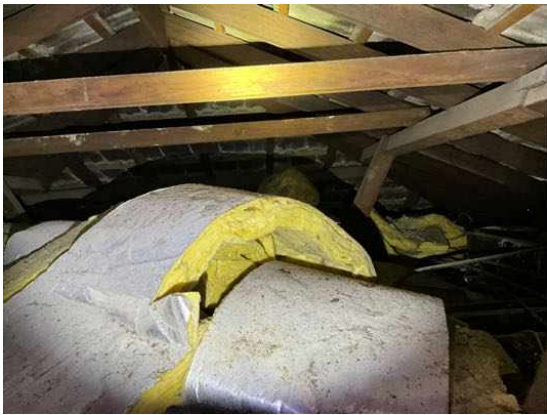
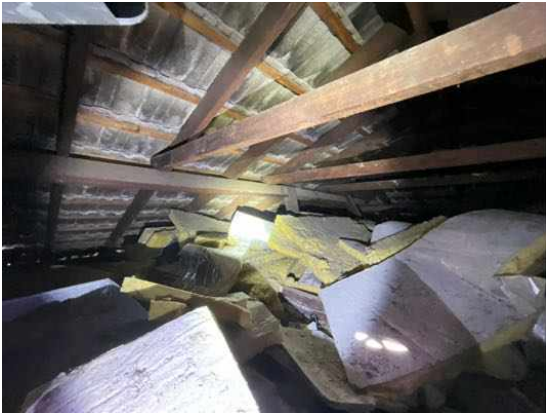
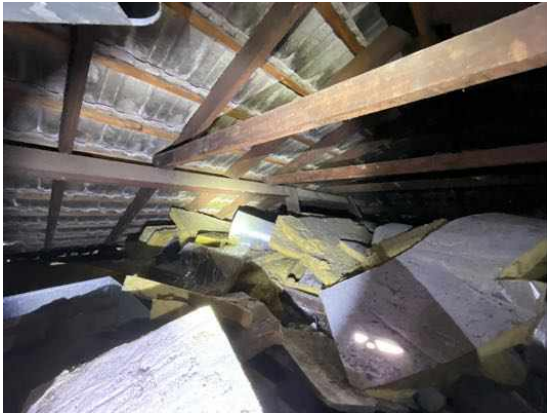
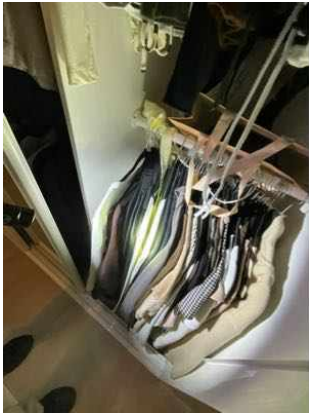
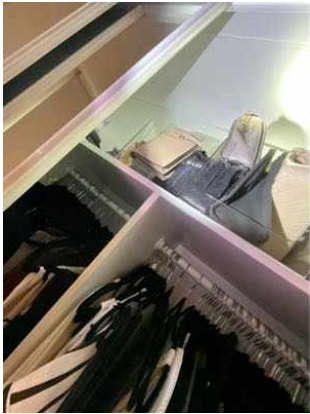
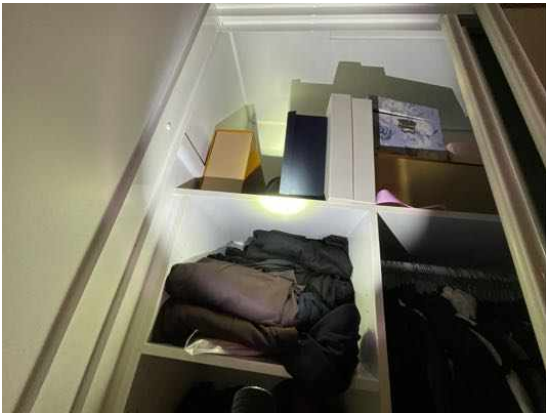
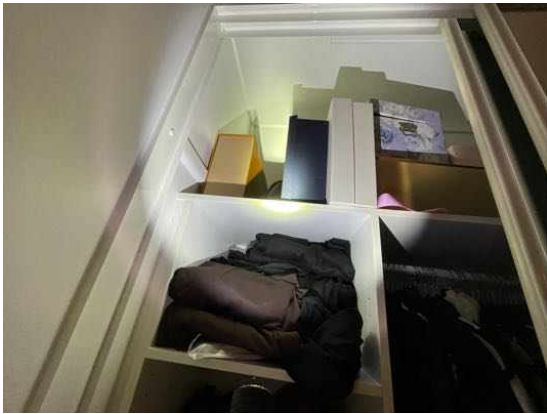
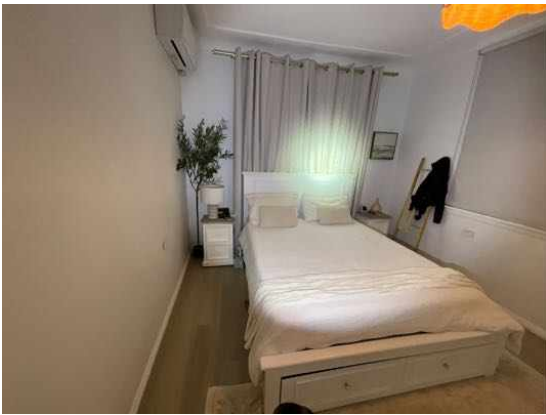
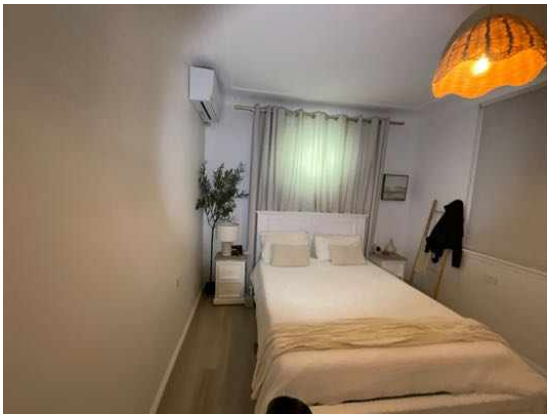
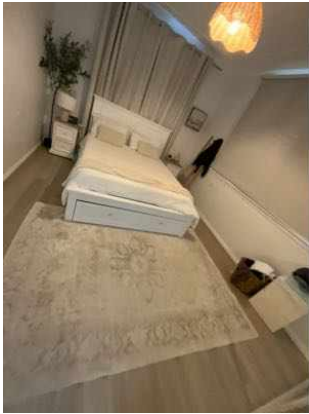
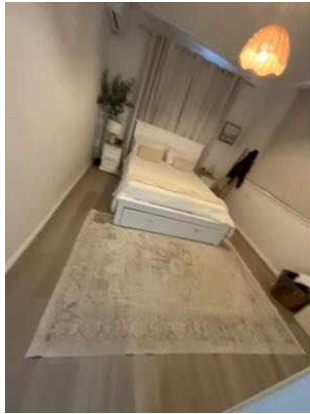
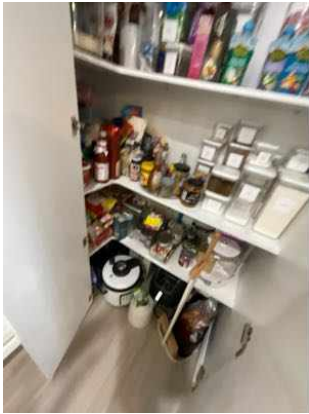
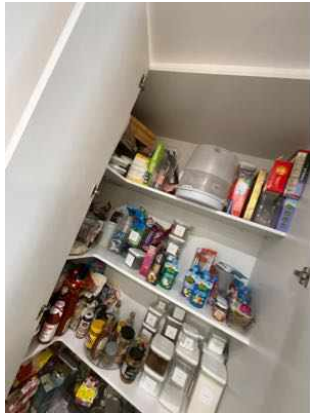
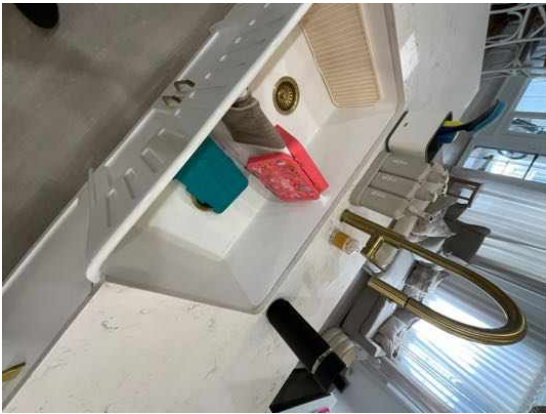
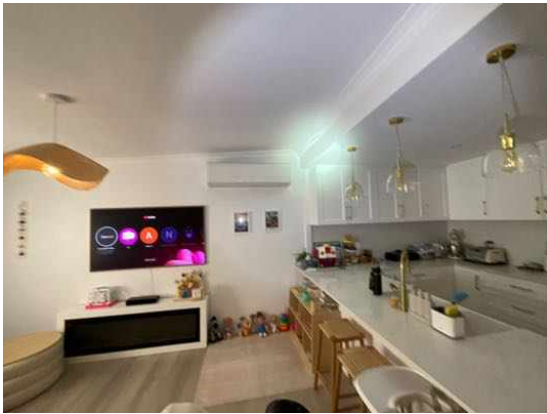
Building: Main Building
Location: All Areas
Finding: Additional Photos - Obstructions and Limitations
Information: These photographs are an indication of the obstructions and limitations which impeded full inspection of the property at the time of inspection. These obstructions can hide an array of defects and should be removed to allow full inspection to be carried out. A re-inspection is recommended once the areas are made accessible.
