Building and Timber Pest Inspection Report

Inspection Date: Wed, 1 Apr 2026

Property Address: 161 Russell Street, Emu Heights NSW 2750

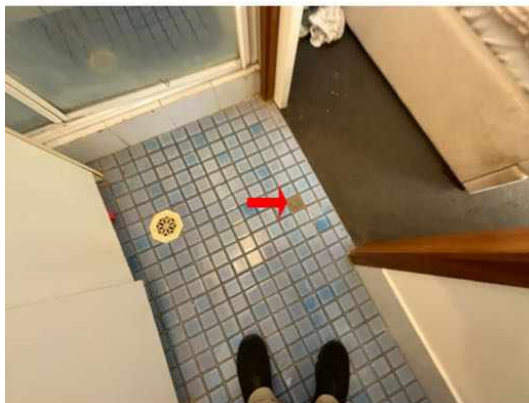
Building:	Main Building
Location:	Ensuite
Finding:	Major Defect – Tiling Failure (Shower Area and Bathroom Floor)
Information:	Observation

At the time of inspection, multiple wall tiles within the shower recess were found to be “drummy” when tested, indicating a loss of adhesion to the substrate. In addition, at least one wall tile was noted as missing within the shower area, leaving the underlying surface exposed.

A missing mosaic floor tile was also observed to the main bathroom floor area outside the shower recess.

Drummy and missing tiles are indicative of failure in the tile adhesion system and may also suggest potential deterioration of the underlying substrate or waterproof membrane.

The missing wall tile within the shower presents a direct pathway for water ingress during use, significantly increasing the risk of concealed moisture damage.

The missing floor tile to the main bathroom area may allow water penetration into the substrate and may also present a minor trip hazard.

Given the location within a wet area, these conditions are considered a major defect requiring prompt attention.

Further invasive investigation may be required to determine the full extent of damage, particularly in concealed areas behind the shower wall and floor finishes.

Early rectification is recommended to prevent further deterioration and potential escalation of repair costs.

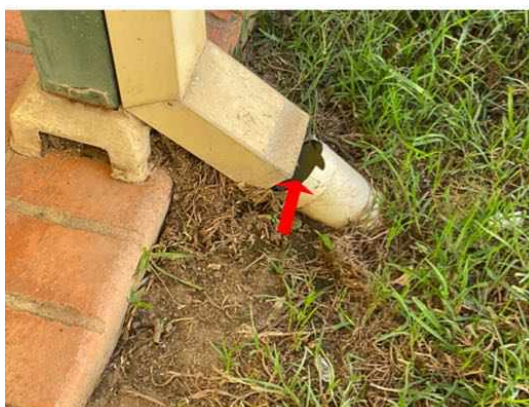
Finding 3.05

Building:	Main Building
Location:	All External Areas
Finding:	Site/Yard Drainage – Below Average.
Information:	Defect – Below Average Site Drainage

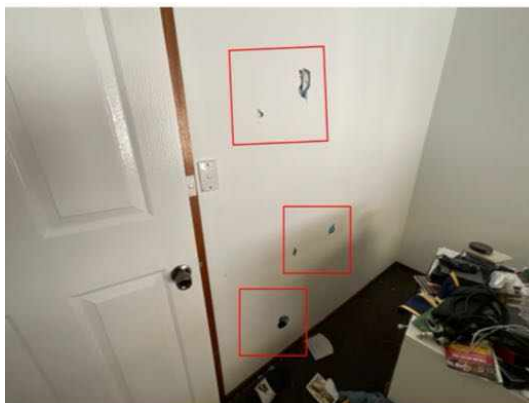
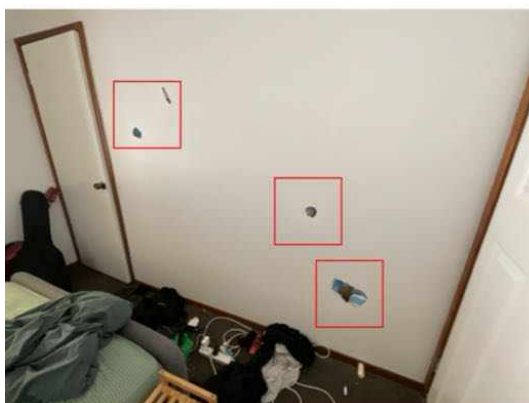
Finding 3.08

Building:	Main Building
Location:	Bedroom
Finding:	Minor Defect – Internal Wall Damage (Impact Holes)
Information:	Observation

Repairs should be carried out by a suitably qualified plasterer or tradesperson. Works should include patching, setting, and finishing of the affected areas to restore the wall surface to an acceptable standard.

Repainting may be required following repairs to ensure a consistent finish. Regular maintenance and prompt repair of similar damage is recommended to maintain the condition and presentation of internal surfaces.

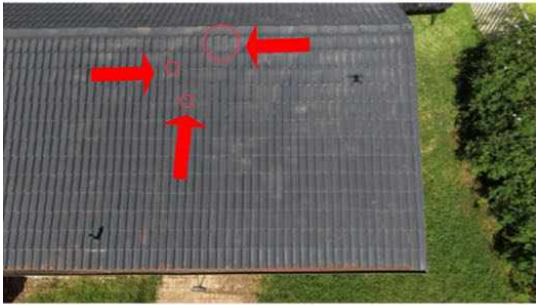
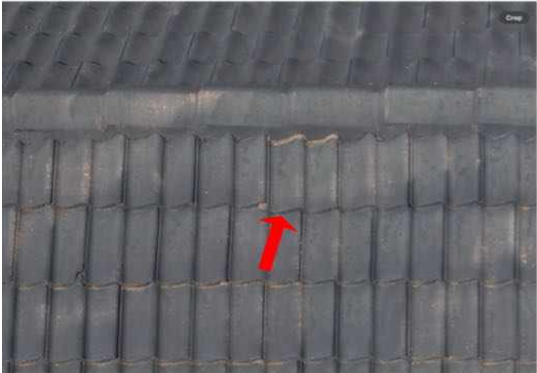
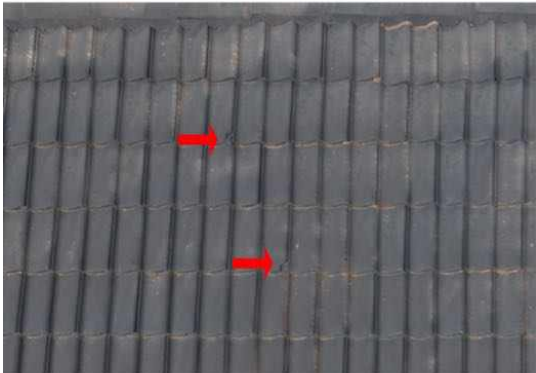
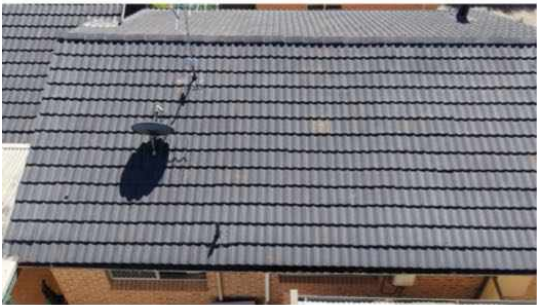
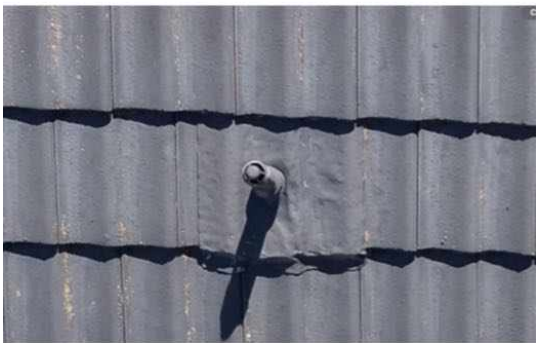
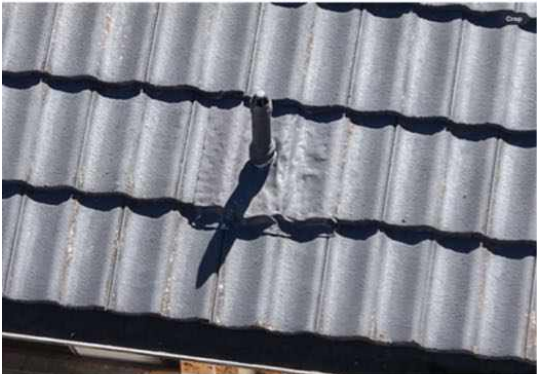
At the time of inspection, the tiled roof covering was found to be in generally sound and serviceable condition, with no evidence of active leakage. Minor defects, including isolated tile damage and localised deterioration to ridge pointing, were observed and should be addressed as part of routine maintenance.

Regular upkeep, including cleaning of gutters and valleys, replacement of damaged tiles, and periodic repointing, is recommended to maintain weatherproofing and extend the overall service life of the roof system.

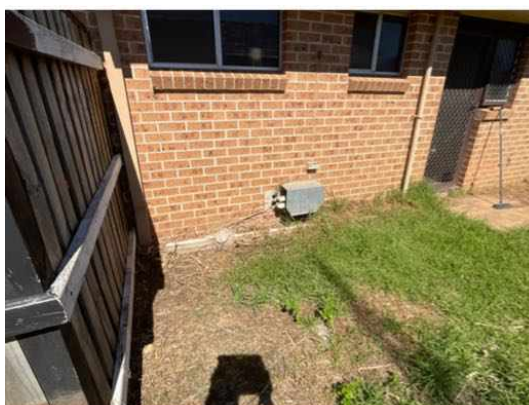
Finding 6.04

Building: Main Building
 Location: All External Areas
 Finding: Bridging of Termite Barriers – Concealed Weep Holes..
 Information: Observation:

- All weep holes should remain exposed and unobstructed across the entire property to allow for effective drainage and visual termite inspections.
- It is strongly advised that any material or structure covering weep holes be removed promptly, and a re-inspection carried out to ensure termite entry is not occurring undetected.
- Where removal of obstructions is not feasible, it is recommended that the area be inspected regularly, ideally every 3 to 6 months, to monitor for signs of termite activity or moisture-related damage.

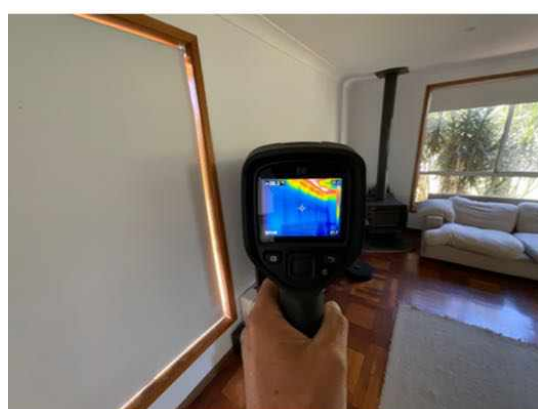
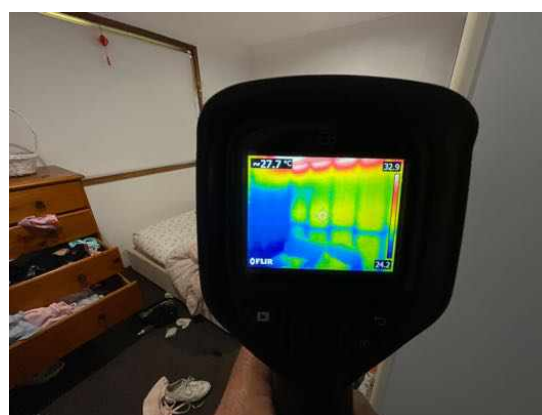
At the time of the inspection, no abnormalities indicating live termite activity were observed. However, it's important to note that various factors—such as obstructions, ambient temperature, and wall material/thickness—can impact the accuracy of thermal readings. In cases where surfaces are visually restricted or obstructed, a comprehensive thermal scan may not always be feasible.

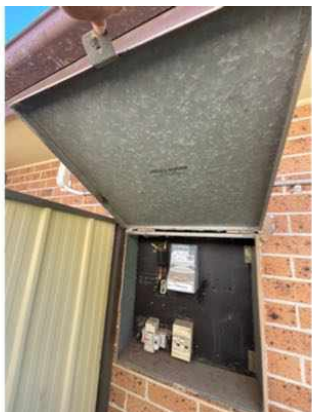
Building: Main Building
 Location: All Areas
 Finding: Termite Management System - Missing Durable Notice..

Proper maintenance and documentation are essential to ensure continued protection. Without a visible durable notice, there is no clear indication of what system (if any) is in place, which may limit the effectiveness of future termite inspections and hinder warranty claims.

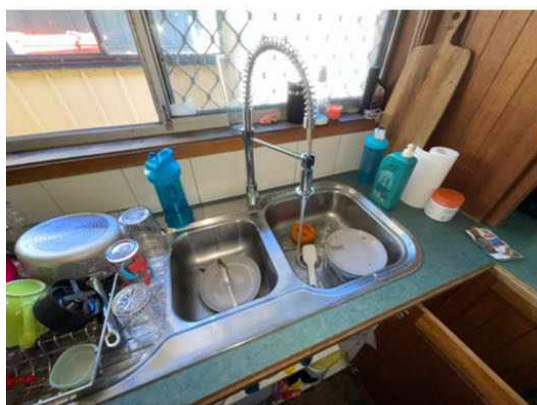
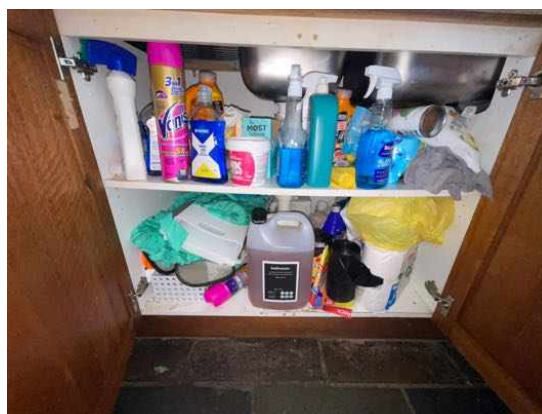
Building: Main Building
 Location: Kitchen
 Finding: Kitchen Sink – Overall Condition & Recommendations.
 Information: Observations:

- The kitchen sink tap(s) were water tested at the time of inspection, with no evidence of leaks or blockages observed in the visible plumbing or drainage.
- No significant water damage was observed to the cabinetry/unit, however, minor water damage was noted, which may be indicative of past moisture exposure.
- Stored items under the sink obstructed access, limiting a full inspection of the plumbing and internal cabinetry.

- Further monitoring and testing are recommended once the tap(s) are in constant use, to identify any drainage issues or signs of slow leaks not evident during the limited inspection.
- For long-term property care, it is advised that sealant and grouting in water-exposed areas be regularly inspected and maintained. A sealant specialist or tiling contractor may be engaged to carry out these works where necessary.
- It is recommended that the stored items beneath the sink be removed to allow for a full re-inspection of the plumbing and cabinetry, ensuring no concealed defects are present.

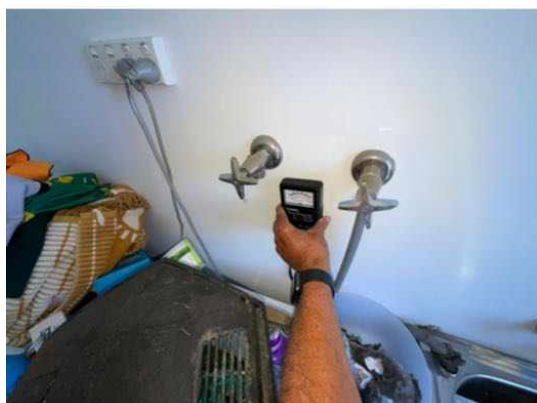
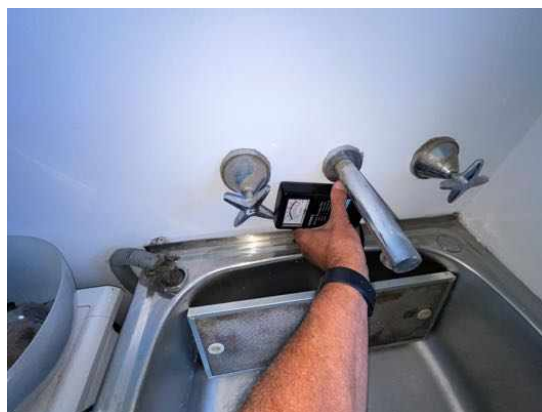
Building: Main Building
 Location: Laundry
 Finding: Laundry - Taps/Plumbing/Drainage.

- The taps to the laundry tub were water tested and inspected, with no evidence of moisture, plumbing or drainage leaks observed at the time of inspection.
- No visible signs of water damage, rust, or corrosion were noted to the cabinetry or surrounding unit during the inspection. The cabinetry is loose not secured.

- Further monitoring or testing is recommended once the taps are placed into regular use, to ensure no leaks develop over time and that the drainage system continues to perform adequately.
- Flexible and mould-resistant sealant should be applied to junctions between the basin and the wall to prevent water ingress that may lead to damage.
- Regular maintenance and prompt replacement of missing or deteriorated sealant is highly recommended, as this is a common wear-and-tear issue.
- Sealant and grouting in wet areas should be maintained as part of the long-term care and upkeep of the property.
- Where required, a sealant specialist or qualified tiling contractor should be appointed to carry out remedial sealing works.

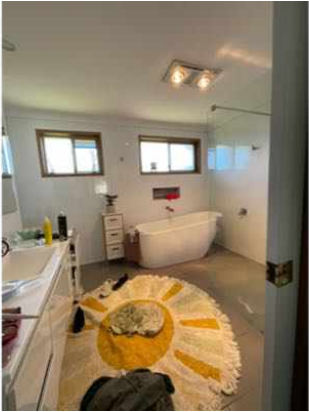
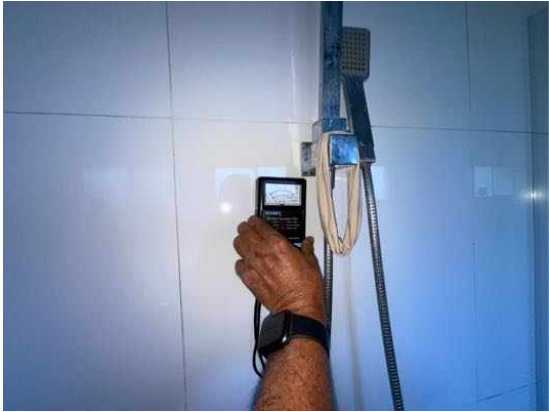
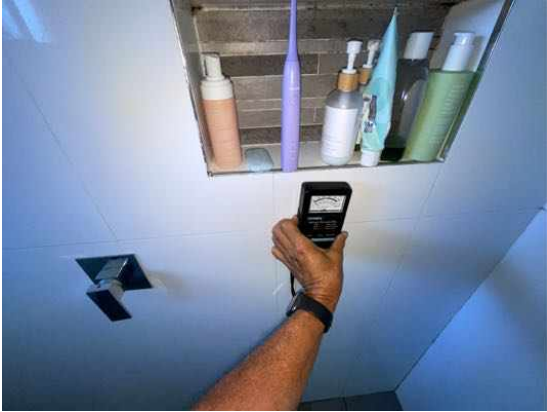
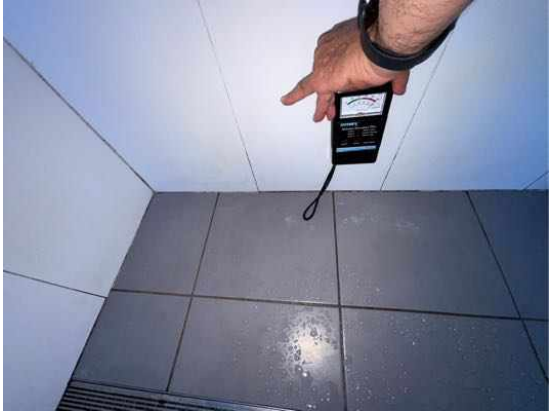
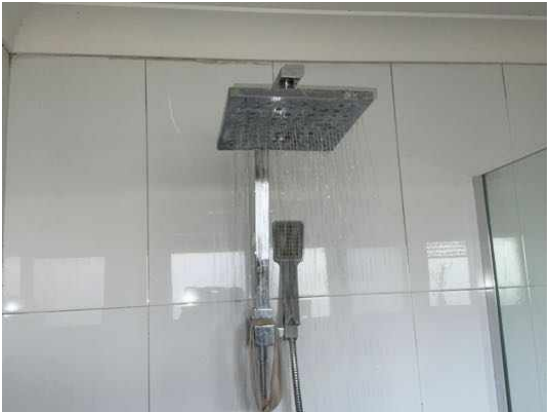
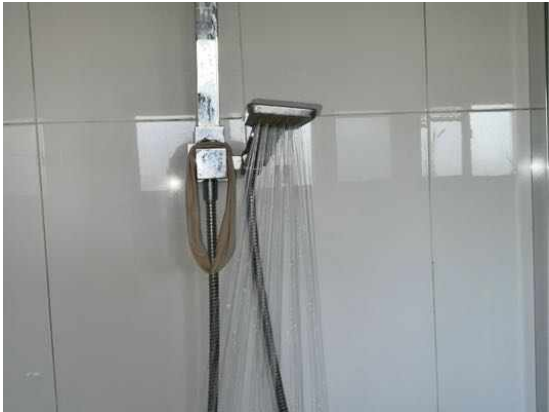
Building: Main Building
 Location: Bathroom
 Finding: Wet Areas - Bathroom(s) - Overall Condition & Recommendations.
 Information: Overall Condition & Recommendations

- Elevated moisture readings were found in the lower shower walls, which is a common occurrence with certain tile types that naturally absorb more moisture. This should be monitored over time.

- Sealing of grout and tiles is recommended to prevent moisture buildup and mould growth in damp areas such as showers.
- The condition of grout and sealant appeared to be average, with some areas potentially requiring cleaning or replacement.

- Mould growth was noted in some areas of grout/sealant. Cleaning or, if necessary, replacing affected grout or sealant is recommended to maintain hygiene and waterproofing integrity.
- The exhaust fan appeared to be operational, which supports moisture control in the bathroom.

- Flood testing of the shower recess is recommended. This may reveal inadequacies in the waterproofing or shower screens, which could lead to water damage in surrounding areas.

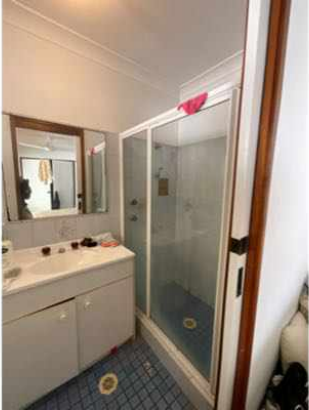
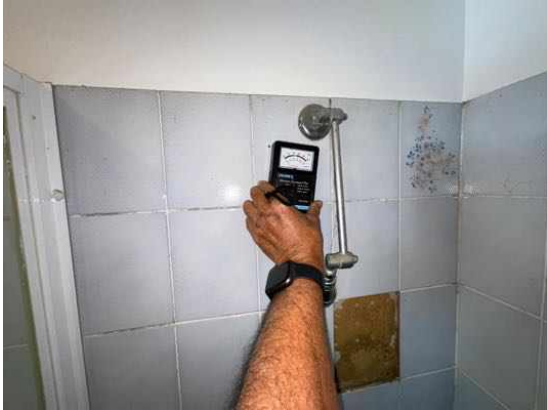
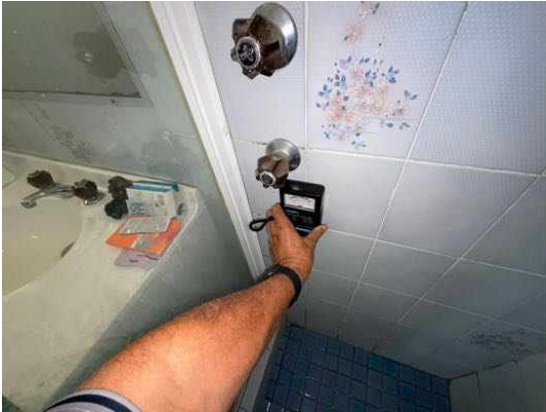
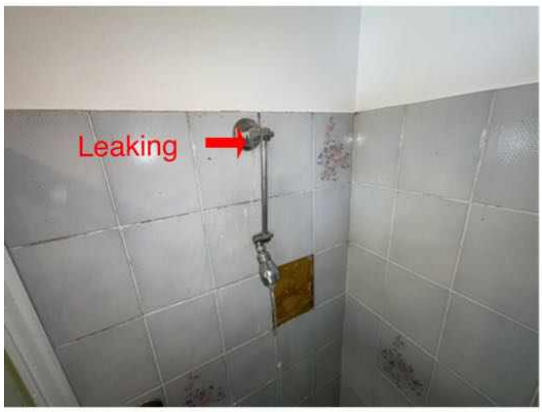
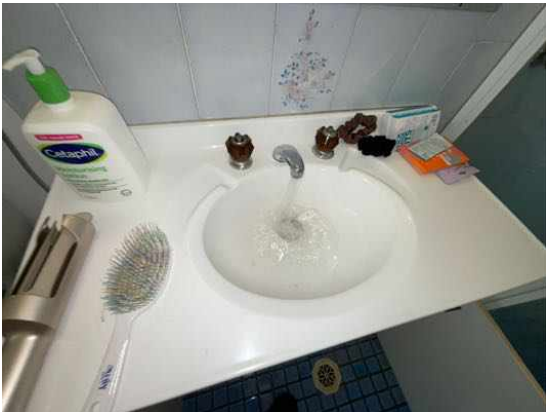
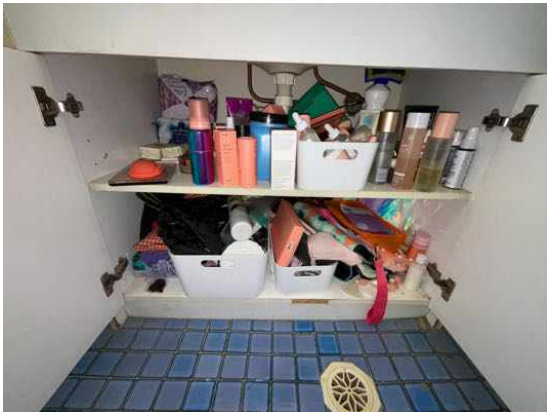
Building: Main Building
 Location: Ensuite
 Finding: Wet Areas - Bathroom(s) - Overall Condition & Recommendations.
 Information: Overall Condition & Recommendations

- Water appeared to be leaking at the shower head during testing of the shower taps and could not be tested. Further investigation is required.
- Drummy loose wall tiles noted in the shower area
- Flood testing of the shower recess is recommended. This may reveal inadequacies in the waterproofing or shower screens, which could lead to water damage in surrounding areas.
- No elevated moisture readings were detected around the tap fittings or behind the shower walls (as viewed from adjacent rooms), suggesting no active plumbing leaks at the time of inspection.
- Elevated moisture readings were found in the lower shower walls, which is a

common occurrence with certain tile types that naturally absorb more moisture. This should be monitored over time.

- Sealing of grout and tiles is recommended to prevent moisture buildup and mould growth in damp areas such as showers.
- The condition of grout appeared to be in poor condition, with some areas potentially requiring replacement.
- Grout in wall and/or floor junctions may crack and deteriorate over time. It is recommended to remove any rigid grout from junctions and replace with flexible, mould-resistant sealant in accordance with best building practices.
- Mould growth was noted in some areas of grout/sealant. Cleaning or, if necessary, replacing affected grout or sealant is recommended to maintain hygiene and waterproofing integrity.
- The exhaust fan appeared to be operational, which supports moisture control in the bathroom.
