Building and Timber Pest Inspection Report

Inspection Date: Thu, 19 Feb 2026

Property Address: 545 Wyndham St, Shepparton VIC 3630,
Australia

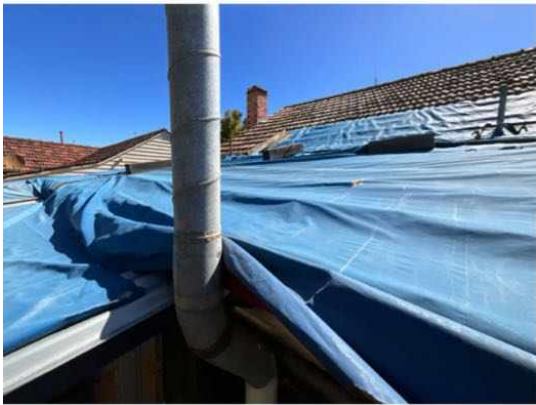
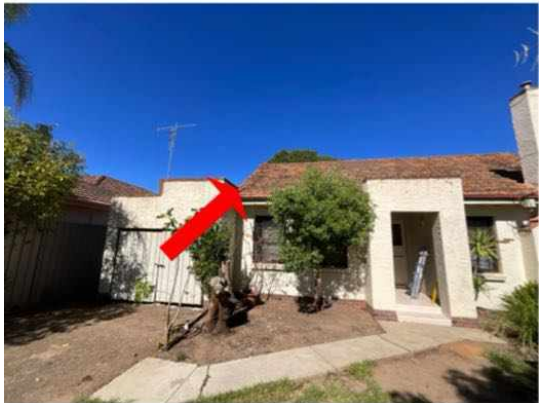
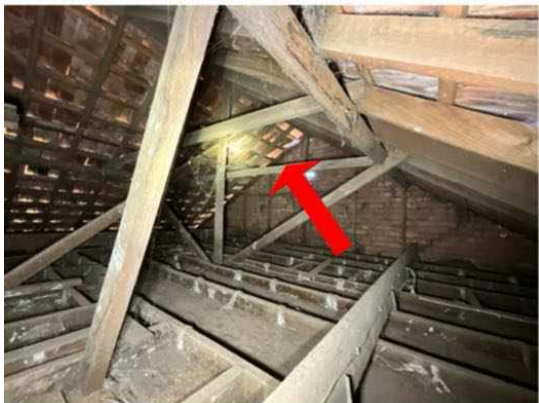
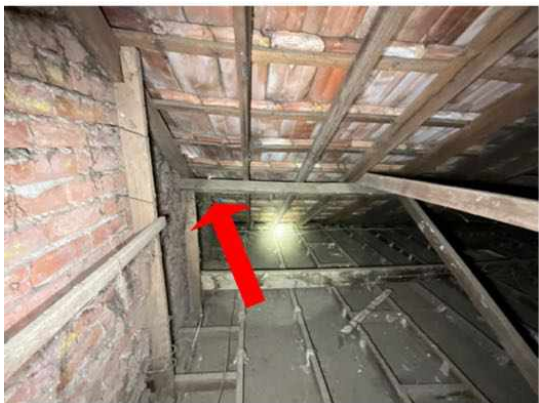
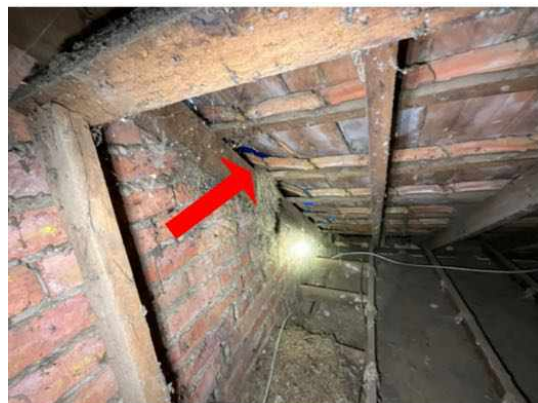
Building: Building 1
Location: Roof Exterior
Finding: Roof tiles - Slippage. General condition
Information: Upon inspection of the exterior roof covering, it was noted that numerous tiles have slipped from their original fixing. Tiles may slip over time due to a number of minor causes, including breakage of tiles, failings in the adjoining battens, or fixings that may have failed.

Roof tiles that have moved from their original position are very likely to allow water penetration into the roof void, exposing roofing structures to excessive moisture. This creates an environment that is conducive to water damage and accelerated deterioration of all associated building elements.

The blue tarp cannot be explained. Leaks may have been apparent at the time of installation but no significant evidence of leaks exists now.

The roof structure appears to be poorly supporting the northern section of the tiles. No movement can be seen in the timber structure. This may be due to poor original installation that has deteriorated over time.

Replacement of loose or missing roofing tiles is recommended immediately to prevent the development of any secondary defects. A roofing restoration specialist should be appointed to complete such works as necessary.

Consultation with a registered builder or structural engineer is recommended to immediately advise on improvements needed to better support the roof tiles.

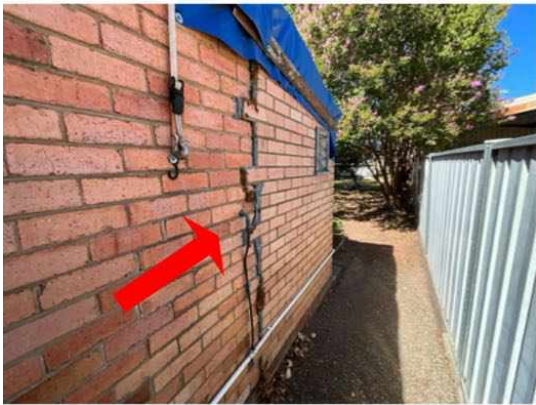
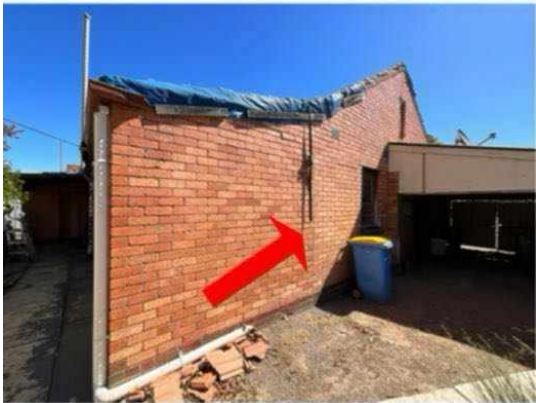
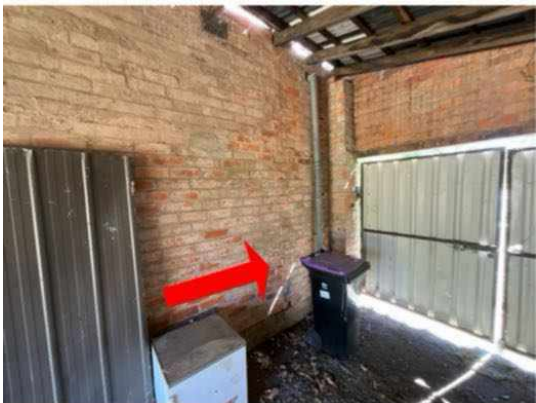
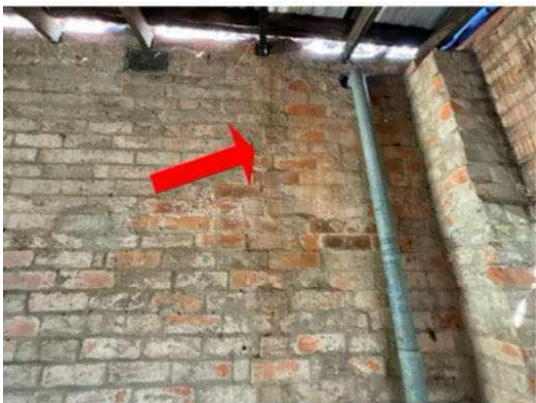
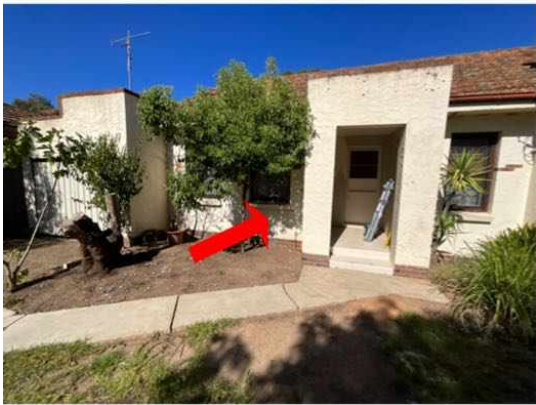
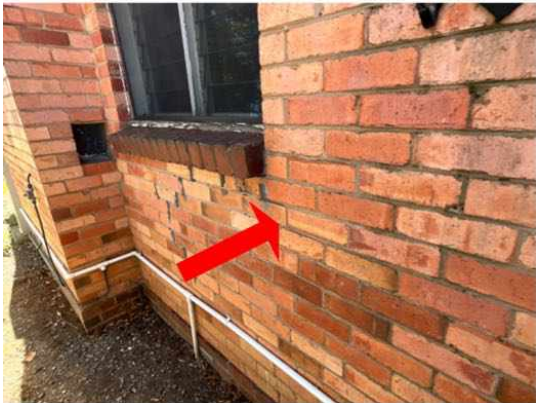
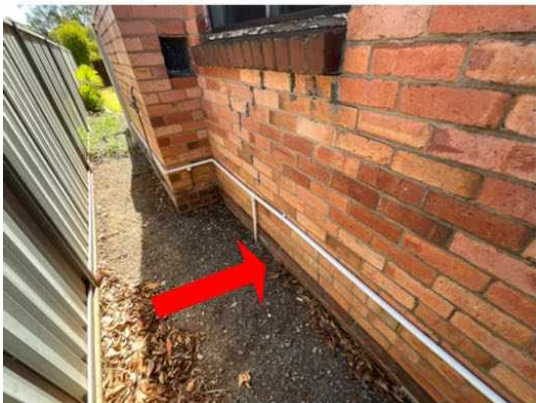
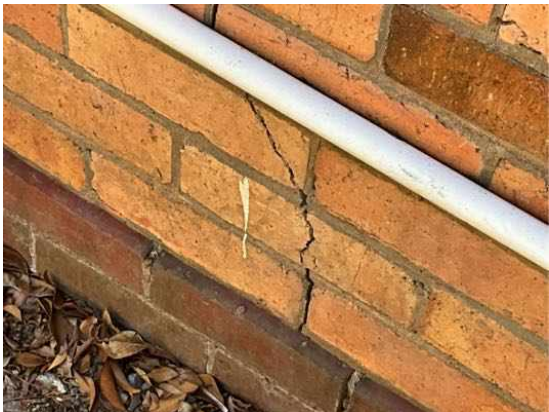
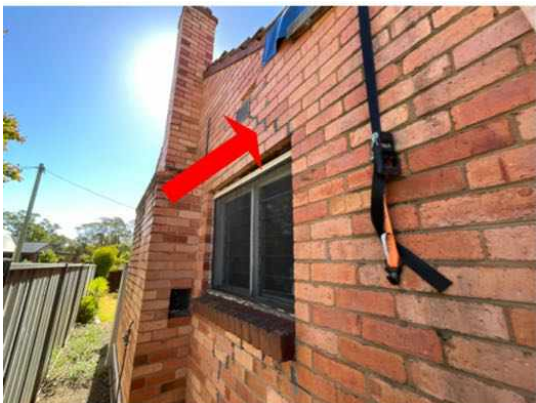
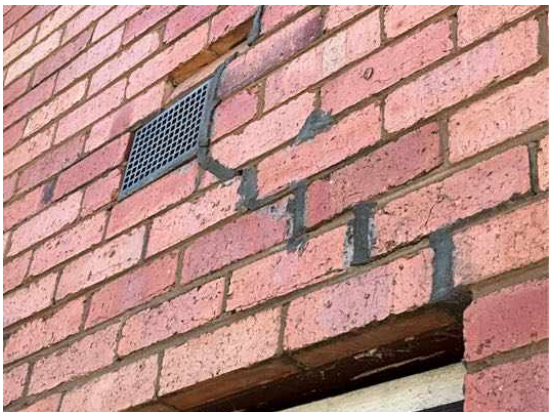
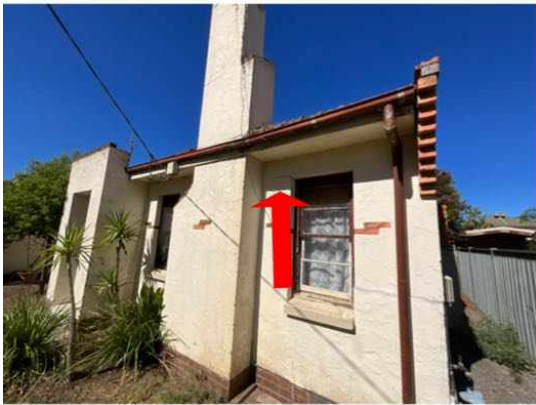
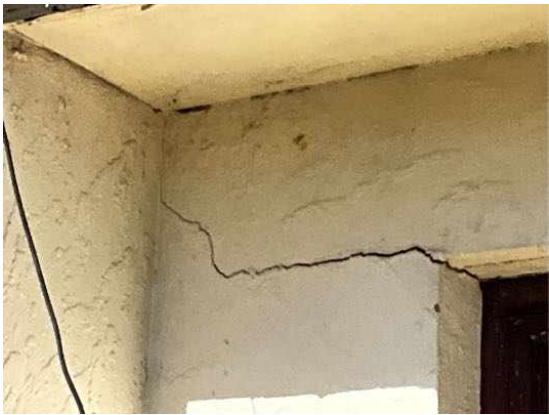
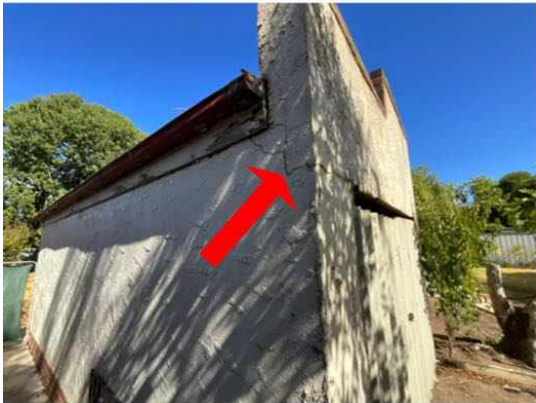
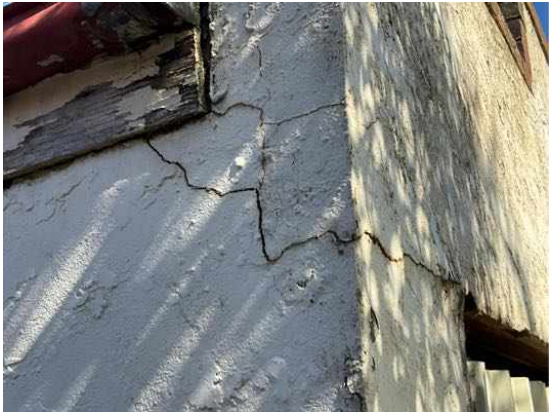
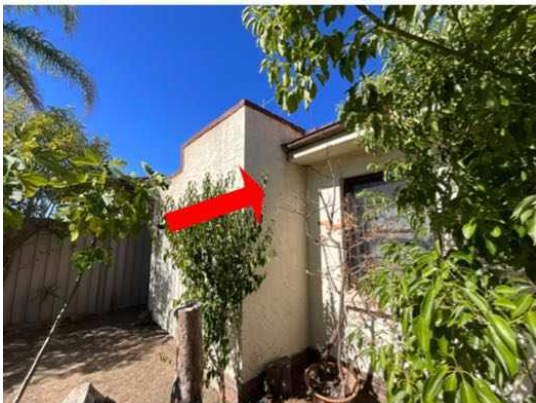
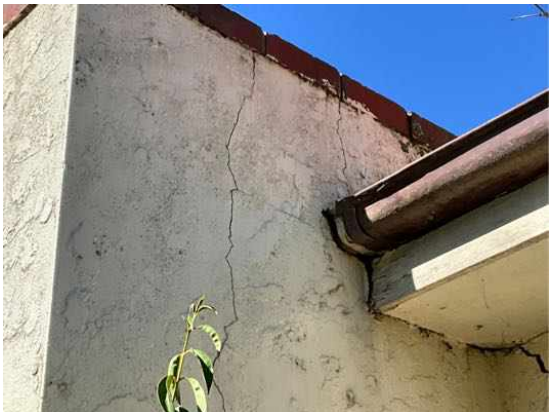
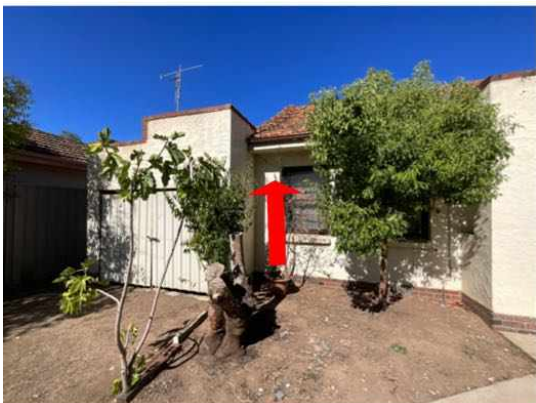
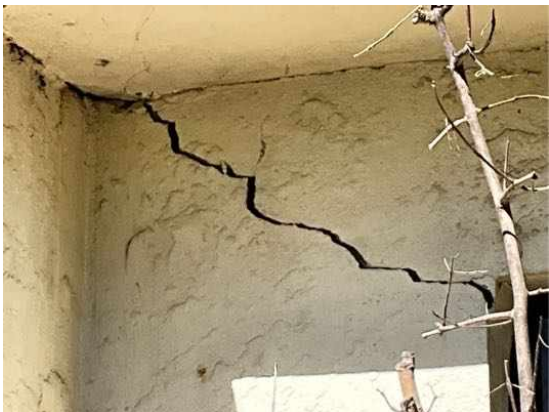
Finding 2.02

Building:	Building 1
Location:	Side, front walls
Finding:	Brickwork - Cracking [Extensive repairs required]
Information:	Major cracking is evident to the brickwork in this area. When managing this degree of cracking, major extensive repair work is generally required. Such work is likely to involve replacement of sections of affected brickwork.

Structural issues are generally the underlying cause of such cracking. It is suspected that this damage has been created due to movement of key structural elements or general subsidence of associated footings.

A structural engineer and bricklayer should be appointed immediately to inspect the structural integrity of the affected brickwork and to assess the safety of the associated structures. The engineer can also nominate a scope of works required for rectification.

Always contact a building inspector or engineer should cracks widen lengthen or become more numerous, even after repair works have been completed.

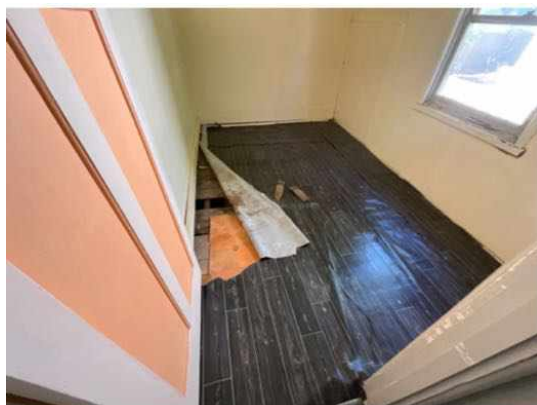
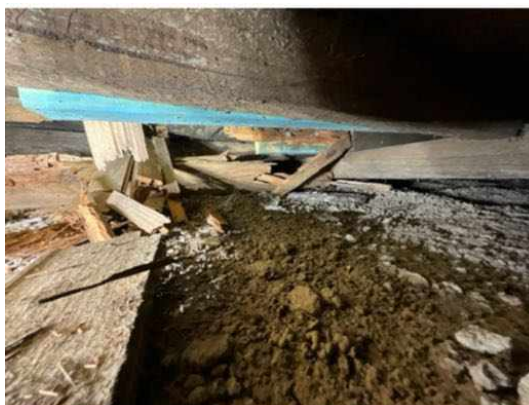
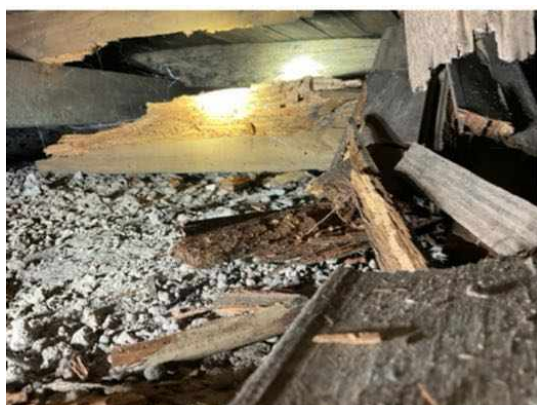
Finding 2.03

Building:	Building 1
Location:	Store Room
Finding:	Fungal decay - present (widespread)
Information:	Fungal decay is also known as wood decay or wood rot generally refers to the deterioration of timber elements when in contact with excessive levels of moisture for a prolonged period of time.

The development of fungal decay is accelerated by temperatures in the range of 5degreeC to 40degreeC as well as the presence of oxygen. Generally fungal decay develops on timber elements that are in use in an external environment which are exposed to rain penetration.

In this case, fungal decay appears to have become widespread and is likely to have affected any adjoining timber elements/structures. The widespread development of fungal decay is likely to have heavily impacted the structural integrity and tensile strength of the affected timber elements and the associated structure.

Timbers affected by widespread fungal decay should be replaced immediately. The cause of the moisture that has led to the development of such decay should also be identified and dealt with in an appropriate manner.

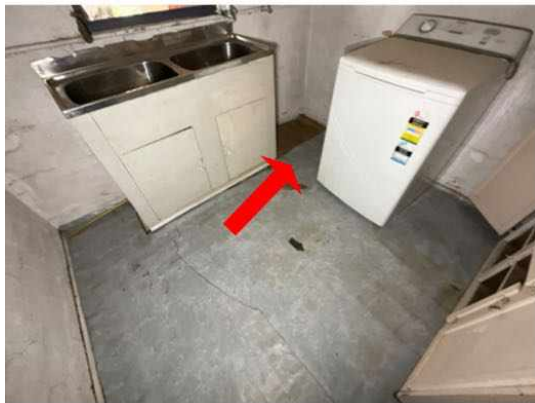
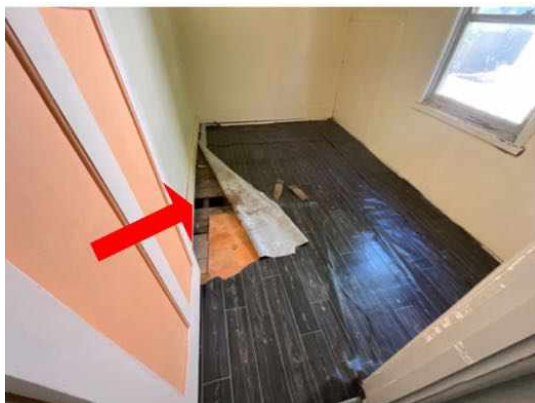
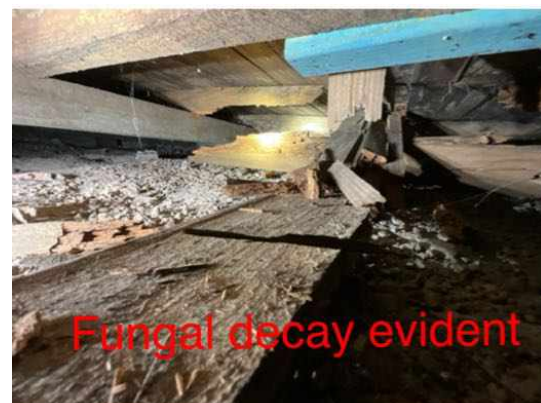
Finding 2.04

Building: Building 1
Location: Laundry, store room, back door area
Finding: Floors - bouncy
Information: The internal flooring in this area was identified as being bouncy at the time of inspection. A bouncy floor surface generally presents as a discernible change in level as they are walked across, in noisy or creaking flooring, or in consequent movement of surrounding furniture and fixtures.

Bouncy floors generally indicate that the floorboards or the subfloor structures are coming loose from the joists that they are installed on. Bouncy flooring may also be the result of gaps between flooring and stumps or joist structures, which require packing.

The client is advised to seek quotations for required repairs from a Registered Builder specialising in re-stumping. The potential resolution may range from packing gaps in subfloor structures through to replacement of subfloors stumps and refixing of flooring.

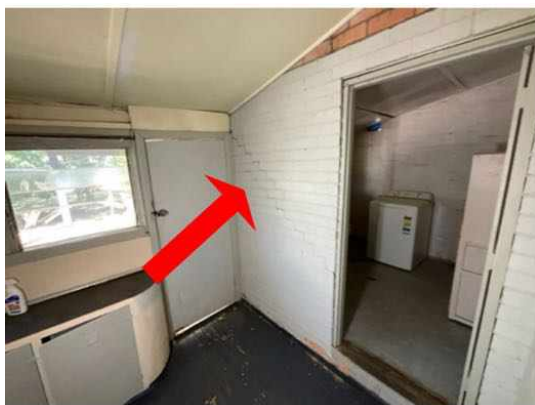
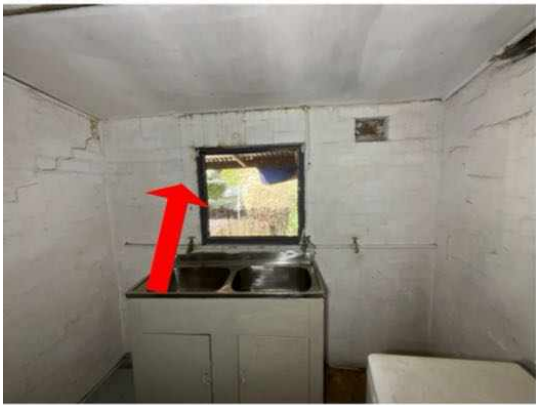
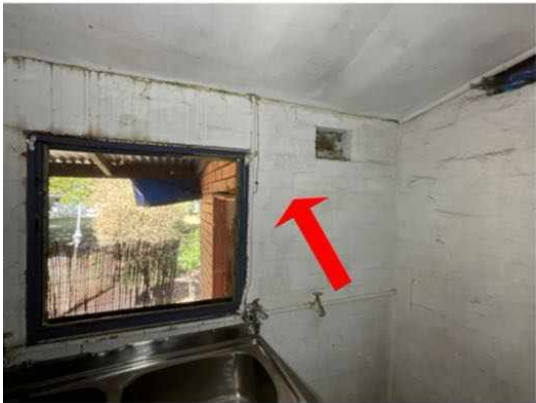
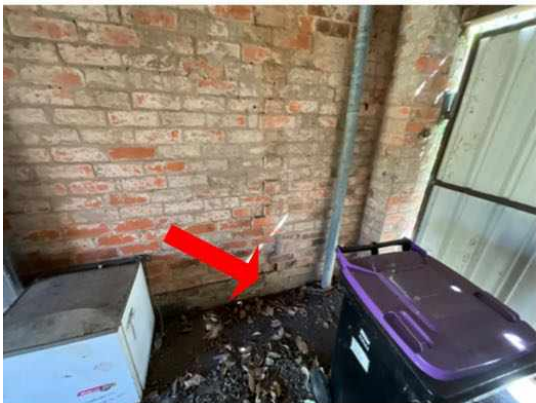
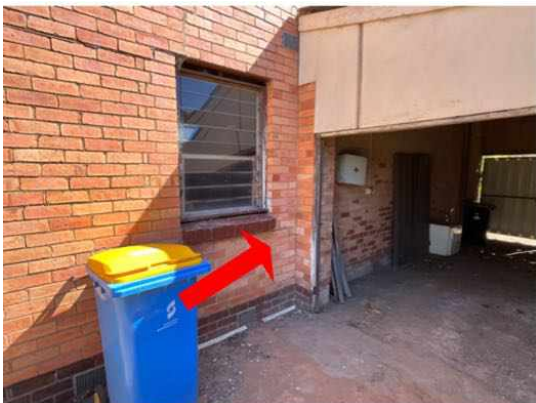
Building:	Building 1
Location:	Laundry, carport area
Finding:	Brickwork - Step cracking
Information:	Step cracking was identified to the brickwork in this area at the time of inspection. Step cracking, which is similar to other forms of cracking, has a variety of possible causes. However, the most common is the subsidence of adjacent footings.

Step cracking is a relatively common defect, and is most likely to occur adjacent to windows, doors and other openings. Mortar failure in the gaps between affected bricks indicates the stresses and tensions affecting the wall.

Where step cracking is extensive or severe, the client is advised to consult a structural engineer. Minor step cracking can be used as a warning sign to address factors causing stress to the wall, which can include the effect of surrounding trees, water leaks, soil erosion, or even the presence of reactive soils in the surrounding area.

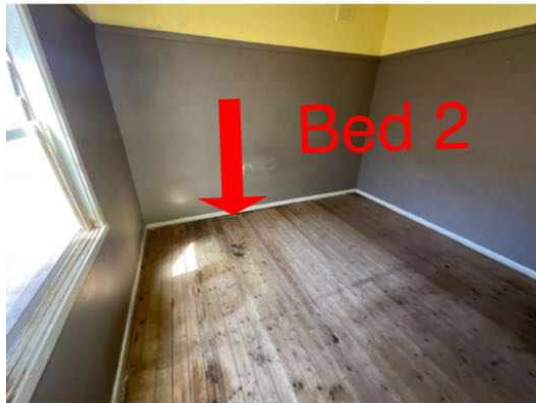
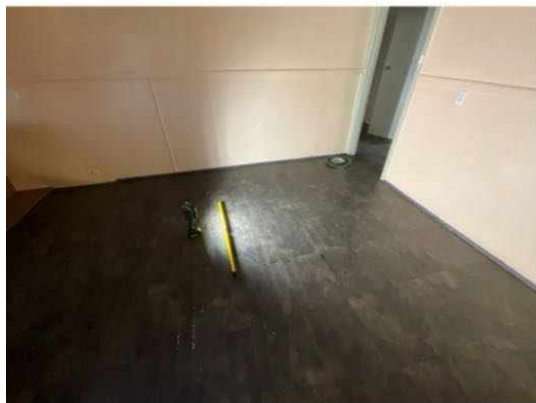
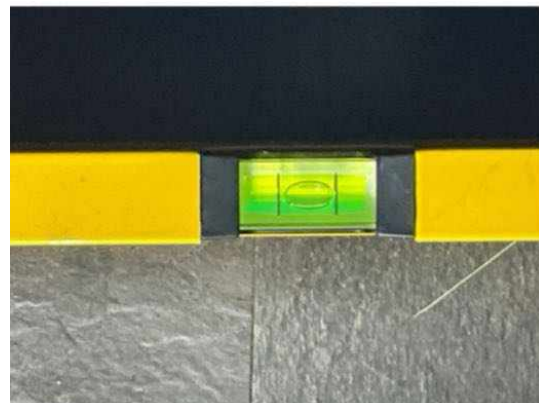
Finding 3.02

Building: Building 1
Location: All Internal Areas
Finding: Flooring - Uneven
Information: The internal flooring in this area is out of level and uneven. Uneven flooring is likely to indicate minor defects such as expected movement of the foundations of the property, but may also indicate subsidence of the associated subfloor stumps.

It is advised that the flooring be closely monitored to identify any further movement. Where flooring remains relatively unchanged for an extended period of time (i.e. several months), it is likely that this defect has been caused by expected movement of the foundations of the property.

However, where flooring is uneven further, potentially invasive inspection of the subfloor structures and stumps in this area is required. In this case, works to repair are likely to be required, and would be carried out by a registered builder specialising in re-stumping.

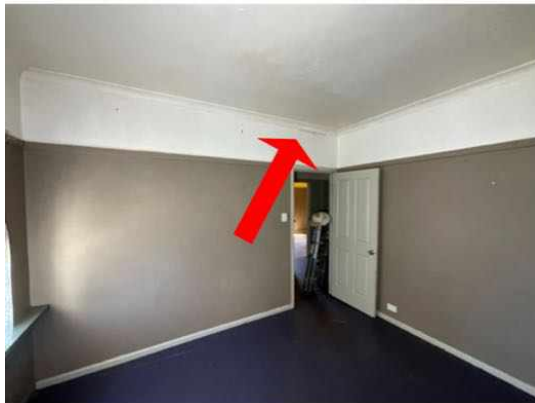
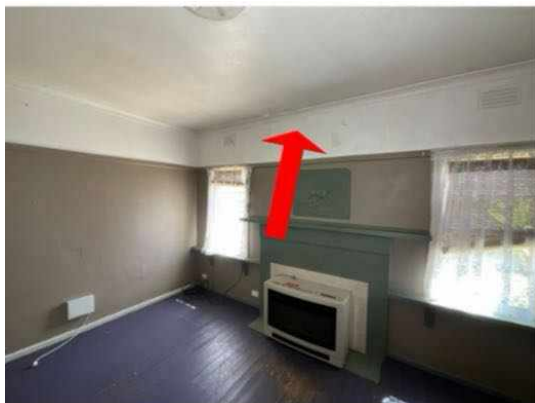
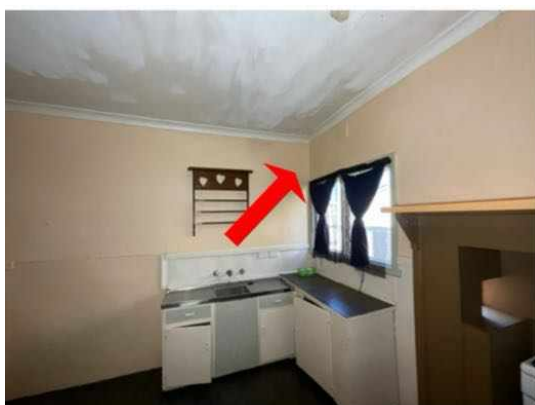
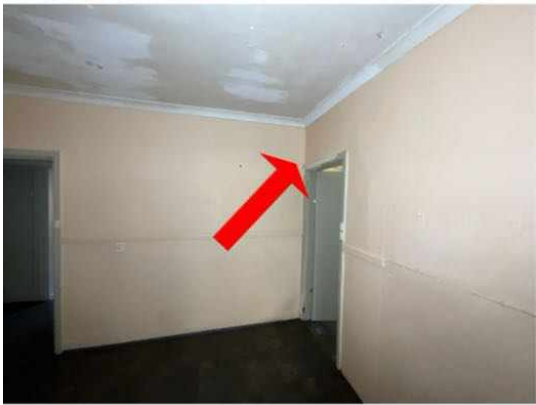
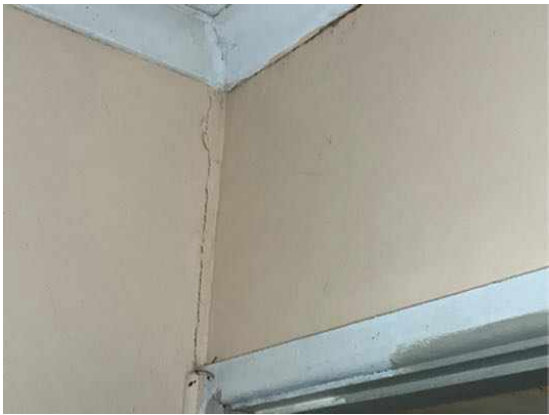
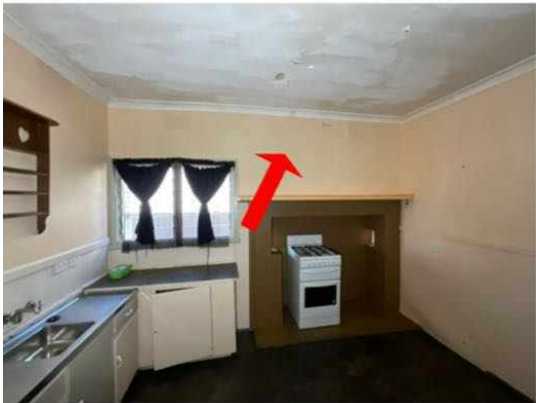
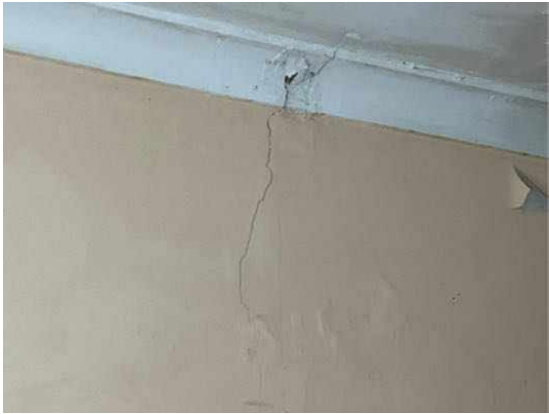
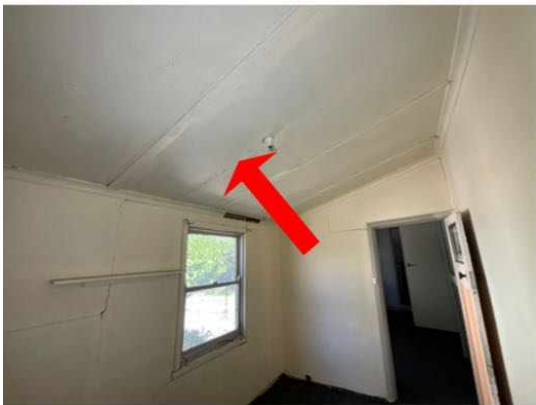
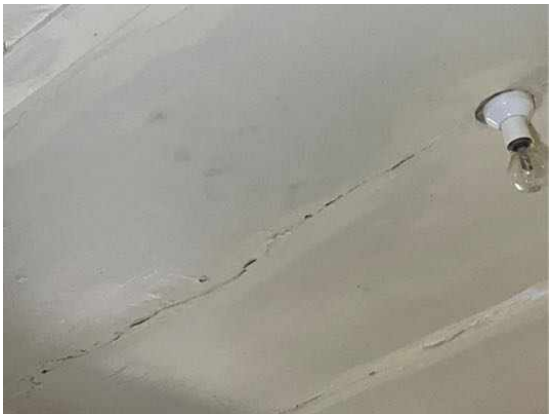
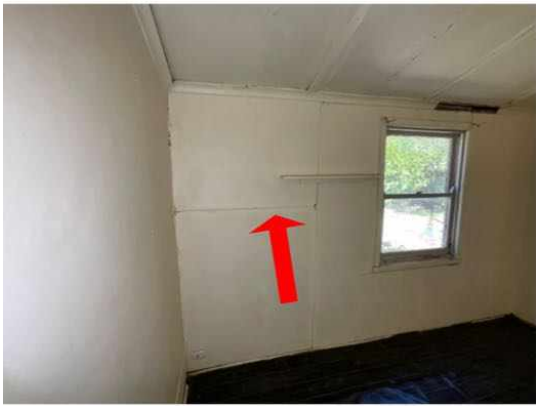
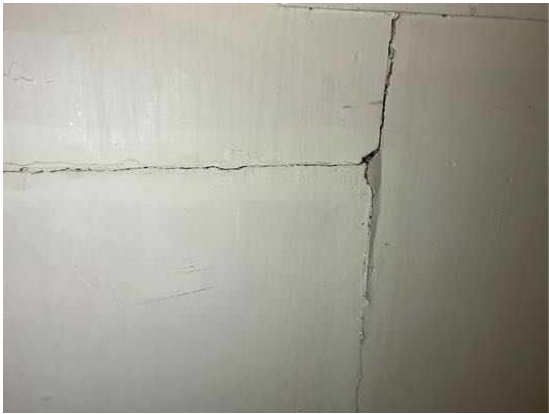
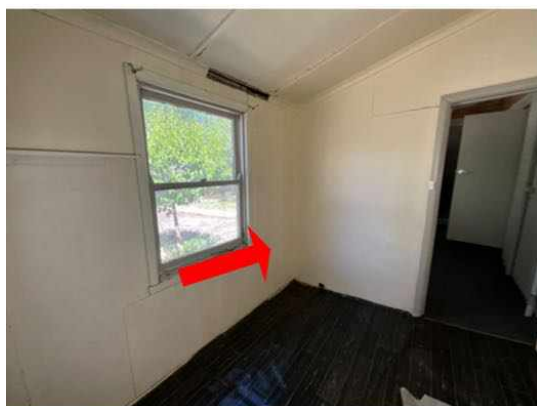
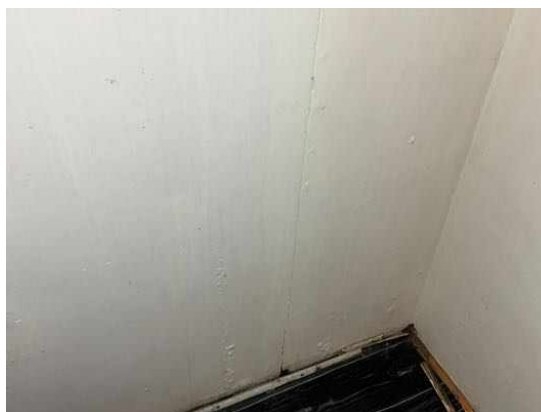
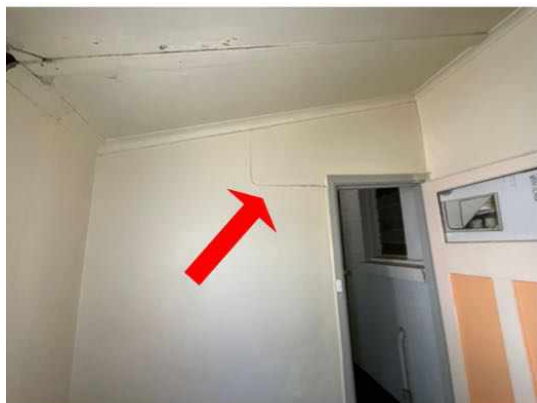
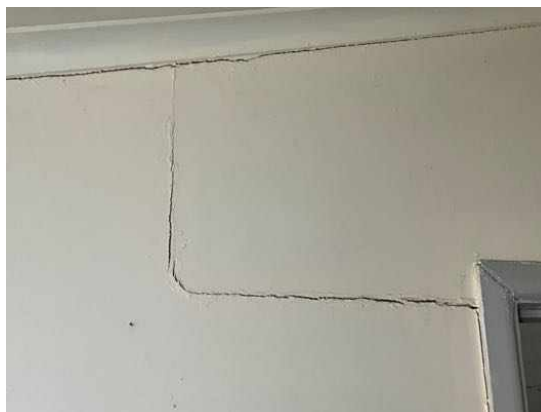
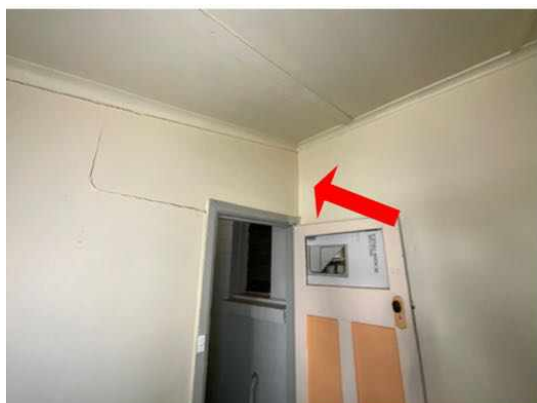
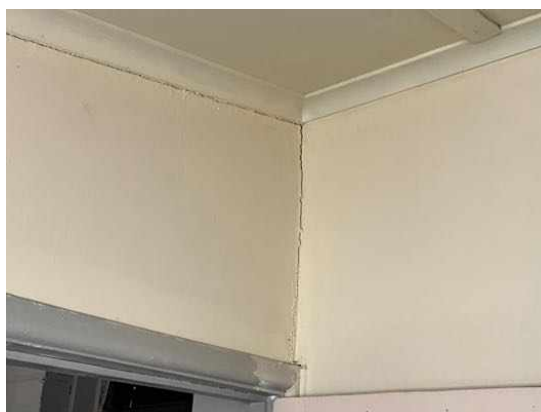
Finding 3.03

Building:	Building 1
Location:	Bedroom 3, kitchen, store room,
Finding:	Cracking - Damage Category 2 - Noticeable (up to 5mm)
Information:	<p>Noticeable cracks are a common occurrence as a result of many primary defects. Such causes may include age, general wear and tear, expected building movement, general expansion/contraction of building materials in different weather conditions, and/or minor failings in the installation or application of building materials.</p> <p>Noticeable cracks may result in minor sticking or jamming of associated doors and windows, which require easement. However, noticeable cracks are easily filled and repaired. A plasterer can be consulted to install an expansion joint at this point to allow</p>

for this movement during different weather conditions.

Monitoring of all cracking should be conducted frequently. Always contact a building inspector should cracks widen, lengthen, or become more numerous. Additionally, your building inspector should also be contacted if associated building elements such as doors and windows become more difficult to operate over time.

Relevant tradespeople, such as carpenters, painters and plasterers, should be appointed to perform remedial works, as deemed necessary.

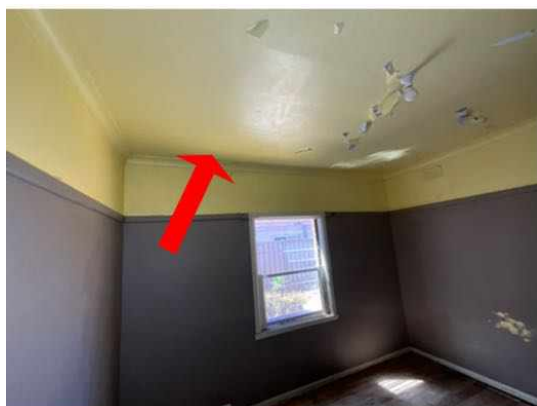
Finding 3.04

Building:	Building 1
Location:	Bedroom 2
Finding:	Ceiling - Sagging
Information:	Sections of the ceiling were found to be sagging at the time of inspection. Sagging to the fixed ceiling structure generally indicates that the building materials have swollen, due to contact with water, or that fixings (e.g. nails or glue) have become loose and require reattachment.

Where minor sagging is evident, comparatively minor works, such as re-gluing of ceiling sheets, may be required. Such works may be performed by relevant tradespeople, such as plasterers and painters. Where excessive moisture has caused

the roofing structure to swell and sag, the source of the water leak should primarily be identified prior to any remedial works being performed.

In some cases, sagging ceiling linings may also indicate that there are structural issues, causing surfaces to warp, twist or sag. Where sagging appears to be major, appointment of a structural engineer is advised to further inspect the property and identify the source and rectification works required.

The appropriate action should be taken by the client as soon as possible to ensure that any potential further damage is limited.

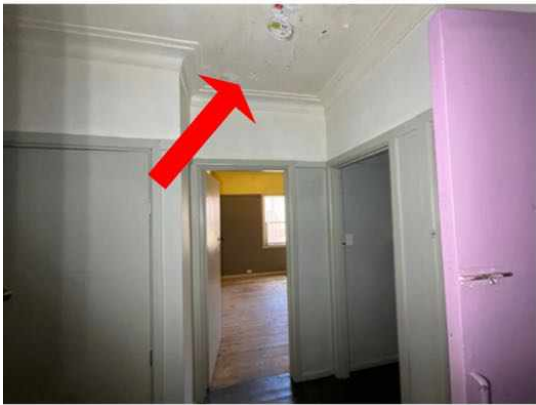
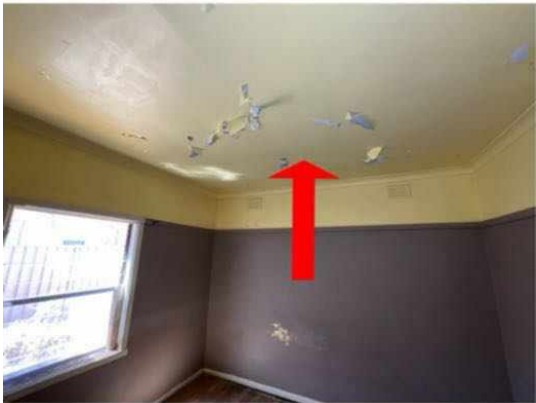
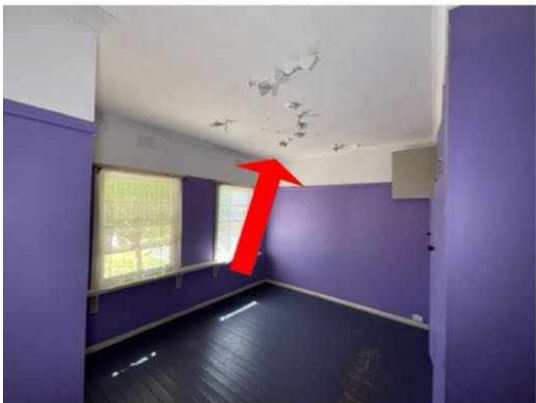
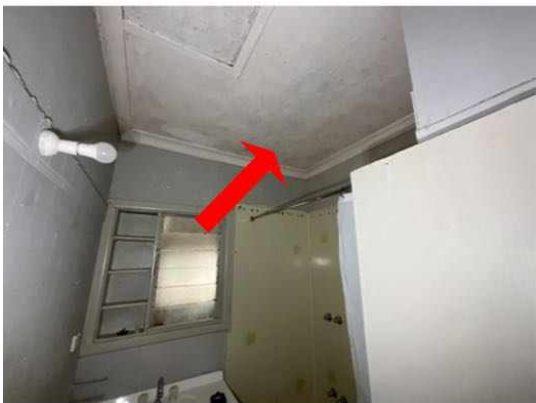
Finding 3.05

Building:	Building 1
Location:	Hall, bed 1,2,bathroom
Finding:	Painted surface - Flaking
Information:	Sections of paint in this area was found to have deteriorated. Paint flaking is generally an indication of excessive moisture in the area, that is currently hidden by the painted surface.

The presence of excessive moisture can have major implications on associated building elements if left unattended. While only seemingly minor at this stage, the damage cannot be determined due to the paint obstructing any further inspection of the damage.

A qualified Painter should be contacted at the Owner's discretion to re-paint the ceiling.

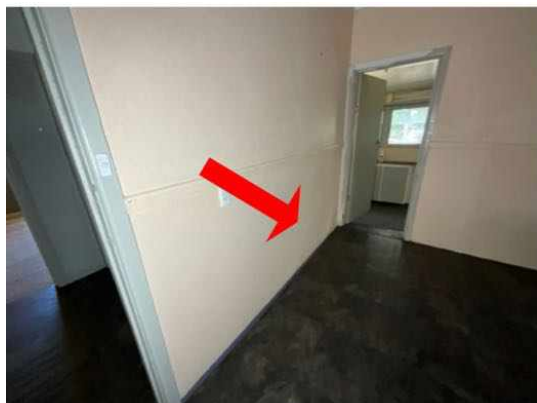
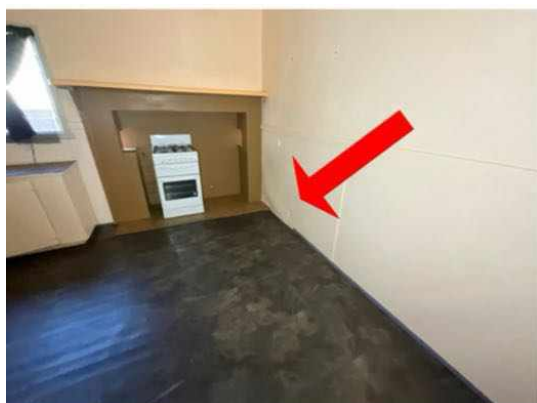
Building: Building 1
 Location: Kitchen
 Finding: Wall lining failing
 Information: The wall lining in this area shows signs of warping. This is most probably a result of excess moisture over time. No excess moisture or termite activity was noted at the time of inspection.

More investigation may be needed. Replacement of the lining should be done by suitable trades, at the discretion of the client, to avoid further deterioration.

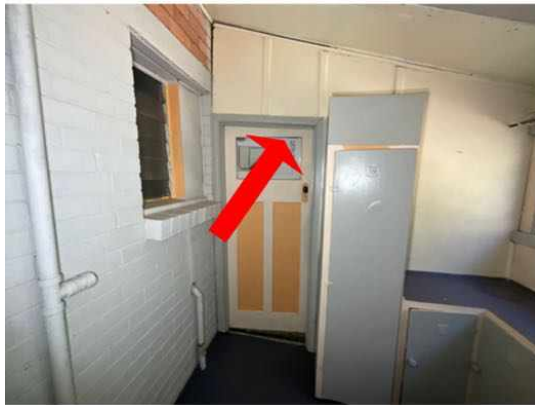
Finding 3.07

Building: Building 1
 Location: Store Room
 Finding: Door- Binding/jamming
 Information: Binding and/or jamming of this door is evident during standard operation. This defect inhibits the functionality of the affected door as well as creating potential for secondary defects to associated building elements, such as damage to the floor covering.

A door that binds to flooring or to the associated door frame may have several causes, ranging from minor defects, such as poor installation of the door or deteriorated hinges, through to major structural issues, such as damage to subfloor structures.

A qualified carpenter or general handyperson should be appointed to perform minor rectification works at client discretion.

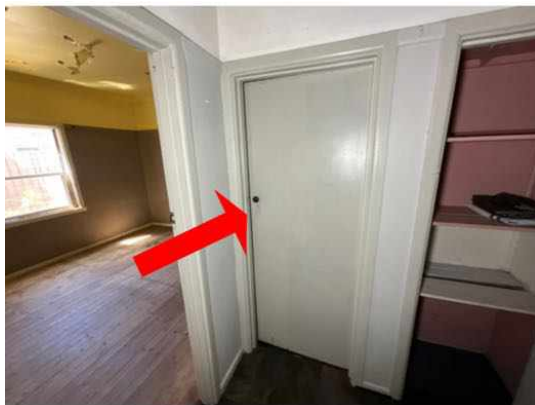
Finding 3.08

Building:	Building 1
Location:	Bathroom
Finding:	Door - Striker plate misaligned
Information:	The striker plate to this door appears to have become misaligned and has consequently resulted in the door's operation being compromised.

This is a common defect and is expected in a property of this age, whether being due to substandard installation or general deterioration of the door hardware.

Readjustment of the striker plate is recommended at client discretion. Works such as these can be completed by a general handyman or qualified carpenter.

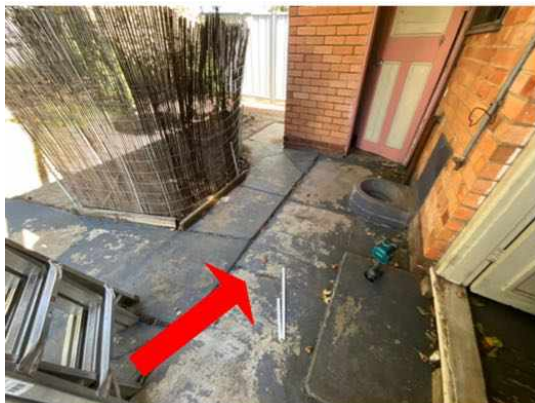
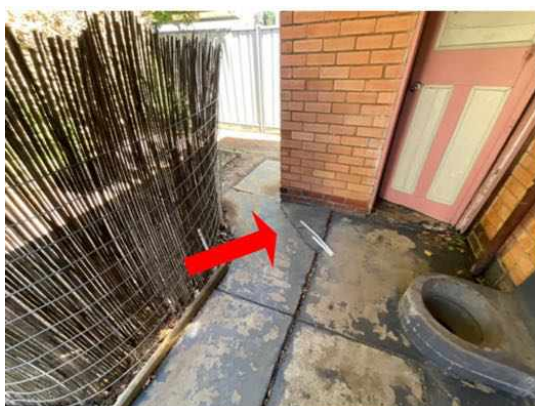
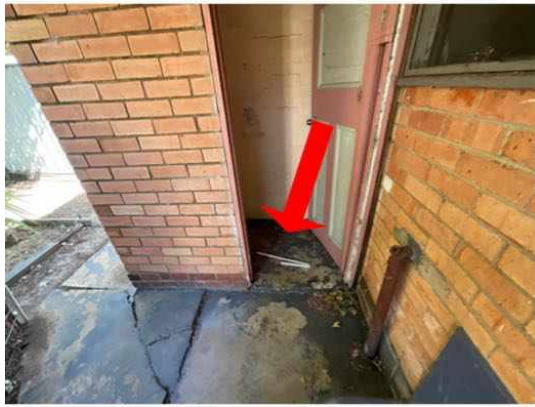
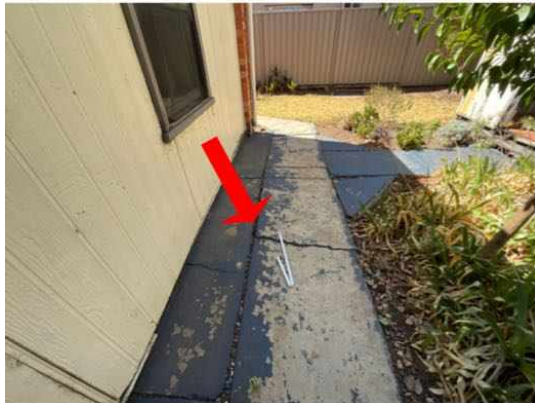
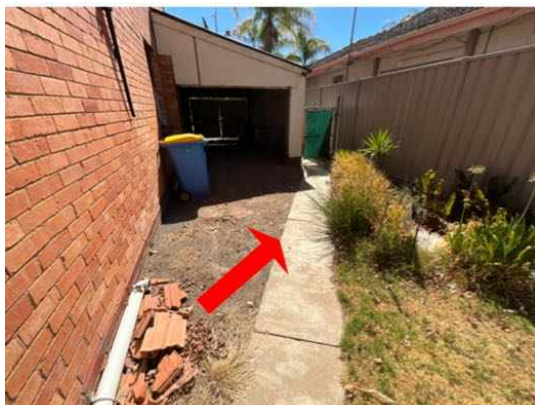
Finding 3.09

Building:	Building 1
Location:	Yard - Back
Finding:	Cracking - External Concrete Paving Damage Category 4 - Gaps in Slab (4mm - 10mm +)

Information: Gaps in the slab were identified in external concrete paving. Gaps in the slab are significant and are likely to lead to the development of safety hazards and secondary defects if left unmanaged, such as the creation of a trip hazard.

General age and expected deterioration of the paved areas is a common cause of this type of cracking. However, expansion and contraction of the slab may also have occurred due to environmental factors. Such factors include variable moisture and weather conditions, the presence of trees and their roots having a settling or lifting affect on the soil, or the effect of load bearing, e.g. heavy vehicles over a sustained period of time.

Cracking to this degree may also be due to poor original installation of the concrete. Factors such as poor compaction of the sub surface and/or inadequate reinforcing of the slab may create cracking and other secondary defects. Gaps in the concrete paving may also have a more significant structural cause, such as subsidence of soils.

Where gaps in the concrete paving are adjacent to structural elements of the building, the advice of a Structural Engineer is advisable before undertaking repairs. Significant repair and likely replacement of the concrete paving is probable.

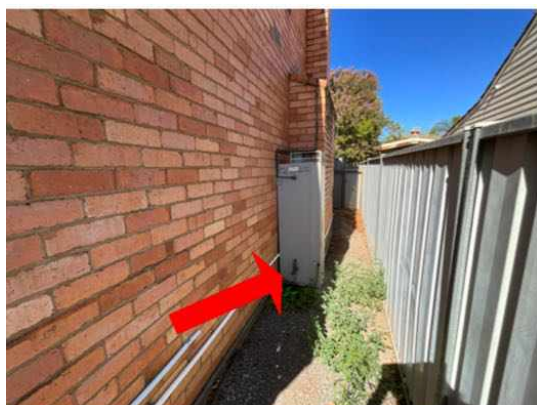
Building: Building 1
 Location: Hws
 Finding: Water leak - Active
 Information: Generally, water leaks occur when a particular area of the property is not weather or water tight. As the surrounding area was found to be damp at the time of inspection, the leak is considered ongoing and hence requires urgent action.

Regardless of the location, even minor leaks that are left unmanaged can lead to serious damage of associated building elements and result in the need for replacement of building materials. Mould and other hazards such as electrical hazards may also arise if the leak is left to develop.

It is highly advised that the cause of the leak be identified and resolved immediately by a licensed plumber to prevent any further damage. Depending on the extent of the damage previously sustained, repair and/or replacement of any affected building materials may be required.

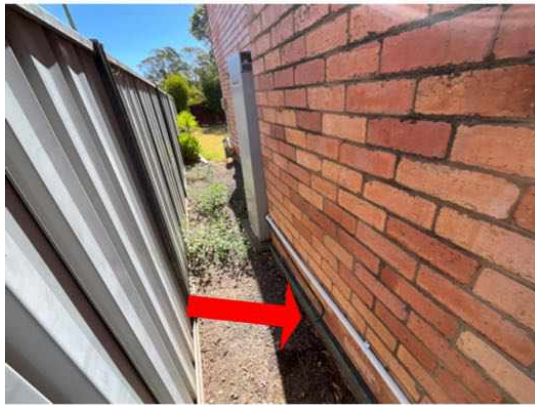
Finding 6.02

Building: Building 1
 Location: Yard - Side
 Finding: HWS Overflow - Not Connected
 Information: The Hot Water System (HWS) overflow was found to be disconnected from storm water drainage and is creating excessive moisture in the surrounding area.

These damp conditions can lead to secondary defects such as rot, rust or corrosion of associated building elements, the formation of fungal decay, or even the creation of potential slip hazards. When coupled with poor site drainage, pooling of water may also attract termite activity to this area.

It is highly recommended that a licensed plumber be appointed to connect the HWS overflow in order to prevent such an environment from being created. These minor works should be carried out as soon as possible.

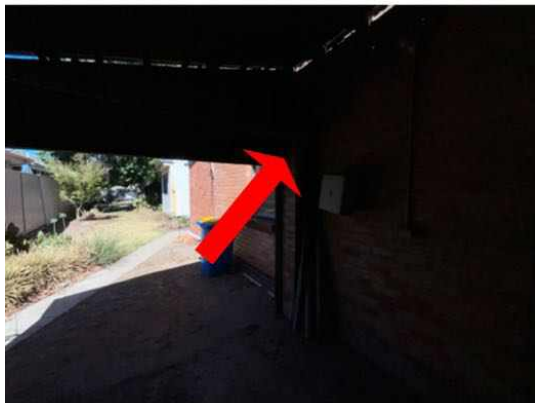
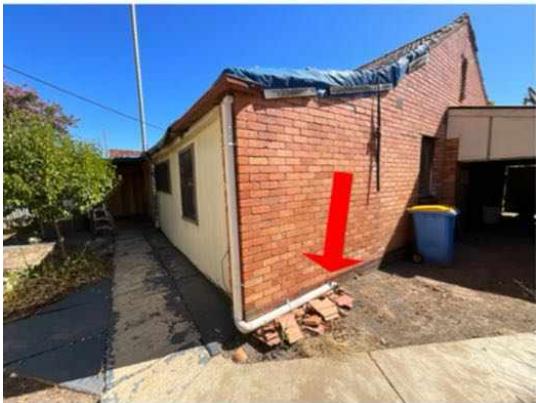
Finding 6.03

Building:	Building 1
Location:	Carport, yard - back
Finding:	Stormwater drain - Not connected
Information:	The roof plumbing is not adequately connected to stormwater drainage on the site. This disconnection negatively impacts the functional capacity of the roof plumbing.

Where roof plumbing doesn't drain adequately, the area at the base perimeter can become excessively damp, potentially creating an environment that is susceptible to rust and corrosion of surrounding building elements, as well as attracting termites and other pests.

It is highly recommended that a plumber be appointed to further inspect the area and to install adequate drainage equipment where necessary.

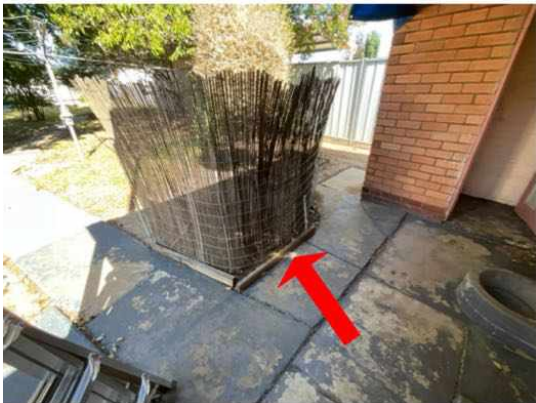
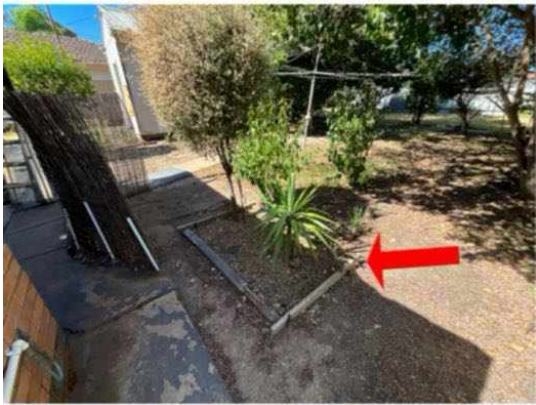
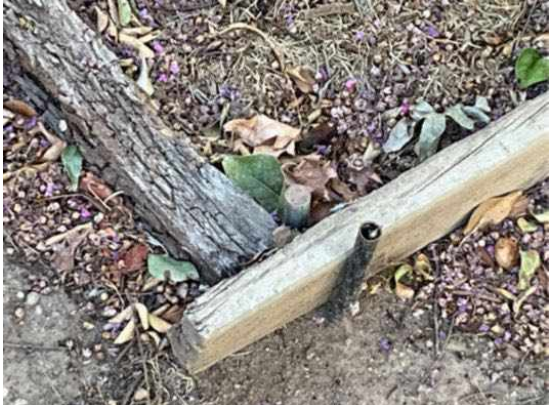
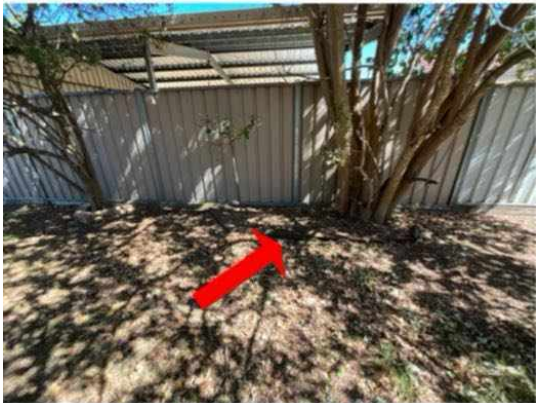
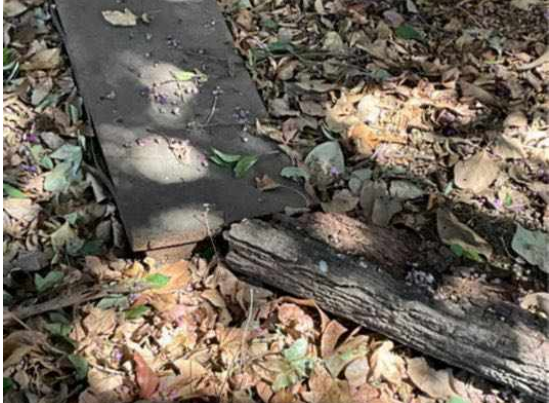
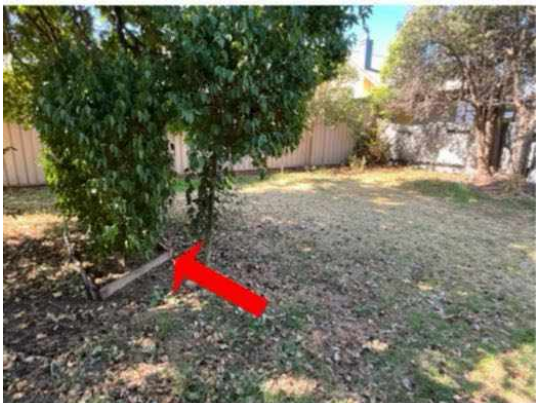
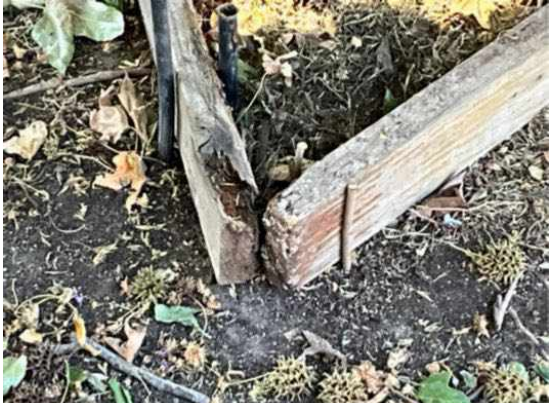
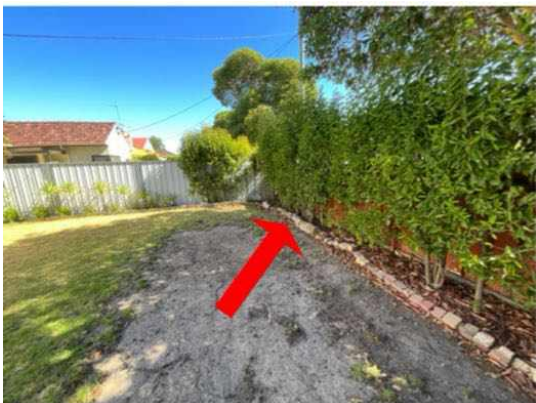
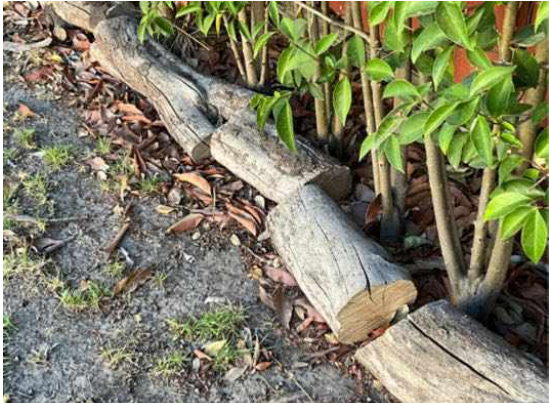
Finding 6.04

Building: Building 1
 Location: Yard - Back, front
 Finding: Untreated or non-durable timbers in a hazardous environment
 Information: To reduce the risk of timber pest attack it is essential that timber used in a hazardous environment (e.g. in direct contact with the ground or frequently exposed to damp conditions) is of sufficient durability and/or is adequately preservative treated.

Untreated timbers in direct contact with the ground are likely to develop severe wood rot and/or fungal decay if left unattended creating attraction for subterranean termites to infest the timbers from surrounding areas.

If untreated or non-durable timbers are found to be in a hazardous environment it is highly advised that replacement of these building elements be performed as soon as possible to aid the protection of the property against termite / timber pest attack.

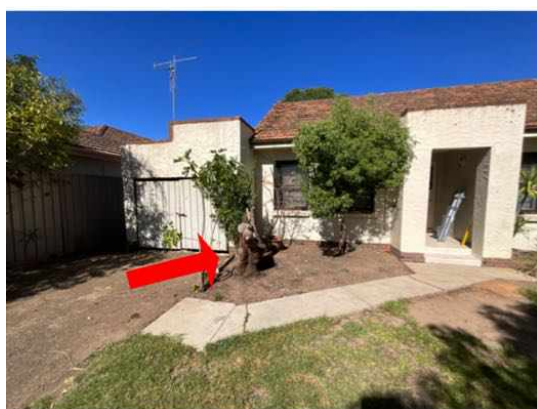
Finding 6.05

Building: Building 1
 Location: Yard - Front
 Finding: Tree Stump in Ground
 Information: Any tree stumps in the yard not removed during the tree removal process provides the opportunity for Termite infestation and is likely to be subject to decay from damp conditions against the stump.

All tree stumps should be removed by professional tree removal services where possible. Meanwhile regular inspections are advised to identify any termite activity in the areas identified.

Services for tree stump removal should be contacted as soon as possible to reduce the risk of timber pest attack.

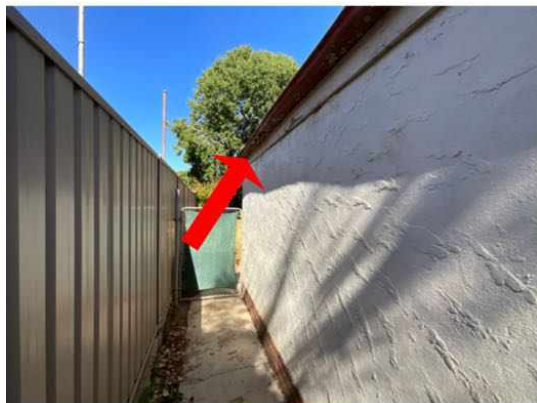
Finding 6.06

Building: Building 1
 Location: Carport
 Finding: Gutters- Deteriorated
 Information: The guttering and some downpipes have deteriorated.

Although not a major problem now, they will deteriorate further if left for an extended period.

Sagging can be seen in the gutter.

A Licensed Plumber should be engaged as soon as possible to advise on any repairs or maintenance that may be required.
