Building and Timber Pest Inspection Report

Inspection Date: Thu, 19 Feb 2026

Property Address: 545 Wyndham St, Shepparton VIC 3630,
Australia

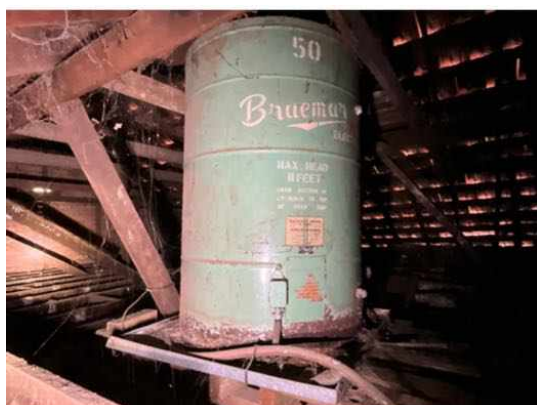
Finding 6.07

Building:	Building 1
Location:	Roof Void
Finding:	Gravity-Fed HWS - Disconnected
Information:	It was noted at the time of inspection that a disconnected gravity-fed hot water system (HWS) remains in this area.

Despite this plumbing structure being unused, it is likely to be storing residual water, and is therefore susceptible to rust and corrosion. If allowed to continue, rust and corrosion is likely to lead to damage to adjoining building elements, and may also make the area susceptible to termite or timber pest activity.

While it is a costly exercise to remove the disused gravity-fed HWS, it is advisable in the short-term future to prevent any further damage to the area. Further consultation with a licensed plumber is required to gain further advice on removal of the structure.

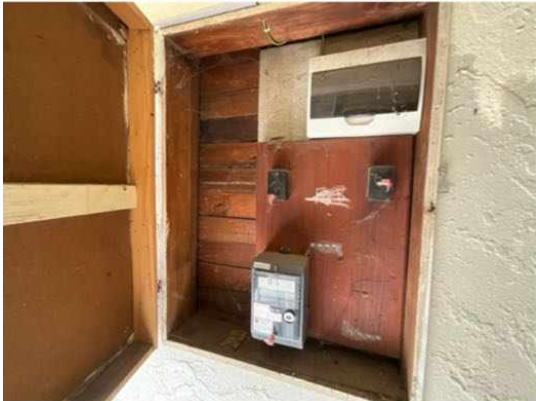
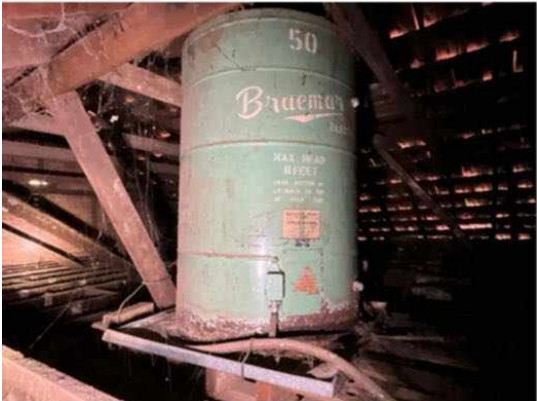
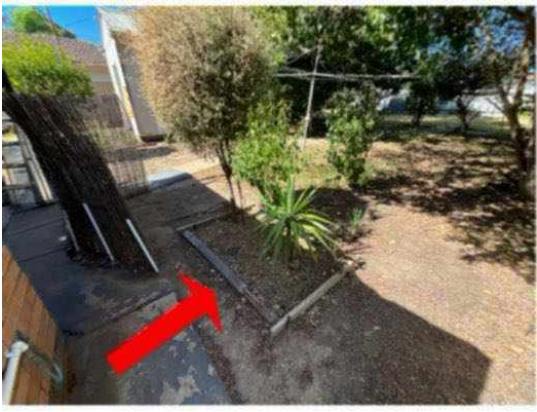
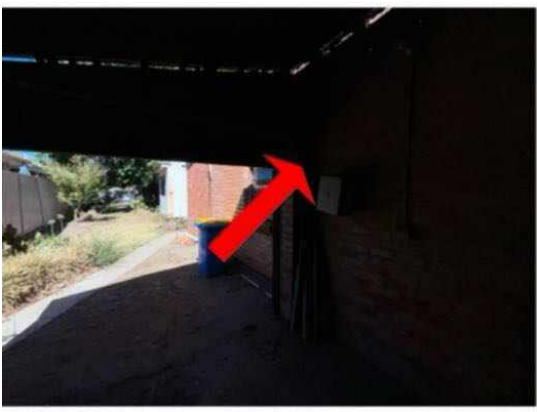
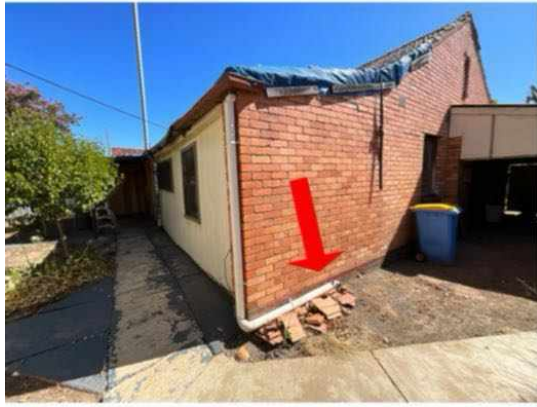
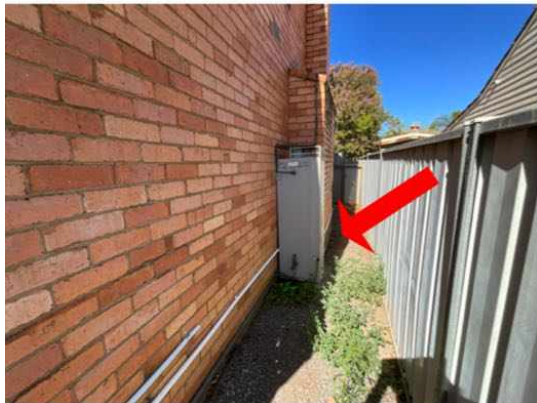
Finding 6.08

Building:	Building 1
Location:	All External Areas
Finding:	Termite Management System - no evidence of a chemical installation
Information:	The application of a post-construction chemical termite barrier is highly recommended

for all properties, particularly if live termite activity has been found on the site previously. Such barriers are highly effective in preventing termite attack on any timber building elements throughout the property.

A durable notice should be placed in the switchboard unit to indicate current termite barriers. At the time of inspection, it appeared as though no termite management system has been installed, with no evidence to suggest preventative works taking place.

The client may consider gaining further advice from a pest controller as to the costs and procedures involved with this application. It is recommended that obtaining such advice be a short-term priority.

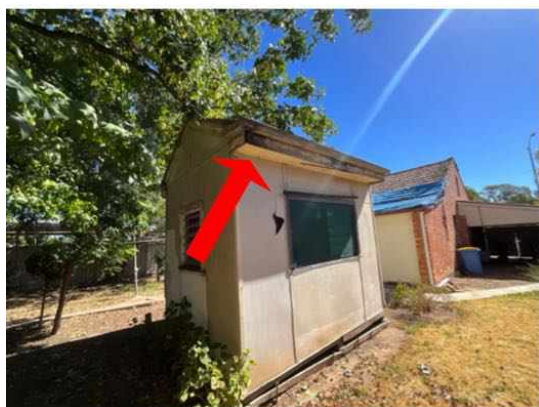
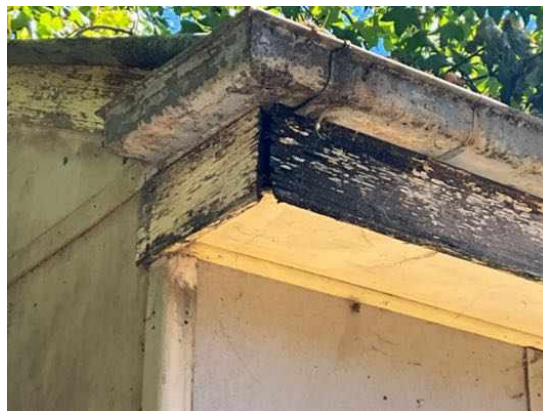
Finding 7.01

Building:	Building 1
Location:	Bungalow
Finding:	Fungal decay - present (localised)
Information:	Fungal decay also known as wood decay or wood rot generally refers to the deterioration of timber elements when in contact with excessive levels of moisture for a prolonged period of time.

The development of fungal decay is accelerated by temperatures in the range of 5degreeC to 40degreeC as well as the presence of oxygen. Generally fungal decay develops on timber elements that are in use in an external environment which are exposed to rain penetration.

In this case although the affected timber element is in a decaying state the extent of any visible damage appears to be localised to a specific area and is yet to spread to other parts of the building element or affect adjoining structures. The fungal decay is therefore likely to be of a relatively superficial nature with minimal impact on the structural integrity or tensile strength of the timber element.

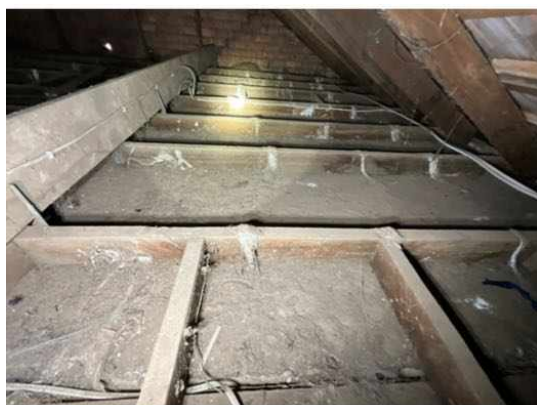
Building:	Building 1
Location:	Roof Void
Finding:	Insulation - Missing
Information:	Upon inspection of the roof void it was noted that insulation is not present.

Insufficient insulation will result in a comparatively higher cost to heat and cool a property as there is a lack of Insulation (or uneven coverage of insulation) which works as a barrier to heat transfer. This helps to keep out unwanted heat in summer and preserves warmth inside your home in winter. It can also help soundproof your home from unwanted airborne noise transfer.

Where insulation is absent, the area does not meet current Australian Standards. Installation of adequate insulation is required and should be conducted as soon as possible.

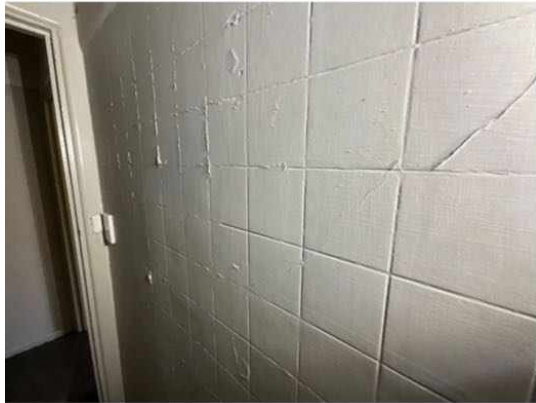
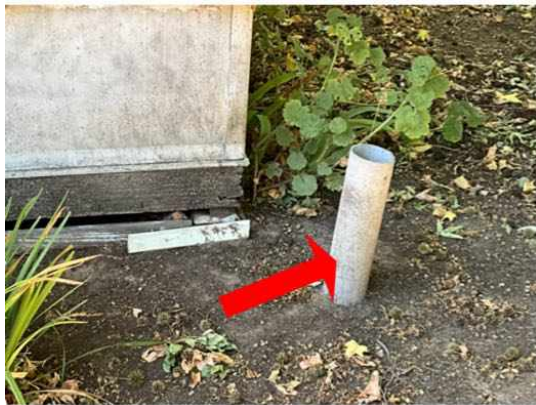
Building:	Building 1
Location:	All Areas
Finding:	Asbestos - Suspected ACM Identified on Site
Information:	Reporting on Asbestos is outside the Scope of this Report. This suspected defect is highlighted as a caution only. We suspect, based on our experience in the building industry, that there is a higher risk of the identified building element containing asbestos.

As Asbestos Reporting is outside the scope of this report, we advise that you consider a separate Asbestos Inspection and Condition Audit, which can include the taking of samples for definitive confirmation of the presence of Asbestos.

In the interim, the client is advised to act with caution, especially when considering any damage to building materials general wear and tear renovations extensions demolition and general maintenance activities due to the suspected presence of Asbestos.

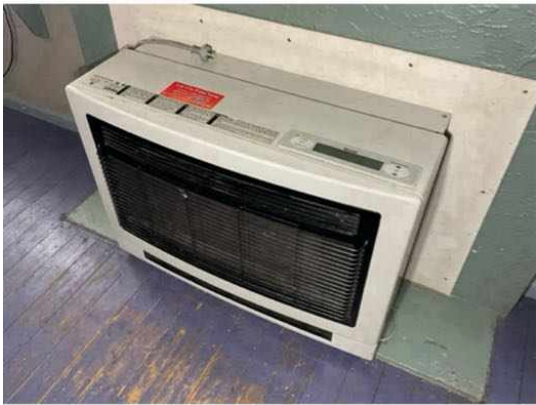
Building: Building 1
Location: All Areas
Finding: Additional Photos - Obstructions and Limitations
Information: These photographs are an indication of the obstructions and limitations which impeded full inspection of the property at the time of inspection. These obstructions can hide an array of defects and should be removed to allow full inspection to be carried out. A re-inspection is recommended once the areas are made accessible.
