# Building and Timber Pest Inspection Report

Inspection Date: Wed, 14 Jan 2026

Property Address: 9/120 Oxford Rd, Ingleburn NSW 2565,  
Australia

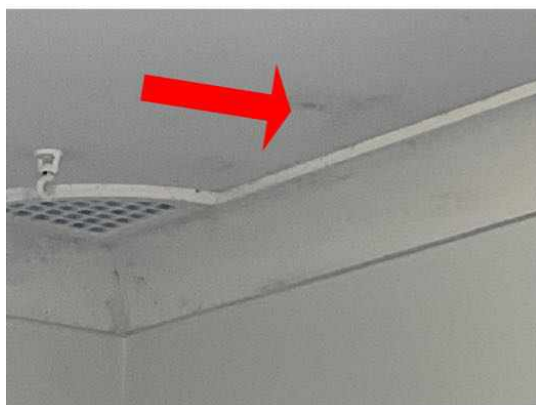
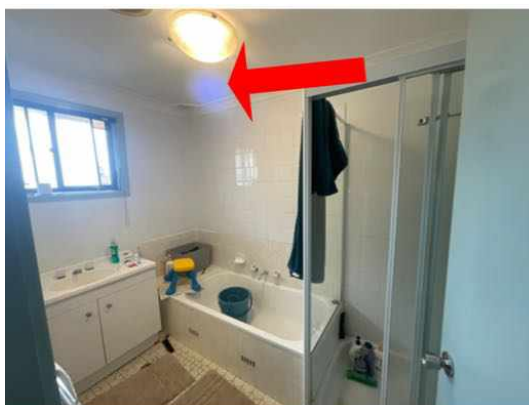
Building:	Main Building
Location:	Bathroom
Finding:	Moisture Damage and Possible Mould – Bathroom Ceiling
Information:	Visible discolouration and patchy staining were observed on the bathroom ceiling, indicative of possible mould or mildew growth. This is likely caused by poor ventilation, inadequate exhaust fan performance, or excessive humidity from regular use of the bathroom.

Prolonged moisture exposure can lead to fungal decay, damage to plasterboard, or create conditions conducive to timber pest activity above the ceiling line.

It is recommended that:

- A licensed plumber or building professional assess for hidden water leaks.
- Exhaust fan performance and airflow be reviewed and upgraded if necessary.
- The affected area be cleaned, treated, and repainted with mould-resistant paint.
- The roof void or ceiling cavity above be inspected for hidden moisture or damage if accessible.

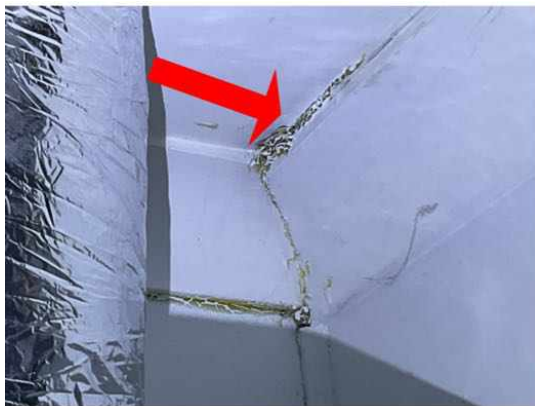
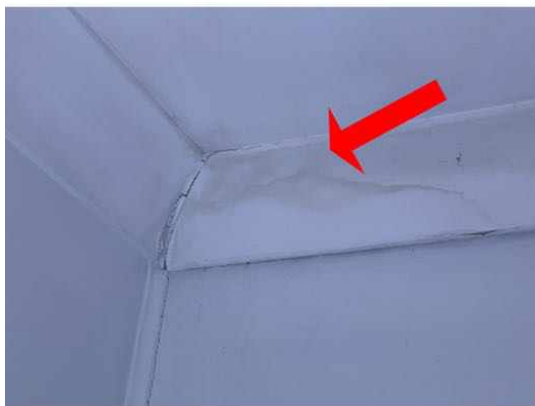
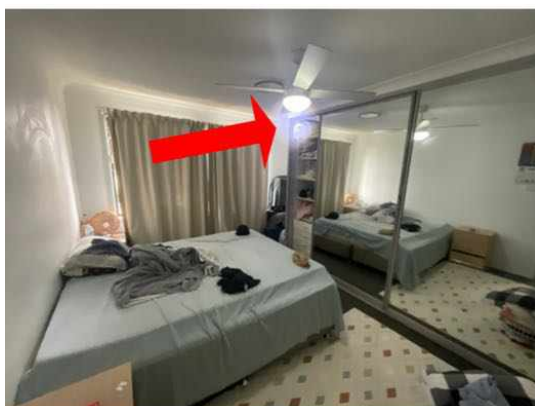
#### Finding 2.01

Finding: Ceiling - Water damaged

Information: Water damage to the ceiling lining is generally an indication of excessive moisture being present in the roof void, usually via a leak to the roof covering.

Where water damage is evident to the ceiling, the primary requirement is to identify and rectify the source of the leak. A roofing plumber should be appointed as soon as possible to identify the leak and perform rectification works as necessary, ensuring the water damage is restricted.

Once the leak is repaired, consultation with relevant tradespeople, including plasterers and painters, is advised. Rectification works may include replacement of ceiling lining or minor repainting, depending on the extent of the damage.

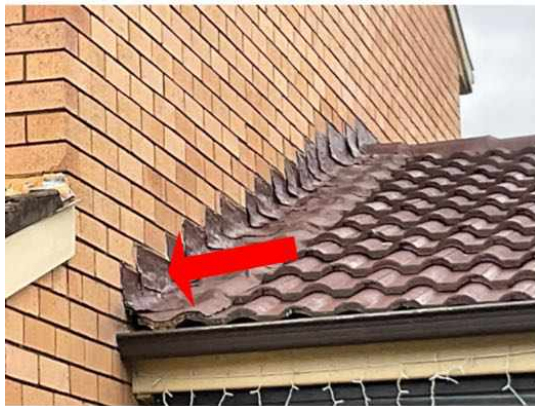
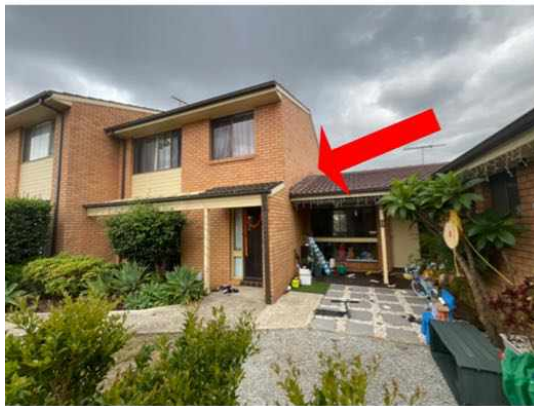
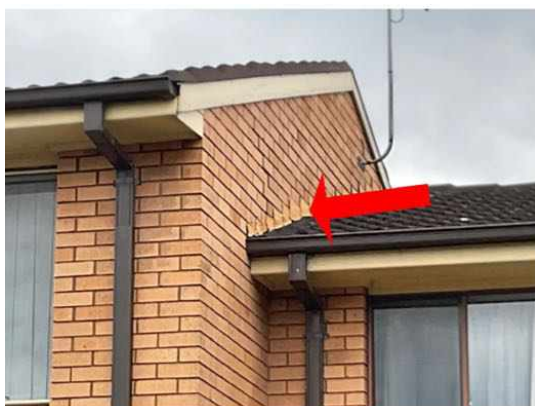
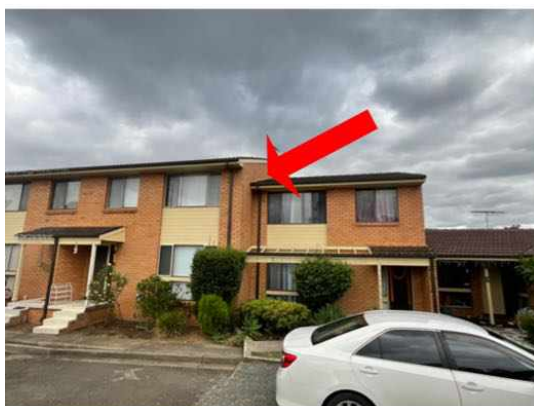
## Finding 2.02

Building: Main Building  
 Location: Roof Exterior  
 Finding: Roof plumbing - Flashing inadequate  
 Information: Some sections of the roof are missing or have inadequate roof flashings. Flashings are metal and other materials which are applied to seals and intersections between roof coverings and building elements. They are designed to aid in weatherproofing of roof joins.

Flashings that are not installed adequately or are missing are likely to result in water penetration to the interior of the property, as well as creating excessively damp conditions against the exterior surfaces and around the base perimeter of the building.

Premature ageing and secondary building defects are imminent where roof plumbing is missing or inadequately installed. Additionally, water pooling also creates an environment that is susceptible to termite and pest infestation.

A roofing plumber should be appointed as soon as possible to install relevant roof plumbing materials, ensuring that no further damage is sustained.

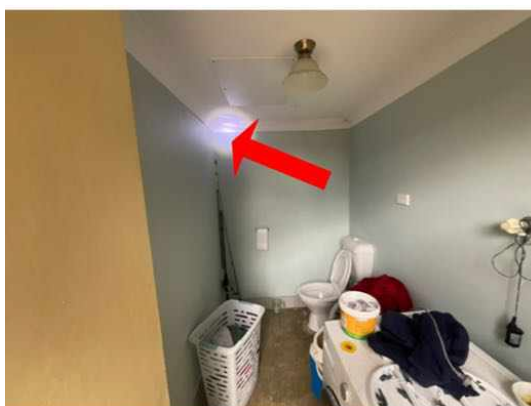
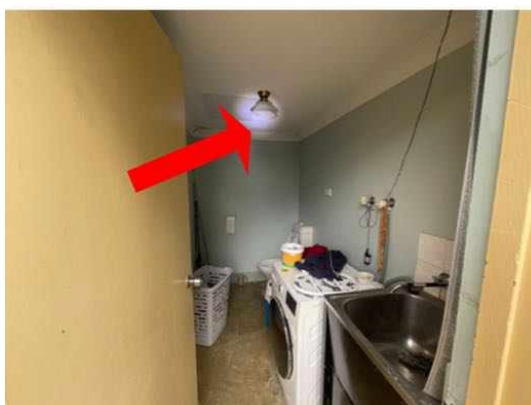
## Finding 2.03

Building: Main Building  
Location: Laundry  
Finding: Water Damage to Laundry Ceiling (Below Bathroom)  
Information: Water damage and staining were observed to the laundry ceiling located beneath the bathroom above. This condition is generally indicative of a plumbing leak or failure of the bathroom waterproofing system, which may include leaking pipework, shower base, floor wastes, or deteriorated waterproof membranes.

Ongoing moisture ingress may result in further deterioration of ceiling linings and concealed structural elements. It is recommended that a licensed plumber and/or waterproofing contractor be engaged to investigate and rectify the source of the leak. Once repaired, damaged ceiling linings should be replaced or repaired and repainted as required.

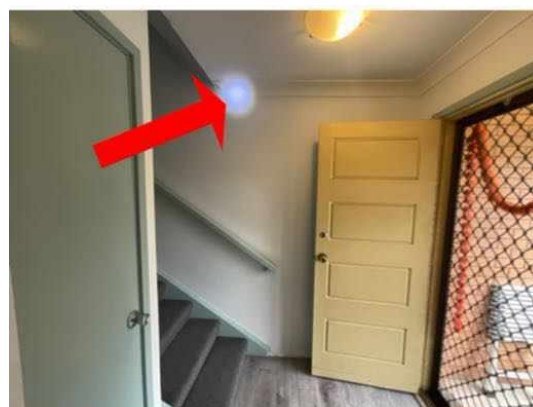
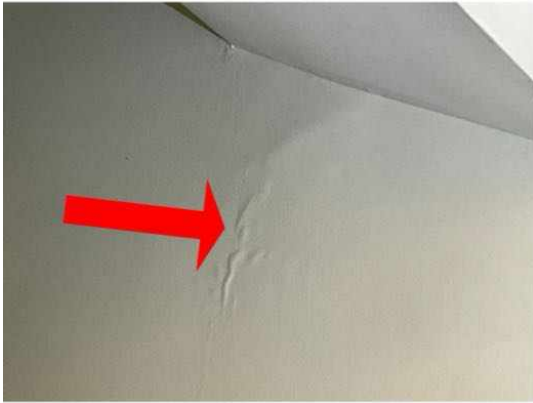
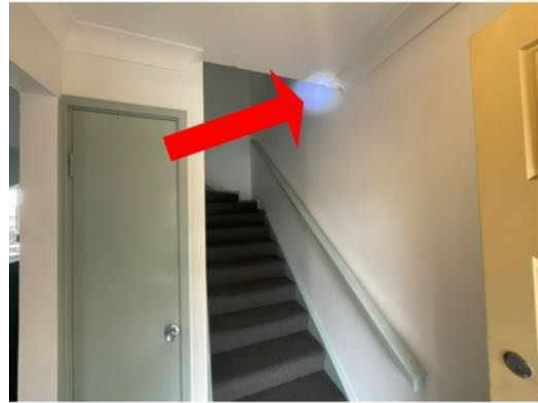
### Finding 2.04

Building:	Main Building
Location:	Stairs - Internal
Finding:	Walls - Water damaged
Information:	Water damaged to sections of the walls in this area was evident at the time of inspection. Water staining indicates that surfaces have been exposed to excessive moisture over time. The minerals and other elements in the water lead to staining, which may graduate to corrosion and deterioration if left unmanaged.

While mostly an appearance defect, water staining can be indicative of more serious defects, which may be currently concealed by wall linings.

Where water staining is active, a licensed plumber must be consulted to identify the cause of the staining and to provide advice on any reparation works that may be required. Replacement of any broken or damaged structures is advised.

Conversely, where water staining is old and inactive, affected building materials may be repaired or replaced at client discretion.

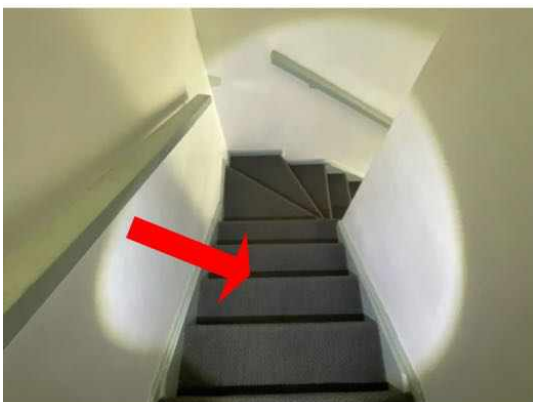
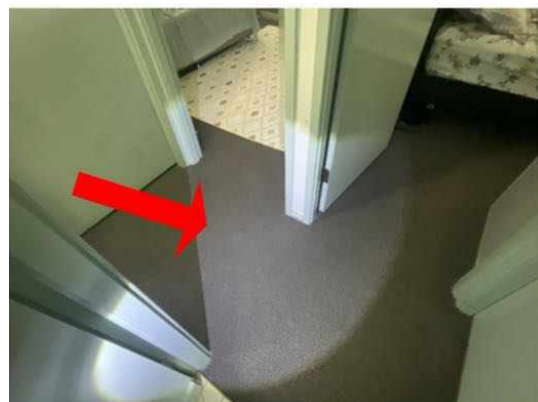
### Finding 3.01

Bouncy floors / stairs generally indicate that the floorboards or the structures are coming loose from the joists that they are installed on. Bouncy flooring may also be the result of gaps between flooring and stumps or joist structures, which require packing.

The client is advised to seek quotations for required repairs from a qualified carpenter. The potential resolution may range from packing gaps in the structures through to replacing and refixing of flooring.

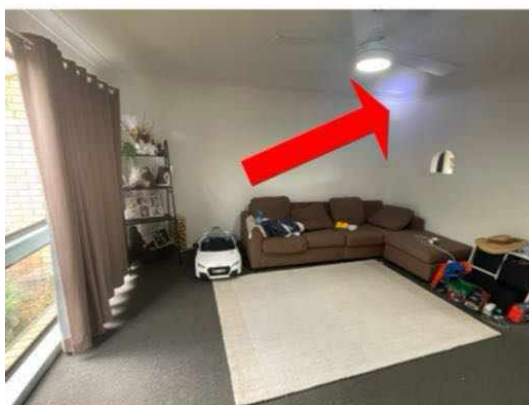
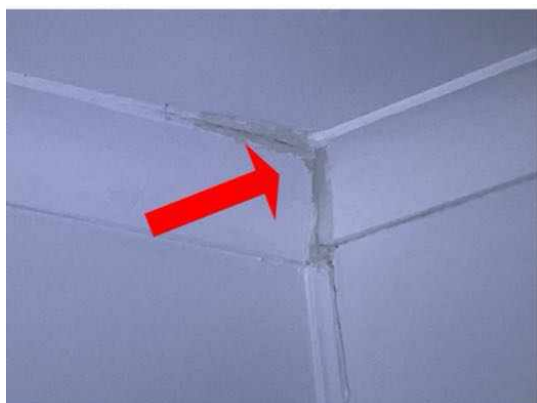
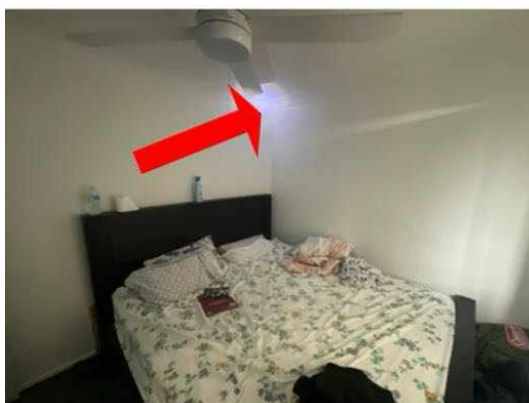
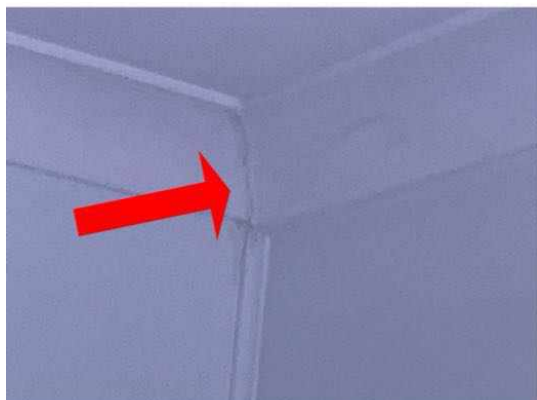
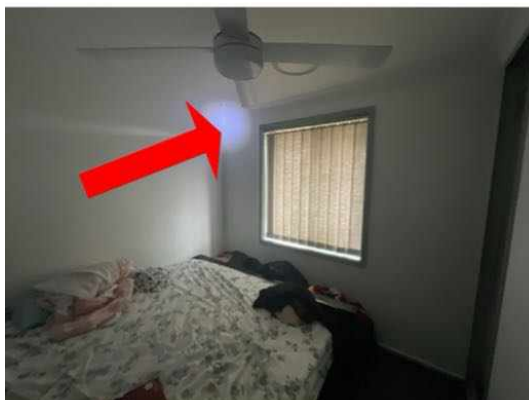
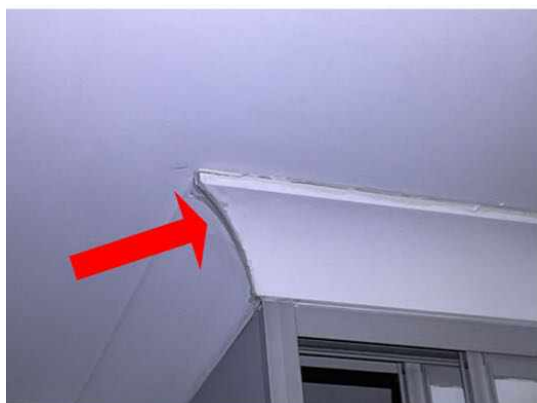
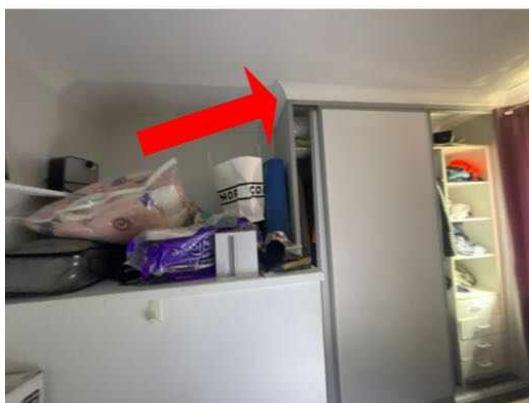
### Finding 3.02

Building:	Main Building
Location:	All Internal Areas
Finding:	Cornices - Sagging
Information:	Sagging and uneven cornices generally indicate that the building materials have swollen, due to contact with water, or the movement of the ceiling joints or that fixings (e.g. nails or glue) have become loose and require reattachment. In some cases, sagging and uneven surfaces may also indicate that there are structural issues causing surfaces to warp, twist, or sag.

Where sagging appears to be major, appointment of a structural engineer is advised to further inspect the property. Otherwise, minor works such as re-gluing of wall/ceiling sheets may be required and should be performed by an aptly qualified plasterer or carpenter.

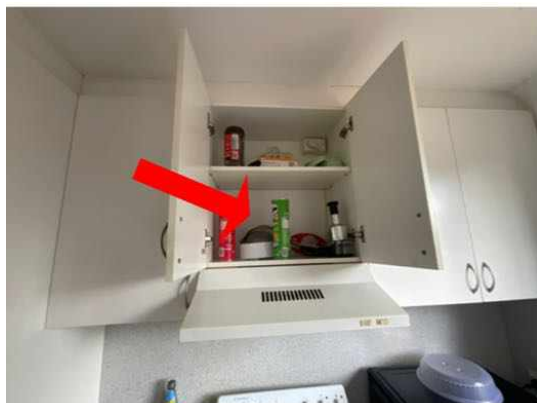
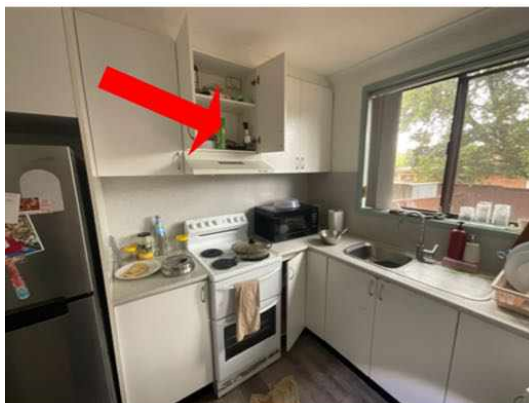
### Finding 3.03

Building:	Main Building
Location:	Kitchen
Finding:	Rangehood - Flue disconnected
Information:	The range hood flue has become disconnected and is allowing the emission of steam and evaporative moisture into the ceiling space above.

While this does not create high potential for secondary defects, development of grease is likely to occur in the surrounding area, necessitating regular cleaning and maintenance.

Consultation with a licensed electrician may be required to reconnect the flue and thus

allow the emission of gases into the external environment. Works should be completed at client discretion.

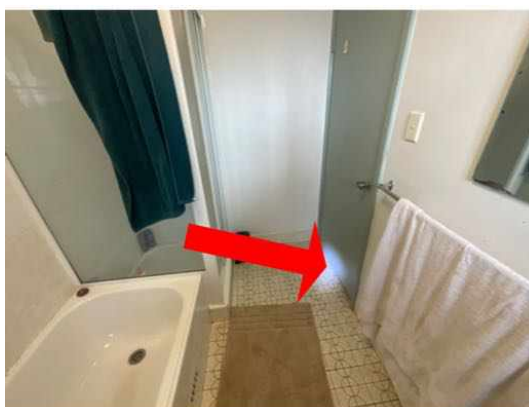
### Finding 3.04

Building: Main Building  
 Location: Bathroom  
 Finding: Door - swelling and damage at the bottom edge  
 Information: Swollen and damaged door base in bathroom due to moisture exposure. Edges show fraying and surface degradation.

Replace or seal the affected door. Ensure door edges are properly sealed to prevent future water damage.

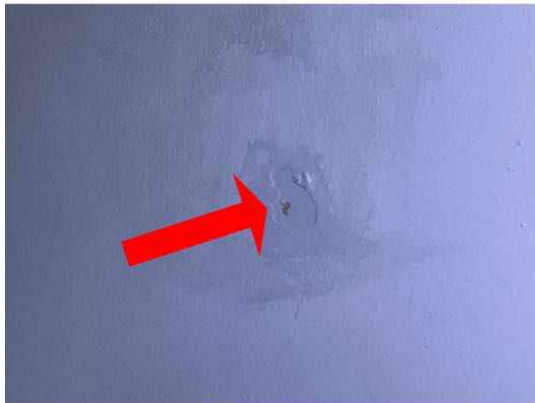
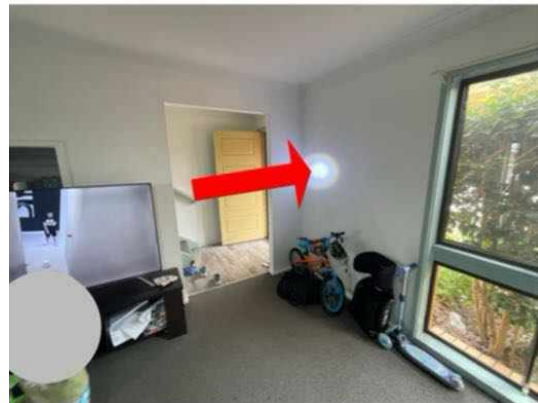
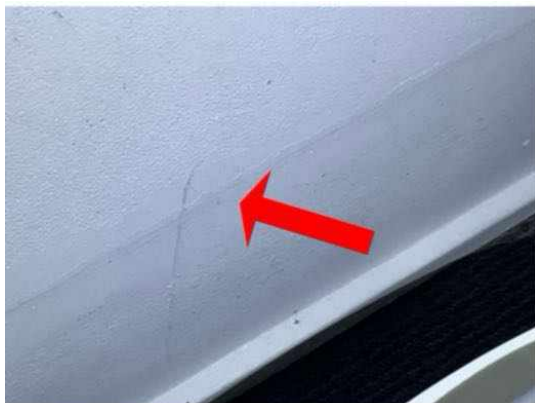
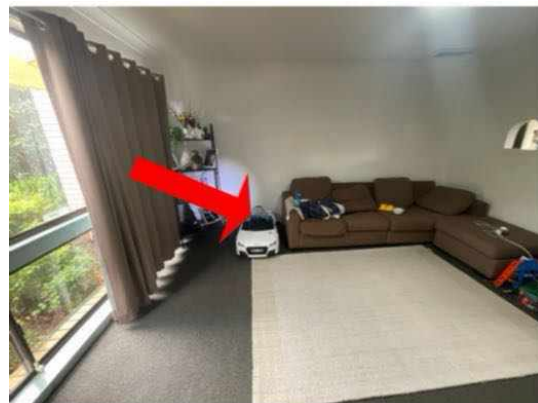
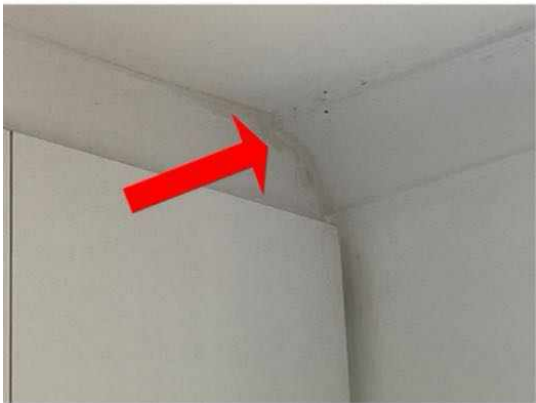
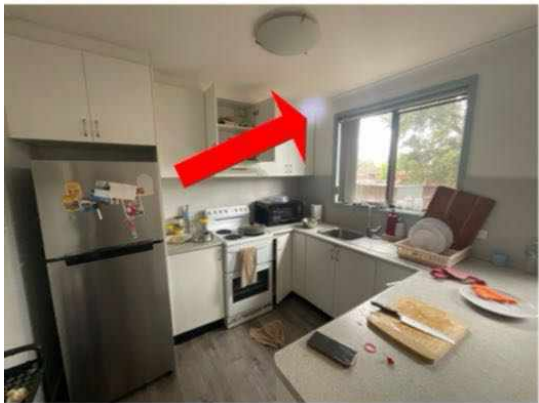
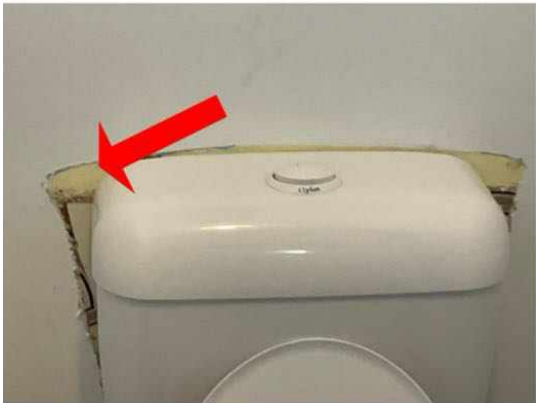
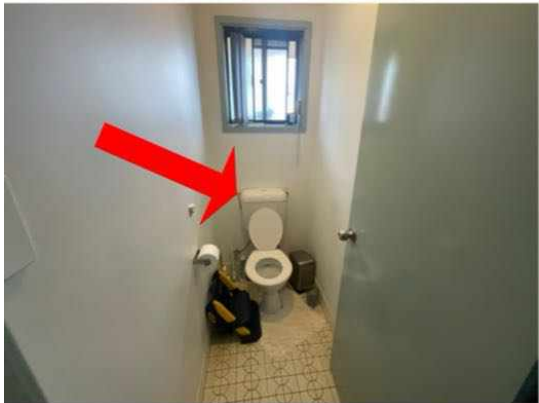
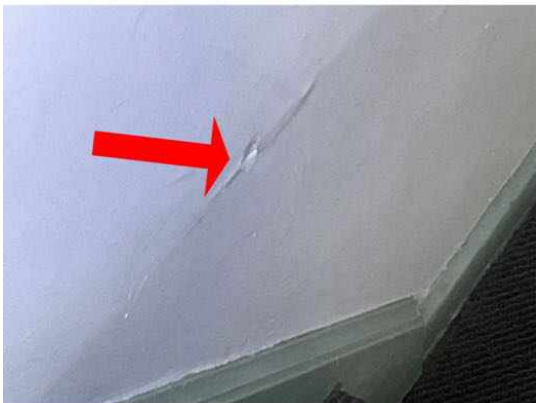
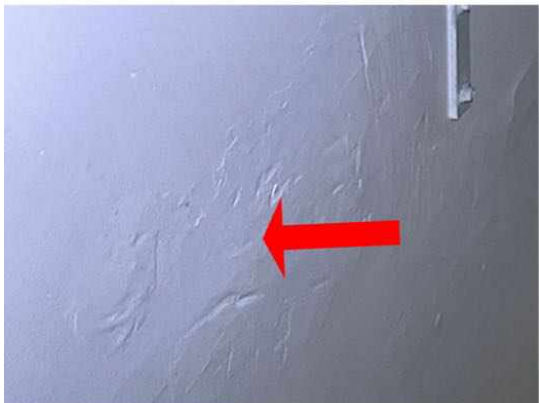
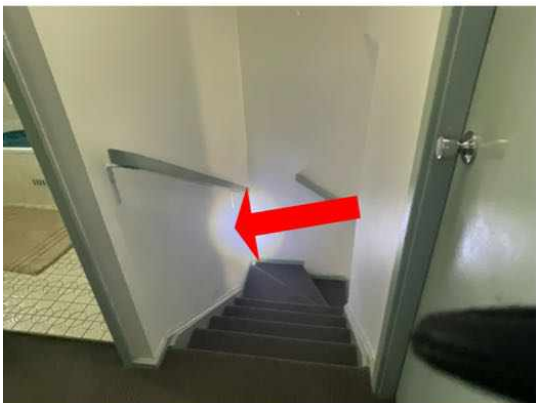
### Finding 3.05

Building: Main Building  
 Location: All Internal Areas  
 Finding: Paint finish - Substandard, Wear and Tear  
 Information: The paint finish in this area was found to have been completed to a substandard level or wear and tear as the normal deterioration of a property from ordinary, everyday use. Exposure to the elements, time, as well as day to day living can cause fair wear and tear.

If this applies, further areas of poor and incomplete finishes could develop over time. Furthermore, substandard, wear and tear paint finishes in areas exposed to moisture, e.g. external areas or wet areas, could lead to deterioration of underlying building materials.

Substandard, wear and tear paint finishes should be sanded back, filled, leveled and repainted, as applicable. Where inadequate paint protection has led to the deterioration of the associated building element, repair and/or replacement of this building element may be required.

A painting contractor should be appointed as soon as possible to perform necessary works to aid the appearance of the affected area and to ensure that the area is protected against further deterioration. Alternatively, the homeowner following manufacturer instructions may be able to provide this service.

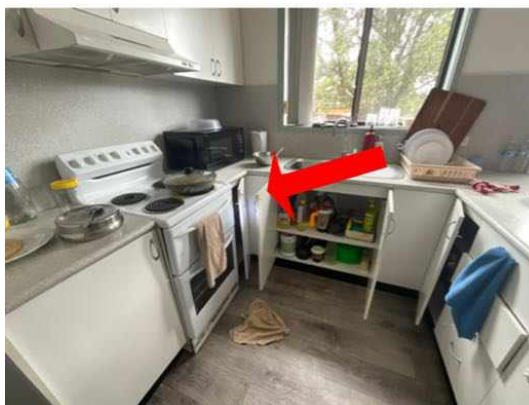
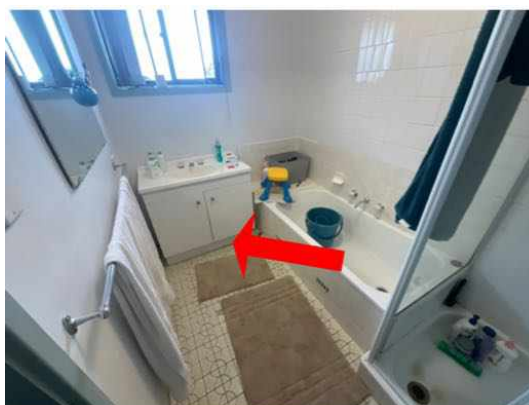
Building:	Main Building
Location:	Kitchen/ Bathroom
Finding:	Delamination of timbers
Information:	Delamination is one means by which composite materials (e.g. layered timber composites) may fail over time. In laminated materials, repeated cyclic stresses may lead to the formation of mini-structures of separate layers, with significant loss of mechanical toughness. Water penetration or the presence of excessive moisture also generally contributes to delamination.

Where building materials have become delaminated, they lose their structural strength, and are likely to have a variety of appearance and serviceability defects as a result.

Delamination of timbers may be repaired where the area affected is minor and/or easily accessible, by gluing and screwing layers back together. However, this is an interim repair, and where delamination has occurred, the client should plan for the replacement of affected timbers sooner than would otherwise be expected.

All timber structures affected by delamination should be replaced as soon as possible to avoid any further damage. Repair and replacement estimates should be sought from a registered builder or qualified carpenter.

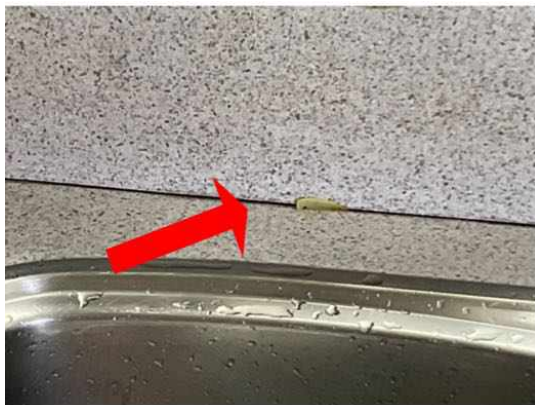
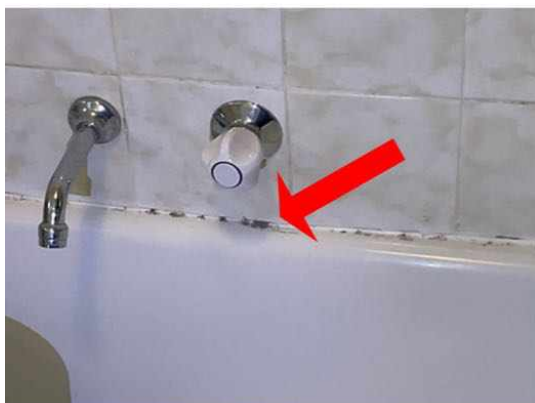
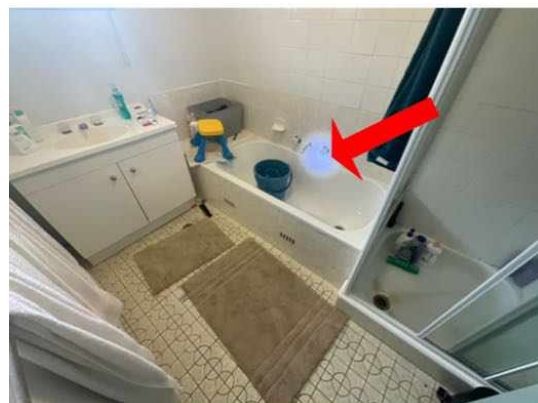
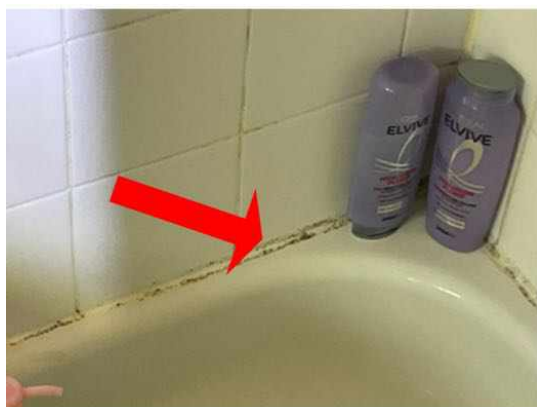
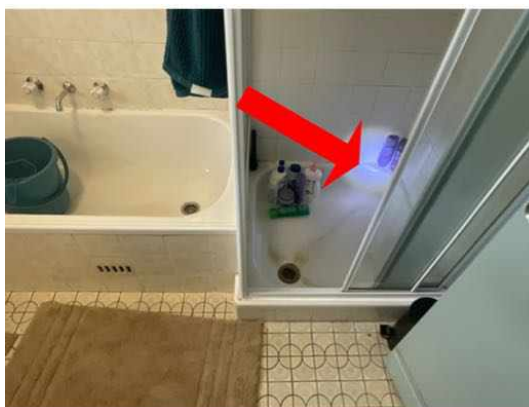
**Finding 3.07**

Building: Main Building  
Location: Kitchen / Bathroom  
Finding: Sealant and grouting - Missing or damaged  
Information: It was noted on inspection that sealant or grout is degraded to the tiled shower alcove and or other areas of the bathroom.

Different materials and floor areas move at different rates, generally causing cracking to grout or sealant at this point. A flexible sealant is required to allow for expected expansion and contraction, while keeping the joint water tight and protective of all associated building materials.

There appears to be excessive mould to the sealant and grout which will likely require scraping out and replacement.

Flexible and mould resistant materials should be applied to affected areas to prevent any subsequent water damage that is likely to occur. Regular maintenance and replacement of damage or missing or damaged sealant and grout is highly recommended to the wet areas, as this is a regular wear and tear defect. Sealant and grouting in areas that come into regular contact with water should be maintained for the long term care of your property.

A sealant specialist or tiling contractor should be appointed to complete these works as soon as possible

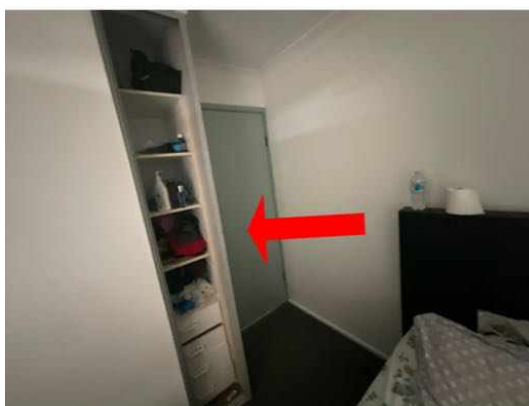
### Finding 3.08

Building:	Main Building
Location:	Bedroom 3
Finding:	Door frames - not square
Information:	It appears that one and / or more doors have been installed in a manner which is not consistent with acceptable standards of workmanship. The door frames are not square and or plumb and require rectification.

Deviation from the manufacturer's installation instructions is considered a defect with reference to Standards and Tolerances.

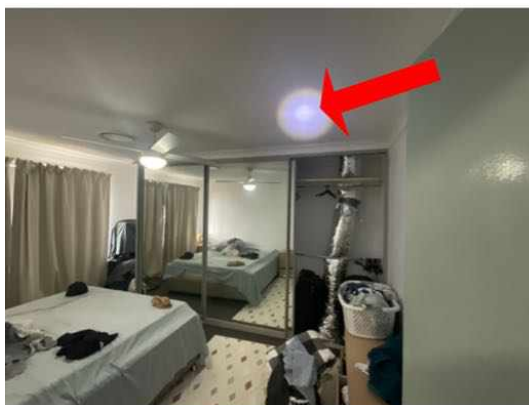
### Finding 3.09

Building:	Main Building
Location:	Bedroom 2
Finding:	Ceiling nails - Popping
Information:	Numerous popped nails were identified in the internal ceiling at the time of inspection. Nails and screws hold simply by the friction between them and the surface they are applied to. Over time, the nails and screws can back out, which is often a result of general ageing and deterioration of the building structure.

If left unmanaged, the ceiling sheets may become loose and unstable, increasing the

rate of deterioration of the internal ceiling and creating potential for the development of secondary defects.

Re-fastening of popped nails will help to maintain the stability of the internal ceiling and associated building elements. Such minor works will also help to improve the appearance of the affected area and secure the ceiling sheets, so as to prevent the onset of ceiling sagging. These works should be performed by a qualified carpenter or plasterer at client discretion.

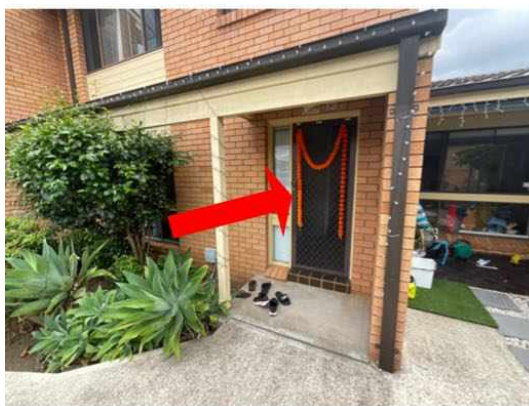
### Finding 3.10

Building:	Main Building
Location:	Entry
Finding:	Door - Binding/jamming
Information:	Binding and/or jamming of this door is evident during standard operation. This defect inhibits the functionality of the affected door as well as creating potential for secondary defects to associated building elements, such as damage to the floor covering.

A door that binds to flooring or to the associated door frame may have several causes, ranging from minor defects, such as poor installation of the door or deteriorated hinges, through to major structural issues, such as damage to subfloor structures.

Where door binding/jamming appears to indicate major structural issues, a registered builder specialising in re-stumping should be appointed to provide an estimate on the cost of rectification.

For minor causes, a qualified carpenter or general handyperson should be appointed to perform minor rectification works at client discretion.

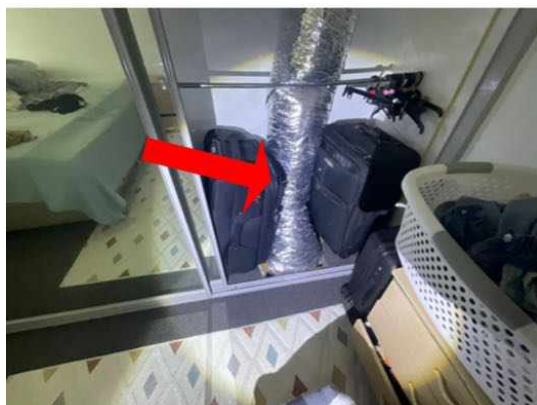
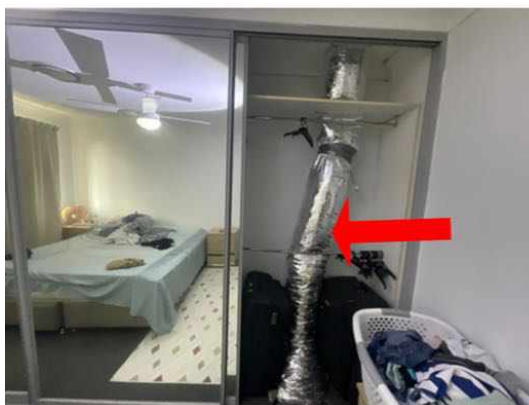
### Finding 3.11

Building:	Main Building
Location:	Bedroom 2
Finding:	Installation - substandard or incomplete
Information:	The installation of this building element appears to have been completed to a substandard level of workmanship or is incomplete. Generally substandard repairs or installation are related to poor workmanship, the use of inappropriate materials, or a failure to complete installation to a suitable standard.

Where installation is substandard and/or incomplete, the client should contact the responsible trade to undertake rectification. Unfinished and substandard building works are likely to degrade more quickly and may create potential for secondary defects to associated building elements.

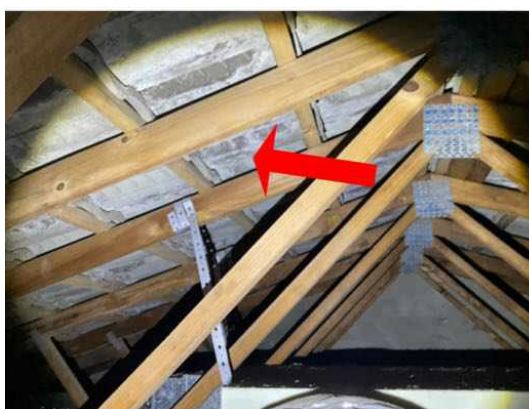
### Finding 3.12

Building:	Main Building
Location:	Roof Void
Finding:	Insulation and Sarking - inadequate
Information:	Upon inspection of the roof void it was noted that insulation is not present. Insufficient insulation will result in a comparatively higher cost to heat and cool a property as there is a lack of Insulation (or uneven coverage of insulation) which works

as a barrier to heat transfer. This helps to keep out unwanted heat in summer and preserves warmth inside your home in winter. It can also help soundproof your home from unwanted airborne noise transfer. Where insulation is absent, the area does not meet current Australian Standards. Installation of adequate insulation is required and should be conducted as soon as possible. Sarking is missing under the roof sheeting. Sarking acts as an insulator that helps with noise reduction and protects against water penetration. Sarking plays a key role in the operation and function of the overall roofing structure and its performance. Although not a requirement at the time of construction, replacement of any missing building element is advisable (although this can be quite expensive to do after the time of construction). Where sarking is missing, regular inspections of the roof tiles for cracking and potential moisture penetration is required. Sarking may be retrospectively fitted by a registered builder at the discretion of the client.

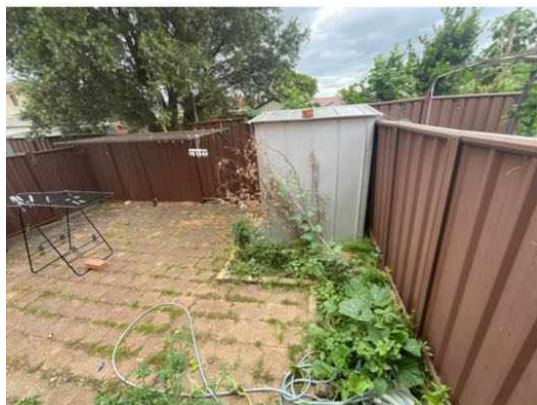
### Finding 6.01

Building:	Main Building
Location:	All Areas
Finding:	Garden Beds - Conditions Conducive to Termites
Information:	Garden beds were found to be evident in the garden area. These garden beds can include untreated timber, and with a combination of moisture from watering hosing can make conditions conducive to termite activity and termite ingress.

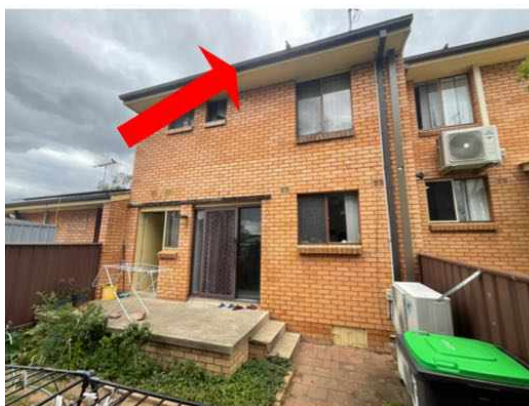
## Finding 6.02

Building:	Main Building
Location:	All Areas
Finding:	Timber - exposed to weather
Information:	External timbers that are frequently exposed to harsh weather conditions require adequate protection in order to maintain their condition. Where timbers have not been painted or treated adequately, general deterioration is likely to occur at an accelerated rate.

If left unattended, replacement of these timbers is likely to be necessary in the short-term future. Adequate treatment of these timbers is required as soon as possible by a painting contractor or general handyman.

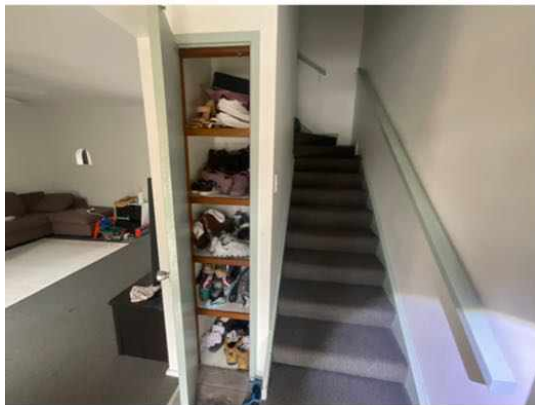
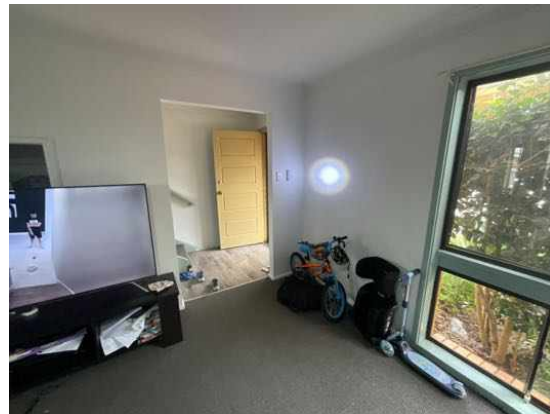
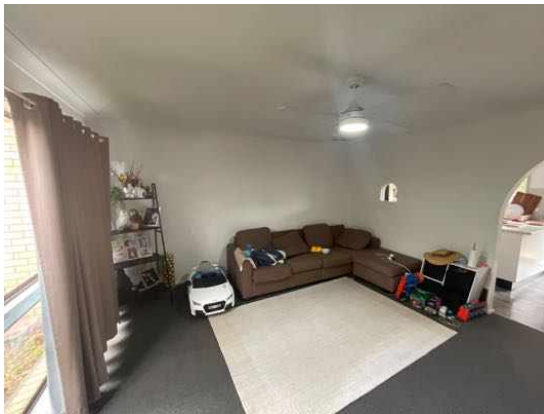
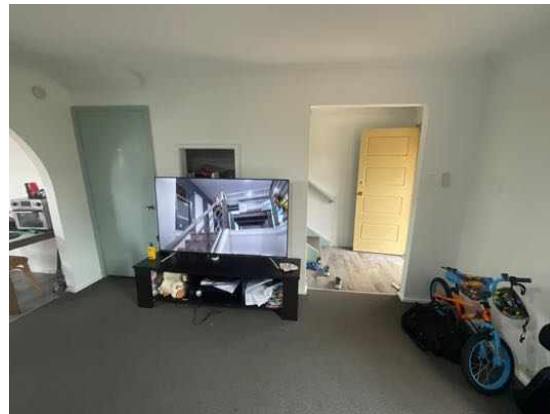
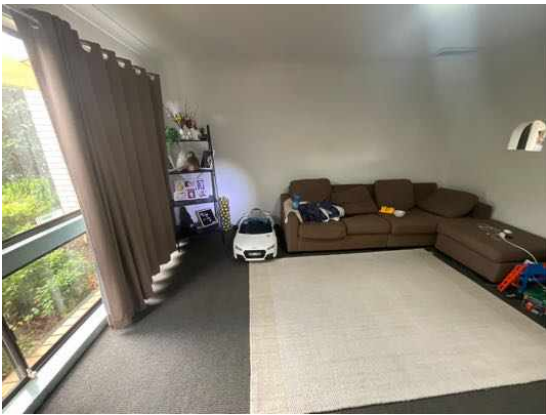
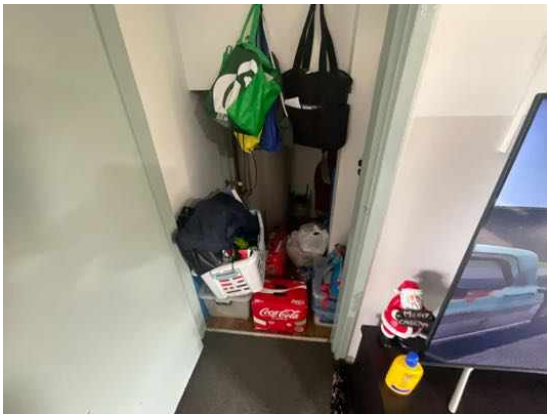
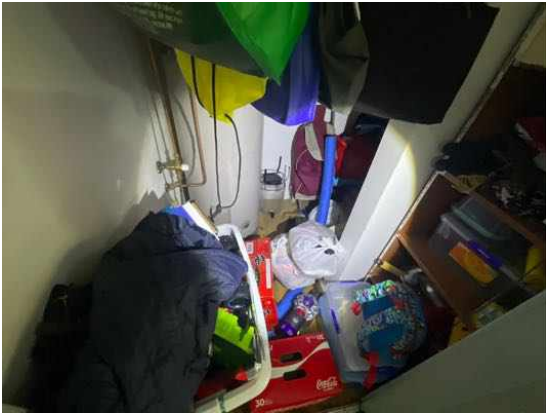
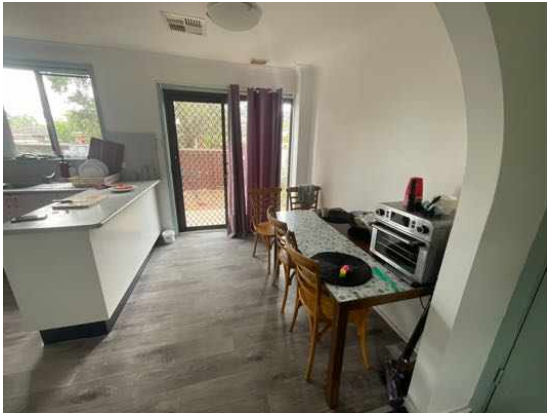
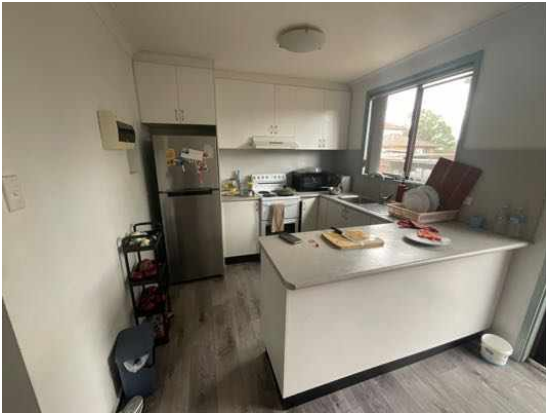
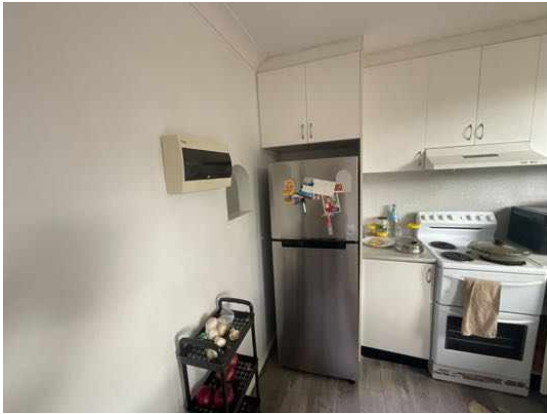
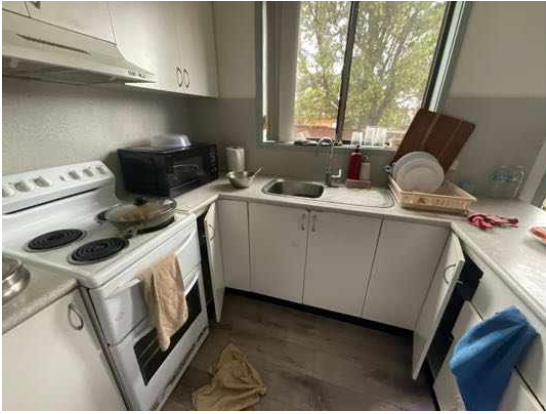
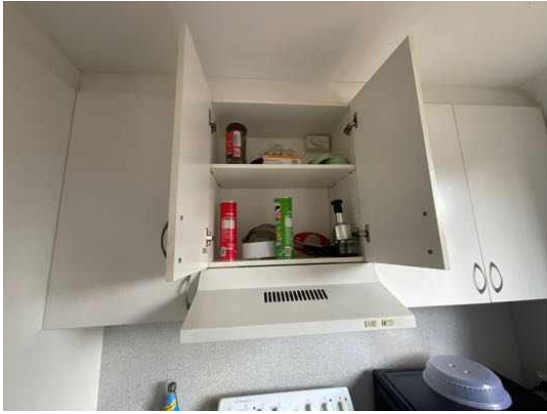
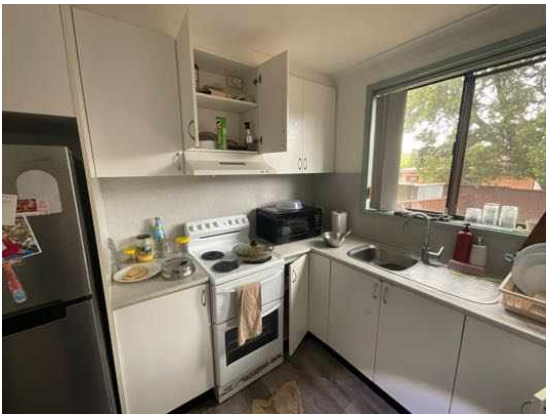
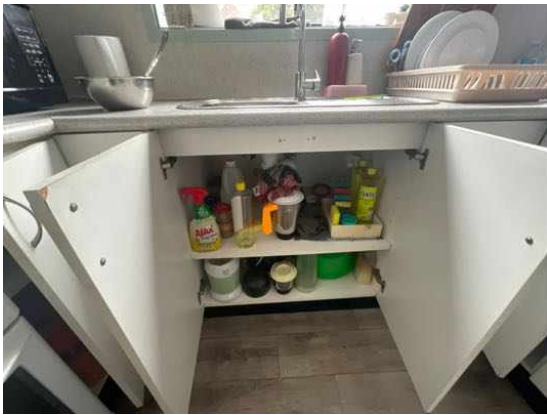
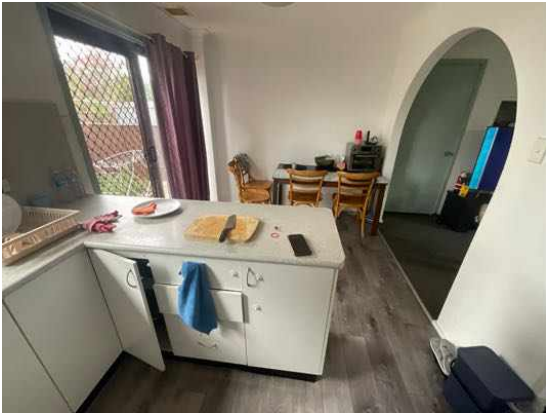
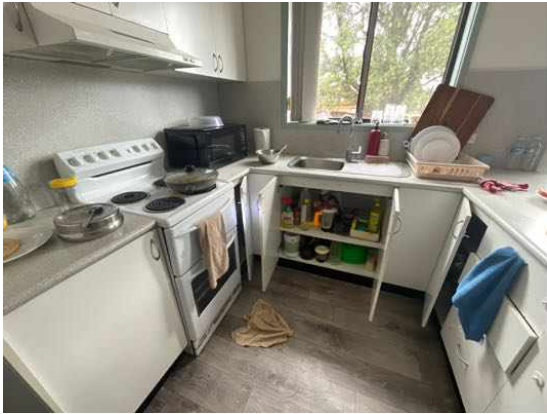
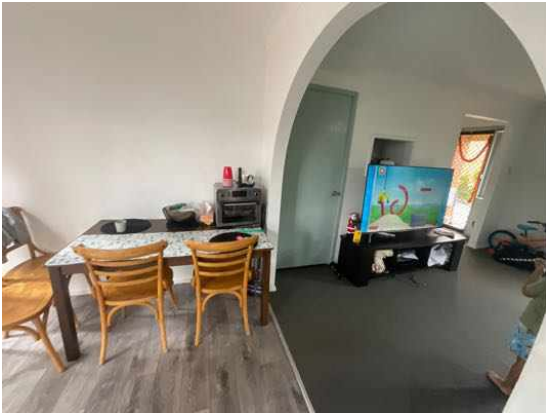
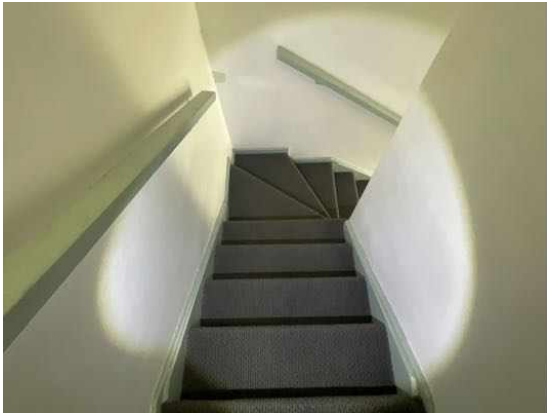
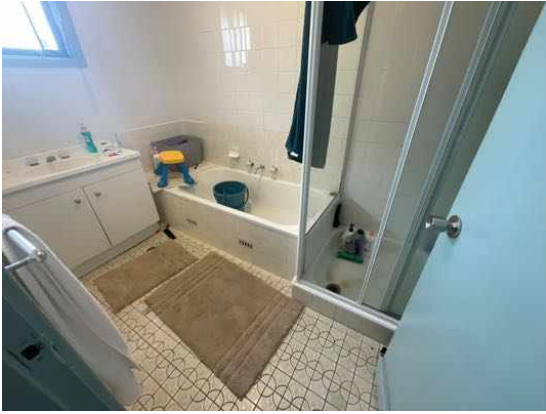
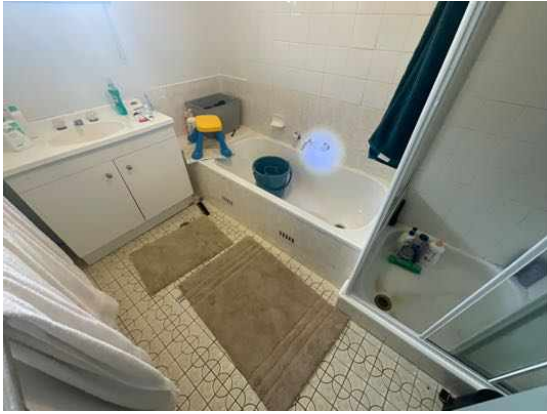
### Noted Item

Building: Main Building  
Location: All Areas  
Finding: Additional Photos - Obstructions and Limitations  
Information: These photographs are an indication of the obstructions and limitations which impeded full inspection of the property at the time of inspection. These obstructions can hide an array of defects and should be removed to allow full inspection to be carried out. A re-inspection is recommended once the areas are made accessible.
