# Building and Timber Pest Inspection Report

Inspection Date: Wed, 14 Jan 2026

Property Address: 9/120 Oxford Rd, Ingleburn NSW 2565,  
Australia

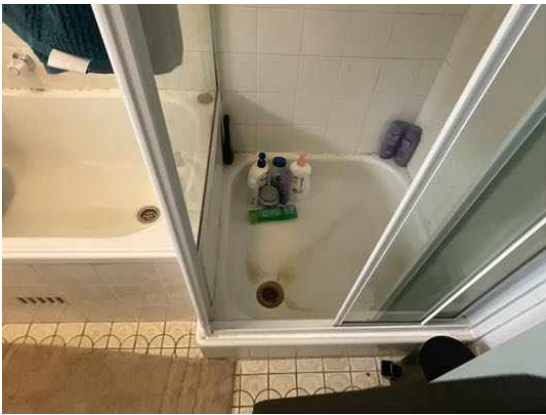
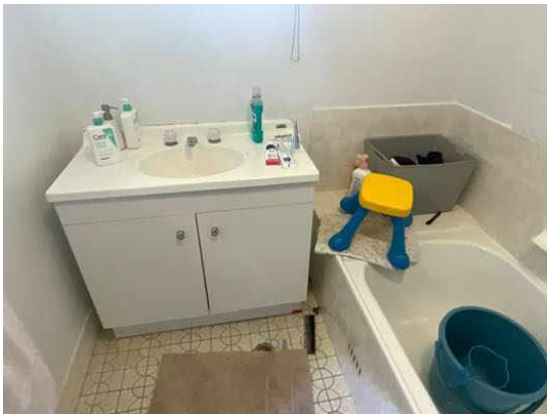
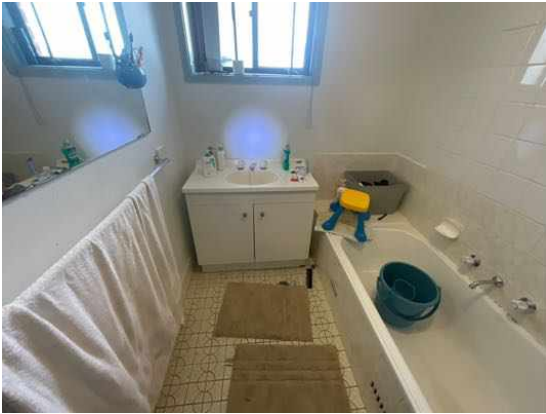
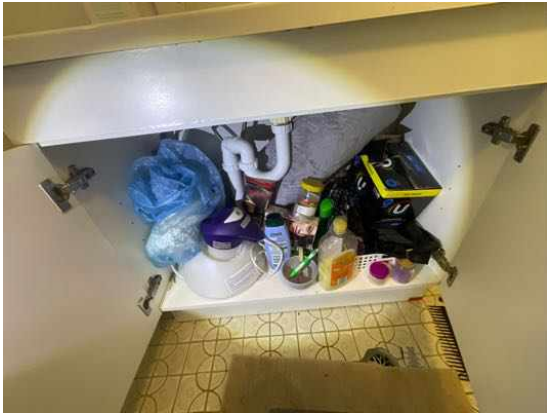
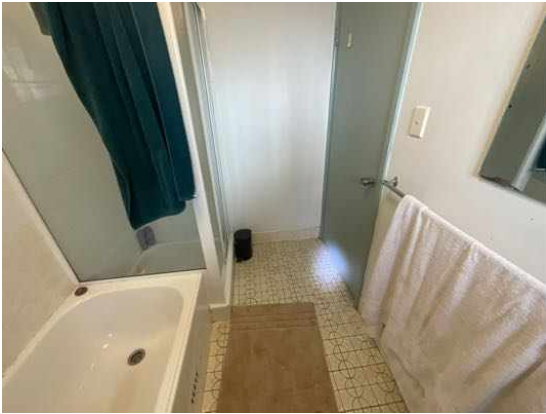
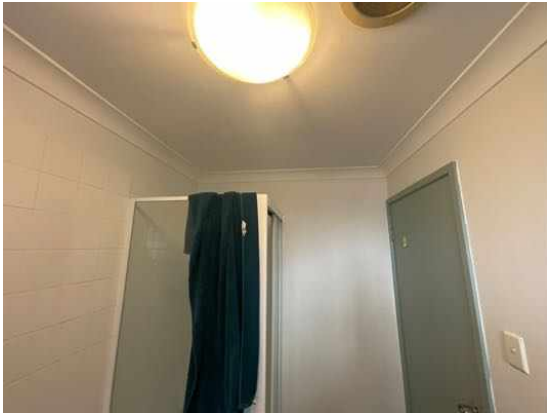
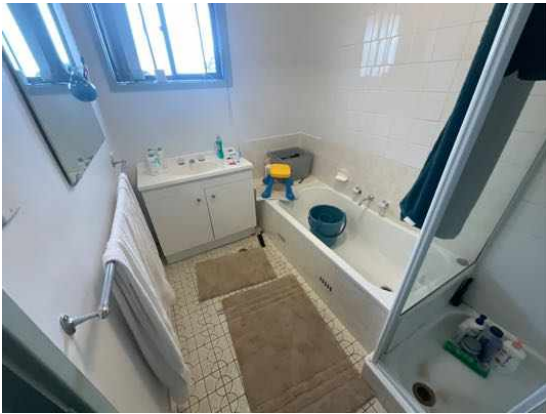
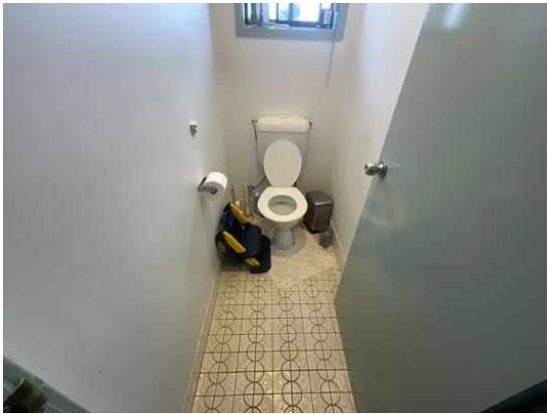
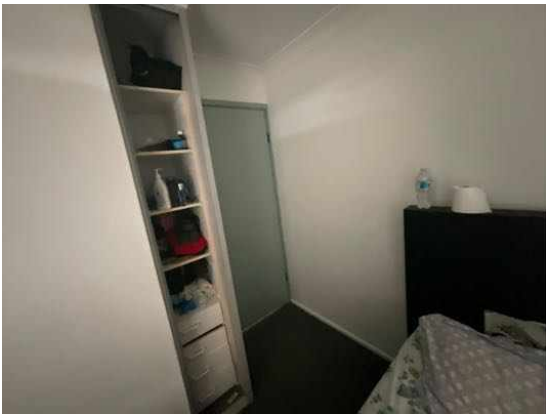
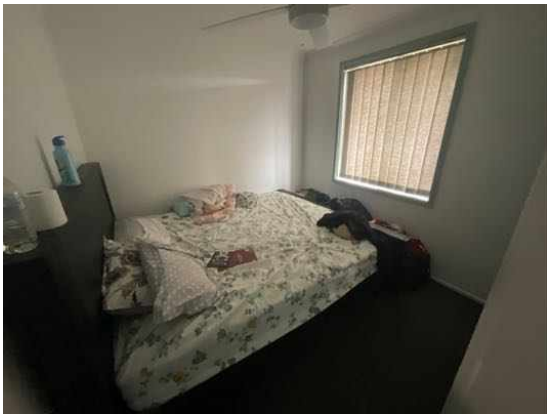
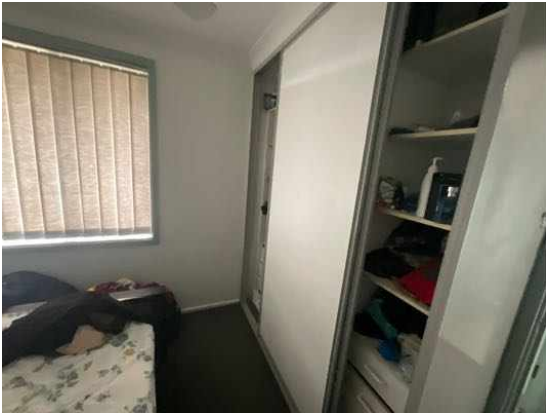
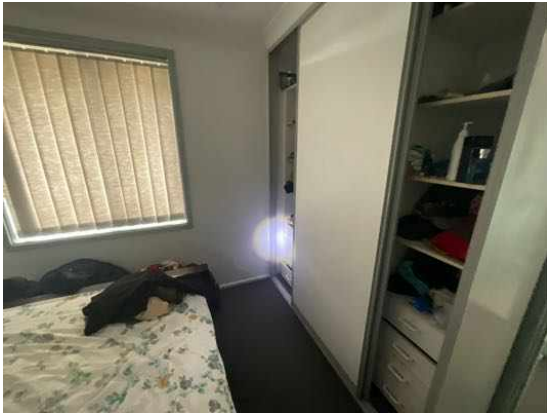
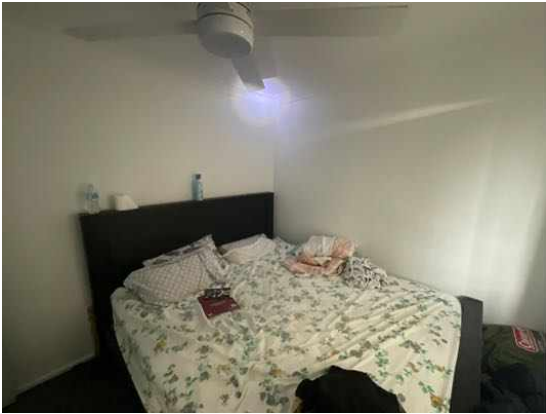
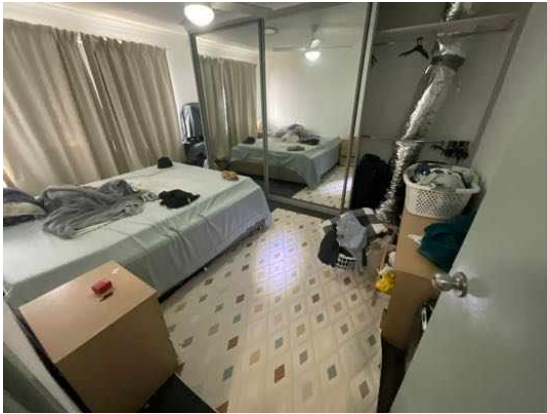
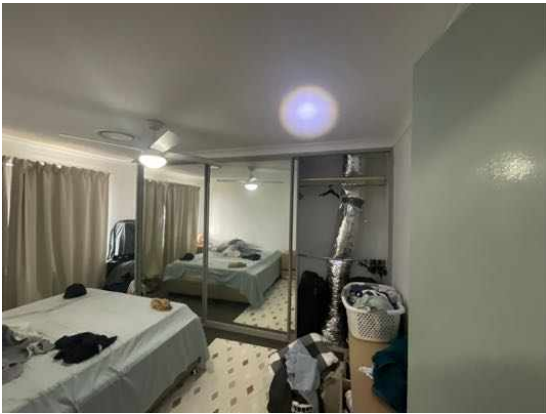
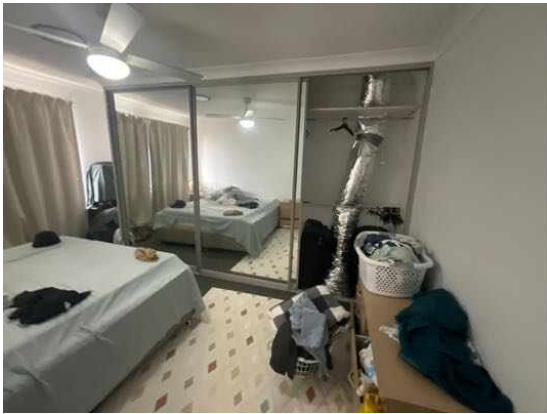
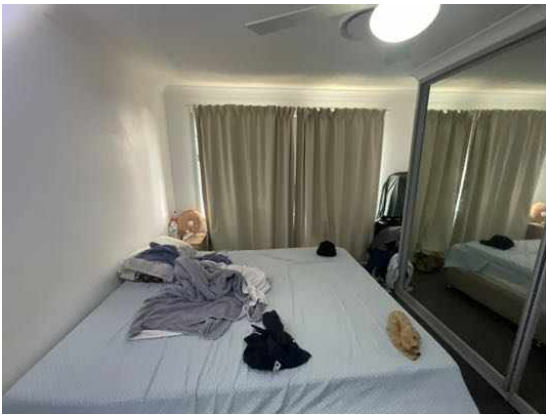
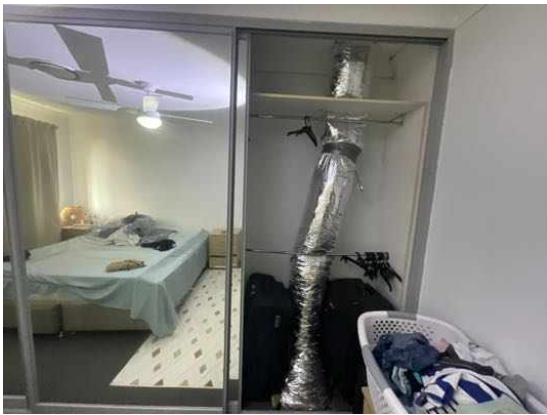
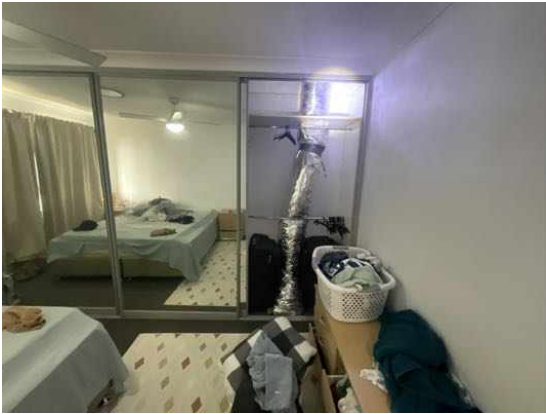
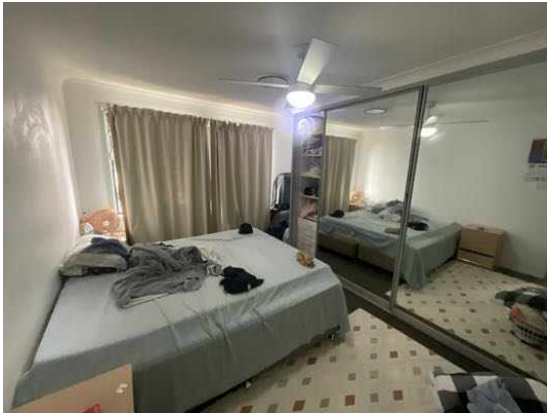
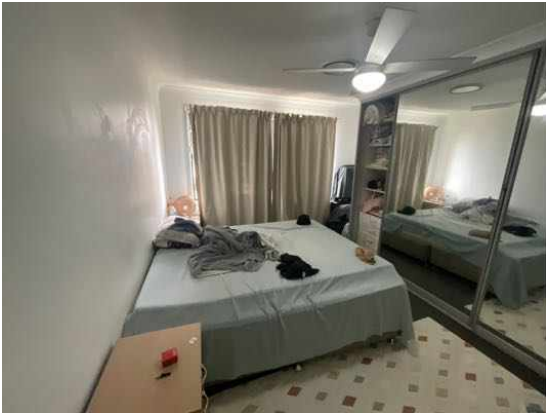
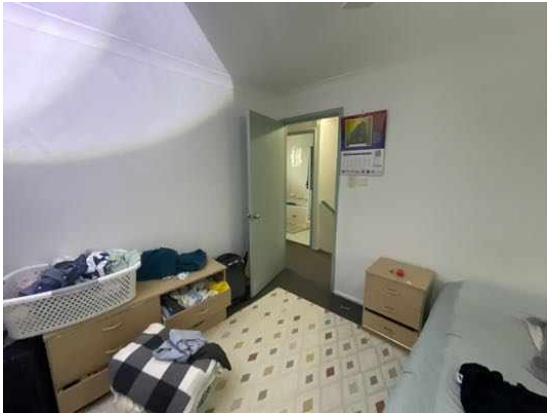
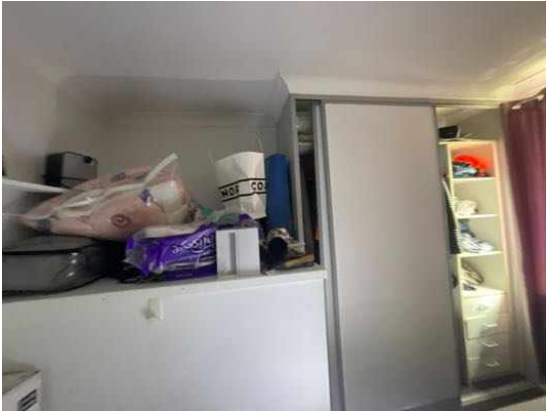
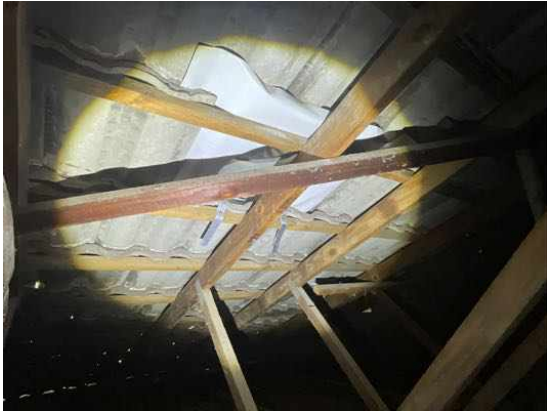
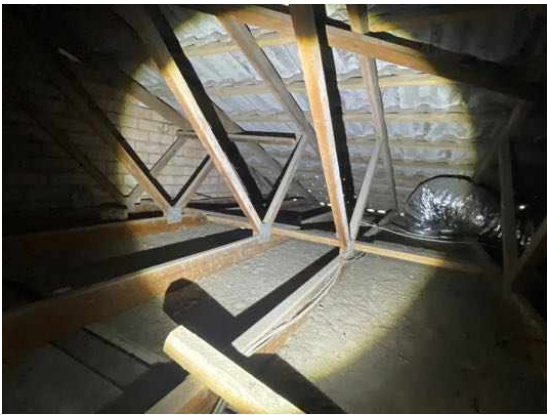
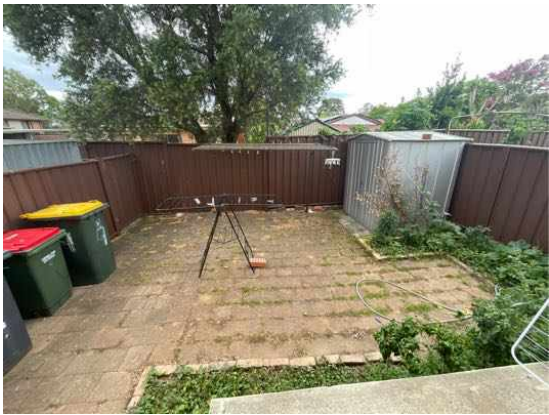
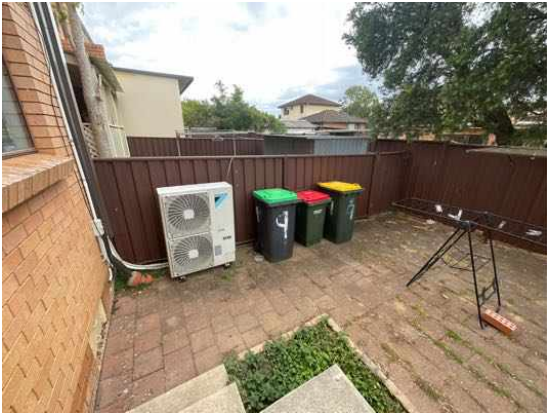
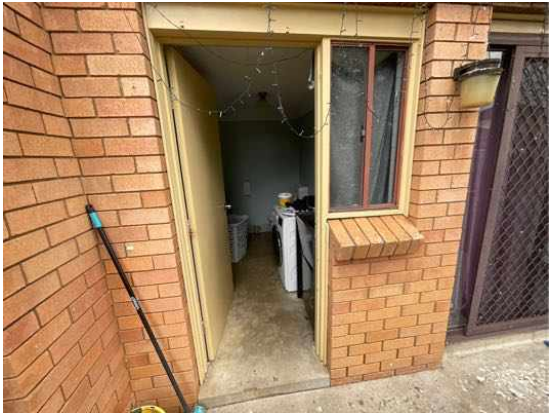
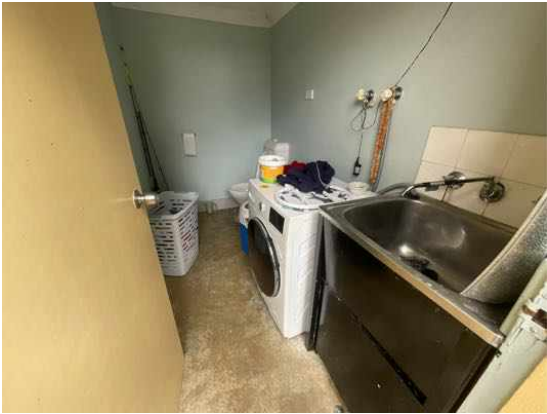
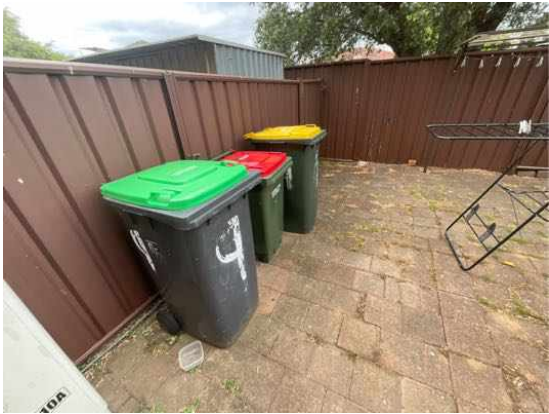
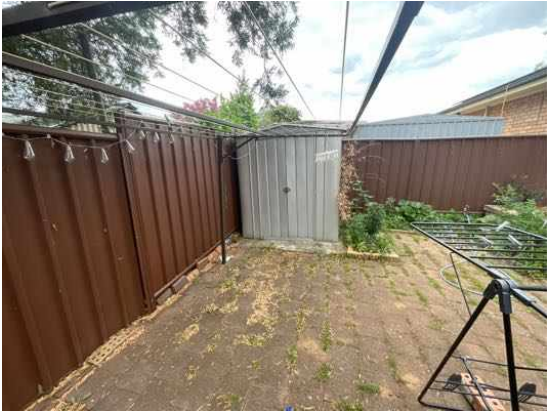
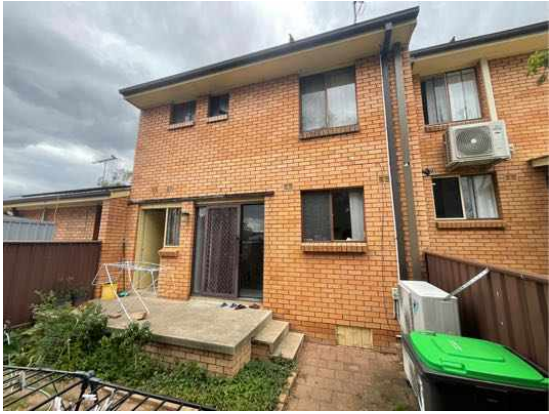
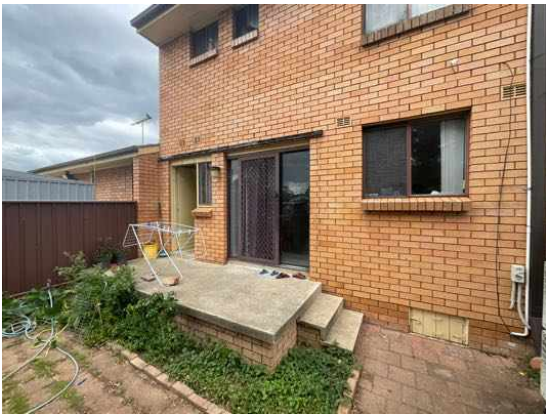
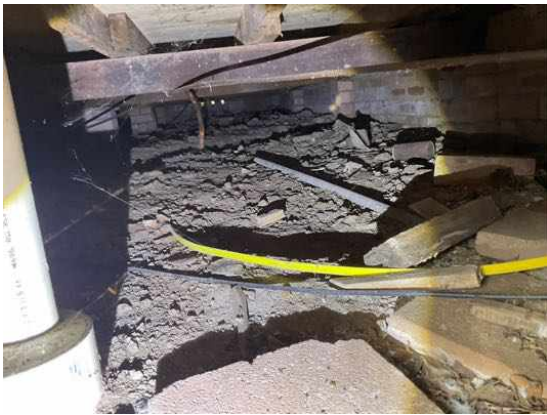
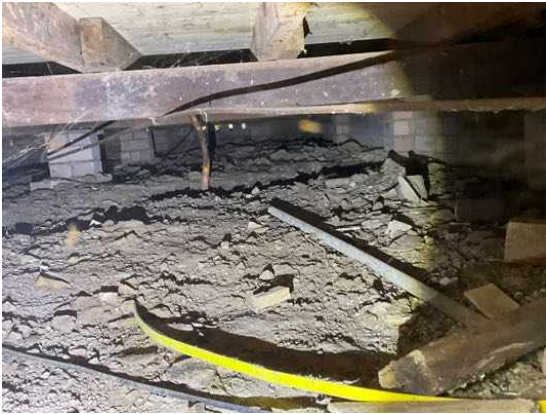
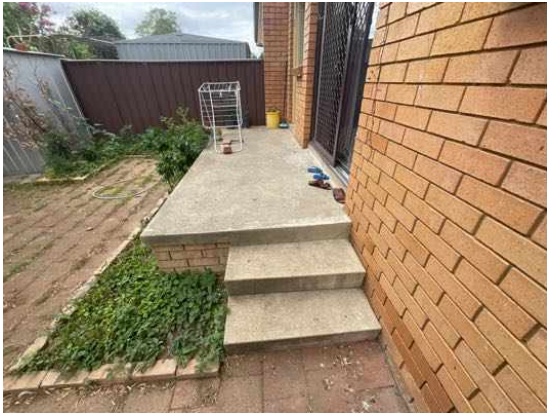
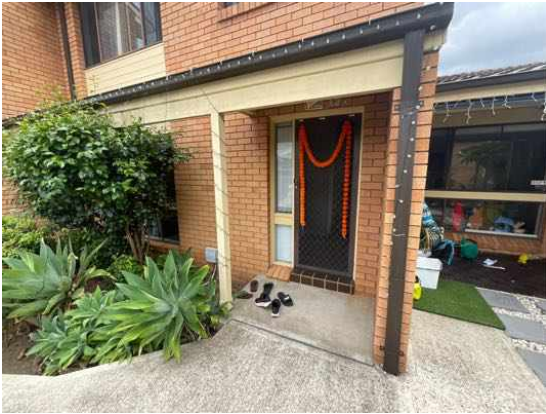
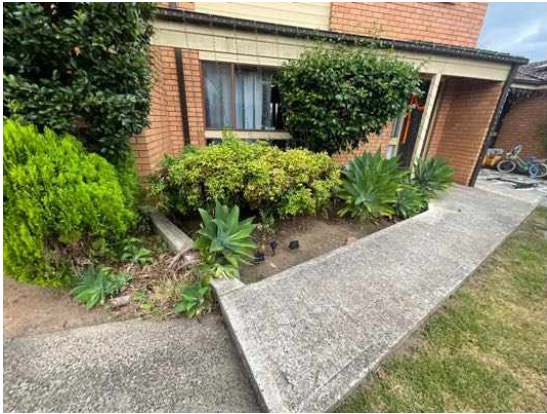
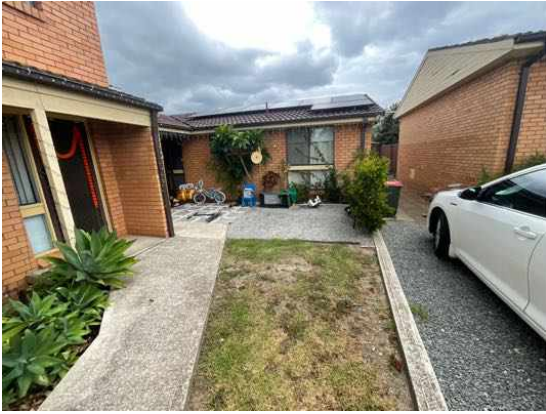
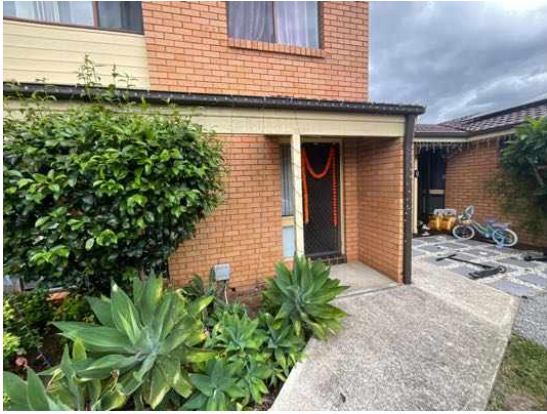
Noted Item

Building: Main Building  
Location: All Areas  
Finding: Additional Photos  
Information: Additional photos are provided for your general reference

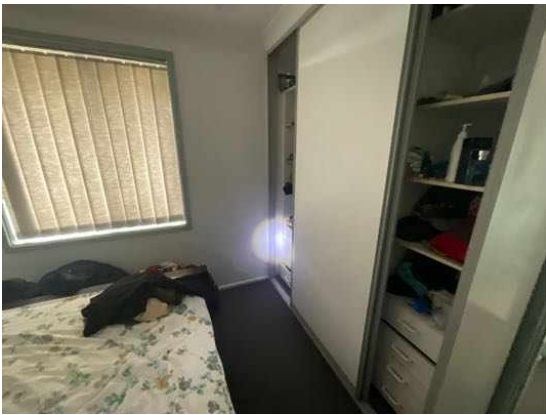
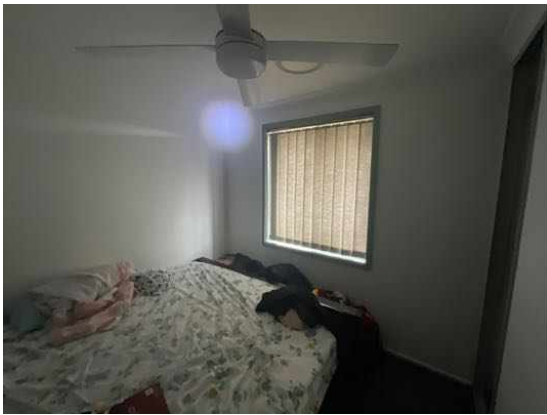
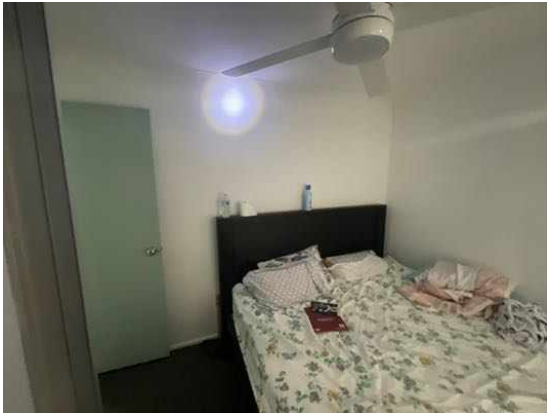
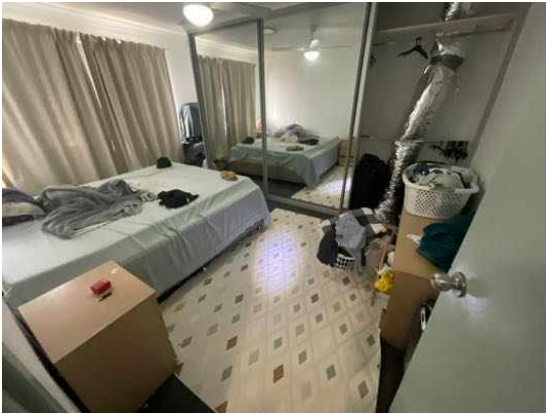
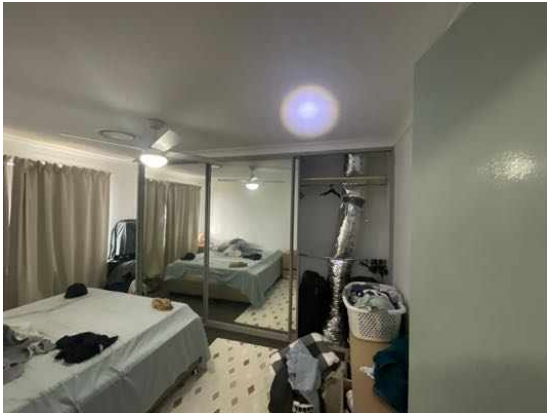
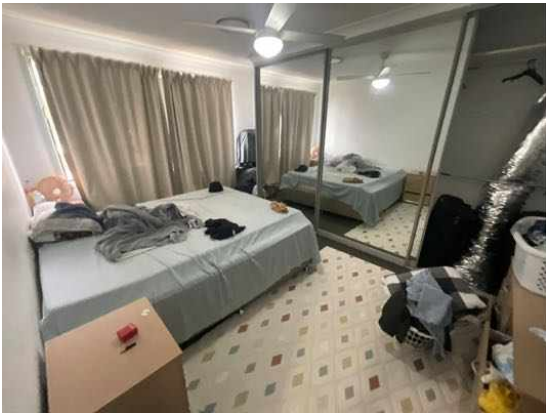
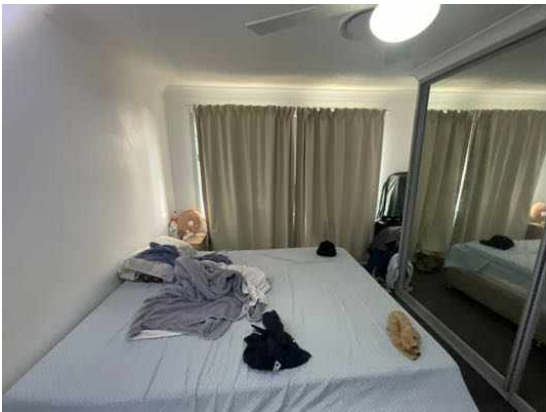
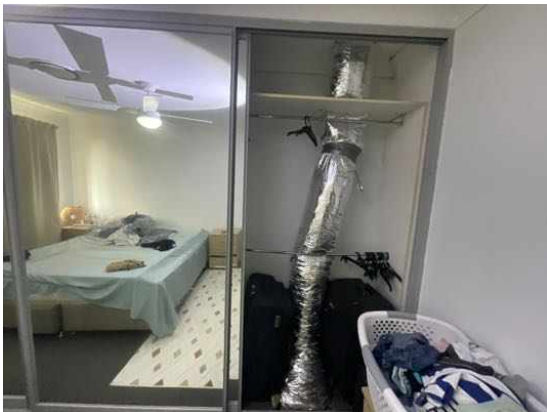
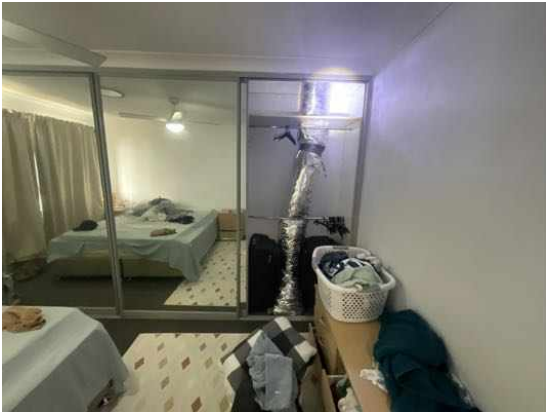
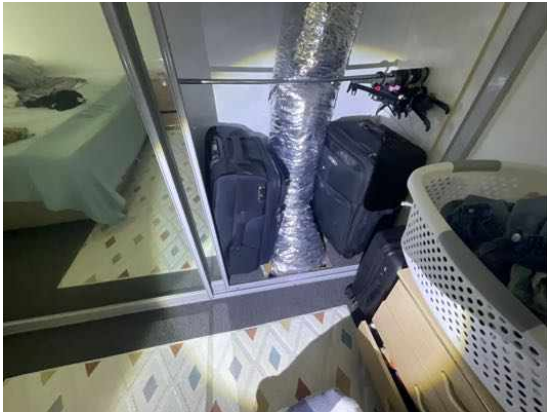
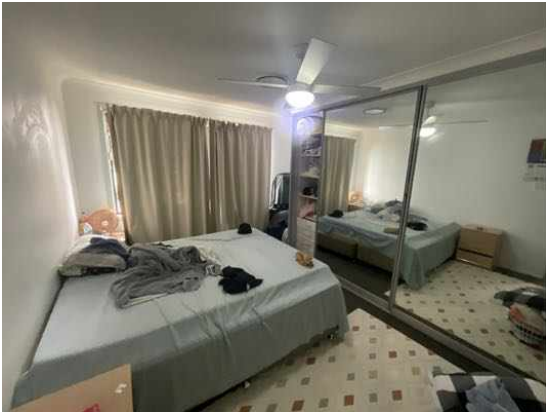
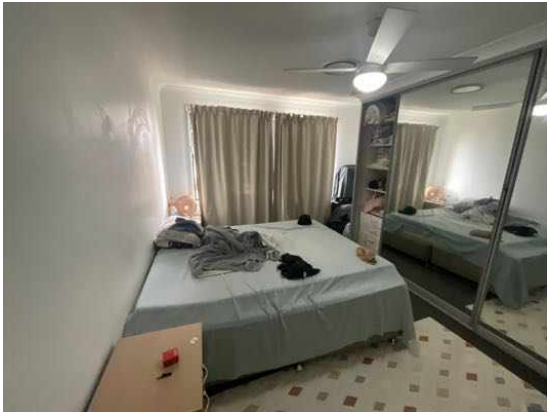
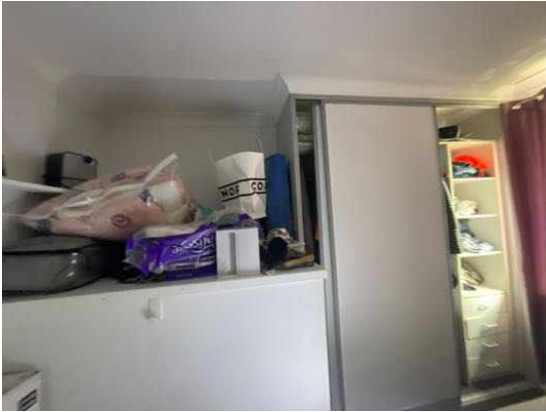
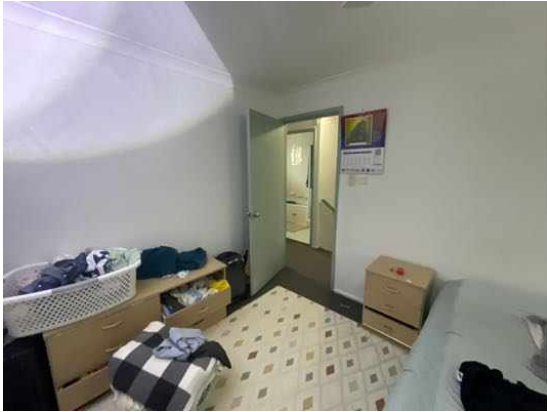
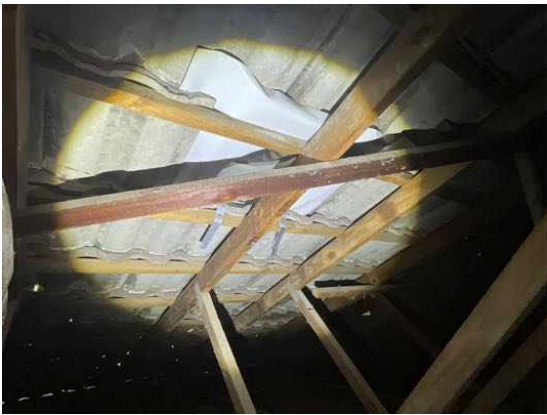
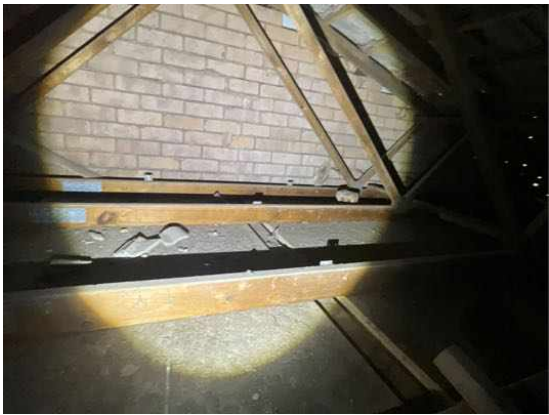
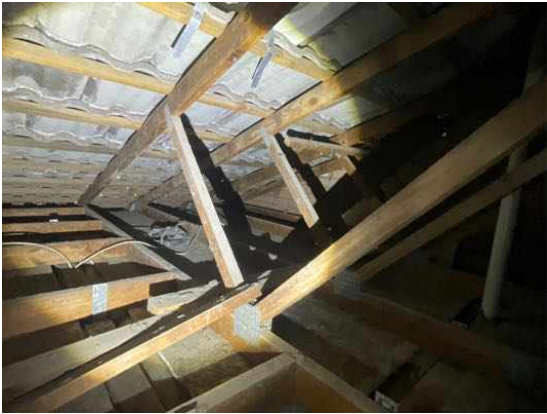
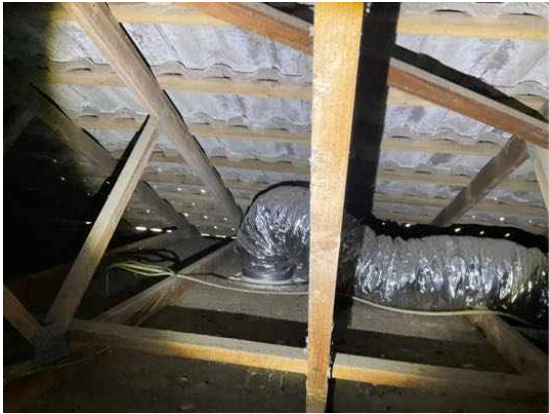
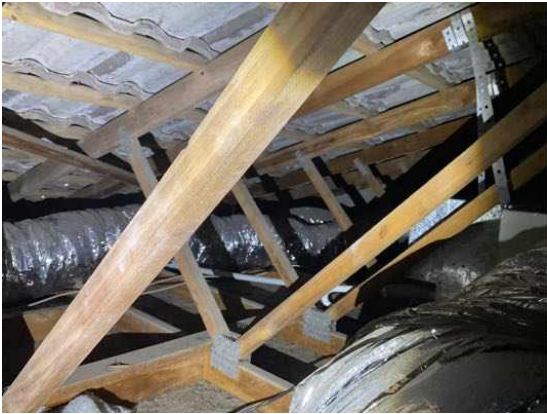
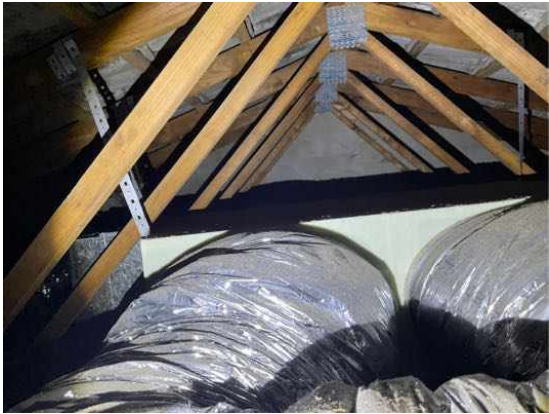
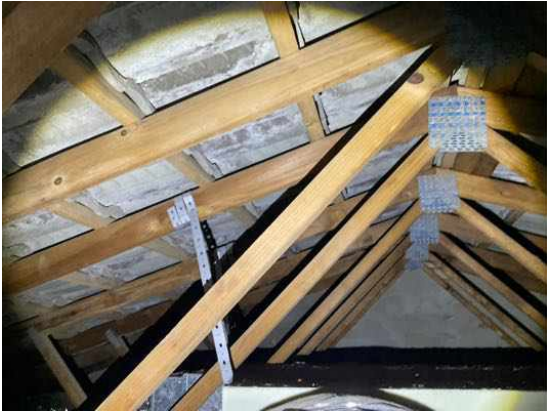
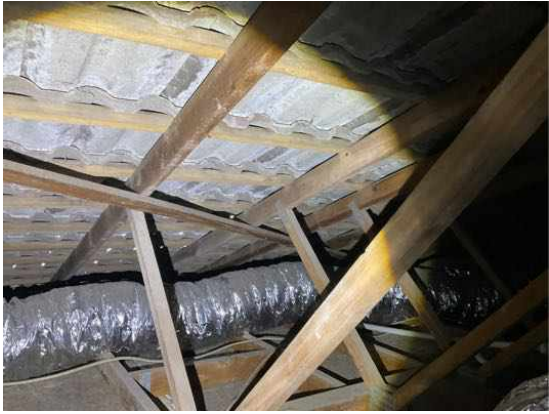
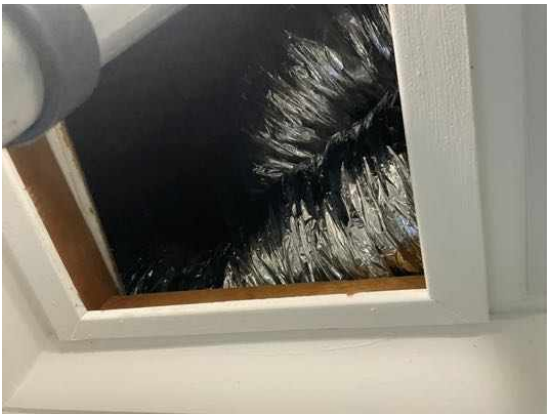
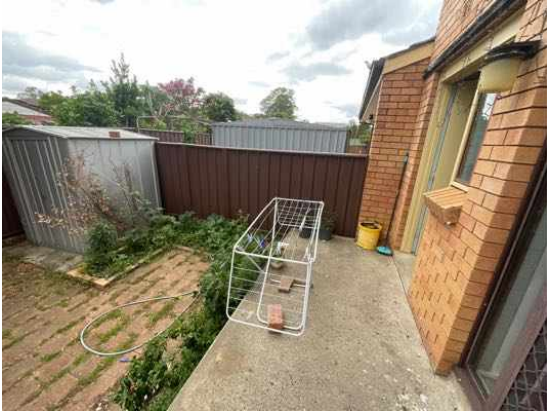
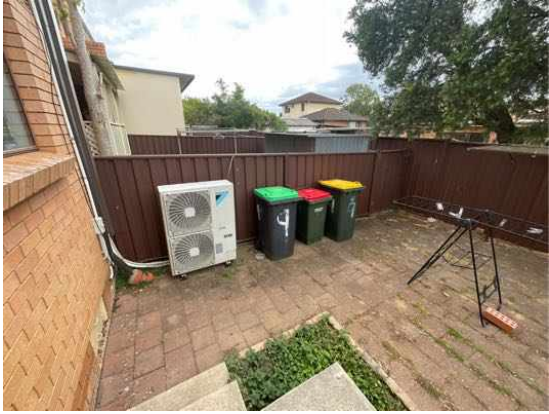
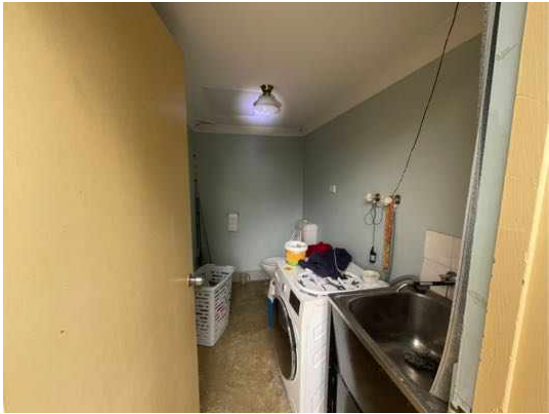
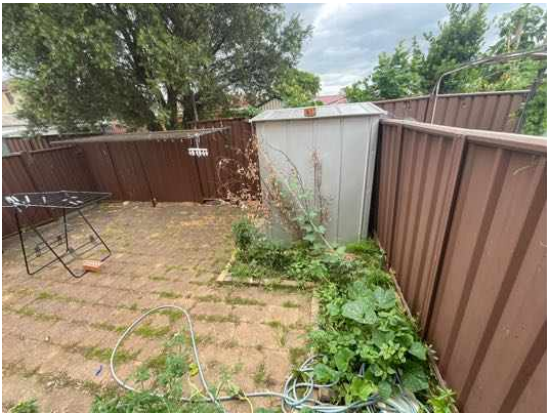
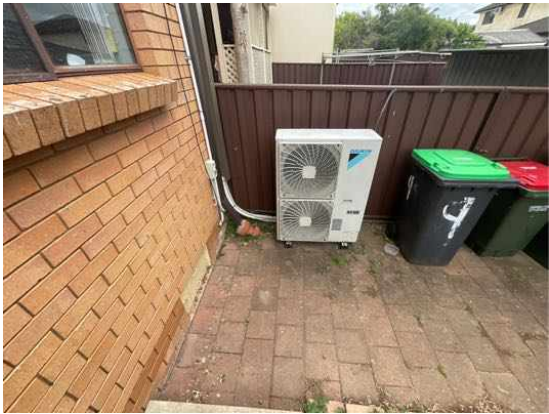
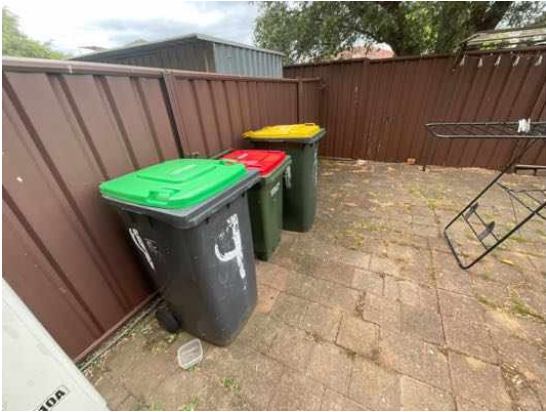
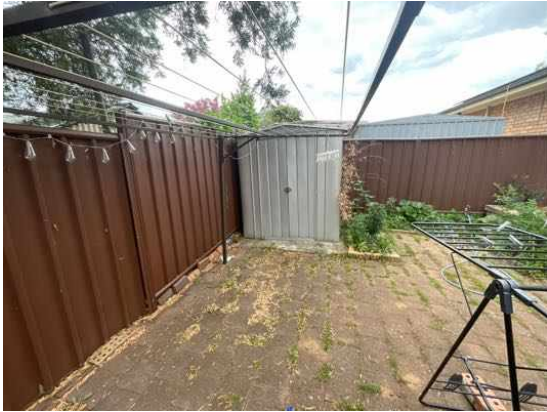
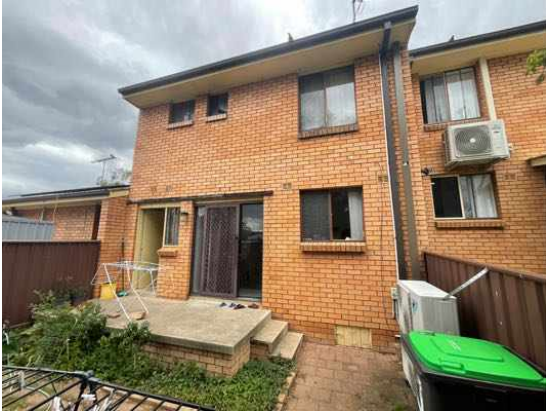
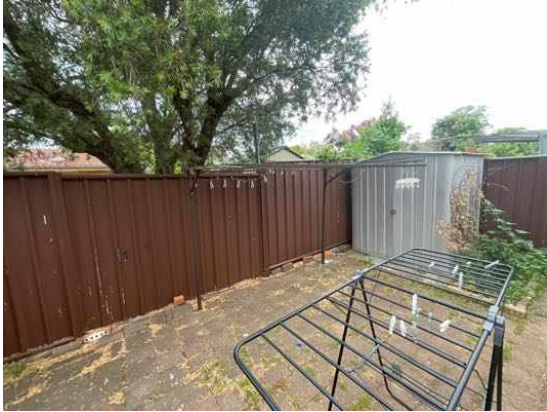
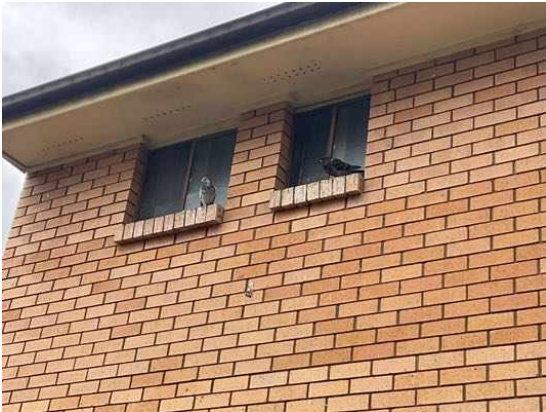
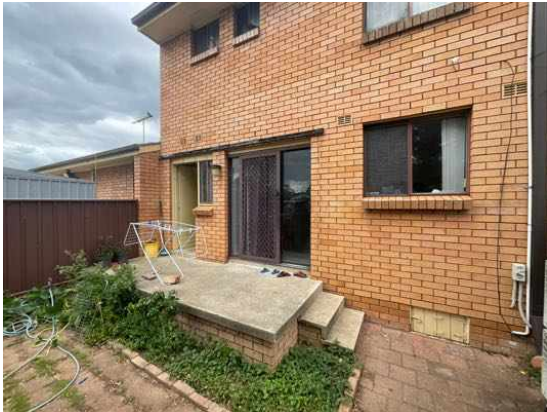
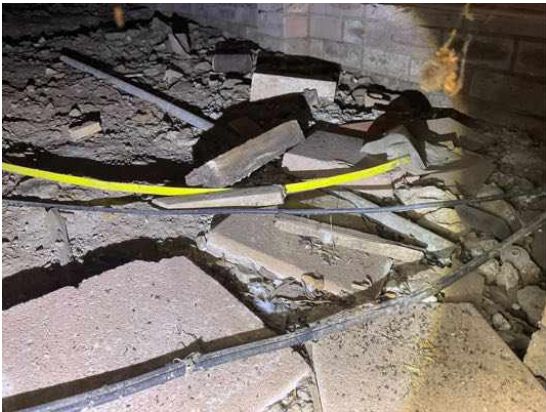
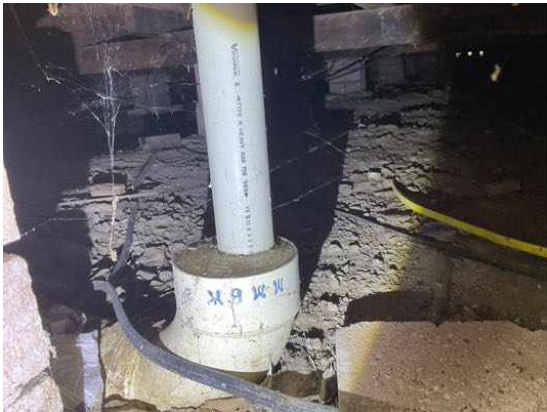
Building: Main Building  
Location: All Areas  
Finding: Additional Photos - Obstructions and Limitations  
Information: These photographs are an indication of the obstructions and limitations which impeded full inspection of the property at the time of inspection. These obstructions can hide an array of defects and should be removed to allow full inspection to be carried out. A re-inspection is recommended once the areas are made accessible.
