# Building and Timber Pest Inspection Report

Inspection Date: Wed, 14 Jan 2026

Property Address: 9/120 Oxford Rd, Ingleburn NSW 2565,  
Australia

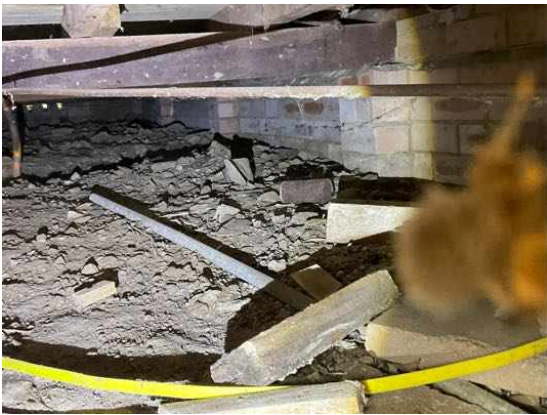
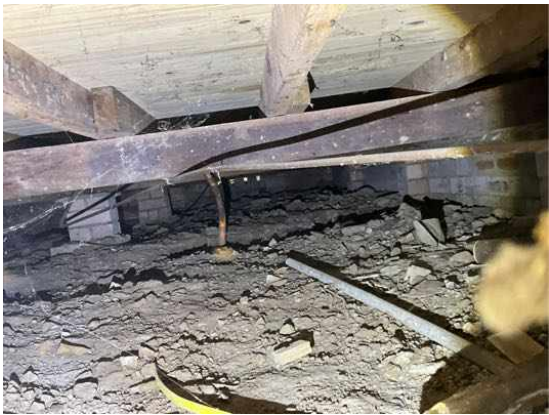
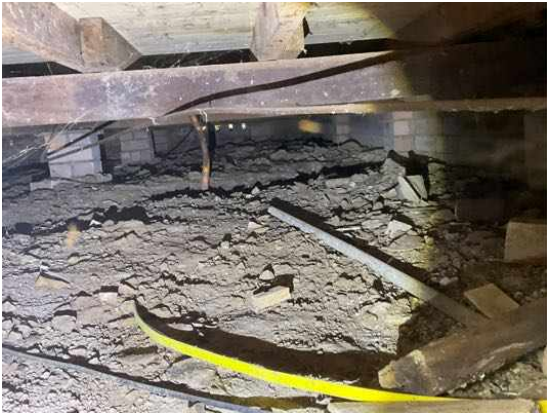
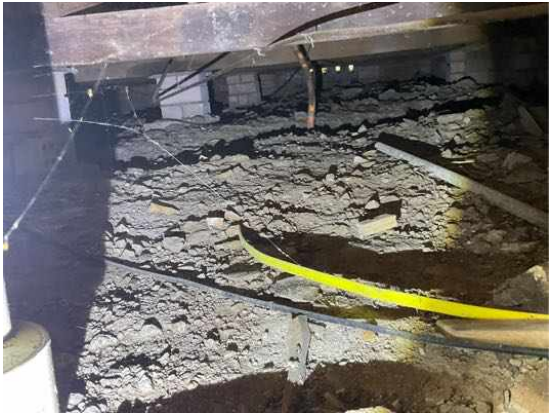
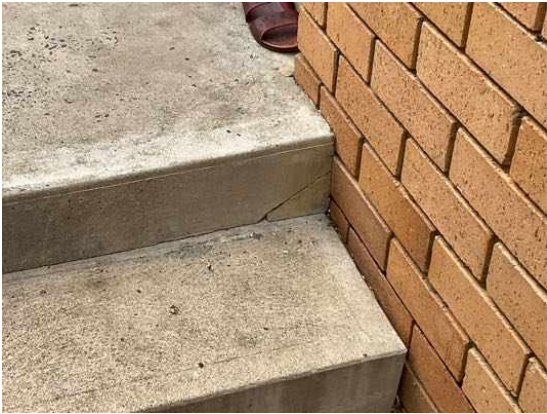
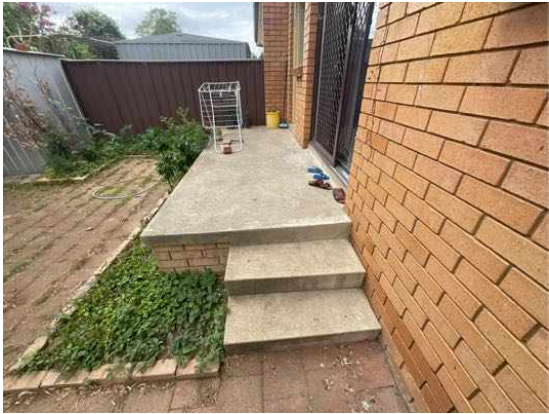
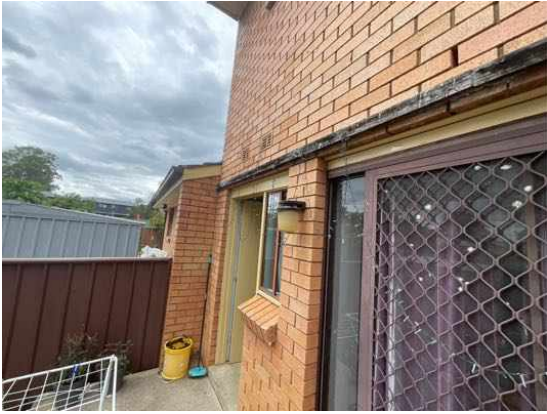
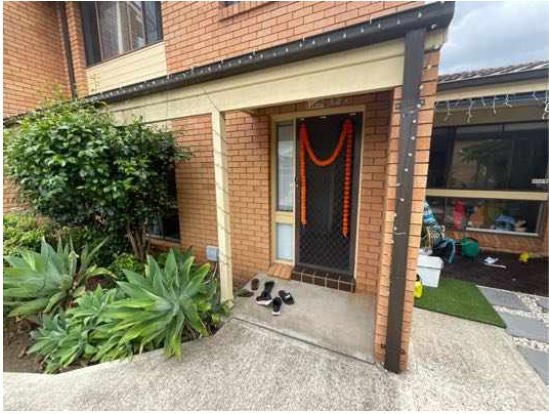
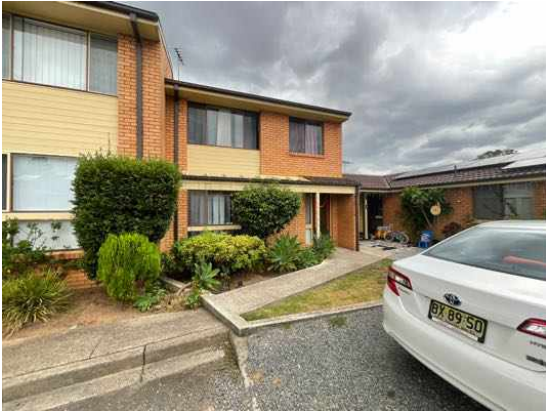
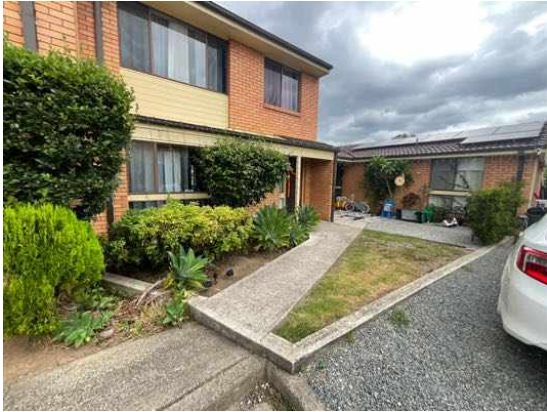
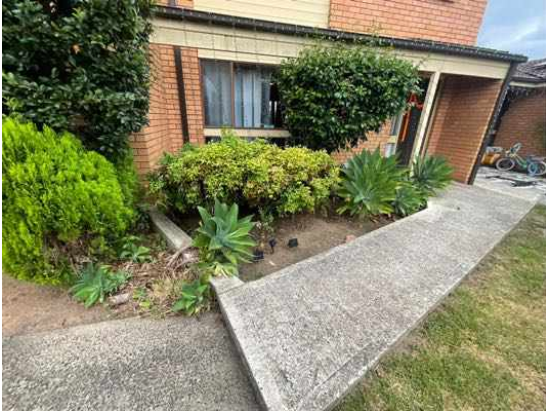
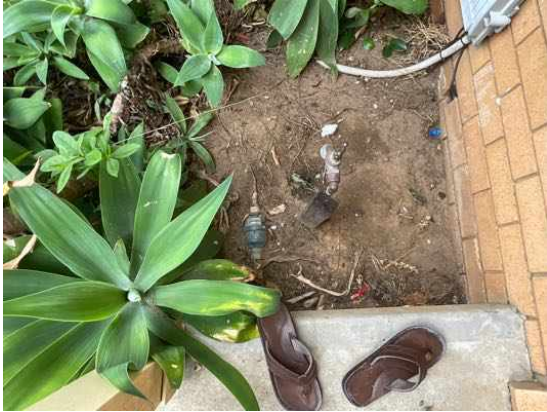
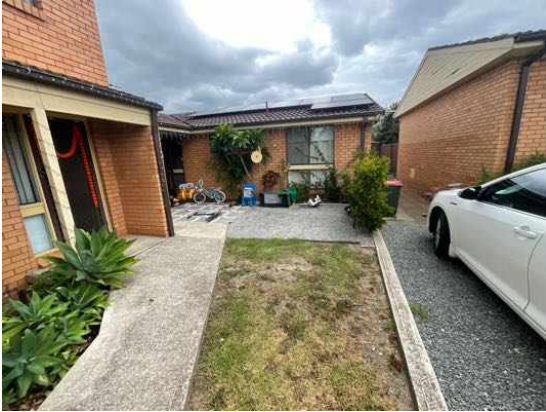
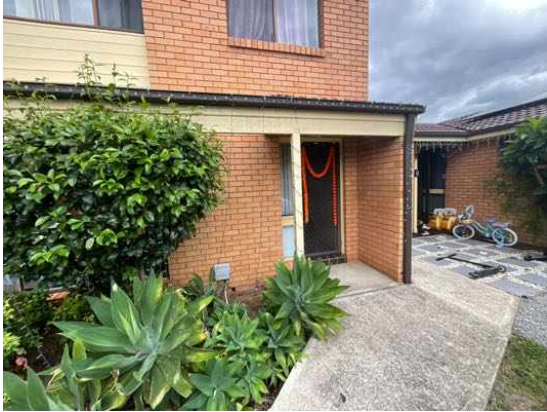
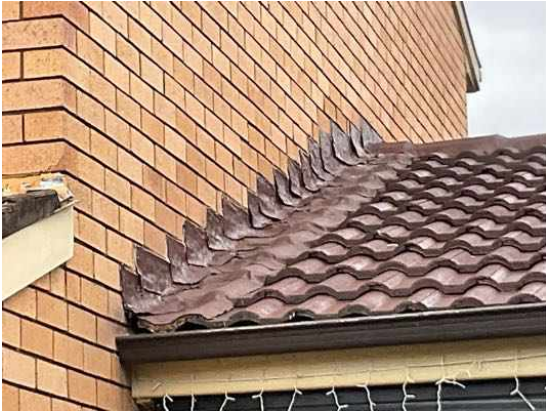
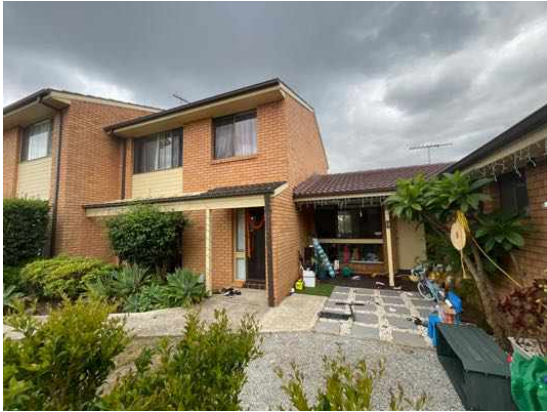
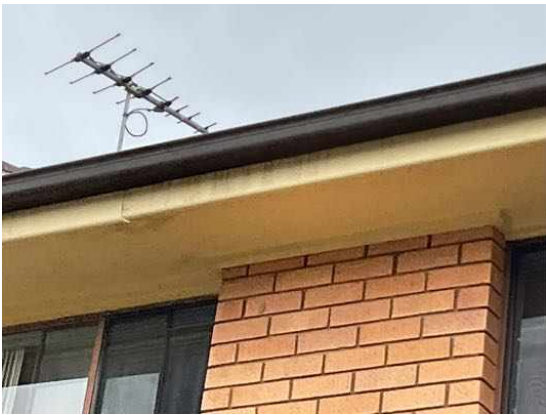
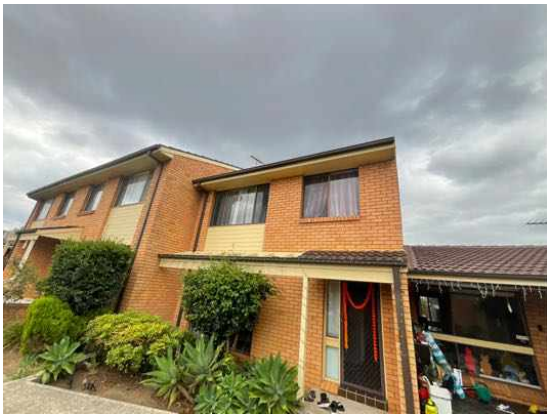
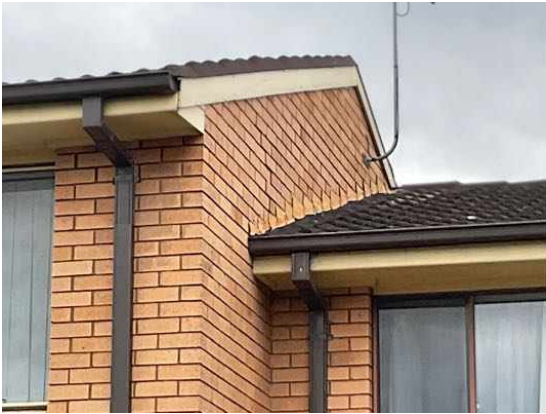
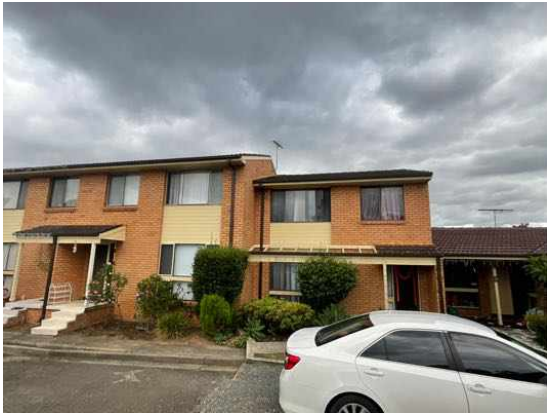
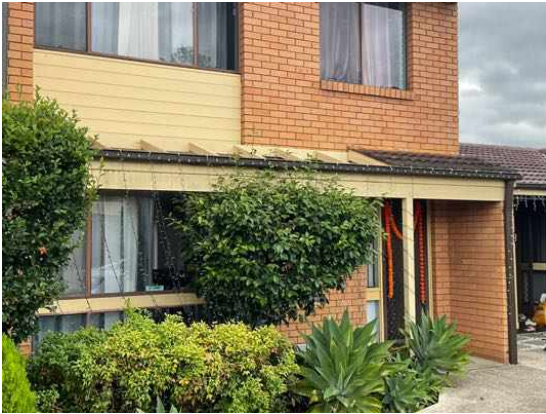
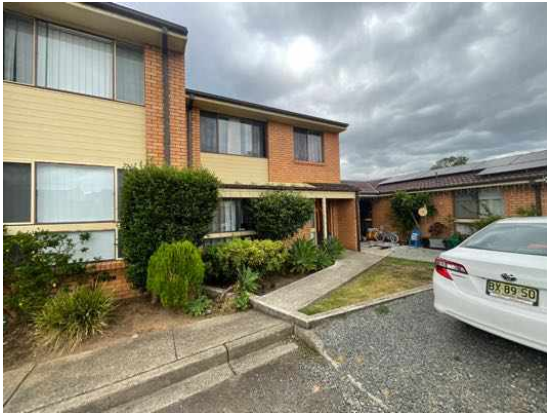
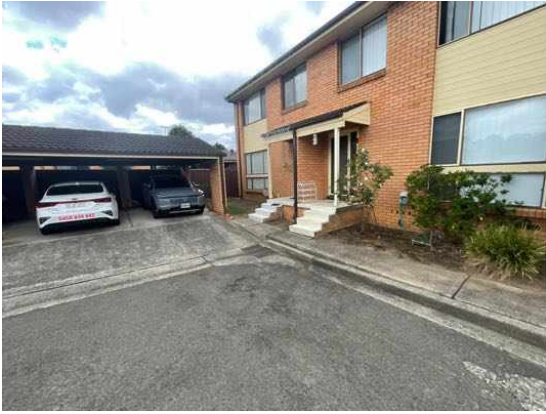
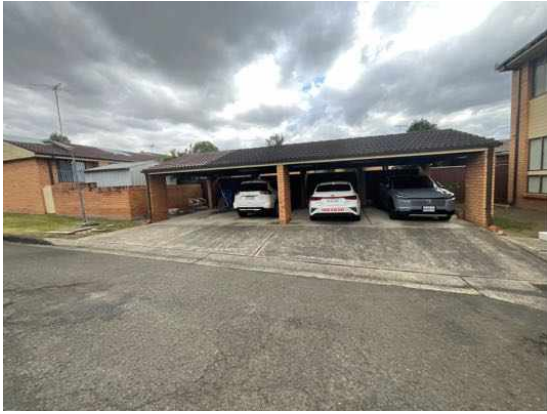
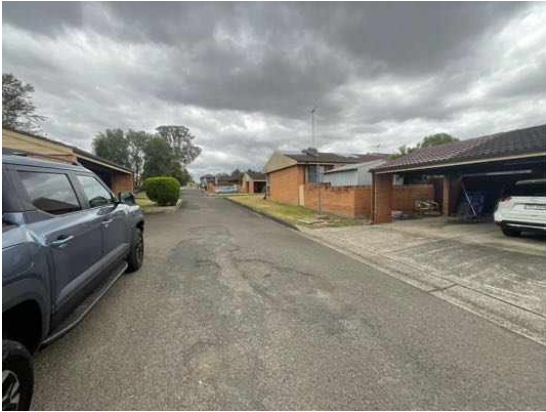
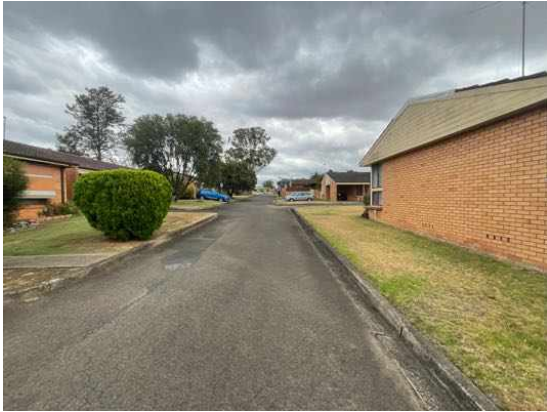
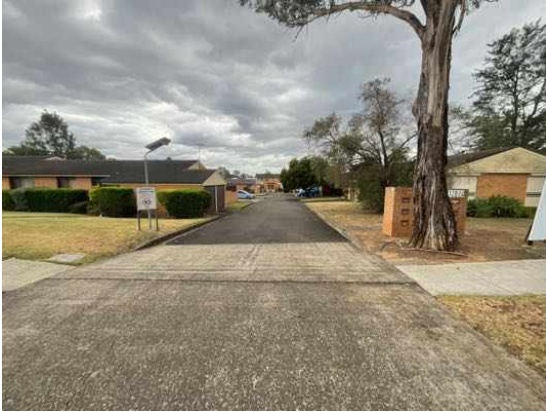
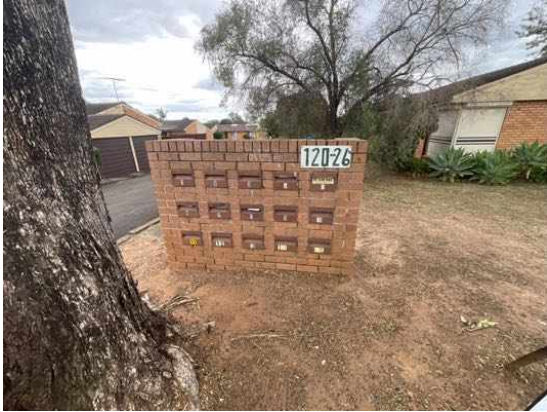
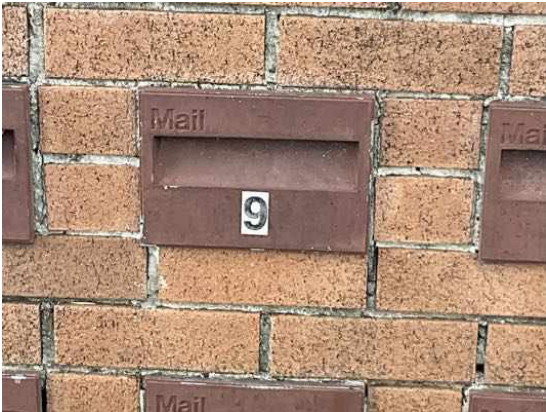
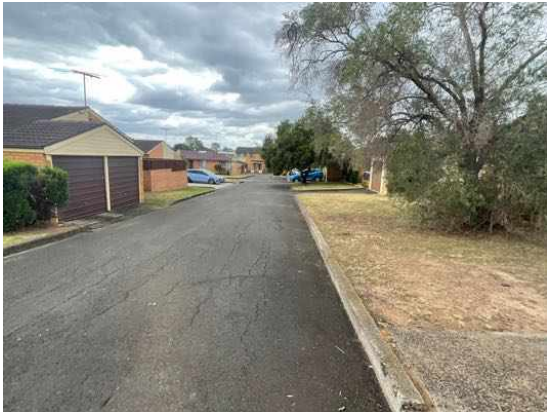
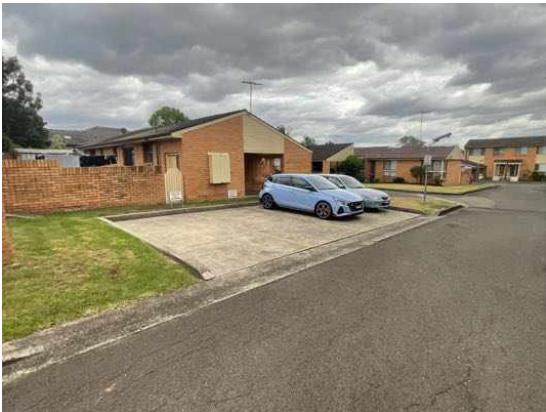
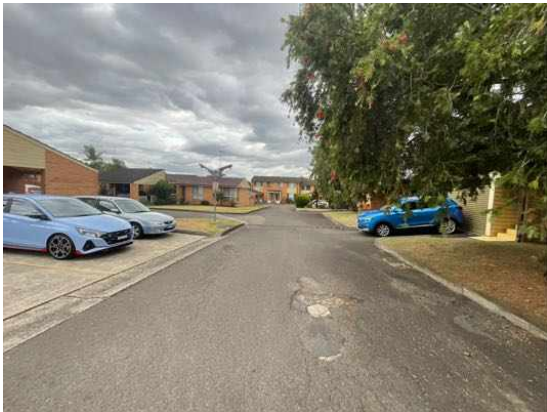
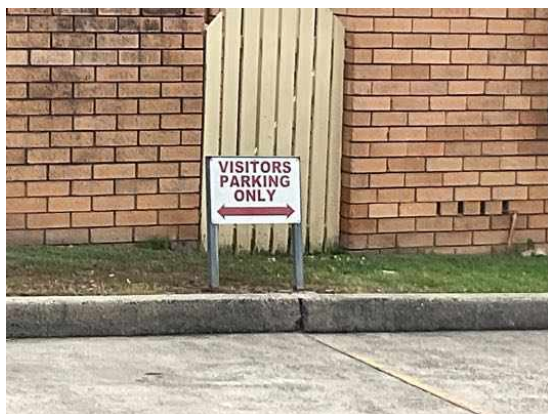
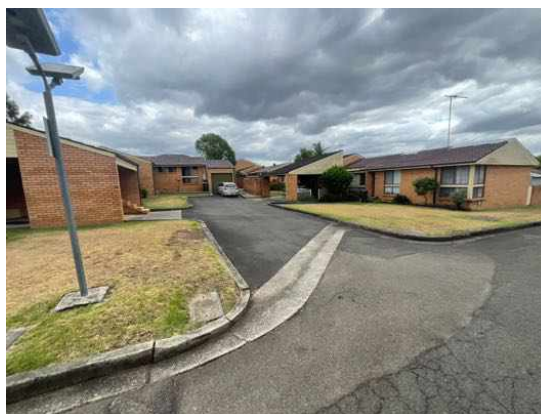
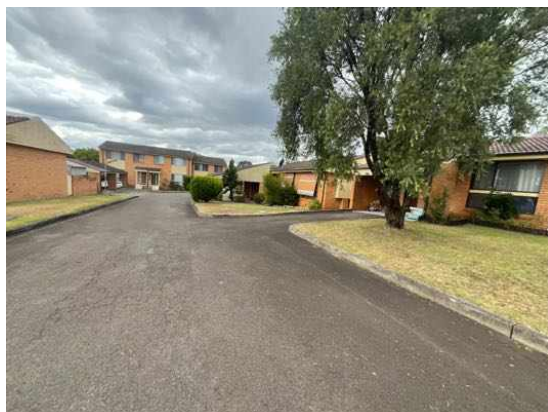
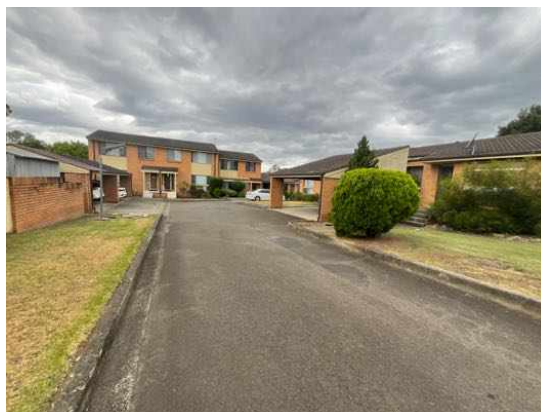
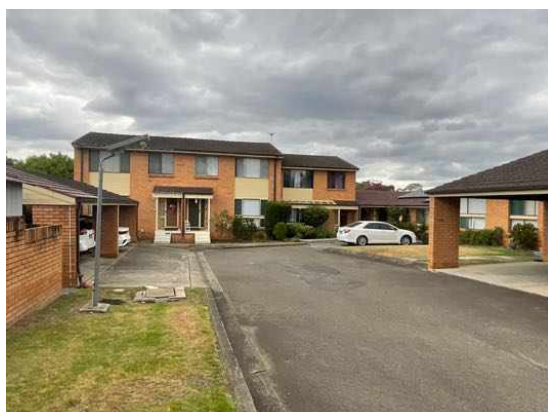
Building: Main Building  
Location: All Areas  
Finding: Additional Photos - Obstructions and Limitations  
Information: These photographs are an indication of the obstructions and limitations which impeded full inspection of the property at the time of inspection. These obstructions can hide an array of defects and should be removed to allow full inspection to be carried out. A re-inspection is recommended once the areas are made accessible.

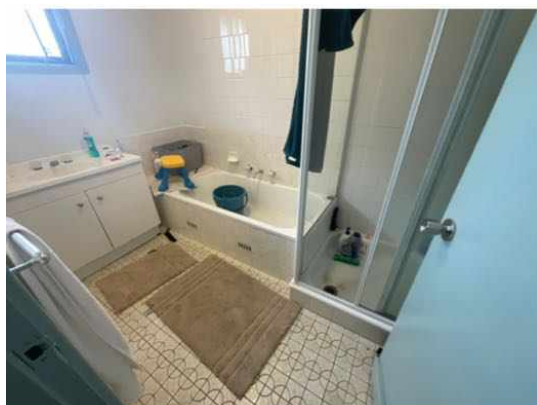
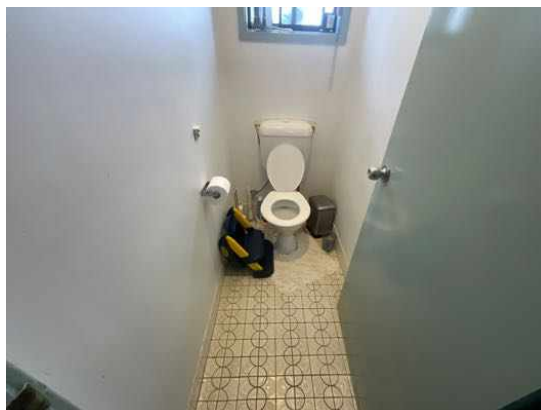
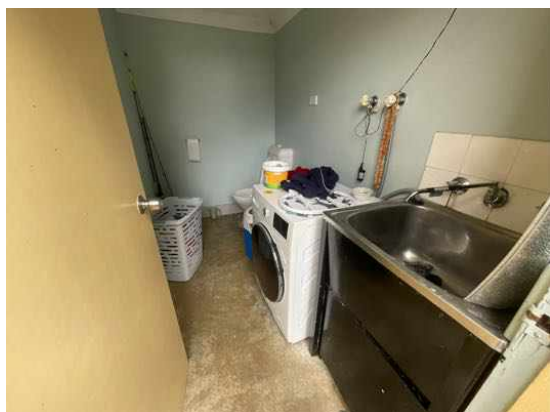
Building:	Main Building
Location:	All Areas
Finding:	Water Proofing Membranes - Information Only
Information:	Internal Water Proofing Membranes, are crucial in preventing water ingress into the property is important to know that the Membrane System used is to Australian Standards and has been installed correctly. Please refer to the original Building Documents or Maintenance Schedule for the relevant information including; - Membrane used and Manufacturers Specifications. - The Installer and Installation Certification. Especially with older property's where this information is unavailable, all wet areas should be monitored. Generally new waterproofing with a certificate may

only have a guarantee of 8yrs. If any leaks, water staining, peeling or bubbling of the paint become evident to any adjacent walls or ceilings below a licensed builder or waterproofing specialist is recommended to investigate further.

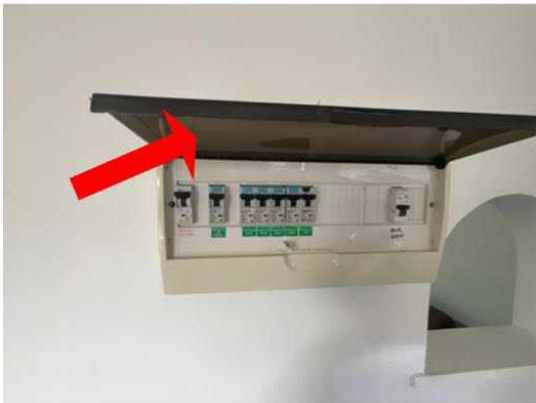
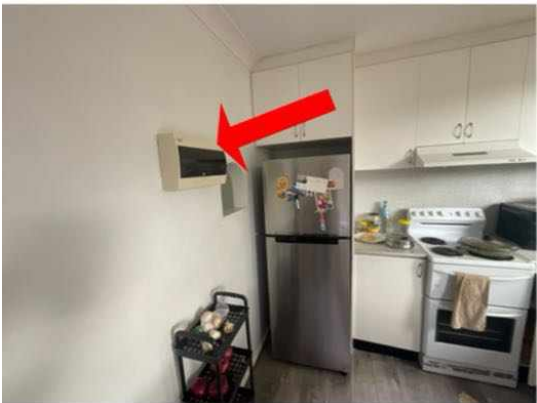
Building:	Main Building
Location:	All Areas
Finding:	Termite Management System - no evidence of a chemical installation
Information:	The application of a post-construction chemical termite barrier is highly recommended for all properties, particularly if live termite activity has been found on the site previously. Such barriers are highly effective in preventing termite attack on any timber building elements throughout the property.

A durable notice should be placed in the switchboard unit to indicate current termite barriers. At the time of inspection, it appeared as though no termite management system has been installed, with no evidence to suggest preventative works taking place.

The client may consider gaining further advice from a pest controller as to the costs and procedures involved with this application. It is recommended that obtaining such advice be a short-term priority.
