Building and Timber Pest Inspection Report

Inspection Date: Tue, 10 Mar 2026

Property Address: 1/118 Good St, Granville NSW 2142, Australia

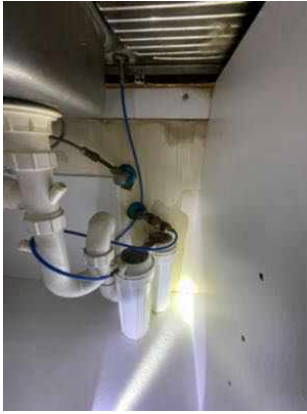
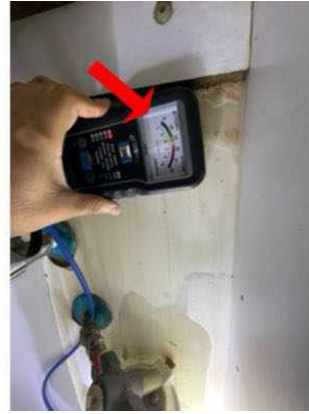
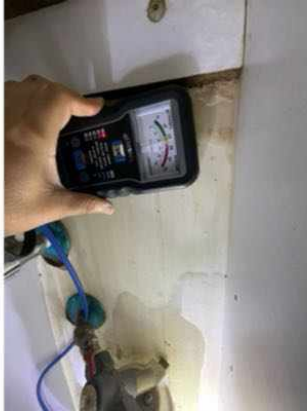
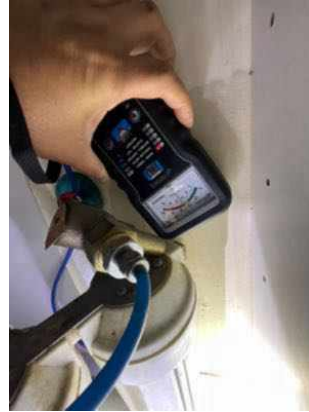
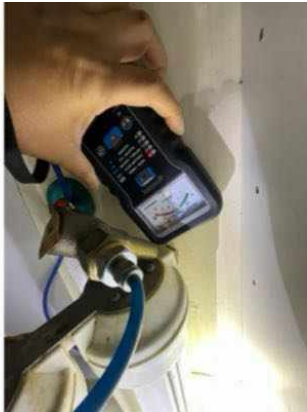
Building: Main Building
Location: Kitchen
Finding: Water damage
Information: The area has sustained water damage resulting in potential structural issues. This damage compromises both the aesthetic and functional aspects.

1 ****Plumber:**** If the water damage is due to plumbing issues, a plumber can fix leaks and ensure there are no further water-related problems.

2 ****General Contractor:**** If the damage is extensive and affects the surrounding area, a general contractor can coordinate the repair work, including any related structural or cosmetic repairs.

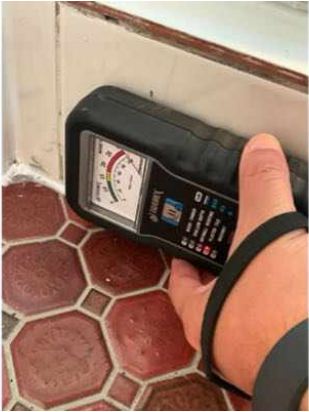
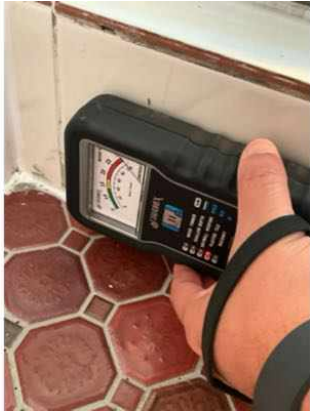
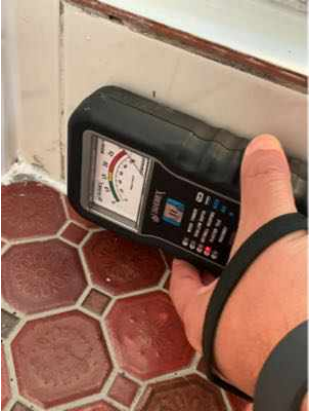
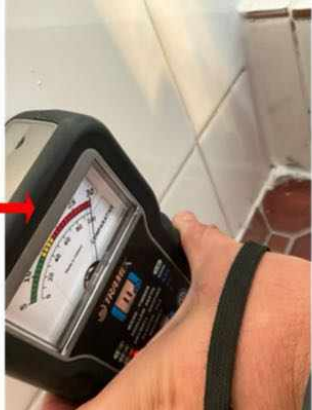
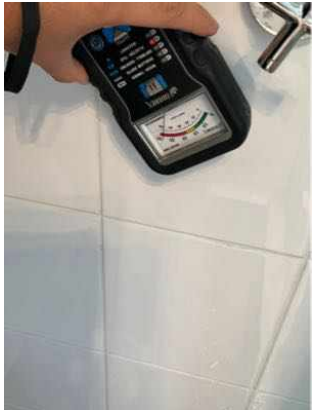
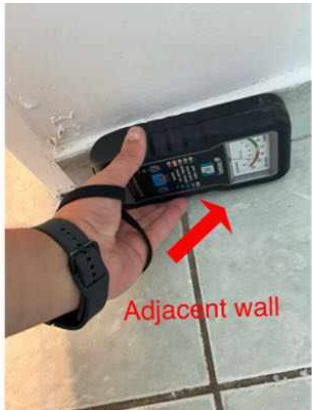
Finding 2.02

Building:	Main Building
Location:	Bathroom
Finding:	Evidence of excessive moisture was present at the time of inspection
Information:	Excessive moisture is present behind the bathroom tiles, indicating a potential water leakage issue within the wall.

The prolonged presence of moisture can lead to mold growth, deteriorate the structure, and create an environment conducive to health hazards. Additionally, it may compromise the adhesive holding the tiles, leading to their detachment.

A licensed plumber or a qualified contractor specializing in water damage remediation

should investigate the source of the moisture, fix any leaks, and address the damage. Additionally, replacing affected tiles and ensuring proper waterproofing are crucial to preventing future issues.

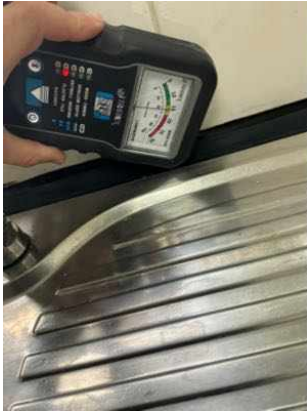
Finding 3.01

Building: Main Building
Location: Kitchen
Finding: Evidence of excessive moisture was present at the time of inspection
Information: Excessive moisture is present behind the bathroom tiles, indicating a potential water leakage issue within the wall.

The prolonged presence of moisture can lead to mold growth, deteriorate the structure, and create an environment conducive to health hazards. Additionally, it may compromise the adhesive holding the tiles, leading to their detachment.

A licensed plumber or a qualified contractor specializing in water damage remediation should investigate the source of the moisture, fix any leaks, and address the damage. Additionally, replacing affected tiles and ensuring proper waterproofing are crucial to preventing future issues.

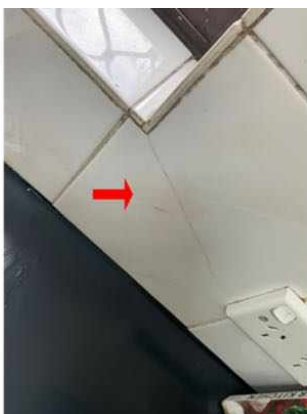
Finding 3.02

Finding: Tiles - Cracked or damaged

Information: Cracking was evident to the tiling in this area at the time of inspection. While the cracking appears to be minor, this area is frequently exposed to water, allowing potential for water penetration into adjoining sections of walls or flooring.

If left unmanaged, water penetration to these areas may lead to subsequent water damage, which is likely necessitate repair work to affected building elements.

A tiling contractor should be appointed to ensure that no further water damage occurs. The re-application of silicone and grouting throughout remaining tile work is also advised, to further protect the area against water penetration.

Where water penetration has led to water damage, appointment of a relevant tradesperson may be required to repair damaged building elements.

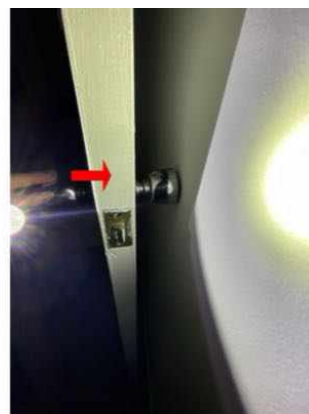
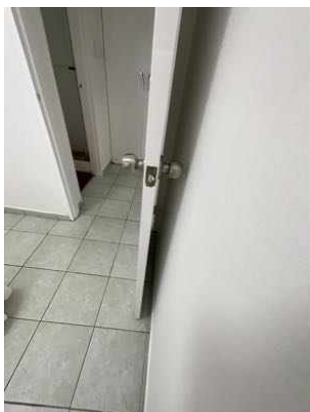
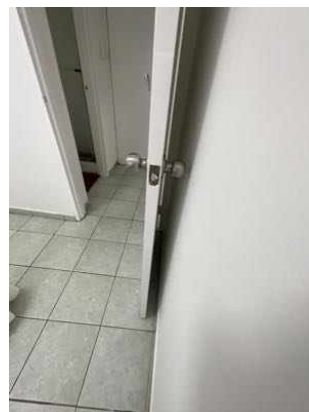
Finding 3.03

Finding: Missing Door Stopper

Information: The door lacks a stopper, which is essential to prevent the door from swinging too far and potentially damaging the wall or the door handle. The absence of a door stopper increases the likelihood of impact damage to both the door and surrounding surfaces over time.

- **Damage Risk:** Moderate risk of damage to the door handle, wall, or door itself from repeated impacts when the door is opened forcefully or by a gust of wind.
- **Wear and Tear Risk:** Increased wear on door hardware and hinges due to the potential for abrupt stops without a dedicated stopper.

- **Engage a Handyperson or Carpenter:** A handyperson or carpenter should install a suitable door stopper to prevent excessive door movement. This could be a floor-mounted or wall-mounted stopper depending on the space and door design.

This issue is a minor defect but should be addressed to prevent potential damage and maintain the integrity of the door and surrounding areas.

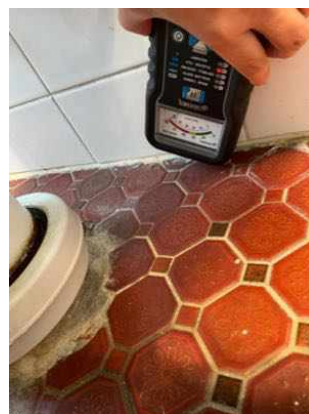
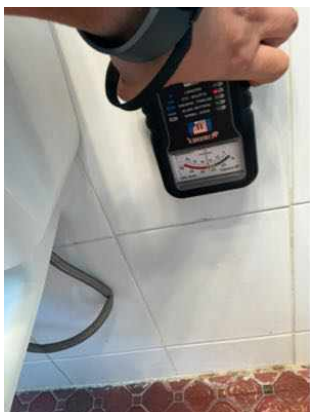
Building: Main Building
Location: Bathroom
Finding: Evidence of excessive moisture was present at the time of inspection
Information: Excessive moisture is present behind the bathroom tiles, indicating a potential water leakage issue within the wall.

The prolonged presence of moisture can lead to mold growth, deteriorate the structure, and create an environment conducive to health hazards. Additionally, it may compromise the adhesive holding the tiles, leading to their detachment.

A licensed plumber or a qualified contractor specializing in water damage remediation should investigate the source of the moisture, fix any leaks, and address the damage. Additionally, replacing affected tiles and ensuring proper waterproofing are crucial to preventing future issues.

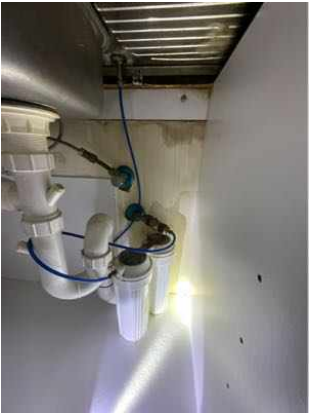
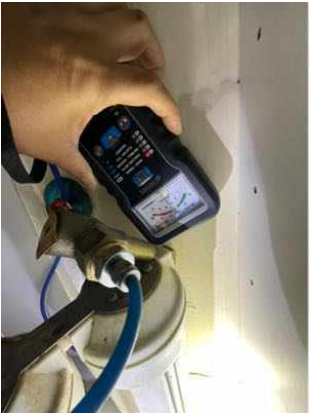
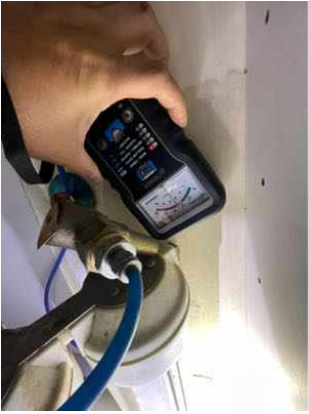
If mould growth has been found there may be environmental biological or health issues involved. In these cases an appropriately qualified inspector should also be contacted.

Prior to any remedial works being performed a qualified plumber should be appointed to further inspect the property and to identify the cause of the excessive moisture. Works to remove affected building elements may then be necessary and should be performed by an appropriate tradesperson.

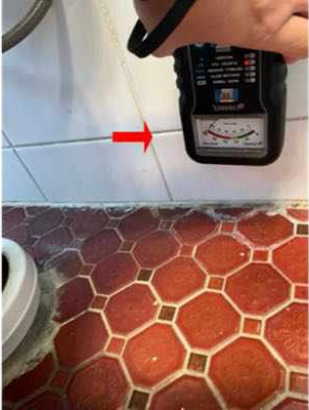
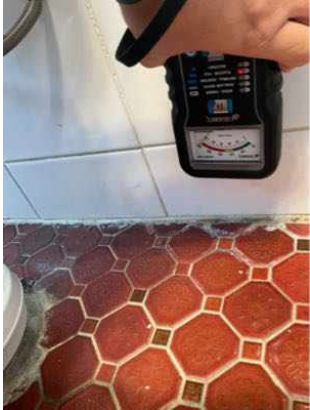
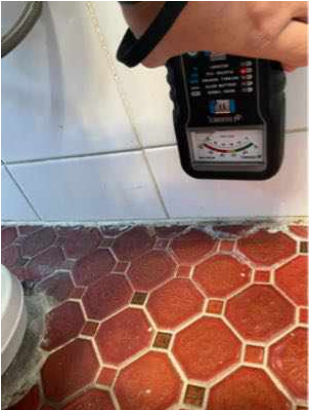
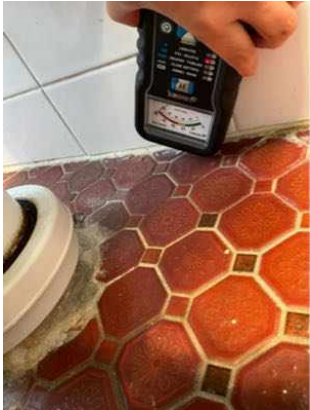
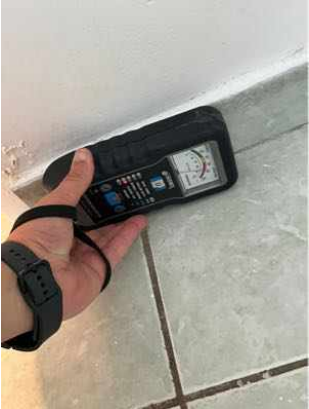
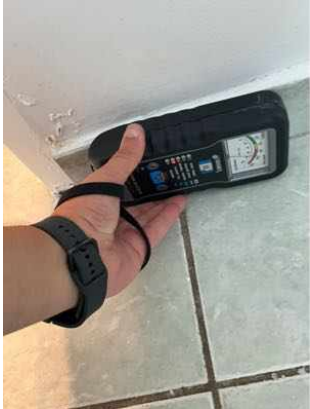
Finding 6.03

Building:	Main Building
Location:	Bathroom
Finding:	Excessive moisture - Conducive to Timber pest
Information:	Excessive moisture can attract termites and produce conditions that promote fungal growth and wood decay.

Prior to any remedial works being performed a qualified plumber should be appointed to further inspect the property and to identify the cause of the excessive moisture. Works to remove affected building elements may then be necessary and should be performed by an appropriate tradesperson.

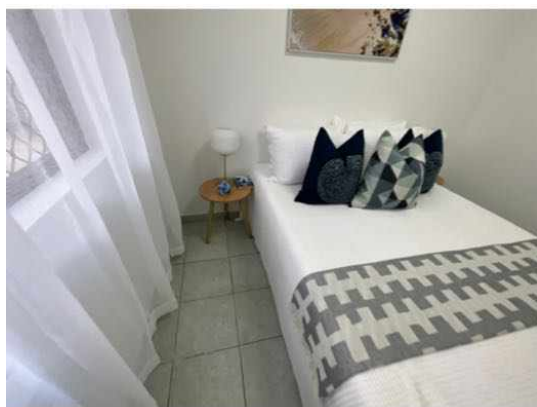
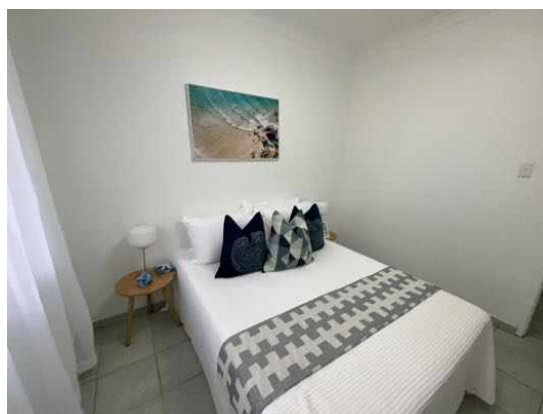
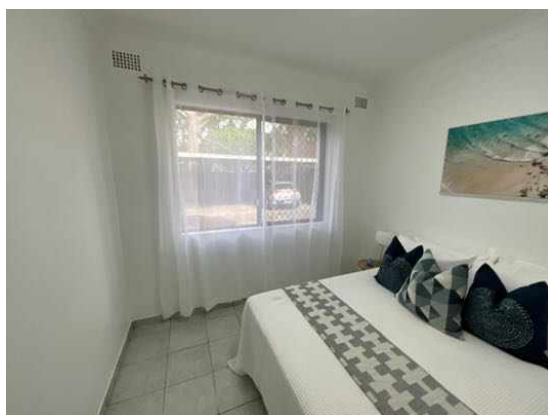
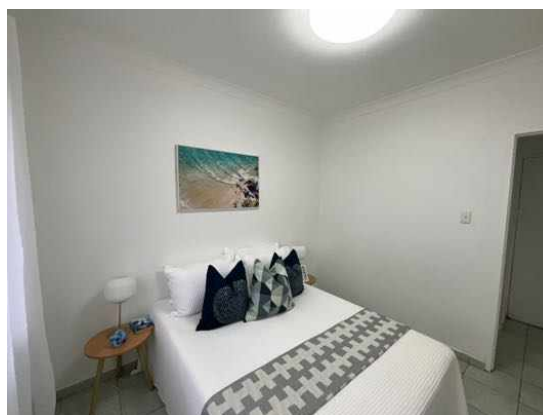
Building: Main Building
Location: All Areas
Finding: Additional Photos - Obstructions and Limitations
Information: These photographs are an indication of the obstructions and limitations which impeded full inspection of the property at the time of inspection. These obstructions can hide an array of defects and should be removed to allow full inspection to be carried out. A re-inspection is recommended once the areas are made accessible.
