Building and Timber Pest Inspection Report

Inspection Date: Wed, 4 Mar 2026

Property Address: 6 Corlis Ave, Eudlo QLD 4554, Australia

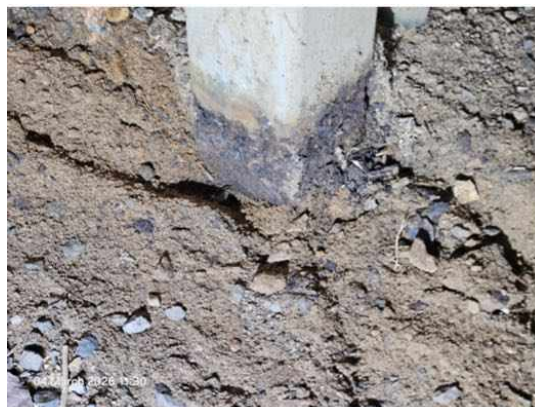
Building: Main Building
 Location: As shown
 Finding: Post base - rusting.
 Information: It was noted at the time of inspection that surface rust is developing at the base of the house subfloor post. This should be treated and coated to prevent possible further deterioration. It is advisable to carry out regular checks on all metal posts.

A licensed painter or suitably qualified handy person could be engaged to carry out the required task.

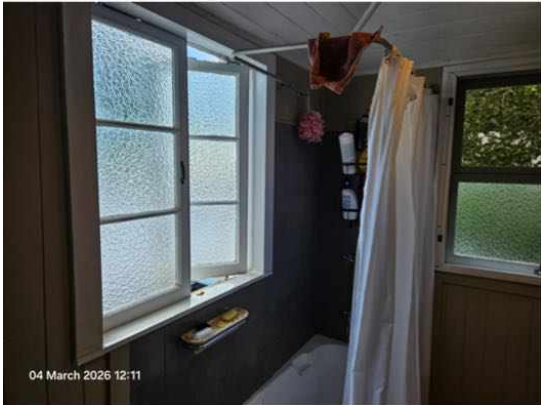
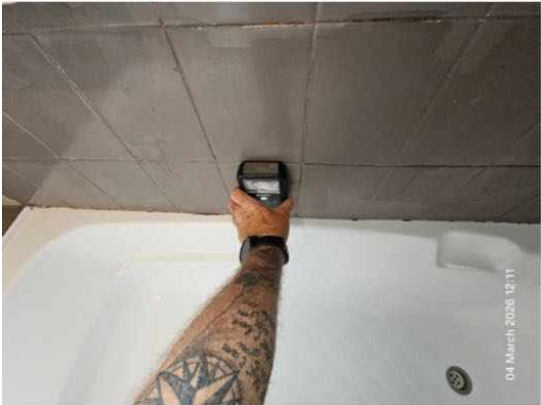
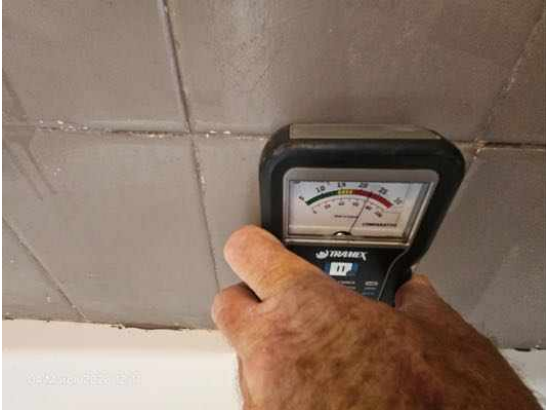
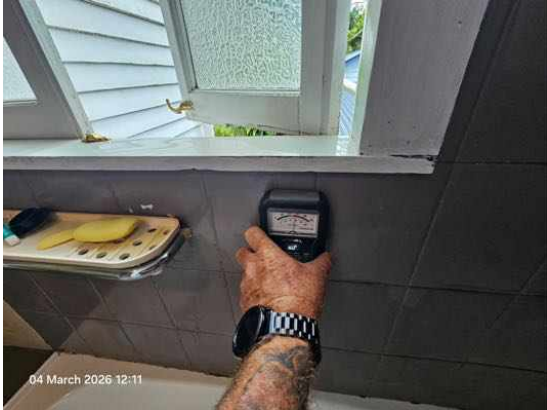
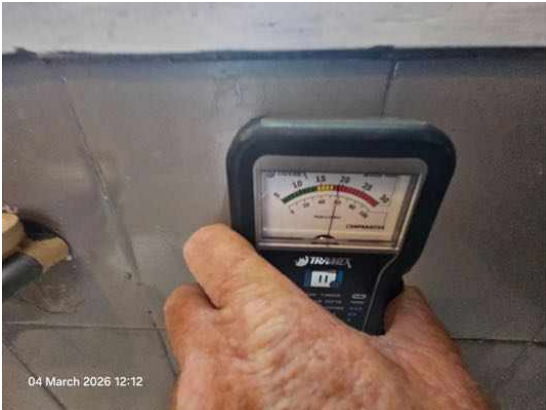
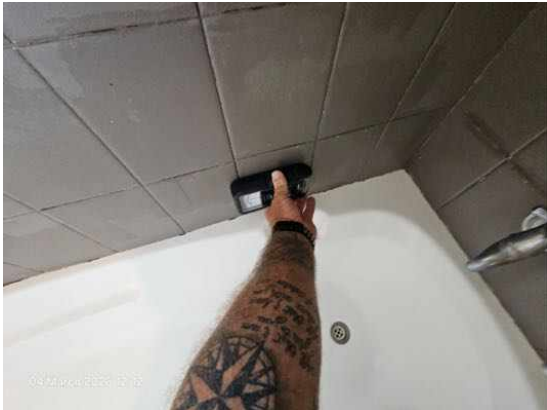
Finding 3.02

Building:	Main Building
Location:	Bathroom
Finding:	Elevated moisture present at the time of inspection - bathroom
Information:	Elevated moisture was noted in the tiled wall surfaces of the bathroom shower.

The levels varied at differing points throughout the recess. This could possibly be due to deteriorated grout and silicone sealants and / or plumbing fittings and fixtures. The grouts and sealants can break down over time and become porous, allowing moisture to enter the wall sheet surface behind the tiles.

Elevated moisture can attract timber pests and vermin, and produce conditions that promote timber pest attack, fungal growth and wood decay.

Tile sheet underlay to the alcove may be an asbestos containing fibre cement product. Exercise caution when renovating.

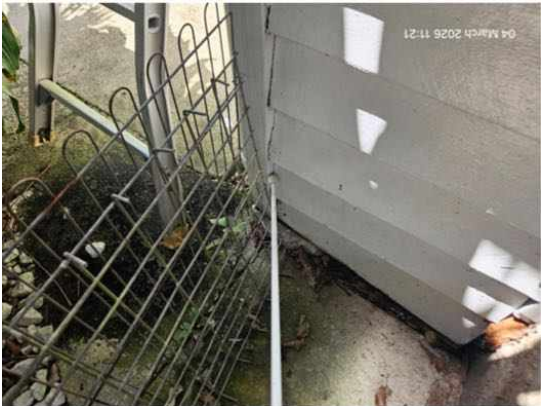
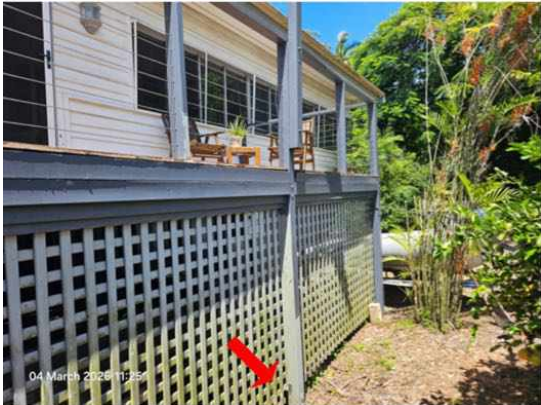
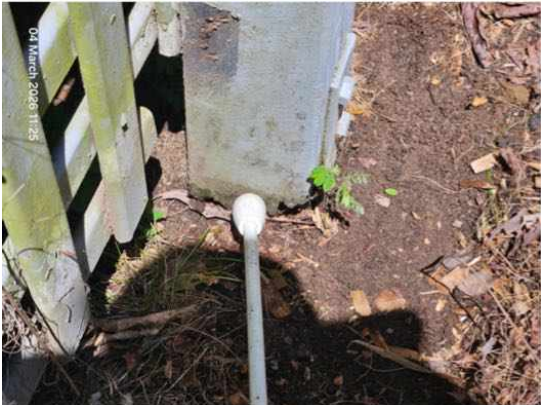
Early intervention and regular maintenance, particularly of exterior timbers, will prolong the useful life of these building elements. Prior to any works being performed, the cause of the moisture that has created the visible wood rot should be identified and addressed in a suitable manner. Replacement of affected timbers may then be a necessary step in protecting surrounding building elements from such deterioration.

A licensed carpenter or licensed builder should be consulted to advise on a solution for the affected building materials.

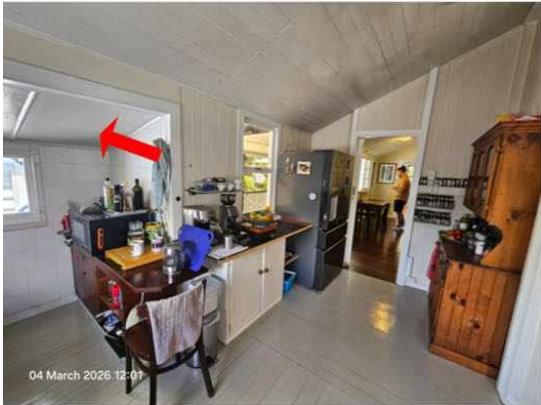
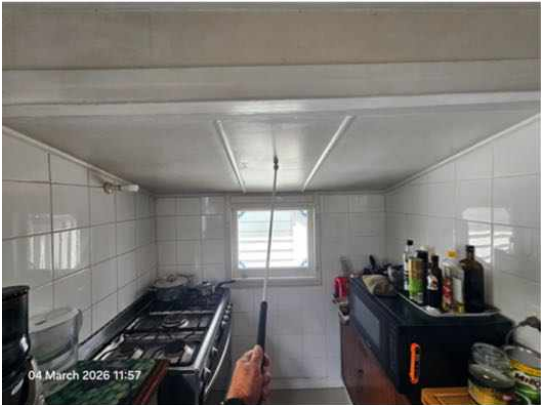
Where the client elects to retain the ACM, the client should regularly monitor the condition of the wall sheets to identify any further damage or deterioration. Such monitoring should be conducted at least annually, but more frequently should damage or evidence of deterioration occur. Additional remedial work is a potential short to medium term solution to reduce the risk presented by the ACM.

No works should be carried out to the ACM or associated building elements without further specialist advice.

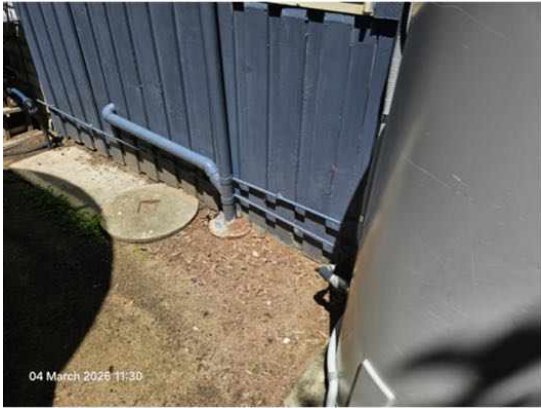
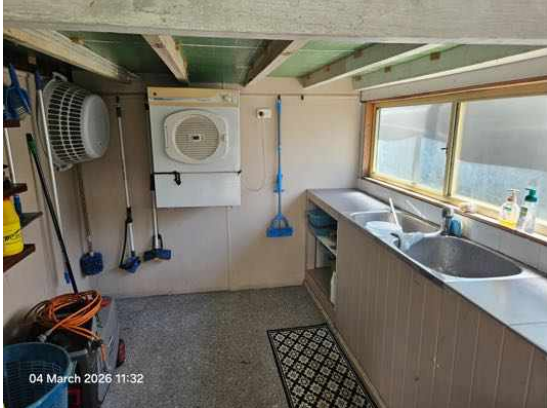
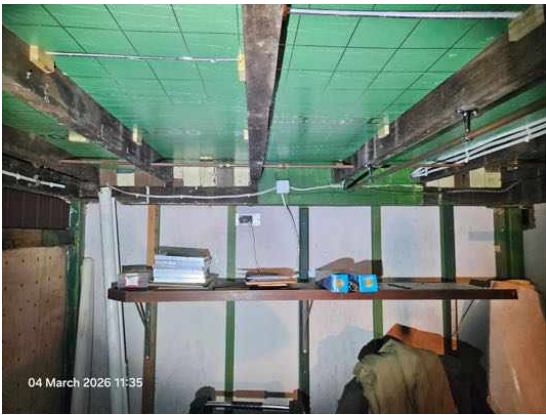
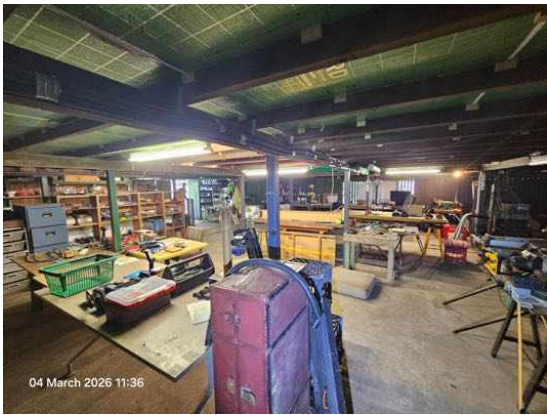
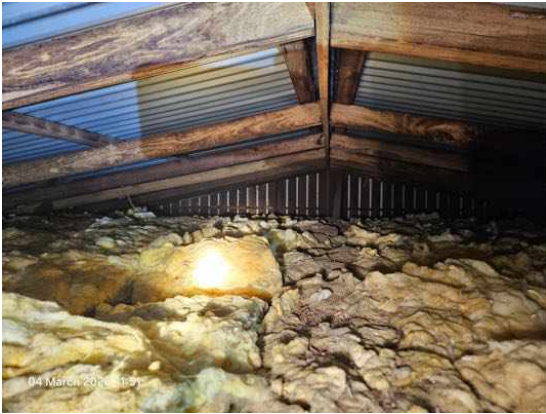
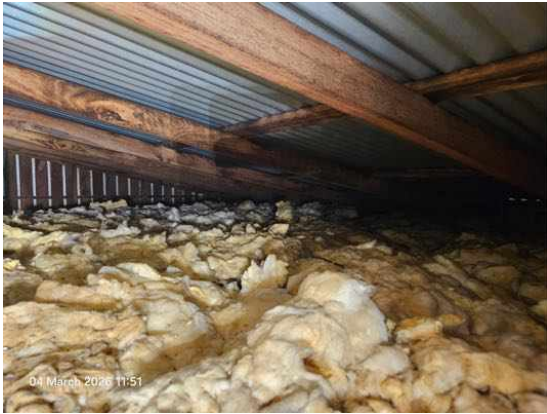
Building: Main Building
Location: All Areas
Finding: Additional Photos - Obstructions and Limitations
Information: These photographs are an indication of the obstructions and limitations which impeded full inspection of the property at the time of inspection. These obstructions can prevent full inspections of the areas shown.

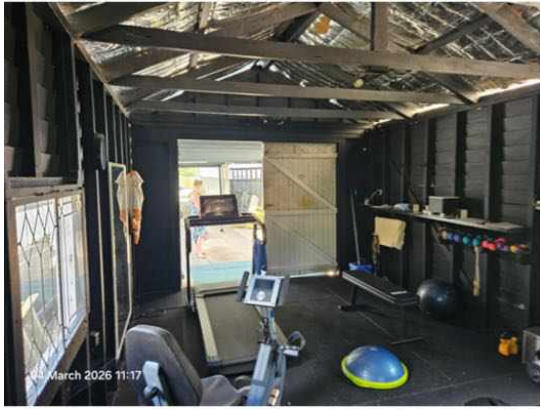
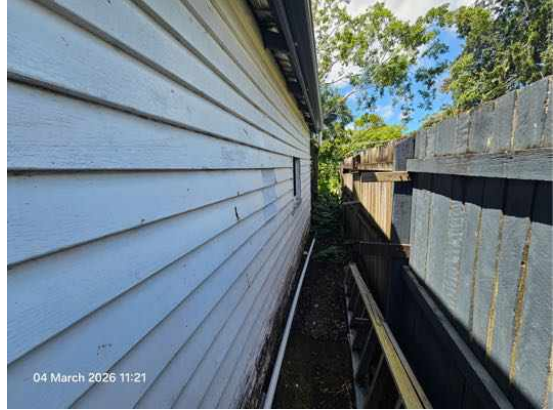
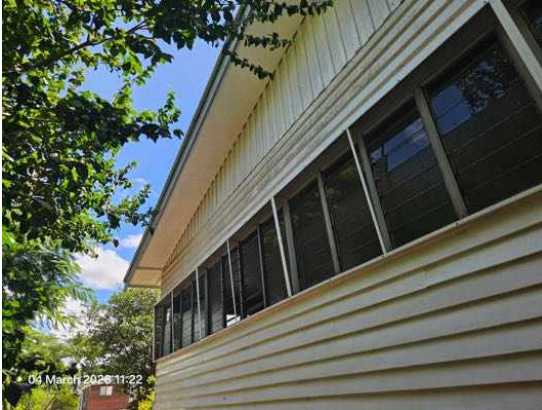
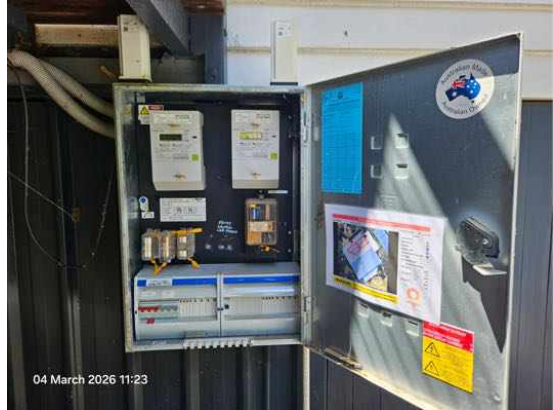
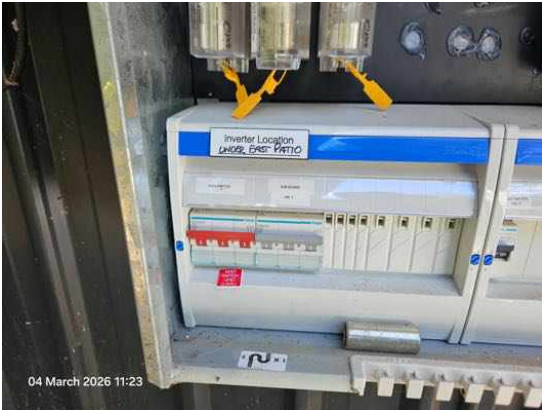
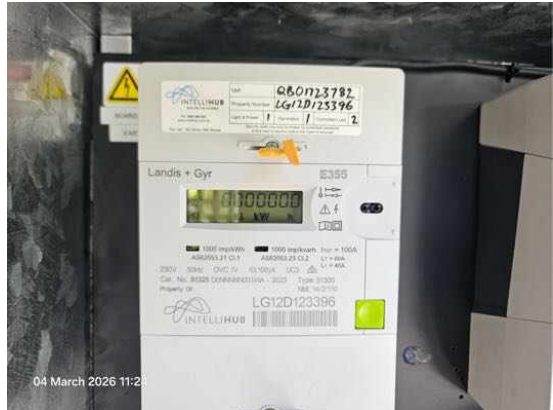
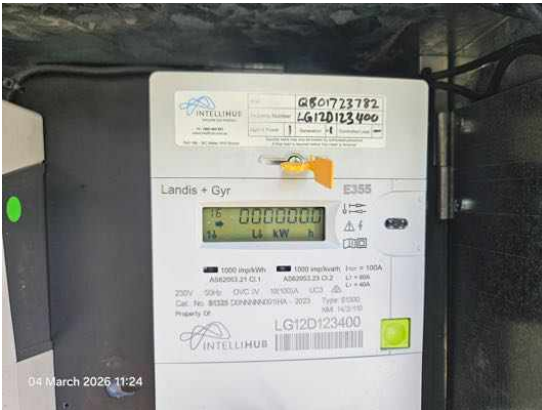
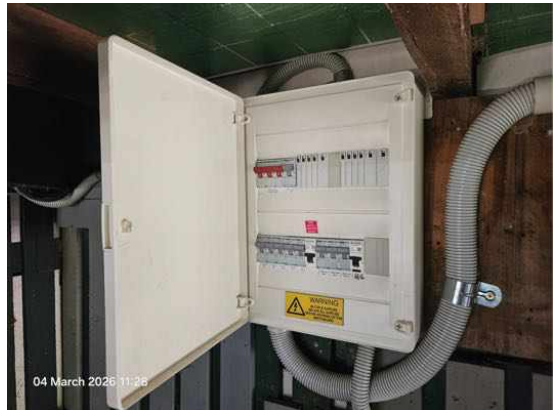
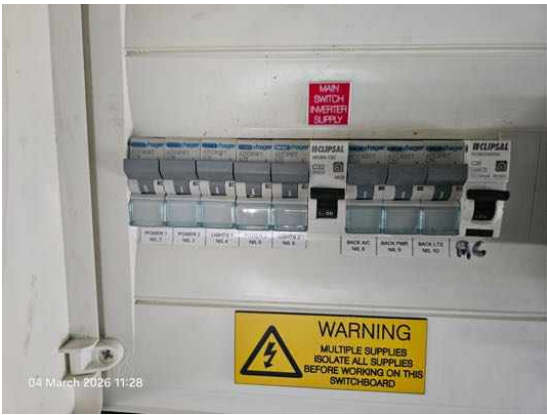
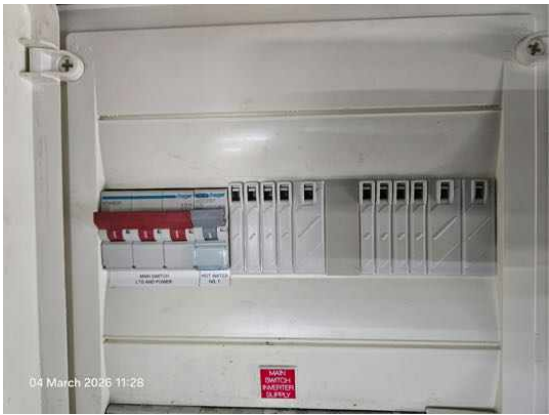
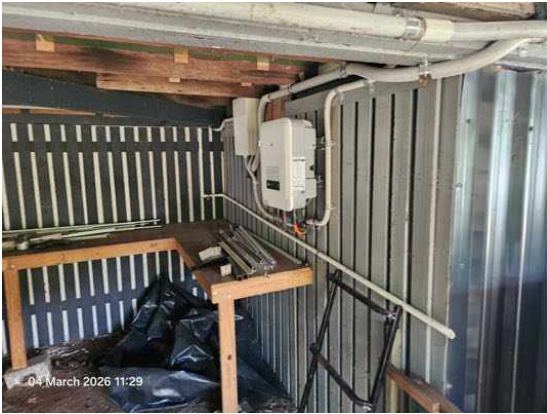
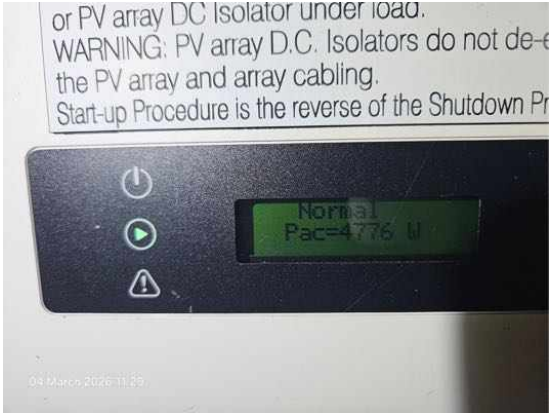
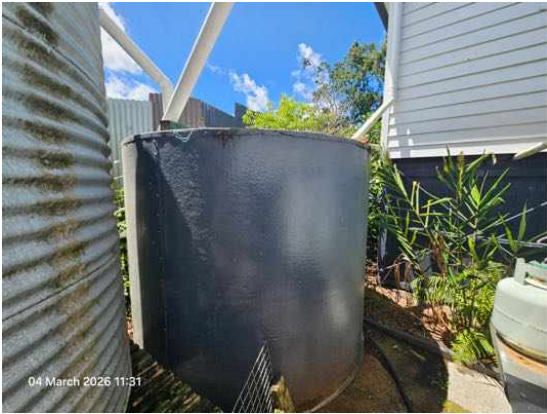
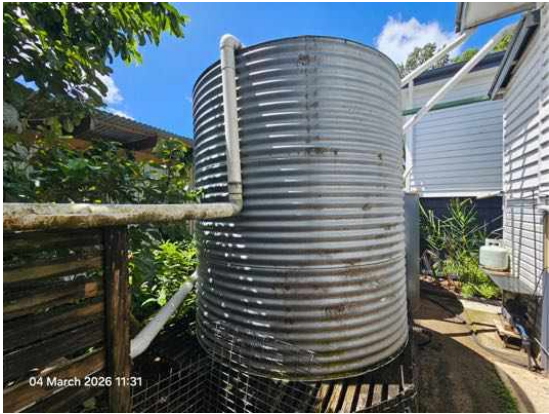
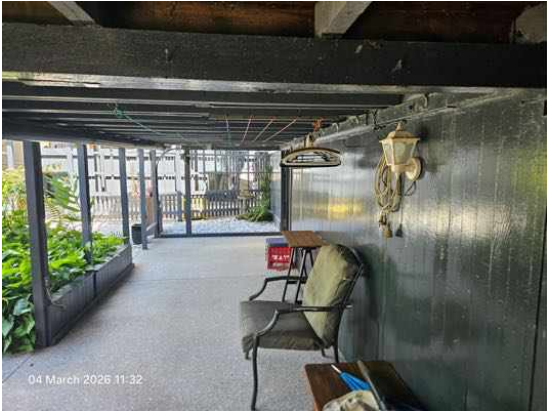
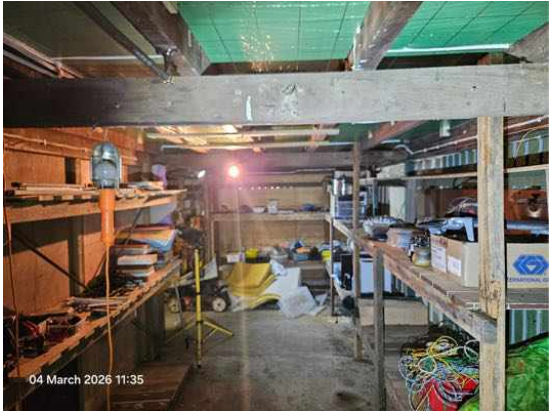
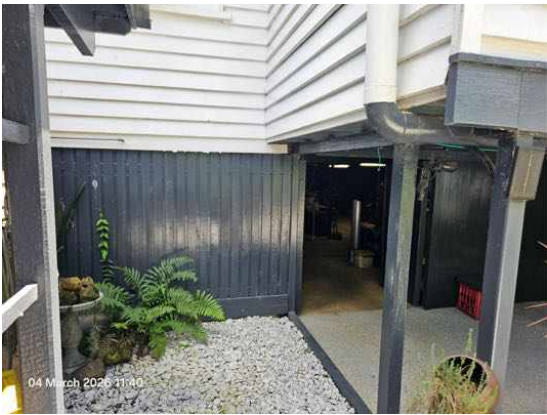
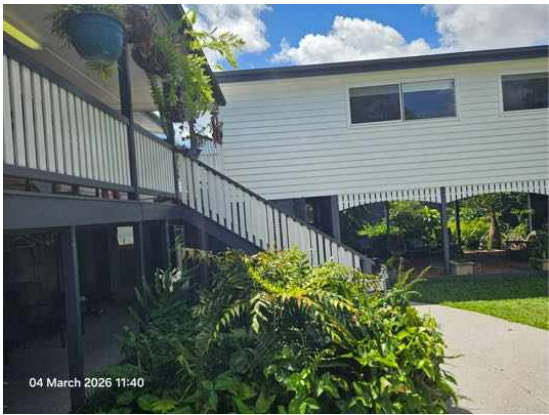
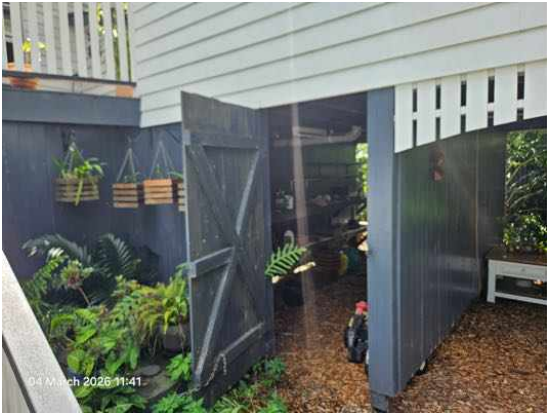
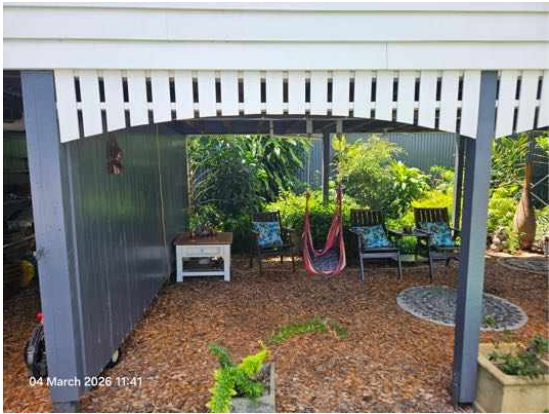
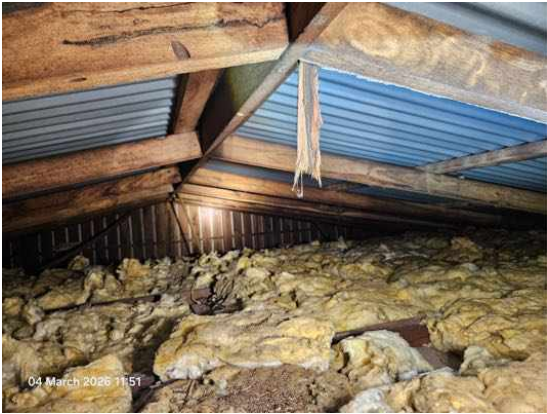
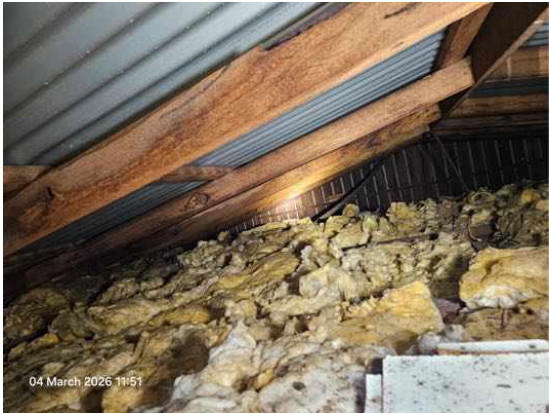
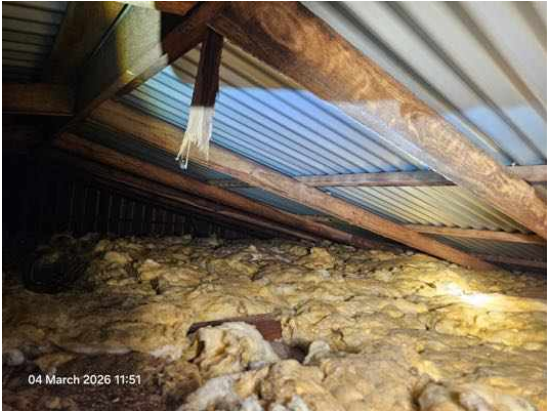
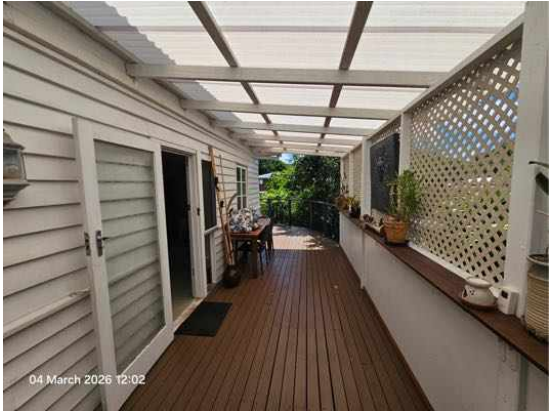
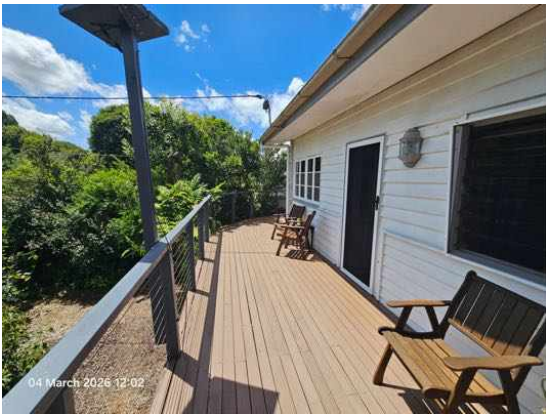
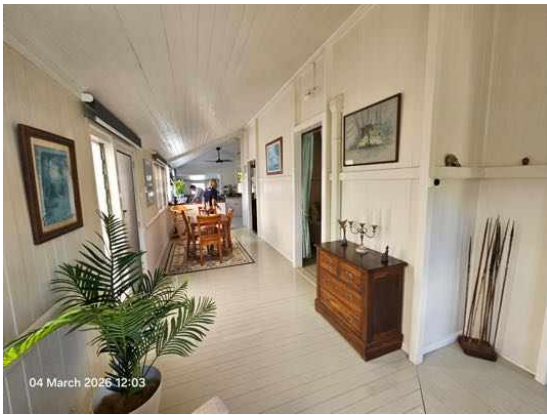
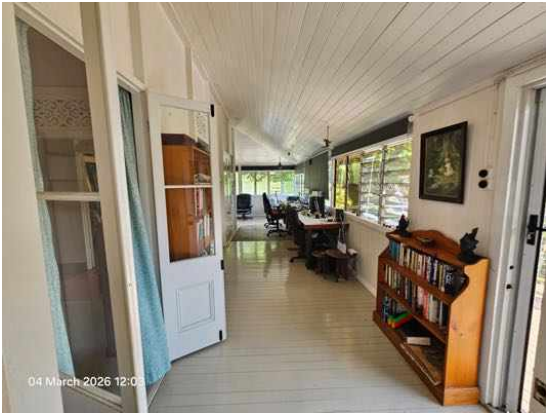
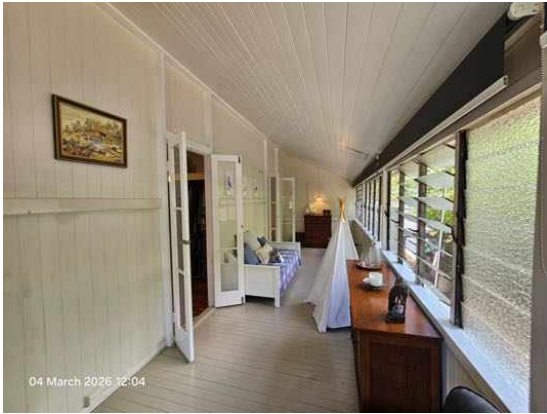
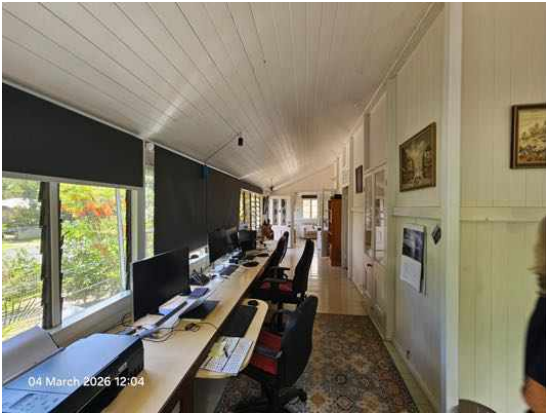
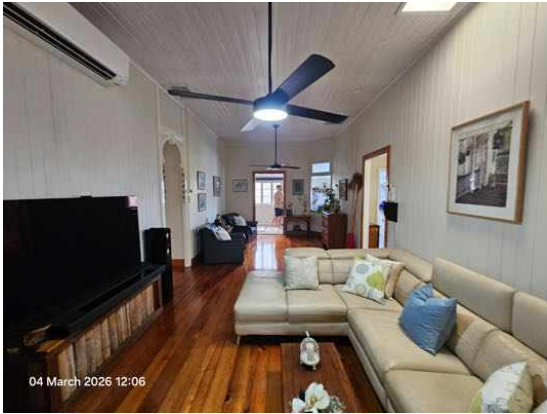
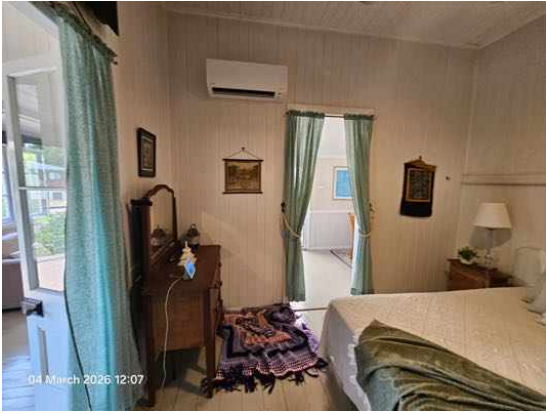
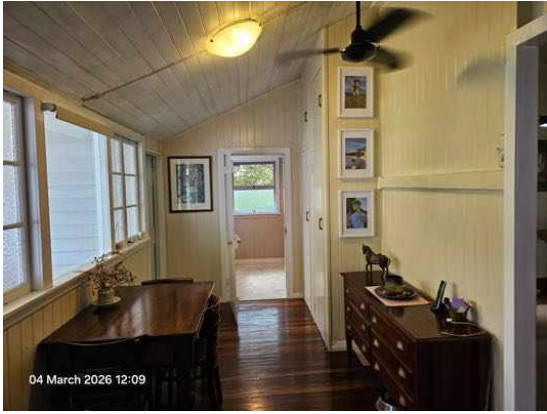
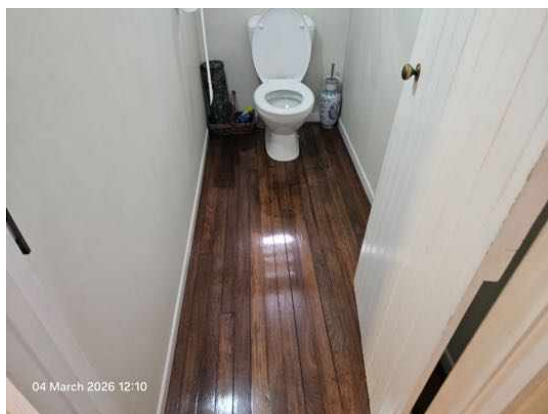
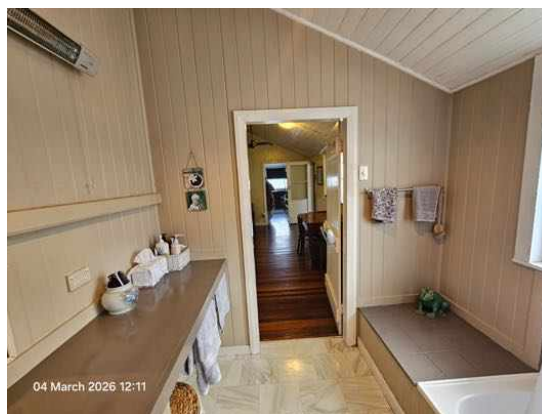
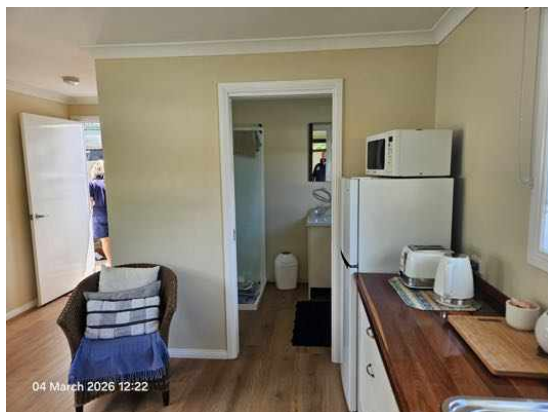
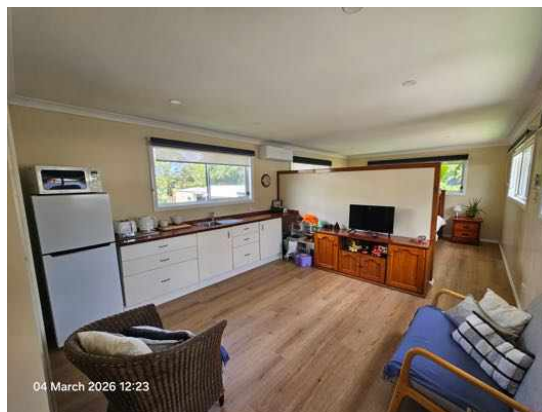
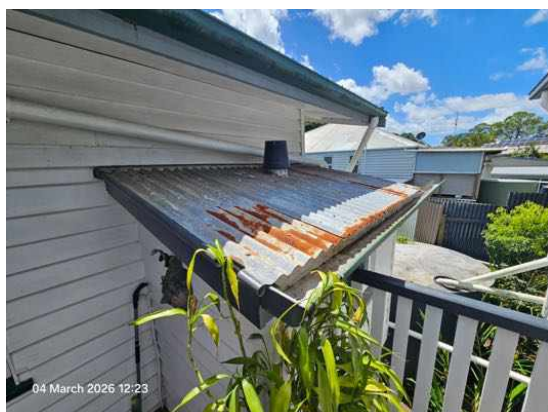
Building: Main Building
Location: All Areas
Finding: Additional Photos for client reference
Information: Additional photos are provided for your general reference.

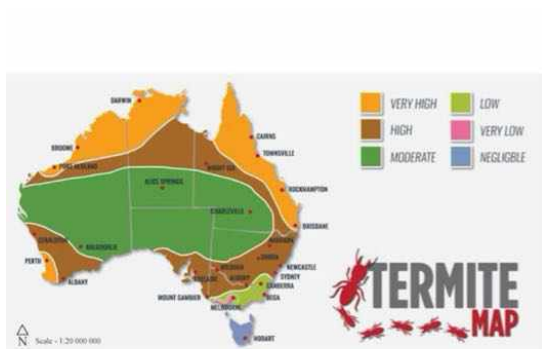
Building: Main Building
 Location: Meter box, kitchen cupboard
 Finding: Durable pest inspection notice - not assessable
 Information: On the day of inspection it was noted that the durable timber pest inspection / treatment notice was missing, not visible or out of date. These notices / stickers are to verify the timber pest inspection dates, the inspector, the currency and type of timber pest system / barrier in place or being used in and around the property.

Annual, or more regular, inspections are crucial in maintaining and managing the properties timber pest risk profile. By not having regular inspections of the property raises the properties risk of undetected defects and damage. Without regular inspection at intervals of not greater than annually the buildings risk profile will categorised as high. Properties with trees within 50m and with gardens close to the building are at greater risk and will have a high risk profile.

It is recommend that a licensed timber pest controller be contacted to assess the properties needs and provide costings for an annual inspection programme.
