Building and Timber Pest Inspection Report

Inspection Date: Fri, 13 Feb 2026

Property Address: 34 Foam St, Elwood VIC 3184, Australia

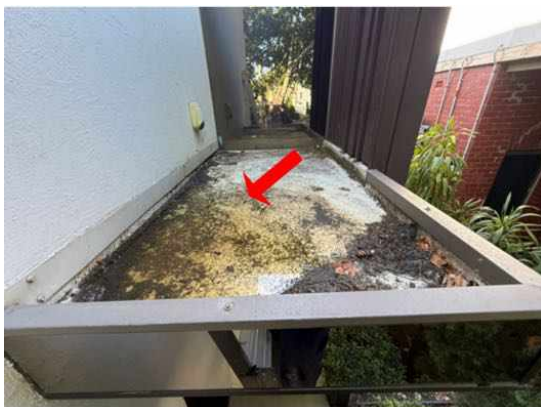
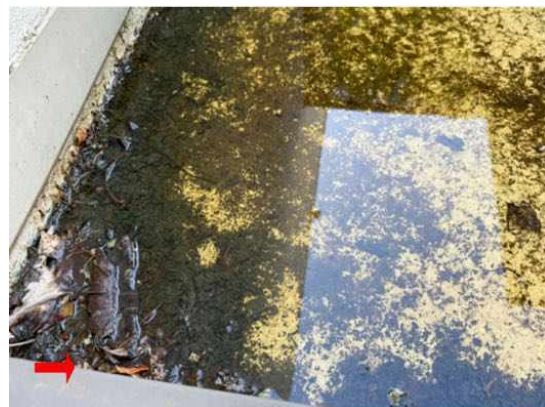
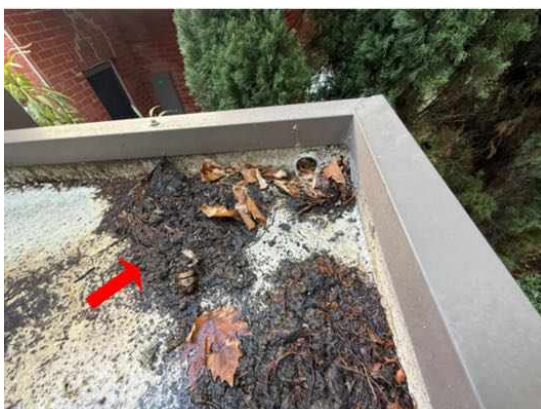
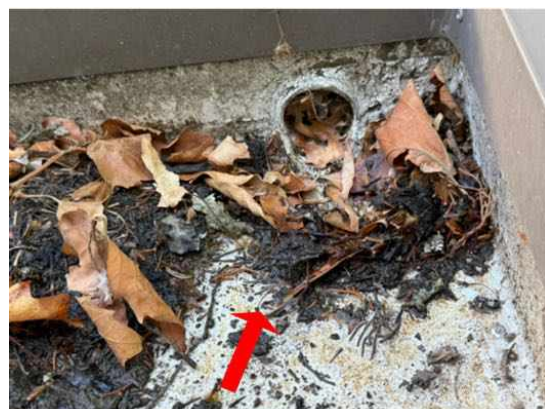
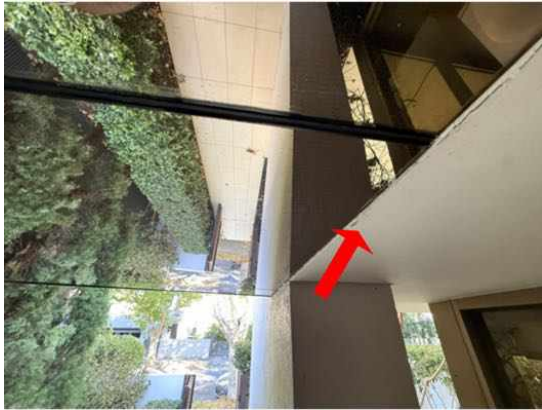
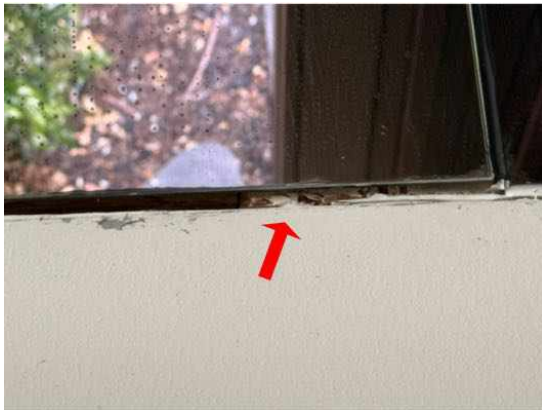
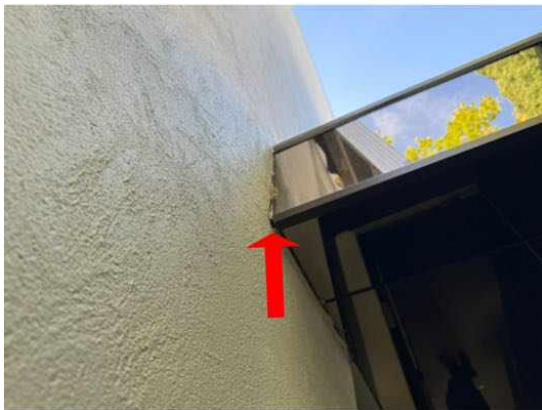
Building:	Main Building
Location:	Roof Exterior
Finding:	Loose Glass Mirror Ceiling Panel
Information:	A glass mirror ceiling panel has dropped and is inadequately supported due to deterioration of the silicone adhesive, caused by prolonged water ingress.

The porch roof above falls toward the building, allowing water to pool, with tree debris observed blocking the drain outlet, resulting in ongoing moisture exposure. This condition has compromised the fixing system and presents a risk of the panel further loosening or detaching and falling, creating a safety hazard to occupants below.

A Licensed Builder, Roof Plumber & Glazier should be engaged immediately to clear the roof drainage, rectify falls where required, address the source of water ingress, and securely refix or replace the affected panel using appropriate mechanical fixings and moisture-resistant materials.

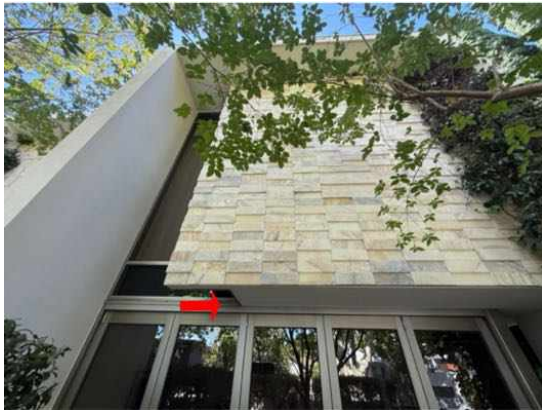
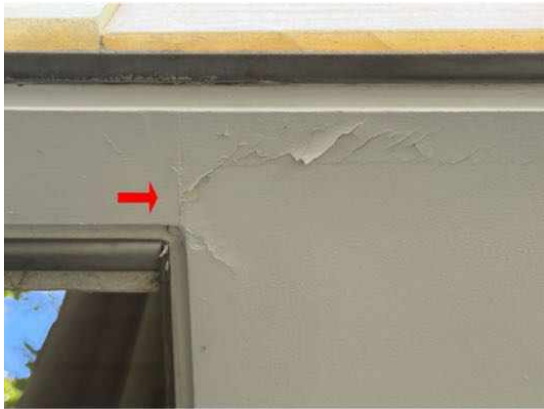
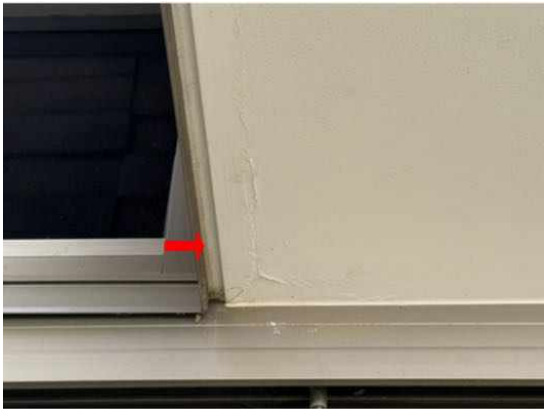
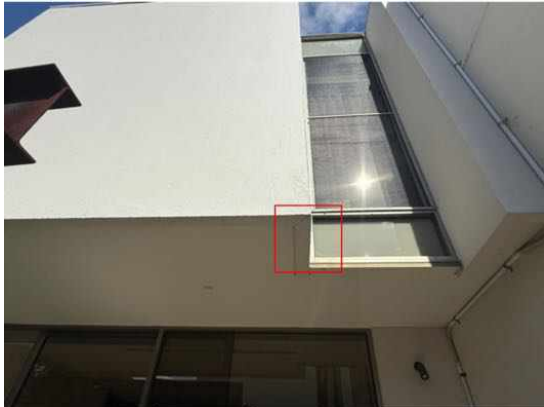
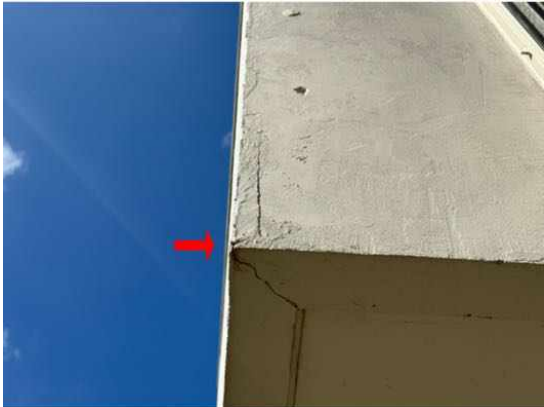
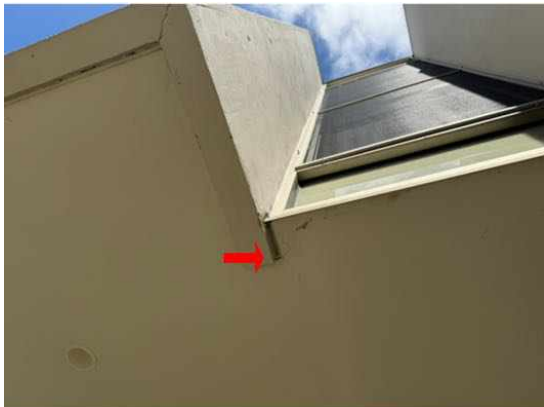
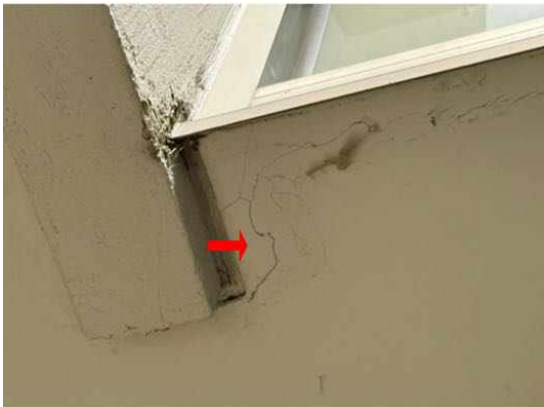
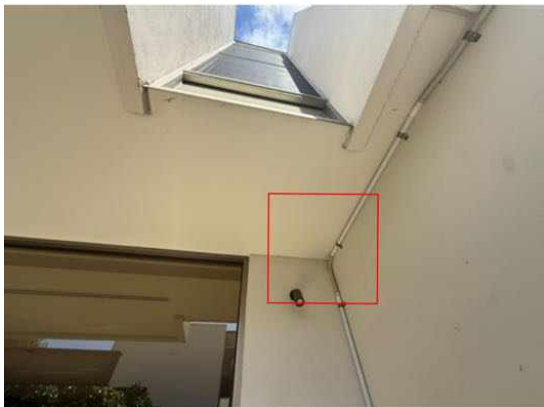
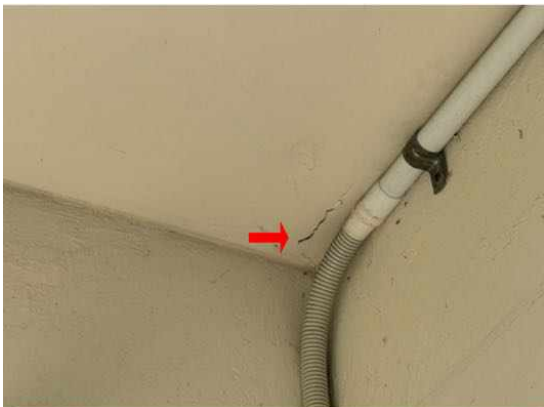
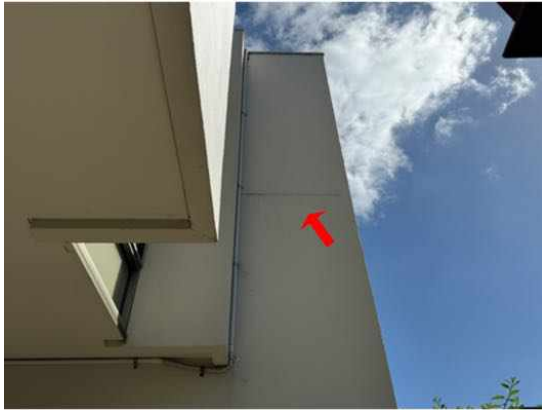
Building: Main Building
Location: Yard - Front & rear
Finding: Cracking Exterior Render - Damage Category 0 - Hairline (less than 1mm)
Information: At the time of inspection cracking in the render at the front and rear of the house, was noticed.

Hairline cracks are very minor in nature and generally are only ever an appearance defect.

While such cracking may be noticeable in some cases, it is quite common and does not indicate any structural damage.

Cracking of this nature can generally be repaired with minor filling and/or repainting. Such works should be performed by a qualified painter or a general handyman.

Monitoring of all cracking should be conducted frequently. Always contact a building inspector should cracks widen, lengthen, or become more numerous.

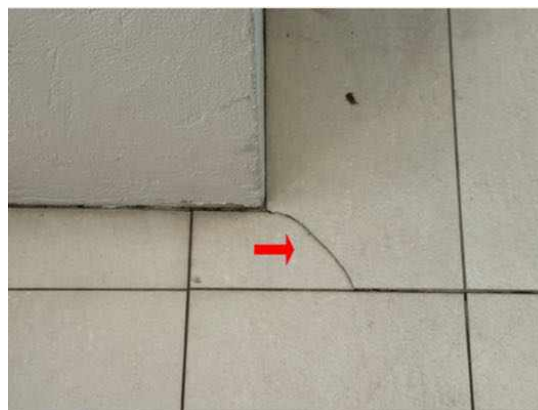
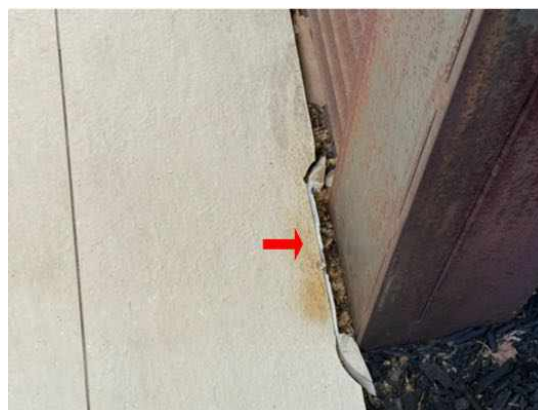
Finding 3.02

Building:	Main Building
Location:	Yard - Back
Finding:	Cracked floor tiles
Information:	Cracking in the floor tiles was evident to the back patio area and front footpath at the time of inspection. It is suspected that this cracking has occurred as a result of minor settlement or shrinkage of the slab.

Cracked tiles throughout the household detract from the overall appearance of the affected areas however it is unlikely to create or lead to any secondary defects.

While not considered a matter of urgency, replacement of cracked floor tiles is recommended at the clients discretion. A tiling contractor may be appointed to perform these works. Where cracks become more numerous, contact a licensed building inspector for further investigation.

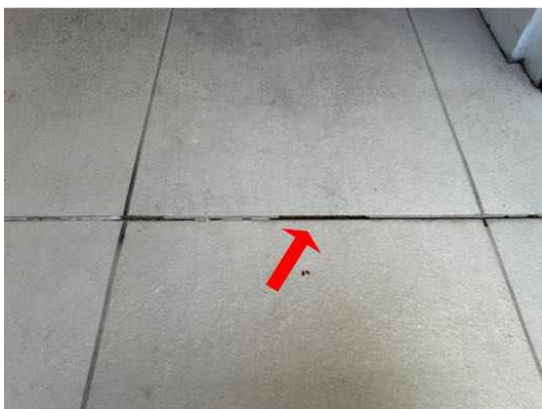
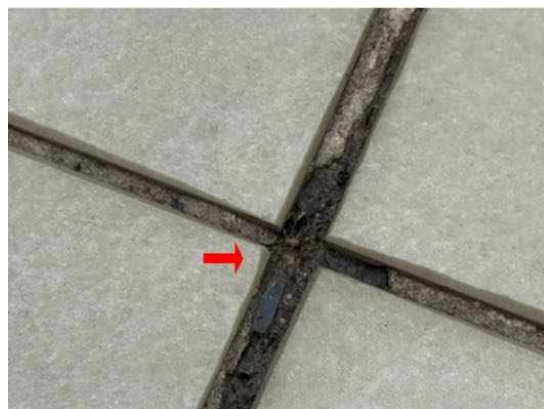
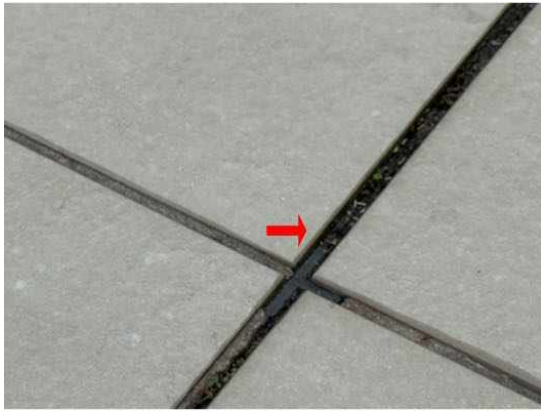
Building: Main Building
 Location: Pool Area
 Finding: Sealant and grouting - Missing or damaged
 Information: It was noted on inspection that sealant or grout is degraded to the tiled area around the pool area.

Different materials and floor areas move at different rates, generally causing cracking

There appears to be excessive mould to the sealant and grout which will likely require scraping out and replacement.

Flexible and mould resistant materials should be applied to affected areas to prevent any subsequent water damage that is likely to occur. Regular maintenance and replacement of damage or missing or damaged sealant and grout is highly recommended to the wet areas, as this is a regular wear and tear defect. Sealant and grouting in areas that come into regular contact with water should be maintained for the long term care of your property.

A sealant specialist or tiling contractor should be appointed to complete these works as soon as possible

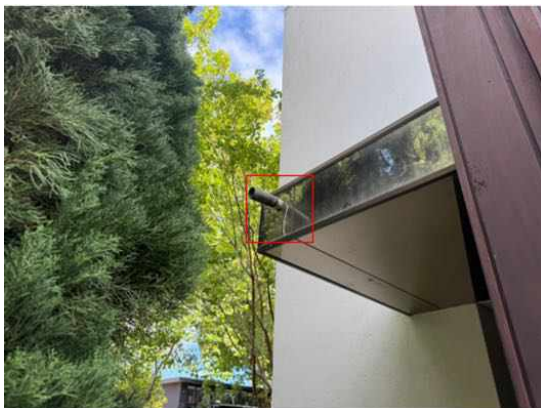
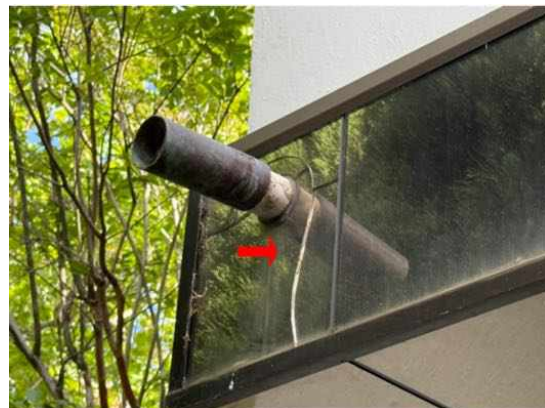
Finding 3.05

Building:	Main Building
Location:	Porch
Finding:	Window - Cracked
Information:	Cracks were identified in the window above the porch entry. Cracking in windows is generally the result of impact damage, and is likely to develop further when left unmanaged.

The likelihood of this window pane further cracking and shattering is increased exponentially, providing a safety hazard in the area. The cracked window also impairs the weather tightness of the building, creating potential for minor water leaks.

A qualified glazier is required to repair the window as soon as possible. Depending on the extent of the cracking, replacement of the window may be required. Please be advised that any persons coming into contact with the cracked window should do so with due caution to avoid any personal injury that may ensue.

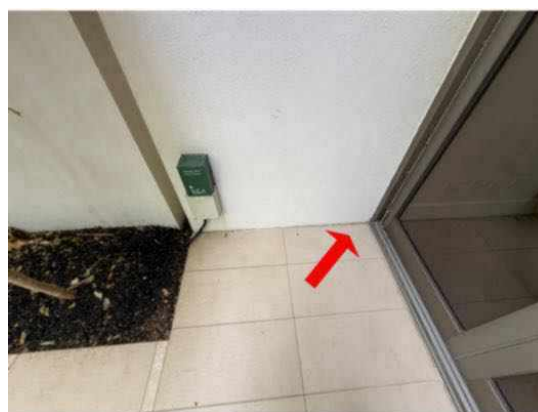
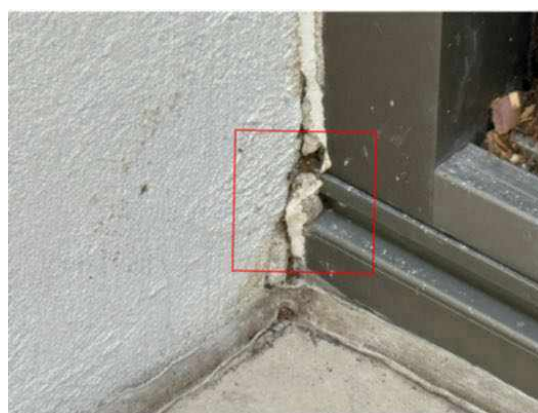
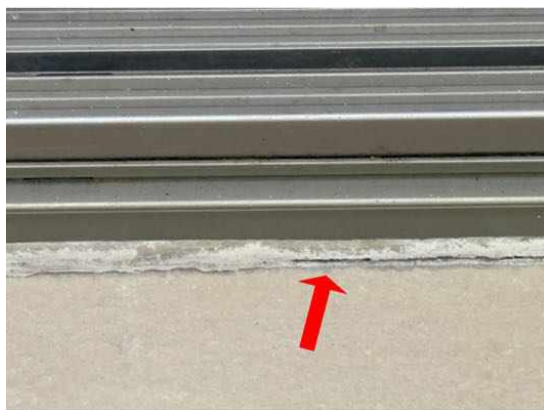
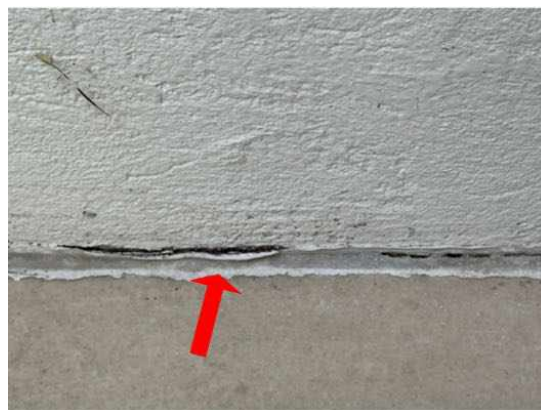
Finding 3.06

Building:	Main Building
Location:	Yard - Front
Finding:	Silicone Missing - Around sliding door Window

Information: It was noted on inspection that silicone sealant was missing to the surrounds of the sliding door window.

This is due to a lack of proper maintenance. Missing sealant around window allows for water egress, pests such as spiders and other insects, increased air flow resulting in a drop in the internal thermal rating.

Flexible, UV and mould resistant materials should be applied to affected areas to prevent any subsequent water damage that is likely to occur. Regular maintenance and replacement of damage or missing or damaged sealant and grout is highly recommended to the wet areas, as this is a regular wear and tear defect. Sealant and grouting in areas that come into regular contact with water should be maintained for the long term care of your property.

A sealant specialist or tiling contractor should be appointed to complete these works immediately. As a minor sealant problem, if left unchecked, can become a major problem.

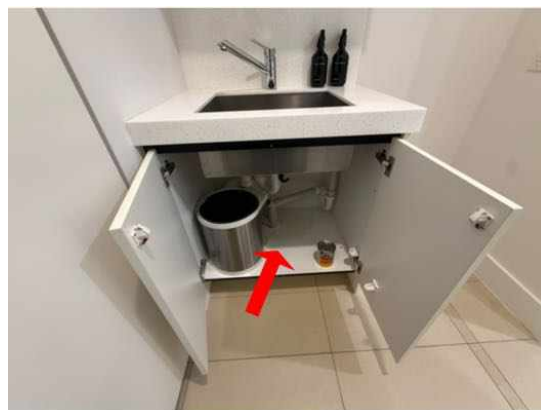
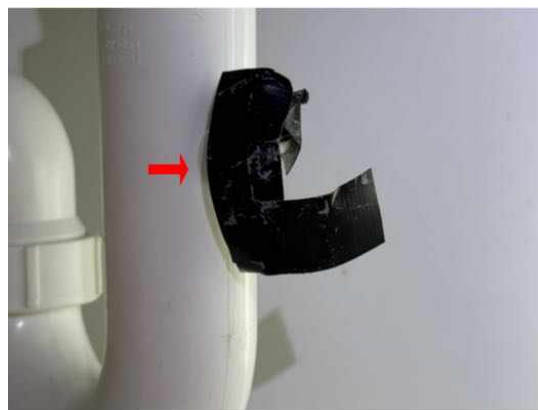
Finding 3.07

Finding: Water staining

Information: Water staining was evident in the laundry cupboard at the time of inspection. Water staining indicates that surfaces have been exposed to excessive moisture over time. The minerals and other elements in the water lead to staining, which may graduate to corrosion and deterioration if left unmanaged.

While mostly an appearance defect, water staining can be indicative of more serious defects, which may be currently concealed by other building elements.

Where water staining is active, a licensed plumber must be consulted to identify the cause of the staining and to provide advice on any reparation works that may be required. Replacement of any broken or damaged structures is advised.

Conversely, where water staining is old and inactive, affected building materials may be repaired or replaced at client discretion. A qualified carpenter or registered builder may be appointed to perform these works.

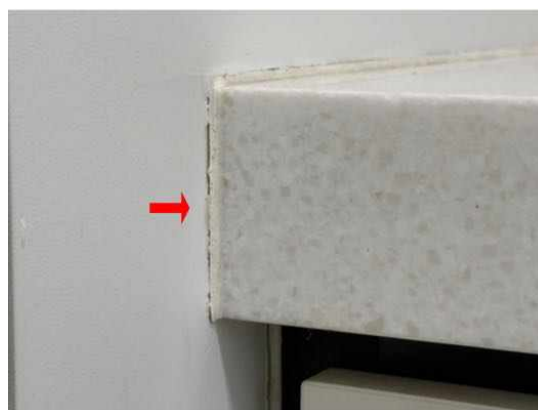
Finding 3.08

Finding: Silicone Deteriorated - laundry

Information: The silicone sealant to the perimeter of the laundry cupboard was observed to be deteriorated, split, and partially missing in sections. Gaps were noted between the basin, wall tiles, and benchtop/wall junctions, indicating loss of effective waterproof sealing.

Failed or deteriorated silicone sealant allows water to penetrate behind finishes during normal use. Over time, this may result in moisture damage to wall linings, cabinetry, or benchtop substrates, and can contribute to mould growth and hygiene concerns within the amenities area.

It is recommended that all deteriorated silicone sealant be removed and replaced with a suitable sanitary-grade waterproof silicone by a plumber or sealant specialist. Works should be carried out immediately, to all basin junctions to reinstate effective waterproofing and maintain hygiene standards.

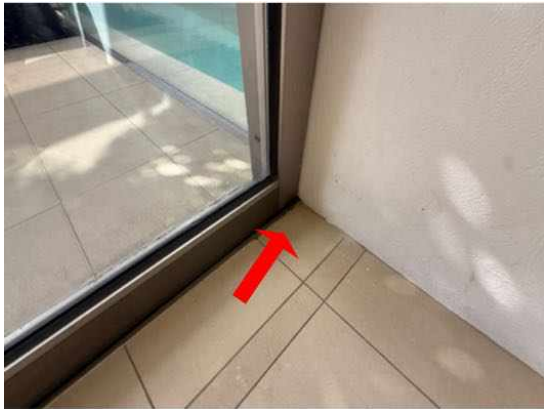
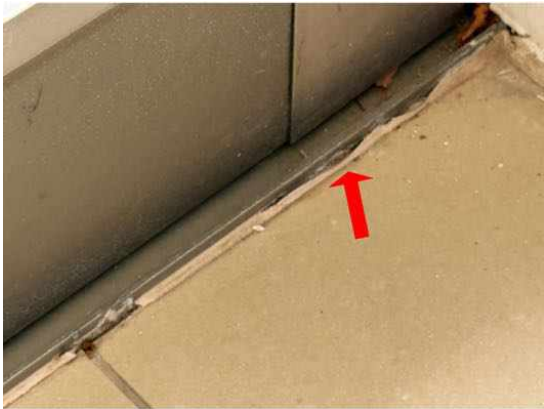
Finding 3.09

Building:	Main Building
Location:	Lounge Room
Finding:	Silicone Missing - Around Windows
Information:	It was noted on inspection that silicone sealant was missing to the surrounds of all the timber windows interior.

This is due to a lack of proper maintenance. Missing sealant around window allows for water egress, pests such as spiders and other insects, increased air flow resulting in a drop in the internal thermal rating.

Flexible, UV and mould resistant materials should be applied to affected areas to prevent any subsequent water damage that is likely to occur. Regular maintenance and replacement of damage or missing or damaged sealant and grout is highly recommended to the wet areas, as this is a regular wear and tear defect. Sealant and grouting in areas that come into regular contact with water should be maintained for the long term care of your property.

A sealant specialist or tiling contractor should be appointed to complete these works immediately. As a minor sealant problem, if left unchecked, can become a major problem.

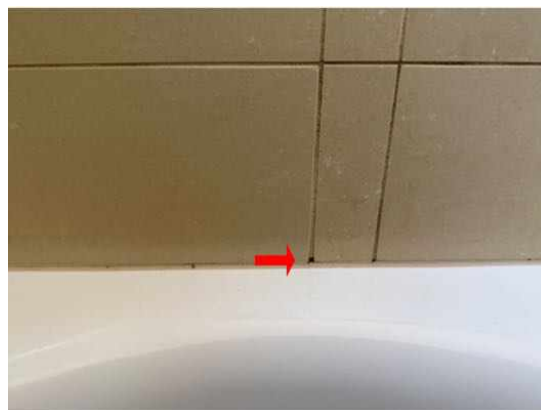
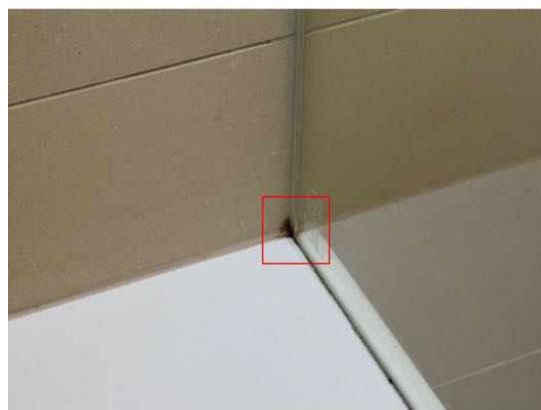
Finding 3.10

Building:	Main Building
Location:	Bathroom
Finding:	Sealant and grouting - Mouldy & Deteriorated
Information:	It was noted on inspection that sealant and grout is degraded and mouldy in the main bathroom shower recess.

When this happens the chances for water penetration of the substrate and timber elements behind the tile wall increases. Once this occurs, it creates a conducive conditions for timber pest attack.

Flexible and mould resistant materials should be applied to affected areas to prevent any subsequent water damage that is likely to occur. Regular maintenance and replacement of damage, missing or damaged sealant and grout is highly recommended to the wet areas, as this is a regular wear and tear defect. Sealant and grouting in areas that come into regular contact with water should be maintained for the long term care of your property.

A licensed plumber, sealant specialist or tiling contractor should be appointed to complete these works immediately.

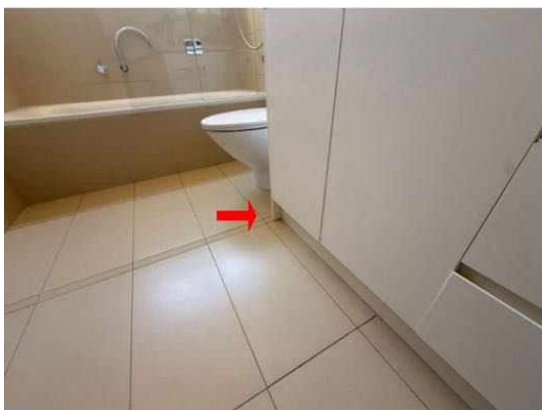
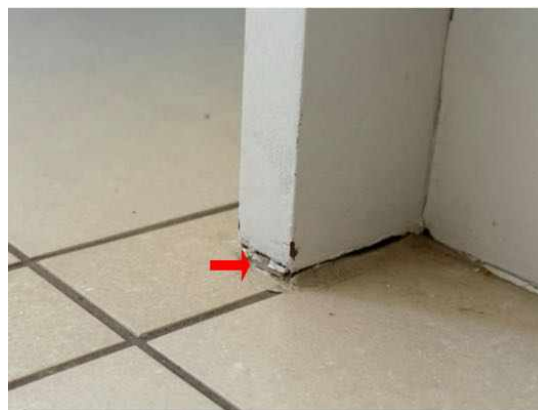
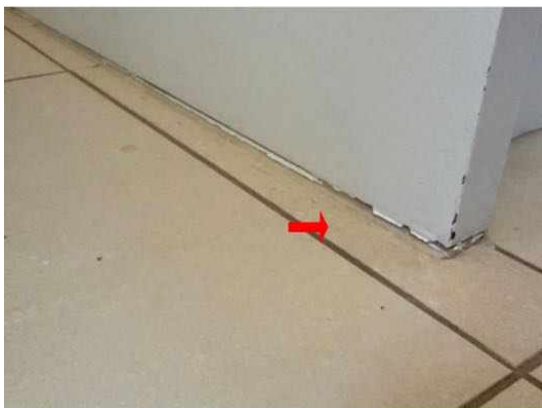
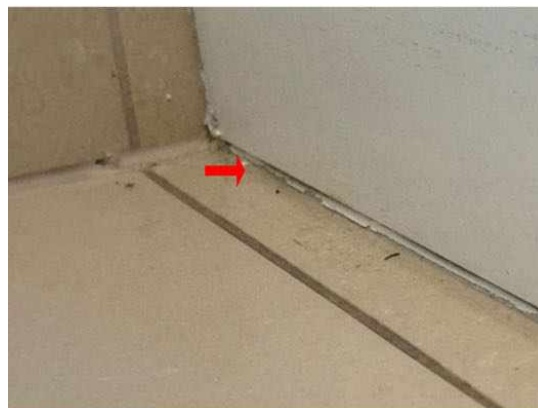
Building:	Main Building
Location:	Bathroom
Finding:	Silicone Deteriorated
Information:	The silicone sealant to the base of the vanity was observed to be deteriorated, split, and partially missing in sections. Gaps were noted between the cupboard and the floor tiles, indicating loss of effective waterproof sealing.

Failed or deteriorated silicone sealant allows water to penetrate behind finishes during normal use. Over time, this may result in moisture damage to the cabinetry, or flooring can contribute to mould growth and hygiene concerns within the amenities area.

It is recommended that all deteriorated silicone sealant be removed and replaced with a suitable sanitary-grade waterproof silicone by a plumber or sealant specialist. Works should be carried out immediately, to all areas to reinstate effective waterproofing and maintain hygiene standards.

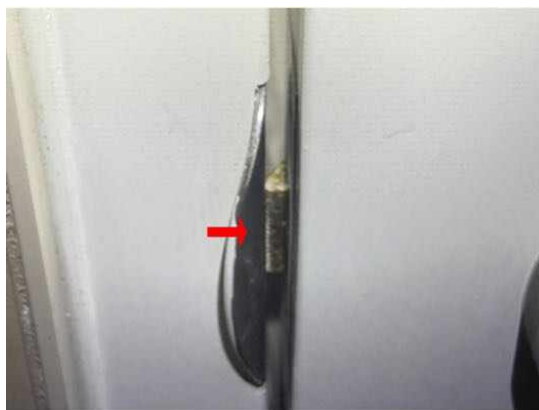
Finding 3.12

Building:	Main Building
Location:	Bathroom
Finding:	Door handle - Not latching
Information:	It was noted that the door in the bathroom was not latching during operation at the time of inspection. Whilst detracting from the functionality of this building element, this minor defect.

It is suspected that this defect has occurred due to minor issues with the associated hinges. Such damage is identified as general wear and tear, which is expected for building elements of this age.

A qualified carpenter or general handyperson may be appointed to perform rectification works as necessary, at client discretion. If left unattended, further functional impairment is likely to occur.

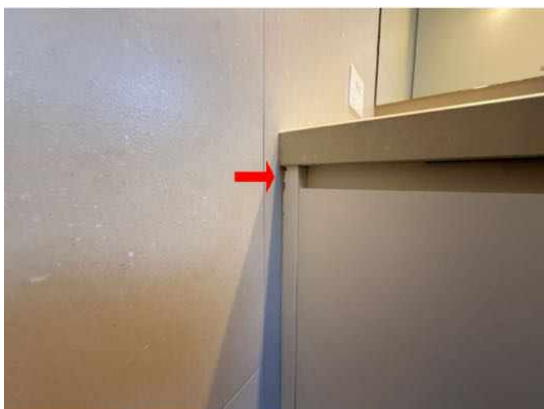
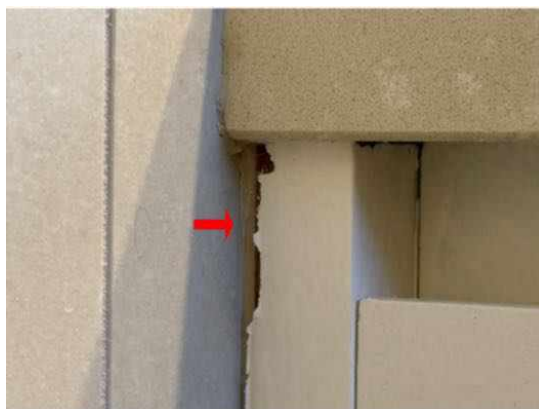
Finding 3.13

Building: Main Building
 Location: Ensuite
 Finding: Paint finish - deteriorated
 Information: The paint finish to the ensuite cupboard was identified as being deteriorated at the time of inspection.

Whilst incomplete or missing paint finish is generally an appearance defect, it can also lead to the development of secondary building defects over time. Incomplete areas of paint finish expose the area to moisture, potentially accelerating the deterioration of underlying building materials.

Incomplete paint finishes should be sanded back, filled, leveled and painted, as applicable. Where inadequate or missing paint protection has led to the deterioration of the associated building element, repair and/or replacement of this building element may be required.

A painting contractor or general handyman should be appointed as soon as possible to perform necessary works to aid the appearance of the affected area and to ensure the area is protected against further deterioration. Alternatively, the homeowner following manufacturer instructions may perform these works.

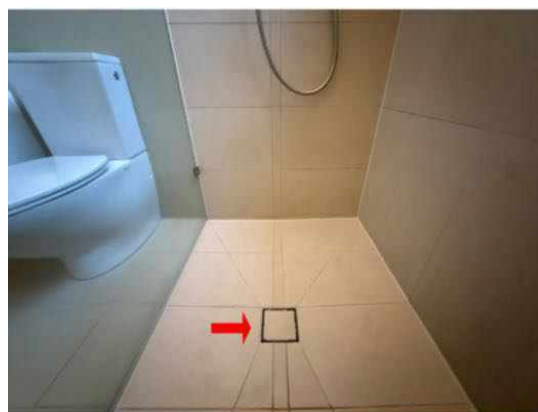
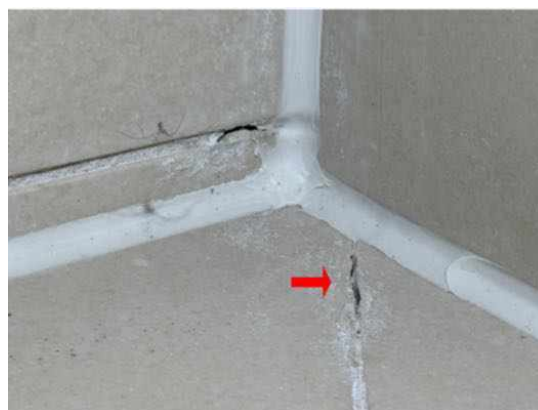
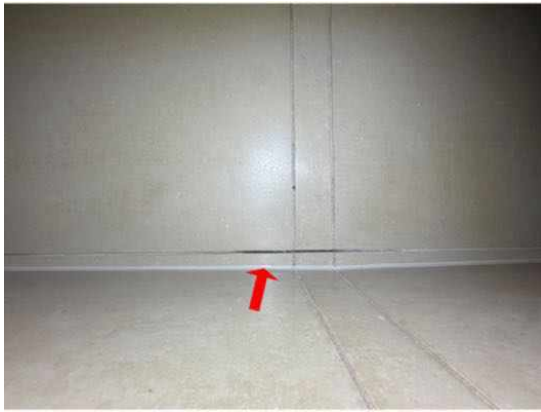
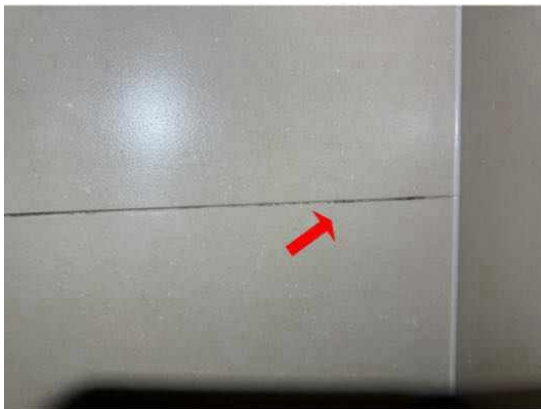
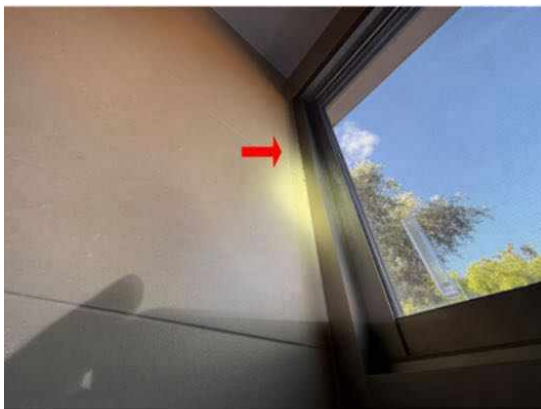
Finding 3.14

Building: Main Building
Location: Ensuite
Finding: Sealant and grouting - Missing or damaged
Information: It was noted on inspection that sealant or grout is degraded to the tiled shower alcove and or other areas of the ensuite.

Different materials and floor areas move at different rates, generally causing cracking to grout or sealant at this point. A flexible sealant is required to allow for expected expansion and contraction, while keeping the joint water tight and protective of all associated building materials.

There appears to be excessive mould to the sealant and grout which will likely require scraping out and replacement.

Flexible and mould resistant materials should be applied to affected areas to prevent any subsequent water damage that is likely to occur. Regular maintenance and replacement of damage or missing or damaged sealant and grout is highly recommended to the wet areas, as this is a regular wear and tear defect. Sealant and grouting in areas that come into regular contact with water should be maintained for the long term care of your property.

A sealant specialist or tiling contractor should be appointed to complete these works as soon as possible

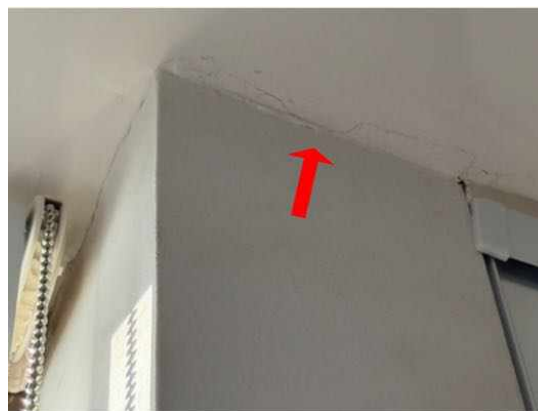
Finding 3.15

Building:	Main Building
Location:	Built In Robe
Finding:	Cracking - Damage Category 1 - Fine (up to 1mm)
Information:	Although fine cracks are quite noticeable, they are often only considered to be an appearance defect, and usually do not indicate any structural damage. Generally, the cause of a fine crack is indicative of a separation between building materials and finishes (e.g. paint, plaster, etc.) along joins.

Cracking of this nature can generally be repaired with minor sanding, filling and/or repainting. Such works should be performed by a qualified painter or a general

handyman.

Monitoring of all cracking should be conducted frequently. Always contact a building inspector should cracks widen, lengthen, or become more numerous.

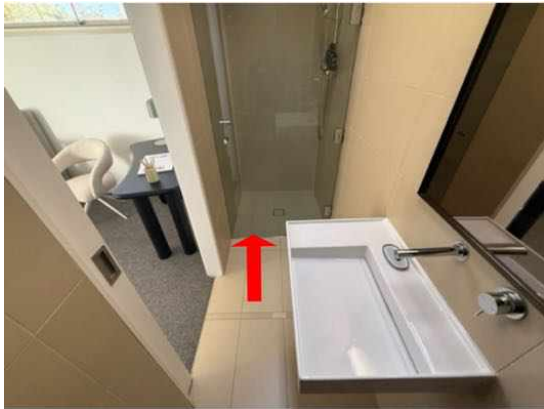
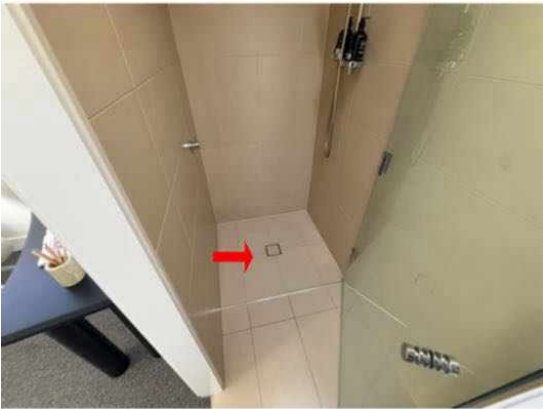
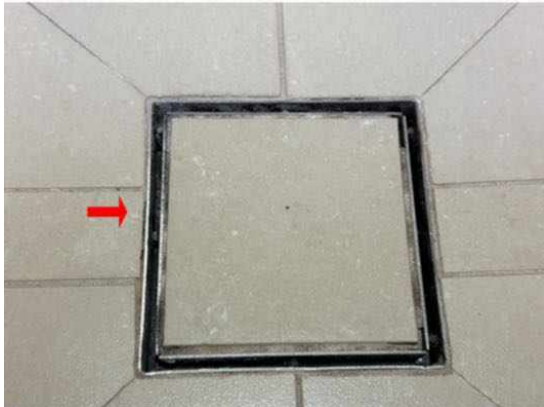
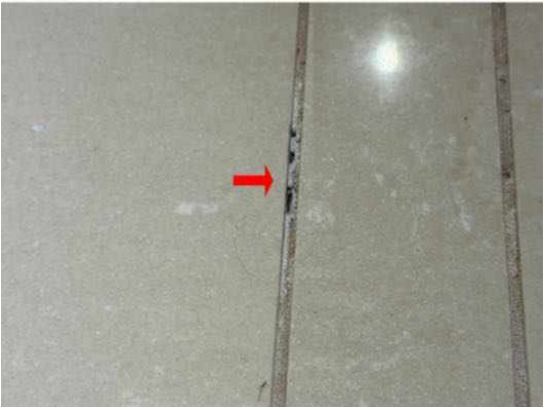
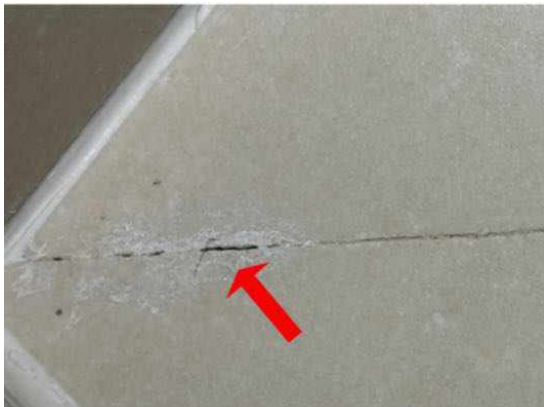
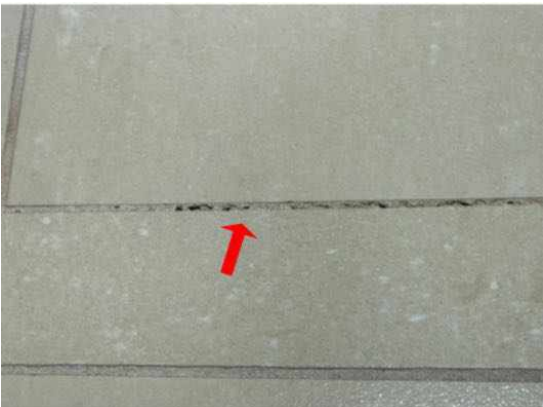
Finding 3.16

Building:	Main Building
Location:	Garage Ensuite
Finding:	Sealant and grouting - Missing or damaged
Information:	It was noted on inspection that sealant or grout is degraded to the tiled shower alcove and or other areas of the ensuite.

Different materials and floor areas move at different rates, generally causing cracking to grout or sealant at this point. A flexible sealant is required to allow for expected expansion and contraction, while keeping the joint water tight and protective of all associated building materials.

There appears to be excessive mould to the sealant and grout which will likely require scraping out and replacement.

Flexible and mould resistant materials should be applied to affected areas to prevent any subsequent water damage that is likely to occur. Regular maintenance and replacement of damage or missing or damaged sealant and grout is highly recommended to the wet areas, as this is a regular wear and tear defect. Sealant and grouting in areas that come into regular contact with water should be maintained for the long term care of your property.

A sealant specialist or tiling contractor should be appointed to complete these works as soon as possible

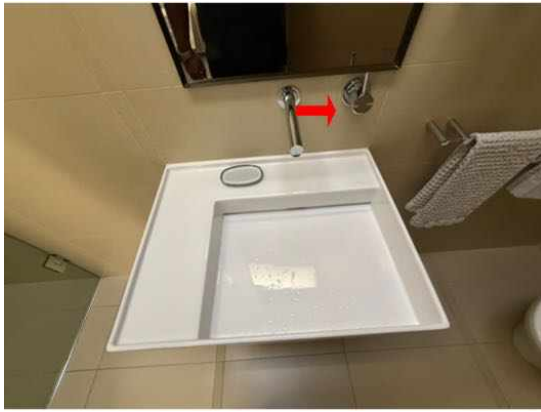
Finding 3.17

Building: Main Building
Location: Garage Ensuite
Finding: Tap - Loose
Information: The tap in this area has not been installed correctly, or has deteriorated with age, and is consequently loose and come off. This tap being loose creates potential for water leaks and subsequent water damage to the surrounding area.

Where taps or spouts are loose, a qualified plumber should be appointed to re-fix the plumbing fitting.

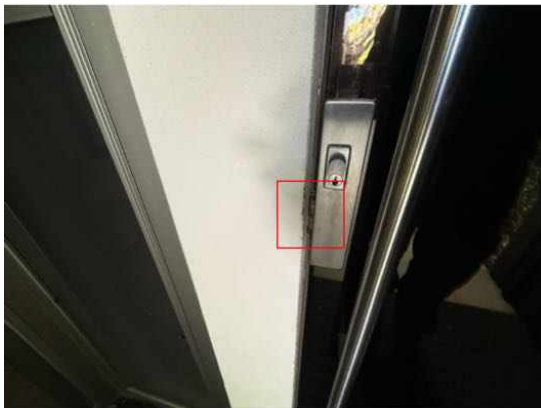
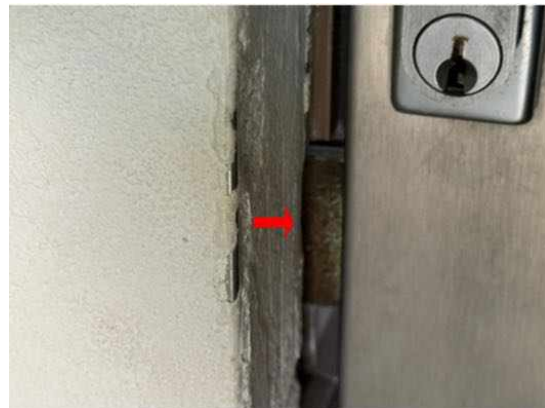
Finding 3.18

Building: Main Building
 Location: Yard - Front
 Finding: Front Entry Door Lock Latch Exposed
 Information: The front entry door lock latch and strike area are exposed due to an excessive gap between the door and frame, allowing access to the latch mechanism when the door is closed.

This condition increases the potential for unauthorised access by shimming or slipping the latch, reducing the overall security performance of the door.

While the lock is currently functional, a qualified locksmith or carpenter should be engaged to adjust the door alignment and/or install an appropriate strike plate or latch guard to fully conceal the latch and restore effective security immediately.

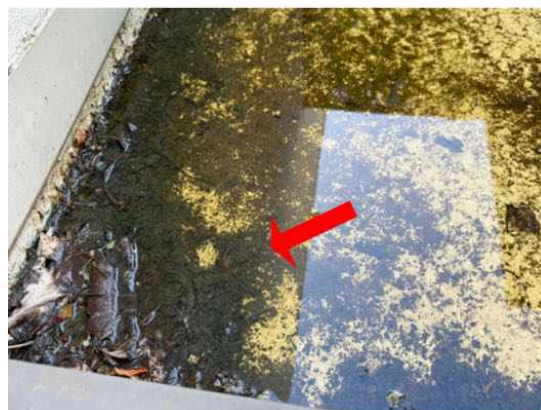
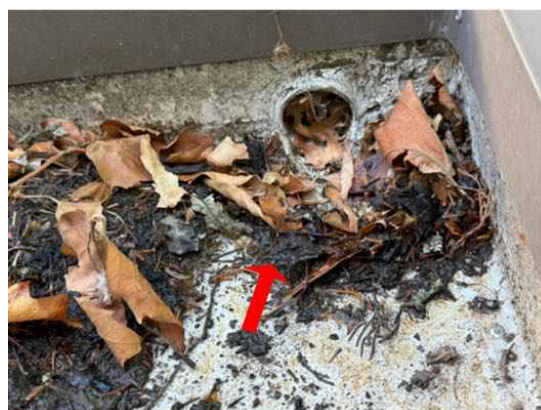
Finding 3.19

Building: Main Building
 Location: Roof Exterior
 Finding: Gutters - Blocked
 Information: Roof plumbing structures, such as guttering and downpipes, should be free of all debris to prevent blockages. Blockages of the guttering and downpipes will lead to

Blocked gutters are likely to lead to high levels of moisture in the affected areas. Such moisture will not only cause rust and decay of the associated building materials, but can also provide conditions that are conducive to termite and timber pest activity. Blockages in gutters should therefore be removed immediately to ensure dry conditions are maintained.

Consult a Licensed Plumber for further specific advice on remedial works that may be required. In the interim, it is highly advised that blocked gutters be removed by the homeowner or a general handyperson as a matter of urgency.

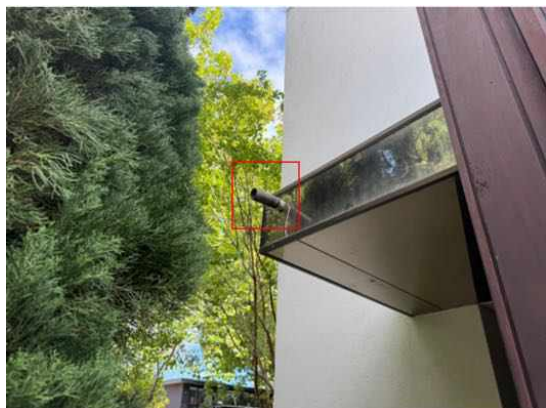
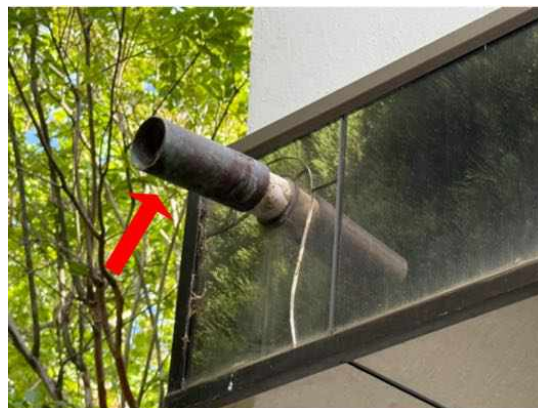
Finding 3.20

Building:	Main Building
Location:	Roof Exterior
Finding:	Stormwater drain - Not connected
Information:	The roof plumbing is not adequately connected to stormwater drainage on the site. This disconnection negatively impacts the functional capacity of the roof plumbing.

Where roof plumbing doesn't drain adequately, the area at the base perimeter can become excessively damp, potentially creating an environment that is susceptible to rust and corrosion of surrounding building elements, as well as attracting termites and other pests.

It is highly recommended that a plumber be appointed to further inspect the area and to install adequate drainage equipment where necessary.

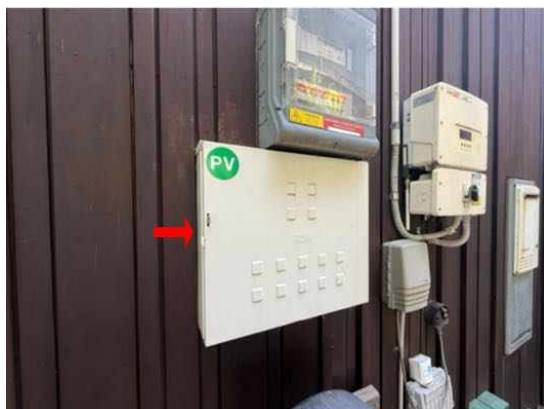
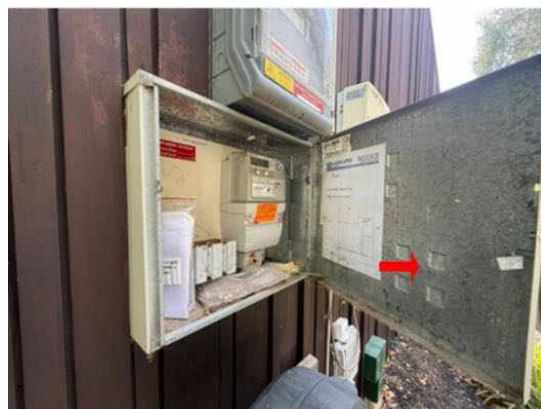
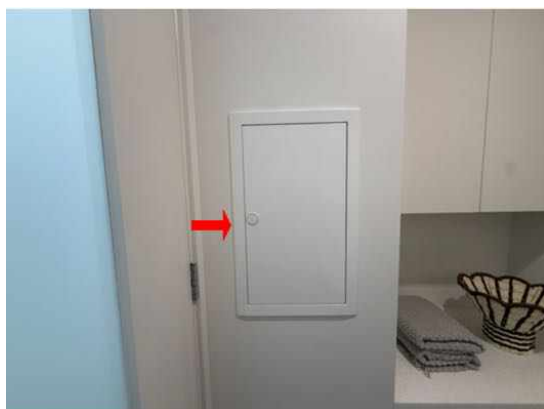
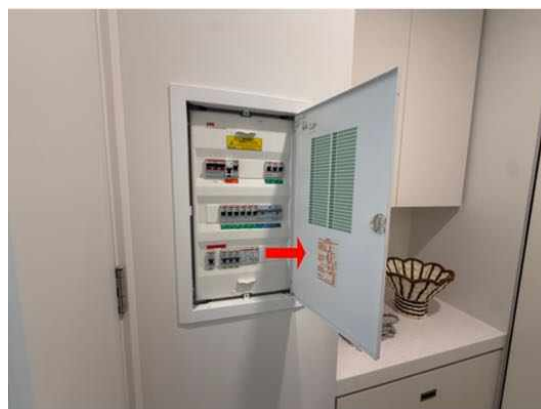
Building:	Main Building
Location:	Yard - Front
Finding:	Termite Management System - no evidence of a chemical installation
Information:	The application of a post-construction chemical termite barrier is highly recommended for all properties, particularly if live termite activity has been found on the site previously. Such barriers are highly effective in preventing termite attack on any timber building elements throughout the property.

A durable notice should be placed in the switchboard unit to indicate current termite barriers. At the time of inspection, it appeared as though no termite management system has been installed, with no evidence to suggest preventative works taking place.

The client may consider gaining further advice from a pest controller as to the costs and procedures involved with this application. It is recommended that obtaining such advice be a short-term priority.

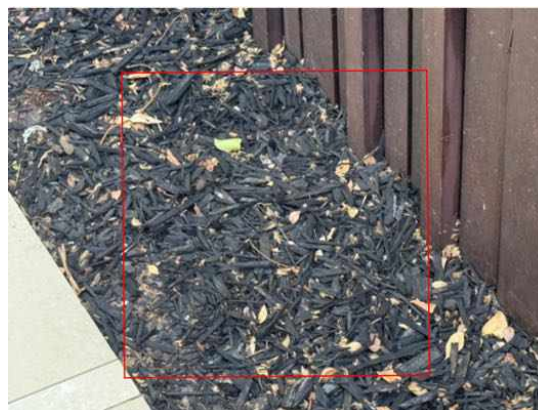
Finding 6.02

Building:	Main Building
Location:	All Areas
Finding:	Mulch - Garden Beds
Information:	Tan bark mulch has been used in garden beds surrounding the perimeter of the property. While commonly used for landscaping, this organic material retains moisture and provides a food source, thus creating conducive conditions for sub terranean termite activity.

A Reduction in mulch levels to no more than 50mm in depth, ensuring it is kept at least 75mm clear of slab edges, weep holes, and structural timbers is recommended. Consider replacing with non-organic ground cover in high-risk areas.

The property owner should consult a qualified landscaper urgently to rectify this condition.

A pest technician should reinspect periodically.

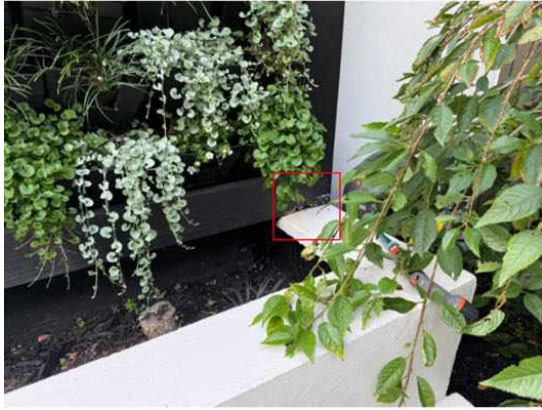
Finding 7.01

Building:	Main Building
Location:	Yard - Back
Finding:	Wood rot - External Garden Timbers
Information:	The external garden Timbers, are showing signs of wood rot.

Wood rot, also known as Fungal Decay, occurs when timbers and other cellulose building materials are exposed to damp conditions on an ongoing basis. This could be the result of exposure to weathering over a prolonged period of time, or the attraction of excessive moisture to the soil.

Wood rot is often associated with general damp problems and is evidenced by a 'musty' smell or mould and mildew occurring on surfaces. If left unmanaged, damp conditions can lead to further decay of the timbers and surrounding building elements.

The stage of decay to the external garden timbers and fence will require removal and replacement to rectify the issue.

A general handyman, carpenter or fencing contractor, may be required to perform these works at the owners discretion.

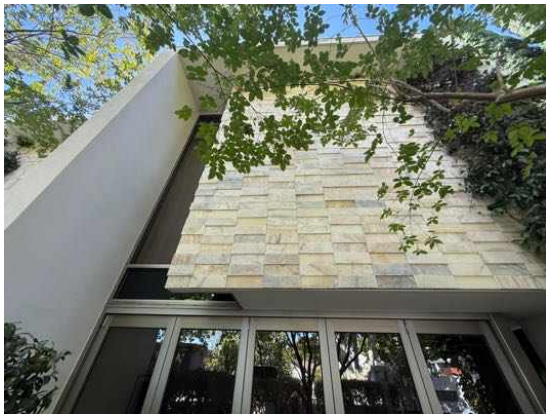
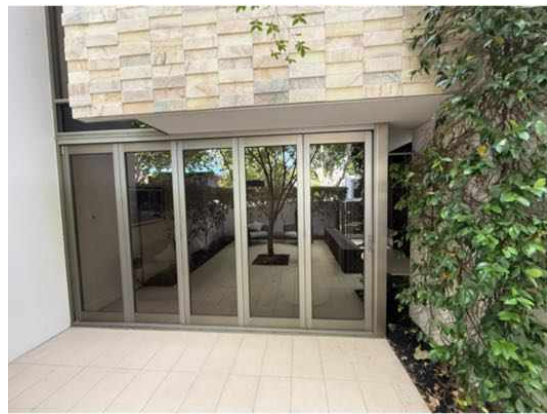
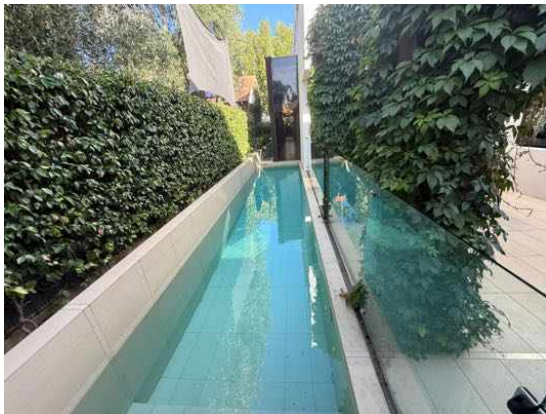
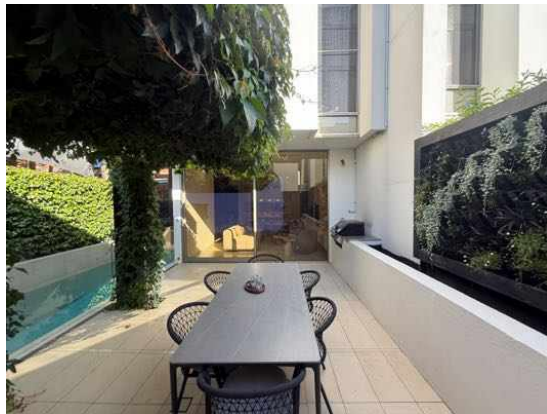
Building: Main Building
Location: All Areas
Finding: Additional Photos - Obstructions and Limitations
Information: These photographs are an indication of the obstructions and limitations which impeded full inspection of the property at the time of inspection. These obstructions can hide an array of defects and should be removed to allow full inspection to be carried out. A re-inspection is recommended once the areas are made accessible.
