Building and Timber Pest Inspection Report

Inspection Date: Fri, 13 Feb 2026

Property Address: 34 Foam St, Elwood VIC 3184, Australia

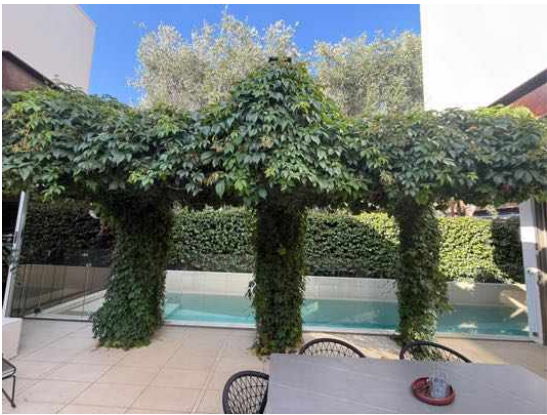
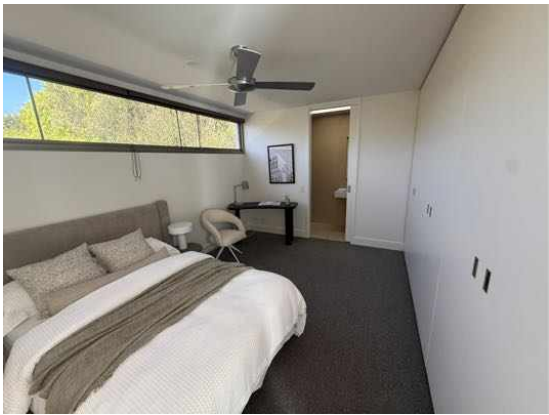
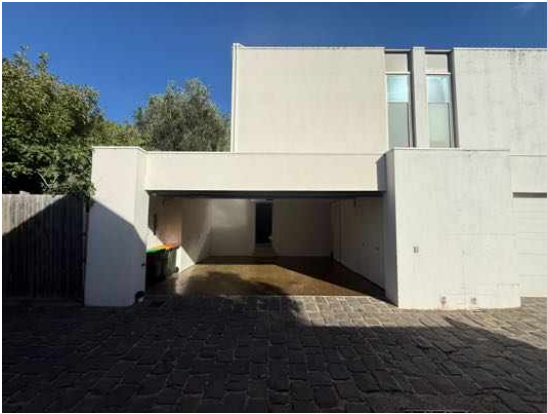
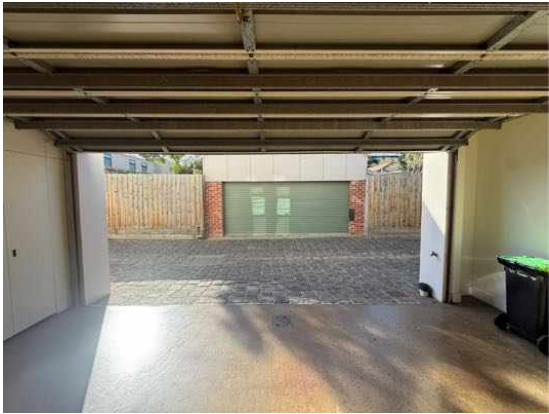
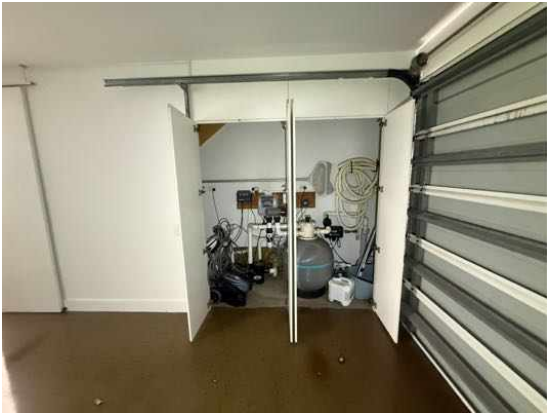
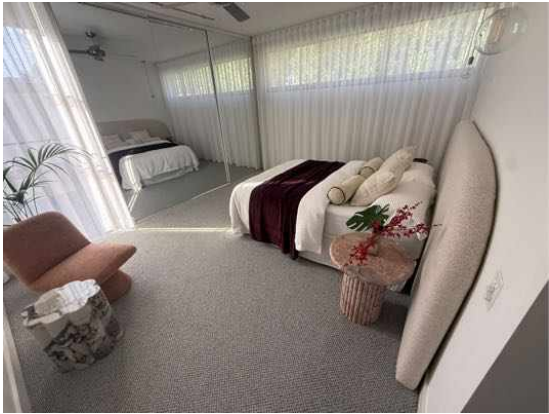
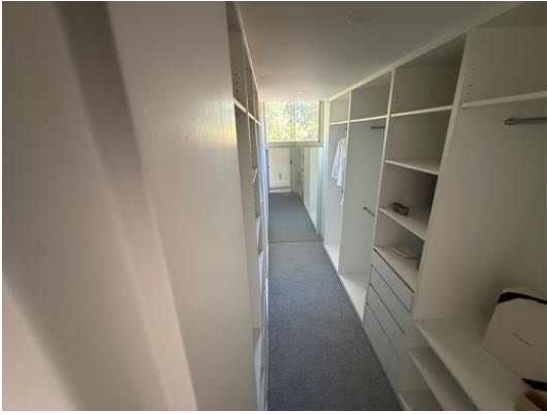
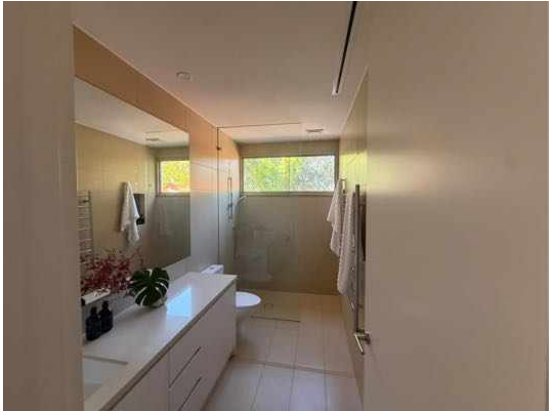
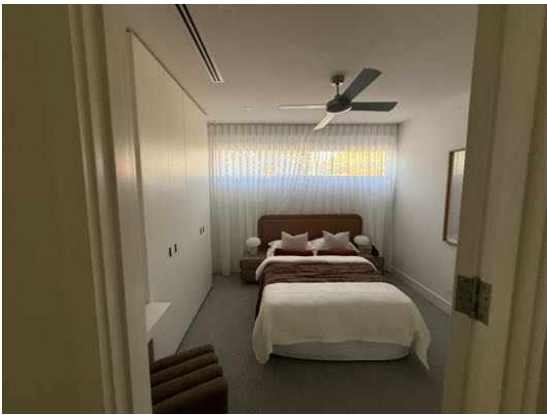
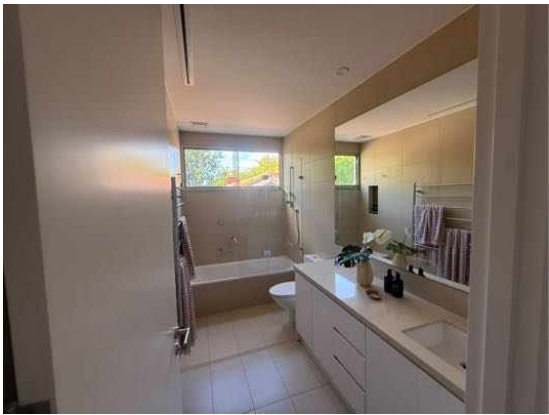
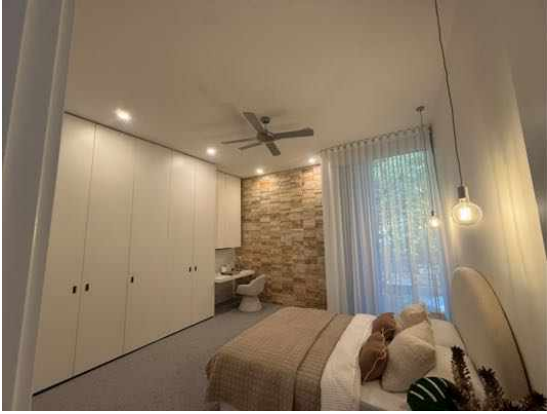
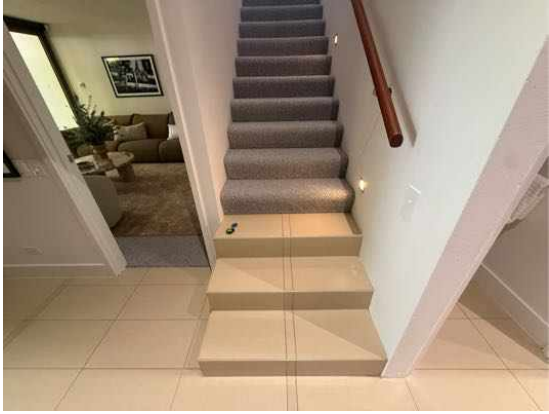
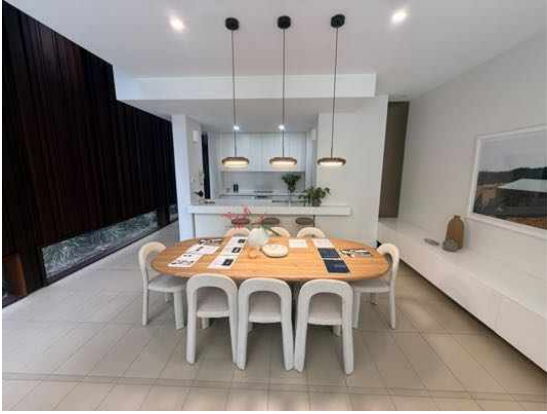
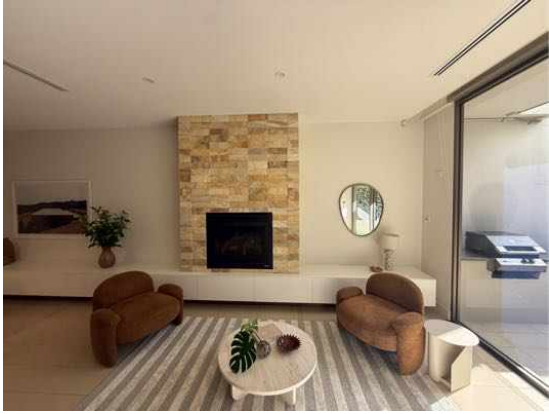
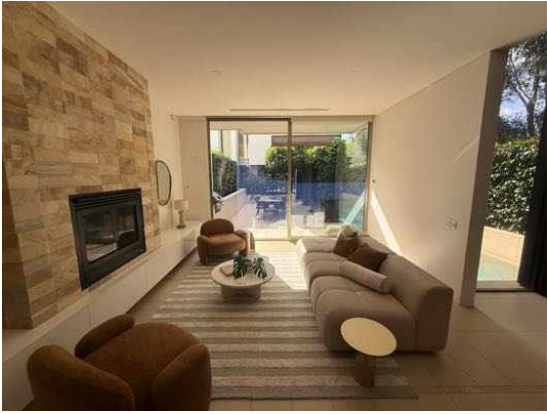
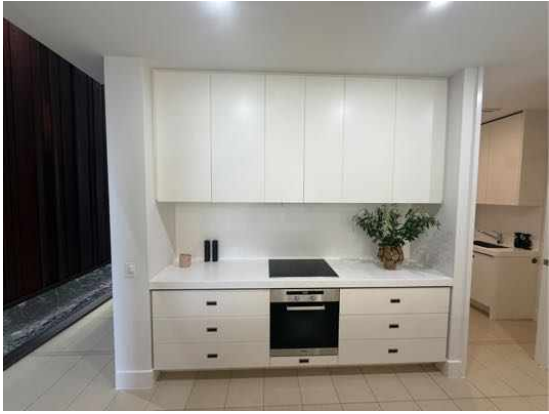
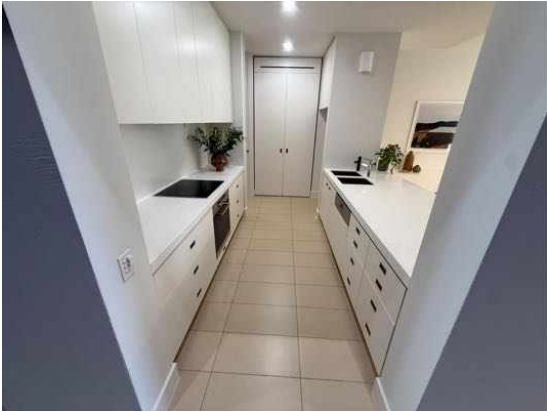
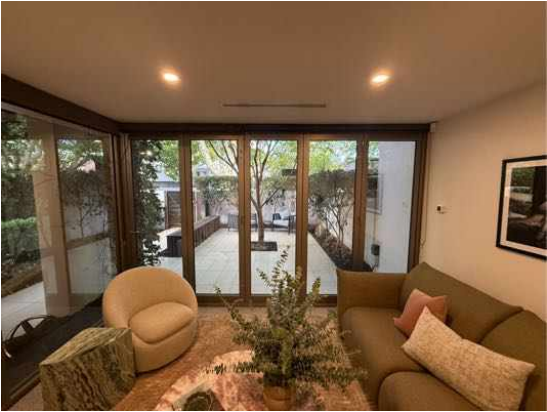
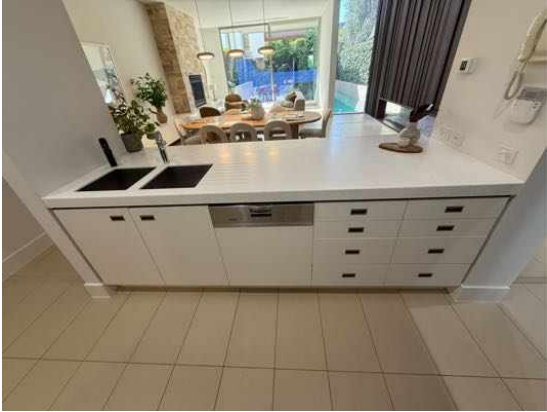
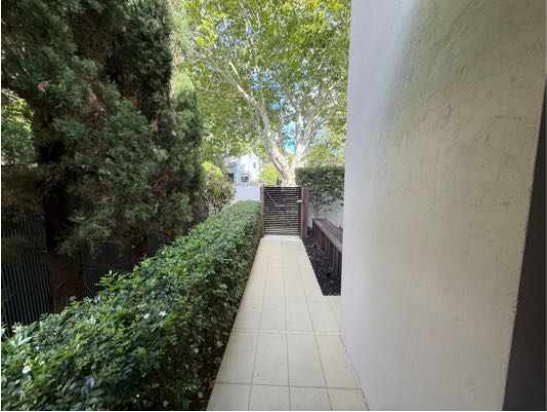
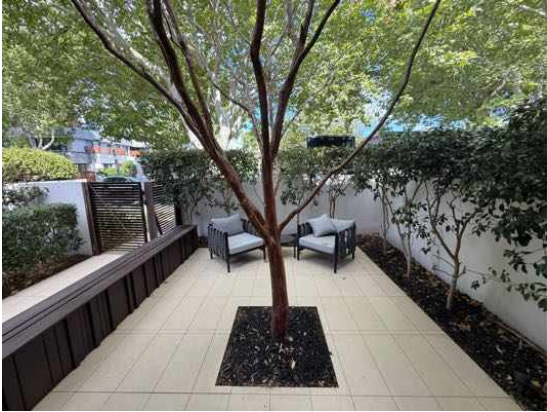
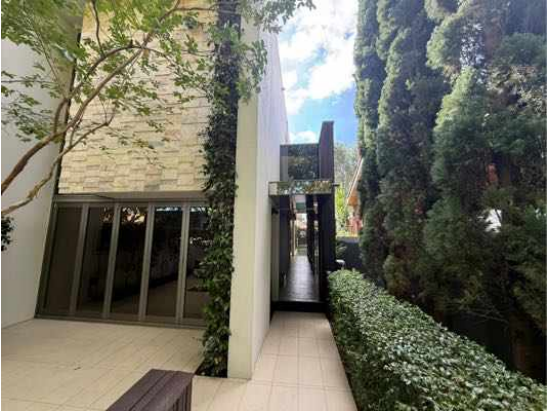
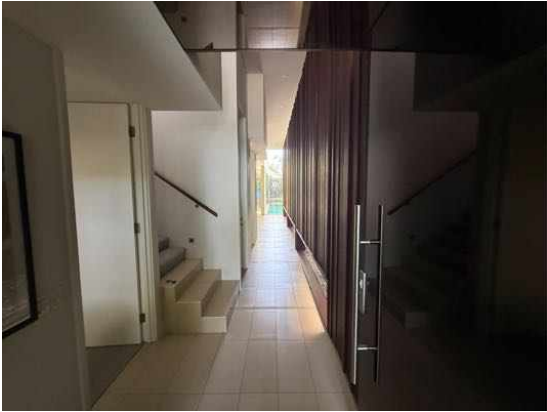
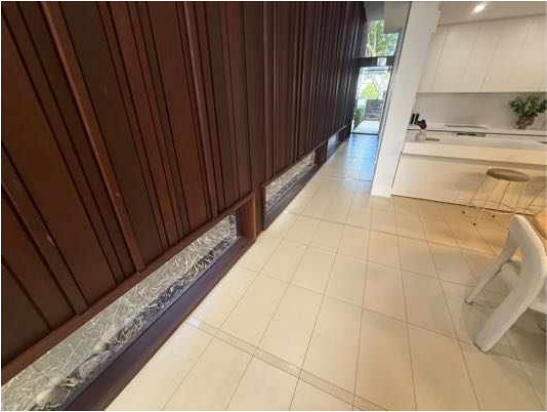
Building: Main Building
Location: All Areas
Finding: Additional Photos - Obstructions and Limitations
Information: These photographs are an indication of the obstructions and limitations which impeded full inspection of the property at the time of inspection. These obstructions can hide an array of defects and should be removed to allow full inspection to be carried out. A re-inspection is recommended once the areas are made accessible.
