# Building and Timber Pest Inspection Report

Inspection Date: Tue, 17 Feb 2026

Property Address: 23 Ronald Ave, Greenwich NSW 2065, Australia

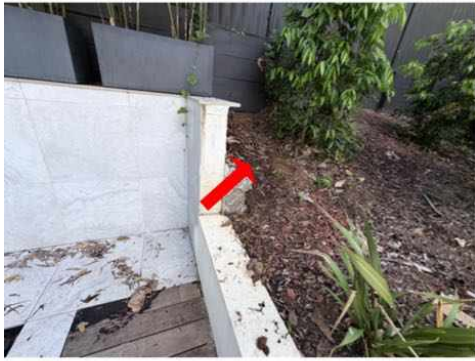
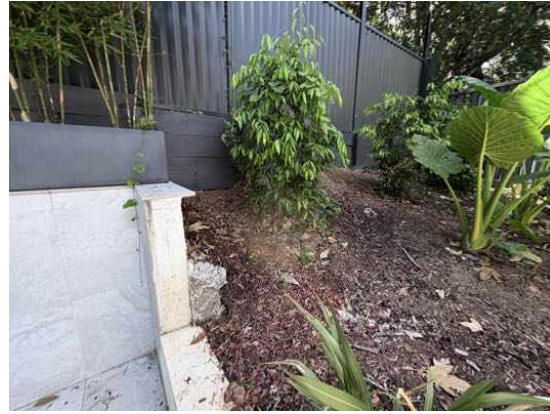
Building: Main Building  
Location: Pool Area  
Finding: Soil Erosion  
Information: Soil erosion from inadequate retaining wall to the back fence and neighbouring property is found.

The soil appears to be washing away at the back of the retaining wall.

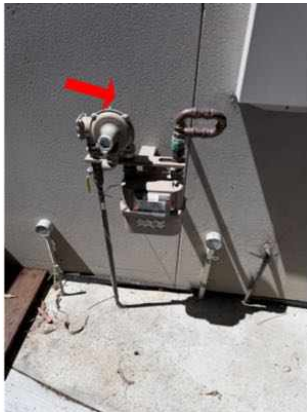
### Finding 1.02

Building: Main Building  
Location: Exterior walls - left side  
Finding: Gas Meter Distance to Electrical Meter  
Information: The gas meter and regulator is required a minimum 500mm away from the electrical meter.

Relocation of the gas meter is required.

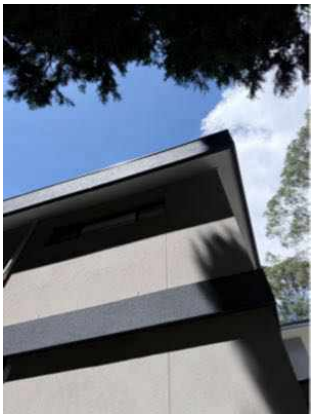
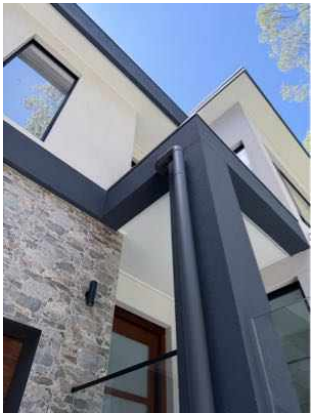
### Finding 2.01

Building: Main Building  
Location: Roof Exterior  
Finding: Overflow of Roof Box Gutter Missing  
Information: No overflow provision has been installed to the box gutter.

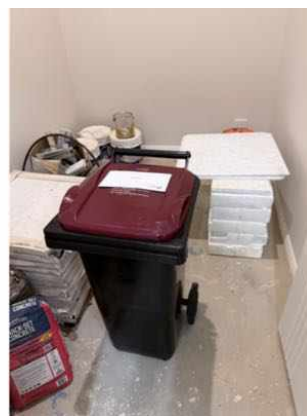
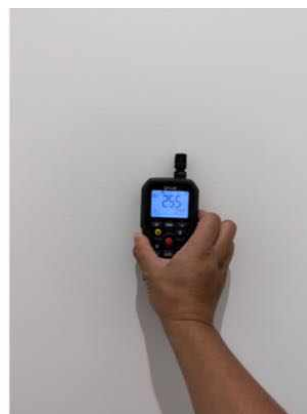
Finding 2.02

Building:	Main Building
Location:	Store Room
Finding:	Damp - Rising
Information:	Rising damp describes the upward movement of water in low sections of building elements (e.g. walls) by capillary action - the movement of water through porous materials such as bricks, sandstone or mortar.

Consultation with a qualified plumber is advised immediately to identify the cause of the damp and perform remedial works as required.

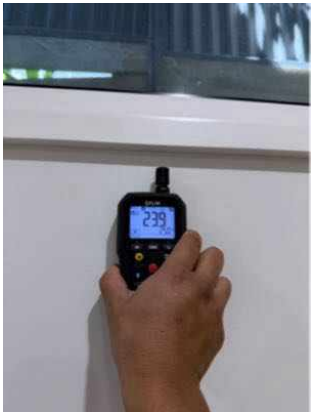
### Finding 2.03

Building:	Main Building
Location:	Bedroom
Finding:	Exterior walls - Lateral damp
Information:	Lateral penetrating damp refers to the sideways movement of moisture, predominantly from the surrounding ground, which tends to affect basement walls and other earth-retaining walls. The implications of unmanaged damp range from mould fungi growth, wood rot and decaying building materials, to finishes including lifting, bubbling, peeling and staining of paint, plaster and wallpaper.

Immediate consultation with a licensed plumber is advised to address the cause of the

damp and to perform remedial works as necessary.

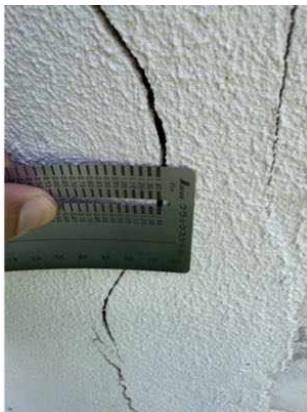
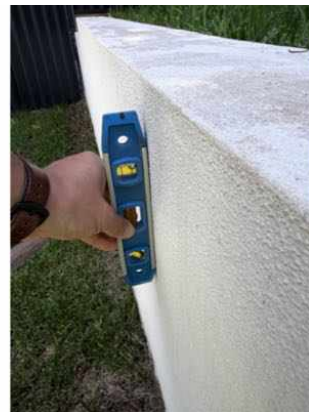
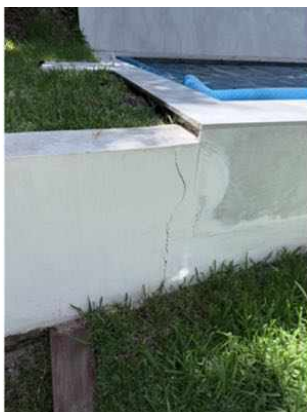
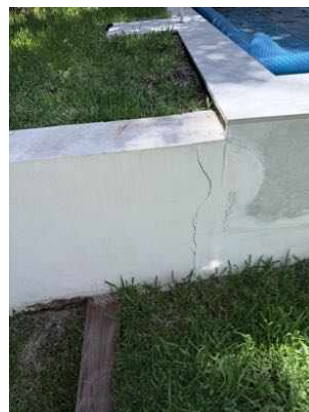
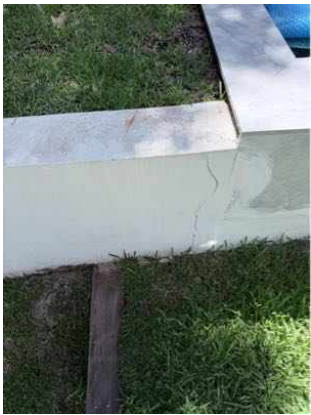
## Finding 2.04

Building:	Main Building
Location:	Pool Area
Finding:	Retaining wall - Defective
Information:	Crack is observed to the retaining wall of greater than 2mm. The retaining wall is measured to be leaning outwards indicating a movement in the retaining wall.

The retaining wall in this area was found to be defective at the time of inspection. Generally, defective retaining walls are caused by poor original design or material use. However, deteriorated retaining walls may also be a result of substandard construction, poor site drainage or unmanaged stormwater flows.

If left unmanaged, the retaining wall may become a safety hazard if it continues to destabilise. Where retaining walls further rot and decay, an environment is created that is conducive to termite and pest infestation.

Significant repair and replacement should be expected. Where retaining walls are considered structural walls, a structural engineer / surveyor should be consulted regarding required remedial works. Otherwise, a landscaper or retaining wall installer may be appointed to repair or replace the wall, at the discretion of the client.

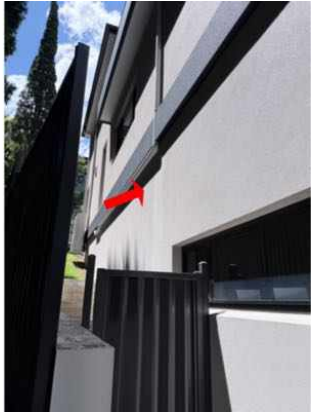
**Finding 3.01**

Building: Main Building  
Location: Exterior walls - left side  
Finding: Water Mark to Side Wall  
Information: Water mark is observed to the left side wall, where a break in the external cladding is observed.

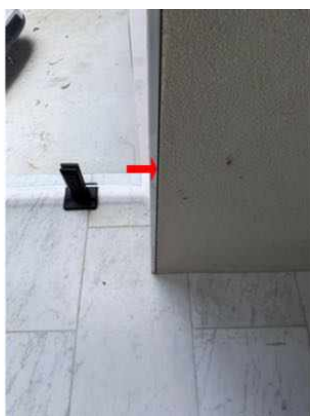
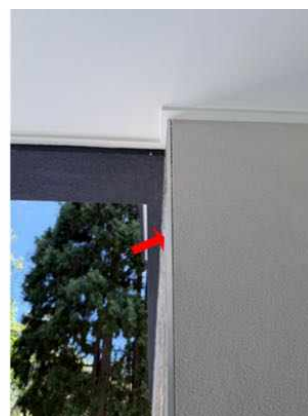
**Finding 3.02**

Building:	Main Building
Location:	Front Elevation
Finding:	Sealant and grouting - Missing or damaged
Information:	It was noted on inspection that sealant or grout is degraded to the tiled shower alcove and or other areas of the bathroom.

There appears to be excessive mould to the sealant and grout which will likely require scraping out and replacement.

Flexible and mould resistant materials should be applied to affected areas to prevent any subsequent water damage that is likely to occur. Regular maintenance and replacement of damage or missing or damaged sealant and grout is highly recommended to the wet areas, as this is a regular wear and tear defect. Sealant and grouting in areas that come into regular contact with water should be maintained for the long term care of your property.

A sealant specialist or tiling contractor should be appointed to complete these works as soon as possible

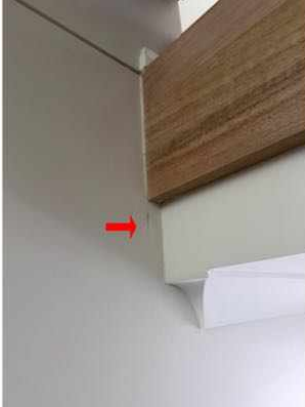
### Finding 3.03

Building:	Main Building
Location:	Stair Landing
Finding:	Cracking - Damage Category 0 - Hairline (less than 1mm)
Information:	Hairline cracks are very minor in nature and generally are only ever an appearance defect. While such cracking may be noticeable in some cases, it is quite common and does not indicate any structural damage.

Cracking of this nature can generally be repaired with minor sanding, filling and/or

repainting. Such works should be performed by a qualified painter or a general handyman.

Monitoring of all cracking should be conducted frequently. Always contact a building inspector should cracks widen, lengthen, or become more numerous.

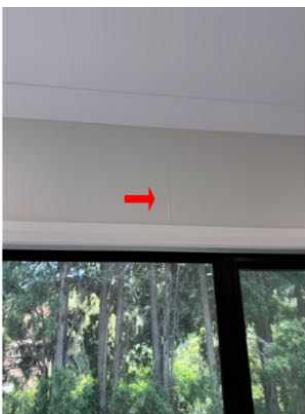
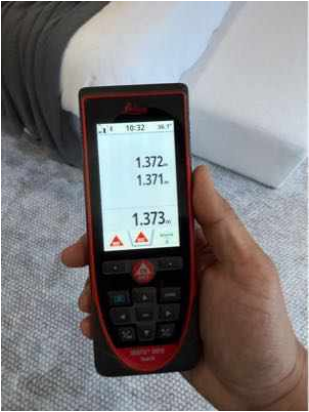
### Finding 3.04

Building:	Main Building
Location:	Bedroom - Master
Finding:	Cracking - Damage Category 0 - Hairline (less than 1mm)
Information:	Hairline cracks are very minor in nature and generally are only ever an appearance defect. While such cracking may be noticeable in some cases, it is quite common and does not indicate any structural damage.

Cracking of this nature can generally be repaired with minor sanding, filling and/or repainting. Such works should be performed by a qualified painter or a general handyman.

Monitoring of all cracking should be conducted frequently. Always contact a building inspector should cracks widen, lengthen, or become more numerous.

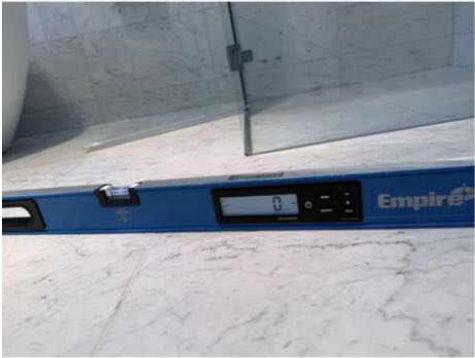
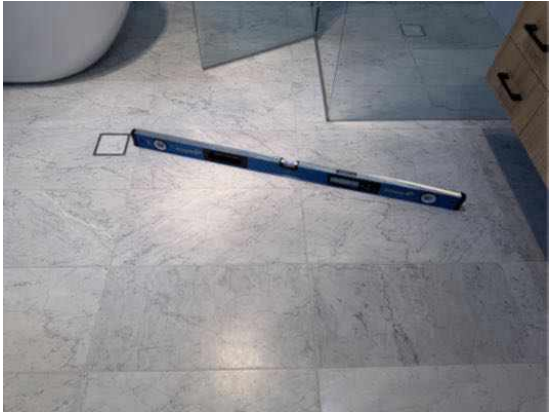
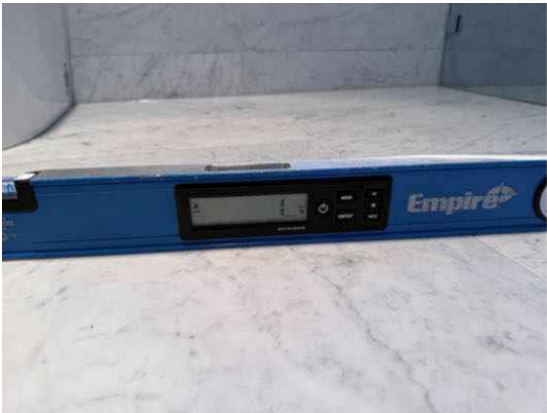
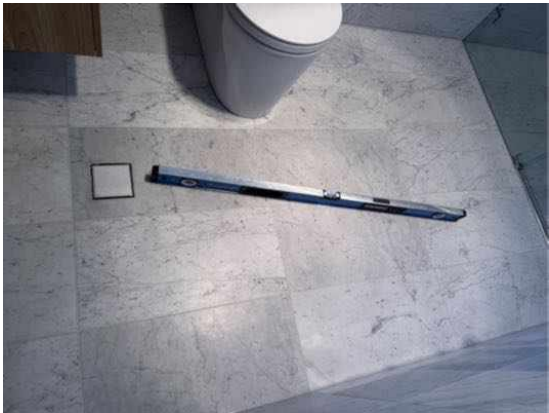
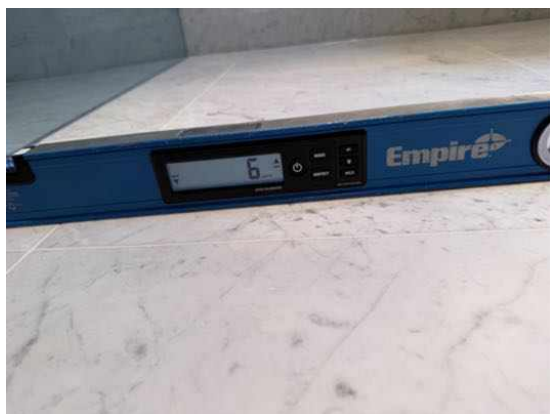
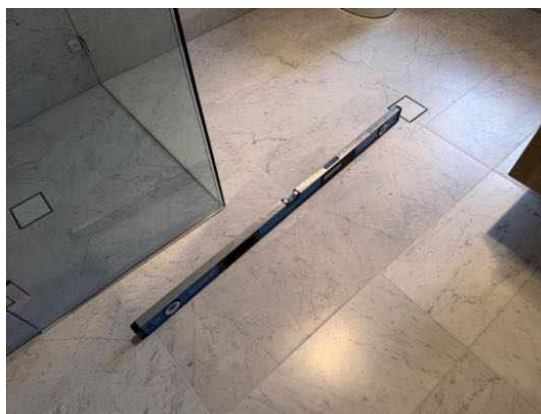
**Finding 3.05**

Building: Main Building  
Location: Bathroom  
Finding: Bathroom Insufficient Fall  
Information: The floor external to the shower area is measured with insufficient fall towards the floor waste.

The fall is required to be 1:100 or 10mm/m.

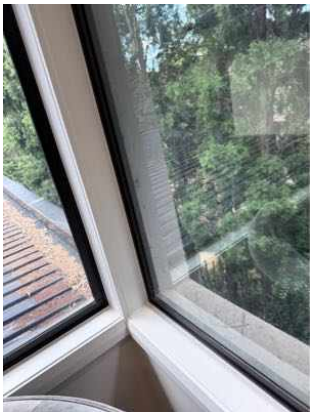
**Finding 3.07**

Building: Main Building  
Location: Bedroom - Master  
Finding: Window Not Cleaned  
Information: Construction render and concrete splashes on the windows has not been cleaned.

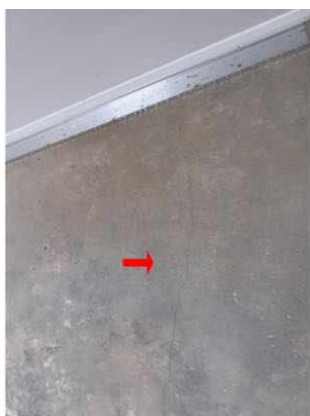
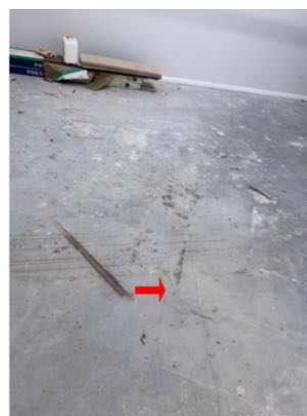
Building: Main Building  
Location: Garage  
Finding: Crack in concrete slab - Category 1

Information: A crack coded as Category 1 was identified in the slab. A Category 1 crack is described as a fine but noticeable crack, with the slab at an otherwise reasonable level.

To be considered Category 1, the approximate width of the crack is less than 1.0mm, or a less than 10mm change in offset when a 3m straight edge is placed over the defect.

Category 1 cracks should be monitored for a period of 12 months. At the end of the monitoring period, identified cracks that are rated greater than Category 2 are considered defects, and require rectification.

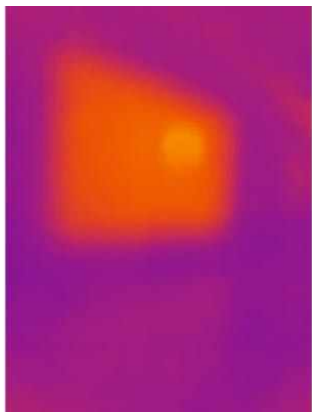
### Finding 3.10

Building: Main Building  
 Location: Bedroom - Master  
 Finding: Insulation - Missing  
 Information: Upon inspection of the roof void it was noted that insulation is not present.

Where insulation is absent, the area does not meet current Australian Standards. Installation of adequate insulation is required and should be conducted as soon as possible.

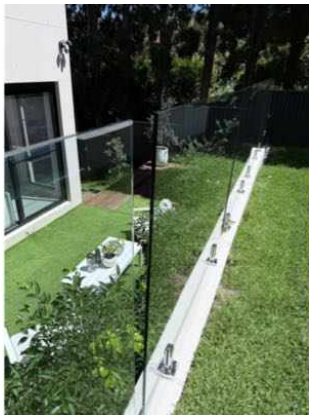
### Finding 3.13

Building:	Main Building
Location:	Pool Area
Finding:	Glass Fence Misaligned
Information:	The glass fence is misaligned.

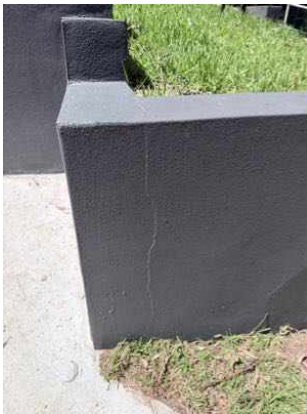
### Finding 3.14

Building:	Main Building
Location:	Yard - Front
Finding:	Cracking - Damage Category 1 - Fine (up to 1mm)
Information:	Although fine cracks are quite noticeable, they are often only considered to be an appearance defect, and usually do not indicate any structural damage. Generally, the cause of a fine crack is indicative of a separation between building materials and finishes (e.g. paint, plaster, etc.) along joins.

Cracking of this nature can generally be repaired with minor sanding, filling and/or repainting. Such works should be performed by a qualified painter or a general handyman.

Monitoring of all cracking should be conducted frequently. Always contact a building inspector should cracks widen, lengthen, or become more numerous.

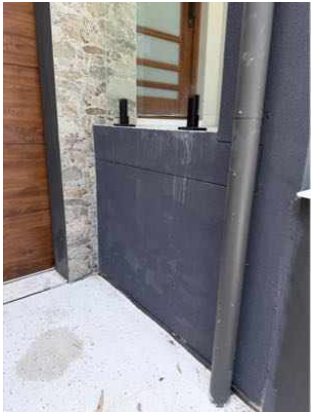
### Finding 3.15

Building:	Main Building
Location:	Yard - Front
Finding:	Water leak - External
Information:	Water leaks were found to be present to exterior plumbing work. Leaks are generally caused by deterioration of the plumbing elements over time, due to exposure to weather conditions, but may have also been caused by minor impact damage.

Such leaking creates damp conditions in the affected area, causing potential for water pooling and subsequent water damage if left unattended. These conditions may also attract termite attack, particularly if the area is subject to minimal levels of sun throughout daylight hours.

It is highly advised that a licensed plumber be appointed to rectify any water leaks that may be present. Areas of repair and replacement of plumbing fittings and fixtures may be required and, as such, a quotation should be sought.

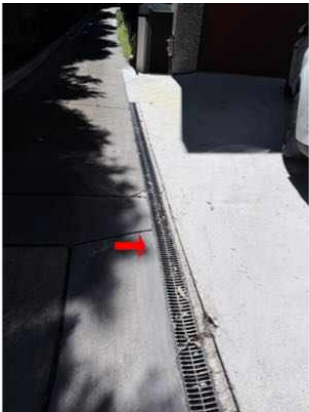
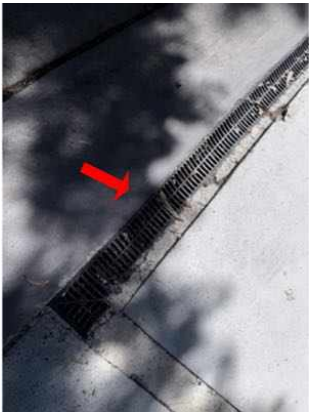
**Finding 3.16**

Building: Main Building  
Location: Yard - Front  
Finding: Drainage Channel - Not Vehicle Grade  
Information: The drainage channel used at the front of the property is not vehicle grade.

Subsidence of the grate is observed.

Overtime the grate will require replacement.

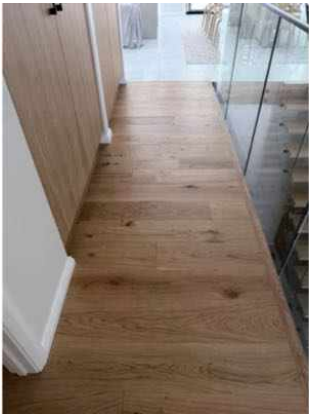
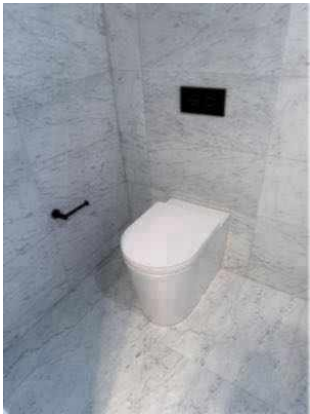
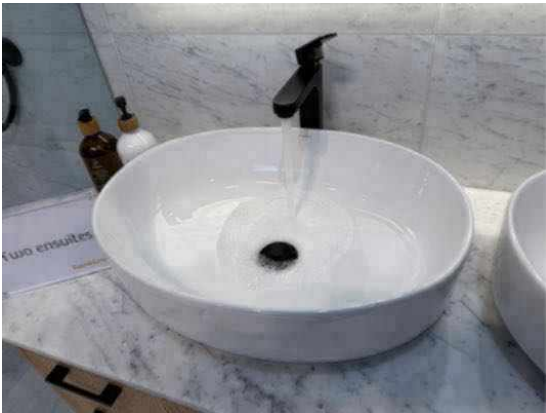
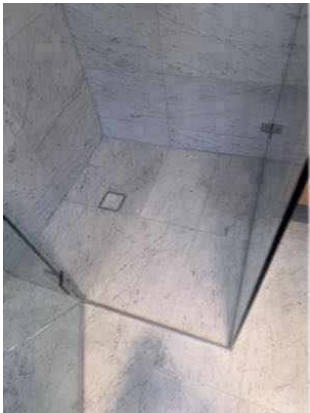
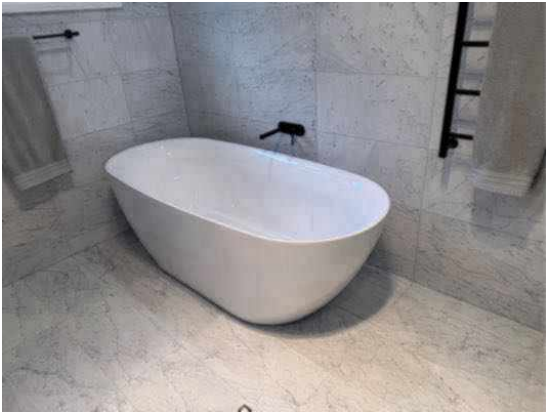
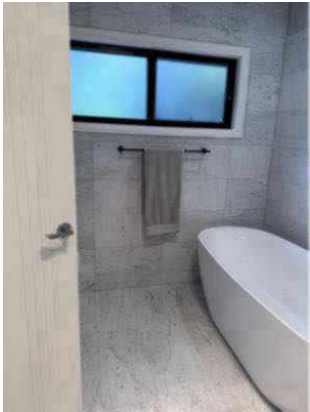
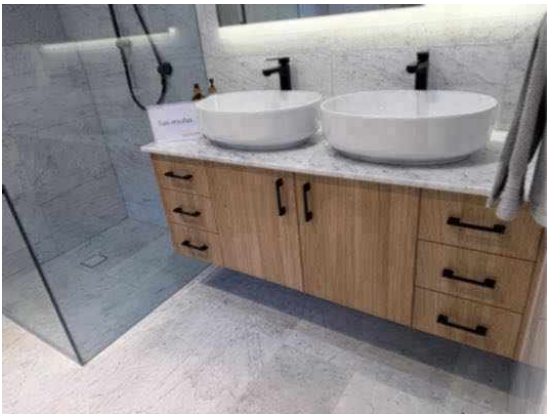
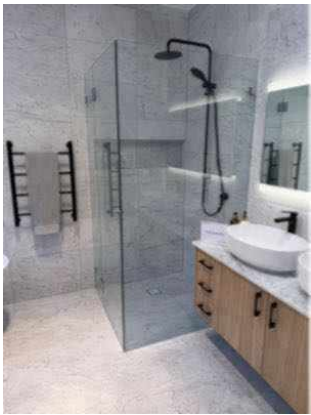
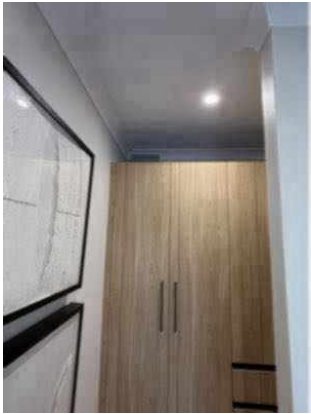
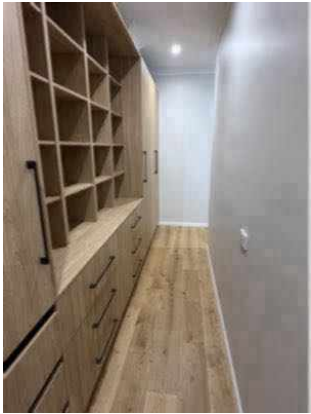
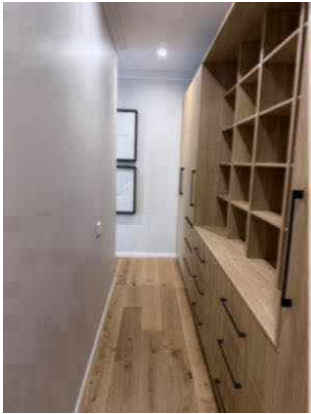
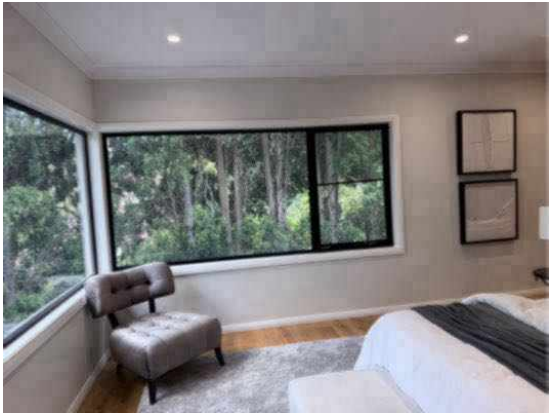
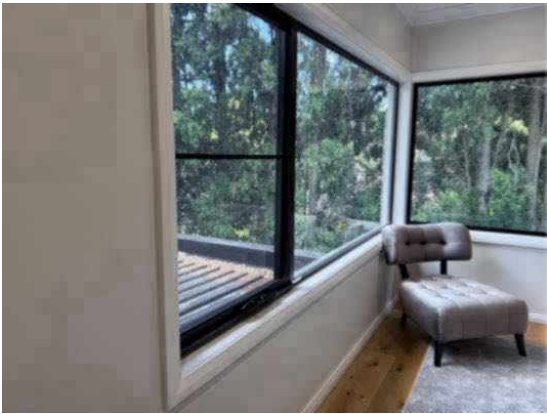
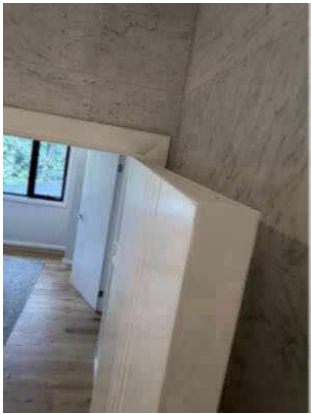
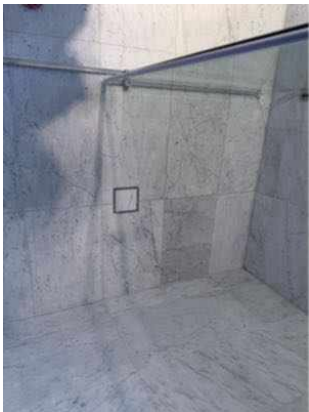
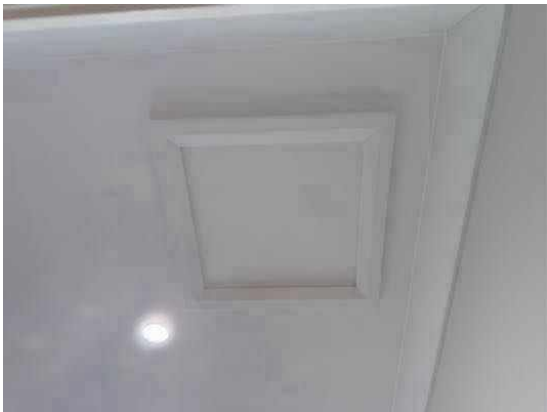
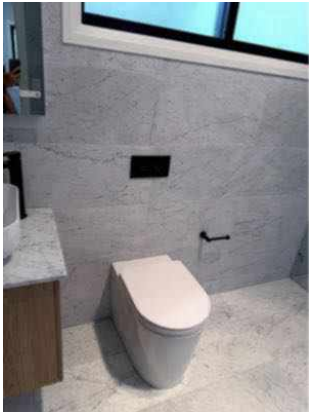
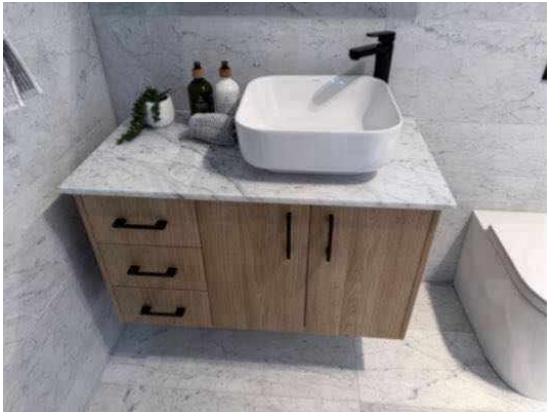
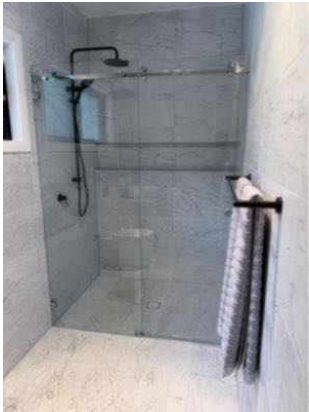
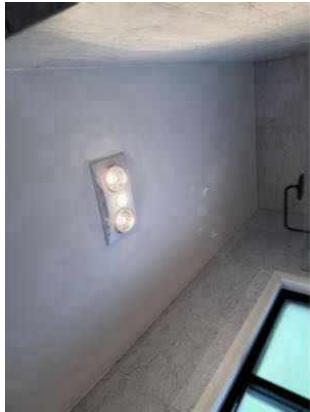
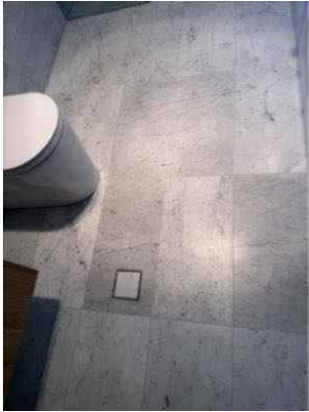
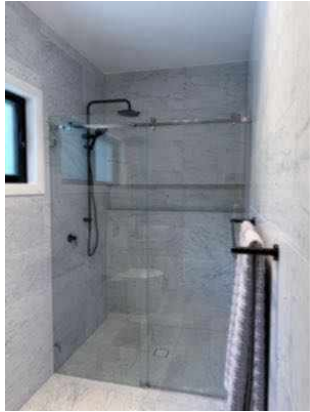
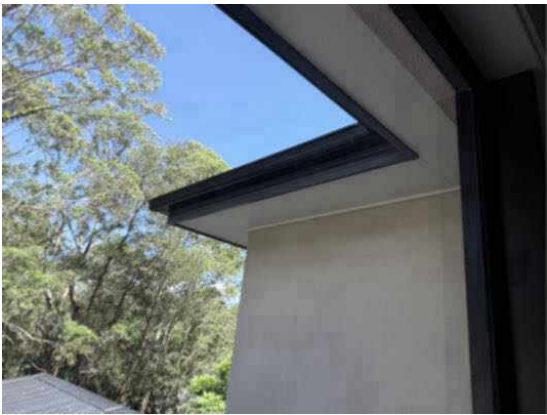
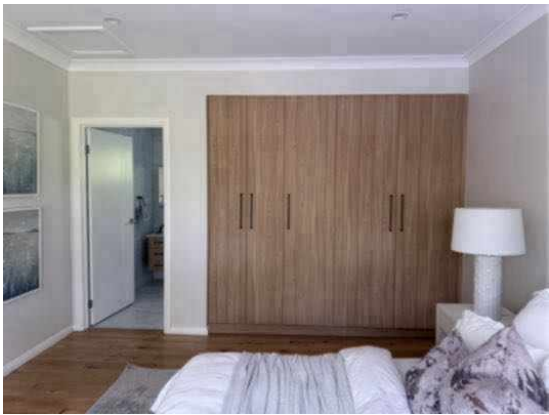
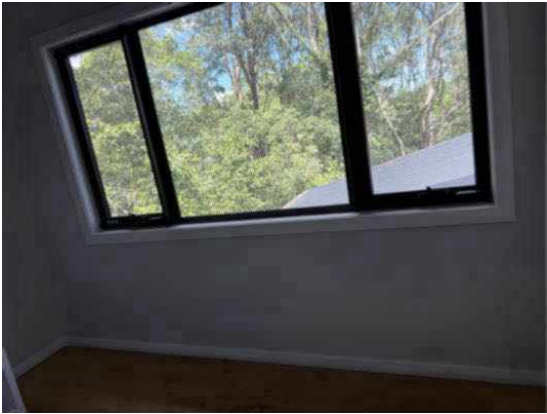
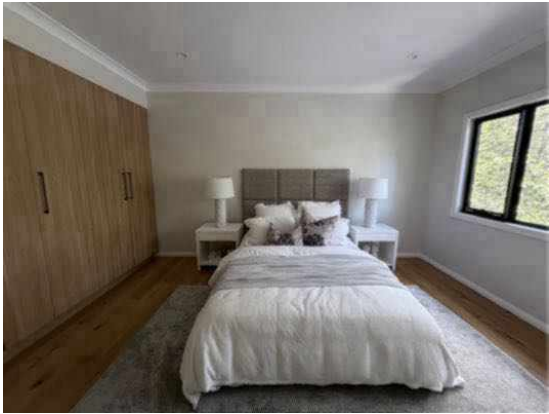
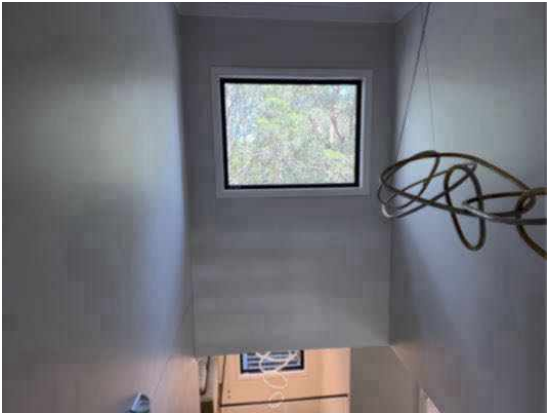
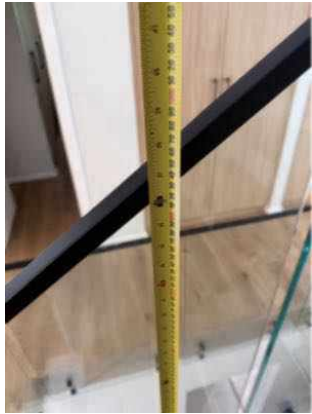
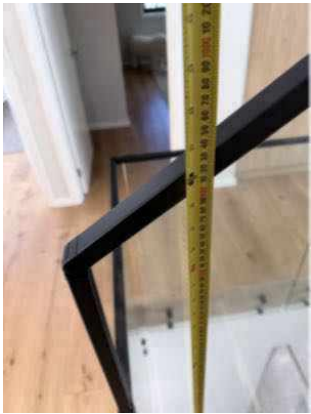
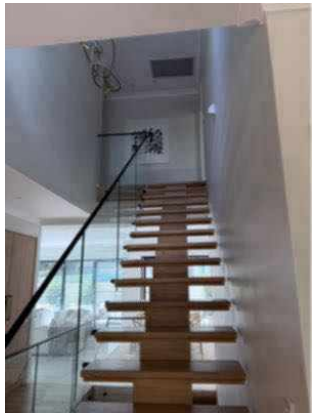
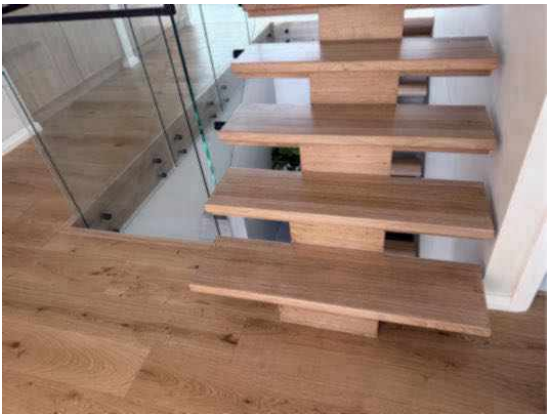
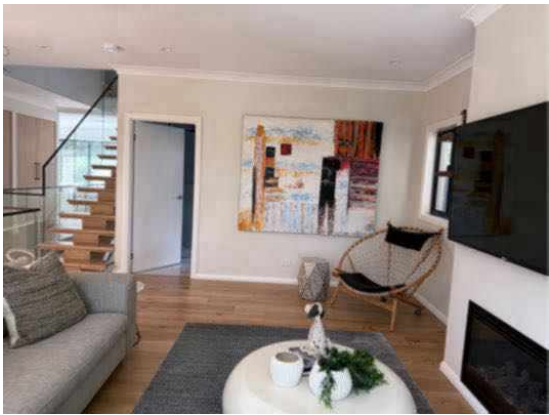
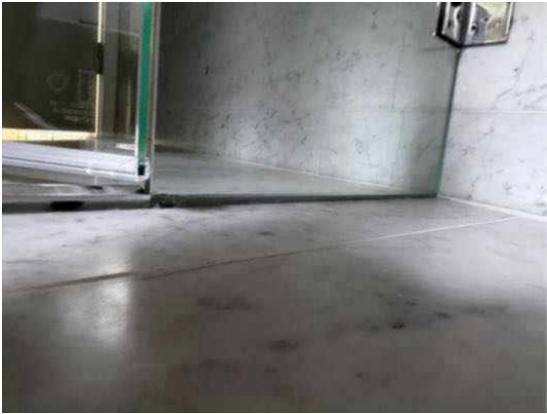
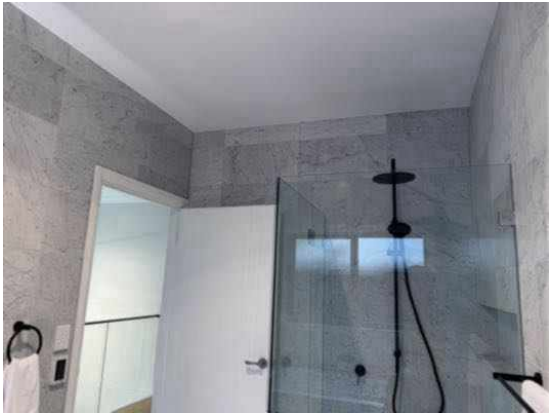
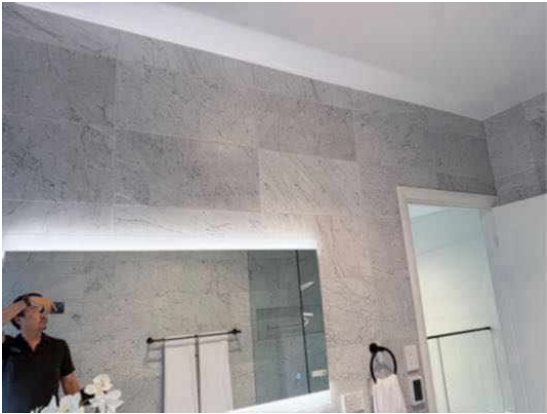
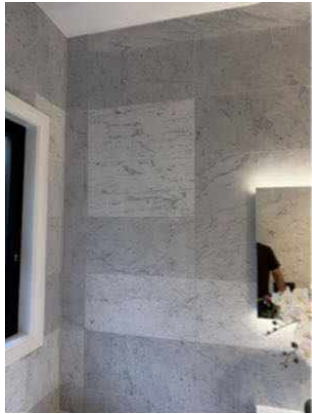
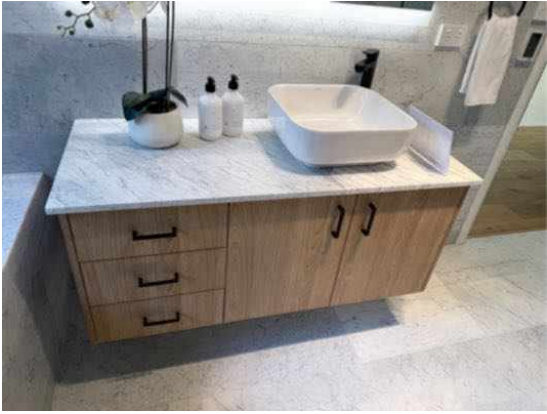
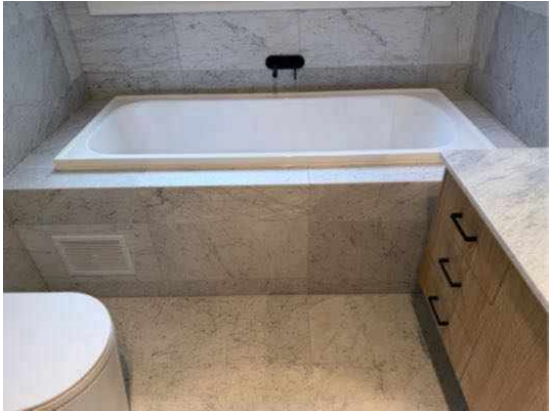
Building: Main Building  
Location: All Internal Areas  
Finding: Additional Photos  
Information: Additional photos are provided for your general reference

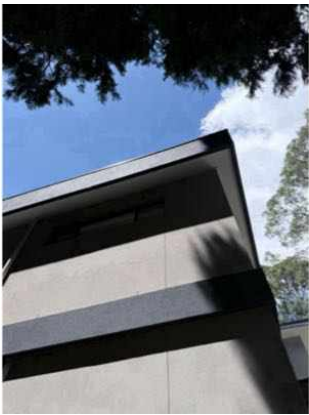
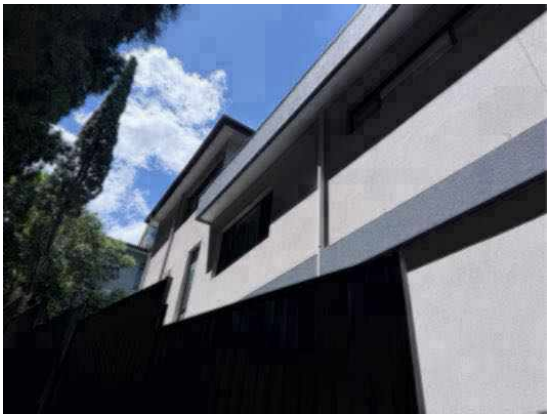
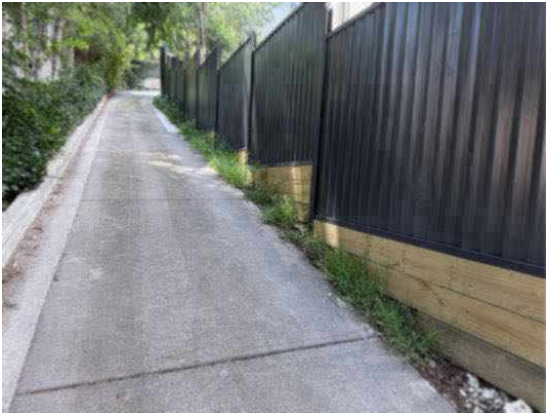
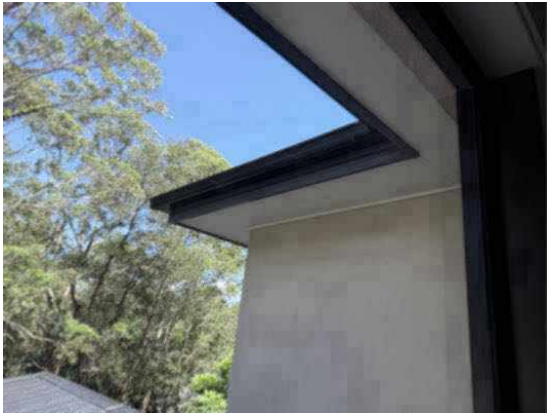
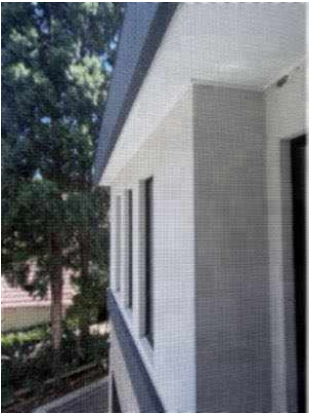
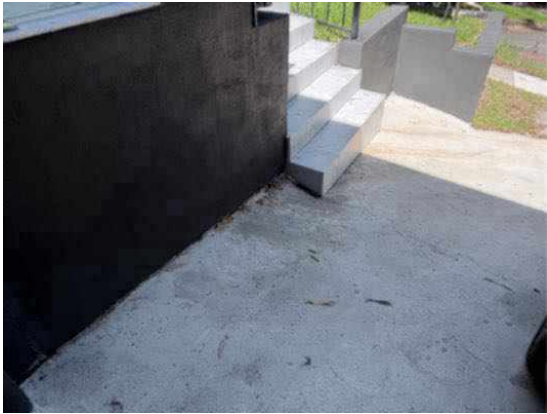
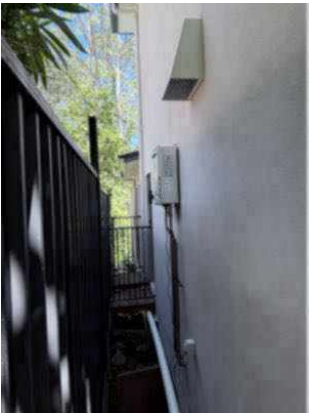
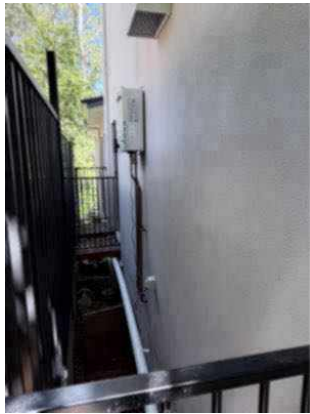
Building: Main Building  
Location: All External Areas  
Finding: Additional Photos  
Information: Additional photos are provided for your general reference
