Building and Timber Pest Inspection Report

Inspection Date: Wed, 01 Apr 2026

Property Address: 86 Princes St, Ryde NSW 2112, Australia

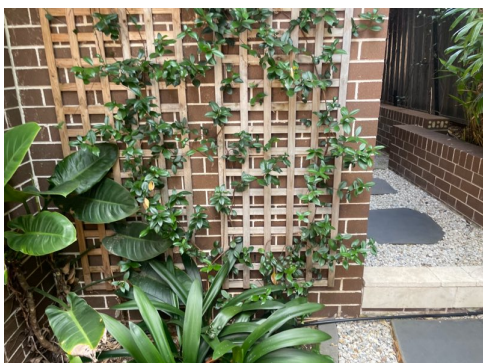
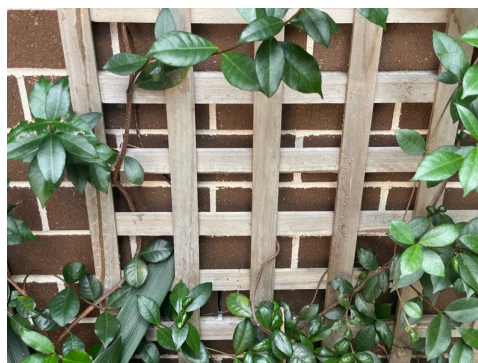
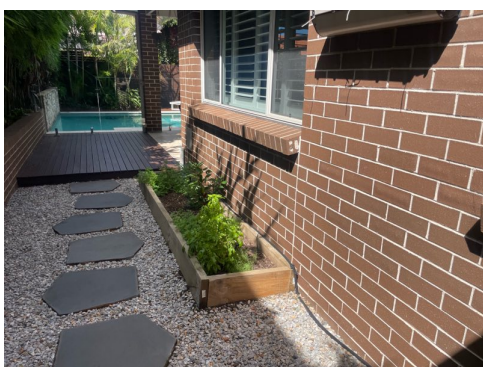
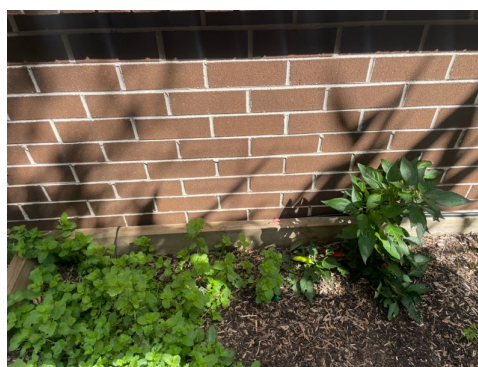
Depending on the nature of the blockage, the homeowner may be able to undertake remedial works to remove blockages. Alternatively, appointment of a registered builder may be required to remove blockages.

Preventative works are necessary in ensuring the structural integrity of the affected brickwork and should be performed as soon as possible.

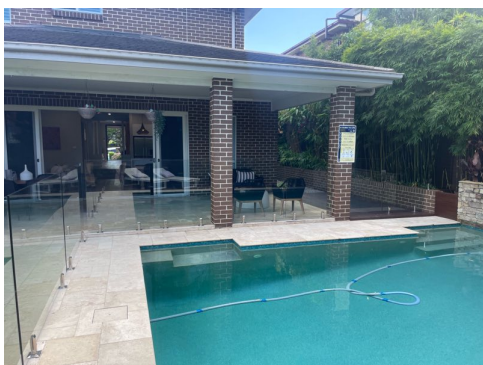
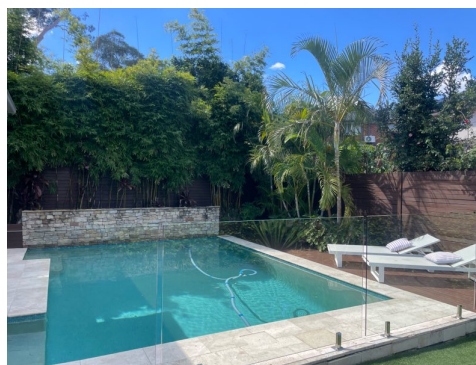
Building:	Main Building
Location:	Swimming Pool
Finding:	Pool fencing/area
Information:	<p>This inspection specifically excludes any inspection of the pool, associated pool equipment and pool surrounds.</p> <p>An inspection should be made by a specialist pool inspector to determine the condition of the pool, pool equipment and surrounds.</p> <p>A pool safety inspection is not included as part of a standard building inspection and must be commissioned separately as a specialist report.</p>
