Building and Timber Pest Inspection Report

Inspection Date: Wed, 11 Mar 2026

Property Address: 14/40 Murev Way, Carrara QLD 4211,
Australia

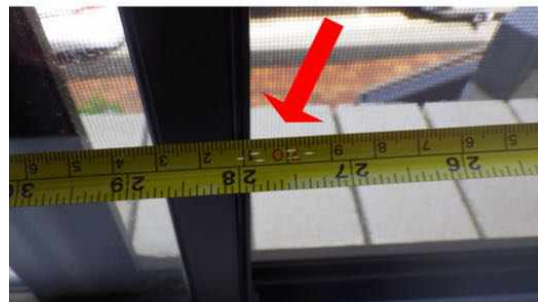
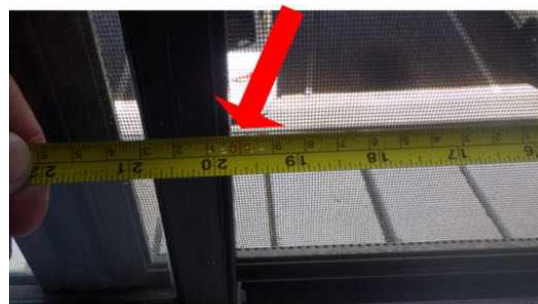
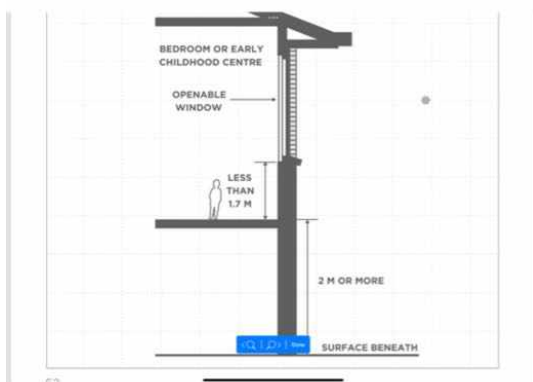
Building: Main Building
Location: Bedrooms > Existing
Finding: Window safety
Information: It was noted that the bedrooms windows are less than 1.7m from the floor and have a fall greater than 2m on the exterior from the sill and as such are required to only open upto 125mm or have security grills fitted.

This is noted as a safety concern and this regulation may not have been in place at the time of construction.

Windows are defective if they do not comply with provision 3.9.2.5 of Volume 2 of the BCA that requires that a window opening must have protection if the floor below the window in a bedroom is 2 m or more above the ground surface beneath.

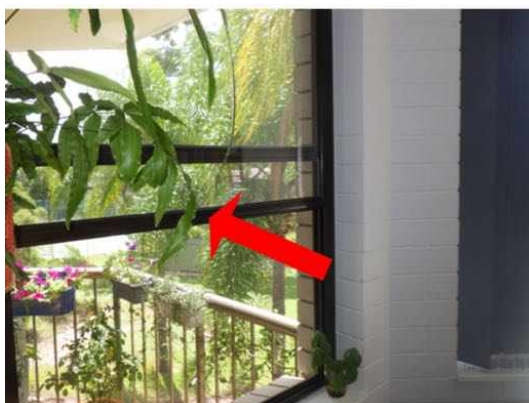
Building: Main Building
 Location: Dining Area > Front Left
 Finding: Window - Springs
 Information: The window sash to the dining area double hung window was found drop rapidly at the time of inspection. It appears the window support springs or balancing system may require adjustment.

Repair of the broken window sash is advised to improve the operational state of the associated window.

An aluminium window service agent could be appointed to repair or adjust the window at the client's discretion.

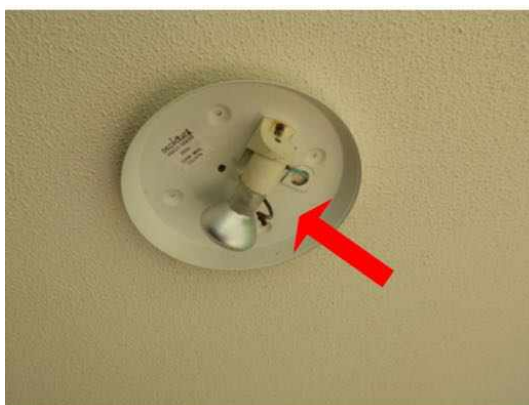
Finding 3.02

Building:	Main Building
Location:	Balcony > Centre
Finding:	Light fitting - Missing cover
Information:	The ceiling light fitting cover in the balcony area was found to be missing at the time of inspection. Damage occurs generally when the building materials have aged and decayed, but may also be indicative of impact damage to the building element (accidental or deliberate).

Left unmanaged, the fitting is unlikely to cause further damage to surrounding building elements. However, the broken light fitting may expose electrical works, and may create a minor safety hazard if there is potential contact with persons in the area.

Repair and/or replacement of the damaged fitting is advised. A Licensed electrician should be appointed to repair/replace the light fitting at the client's discretion.

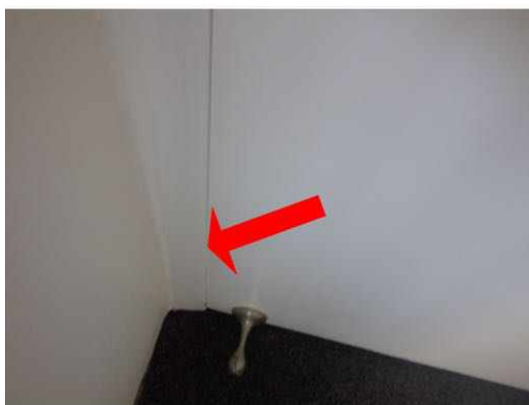
Finding 3.03

Building:	Main Building
Location:	Bedroom - Master > Front
Finding:	Door - Binding/Jamming
Information:	Minor binding and/or jamming of the main bedroom door on the door frame was

evident during standard operation. This defect can inhibit the functionality of the affected door as well as creating potential for secondary defects to associated building elements, such as damage to the door framing.

A door that binds to the associated door frame or sill may have several causes, such as poor installation of the door or deteriorated hinges.

A qualified carpenter or general handyperson could be appointed to perform minor rectification works at client discretion.

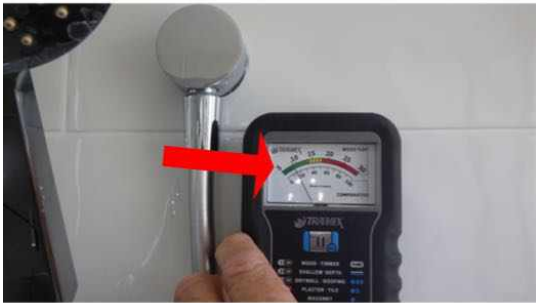
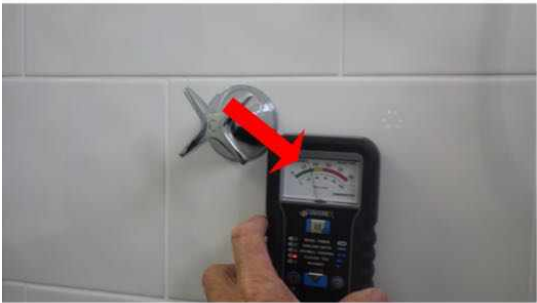
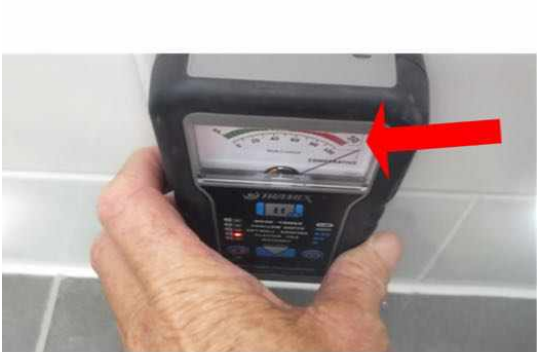
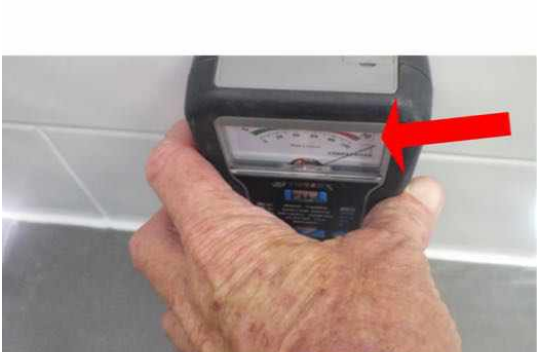
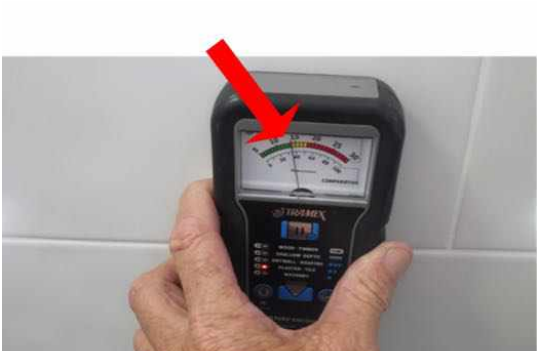
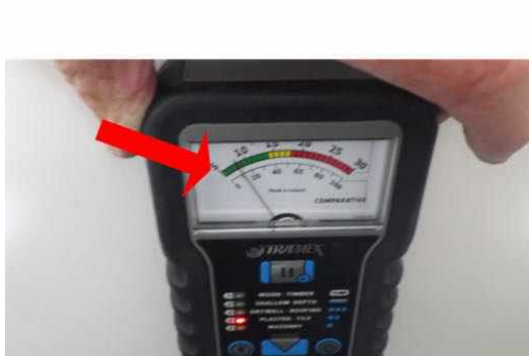
Finding 3.04

Building:	Main Building
Location:	Ensuite > Centre Right
Finding:	Shower - Monitor
Information:	Elevated moisture level readings were recorded to the lower 300mm of wall to the ensuite shower alcove at the time of inspection. There was no elevated moisture level readings around the tap area, and no elevated readings transferring to the other side of the wall in the areas where moisture readings were able to be obtained. Both sealant and grout appear in good condition at present.

This defect is quite common, and is suspected to have been caused by moisture permeating or leaching through the grouting and perhaps gaps in the sealant.

Monitoring the area is advised and if any visual signs of excessive moisture appear (peeling paint, mould) then consultation with a qualified plumber or bathroom specialist would be advised.

Always ensure that sealant and grout is in good condition to prevent any moisture issues occurring in the future.

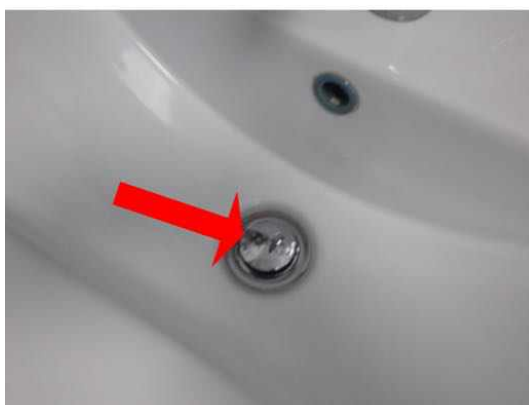
Finding 3.05

Building: Main Building
 Location: Powder Room > Front Left
 Finding: Basin - Pop up waste stiff.
 Information: The powder room basin pop up waste was stiff to operate at the time of inspection. It is advised that maintenance is carried out on the waste so as it functions as intended.

A handyman could be appointed to perform any remedial works where required.

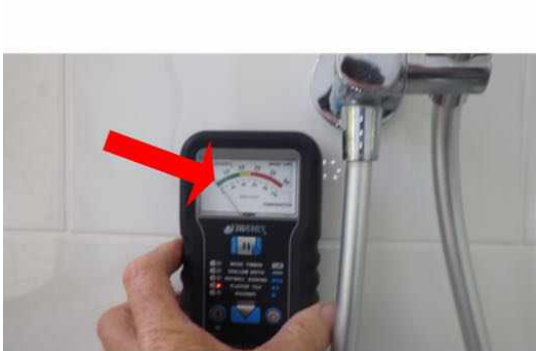
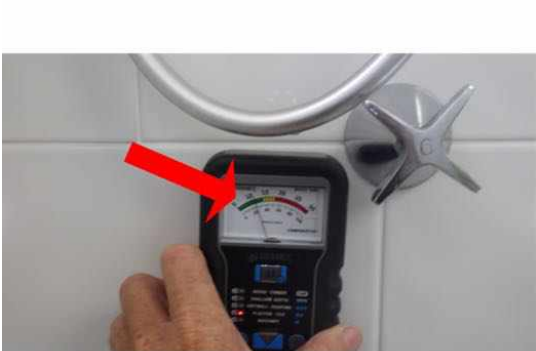
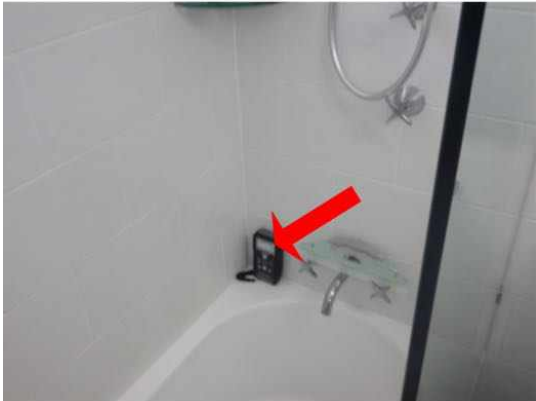
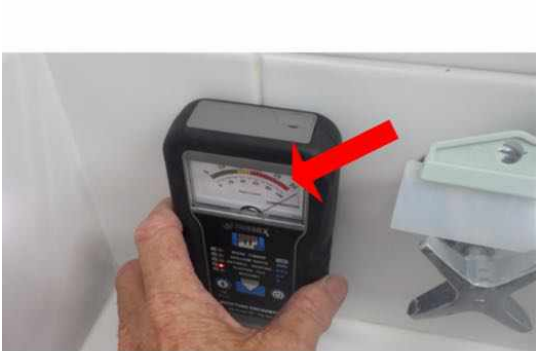
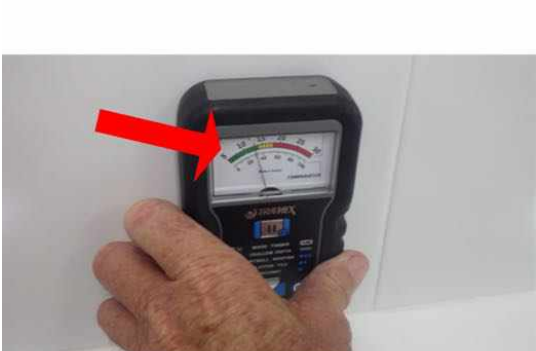
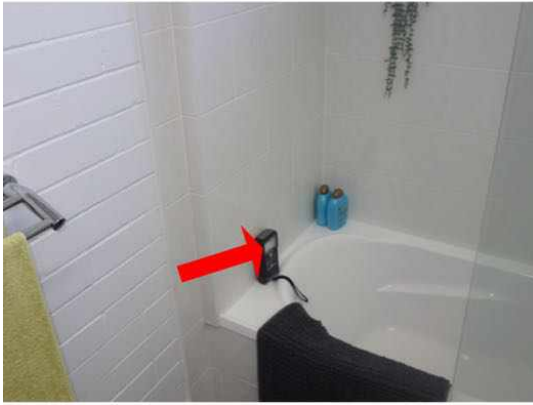
Finding 3.06

Building: Main Building
 Location: Bathroom Area > Rear Right
 Finding: Shower - Monitor
 Information: Elevated moisture level readings were recorded to the lower 200mm of right side wall to the bathroom shower alcove at the time of inspection. There was no elevated moisture level readings around the tap area. No readings to the other side of the wall were able to be obtained. Both sealant and grout appear in good condition at present.

This defect is quite common, and is suspected to have been caused by moisture permeating or leaching through the grouting and perhaps gaps in the sealant.

Monitoring the area is advised and if any visual signs of excessive moisture appear

(peeling paint, mould) then consultation with a qualified plumber or bathroom specialist would be advised.

Always ensure that sealant and grout is in good condition to prevent any moisture issues occurring in the future.

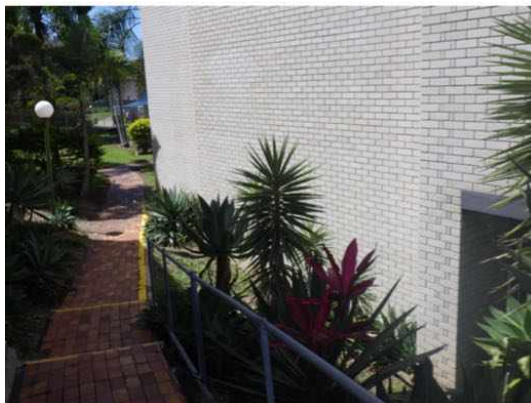
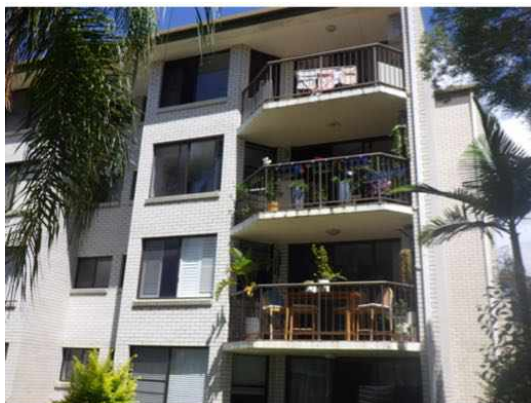
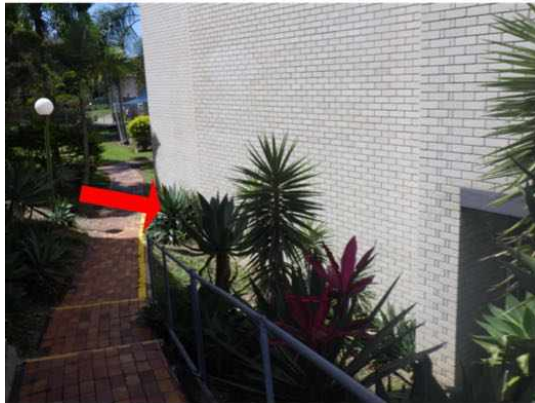
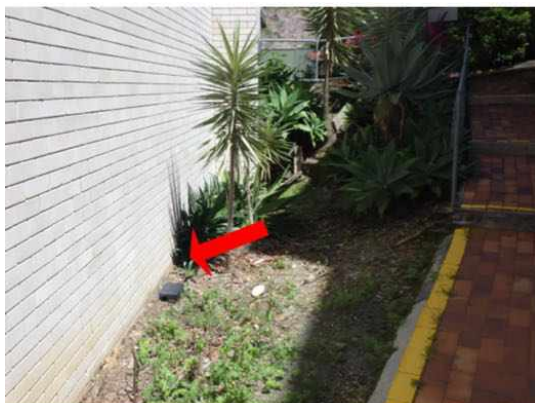
Finding 6.02

Building:	Main Building
Location:	External Areas > Ground Level
Finding:	Garden Beds - Conditions Conducive to Termites
Information:	Garden beds and external landscape areas were found to contain tree stumps, timber debris and garden waste at the time of inspection (as per example photos). These garden beds can include untreated timber, and with a combination of moisture from watering hosing can make conditions conducive to termite activity and termite ingress. Removal of any garden debris or timber is highly advised. Frequent pest inspections are advised to readily identify any termite activity in these areas.

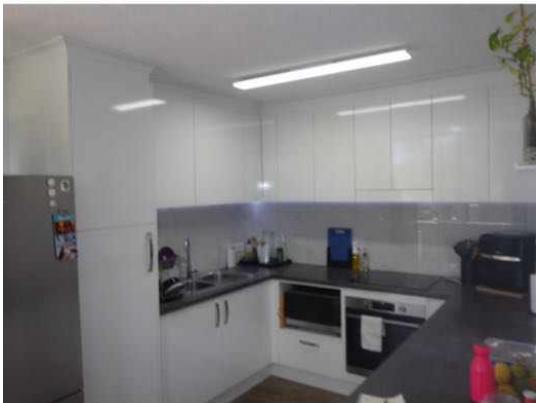
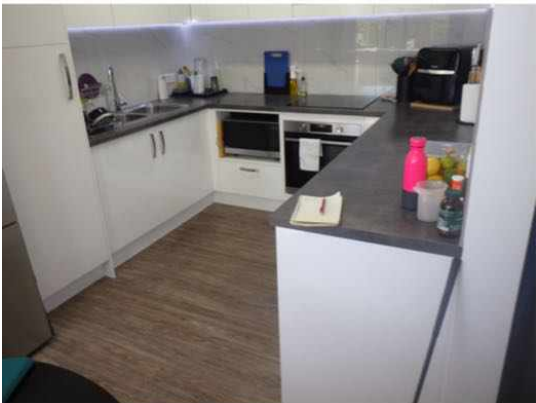
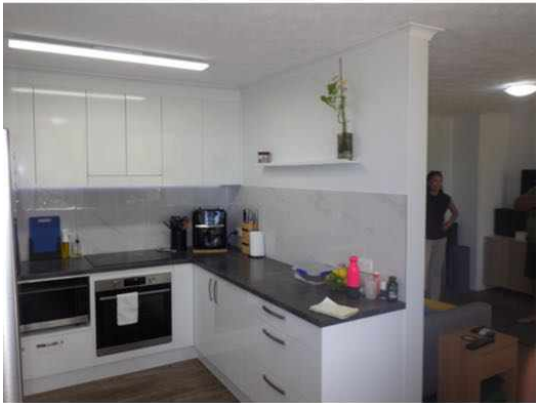
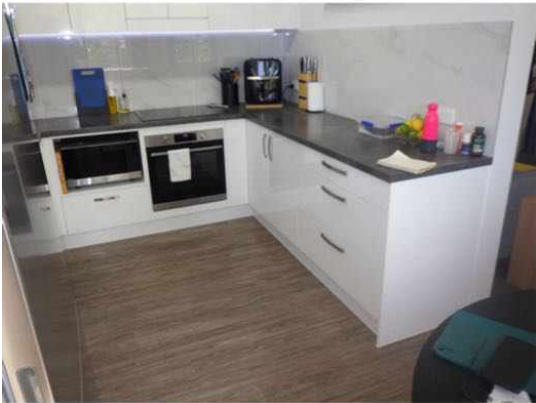
Building: Main Building
Location: Kitchen > Existing
Finding: No obvious defect

Information: No obvious defects found at the time of inspection.

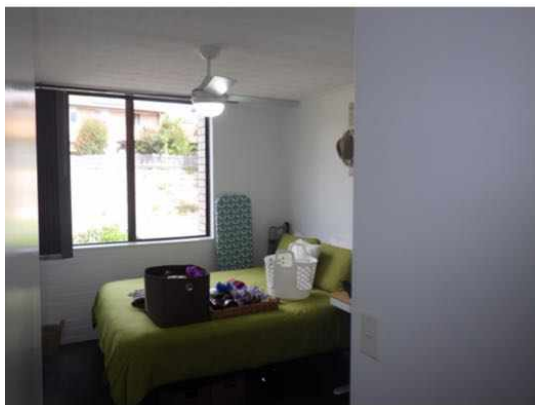
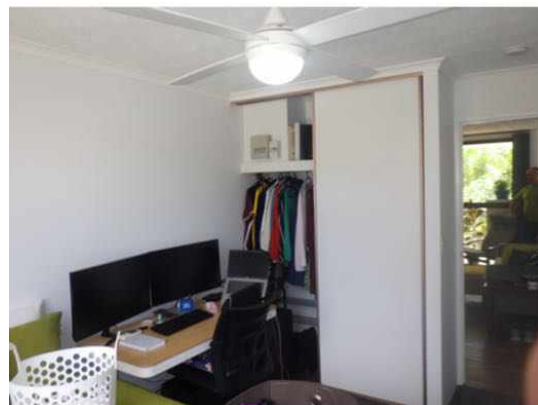
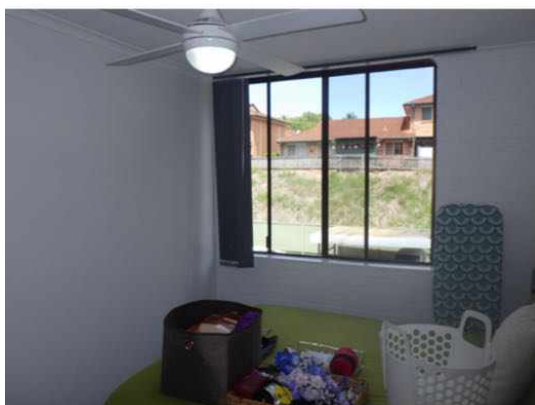
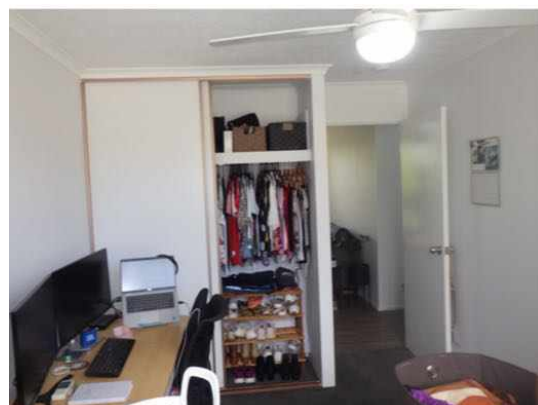
Building: Main Building
Location: Bedroom 2 > Existing
Finding: No obvious defect
Information: No obvious defects found at the time of inspection.

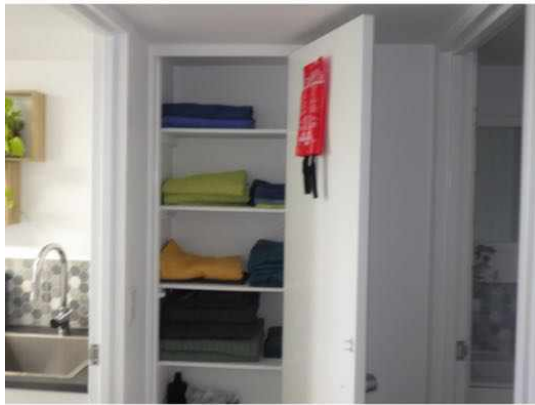
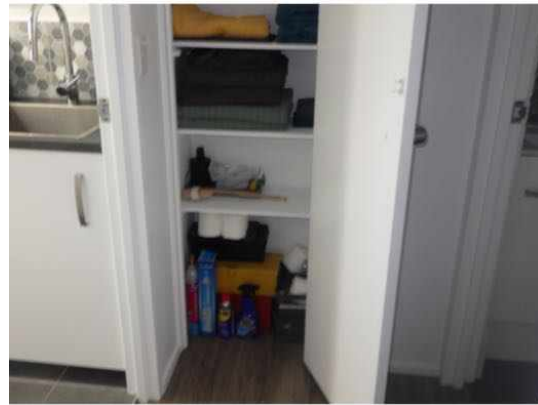
Building: Main Building
Location: Linen Cupboard > Existing
Finding: No obvious defect
Information: No obvious defects found at the time of inspection.

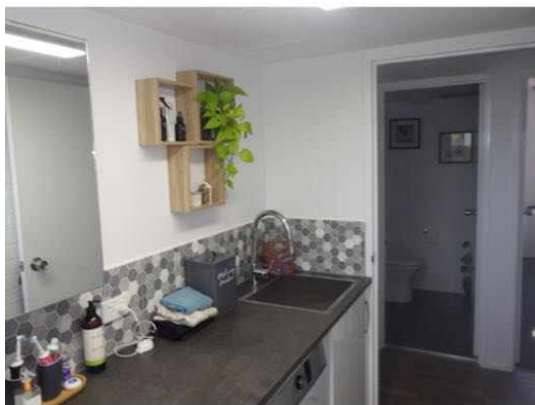
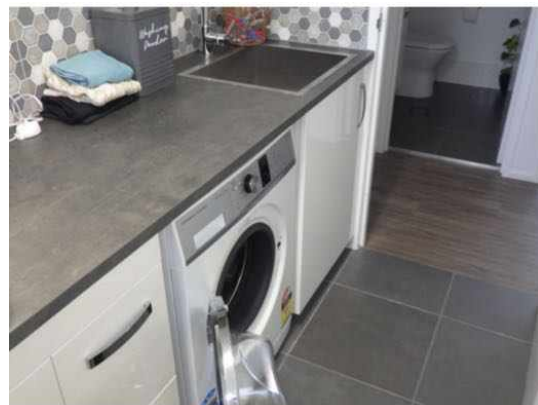
Building: Main Building
Location: Laundry Area > Existing
Finding: No obvious defect
Information: No obvious defects found at the time of inspection.

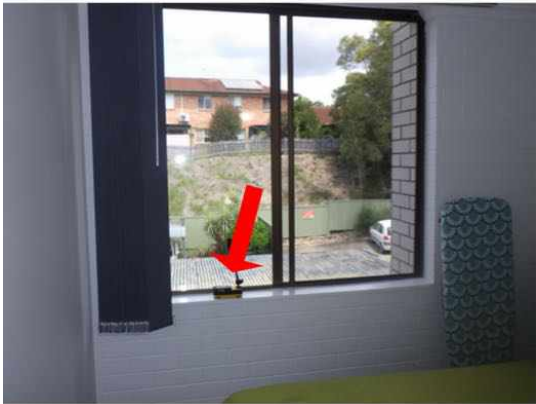
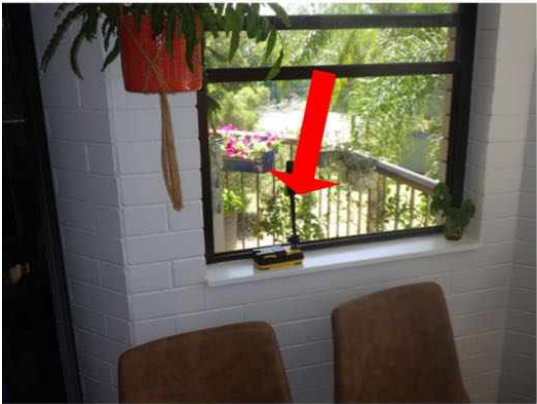
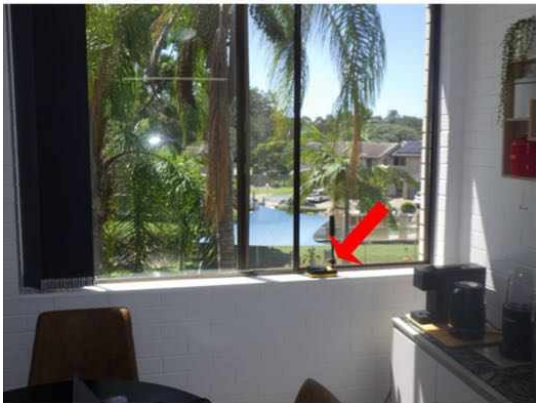
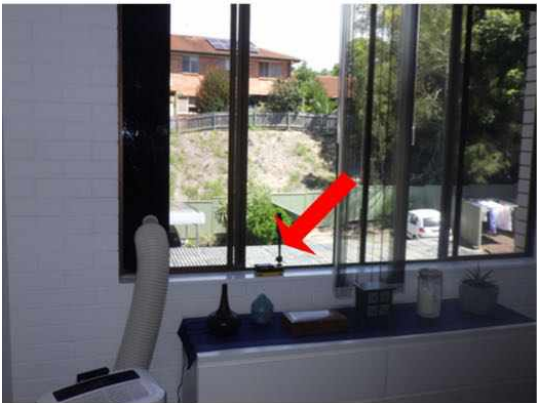
Building: Main Building
 Location: Internal Areas > Existing
 Finding: Termitracker
 Information: The termitracker itracker was positioned randomly to internal window frame areas checking for signs of termite activity.

No activity was recorded at the time of inspection.

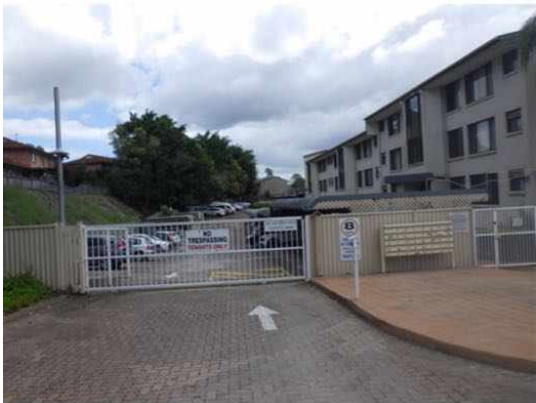
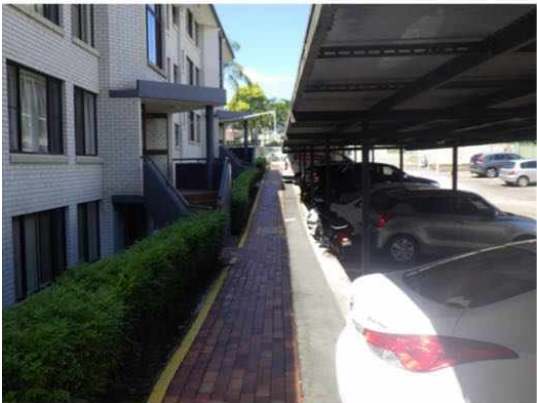
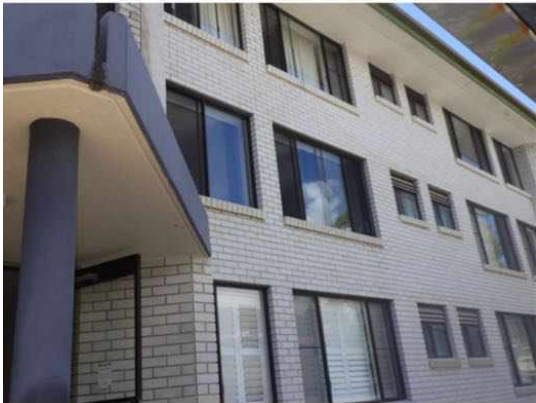
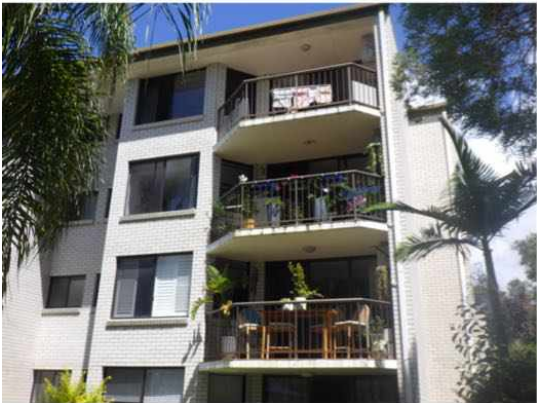
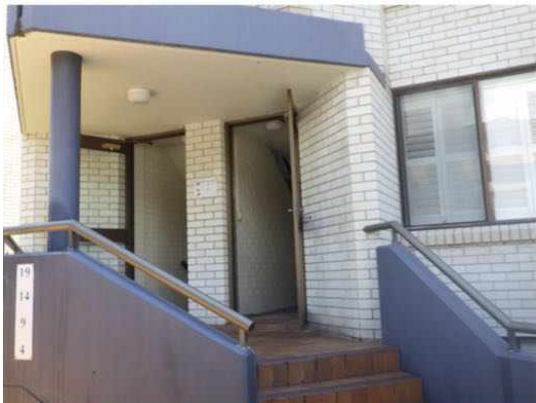
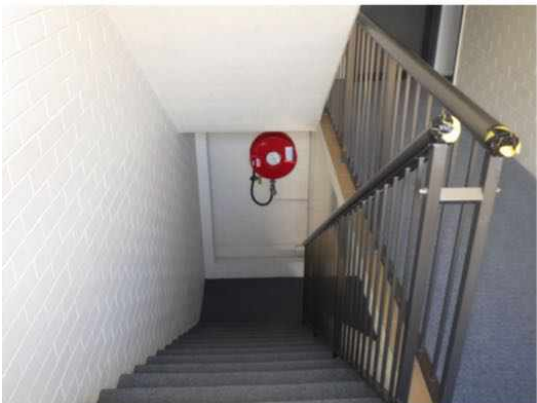
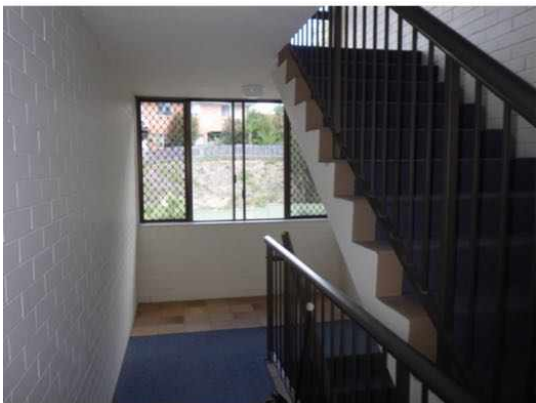
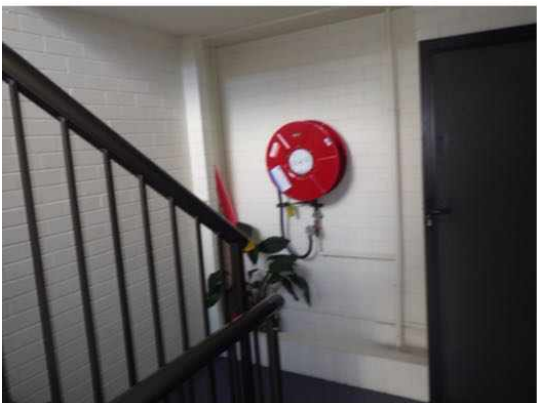
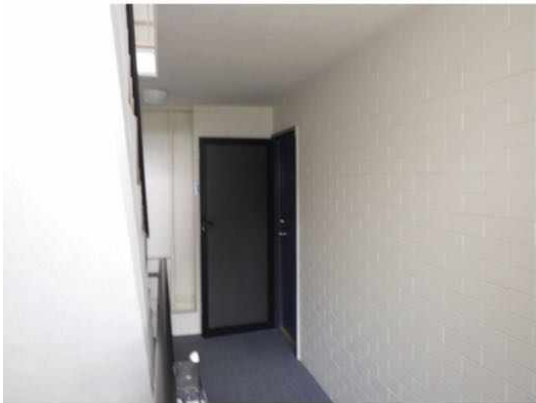
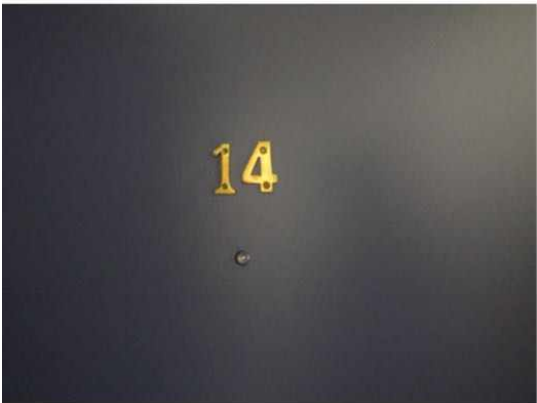
Building: Main Building
Location: External Areas > Existing
Finding: Additional Photos
Information: Additional photos are provided for your general reference
