Building and Timber Pest Inspection Report

Inspection Date: Mon, 9 Mar 2026

Property Address: 201/1 Mahogany Ave, Macquarie Park NSW
2113, Australia

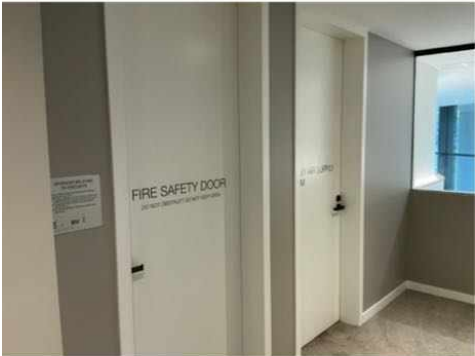
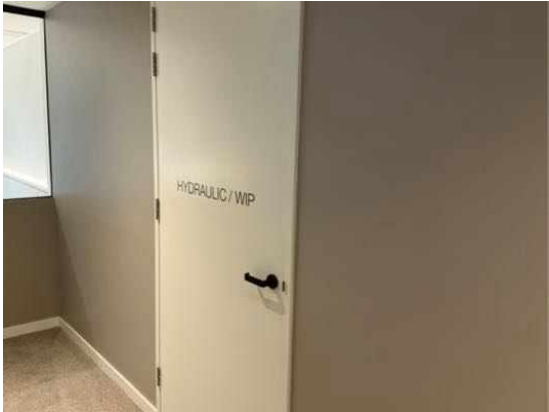
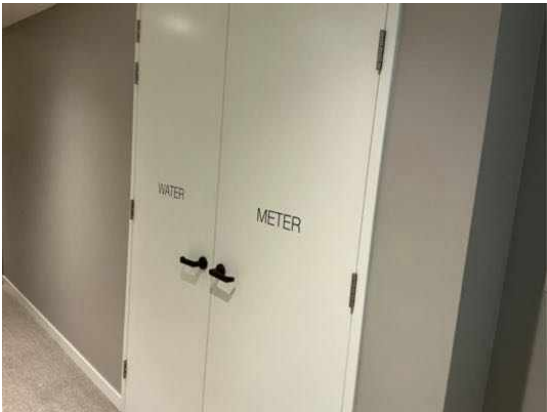
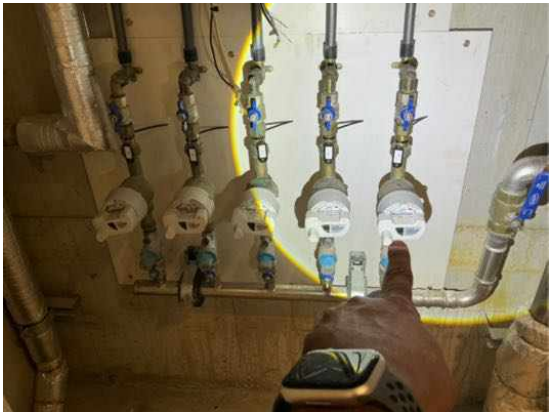
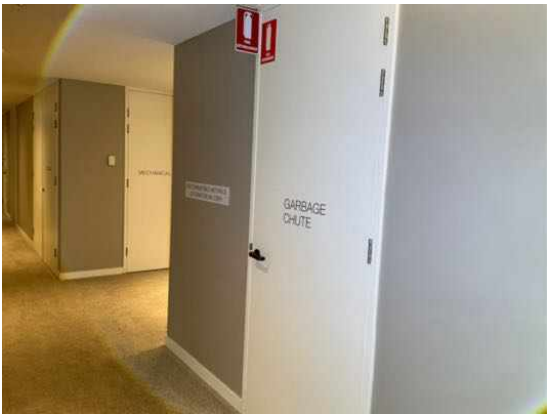
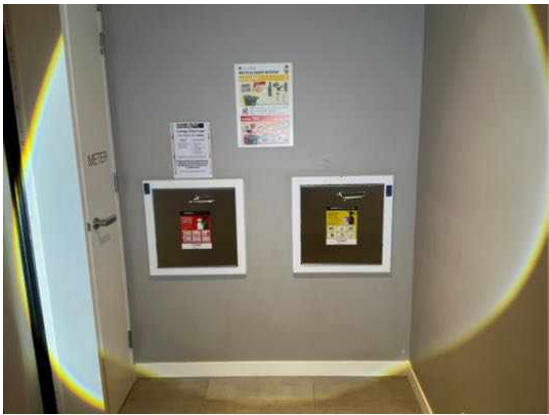
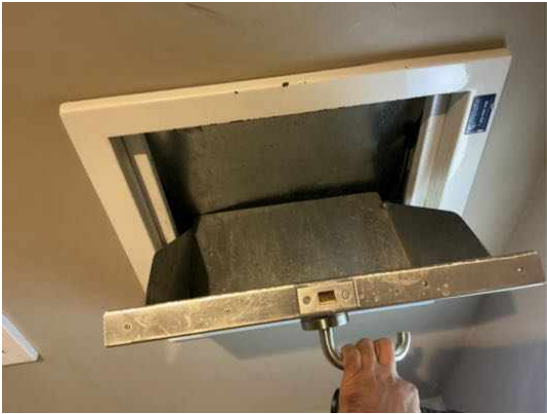
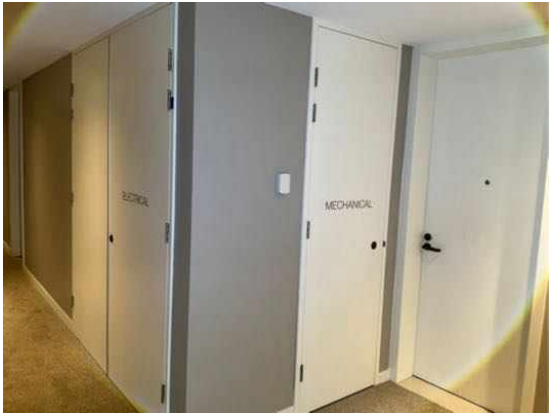
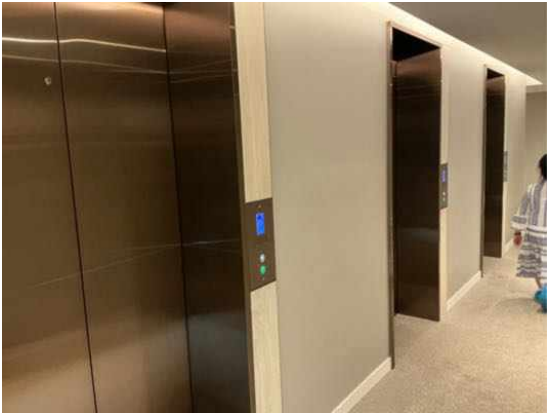
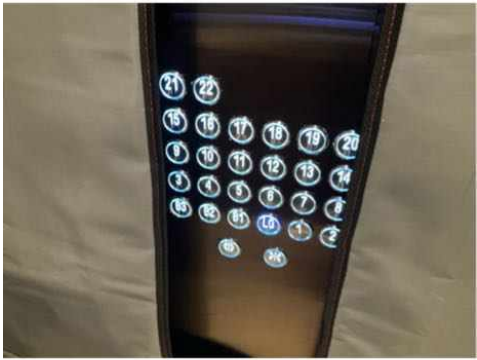
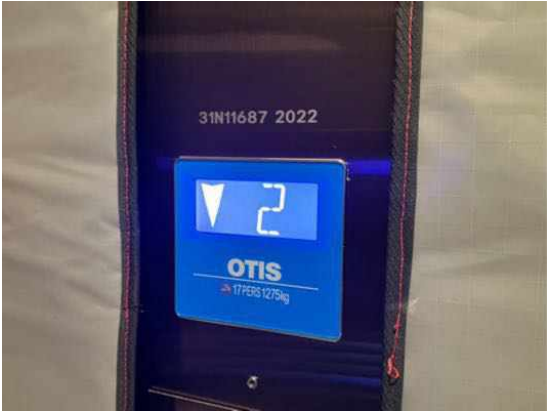
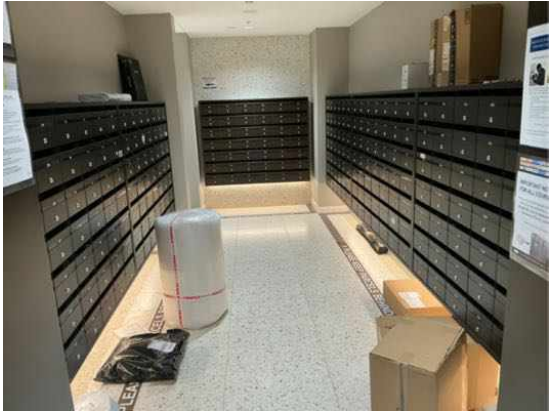
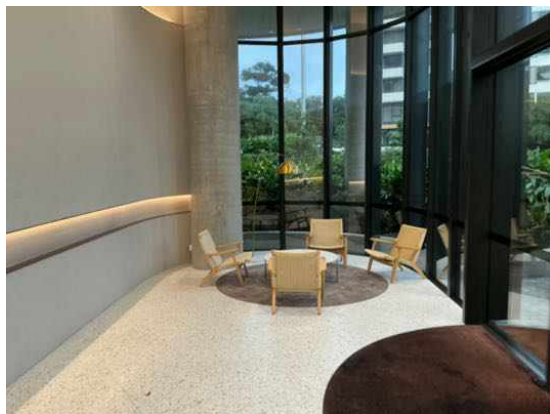
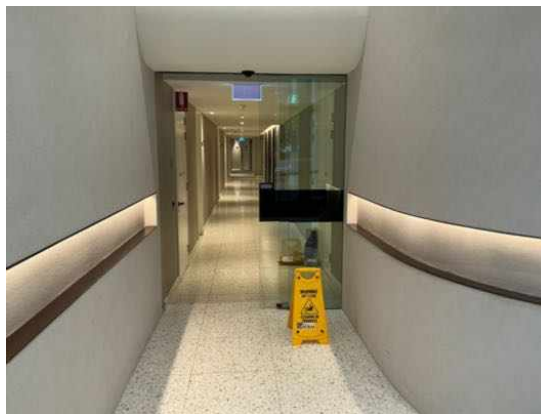
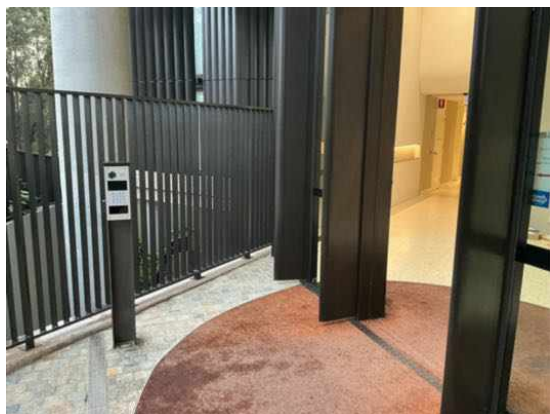
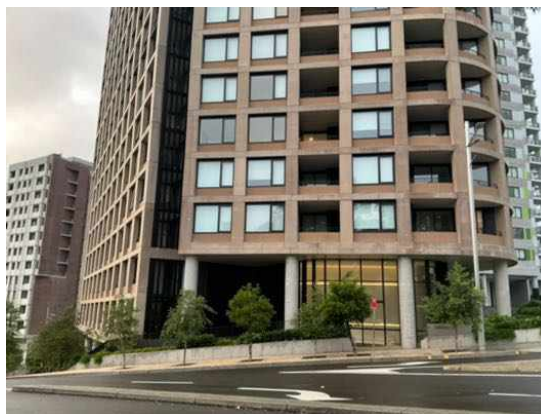
Building: Main Building
Location: All Areas
Finding: Additional Photos of Common Areas
Information: Additional photos have been provided for your general reference. These images serve as visual documentation of the current condition of the common areas within the building complex at the time of inspection. It is recommended that the client consult with strata management regarding any necessary repairs or maintenance required throughout the complex. These photographs are intended to illustrate the present state of the common areas and should be used as a basis for discussing and prioritizing any needed remedial works with the relevant parties.

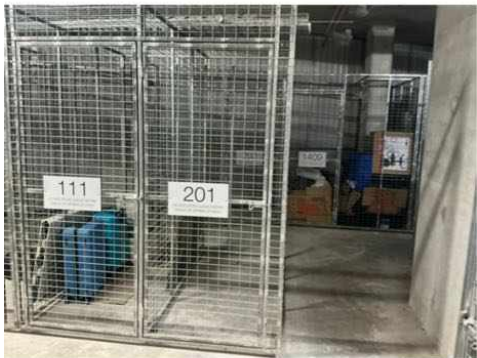
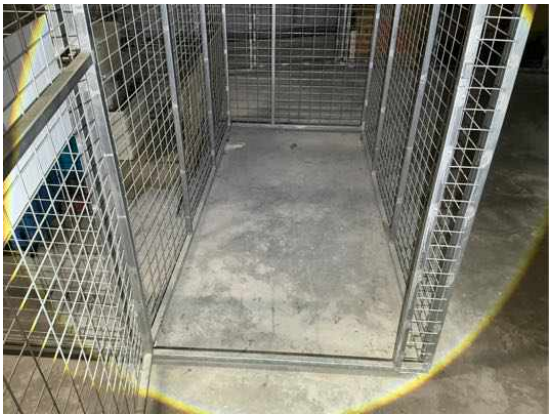
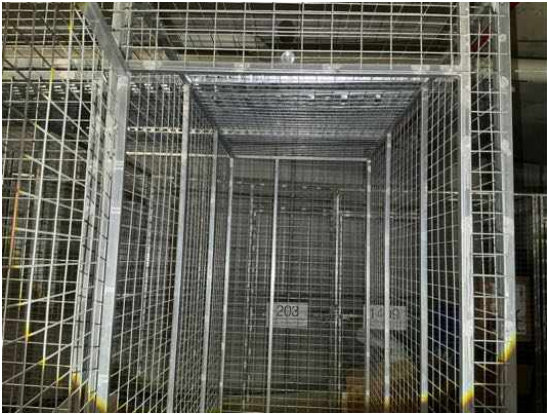
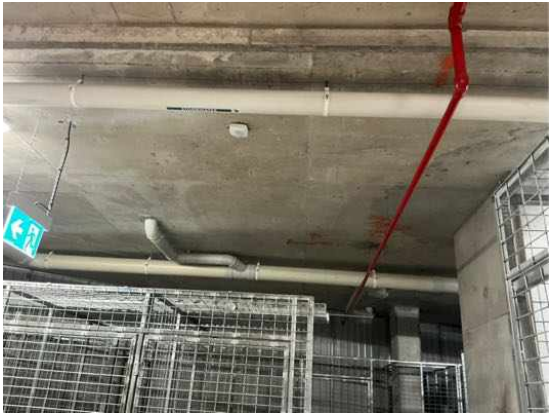
Building:	Main Building
Location:	Lower Ground
Finding:	Allocated Car Spaces & Storage Room
Information:	<p>The accompanying photos are provided for your general reference, showcasing the current condition of the car parking spots and storage rooms as observed at the time of inspection. It is important to note that these images are meant to serve as a visual snapshot of the property's features at the time of the assessment. However, the client is strongly advised to confirm all allocations, such as car parking spots, storage rooms, and any associated rights or access, within the terms of the contract. Verifying these allocations through the contract ensures clarity and avoids potential disputes regarding ownership or usage. The photos included are intended to give an overview of the designated areas, but the final details should always be cross-referenced with the contractual agreements for accuracy and completeness.</p>
