Building and Timber Pest Inspection Report

Inspection Date: Fri, 27 Feb 2026

Property Address: 72 Sussex St, Cabramatta NSW 2166,
Australia

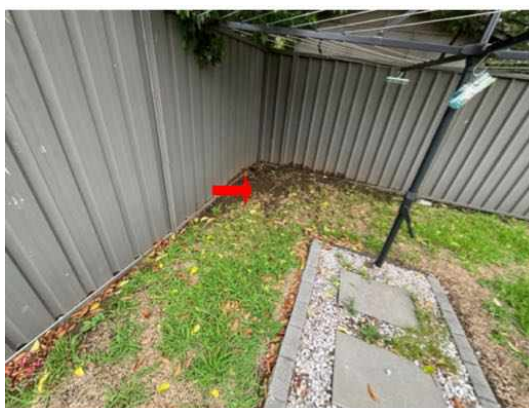
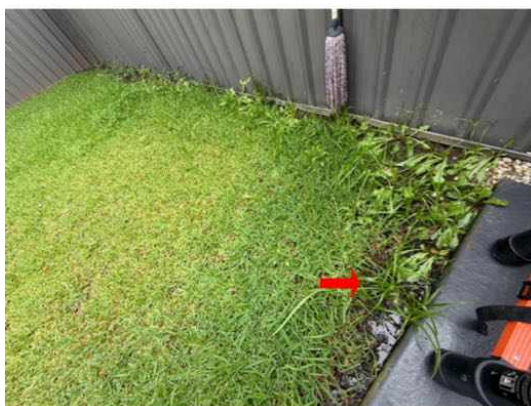
Building: Main Building
Location: Front loan
Finding: Site drainage— Inadequate
Information: The site drainage in this area was found to be inadequate at the time of inspection, creating potential for subsequent water damage to associated building elements. This is additionally conducive to termite activity.

It is important that water does not lie against the base of walls; surrounding paths and ground levels should be sloped to drain water away from walls. Downpipes should not discharge stormwater onto lower walls or plinths. Stormwater should be carried away by large, regularly cleaned drains. Ground levels may need to be lowered to expose a buried DPC.

Where site drainage is inadequate, installation of an Agricultural (Aggie) Drain may be required. A licensed plumber should be appointed to further inspect the property and perform any remedial works as necessary. Water damage and secondary defects are likely to occur if left unmanaged.

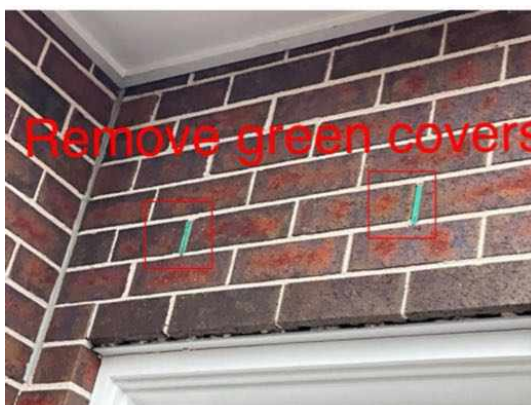
Finding 3.02

Building:	Main Building
Location:	Multiple areas
Finding:	Blockage of weepholes
Information:	Weep holes in the exterior brickwork of the property are designed to allow condensation that may build up between the brickwork and subsequent timber framework to drain from within the wall hence preventing any deterioration of the timber building elements.

Build-up of moisture is likely to occur if weep holes are covered.

It is highly recommended that weep holes are left exposed in all areas throughout the external property. A general handyman must be appointed to ensure all weep hole covers are removed.

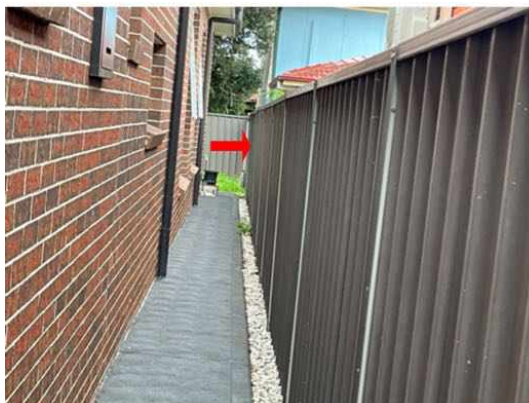
Finding 3.03

Building:	Main Building
Location:	Fencing
Finding:	Fencing - Deteriorated
Information:	It was noted at the time of inspection that sections of the fencing in this area has deteriorated. Typically fencing deteriorates due to age and or wear, rot and or rust

which is generally expected for a structure of this age, due to prolonged exposure to weather conditions. Sometimes inadequate installation or maintenance can be to blame.

If left unattended, it is likely that further damage will occur. It is suspected that repair of several elements of the fencing may be required however replacement may be a consideration of the client also.

A licensed fencing contractor should be appointed to provide further advice and perform rectification works as necessary.

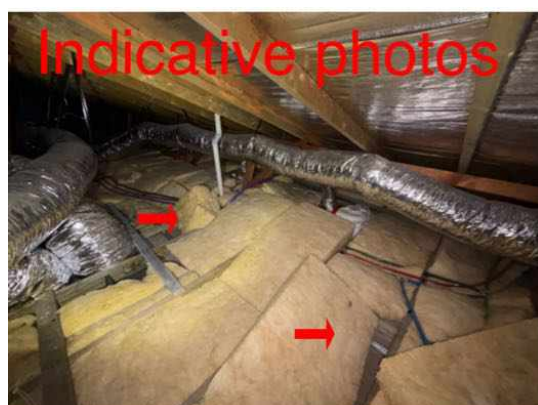
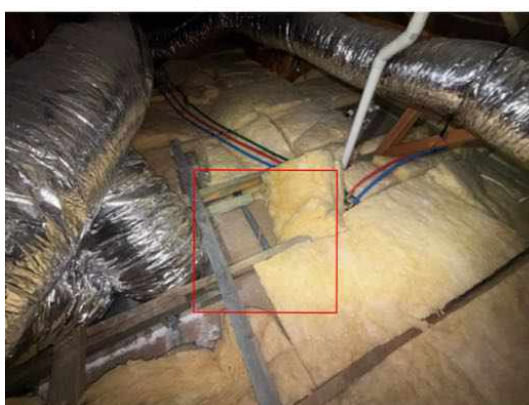
Upon inspection of the roof void it was noted that some insulation is removed and or misplaced.

Insufficient insulation will result in a comparatively higher cost to heat and cool a property as there is a lack of Insulation (or uneven coverage of insulation) which works as a barrier to heat transfer. This helps to keep out unwanted heat in summer and preserves warmth inside your home in winter. It can also help soundproof your home from unwanted airborne noise transfer.

Installation of adequate insulation is required and should be conducted as soon as possible.

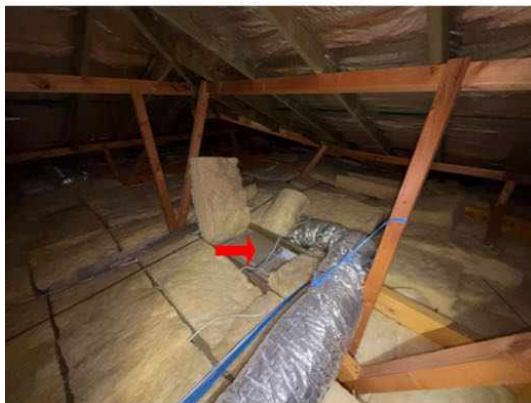
Building:	Main Building
Location:	Roof Void
Finding:	Internal air conditioning unit - Missing condensation tray
Information:	The internal air conditioning unit in the roof was found to be missing the condensation tray at the time of inspection.

An internal air conditioning unit inside the roof must have a secondary drip tray with a separate drain line to ensure any condensation is dealt with accordingly to avoid water leaks.

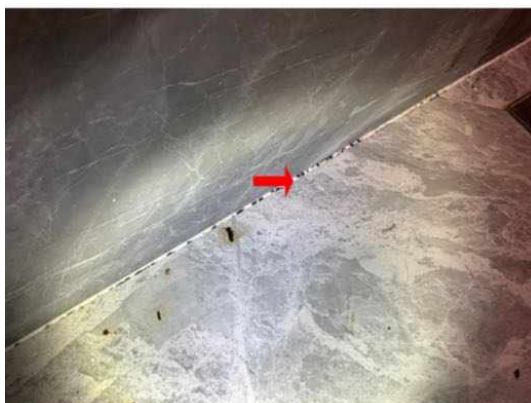
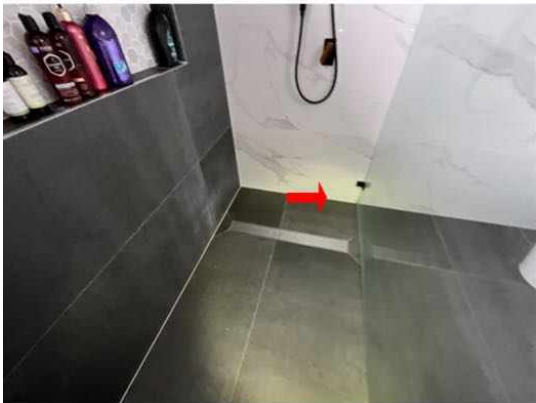
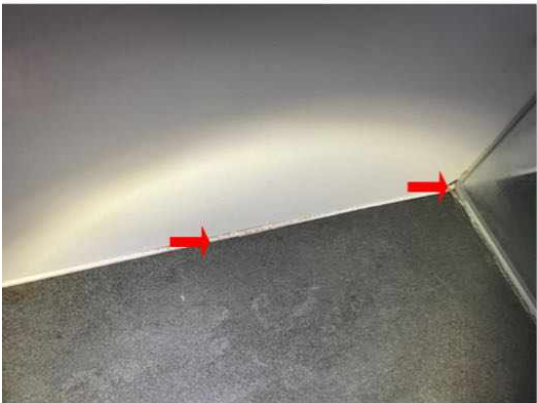
Finding 3.06

Building: Main Building
Location: All Wet Areas
Finding: Sealant and grouting - Missing or damaged
Information:

It was noted on inspection that sealant or grout is degraded to this area.

Different materials and floor areas move at different rates, generally causing cracking to grout or sealant at this point. A flexible sealant is required to allow for expected expansion and contraction, while keeping the joint water tight and protective of all associated building materials.

Flexible and mould resistant materials should be applied to affected areas to prevent any subsequent water damage that is likely to occur. Regular maintenance and replacement of damage or missing or damaged sealant and grout is highly recommended to the wet areas, as this is a regular wear and tear defect. Sealant and grouting in areas that come into regular contact with water should be maintained for the long term care of your property.

A sealant specialist should be appointed to complete these works as soon as possible.

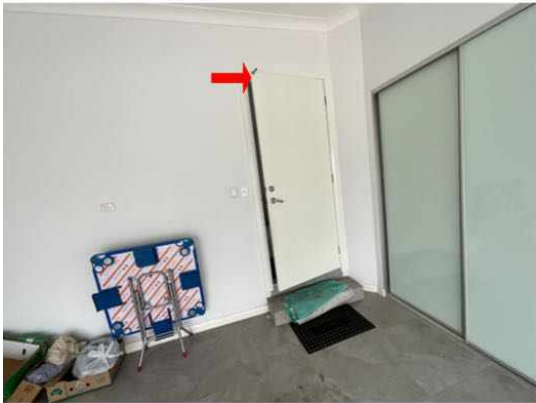
Finding 3.07

Building: Main Building
Location: Garage, master WIR
Finding: Door - Binding/jamming
Information:

Binding and/or jamming of this door is evident during standard operation. This defect inhibits the functionality of the affected door as well as creating potential for secondary defects to associated building elements, such as damage to the floor covering or adjacent frame.

A door that binds to flooring or to the associated door frame may have several causes, ranging from minor defects, such as poor installation of the door or deteriorated hinges.

A licensed carpenter should be appointed to perform minor rectification works at client discretion.

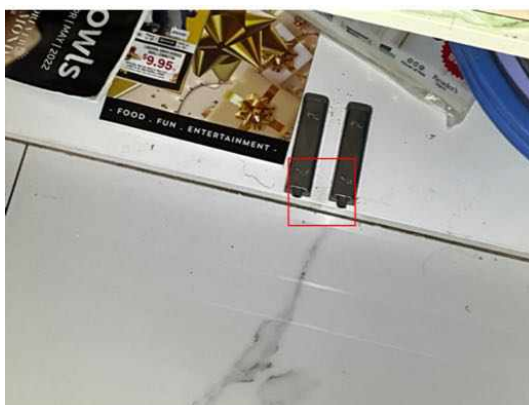
Finding 3.08

Building:	Main Building
Location:	Kitchen
Finding:	Building element - Damaged
Information:	Push to open mechanism to the cupboard door was found to be defective, requiring adjustment.

Repair and/or replacement of damaged elements is advised to ensure that additional secondary defects do not arise as a consequence. Such works are necessary, as all building elements play a key role in the operation and function of the overall structure and its performance.

A general handyman should be appointed to repair or replace the affected building element.

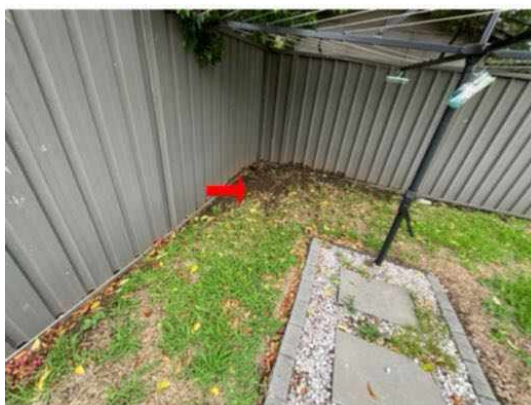
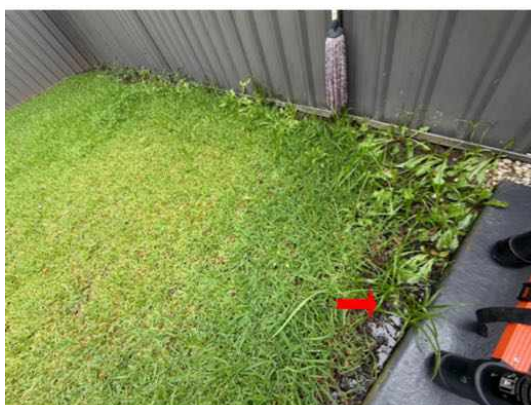
Building: Main Building
 Location: Front loan
 Finding: Site drainage— Inadequate
 Information: The site drainage in this area was found to be inadequate at the time of inspection, creating potential for subsequent water damage to associated building elements. This is additionally conducive to termite activity.

It is important that water does not lie against the base of walls; surrounding paths and ground levels should be sloped to drain water away from walls. Downpipes should not discharge stormwater onto lower walls or plinths. Stormwater should be carried away by large, regularly cleaned drains. Ground levels may need to be lowered to expose a buried DPC.

Where site drainage is inadequate, installation of an Agricultural (Aggie) Drain may be required. A licensed plumber should be appointed to further inspect the property and perform any remedial works as necessary. Water damage and secondary defects are likely to occur if left unmanaged.

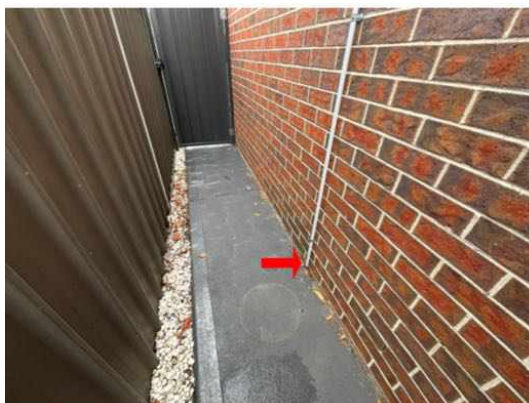
Finding 6.02

Building:	Main Building
Location:	Yard - Side
Finding:	Overflow - Not plumbed for drainage
Information:	The overflow is not plumbed or connected to suitable drainage, which can result in the surrounding area becoming excessively damp.

These damp conditions can lead to secondary defects such as rot, rust or corrosion of associated building elements, the formation of fungal decay, or even the creation of potential slip hazards. When coupled with poor site drainage, pooling of water may also attract termite activity to this area.

It is highly recommended that a licensed plumber be appointed to install adequate drainage to the overflow. These works will ensure that the area remains dry and free of any secondary defects.

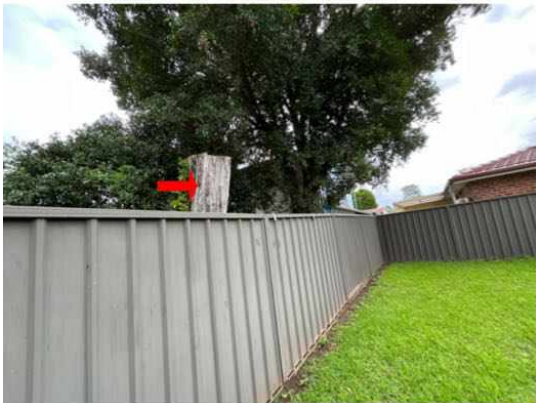
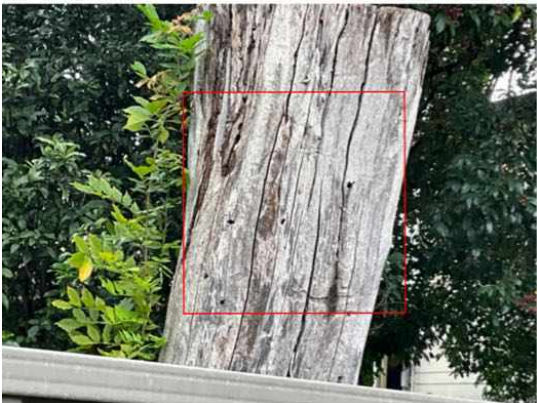
Building:	Main Building
Location:	Trees
Finding:	Evidence of wood borer activity identified
Information:	Wood borers small beetles that colonise in exposed timber elements are a common timber pest that are regularly mistaken for termites. Although wood borer activity is generally not detrimental to the affected timber they may lead to serious damage and necessitate replacement of certain building elements if left unattended.

As no live wood borer activity was identified treatment is not required at this time. Replacement of affected timbers may be considered by the client for superficial reasons.

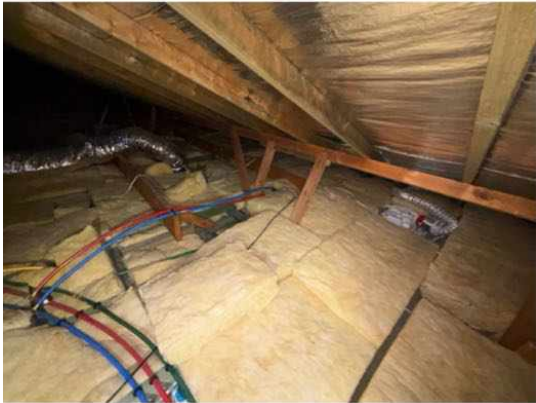
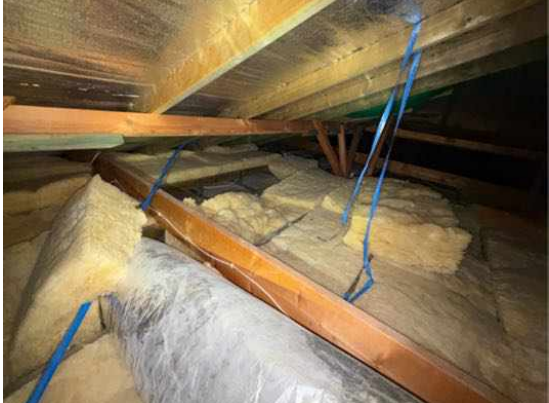
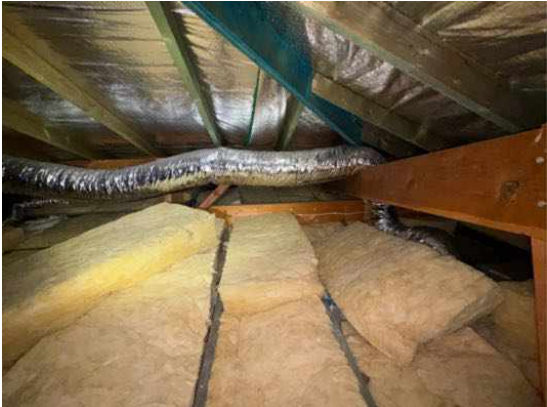
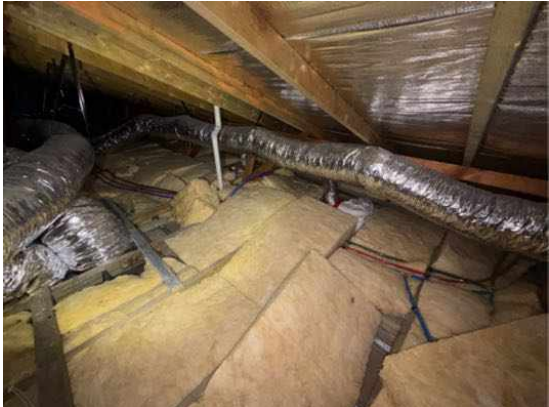
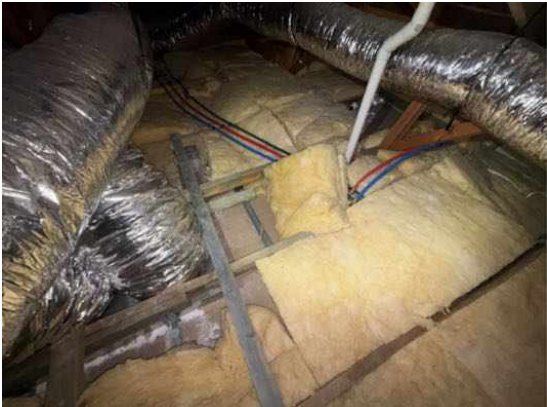
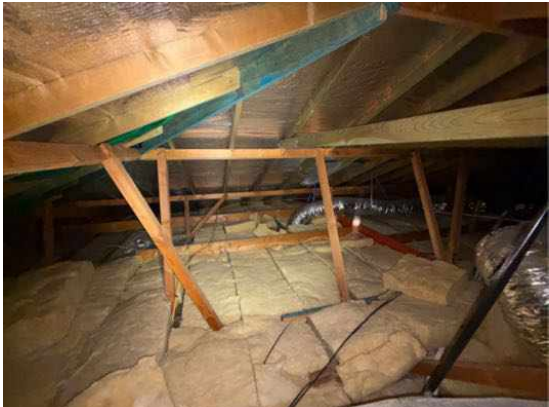
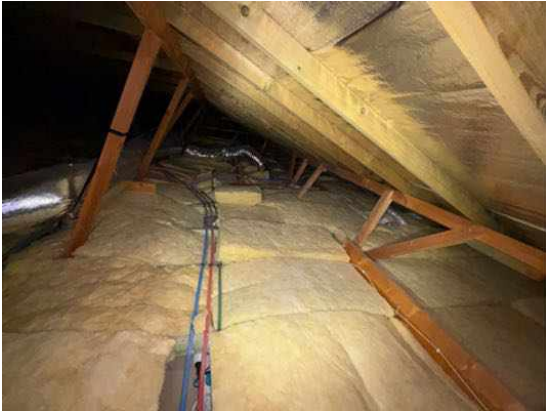
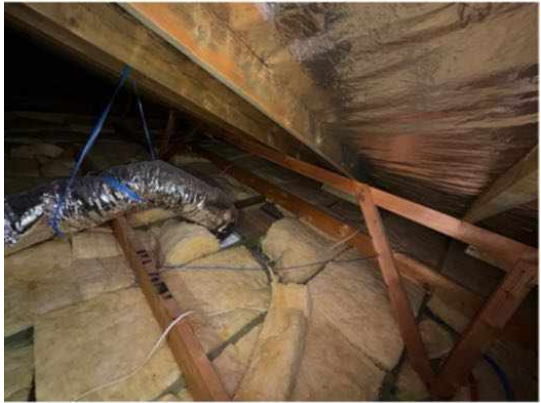
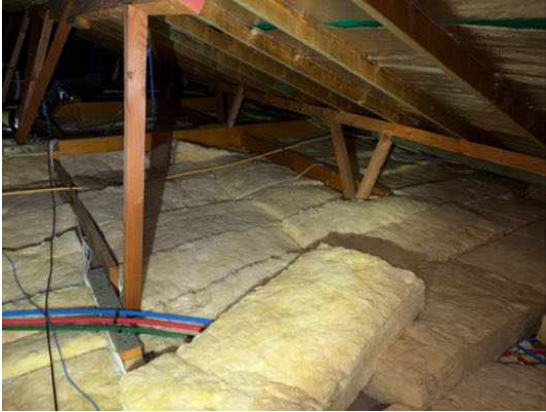
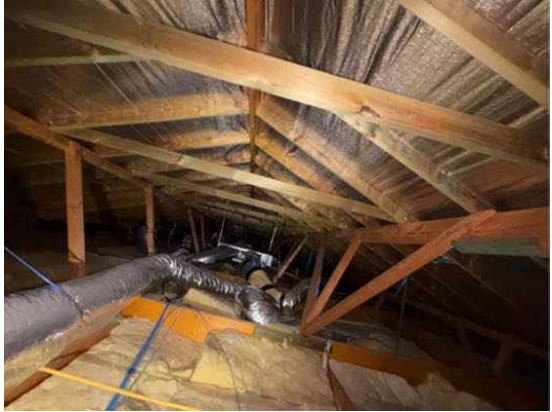
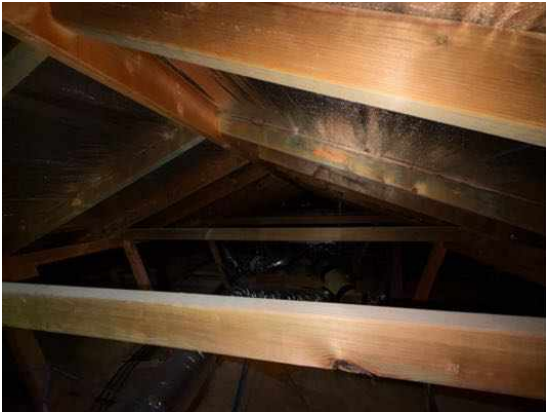
Building: Main Building
Location: Roof Void
Finding: Additional Photos
Information:

Additional photos are provided for your general reference.

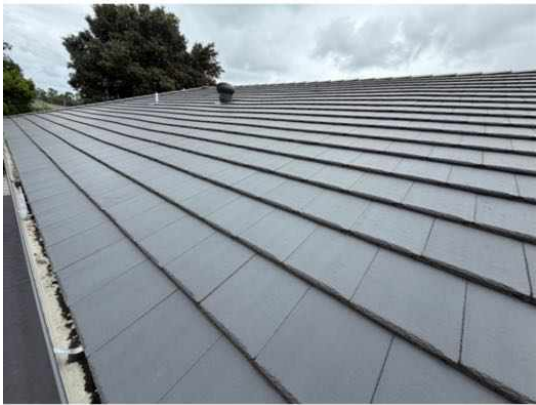
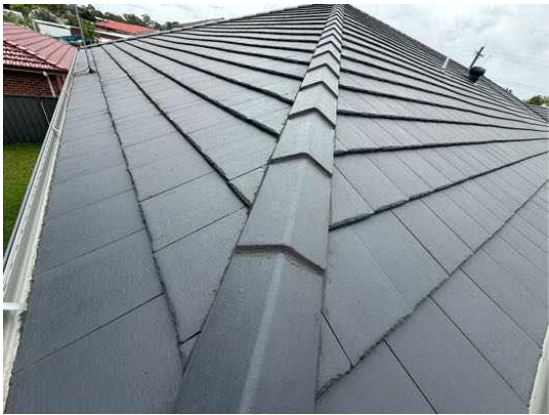
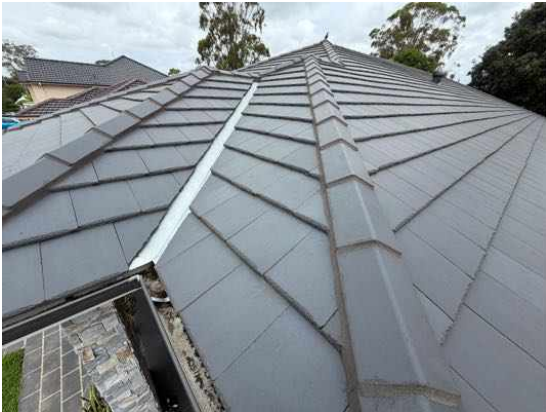
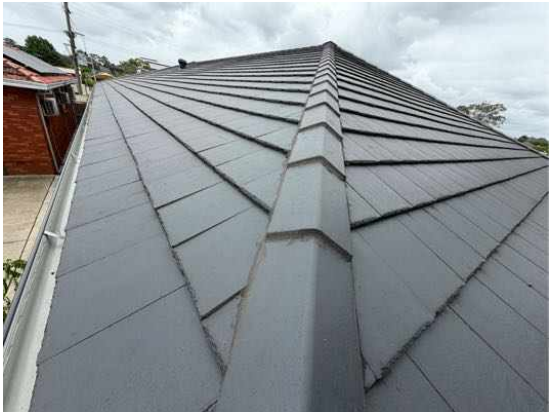
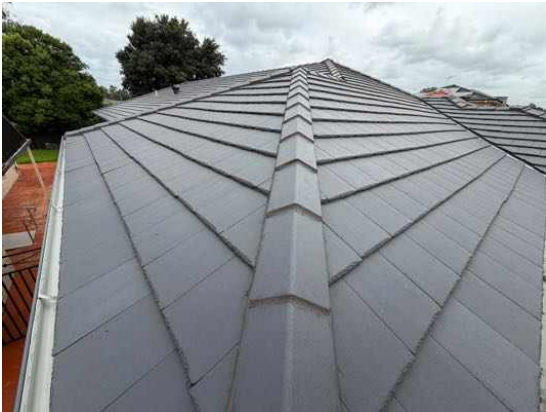
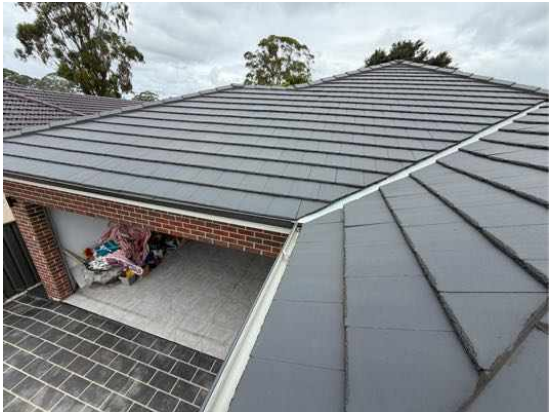
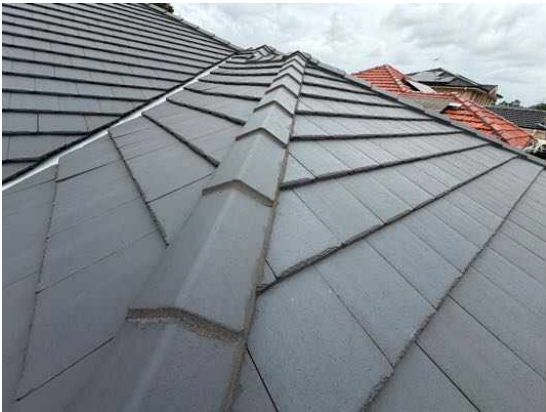
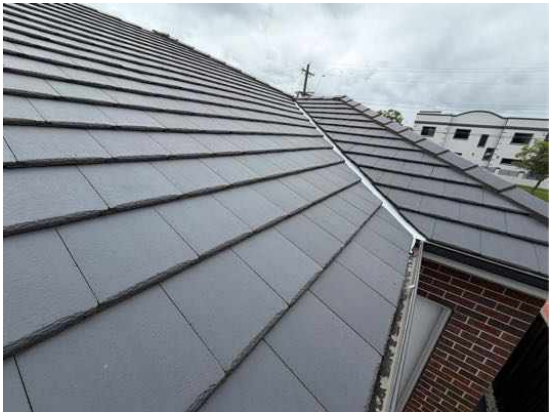
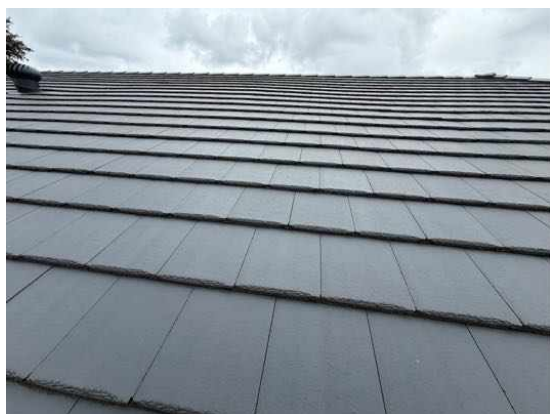
Building: Main Building
Location: Roof Exterior
Finding: Additional Photos
Information:

Additional photos are provided for your general reference.

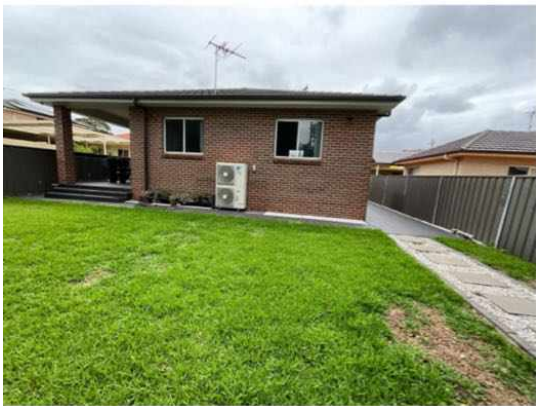
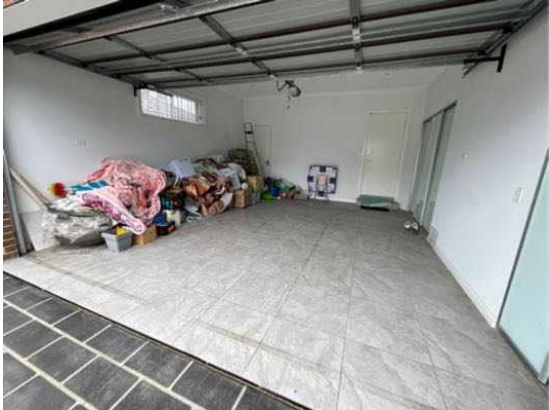
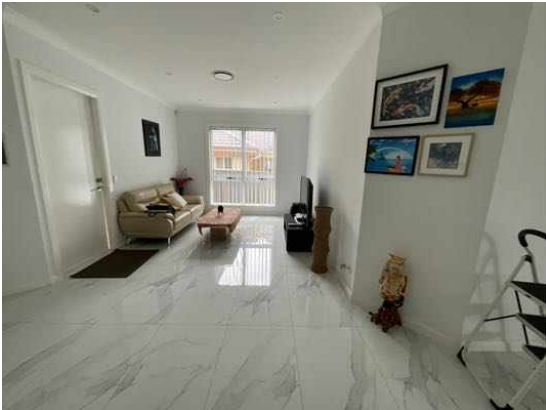
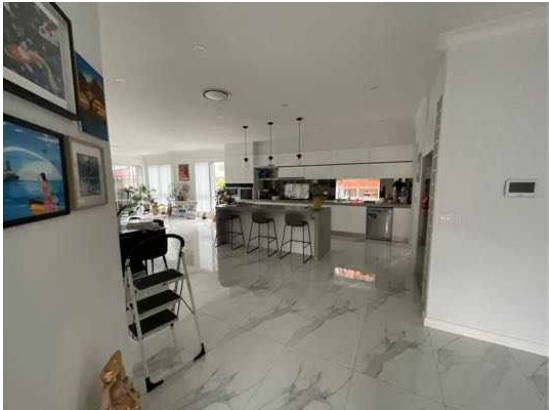
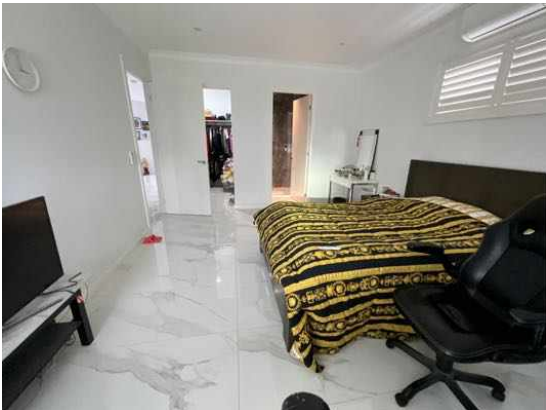
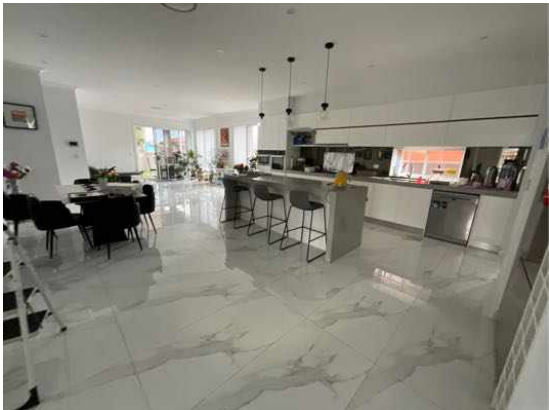
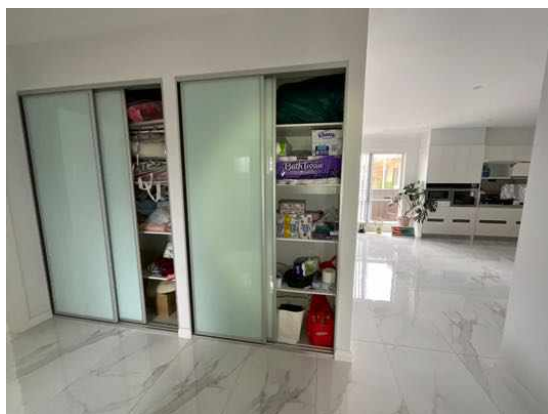
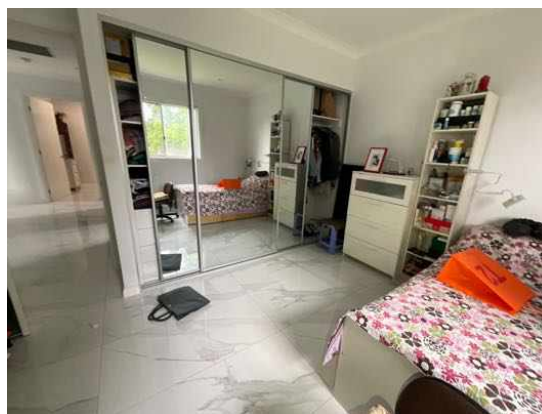
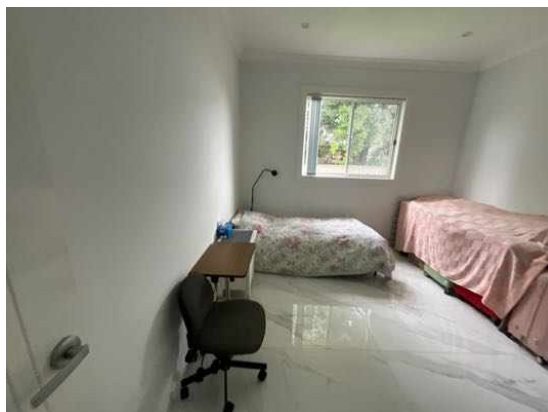
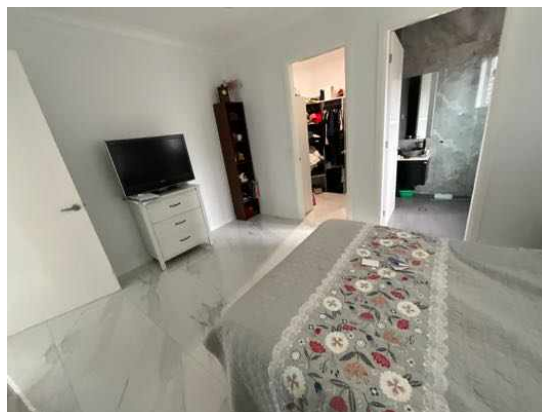
Building: Main Building
Location: All Areas
Finding: Additional Photos - Obstructions and Limitations
Information:

These photographs are an indication of the obstructions and limitations which impeded full inspection of the property at the time of inspection. These obstructions can hide an array of defects and should be removed to allow full inspection to be carried out. A re-inspection is recommended once the areas are made accessible.
