## Building and Timber Pest Inspection Report

Inspection Date: Mon, 12 Jan 2026

Property Address: 12/14 River Esplanade, Mooloolaba QLD  
4557, Australia

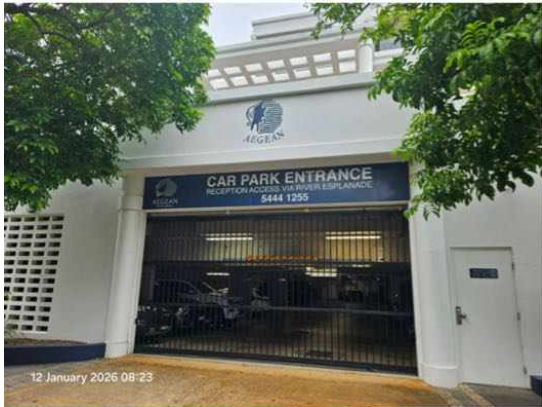
12 January 2026 08:23

Building: Main Building  
 Location: All Areas  
 Finding: Additional Photos for client reference  
 Information: Additional photos are provided for your general reference.
