Building and Timber Pest Inspection Report

Inspection Date: Wed, 4 Mar 2026

Property Address: 9a Bonneville Bvd, Goulburn NSW 2580,
Australia

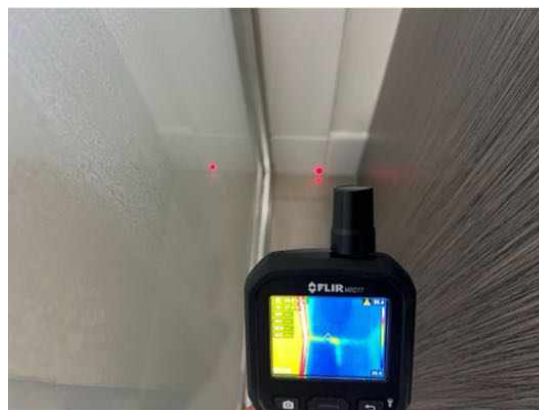
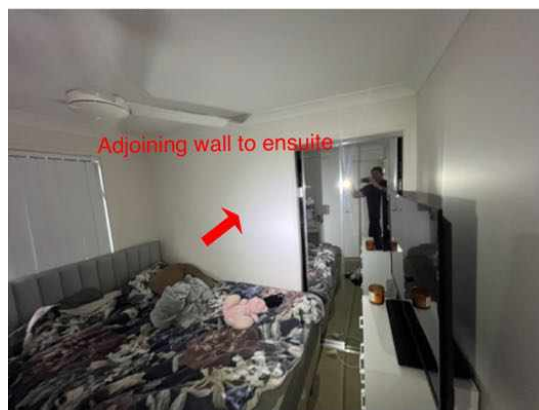
Building: Main Building
Location: Ensuite
Finding: Wet Area - Moisture Tracking
Information: Thermal imaging undertaken during the inspection identified temperature anomalies consistent with moisture tracking from the shower area toward the adjoining vanity section of the bathroom. This pattern is commonly associated with moisture movement across tiled surfaces or through underlying building materials and may indicate deterioration of sealant joints, grout lines, or potential deficiencies within the waterproofing system.

Wet areas are frequently exposed to water, and where moisture is able to migrate beyond the immediate shower enclosure it may penetrate concealed sections of flooring or adjoining wall structures. If left unmanaged, this condition may lead to progressive moisture damage to surrounding building elements.

The adjoining wall area was obstructed at the time of inspection and could not be visually assessed for any associated moisture damage. Thermal imaging identifies temperature variations only and does not confirm the presence or extent of concealed moisture or damage.

A licensed plumber or tiling contractor should be appointed to further assess the shower enclosure, adjoining tile junctions, and waterproofing integrity to ensure the area remains adequately sealed against water penetration and to determine whether remedial works are required.

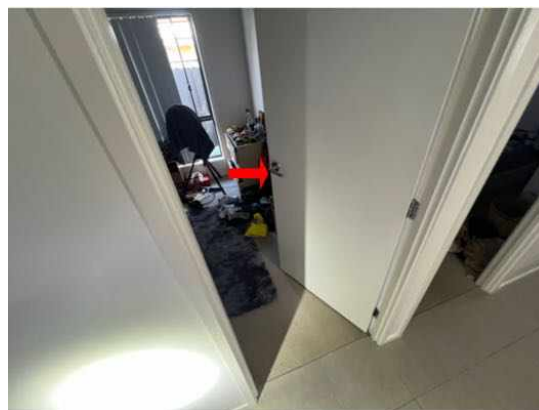
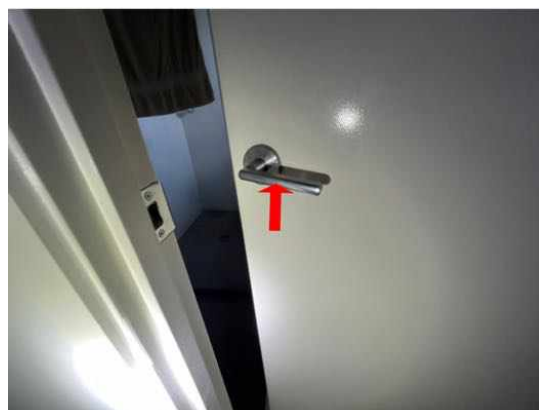
Finding 3.02

Building:	Main Building
Location:	All Internal Areas
Finding:	Door Handle - Loose
Information:	The door handle lever in this area was identified as loose at the time of inspection. A loose door handle can impede the proper operation of the door and, if left unattended, may lead to further deterioration or damage to the associated door structure.

This defect is typically caused by wear and tear, insufficient fixing, or deterioration of the handle's components.

It is recommended that a qualified carpenter or general handyperson be appointed to secure or replace the handle to restore its functionality and ensure proper operation.

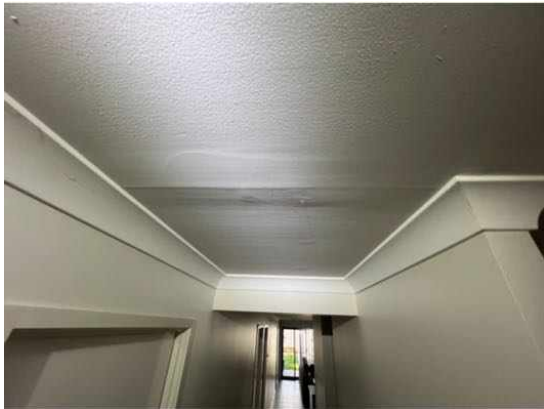
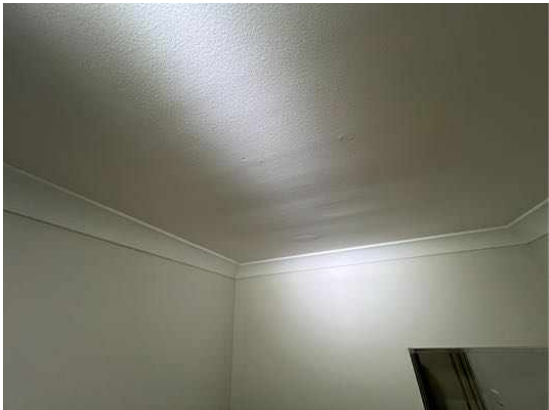
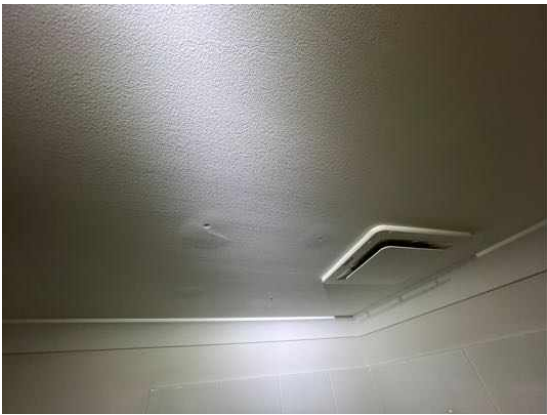
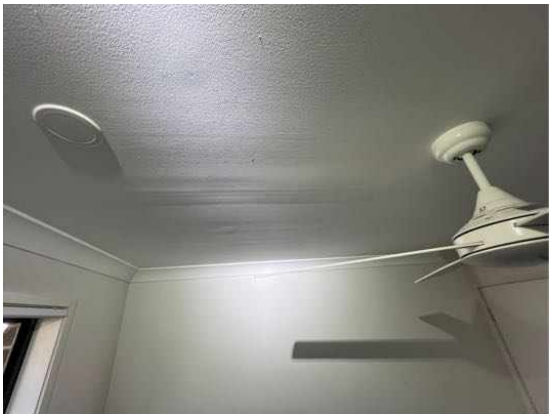
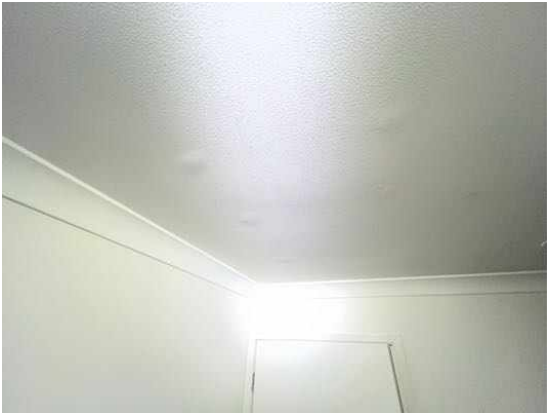
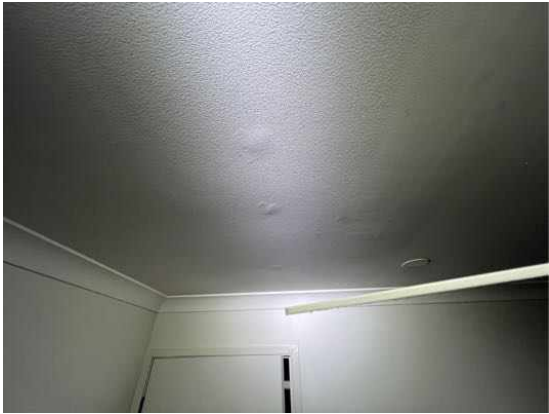
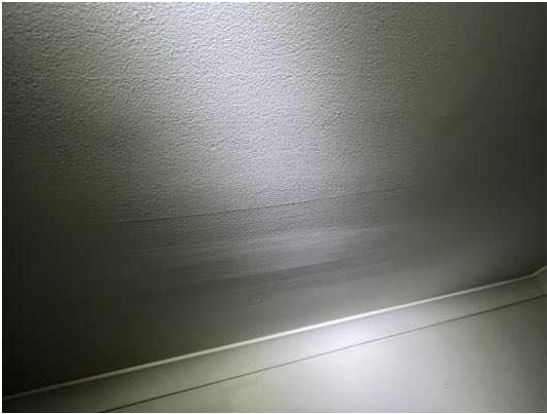
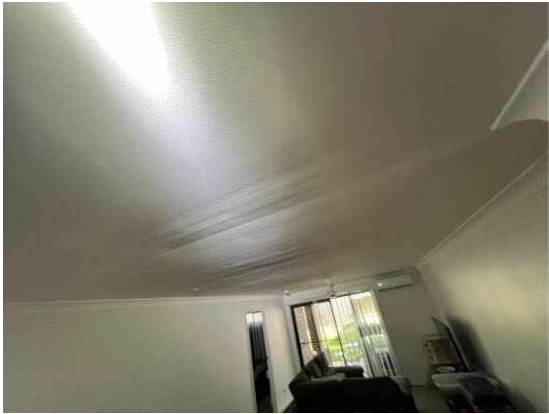
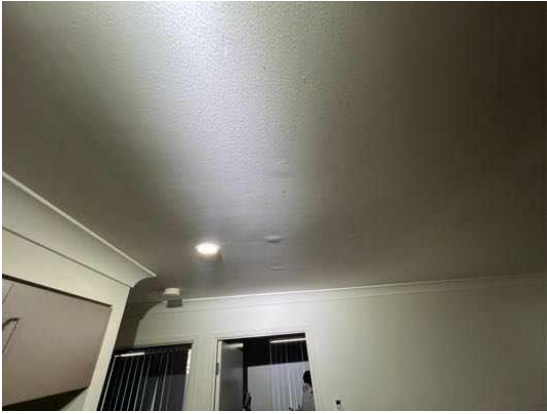
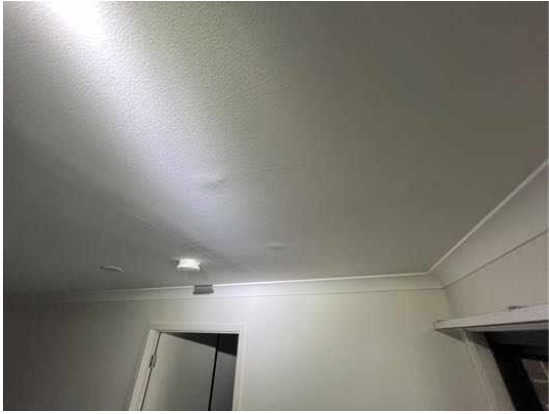
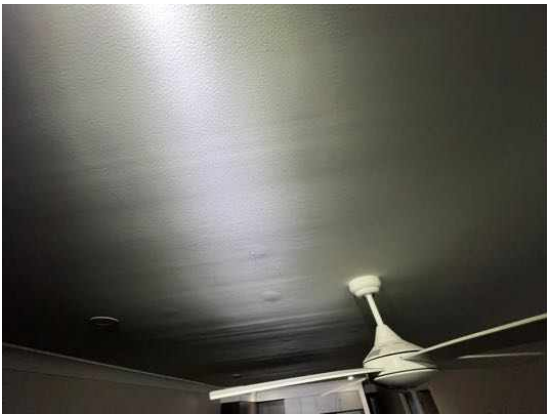
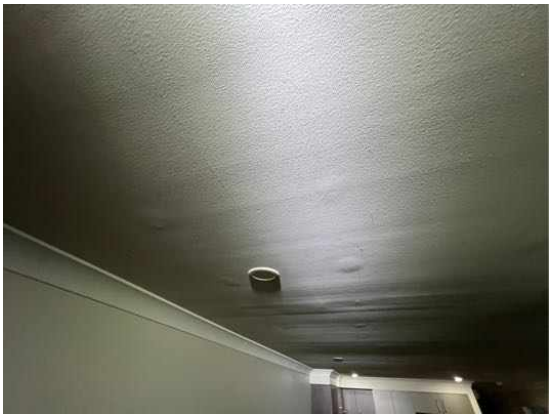
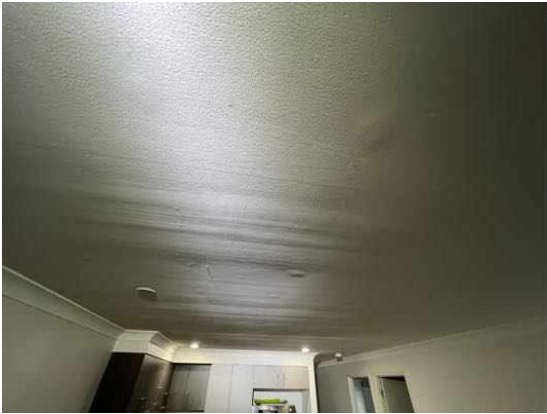
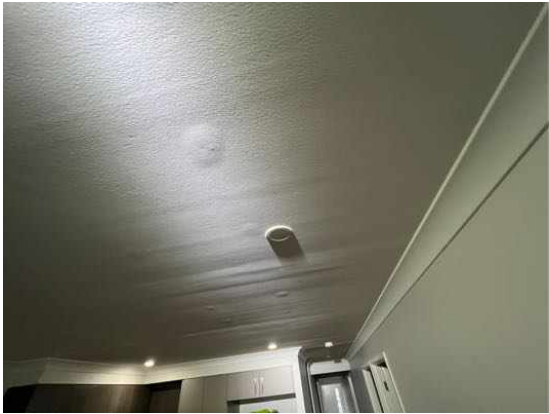
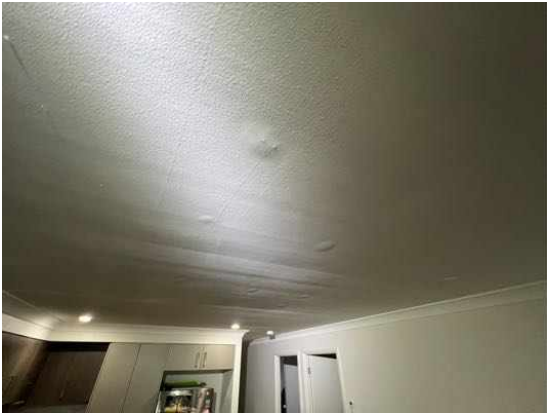
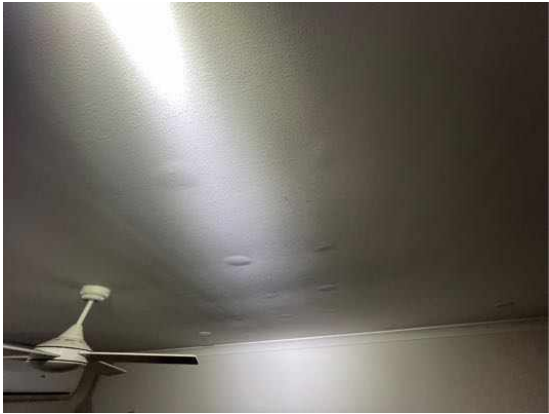
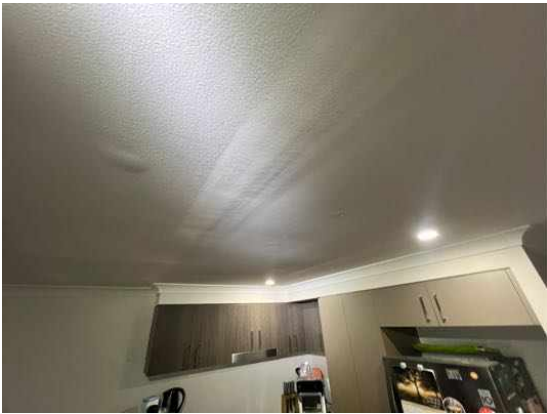
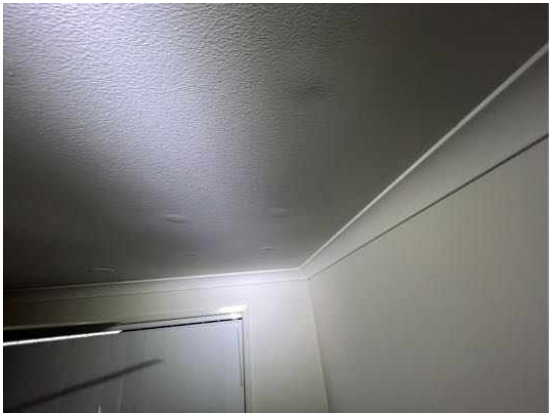
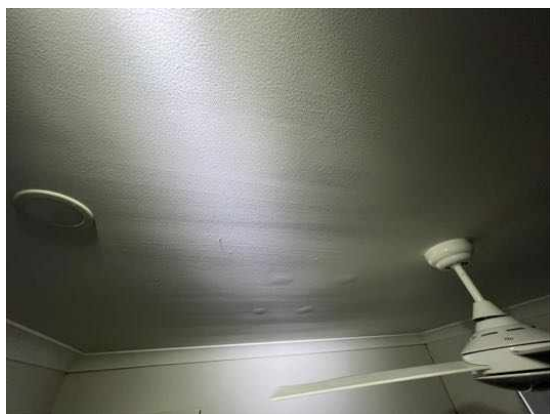
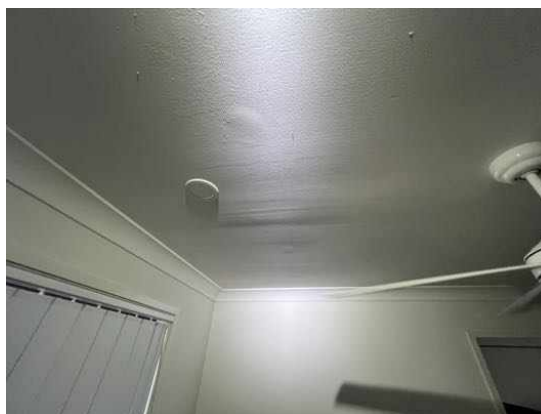
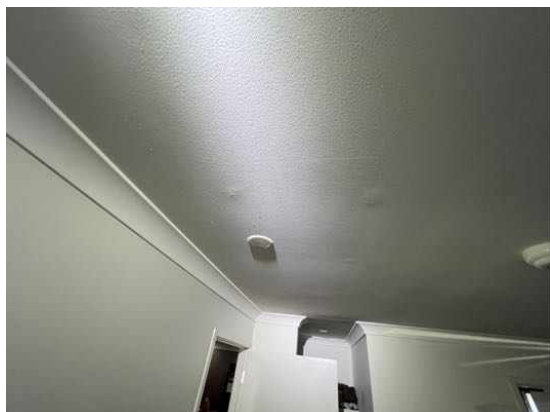
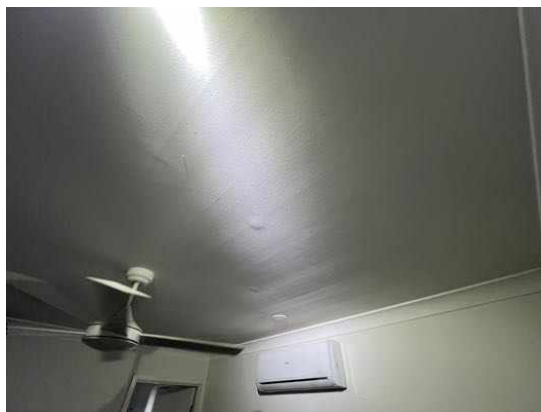
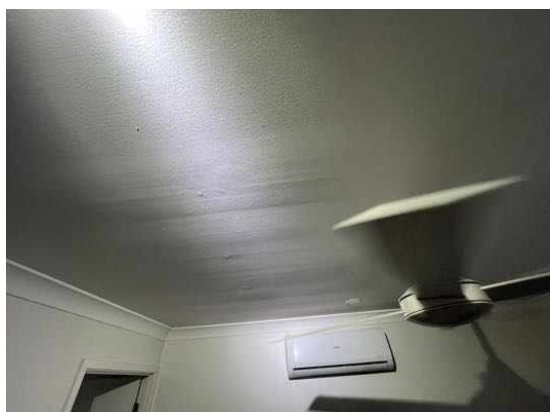
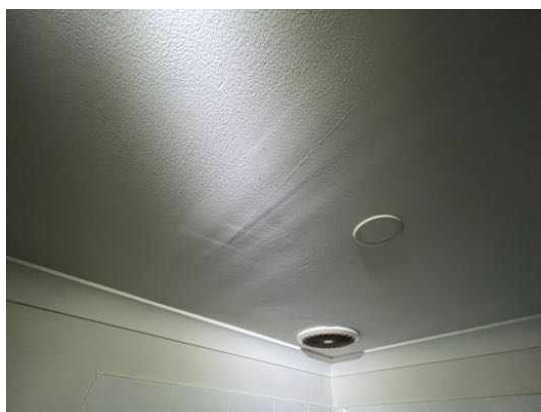
Finding 3.03

Building:	Main Building
Location:	Entry, Hallway, Office, Bathroom, Living, Dining, Bedroom 3, Bedroom 2, Bedroom 1, Ensuite
Finding:	Ceiling linings - Poor workmanship
Information:	Ceiling linings in these areas were observed to display poor finishing and surface irregularities at the time of inspection. Visible screw flushing finishes, inadequate flushing of joints and uneven surface areas were evident across sections of the ceiling lining. These conditions are typically associated inadequate plasterboard finishing or insufficient setting and sanding of joint compound during installation.

While primarily aesthetic in nature, poor finishing of this kind may become more noticeable over time and may require remedial patching and refinishing to achieve an acceptable appearance.

A plastering contractor should be appointed to assess the affected ceiling areas and undertake repairs as required to improve the finish and presentation of the ceiling lining.

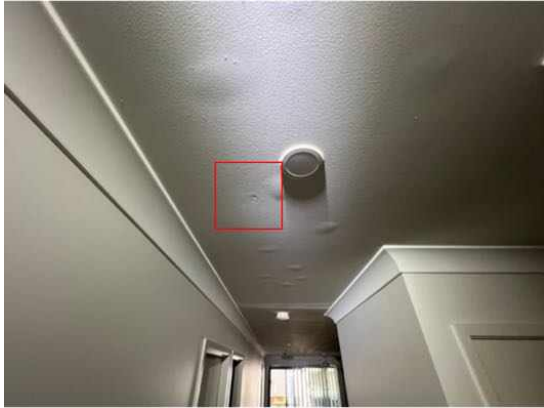
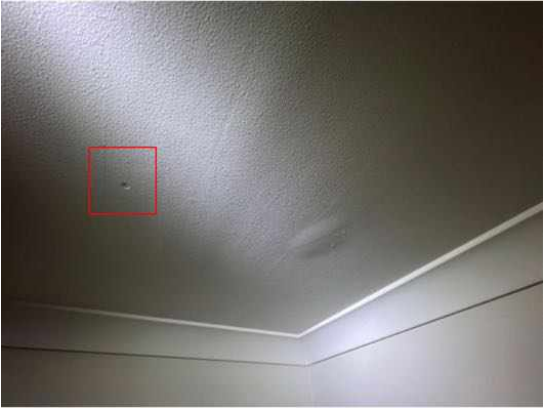
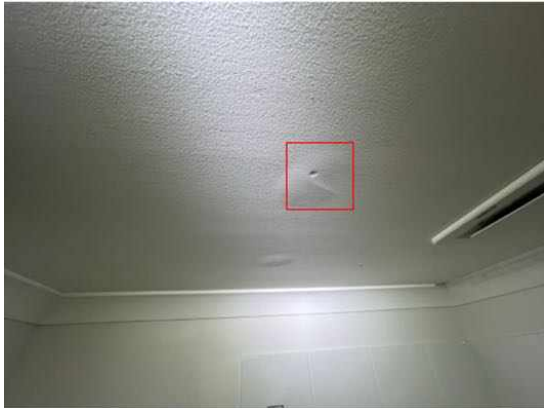
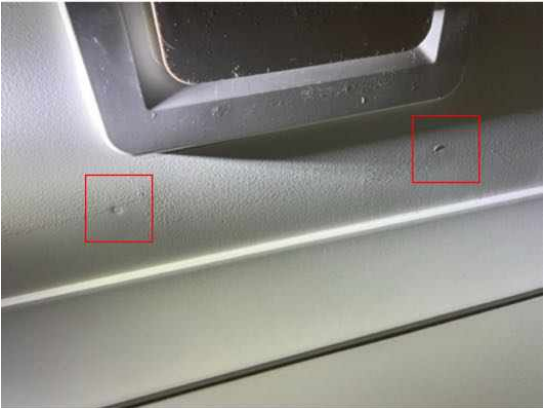
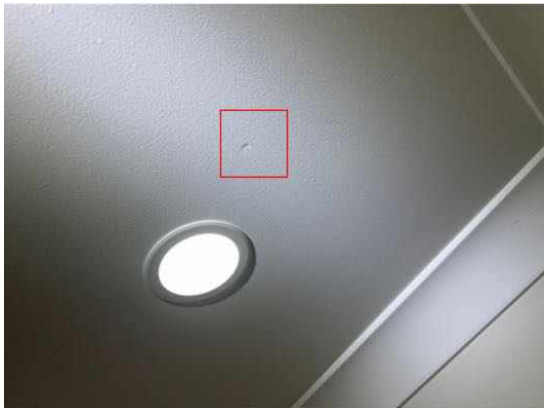
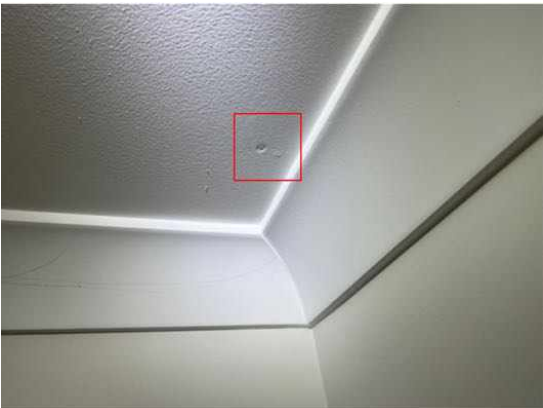
Finding 3.04

Building:	Main Building
Location:	Hallway, Bathroom, Toilet (WC), Ensuite
Finding:	Ceiling nails - Popping
Information:	Numerous popped nails were identified in the internal ceiling at the time of inspection. Nails and screws hold simply by the friction between them and the surface they are applied to. Over time, the nails and screws can back out, which is often a result of general ageing and deterioration of the building structure.

If left unmanaged, the ceiling sheets may become loose and unstable, increasing the rate of deterioration of the internal ceiling and creating potential for the development of secondary defects.

Re-fastening of popped nails will help to maintain the stability of the internal ceiling and associated building elements. Such minor works will also help to improve the appearance of the affected area and secure the ceiling sheets, so as to prevent the onset of ceiling sagging. These works should be performed by a qualified carpenter or plasterer at client discretion.

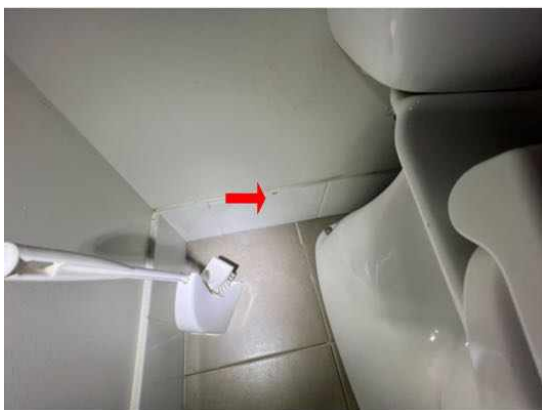
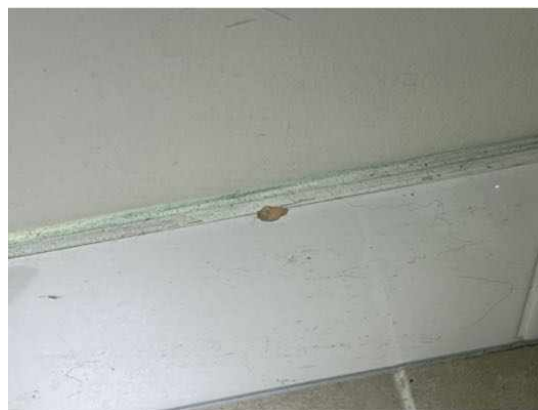
Finding 3.07

Information: A small chip was observed to the tile in this area. This type of damage commonly occurs from minor impact or general use over time and is considered a minor cosmetic defect.

While the condition does not currently affect the function of the tiled surface, damaged edges may become more noticeable over time and could allow minor deterioration of the tile edge if left unmanaged.

A tiling contractor should be appointed to assess the affected tile and carry out repairs or replacement if considered necessary.

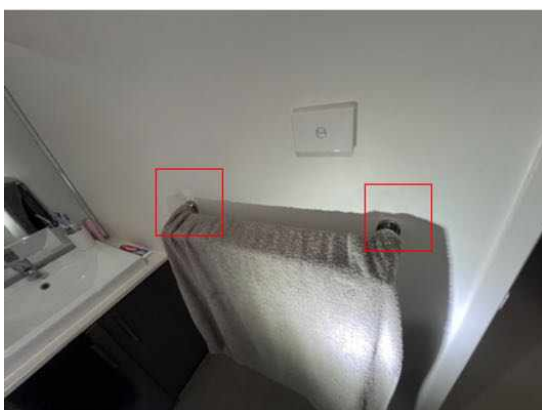
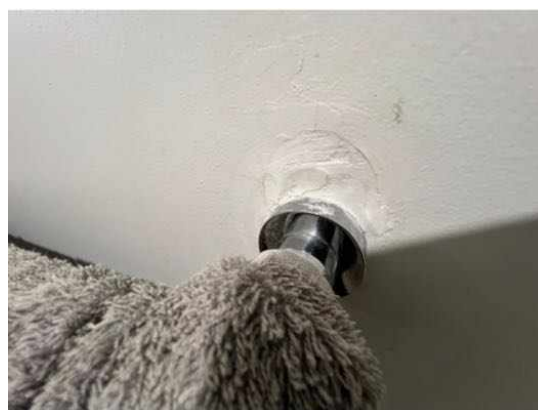
Finding 3.08

Building:	Main Building
Location:	Bathroom
Finding:	Plasterboard - Damaged
Information:	Breakage occurs generally when the building materials have either aged and decayed, or as a result of damage (accidental or deliberate).

Repair and/or replacement of broken elements is advised to ensure that additional secondary defects do not arise as a consequence. Such works are necessary, as all building elements play a key role in the operation and function of the overall structure and its performance.

A plasterer or general handy person should be appointed to repair or replace the affected building element prior to any subsequent damage being caused followed by a painter.

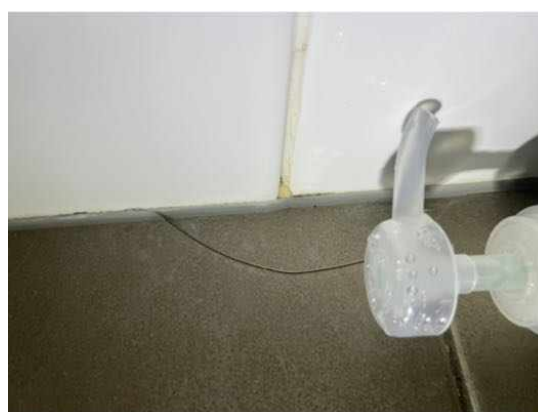
Building:	Main Building
Location:	Bathroom
Finding:	Tiles - Cracked or damaged
Information:	Cracking was evident to the tiling in this area at the time of inspection. While the cracking appears to be minor, this area is frequently exposed to water, allowing potential for water penetration into adjoining sections of walls or flooring.

If left unmanaged, water penetration to these areas may lead to subsequent water damage, which is likely necessitate repair work to affected building elements.

A tiling contractor should be appointed to ensure that no further water damage occurs. The re-application of silicone and grouting throughout remaining tile work is also advised, to further protect the area against water penetration.

Where water penetration has led to water damage, appointment of a relevant tradesperson may be required to repair damaged building elements.

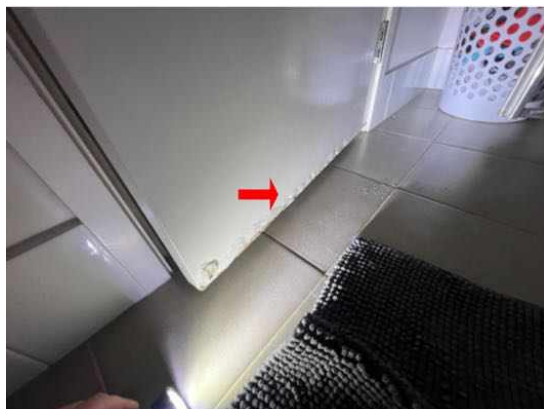
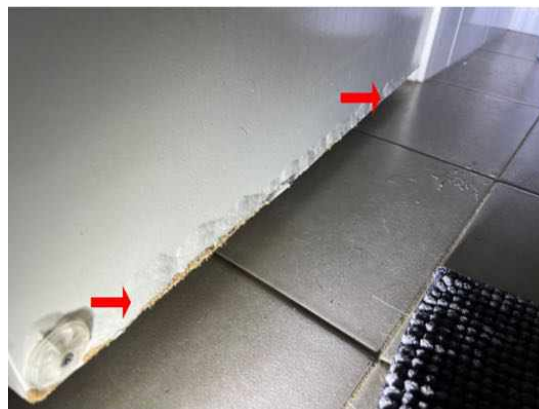
Finding 3.12

Building:	Main Building
Location:	Bathroom
Finding:	Wet Area Door - Localised moisture damage

Information: Localised moisture damage was observed to the bottom of the wet area door. This condition is commonly caused by prolonged exposure to moisture, often from inadequate sealing or water splash during use.

If left unmanaged, further deterioration may occur, potentially affecting door operation and the appearance or durability of the material.

It is recommended that the door be monitored for ongoing moisture exposure and resealed or replaced if deterioration progresses.

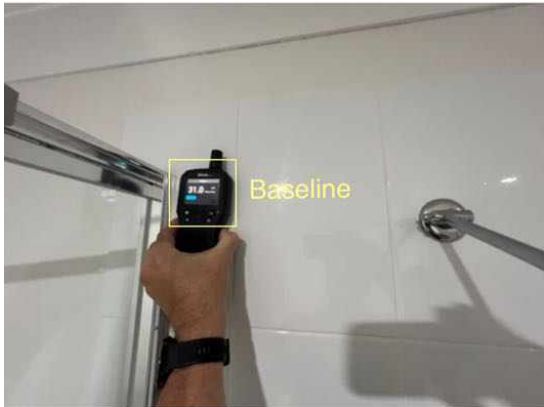
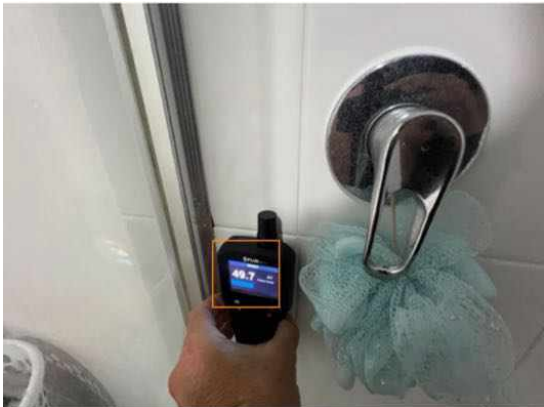
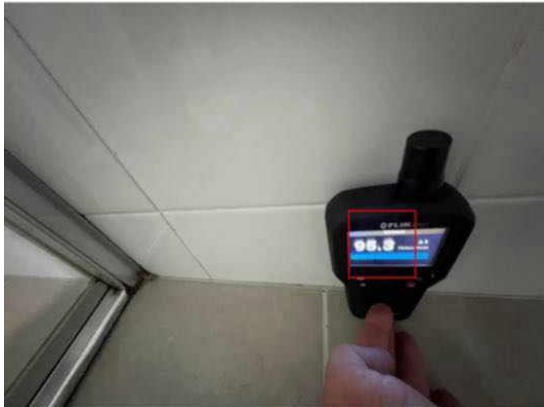
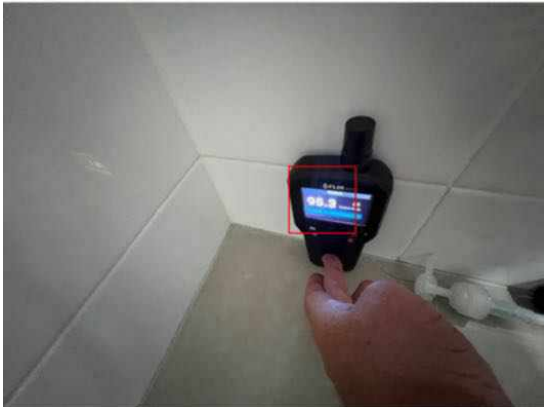
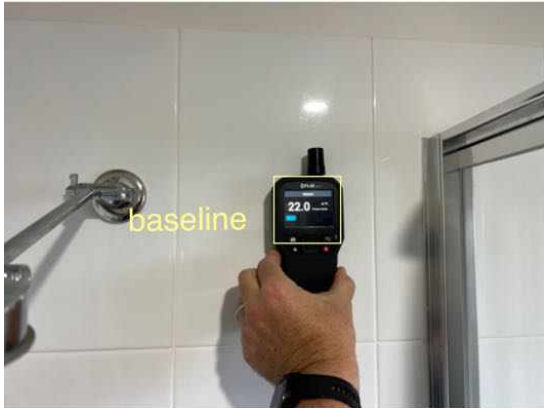
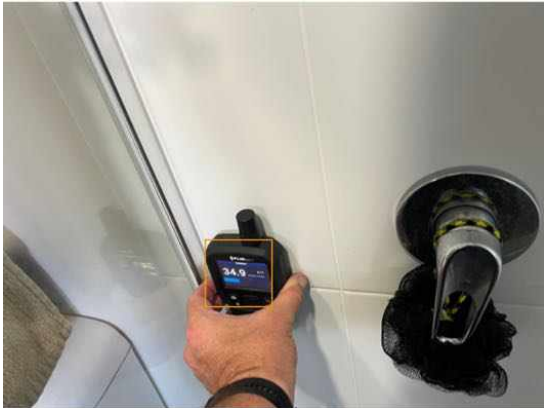
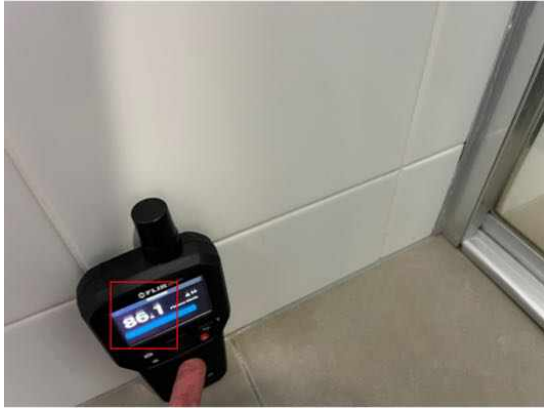
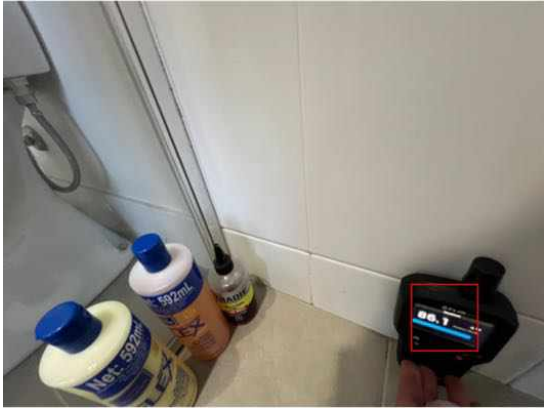
Finding 3.13

Building: Main Building
 Location: Bathroom, Ensuite
 Finding: Moisture in shower - No action required
 Information: Moisture is evident behind the tiles to the shower alcove. This defect is quite common, and is suspected to have been caused by moisture permeating through the grouting in this area.

Given that no moisture was detected around plumbing and at the other side of the wall, no action is required on this defect.

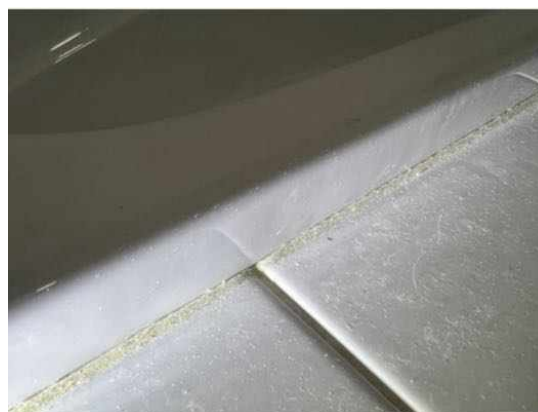
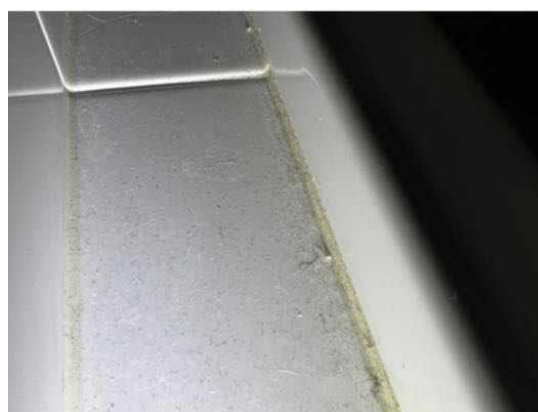
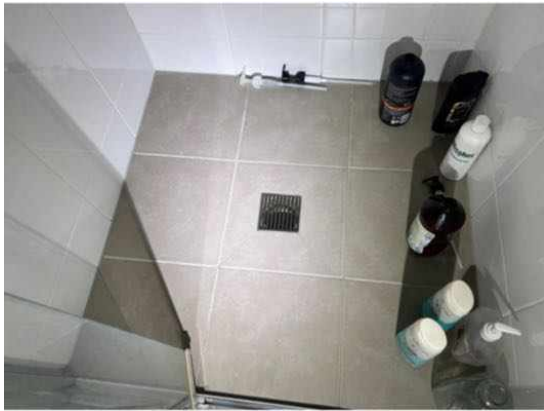
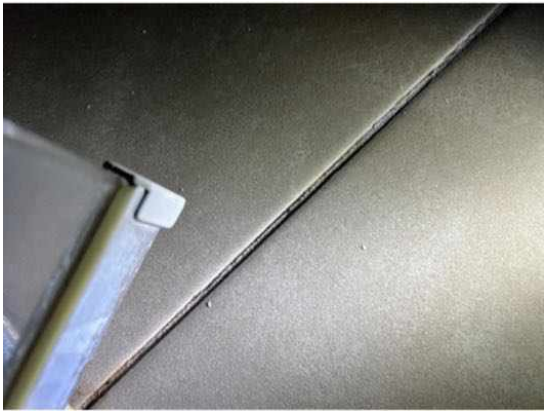
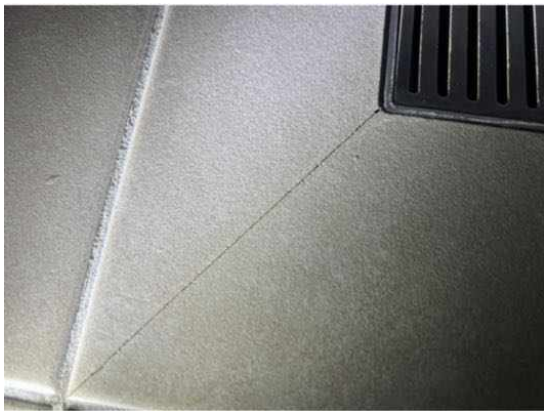
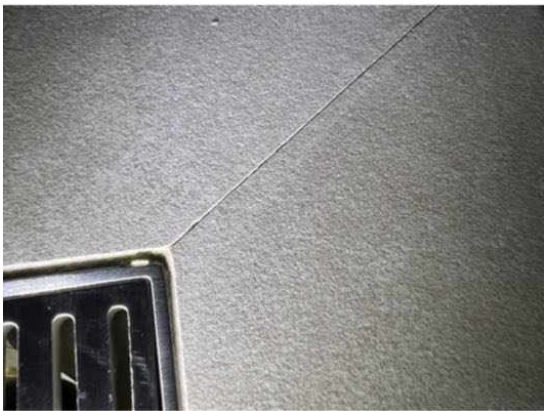
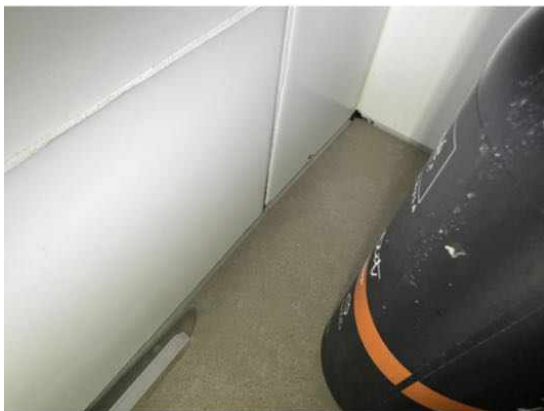
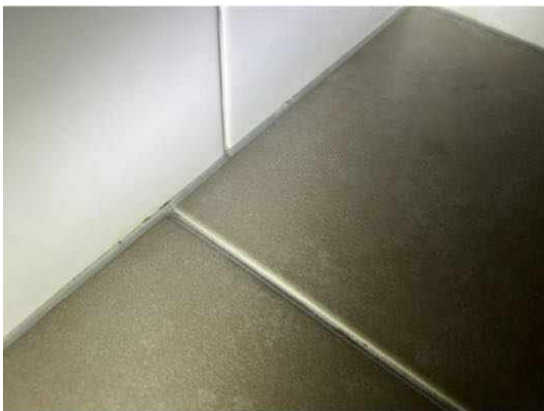
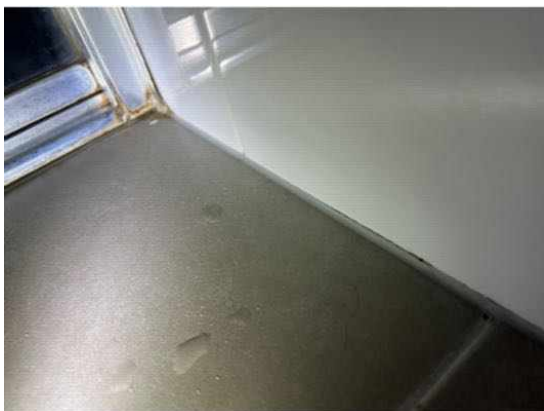
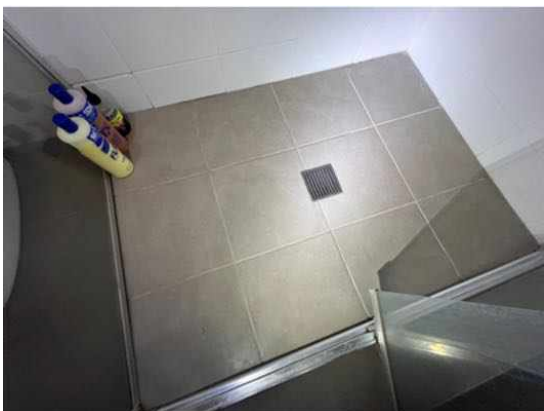
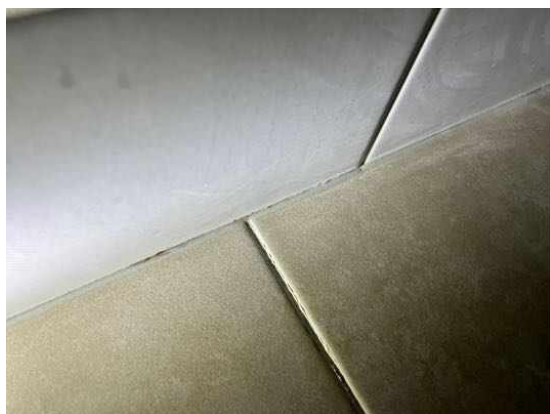
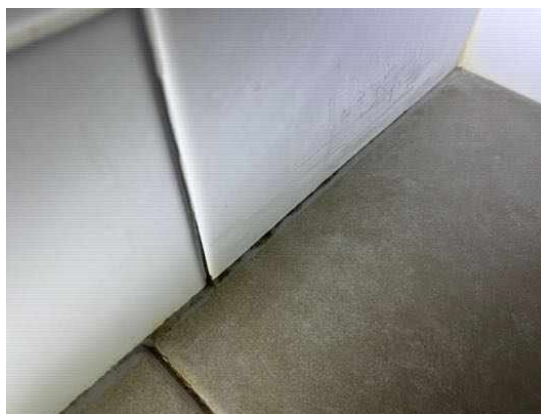
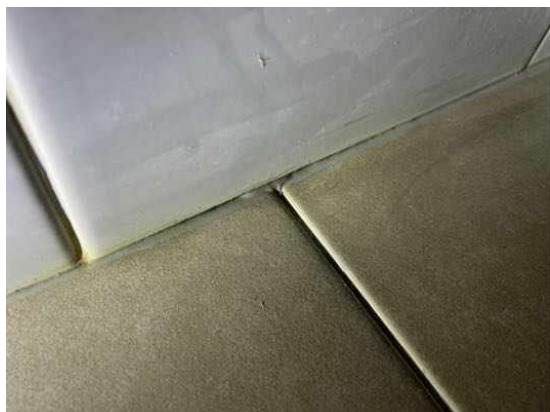
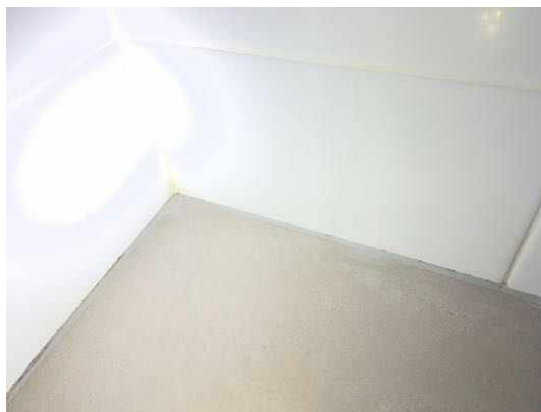
Finding 3.14

Building: Main Building
Location: Bathroom, Ensuite
Finding: Sealant and grouting - Missing or damaged
Information: It was noted on inspection that sealant or grout is degraded to the tiled shower alcove and or other areas of the bathroom.

Different materials and floor areas move at different rates, generally causing cracking to grout or sealant at this point. A flexible sealant is required to allow for expected expansion and contraction, while keeping the joint water tight and protective of all associated building materials.

There appears to be excessive mould to the sealant and grout which will likely require scraping out and replacement.

Flexible and mould resistant materials should be applied to affected areas to prevent any subsequent water damage that is likely to occur. Regular maintenance and replacement of damage or missing or damaged sealant and grout is highly recommended to the wet areas, as this is a regular wear and tear defect. Sealant and grouting in areas that come into regular contact with water should be maintained for the long term care of your property.

A sealant specialist or tiling contractor should be appointed to complete these works as soon as possible

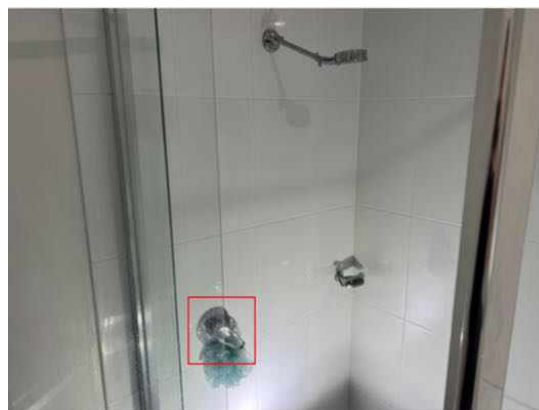
Finding 3.15

Building:	Main Building
Location:	Bathroom, Ensuite
Finding:	Tap - Water hammer
Information:	This tap shows evidence of water hammer being present. Water hammer, a pressure surge resulting when a fluid is forced to suddenly change direction, is a common defect in plumbing fittings, particularly those that are aged and not frequently maintained. Water hammer is generally caused by factors that create high water pressure in the affected plumbing fixture, usually evidenced by a faint banging noise during operation of the affected tap.

Although water hammer is generally considered to be a minor defect, subsequent damage such as erosion of tap hardware and/or water damage to associated building elements is likely to occur if left unmanaged.

A licensed plumber should be appointed as soon as possible to replace any affected tap hardware and perform any remedial works as necessary. Please be advised that the appointment of a cabinet maker or qualified carpenter may be necessary if water damage to associated building elements has occurred.

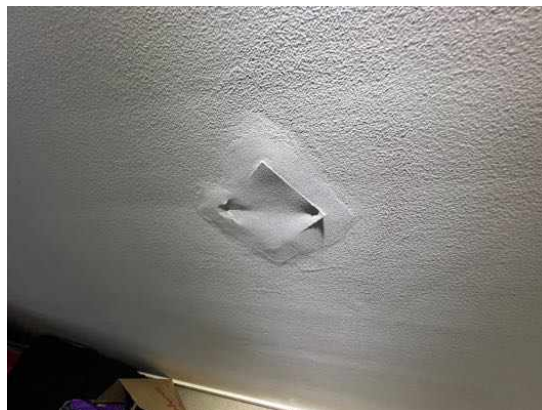
Finding 3.16

Building:	Main Building
Location:	Bedroom 3
Finding:	Wall - Incomplete or substandard works
Information:	The patch to this plasterboard finishing in this area appears to be incomplete or have been completed to a substandard level.

Works that have not been completed to a satisfactory level create potential for the development of building defects and may impede on the safety and integrity of the overall structure.

It is highly recommended that a licensed plasterboard contractor or painter should be appointed to finish the wall.

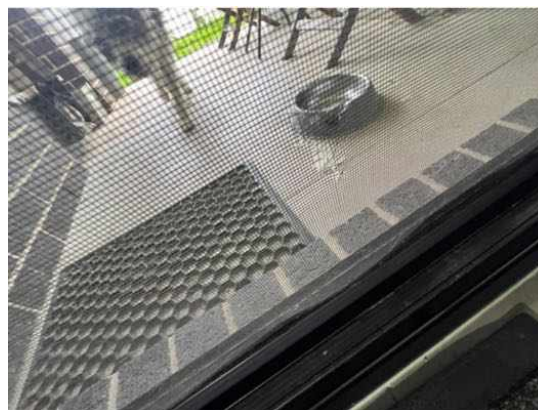
Building:	Main Building
Location:	Living Room
Finding:	Flyscreen - Damaged
Information:	The Flyscreen is as a result of damage (accidental or deliberate).The building element detracts from the operational state of the window.

Where not replaced/repared, damaged flyscreens allow pest and insect ingress into the adjoining room/s. Such works are necessary, as all building elements play a key role in the operation and function of the overall structure and its performance.

A general handy person may be appointed to replace/repair Flyscreen at the discretion of the client.

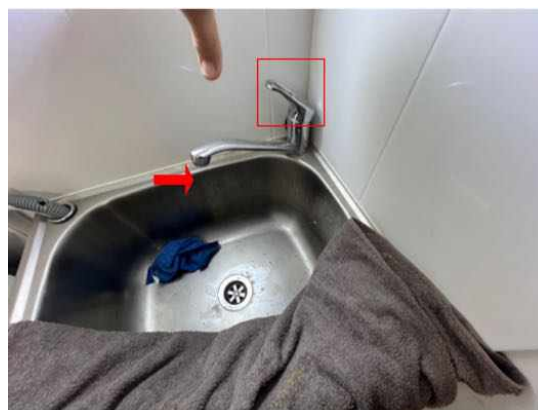
Finding 3.20

Building:	Main Building
Location:	Laundry
Finding:	Laundry Tap - No Water Flow to One Outlet
Information:	One side of the laundry tap assembly was found to have no water flow. This may be due to the washing machine not being connected or the isolation valve being closed. The client should seek advice from a licensed plumber to confirm operation once appliances are installed and connected.

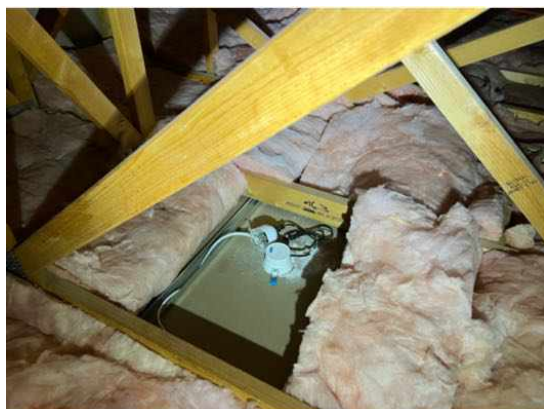
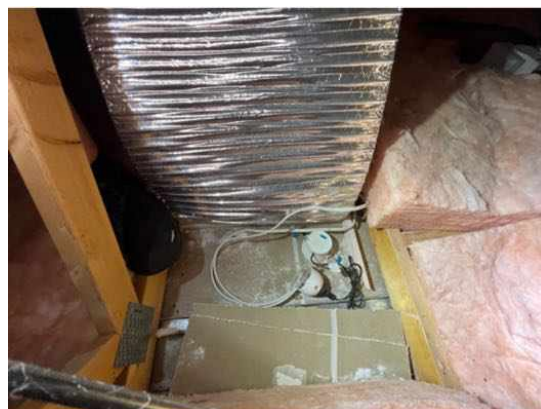
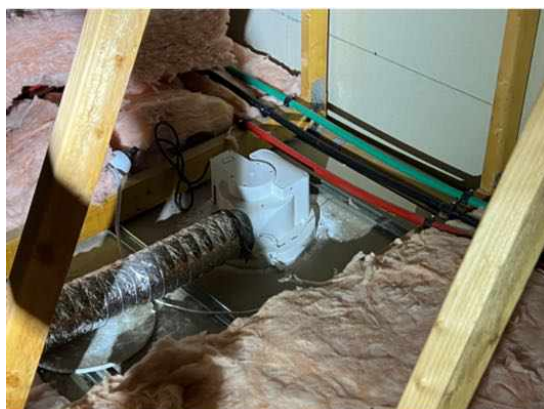
Finding 3.21

Building:	Main Building
Location:	Roof Void
Finding:	Insulation - Missing in areas
Information:	Upon inspection of the roof void it was noted that insulation is not present in some areas

Insufficient insulation will result in a comparatively higher cost to heat and cool a property as there is a lack of Insulation (or uneven coverage of insulation) which works as a barrier to heat transfer. This helps to keep out unwanted heat in summer and preserves warmth inside your home in winter. It can also help soundproof your home from unwanted airborne noise transfer.

Where insulation is absent, the area does not meet current Australian Standards. Installation of adequate insulation is required and should be conducted as soon as possible.

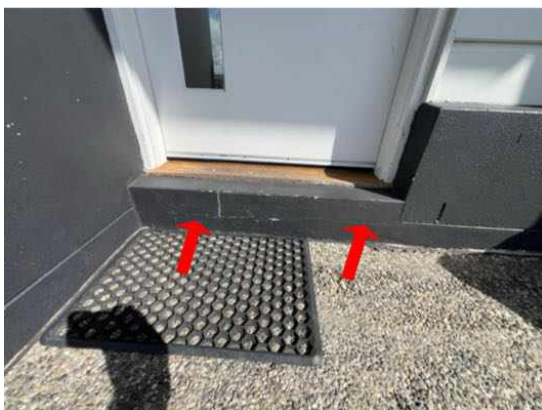
Finding 3.22

Building:	Main Building
Location:	Exterior walls - front
Finding:	Render - cracks
Information:	Cracking was observed to sections of the external rendered wall surfaces at the time of inspection. Cracking to rendered finishes commonly occurs due to minor building movement, shrinkage of the render material, or environmental exposure over time.

While often cosmetic in nature, cracks within rendered surfaces may allow moisture penetration behind the render coating if left unmanaged, which may contribute to deterioration of the render finish or underlying wall materials over time.

A rendering contractor should be appointed to assess the affected areas and undertake repairs as required to prevent moisture ingress and further deterioration of the rendered surface.

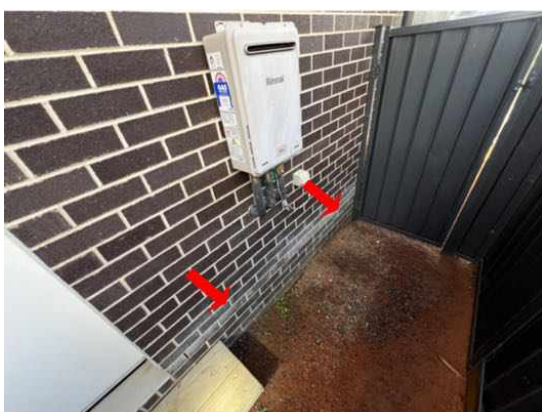
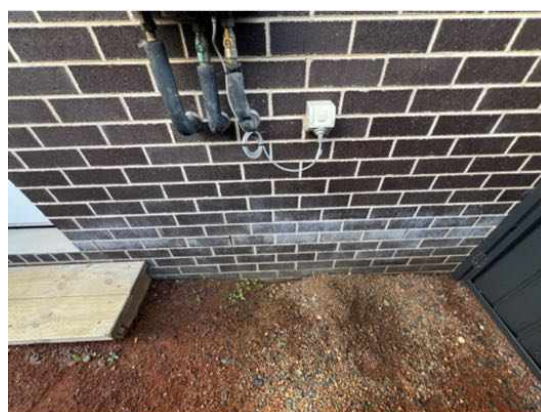
Finding 3.24

Building:	Main Building
Location:	Exterior walls - left side

Finding: Perimeter Surface - Insufficient Fall
 Information: The perimeter surface or ground levels were found to have an inadequate slope away from the adjoining building structure, creating potential for water pooling in this area.

Perimeter paving is required to fall from the building by a minimum of 25mm in the first metre and bare ground should fall away from the house by 50mm in the first meter. This standard ensures that excessive moisture does not pool around the base of building structures, which creates potential for water and structural damage, as well as making the area susceptible to termite and timber pest activity.

Where paving or ground levels do not have adequate fall, a licensed paving contractor, tiler or registered builder should be appointed to install or remove and re-level surface.

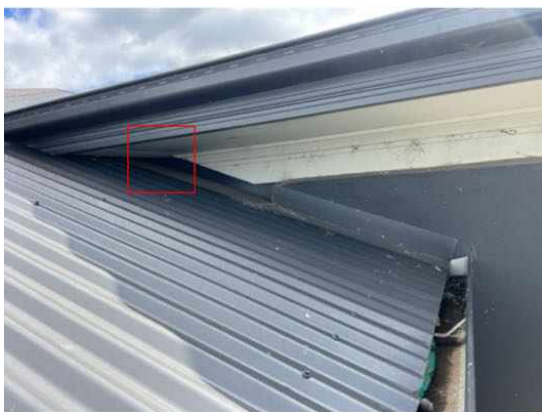
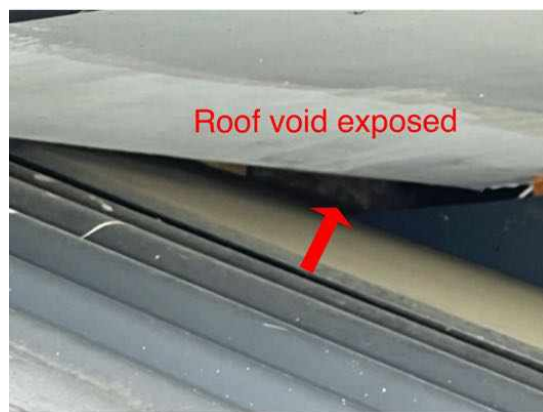
Finding 3.27

Finding: Roof plumbing - Flashing inadequate

Information: Some sections of the roof are missing or have inadequate roof flashings. Flashings are metal and other materials which are applied to seals and intersections between roof coverings and building elements. They are designed to aid in weatherproofing of roof joins.

Flashings that are not installed adequately or are missing are likely to result in water penetration to the interior of the property, as well as creating excessively damp conditions against the exterior surfaces and around the base perimeter of the building.

Premature ageing and secondary building defects are imminent where roof plumbing is missing or inadequately installed. Additionally, water pooling also creates an environment that is susceptible to termite and pest infestation.

A roofing plumber should be appointed as soon as possible to install relevant roof plumbing materials, ensuring that no further damage is sustained.

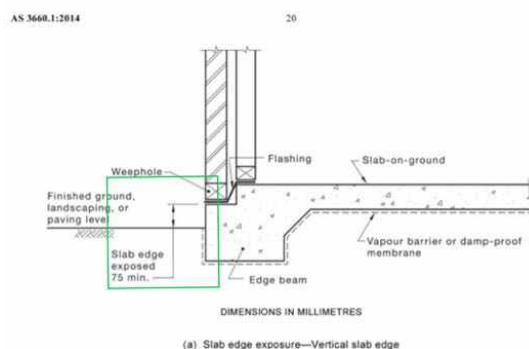
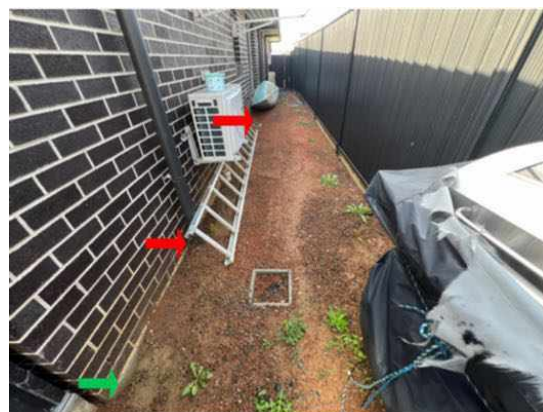
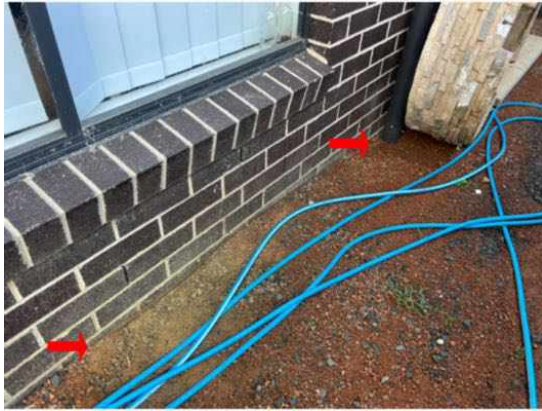
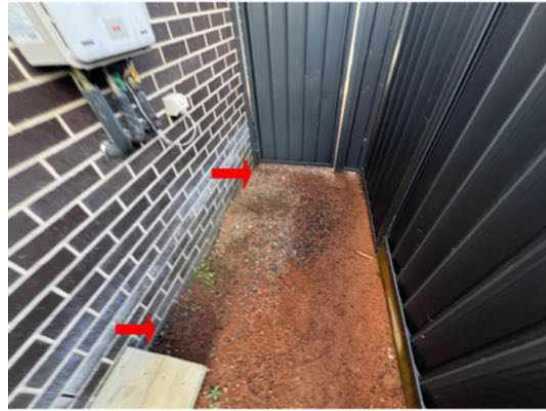
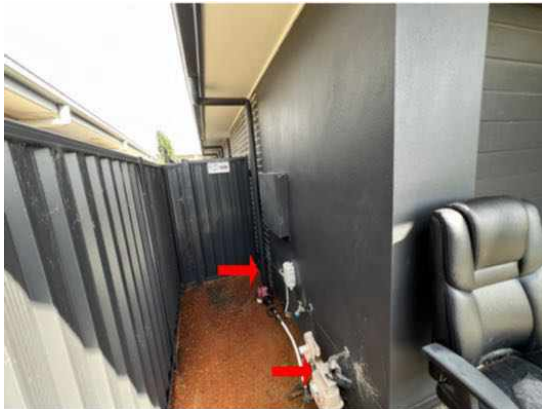
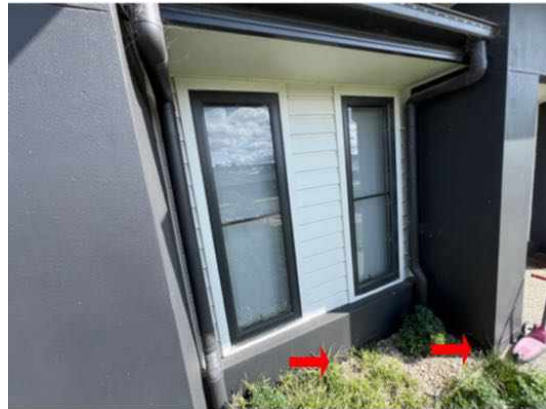
Finding 6.03

Building:	Main Building
Location:	Alfresco
Finding:	Bridging of termite barrier
Information:	Bridging of termite barriers occurs when termites bridge (usually by building a mud tunnel) a termite barrier or inspection zone or where termites have a passage allowing them to bridge the barrier.

Generally this takes the form of finished ground levels external paving or concrete being retrospectively installed above the damp course level the adjacent internal floor level or weep and ventilation holes.

Where bridging has occurred full inspection is prevented and termites may enter a property in a concealed or undetectable manner.

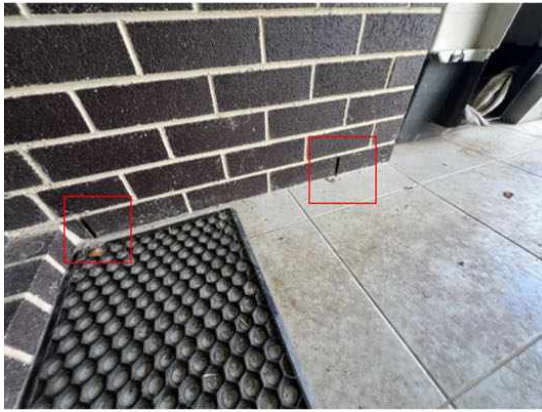
Finding 6.04

Building:	Main Building
Location:	Porch, Alfresco
Finding:	Bridging of physical termite barriers - Concrete Patio
Information:	The tiled concrete pad to the patio and alfresco including other areas directly abuts dwelling causing bridging. Bridging is the span of a physical termite barrier or inspection zone so that subterranean termites have an entry point over or around that barrier.

Where a concrete patio is retrospectively installed against an external wall, this provides a concealed entry point for termites.

The client should consider obtaining further advice from a timber pest technician regarding treatments required in this area. It is recommended that obtaining such advice be a short-term priority.
