Building and Timber Pest Inspection Report

Inspection Date: Wed, 4 Mar 2026

Property Address: 9a Bonneville Bvd, Goulburn NSW 2580,
Australia

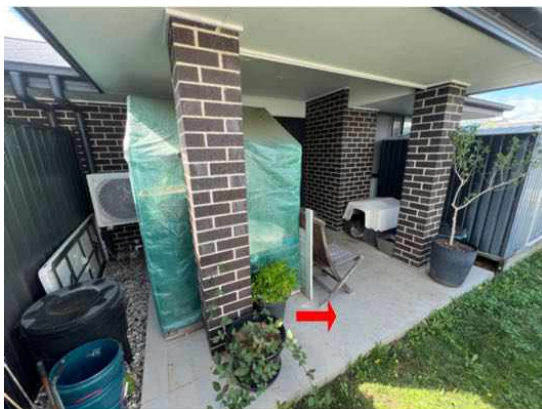
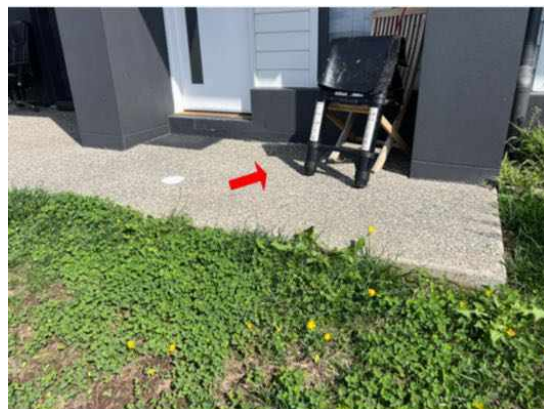
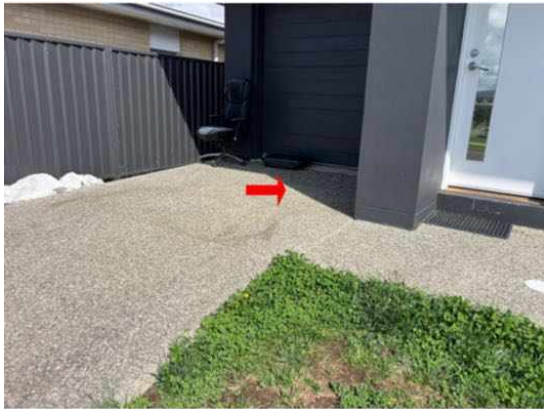
Finding 6.05

Building: Main Building
 Location: Alfresco
 Finding: Bridging of termite barrier - brick piers.
 Information: Brick pier that are attached from ground to structure without a visible inspection zone (barrier 75mm AFL) causes a bridging point. Bridging of termite barriers occurs when termites bridge (usually by building a mud tunnel) a termite barrier or inspection zone or where termites have a passage allowing them to bridge the barrier.

Generally this takes the form of finished ground levels external paving or concrete being retrospectively installed above the damp course level the adjacent internal floor level or weep and ventilation holes.

Where bridging has occurred full inspection is prevented and termites may enter a property in a concealed or undetectable manner.

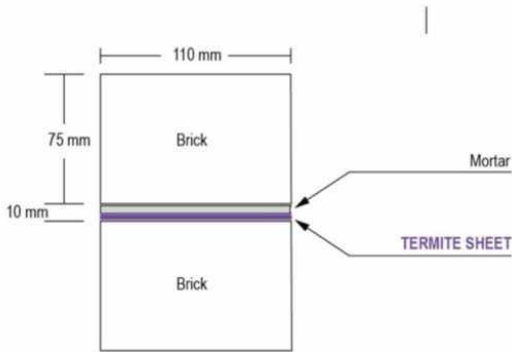
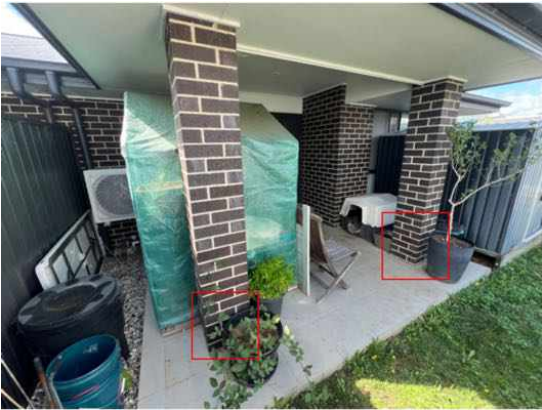
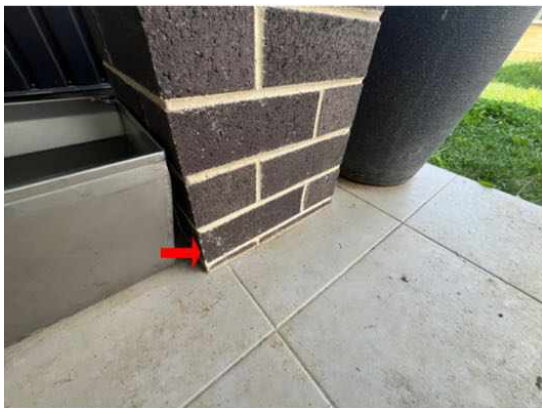
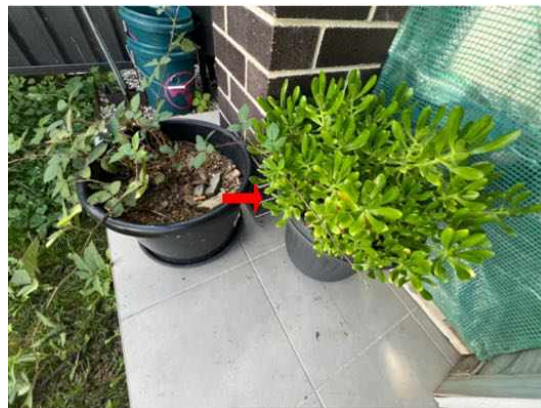
Finding 6.06

Building: Main Building
 Location: Shed
 Finding: Bridging - Attachments to Buildings.
 Information: Bridging occurs when items against a building provide a concealed entry point for termites into the building or by passing around a termite management system.

Where any part of an attachment to a building is not isolated and is not provided with a clear gap of not less than 25mm from the building, bridging occurs. Attachments to buildings such as hot water services, downpipes, verandahs, decks, steps, fences, service conduits and the like provide the opportunity for concealed entry.

Building attachments of this nature need to be frequently inspected for termite activity by a qualified inspector

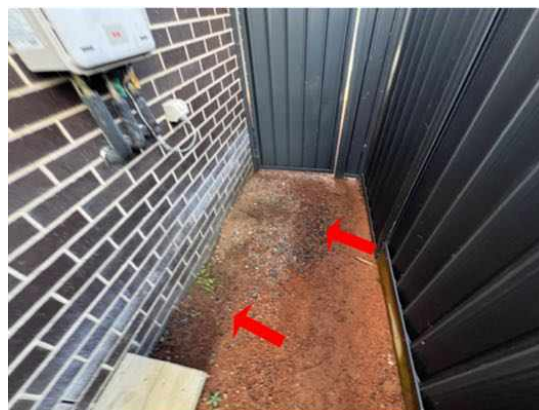
Finding 6.08

Building:	Main Building
Location:	Exterior walls - left side
Finding:	External taps - Not plumbed for drainage
Information:	The External taps is not plumbed or connected to suitable drainage, which has resulted in the surrounding area becoming excessively damp. These damp conditions can lead to secondary defects such as rot, rust or corrosion of associated building elements, the formation of fungal decay, or even the creation of potential slip hazards. When coupled with poor site drainage, pooling of water may also attract termite activity to this area. It is highly recommended that a qualified plumber be appointed to install adequate drainage to the overflow. These works will ensure that the area remains dry and free of any secondary defects.

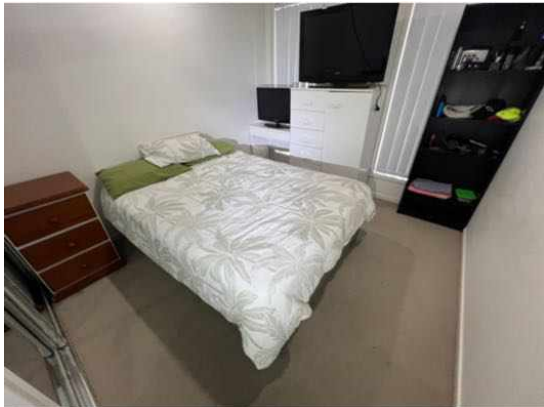
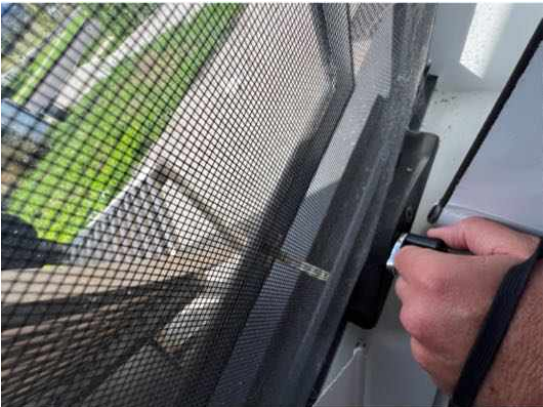
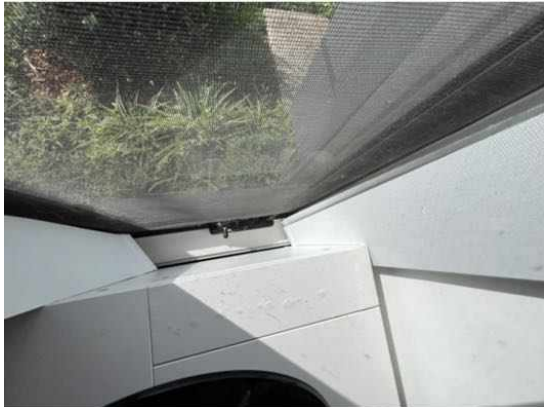
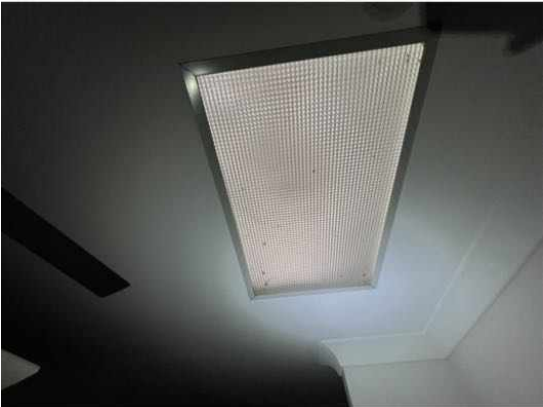
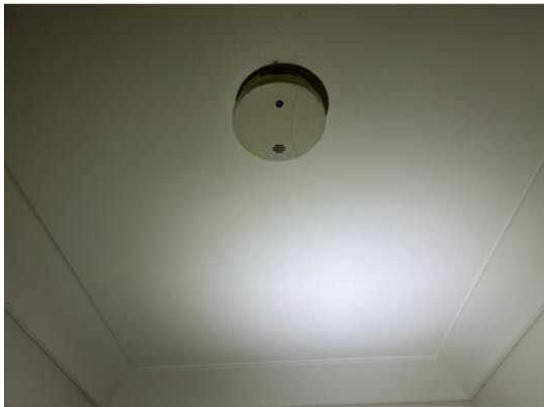
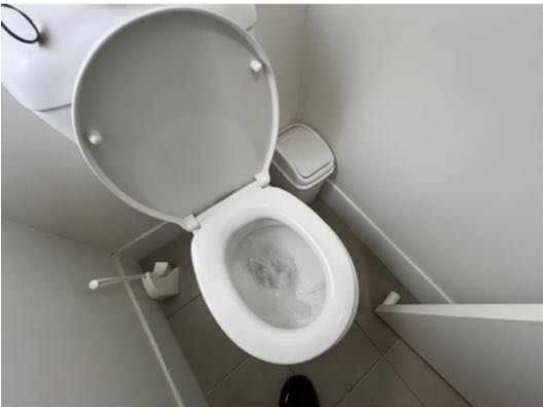
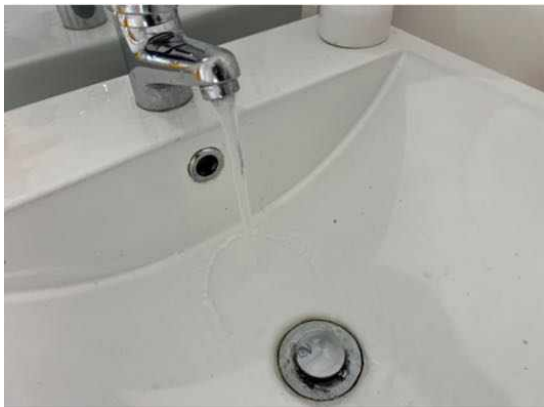
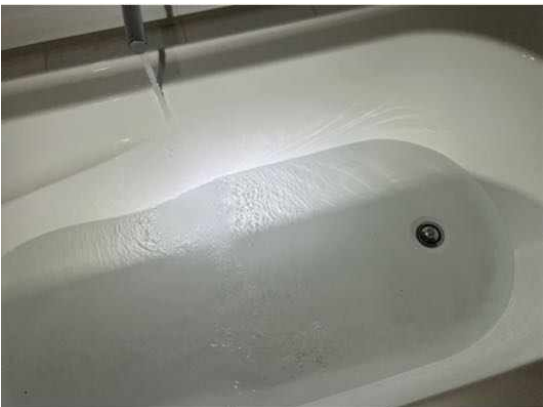
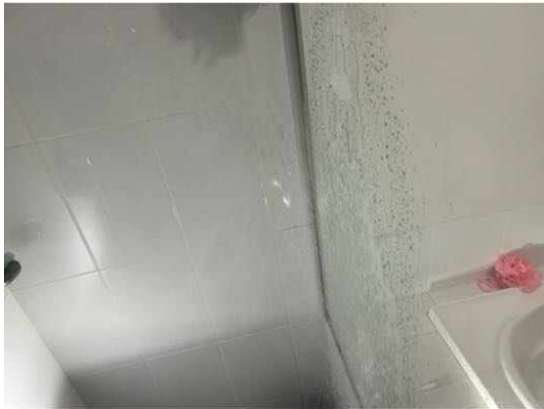
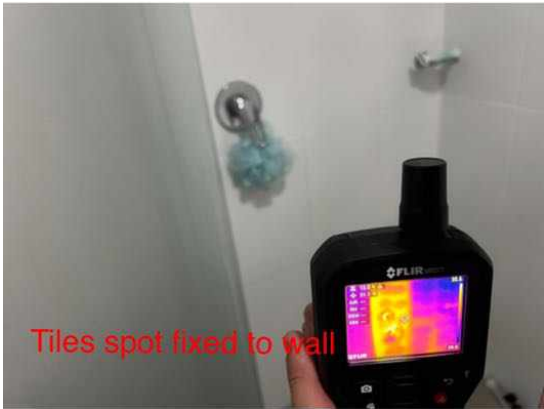
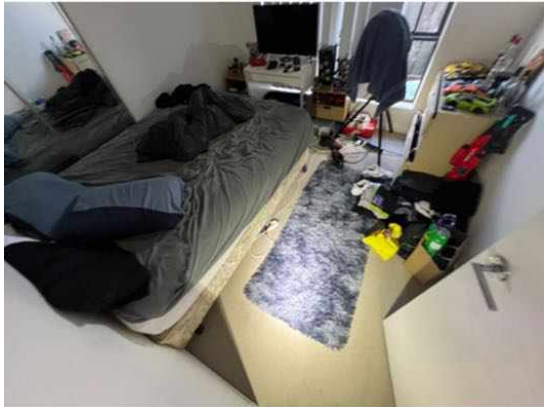
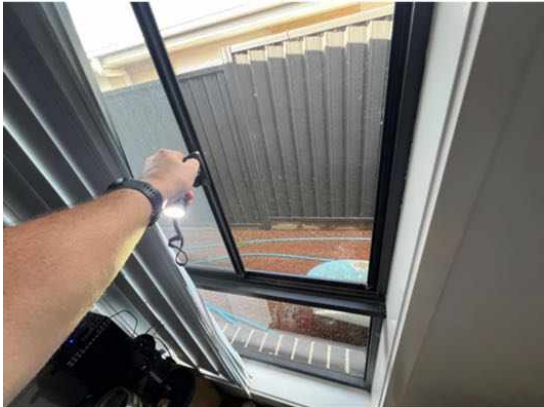
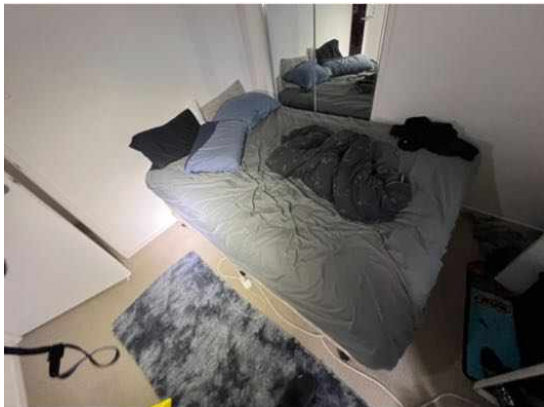
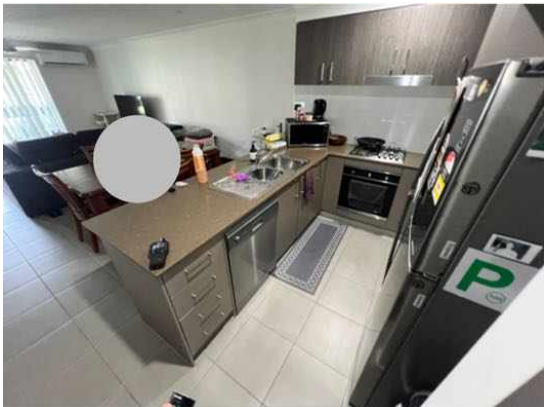
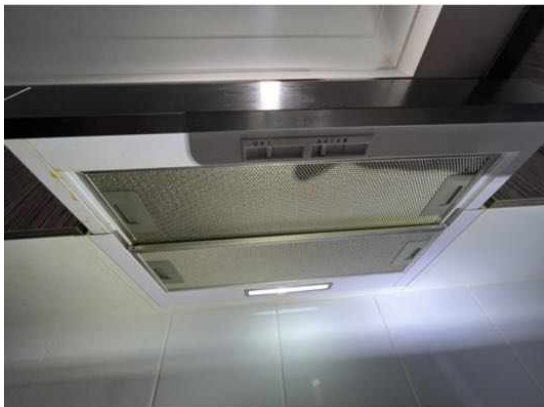
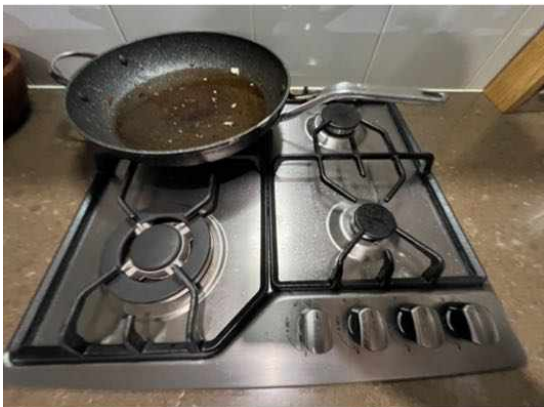
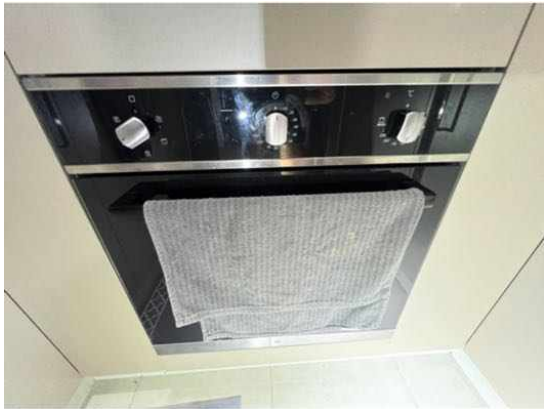
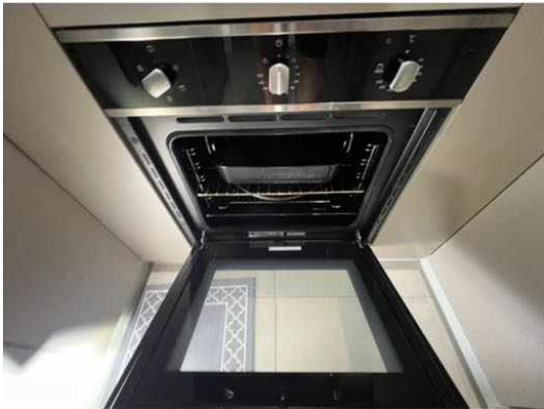
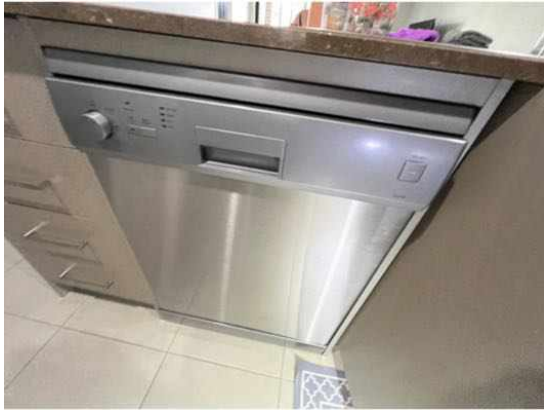
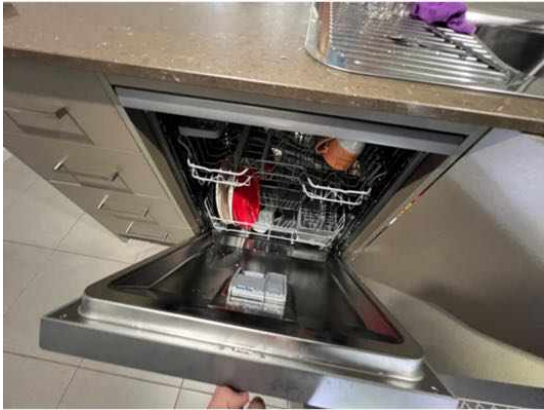
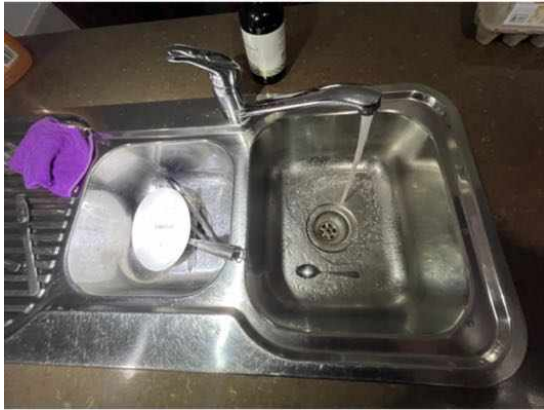
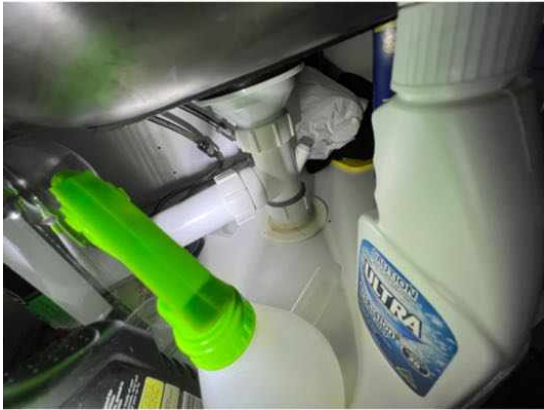
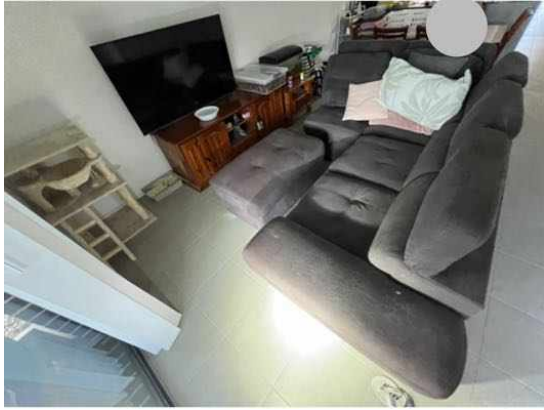
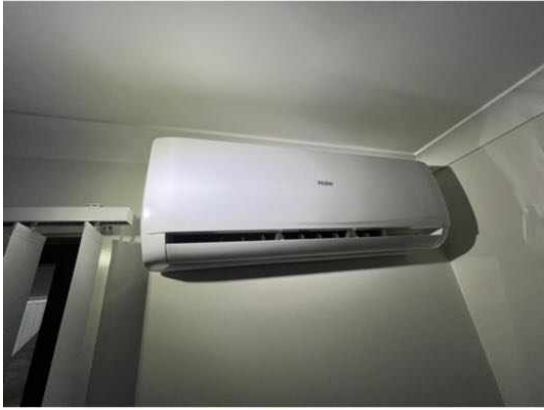
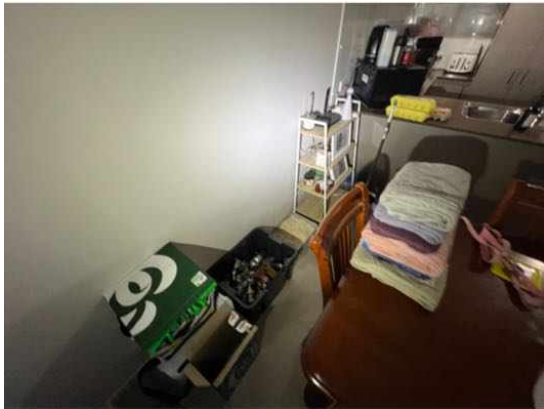
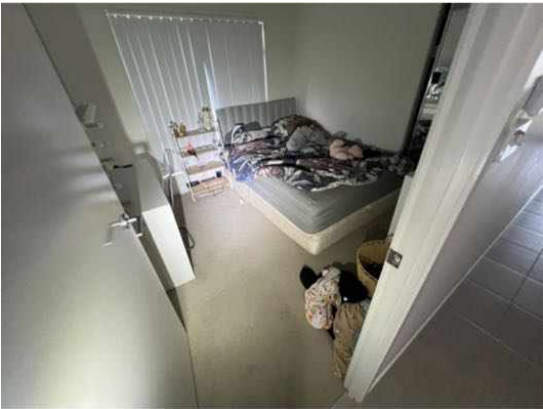
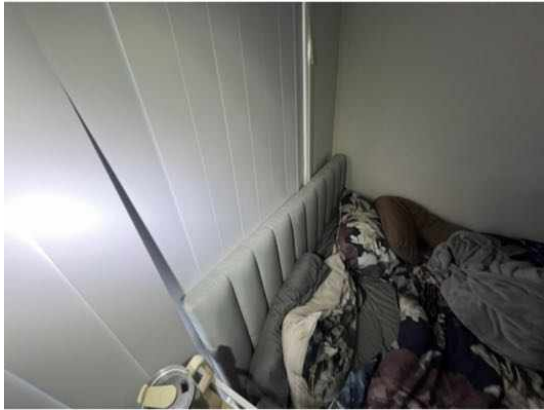
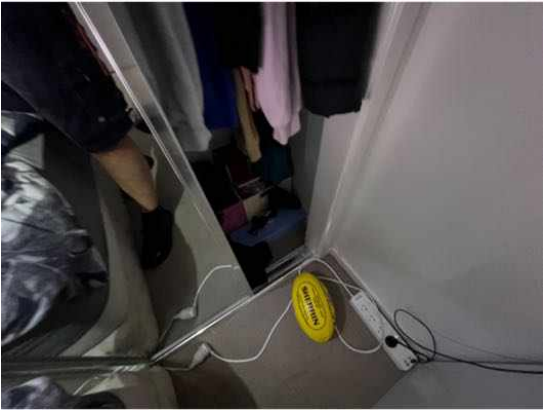
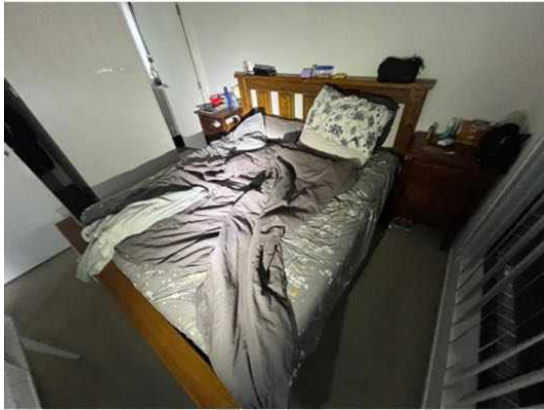
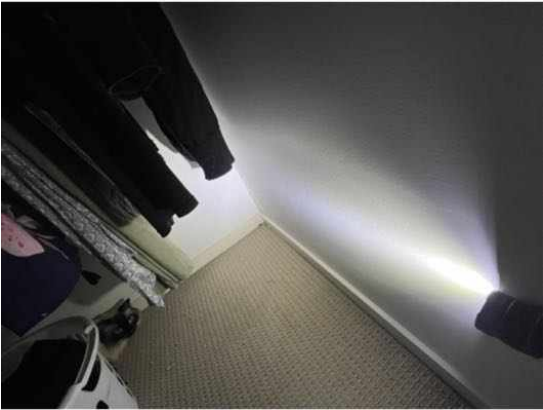
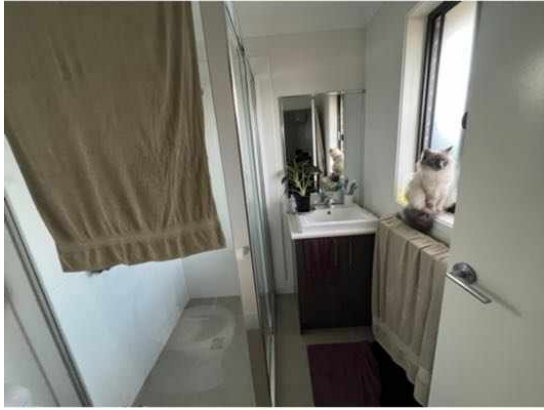
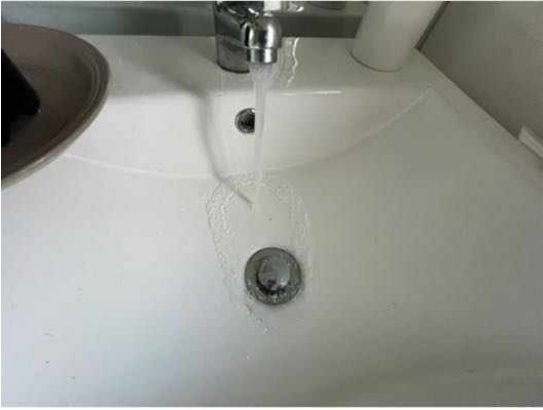
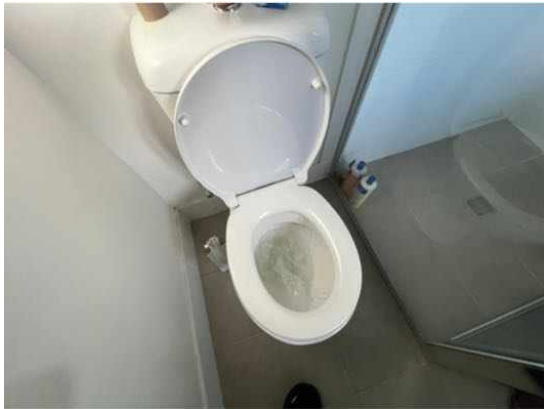
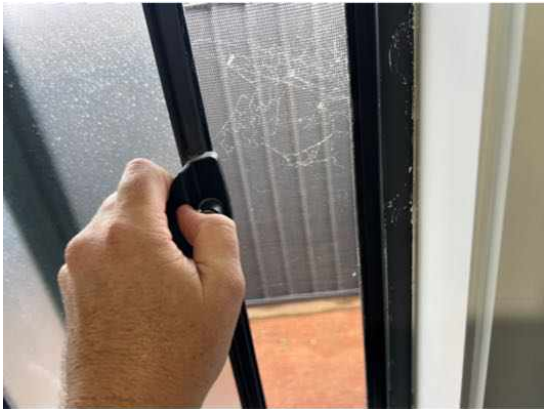
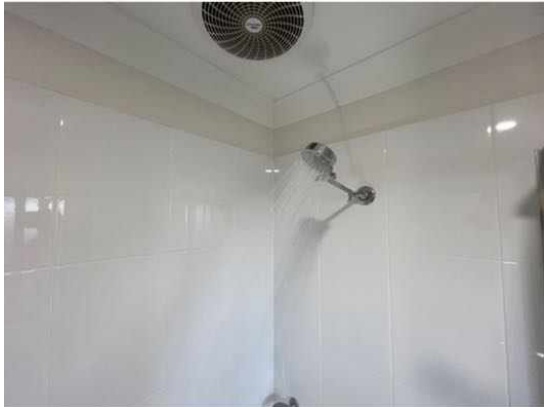
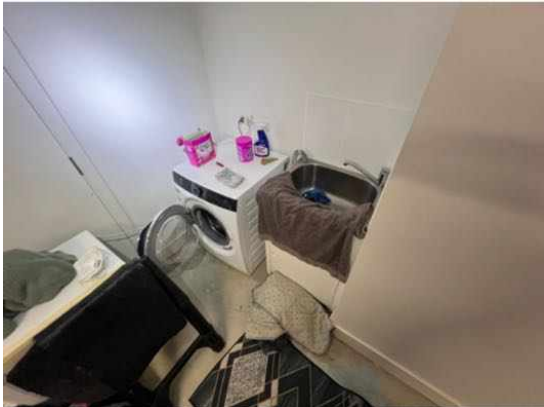
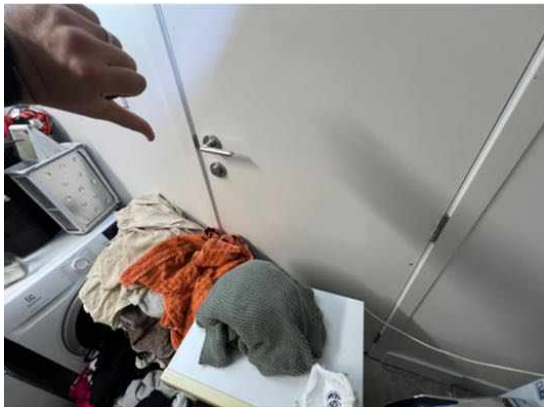
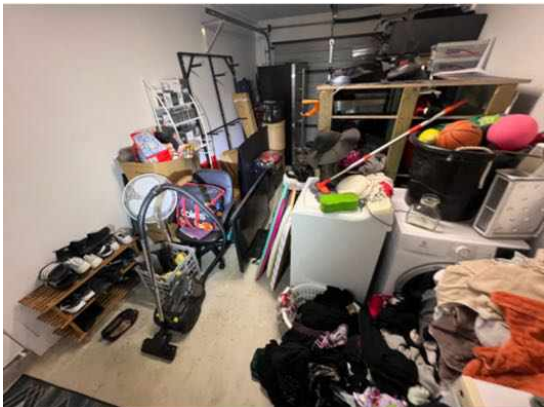
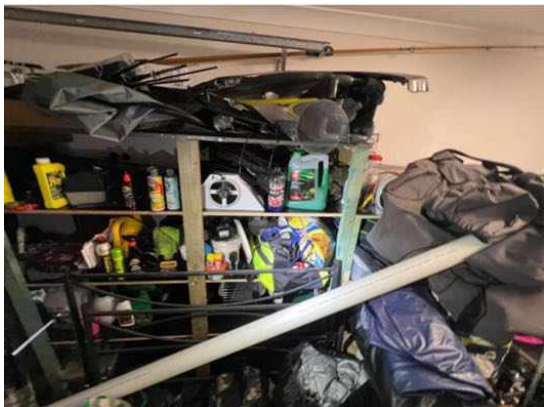
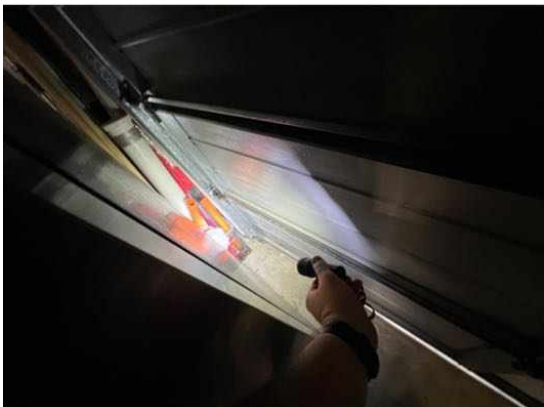
Finding: FYI - Additional Photos

Information: Additional photos are provided for your general reference and may include obstructions, testing of water & windows, moisture readings or minor maintenance items.

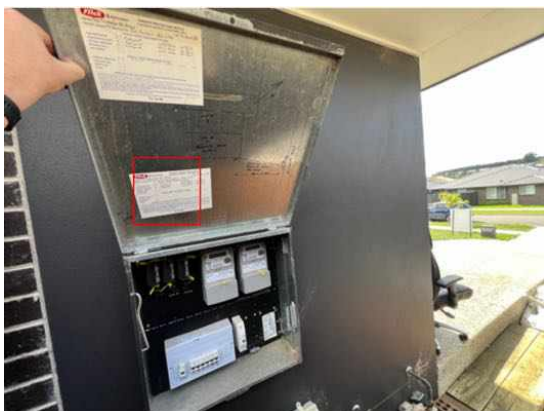
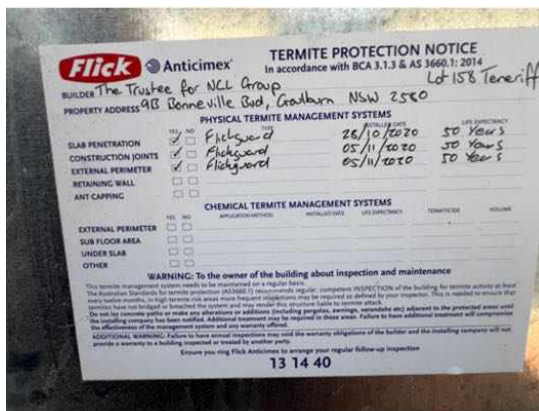
Noted Item

The following items were noted as - Evidence of a previous termite management program

Where a Termite Management System has been identified you should refer to the type of barrier date of installation warranty conditions and any documentation provided by a builder or past owner. Consult the company who installed the barrier to confirm whether the system is still under warranty.
