## Timber Pest Inspection Report

Inspection Date: Wed, 25 Feb 2026

Property Address: 5 Eltham St, Flemington VIC 3031, Australia

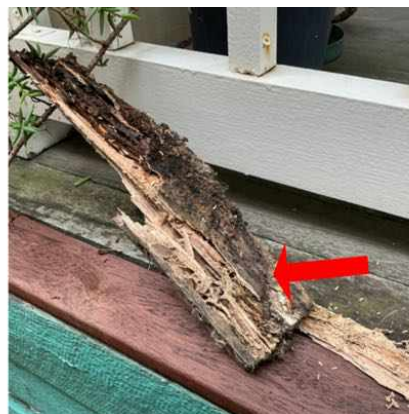
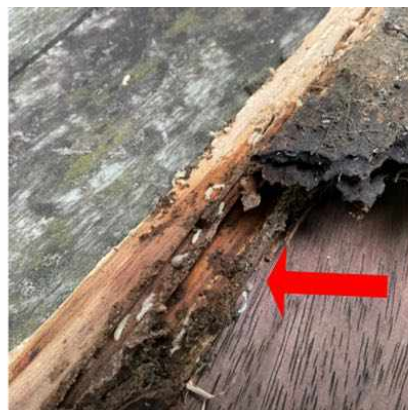
Building: Main Building  
 Location: Subfloor  
 Finding: Evidence of live *Coptotermes* Spp termite activity was identified  
 Information: Confirmation of species must be made by a lab. Based on in field observations the species identification is preliminary in nature only. *Coptotermes* Spp are a common termite family that are generally distributed Australia-wide. The presence of these termite species is typically difficult to detect by the untrained eye as nests in domestic households are usually found completely underground or within living/dead vegetation.

*Coptotermes* Spp are known to attack both living and/or dead trees as well as seasoned timber that may be used throughout the external area of a property. The most common form of attack is on sleeper retaining walls that are in direct contact with the ground. If these timbers are non-durable and/or untreated ingress is provided for *coptotermes* or other species of subterranean termites directly from the surrounding grounds and into the timber.

If evidence of live *coptotermes* spp activity is found during inspection treatment is required immediately to prevent any further damage that will inevitably ensue if left unattended. Treatment options include the installation of bait stations with the view of directly eradicating the colony or the installation of a post-construction chemical barrier which is designed to prevent the reoccurrence of termite infestation. Remedial works or replacement of affected timber builder elements may also be required.

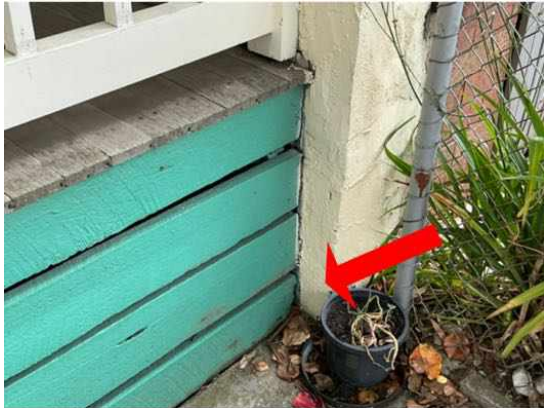
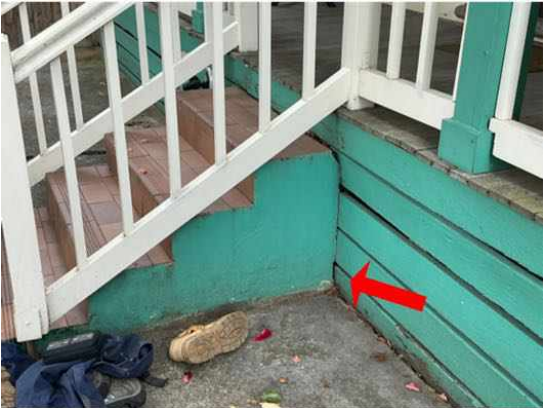
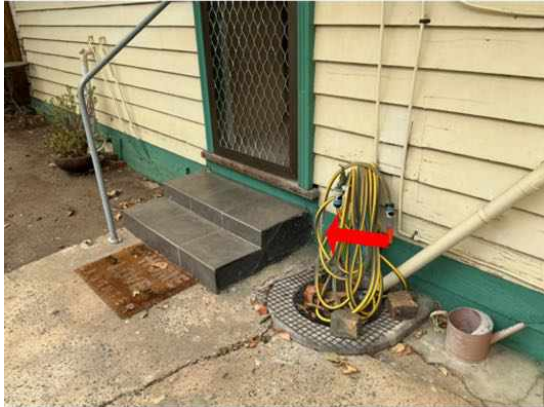
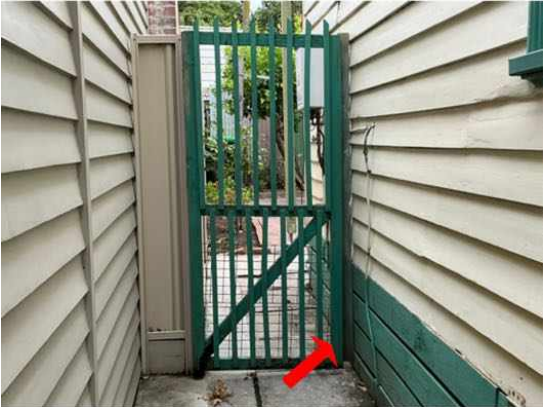
It is important for internal flooring to be raised above adjacent external ground levels. Where external ground levels are above internal flooring water pooling and subsequent internal flooding is likely to occur which may attract termite activity to the internal area.

It is highly advised that a landscaper or paver be appointed to lower external grounds that are raised above adjacent internal flooring. Alternatively if external grounds and internal flooring is level installation of a raised door sill may be appropriate in preventing any water pooling in the area.

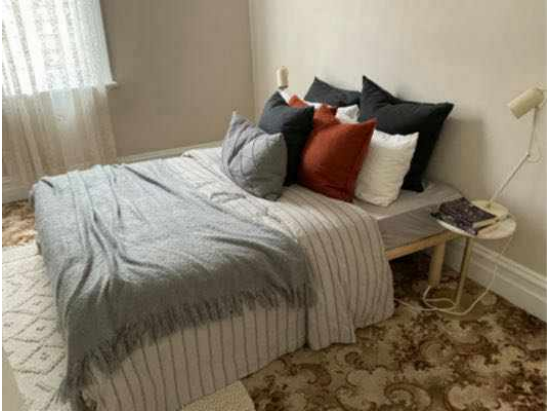
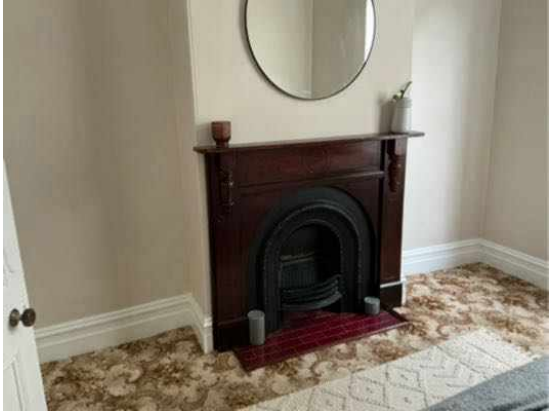
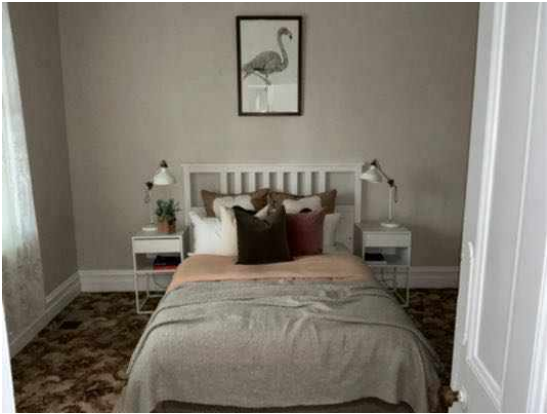
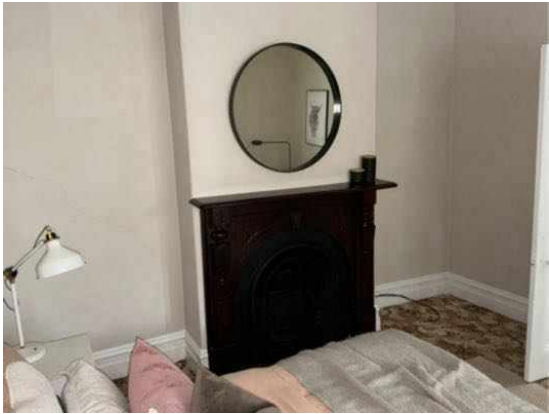
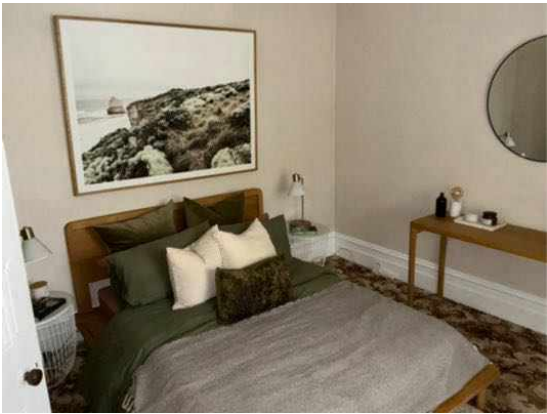
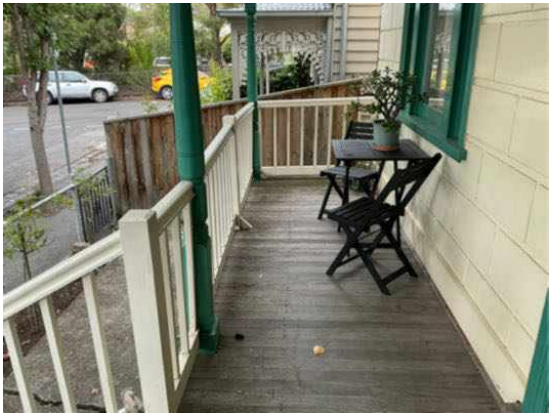
Building: Main Building  
Location: All Areas  
Finding: Additional Photos - Obstructions and Limitations  
Information: These photographs are an indication of the obstructions and limitations which impeded full inspection of the property at the time of inspection. These obstructions can hide an array of defects and should be removed to allow full inspection to be carried out. A re-inspection is recommended once the areas are made accessible.
