Building and Timber Pest Inspection Report

Inspection Date: Mon, 23 Feb 2026

Property Address: 2/14 Prospect St, Pascoe Vale VIC 3044,
Australia

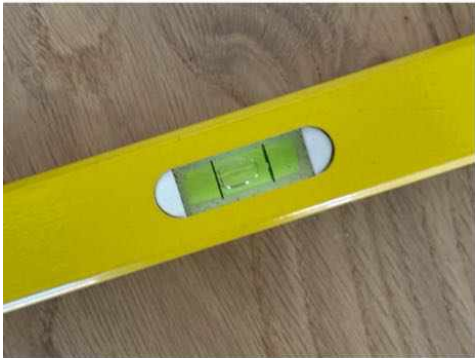
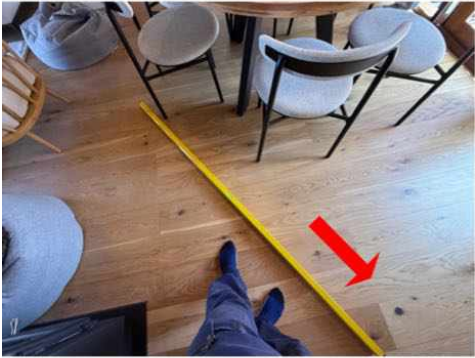
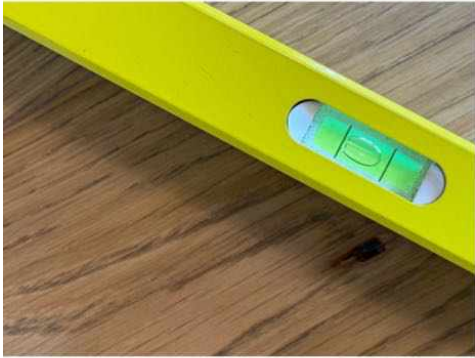
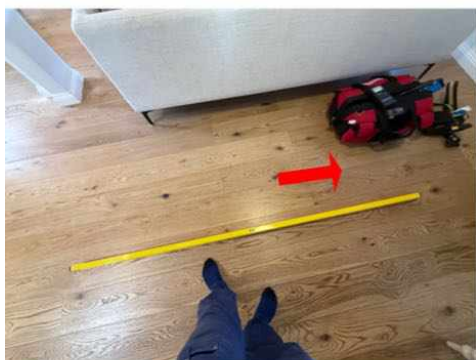
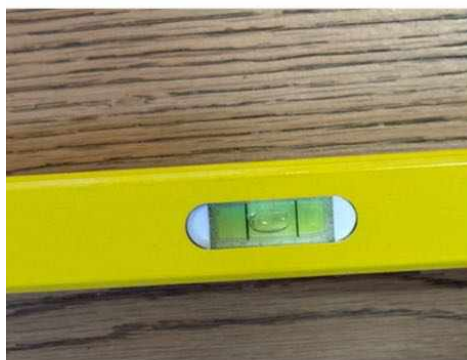
Building:	Main Building
Location:	All Internal Areas
Finding:	Subsidence- minor to moderate
Information:	It appears that the Sub structure has been affected by movement of the foundations, often referred to as sinking or subsidence.

General subsidence is usually initiated by changes in soil moisture content. The most critical factor is identifying the specific causes, and identifying if this is a recurring or ongoing problem, or one that has been resolved by previous works in the past.

The following statement has been referenced from VBA guide to standard & tolerances (part 2.08)- Slab Levelness: Except where documented otherwise, new floors are defective if within the first 24 months of handover they differ in level by more than 10 mm in any room or area, or more than 4 mm in any 2 m length. The overall deviation of floor level to the entire building footprint shall not exceed 20 mm. Our max documented deviation was 20-25 mm in 2 m distance.

If in future secondary defects like door binding, major internal cracking is noticed. It will be advised to begin by consulting a structural engineer to determine the required scope of works. This generally includes some form of underpinning or resin injections, as well as addressing the underlying cause. Consultation with a geotechnical engineer may also be necessary where changes to soil moisture content is apparent.

A Registered Builder specialising would then generally carry out works as advised by an Engineer.

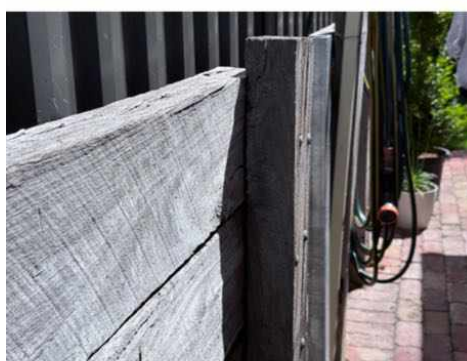
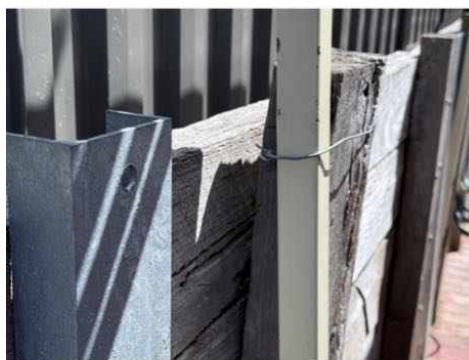
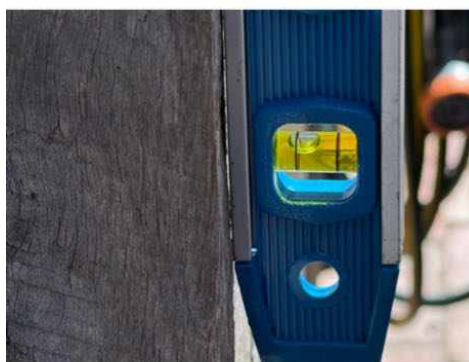
Finding 3.02

Information: The retaining wall in this area was found to be bowing (minor) at the time of inspection. Generally, defective retaining walls are caused by poor original design or material use. However, deteriorated retaining walls may also be a result of general deterioration, poor site drainage or unmanaged stormwater flows.

If left unmanaged, the retaining wall may become a safety hazard if it continues to destabilise (monitoring recommended, new support posts are already installed). Where retaining walls further rot and decay, an environment is created that is conducive to termite and pest infestation. Significant repair and replacement should be expected at that stage.

Where retaining walls are considered structural walls, a structural engineer / surveyor should be consulted regarding required remedial works. Otherwise, a landscaper or retaining wall installer may be appointed to repair or replace the wall, at the discretion of the client.

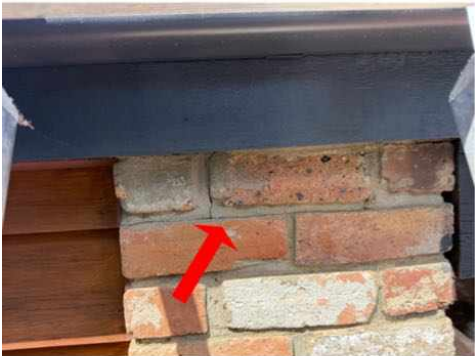
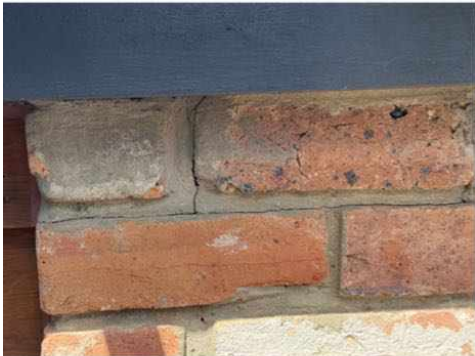
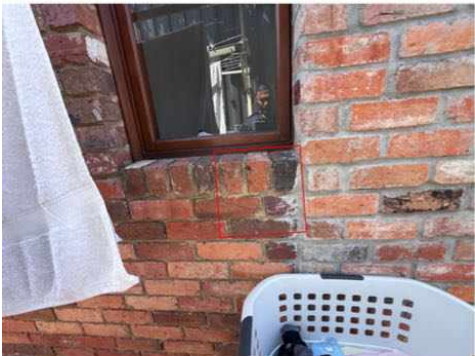
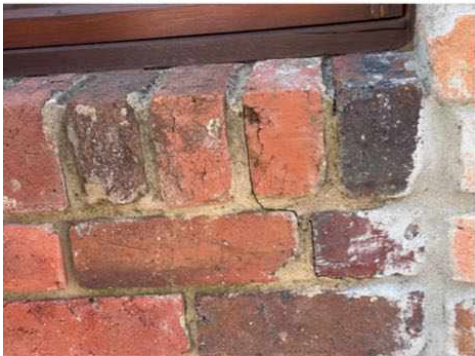
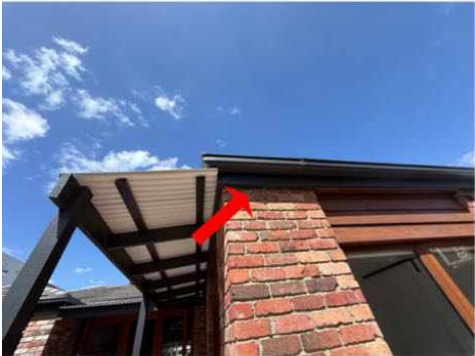
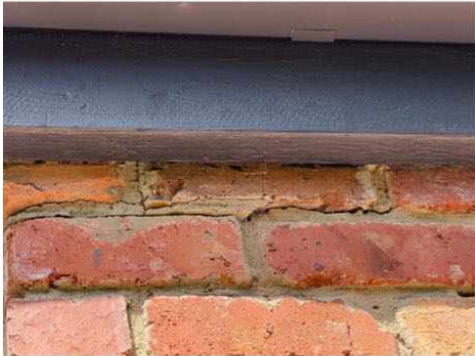
Finding 3.03

Finding: Brickwork - Cracking [Fine]

Information: Although fine cracks are quite noticeable, they are often only considered to be an appearance defect and usually do not indicate any structural damage. Generally, the cause of a fine crack is indicative of a separation between brickwork and mortar throughout the structure, but single bricks may also show cracks of this nature.

Cracking of this nature can generally be repaired with minor filling and should be conducted by a qualified bricklayer.

Always contact a building inspector should cracks widen lengthen or become more numerous.

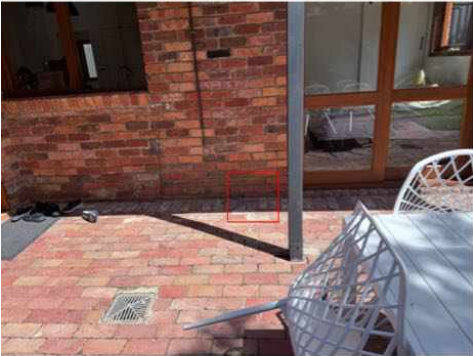
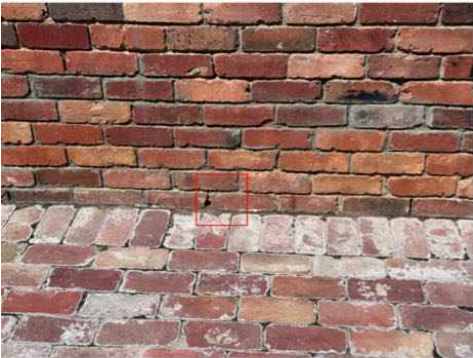
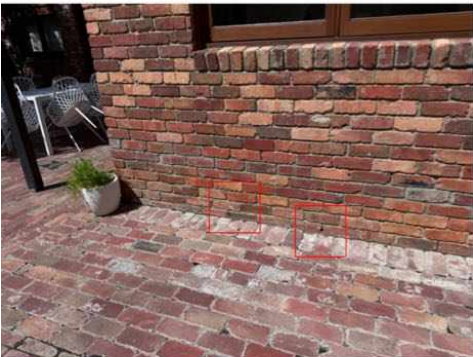
Building: Main Building
 Location: Some External Areas
 Finding: Weep holes - Partially Blocked
 Information: It was noted during the time of inspection that some of the weep holes to the brickwork were blocked. Weep holes are designed to allow water from leaks or seepages in brickwork to be directed to the external environment, prior to entering the wall cavity or associated building materials. Weep holes should therefore be kept clean and free of debris or blockages.

Blocked weep holes are likely to result in the presence of excessive moisture within the brickwork and associated structures, creating potential for water damage and moisture problems. Can also allow concealed termite ingress.

Depending on the nature of the blockage, the homeowner may be able to undertake remedial works to remove blockages. Alternatively, appointment of a registered builder may be required to remove blockages. Preventative works are necessary in ensuring the structural integrity of the affected brickwork and should be performed as soon as possible.

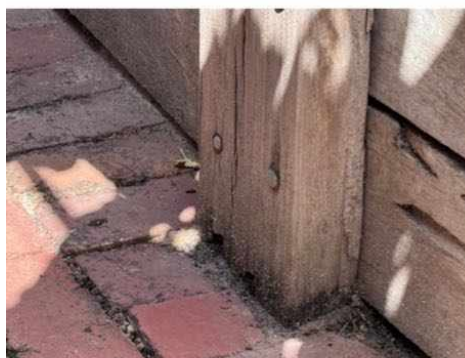
The development of fungal decay is accelerated by temperatures in the range of 5degreeC to 40degreeC as well as the presence of oxygen. Generally fungal decay develops on timber elements that are in use in an external environment which are exposed to rain penetration.

In this case although the affected timber element is in a decaying state the extent of any visible damage appears to be localised to a specific area and is yet to spread to other parts of the building element or affect adjoining structures. The fungal decay is therefore likely to be of a relatively superficial nature with minimal impact on the structural integrity or tensile strength of the timber element.

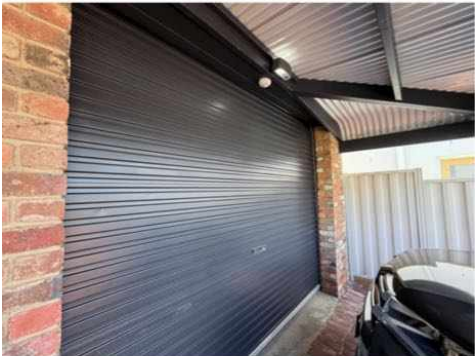
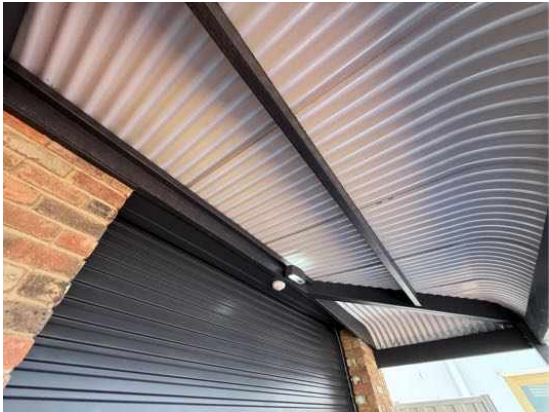
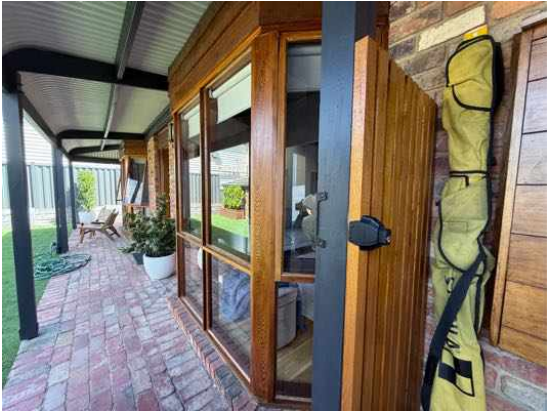
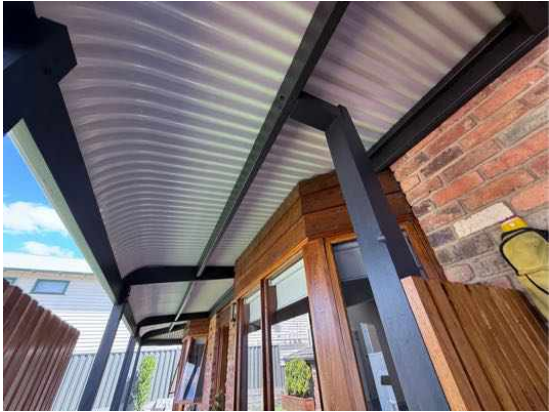
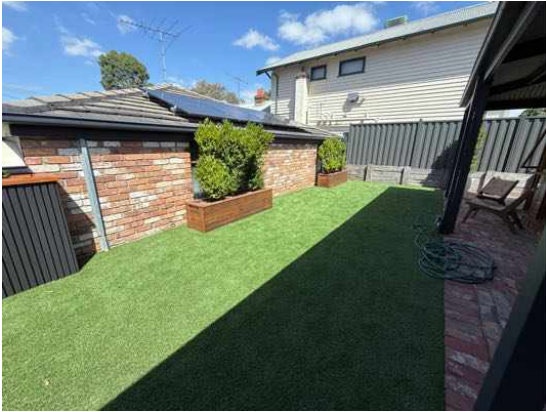
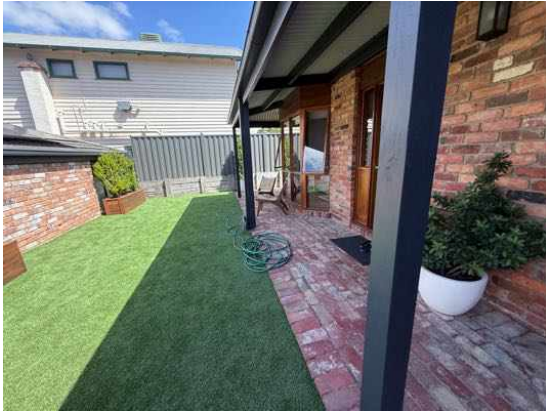
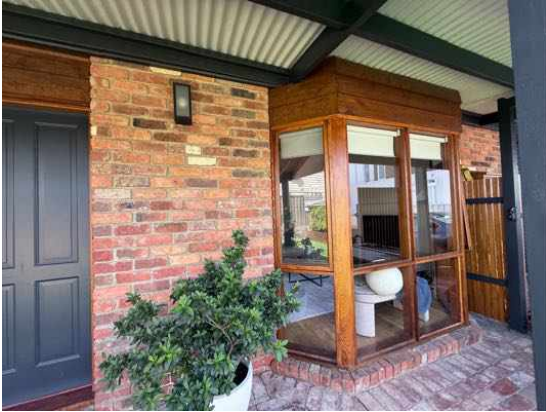
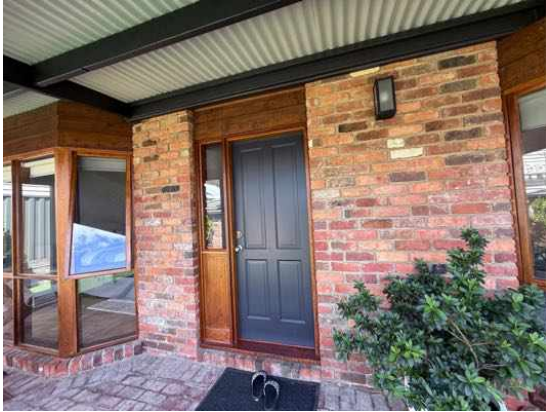
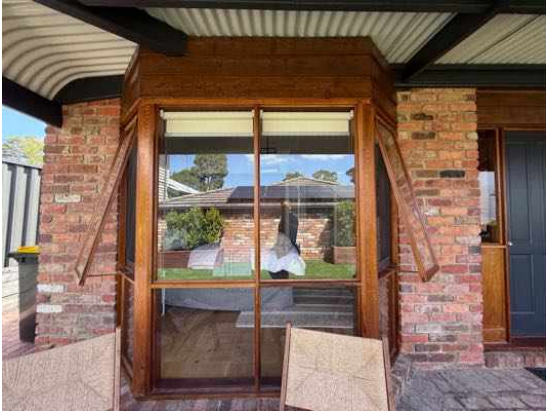
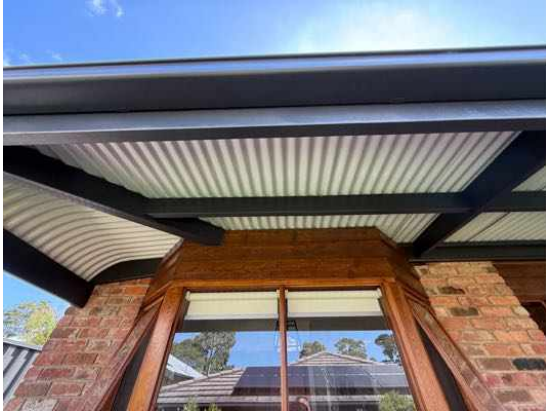
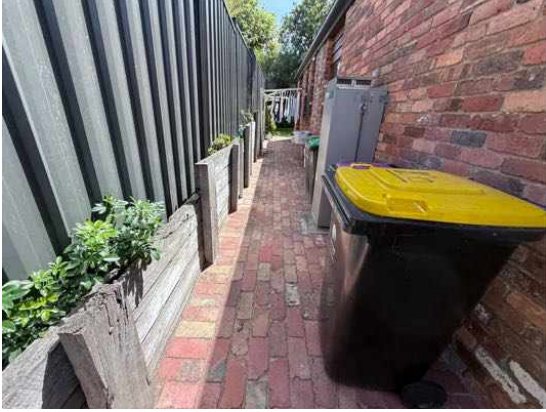
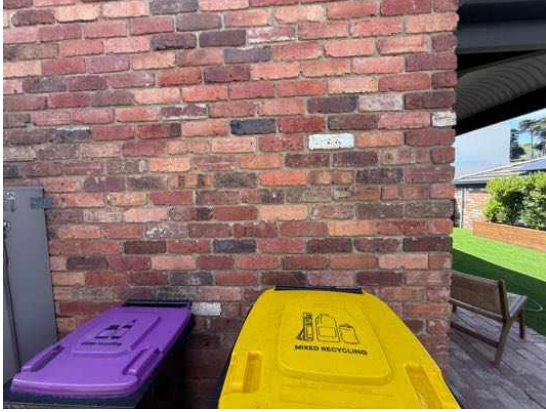
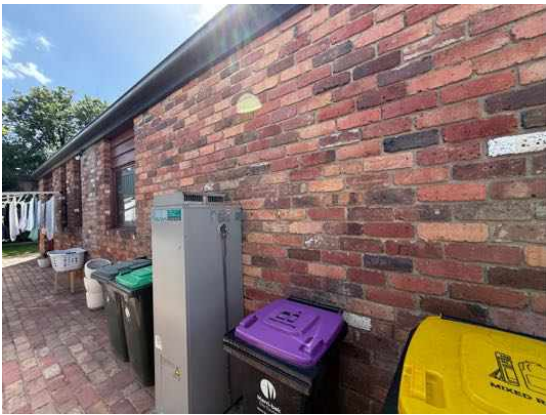
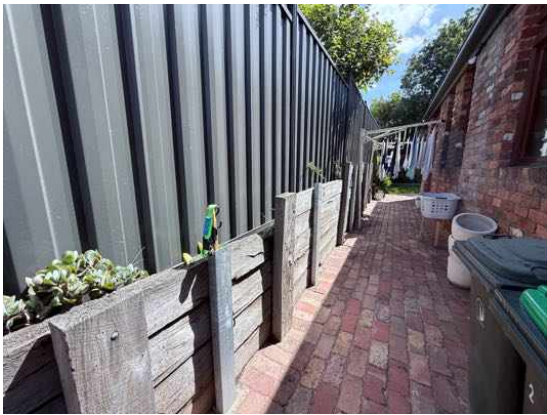
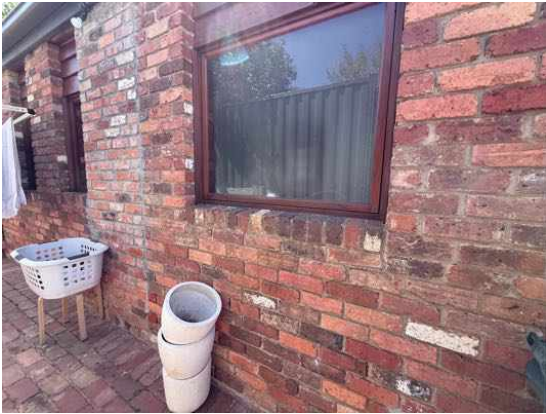
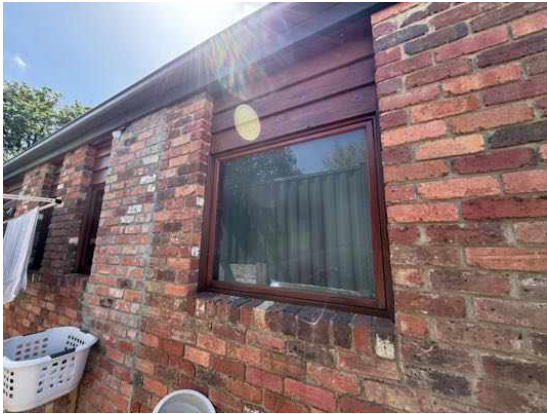
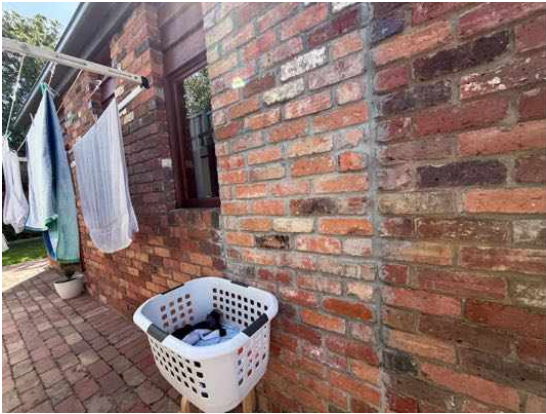
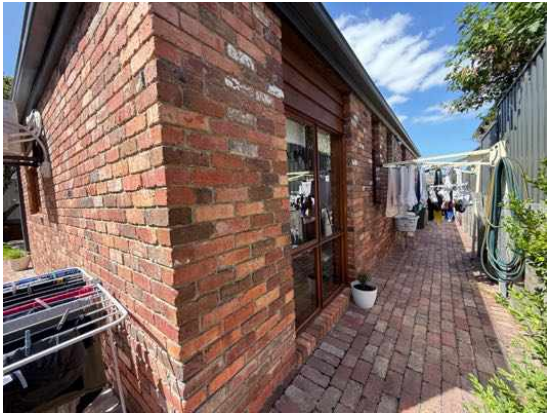
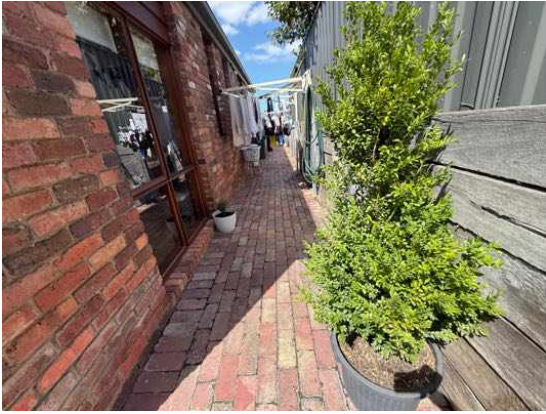
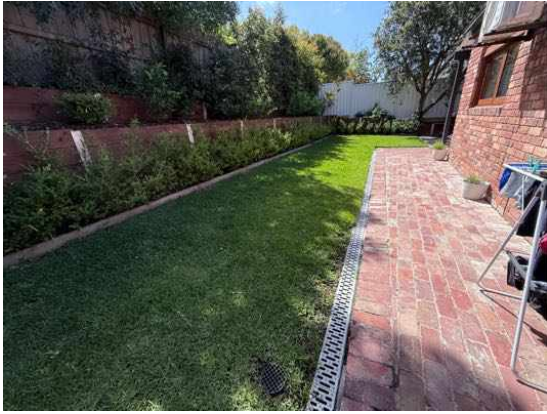
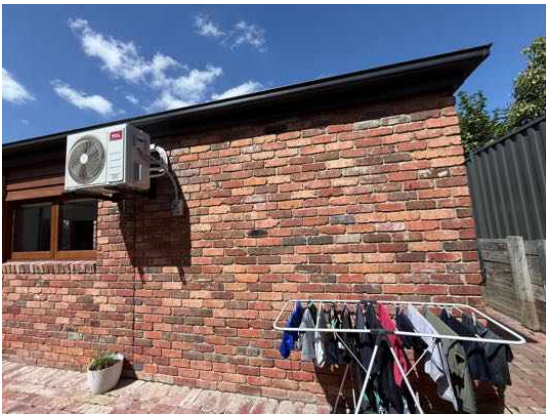
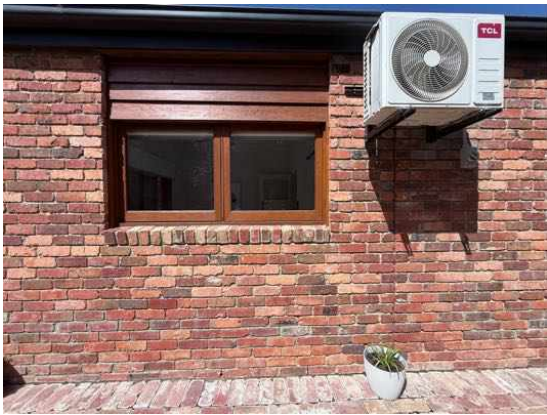
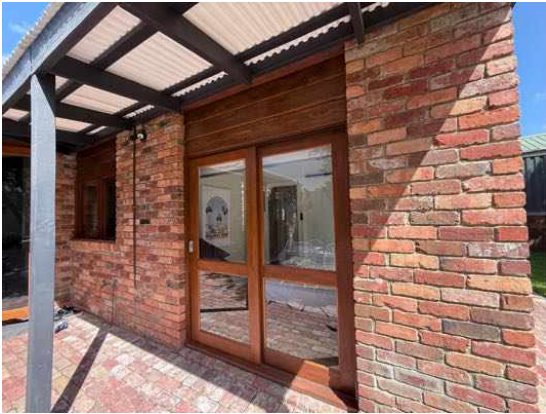
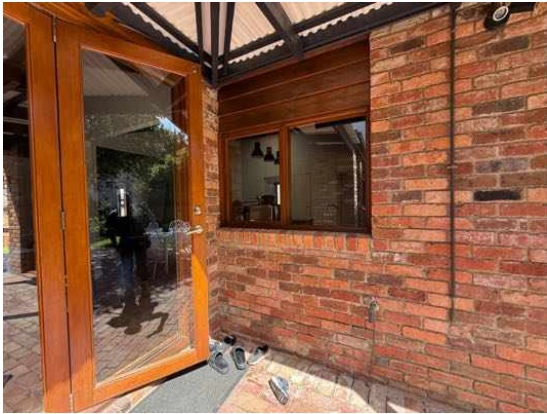
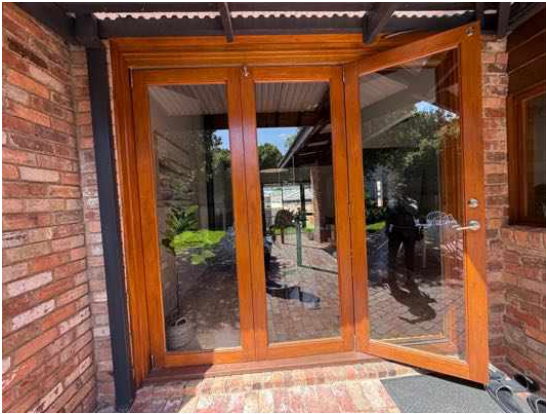
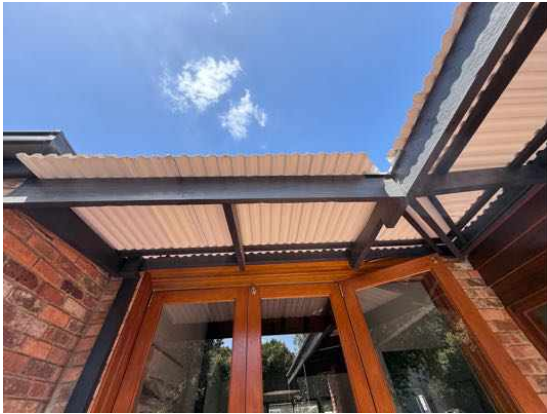
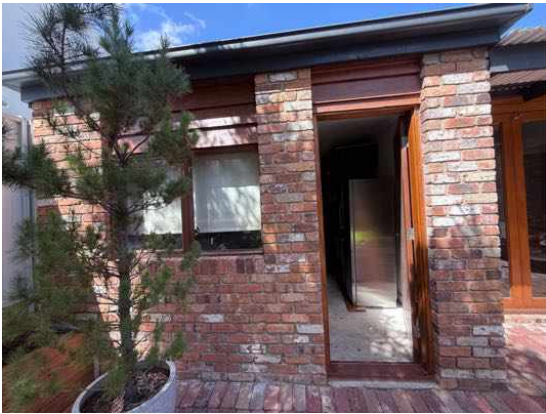
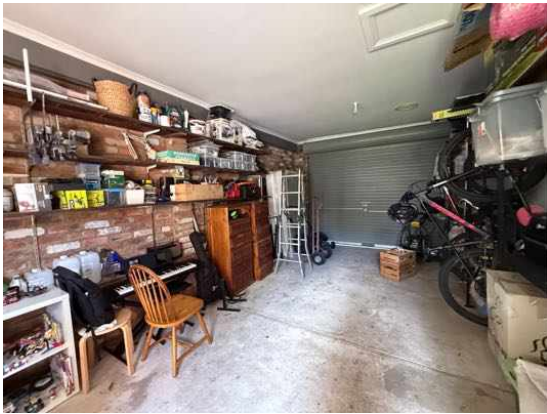
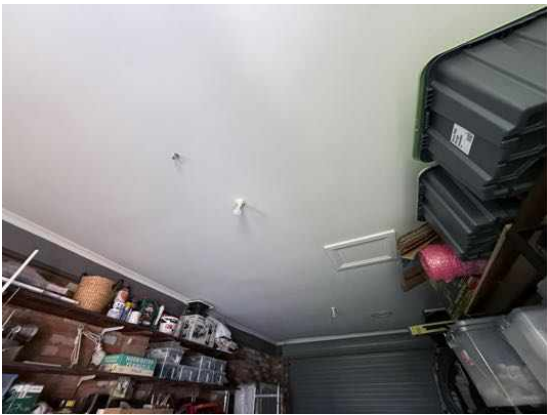
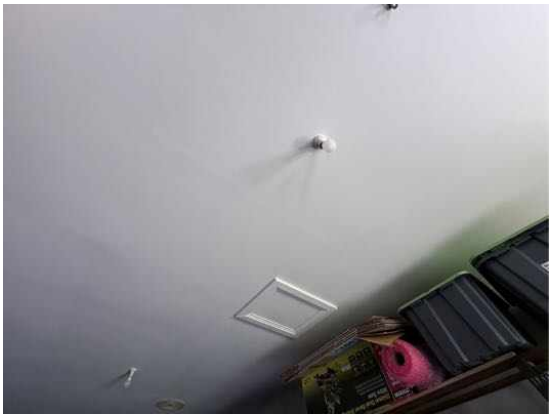
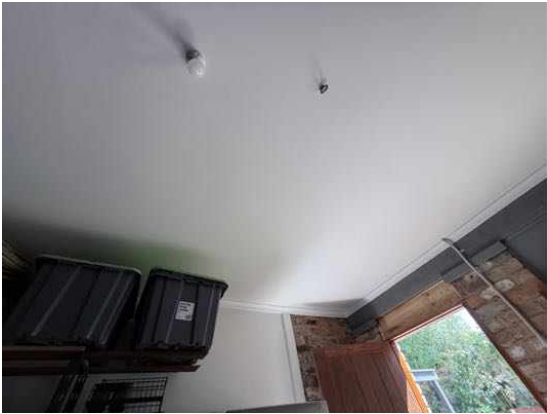
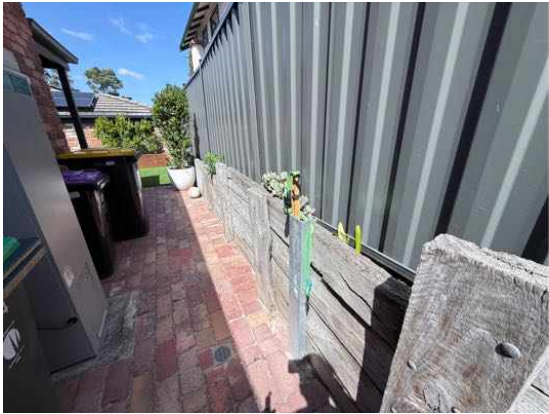
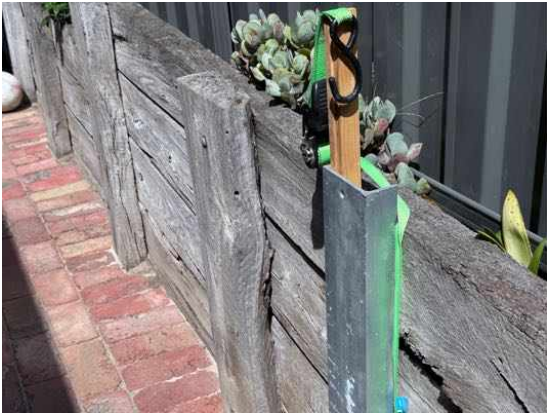
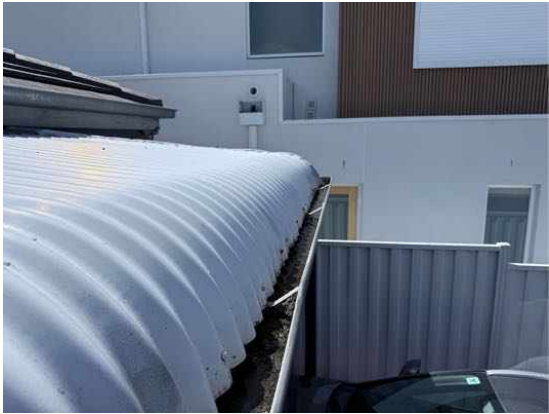
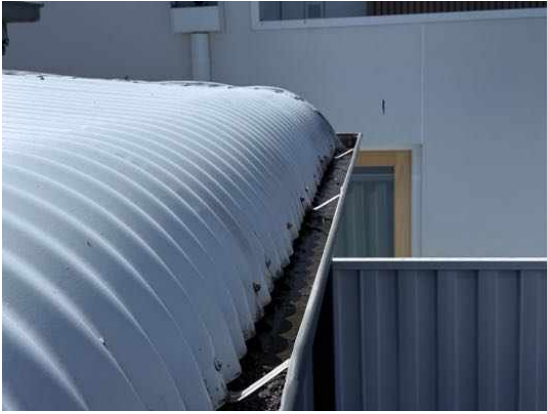
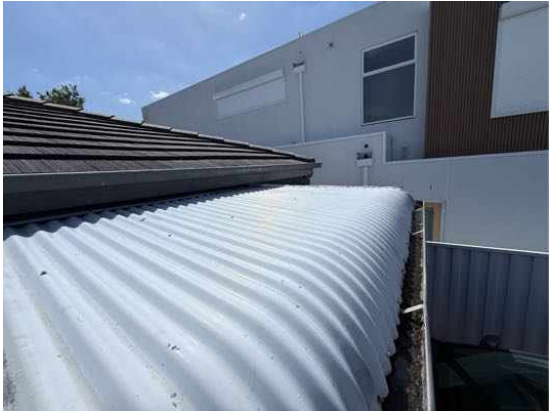
Building: Main Building
Location: All Areas
Finding: Additional photos & Obstruction/Limitations.
Information: Additional photos for general documentation. May have some minor maintenance items not listed in the defects section.

Furthermore, some photographs are an indication of the obstructions and limitations which impeded full inspection of the property at the time of inspection. These obstructions can hide an array of defects and should be removed to allow full inspection to be carried out. A re-inspection is recommended once the areas are made accessible.
