# Building and Timber Pest Inspection Report

Inspection Date: Tue, 10 Feb 2026

Property Address: 11 Lois Ct, Trafalgar VIC 3824, Australia

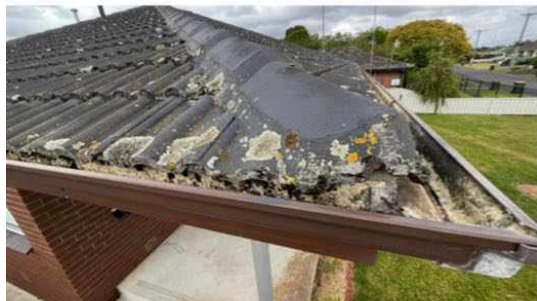
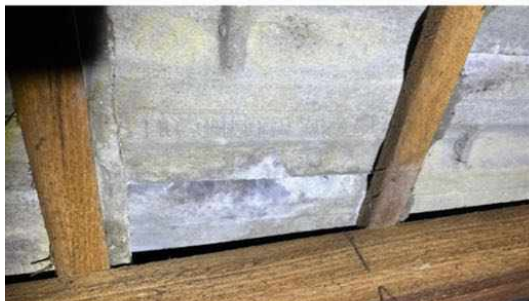
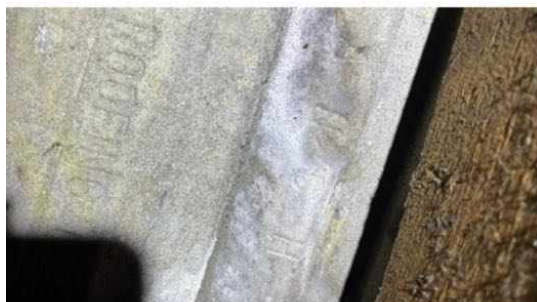
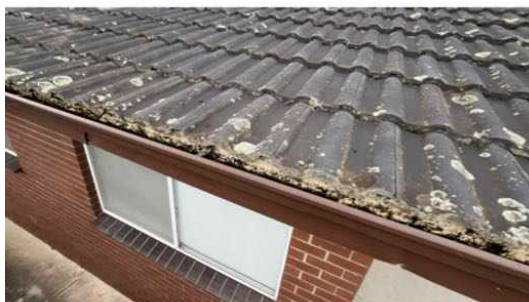
If left unaddressed, this deterioration could compromise the roof's ability to provide a watertight barrier, potentially leading to water ingress and damage to the interior structure. Additionally, weakened edges may further degrade, increasing the risk of tiles becoming dislodged during strong winds or storms.

It is recommended to engage a licensed roof plumber to assess the extent of the deterioration and undertake necessary replacement or restoration work. Prompt action will help ensure the roof remains weatherproof and structurally sound.

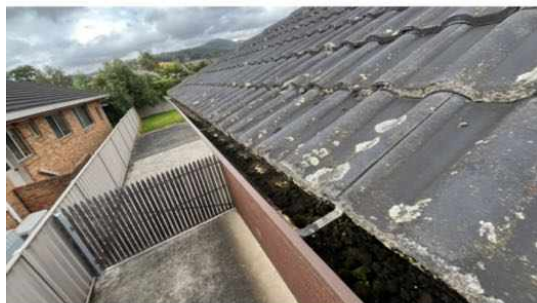
### Finding 3.11

Building:	Main Building
Location:	Roof Exterior
Finding:	Gutters - Partially Blocked
Information:	Roof plumbing structures, such as guttering and downpipes, should be free of all debris to prevent blockages. Blockages of the guttering and downpipes will lead to pooling and accumulated water overflows, which is likely to subsequently flood eaves and exterior walls.

Blocked gutters are likely to lead to high levels of moisture in the affected areas. Such moisture will not only cause rust and decay of the associated building materials, but can also provide conditions that are conducive to termite and timber pest activity. Blockages in gutters should therefore be removed immediately to ensure dry conditions are maintained.

Consult a Licensed Plumber for further specific advice on remedial works that may be required. In the interim, it is highly advised that blocked gutters be removed by the homeowner or a general handyperson as a matter of urgency.

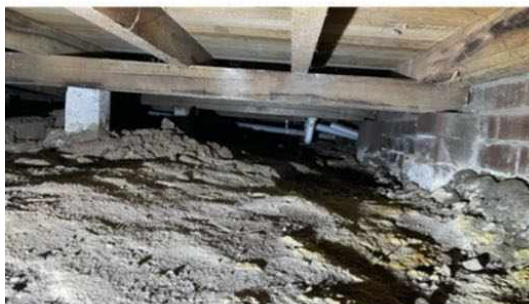
### Finding 3.12

Building:	Main Building
Location:	Subfloor
Finding:	Subfloor – Inappropriate Pipe Discharge and Termite Risk
Information:	Two pipes were observed discharging water directly into the subfloor area at the time of inspection. This arrangement allows water to accumulate beneath the dwelling rather than being directed to an approved stormwater drainage point. The source and function of the discharge pipes could not be fully determined within the scope of this visual, non-invasive inspection.

Uneven ground surfaces can allow water to pond or accumulate beneath the dwelling, contributing to elevated moisture levels. Inadequate subfloor ventilation restricts natural air circulation, preventing effective drying of moisture. These combined conditions create an environment conducive to timber decay, mould growth, corrosion of metal components, and increased termite risk, as termites are attracted to damp and poorly ventilated areas. Prolonged exposure to such conditions may adversely affect the durability and structural integrity of subfloor timbers.

It is recommended that a registered builder assess the subfloor area and implement measures to improve drainage and ground grading to prevent water accumulation. Additional compliant subfloor ventilation should be installed as required to promote adequate airflow in accordance with current standards. Ongoing monitoring of the subfloor environment is advised to ensure moisture levels remain within acceptable limits.

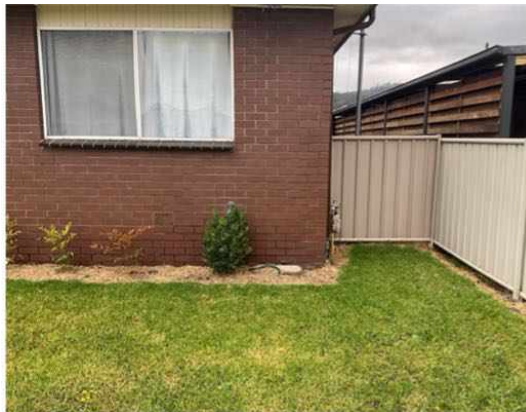
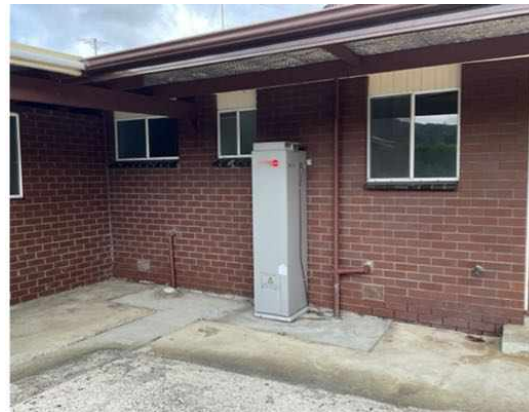
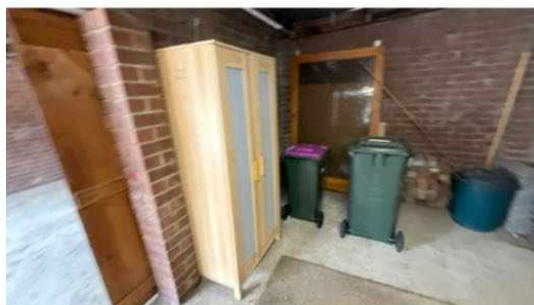
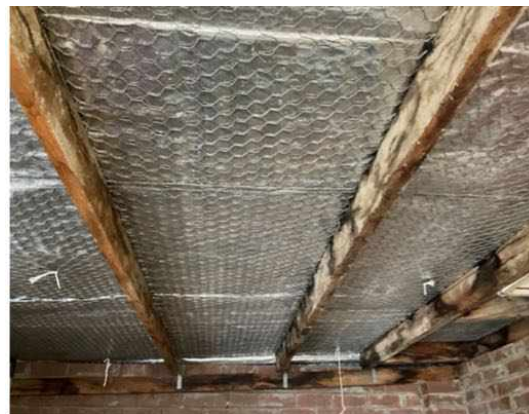
#### Noted Item

Building: Main Building  
 Location: All External Areas  
 Finding: Obstructions and Limitations - External areas  
 Information: These photographs are an indication of the obstructions and limitations which impeded full inspection of the external areas of the property at the time of inspection. These obstructions can hide an array of defects and should be removed to allow full inspection to be carried out.

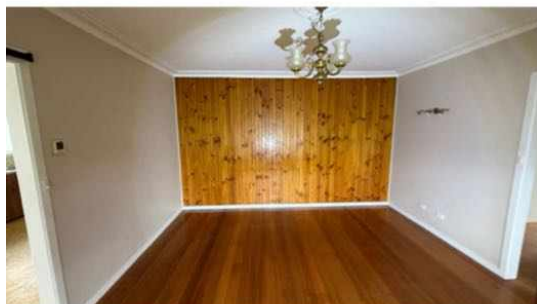
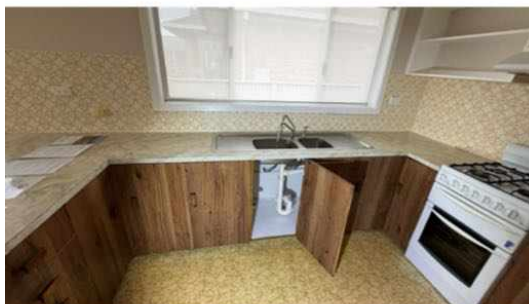
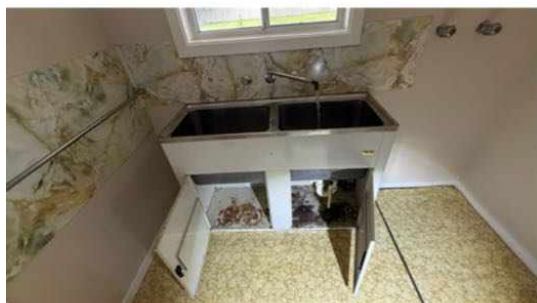
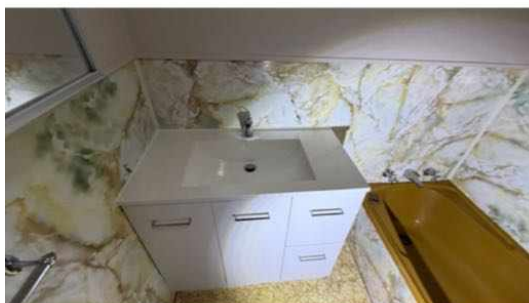
#### Noted Item

Building: Main Building  
 Location: All Internal Areas  
 Finding: Obstructions and Limitations - Internal areas  
 Information: These photographs are an indication of the obstructions and limitations which impeded full inspection of the internal areas of the property at the time of inspection. These obstructions can hide an array of defects and should be removed to allow full

inspection to be carried out. A re-inspection is recommended once the areas are made accessible.

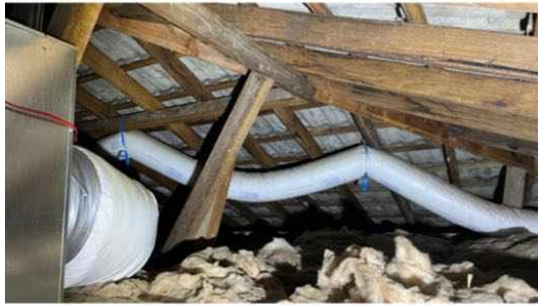
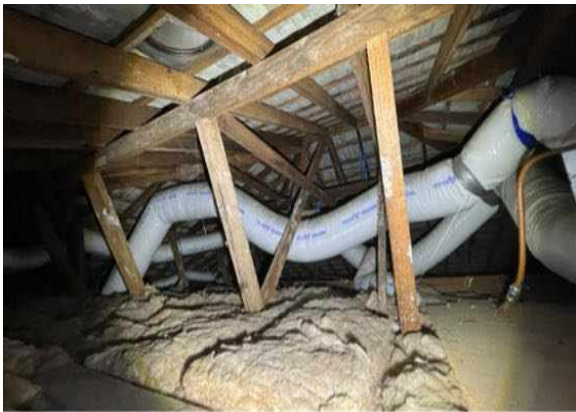
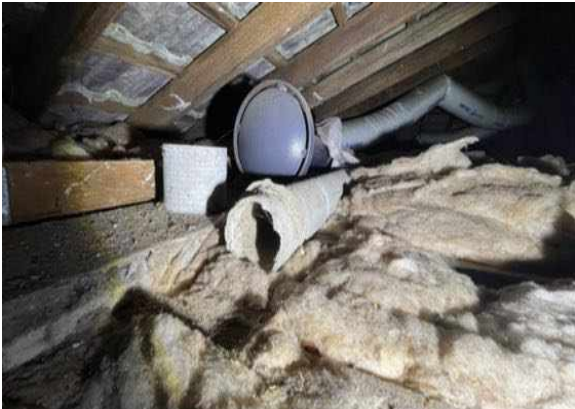
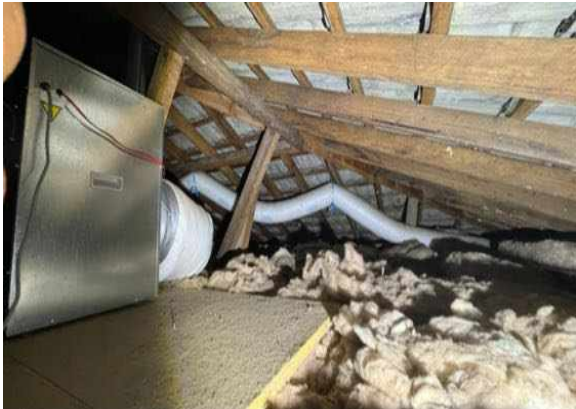
### Noted Item

Building:	Main Building
Location:	Roof Void
Finding:	Obstructions and Limitations - Roof Cavity
Information:	These photographs are an indication of the obstructions and limitations which impeded full inspection of the roof cavity of the main building at the time of inspection. These obstructions can hide an array of defects and should be removed to allow full inspection to be carried out. A re-inspection is recommended once the areas are made accessible.

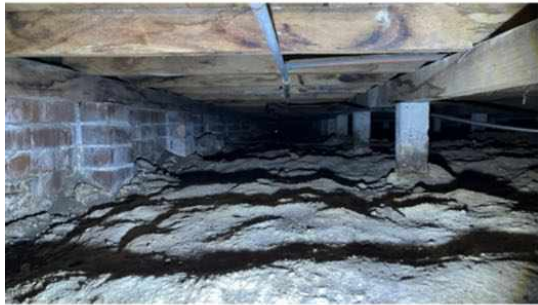
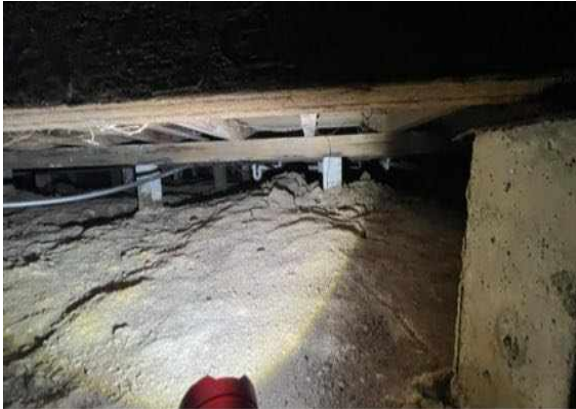
**Noted Item**

Building: Main Building  
Location: Subfloor  
Finding: Obstructions and Limitations - Subfloor  
Information: These photographs are an indication of the obstructions and limitations which impeded full inspection of the subfloor of the main building at the time of inspection. These obstructions can hide an array of defects and should be removed to allow full inspection to be carried out. A re-inspection is recommended once the areas are made accessible.
