Building and Timber Pest Inspection Report VR

Inspection Date: Thu, 11 Dec 2025

Property Address: 20 Hakea Ave, Frenchs Forest NSW 2086,
Australia

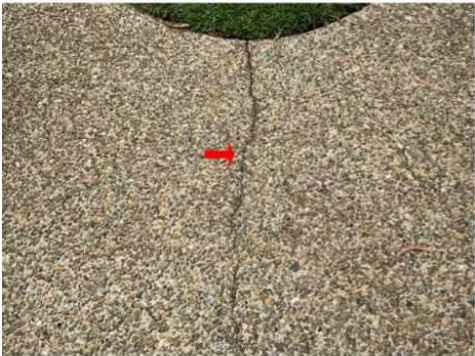
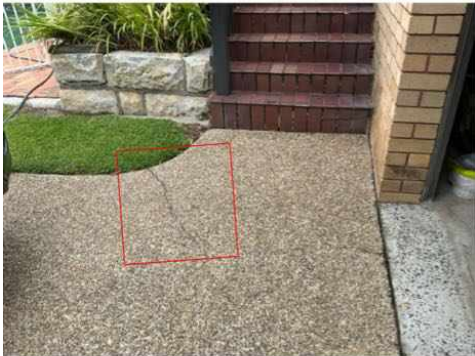
Building: Main Building
Location: Garage, Driveway
Finding: Crack in concrete slab - Category 2
Information: A crack coded as Category 2 was identified in the slab. A Category 2 crack is described as a distinct crack, with the slab being noticeably curved or changed in level.

To be considered Category 2, the approximate width of the crack is less than 2.0mm, or a change in offset of less than 15mm when a 3m straight edge is placed over the defect.

Category 2 cracks to slabs should be monitored for a period of 12 months. At the end of the monitoring period, cracks rated greater than Category 2 are considered defects that require rectification.

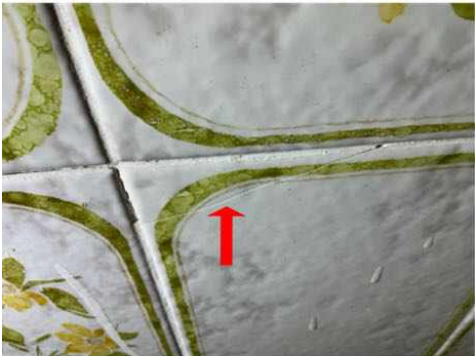
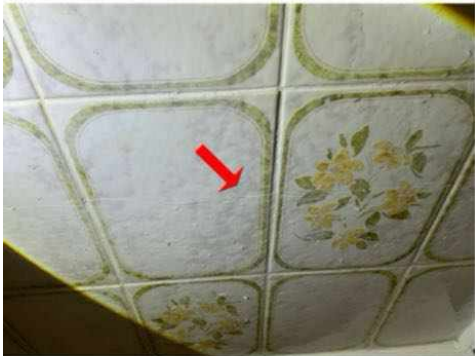
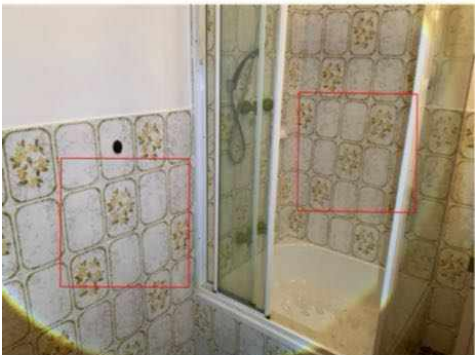
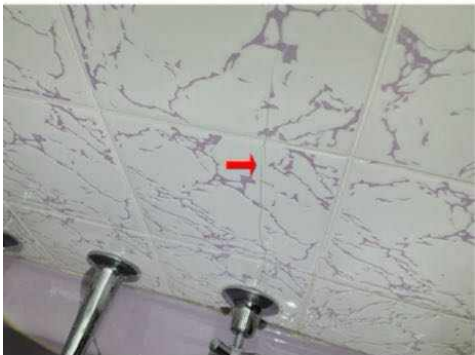
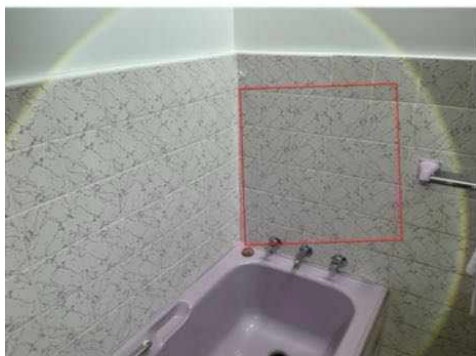
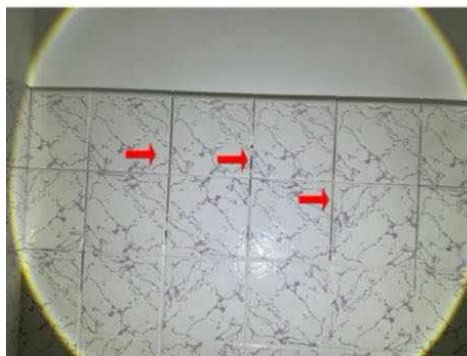
Finding 3.02

Building: Main Building
Location: All Bathrooms
Finding: Tiles - Cracked/Damaged (VR)
Information: Cracks were noted in the floor tiles at the time of inspection, likely caused by minor settlement or shrinkage. While the cracks are not serious, they may allow water to enter nearby walls or flooring if left unsealed. Replacement of the cracked tiles is recommended at the client's discretion, and a licensed tiler can carry out this work

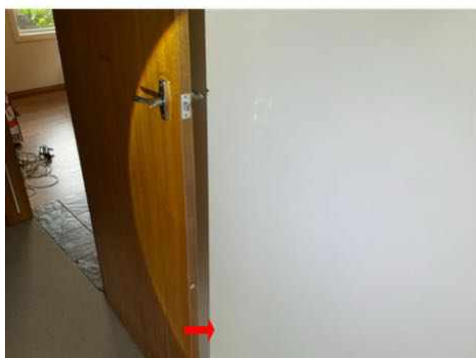
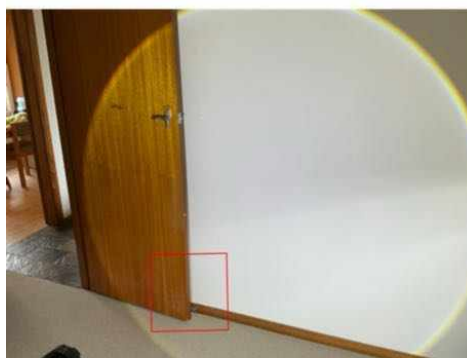
Finding 3.03

Building: Main Building
 Location: Bedroom 1
 Finding: Door Stopper(s) - Missing (VR)
 Information: At the time of inspection, it was noted that a door stopper was missing in this area.

The absence of a door stopper can lead to potential damage to the door, wall, or surrounding finishes, as the door may swing open too far and impact the wall or adjacent objects.

The client is advised to engage services of a handyman to install the door stopper at own discretion.

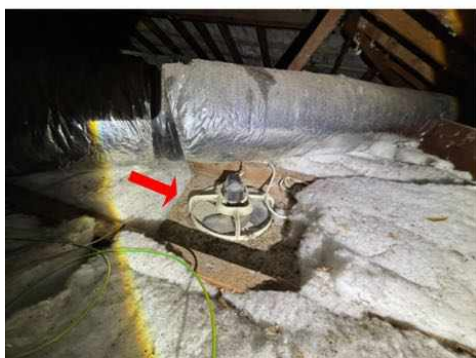
Finding 3.04

Building: Main Building
 Location: Roof Void
 Finding: Vent - Extracted into Roof Space
 Information: At the time of inspection, it was noted that the exhaust vent terminates into the roof space rather than being ducted outside which is a very common defect. This setup may allow moisture to build up over time, which could affect roof materials if left unaddressed. It is recommended that a licensed electrician re-route the ducting so the

exhaust discharges externally in line with standard building practice.

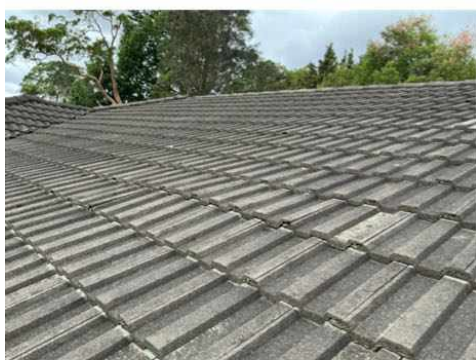
Finding 3.05

Building:	Main Building
Location:	Roof Exterior
Finding:	Roof Tiles - Weathered (VR)
Information:	At the time of inspection, the roof tiles were noted to be weathered, which is consistent with age and normal exposure to the elements. While no immediate concerns were observed, it is recommended that the roof tiles be monitored and maintained as required to help ensure ongoing weather protection.

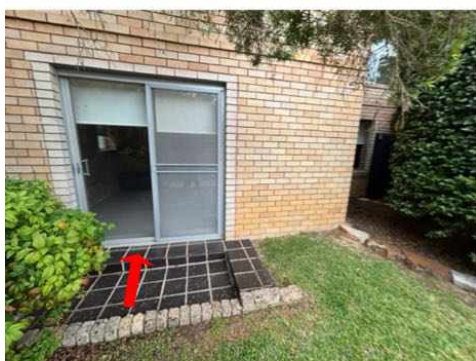
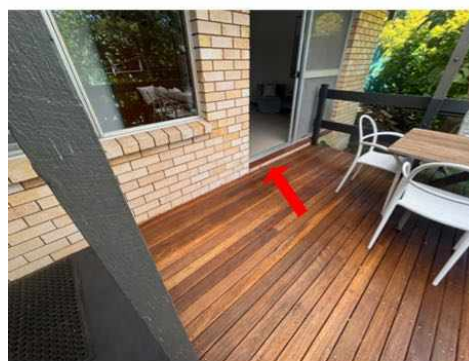
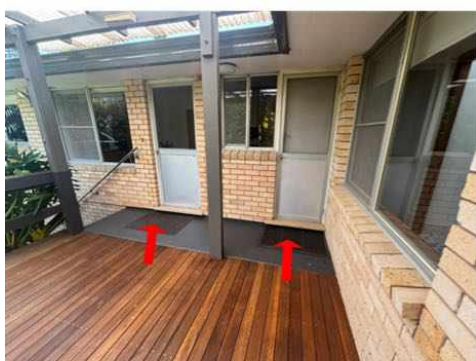
Building: Main Building
 Location: Deck, Lower Floor Entrance
 Finding: Bridging or Breaching of Termite Barriers - Adjacent Internal Flooring (VR)
 Information: Bridging occurs when a termite barrier is spanned, while breaching occurs when a hole or gap is present, both of which provide concealed entry points for termites. Where external ground levels are equal to or higher than the internal floor level, the risk of termite activity is increased due to the potential concealment of entry paths.

It is recommended that external ground levels be reduced to ensure they remain below the adjacent internal floor level. Where this is not practical, a licensed pest controller should be engaged to carry out termite treatment around the building perimeter and within the subfloor (if applicable) to minimise the risk of infestation.

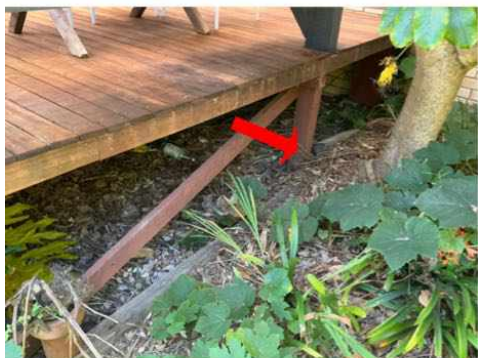
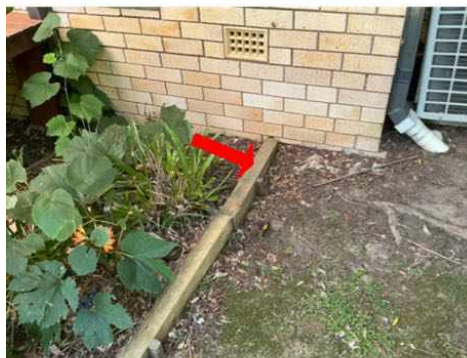
Finding 6.02

Building: Main Building
 Location: Deck
 Finding: Timber Directly Attached to Building & Ground
 Information: At the time of inspection, timber materials were noted to be directly attached to the external wall of the dwelling. This practice is considered a conducive condition for termite activity, as it provides both a potential food source and concealed entry point

for termites into the structure.

It is recommended that the timber be removed, isolated, or appropriately treated to reduce the risk of termite infestation. A licensed pest management specialist should be consulted for further assessment and advice in line with AS 3660.2 (Termite Management).

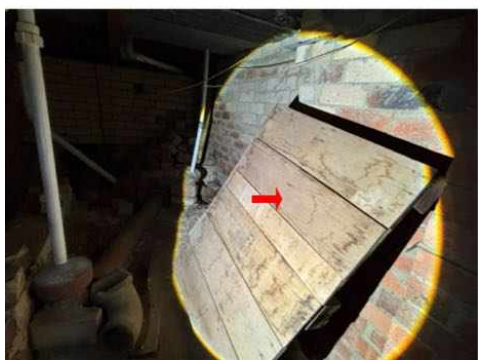
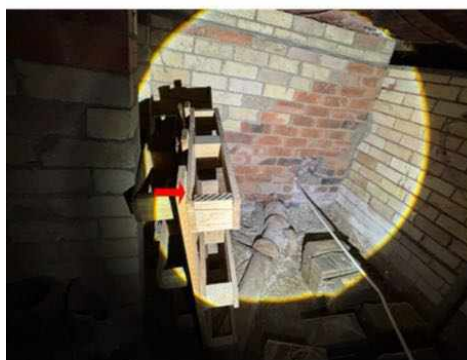
Finding 6.03

Information: The storage of timber around external areas or within subfloor spaces poses a significant risk of attracting termite activity. Timber left exposed to moisture can develop wood rot, creating an ideal environment for termites and other timber pests. When placed directly on the ground or in damp, concealed subfloor areas, this timber can act as a bridge for termites to enter the structure, potentially causing serious and costly damage.

In addition to termites, stored timber can promote mould, mildew, and fungal growth, which may affect both the structure and the health of occupants.

To reduce these risks, it is strongly advised that any stored timber be removed.

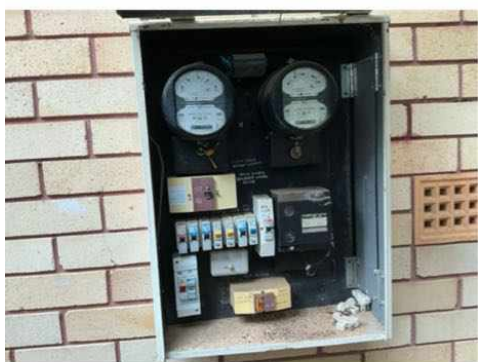
Finding 6.04

Building:	Main Building
Location:	Meter Box
Finding:	Termite Management System - No Evidence of Installation (VR)
Information:	No evidence of a termite management system was identified at the time of inspection. A post-construction chemical termite barrier is strongly recommended to provide long-term protection. The client should consult a licensed pest controller for advice on installation and costs.

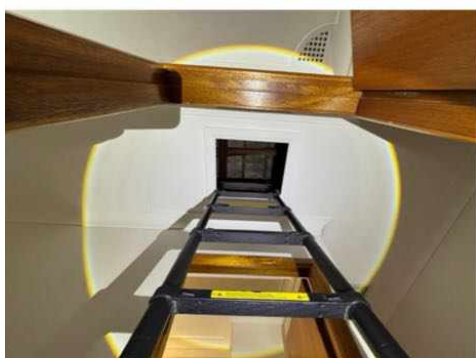
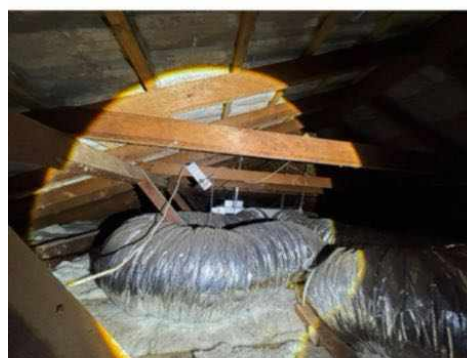
Noted Item

Building:	Main Building
Location:	Roof Void
Finding:	Obstructions, Limitations, and General Roof Space Condition
Information:	The photographs provided document both the general condition and the obstructions and limitations that were present in the roof cavity of the main building at the time of inspection. These obstructions—such as insulation materials, stored items, structural elements, or electrical wiring—restricted safe and adequate access to key areas within the roof space. As a result, a comprehensive inspection of all components could not be completed.

Obstructions of this nature may conceal a variety of potential defects, including damaged framing, compromised insulation, evidence of moisture ingress, pest activity, or electrical hazards. While no major issues were observed in the visible areas, the presence of these limitations means that some defects may remain undetected.

It is recommended that these barriers be removed or repositioned to facilitate full and safe access to the roof space. Once clear, a follow-up inspection should be conducted to allow for a thorough assessment of all concealed areas. This will help ensure that the condition of the roof cavity is accurately evaluated and any hidden issues are appropriately identified and addressed.

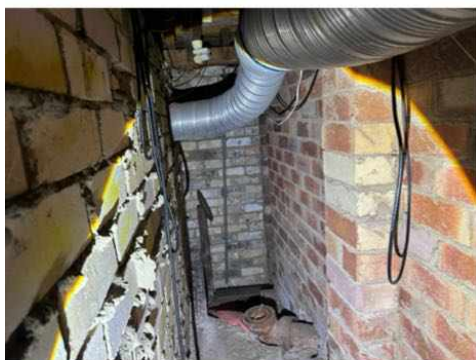
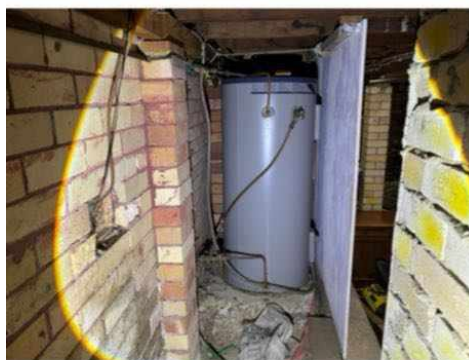
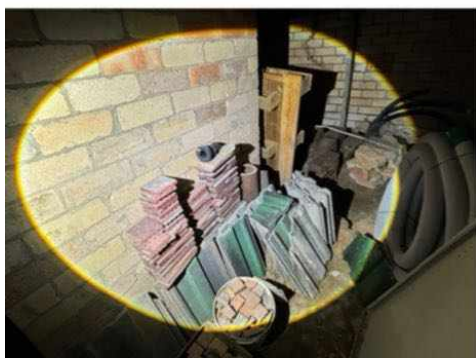
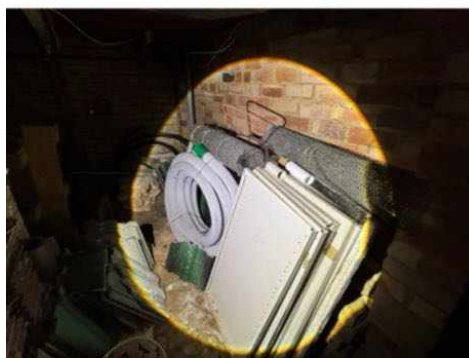
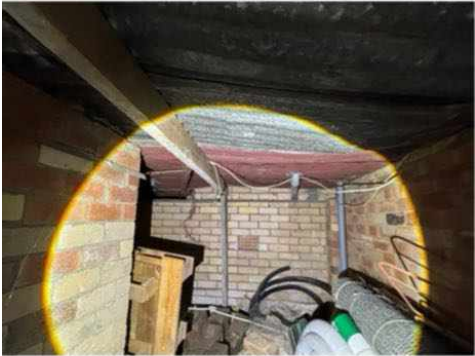
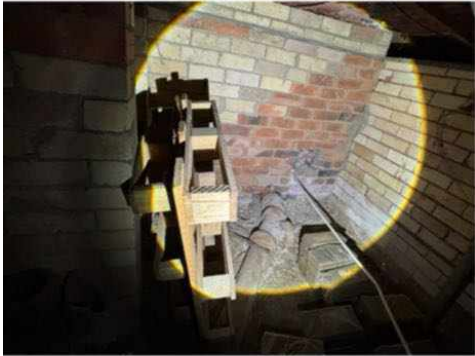
Building: Main Building
Location: Subfloor
Finding: Obstructions, Limitations, and General Subfloor Condition
Information: The attached photographs illustrate the obstructions and access limitations that restricted a full inspection of the subfloor area of the main property at the time of assessment. Items such as stored materials, construction debris, low-hanging services, and insulation impeded movement and visibility within key sections of the subfloor. In addition, the limited crawl height further restricted safe access to inspect critical structural components.

Restricted access and confined spaces can significantly hinder the ability to evaluate important elements such as floor joists, bearers, stumps, drainage, subfloor ventilation, and signs of moisture or pest activity. These obstructions may also conceal defects such as timber decay, water ingress, termite damage, inadequate support, or ventilation issues that are not immediately visible during a limited inspection.

While no major concerns were identified in the accessible areas, a full and unobstructed inspection is necessary to properly assess the overall condition of the subfloor. It is recommended that obstructions be removed and access improved where possible. Once adequate clearance is provided, a re-inspection should be arranged to ensure that any concealed defects can be identified and addressed accordingly. This will assist in providing a more comprehensive understanding of the subfloor's condition and reduce the risk of unforeseen issues.

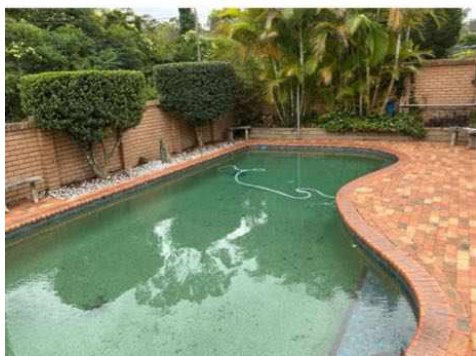
Building:	Main Building
Location:	Pool Area
Finding:	FYI - Pool Area
Information:	This inspection explicitly excludes any assessment of the pool, spa, associated pool equipment, and the surrounding areas. As a standard building inspection does not encompass these elements, it is crucial for the client to understand that no evaluation has been conducted regarding the condition, functionality, or safety compliance of the pool or its associated systems. This includes, but is not limited to, pumps, filters, heating equipment, and structural integrity of the pool or spa surrounds.

To gain a comprehensive understanding of the condition and compliance of these components, it is highly recommended that the client engages a specialist pool inspector. A pool inspection will evaluate the structural condition of the pool, ensure the functionality of all associated equipment, and assess whether the pool and its surroundings meet current safety regulations. In particular, pool safety requirements, including fencing and access controls, are subject to stringent regulatory standards, which must be verified separately by a qualified pool inspector.

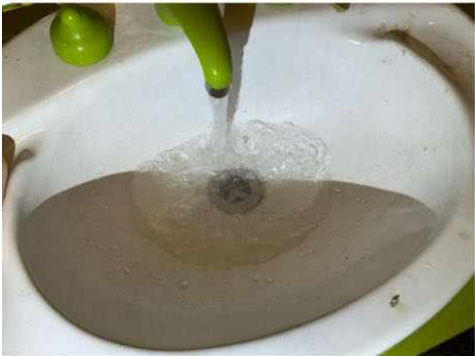
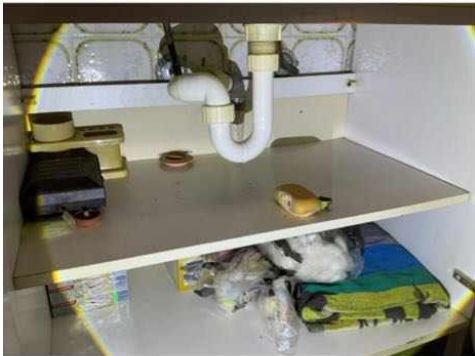
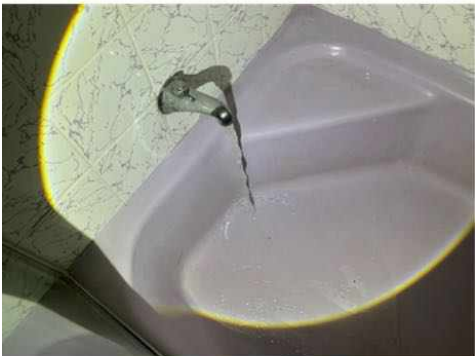
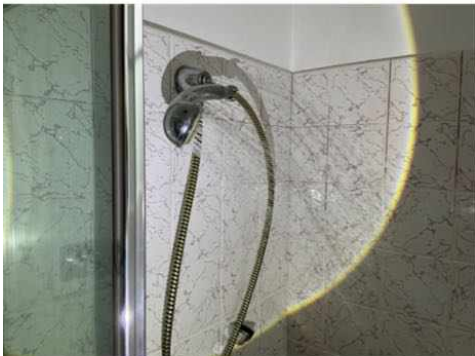
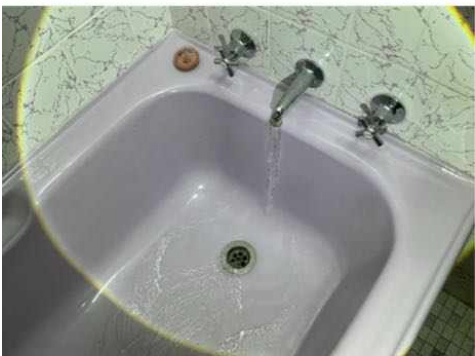
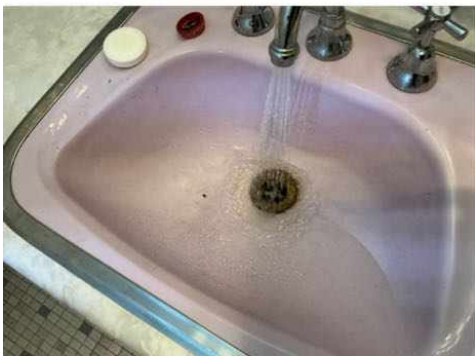
Building:	Main Building
Location:	All Areas
Finding:	FYI - Taps, Drainage & Toilets Tested and Cabinetry Obstructions
Information:	During the inspection, all accessible taps, drainage systems, and toilets were tested for water flow and drainage efficiency, and checked for any visible signs of leakage. At the time of the inspection, no issues were noted in these areas. Unless highlighted in a separate defect statement, no immediate remedial work appears necessary. Supporting images may be found in the additional photos section for reference.

It is important to note that while a visual inspection of cupboards and cabinetry beneath sinks and vanities was undertaken, stored personal items and fixtures presented obstructions that limited full visibility of the internal areas. As per standard inspection practices, inspectors are not permitted to move or disturb personal belongings during the inspection process. Therefore, only visible and accessible sections were inspected, and concealed water damage or plumbing defects may not have been detected.

Given this, a re-inspection is recommended after all obstructions have been cleared to allow for a comprehensive assessment of these areas. Regular maintenance and monitoring of plumbing and drainage systems is also advised to ensure ongoing functionality and early detection of potential issues.

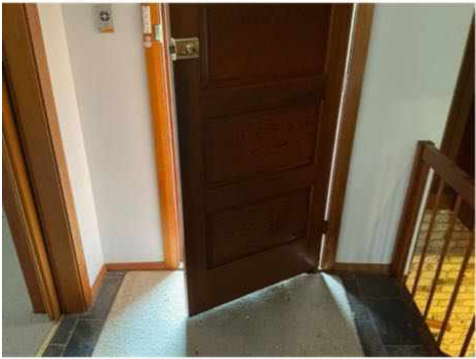
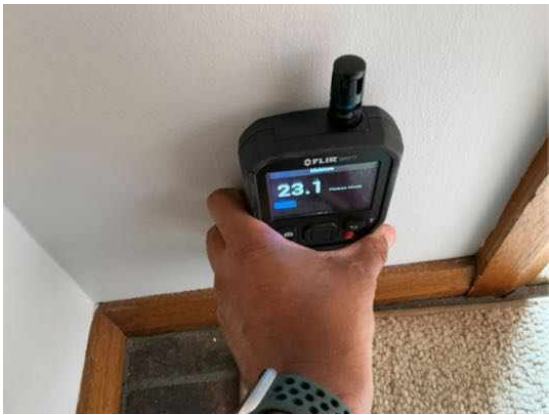
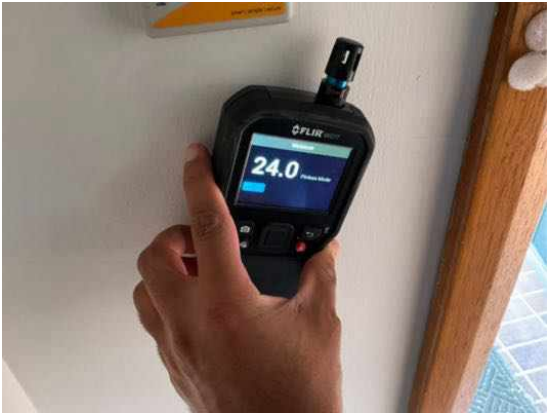
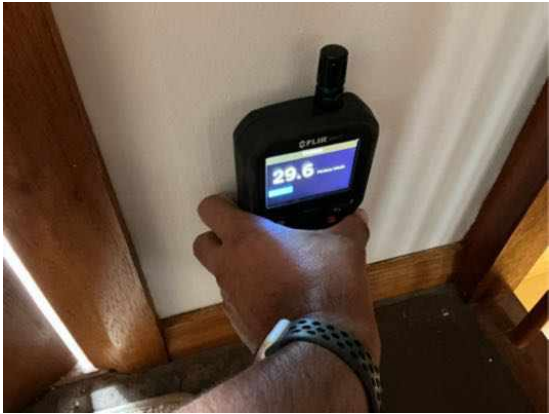
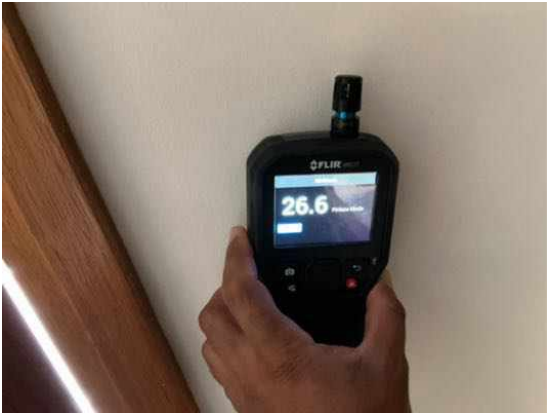
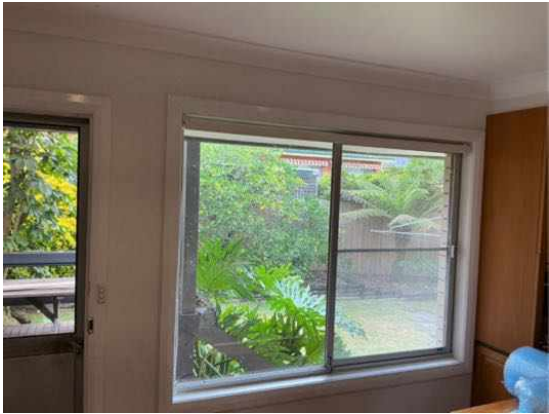
Building: Main Building
 Location: All Areas
 Finding: Additional Photos - Moisture Meter Readings (VR)
 Information: Moisture meter readings were taken at various locations throughout the property during the inspection. All readings were within the normal range, and no elevated moisture levels were detected at the time of assessment. Additional photos have been provided to show the specific areas tested for further clarity.

It is important to note that moisture levels can fluctuate over time due to weather, humidity, and environmental conditions. While readings were normal during the inspection, future changes may still result in dampness, mould growth, or deterioration of building materials if left unmonitored. Any defects relating to moisture have been detailed separately in the defect statements within this report.

The client is encouraged to monitor moisture-prone areas regularly, particularly during wet seasons or periods of high humidity, and to contact the inspector directly for clarification or further advice if required.

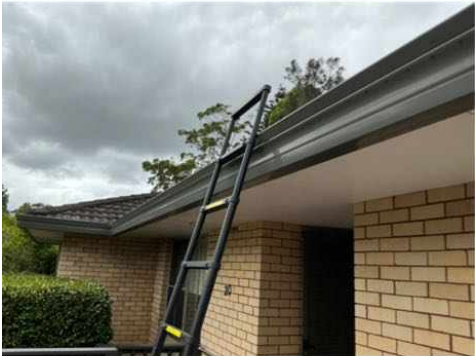
Information: As part of the information provided, please note that the attached roof photos represent the condition of the roof at the time of inspection. These photos are for visual reference only and do not constitute a detailed roofing assessment. Any defects or issues identified with the roof are mentioned separately in the defect statements. It is strongly recommended that the client engage a qualified roofer to conduct a thorough inspection of the roof, ensuring that any potential issues, such as leaks, structural integrity, or wear and tear, are properly identified and addressed.

Additionally, the condition of the roof may change over time due to weather, natural wear, or other unforeseen factors. Regular maintenance and inspections by a licensed professional are advised to ensure the roof remains in good condition and to avoid costly repairs in the future. The information provided in these photos should be considered a snapshot of the roof's condition during the time of inspection and not a guarantee of its future performance.

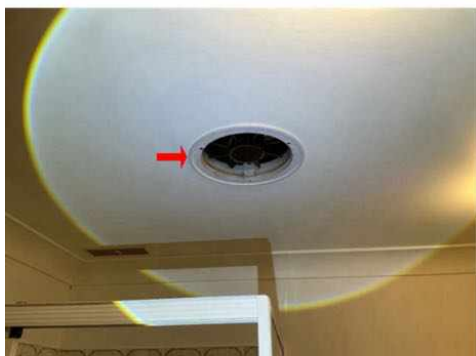
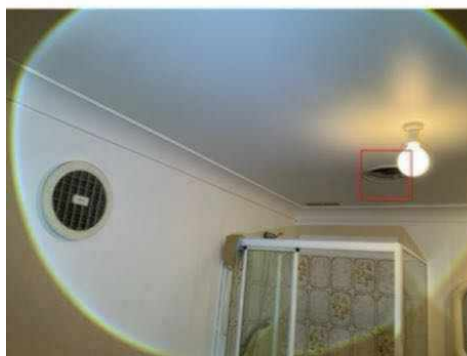
Building:	Main Building
Location:	Bathroom Lower Floor
Finding:	Non Functional Exhaust Fan
Information:	At the time of inspection, one exhaust fan was noted to be non-operational and missing its cover. It was also observed that another exhaust fan in the same area was functioning as intended. As the non-working fan is not required, it is recommended that a licensed electrician remove the unused fan and make good the opening for a neat and finished appearance.

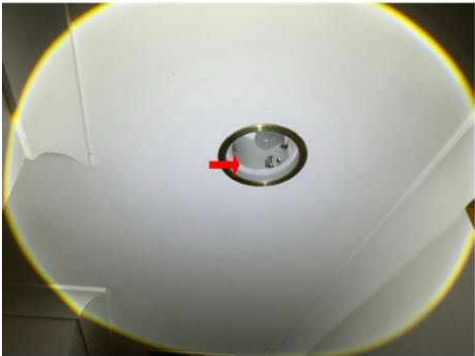
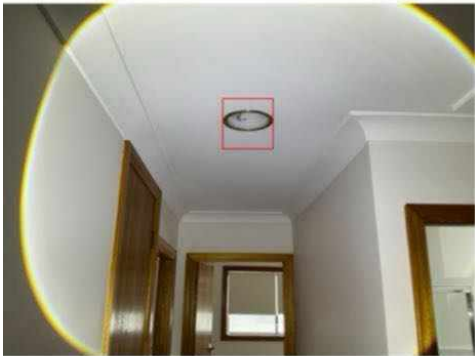
Building:	Main Building
Location:	Hallway
Finding:	Light Cover - Missing
Information:	At the time of inspection, it was observed that the light cover for the ceiling light fixture is missing. The absence of the light cover exposes the bulbs and internal components. It is recommended to replace the missing light cover promptly to ensure safety and restore the visual integrity of the lighting fixture.
