Building and Timber Pest Inspection Report

Inspection Date: Tue, 10 Mar 2026

Property Address: 10 Crabapple Cl, Bowral NSW 2576,
Australia

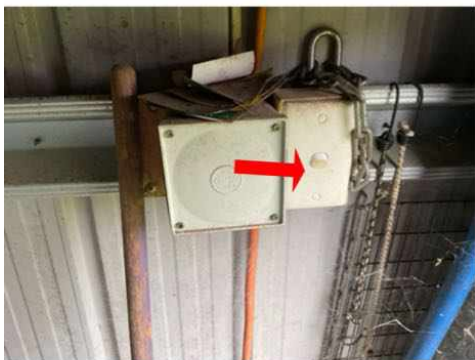
Building: Building 1
Location: Garage
Finding: Light switch faulty - requires electrician
Information: The light switch in the garage emitted sounds making it unsafe to use. The lights did not work on turning this on.

This damaged fitting may be a safety hazard if there is potential contact with persons in the area.

A Licensed electrician should be appointed to rectify these areas immediately.

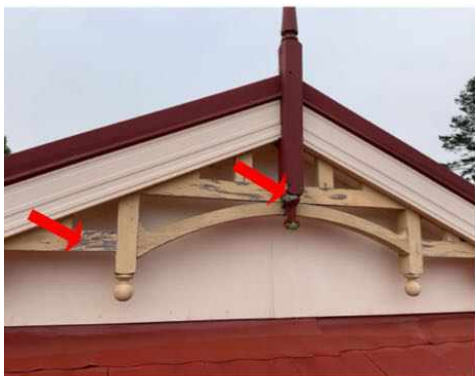
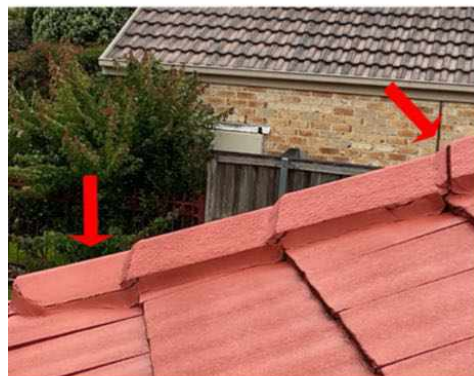
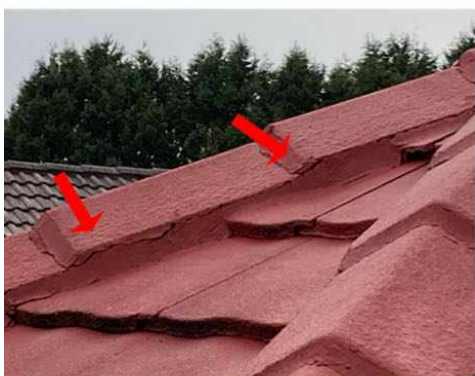
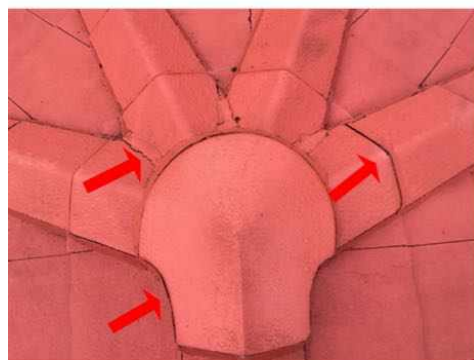
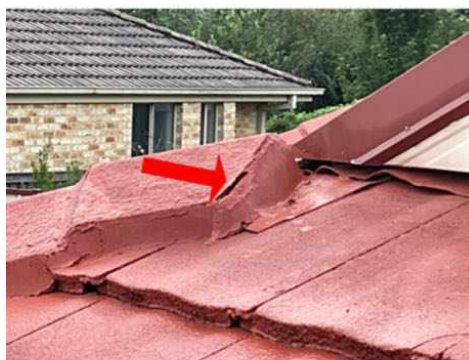
Building: Building 1
Location: Roof Exterior
Finding: Roofing areas - Weathered
Information: Upon inspection of the exterior roofing, the majority of the roof tiles were considered to be in a good condition, with the roof mortar in fair condition.

Where left unmanaged, deteriorating roofing materials are likely to lead to a number of secondary defects, including minor water leaks and weather exposure to internal roofing structures.

Re-sealing and replacing many small areas of gaps and damage must be undertaken by the client to help preserve and extend the life span of these roofing areas.

Consultation with a roofing contractor is highly advised to gain advice on cost of remedial works that may be required in the short to medium term.

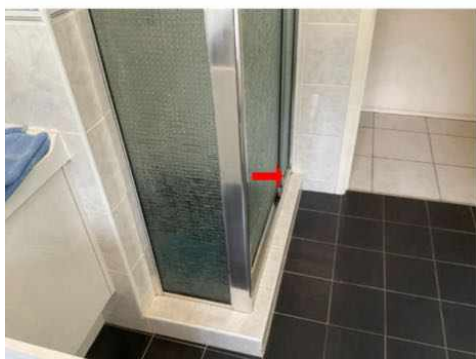
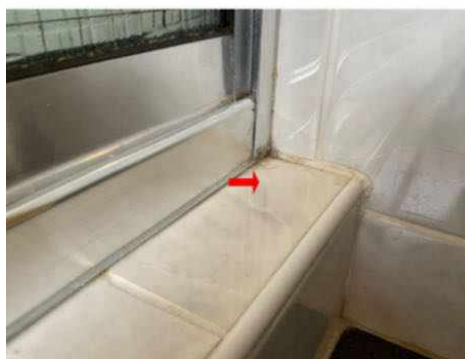
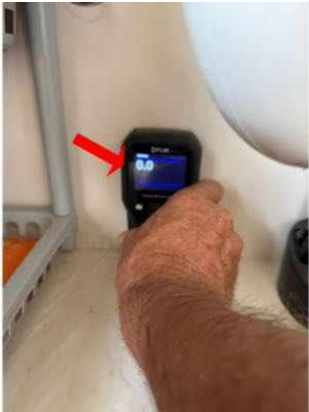
Building:	Building 1
Location:	Bathroom
Finding:	Shower screen leaking and water found
Information:	Leaking was evident to the shower screening at the time of inspection. It is suspected that the leaking has occurred as a result missing sealant. Leaking from the shower , where left unattended, is likely to lead to water damage to adjoining flooring and walls. Such damage can lead to water damage and necessitate extensive remedial works being required.

Water was found under the vanity and rear staining was observed however the taps were run for 5 minutes and no leaks were found.

This may be old staining or something spilt in this cupboard. Active water leaks may also create an environment that is susceptible to the formation and development of mould.

Appointment of a sealant expert is required to repair or replace this missing sealant. Such works should be performed as soon as possible to ensure that no further damage occurs.

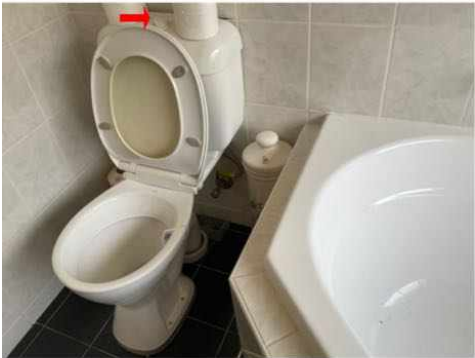
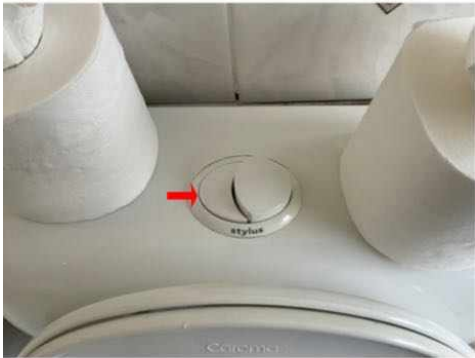
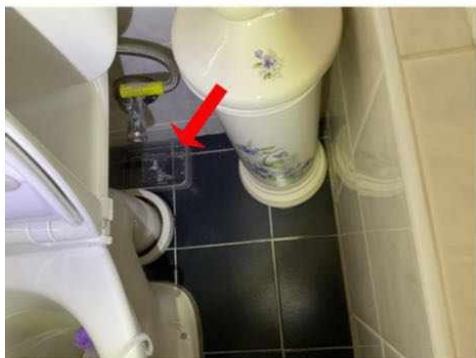
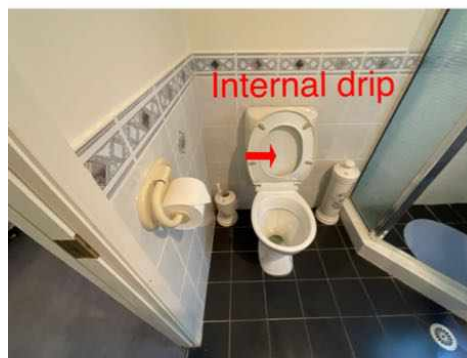
Finding 3.04

Building: Building 1
 Location: Bathrooms
 Finding: Toilet - Flush Button jamming and very slow leaks
 Information: The bathroom toilet flush button needs to be adjusted by a plumber as it is currently sticking or difficult to operate. A tray at the rear of the toilet indicates a very small occasional water leak. The ensuite toilet also has a slow internal continual drip also requiring adjustment. Non-operational building elements such as this are vital to the function of the household and must be fixed. A qualified plumber should be appointed immediately to repair the toilets and return it to an operational state.

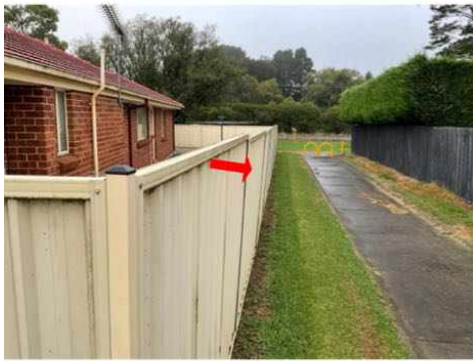
Finding 3.07

Building:	Building 1
Location:	Pictured fence
Finding:	Fence damaged - leaning
Information:	Evidence of damage to the pictured right fence was identified at the time of the inspection. The likely cause of this fence leaning is not enough concrete used in the post footings. If left unmanaged this fence may deteriorate further. It is suggest a fencing contractor be engaged for rectification when convenient.

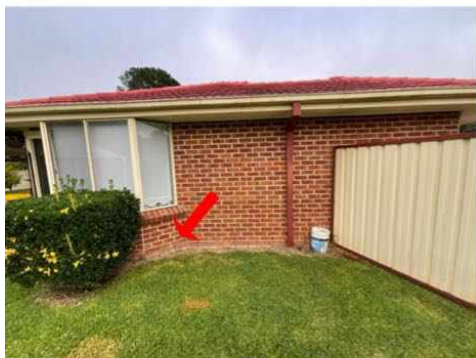
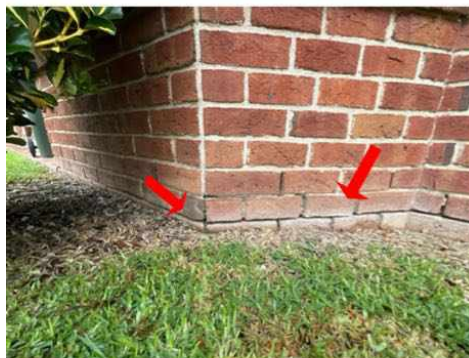
Finding 3.08

Building:	Building 1
Location:	Exterior walls
Finding:	Brickwork - Deteriorated mortar
Information:	Mortar, or 'bedding', is the material which fills joints and intersections between bricks in masonry walls and structures. Sections of mortar in this brickwork were identified as having deteriorated, which is generally expected for a property of this age and condition.

Mortar may deteriorate as a result of age of building materials, minor movement of bricks, or frequent exposure to weathering. Mortar should be replaced to ensure that bricks remain in their intended location and to prevent gaps, which would allow water or moisture ingress and secondary damage as a result.

Mortar deterioration can be addressed by a bricklayer where areas of deterioration are localised and easily accessible. Alternatively, appointment of a registered builder is advised, to repoint large areas of decaying mortar. Where secondary structural defects have become evident, consultation with a structural engineer may be required.

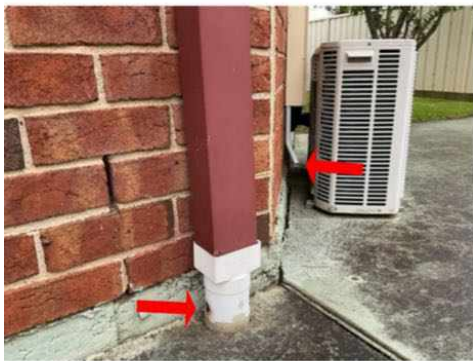
Finding 3.09

Building:	Building 1
Location:	Right wall
Finding:	Site drainage - Inadequate
Information:	The site drainage in this areas was found to be inadequate at the time of inspection, creating potential for subsequent water damage to associated building elements.

The air conditioners and hot water system overflow run against the house walls. The water tank overflow has a small crack.

Where site drainage is inadequate, installation of an Agricultural (Aggie) Drain may be required. A qualified plumber should be appointed to further inspect the property and perform any remedial works as necessary. Secondary defects are likely to occur if left unmanaged.

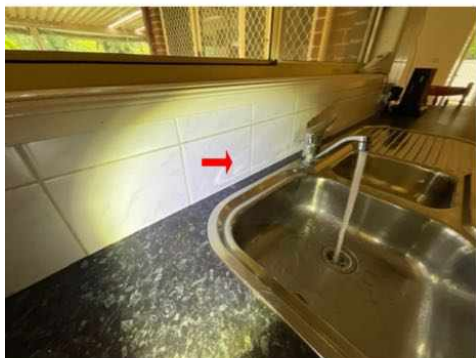
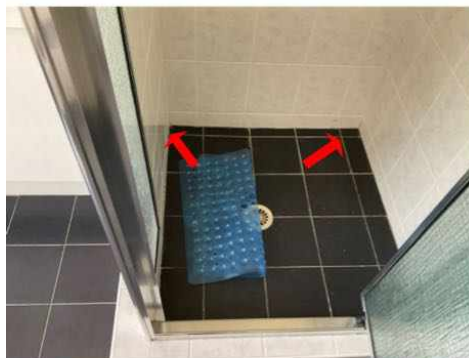
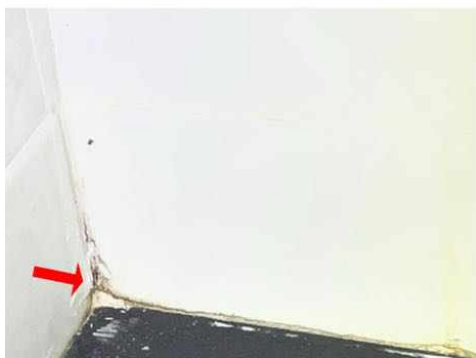
Building:	Building 1
Location:	Kitchen and bathrooms
Finding:	Sealant and grouting - Missing or damaged
Information:	It was noted on inspection that small areas of sealant or grout is degraded to these pictured wet areas.

Different materials and floor areas move at different rates, generally causing cracking to grout or sealant at this point. A flexible sealant is required to allow for expected expansion and contraction, while keeping the joint water tight and protective of all associated building materials.

Flexible and mould resistant materials should be applied to affected areas to prevent any subsequent water damage that is likely to occur. Regular maintenance and replacement of damage or missing or damaged sealant and grout is highly recommended to the wet areas, as this is a regular wear and tear defect. Sealant and grouting in areas that come into regular contact with water should be maintained for the long term care of your property.

A sealant specialist or tiling contractor should be appointed to complete these works as soon as possible

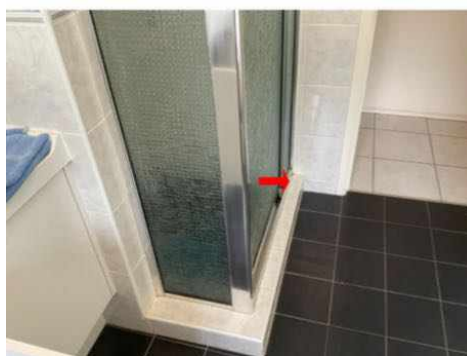
Finding 3.14

Building:	Building 1
Location:	Bathrooms
Finding:	Shower screens - Leaking and poor ensuite shower flow
Information:	Leaking was evident to the shower screening at the time of inspection. It is suspected that the leaking has occurred as a result missing sealant. Leaking from the shower , where left unattended, is likely to lead to water damage to adjoining flooring and walls. Such damage can lead to water damage and necessitate extensive remedial works being required. Active water leaks may also create an environment that is susceptible to the formation and development of mould. The ensuite shower also had poor water flow and it is suspected the ageing shower head is blocked.

Appointment of a sealant expert is required to repair or replace this missing sealant. Such works should be performed as soon as possible to ensure that no further damage occurs.

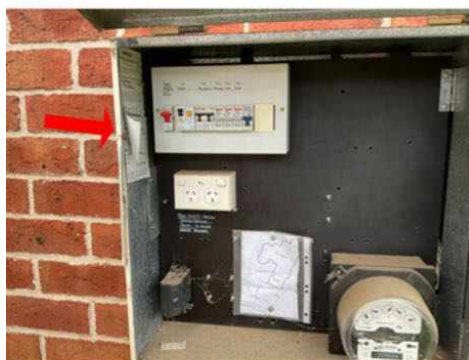
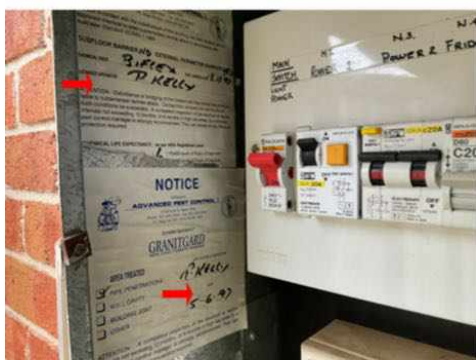
Building:	Building 1
Location:	Meter Box
Finding:	Termite Management System - no evidence of a chemical installation
Information:	The application of a post-construction chemical termite barrier is highly recommended for all properties. Such barriers are highly effective in preventing termite attack on any timber building elements throughout the property.

A durable notice should be placed in the switchboard unit to indicate current termite barriers. At the time of inspection, the durable notice was evident and it appeared as though no chemical termite management system has been installed, with no evidence to suggest preventative works taking place since the property was built in 1997.

The client may consider gaining further advice from a pest controller as to the costs and procedures involved with a 'chemical' application. It is recommended that obtaining such advice be a short-term priority.

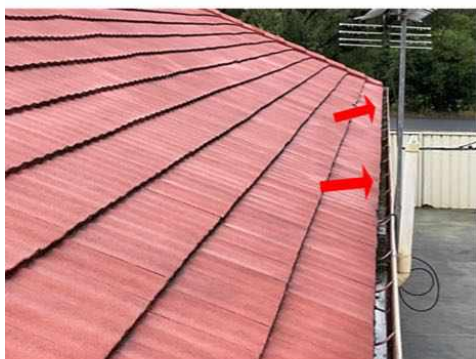
Blocked gutters are likely to lead to high levels of moisture in the affected areas. Such moisture will not only cause rust and decay of the associated building materials, but can also provide conditions that are conducive to termite and timber pest activity. Blockages in gutters should therefore be removed immediately to ensure dry conditions are maintained.

It is highly advised that gutters be cleaned by the homeowner or a general handyperson as a matter of urgency.

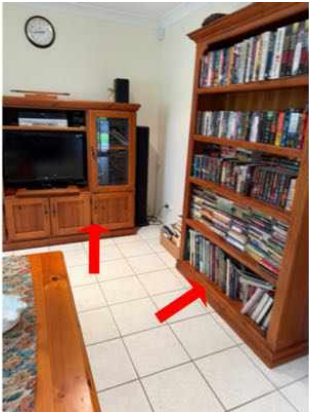
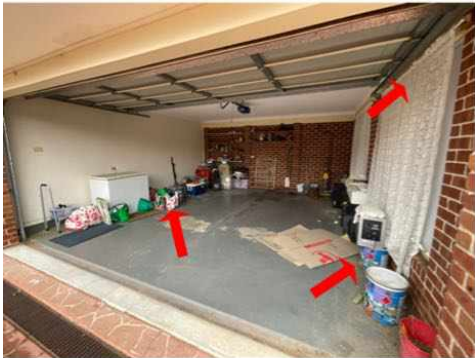
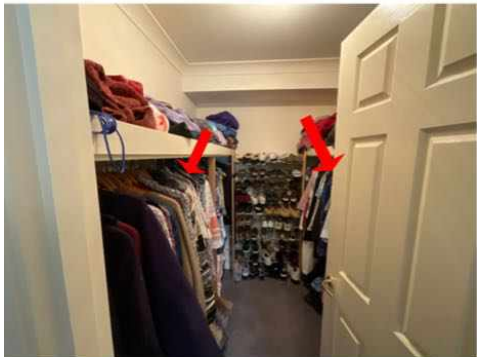
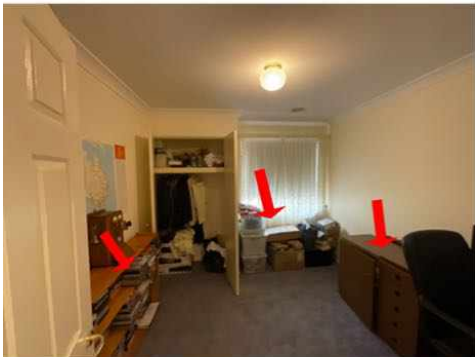
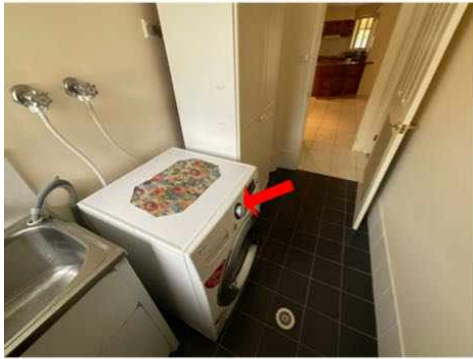
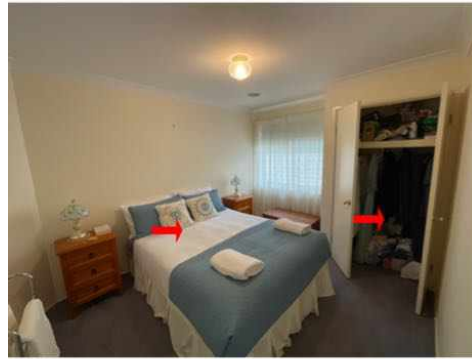
Building: Building 1
 Location: All Internal Areas
 Finding: Additional Photos - Obstructions and Limitations of INTERNAL AREAS
 Information: These photographs are an indication of the obstructions and limitations which impeded full inspection of Internal areas at the time of inspection. These obstructions can hide an array of defects and should be removed to allow full inspection to be carried out. A re-inspection is recommended once the areas are made accessible.

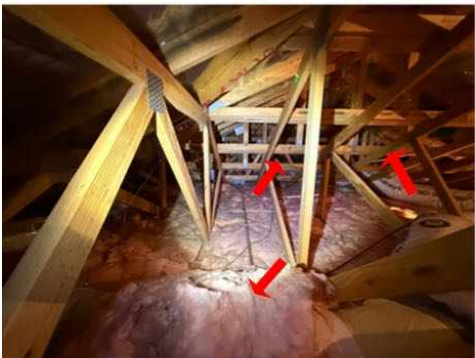
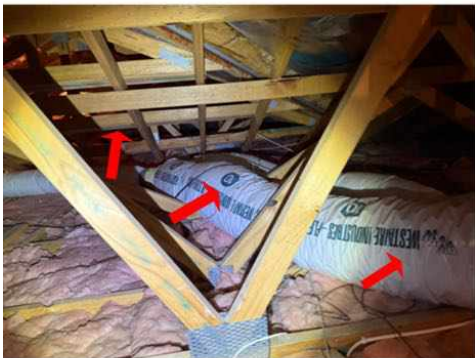
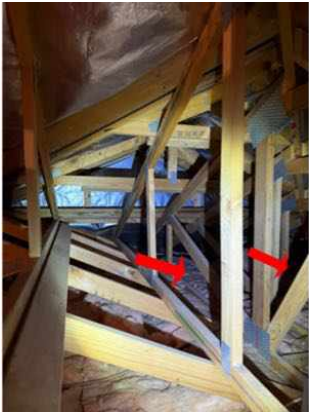
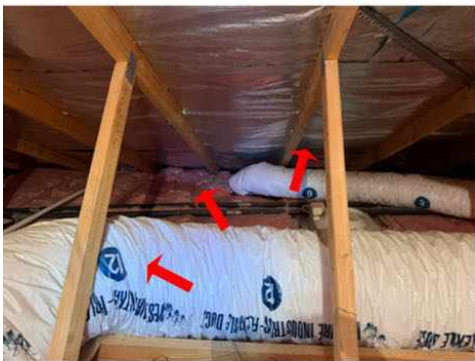
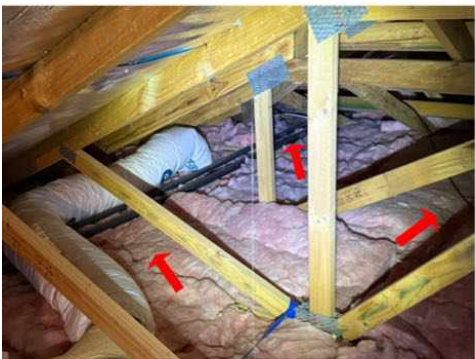
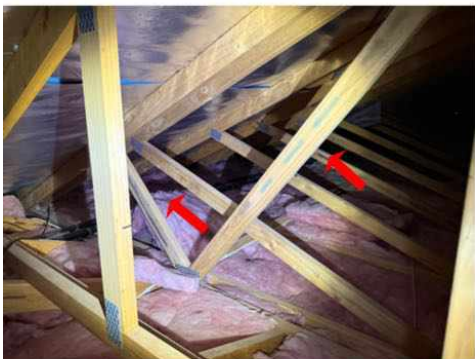
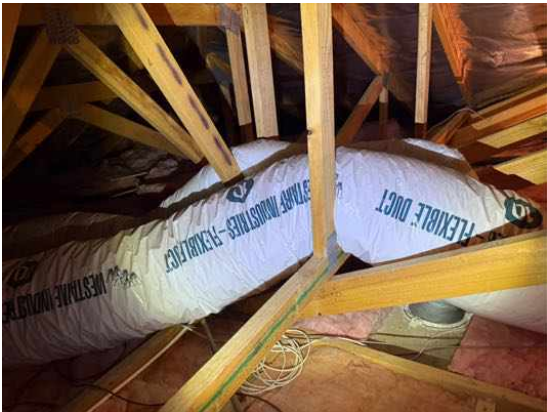
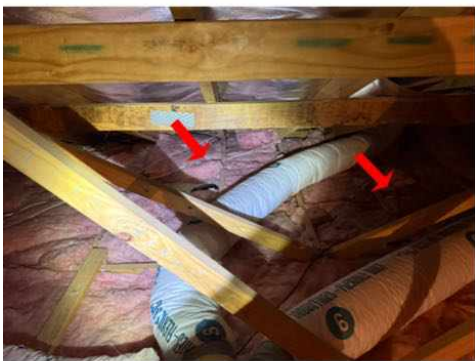
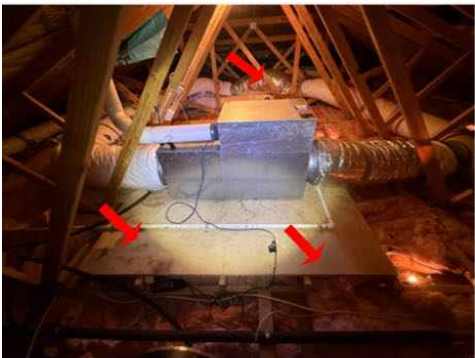
Building:	Building 1
Location:	All Roof cavity areas
Finding:	Additional Photos - Obstructions and Limitations of the ROOF CAVITY
Information:	<p>These photographs are an indication of the obstructions and limitations which impeded full inspection of roof cavity areas at the time of inspection. These obstructions can hide an array of defects and should be removed to allow full inspection to be carried out if applicable. A re-inspection is recommended once the areas are made accessible.</p> <p>The inspection was also limited to areas with an allowable crawl space of 600mm x 600mm, in particular towards the external walls where the roof line diminishes, these areas were not accessible.</p>

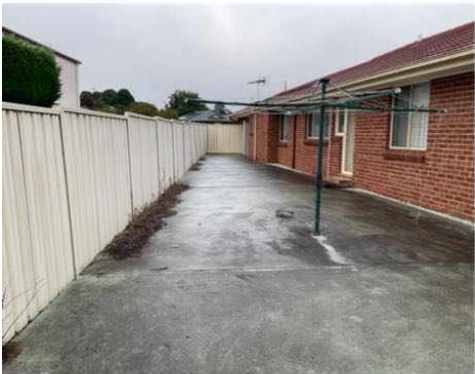
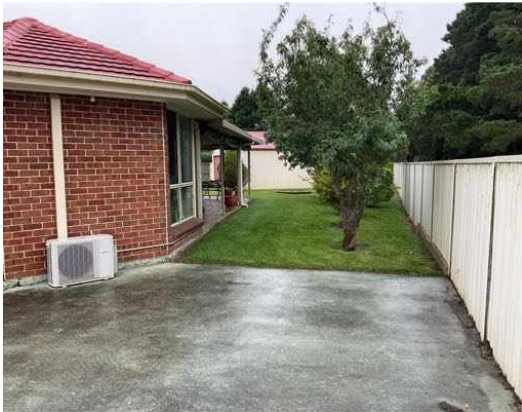
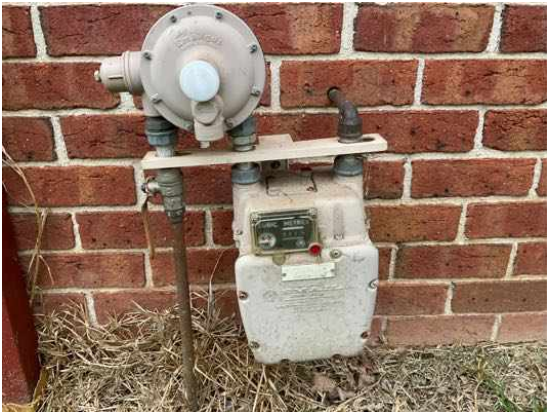
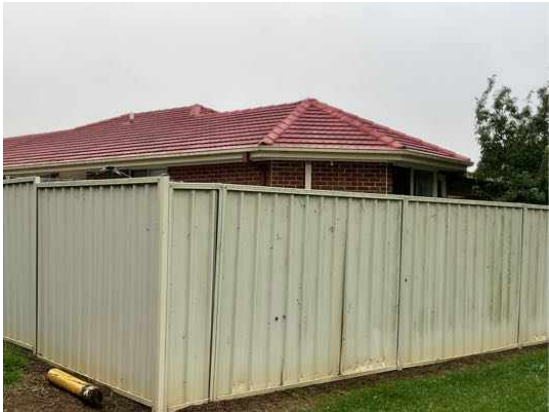
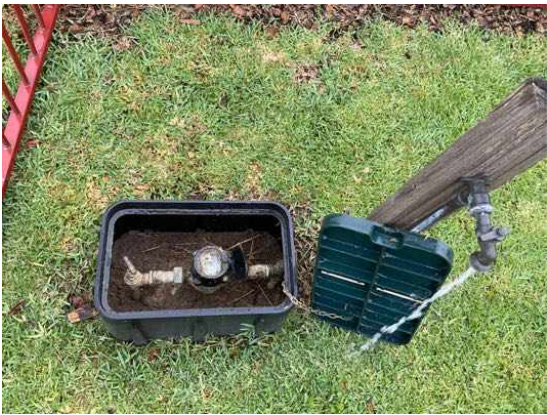
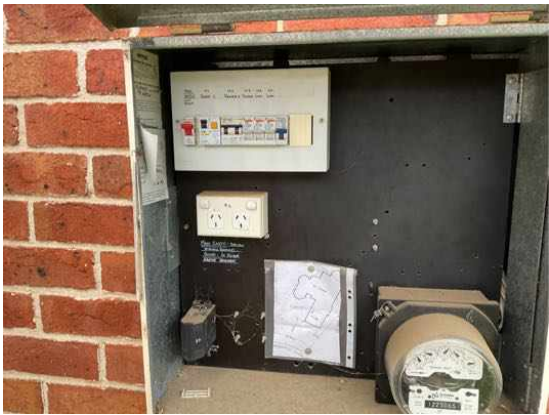
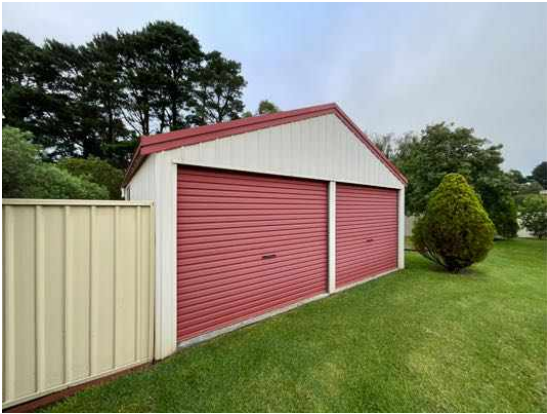
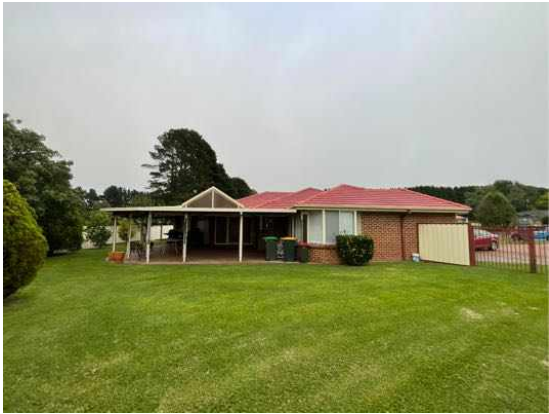
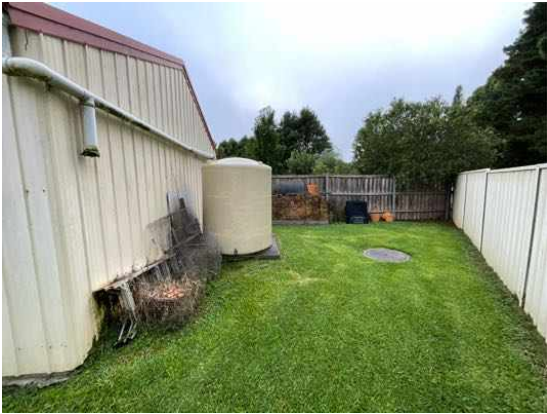
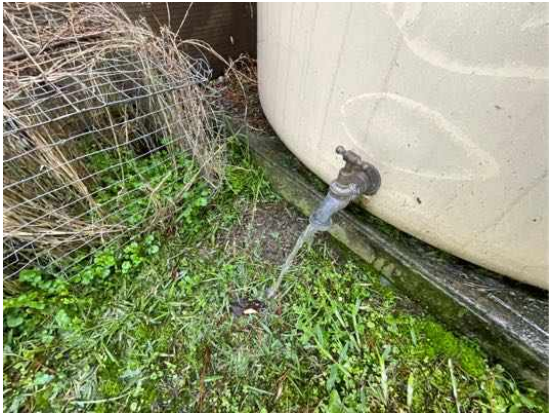
Building: Building 1
Location: All External Areas
Finding: Additional Photos
Information: Additional photos are provided for your general reference

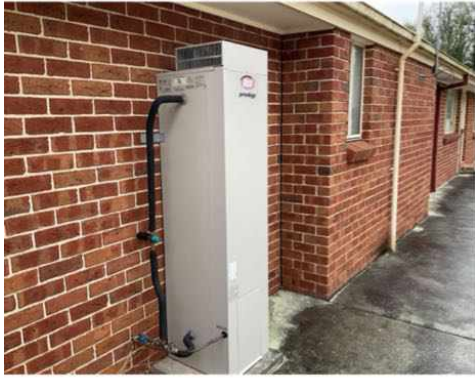
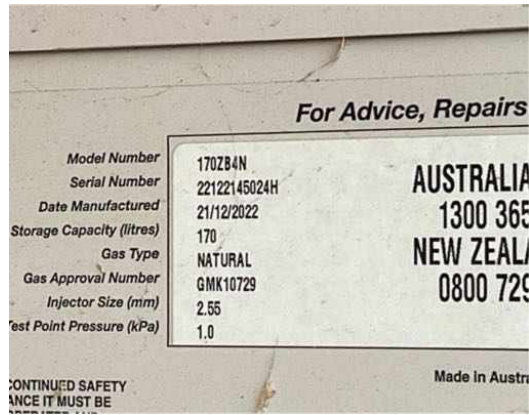
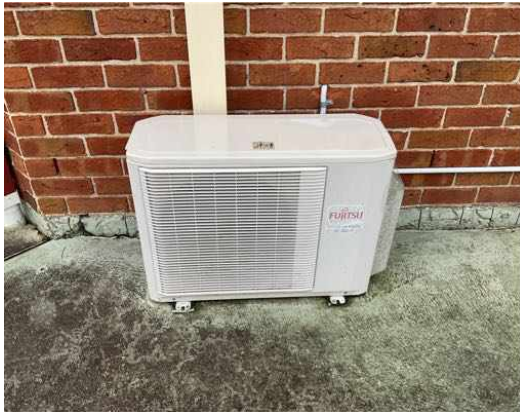
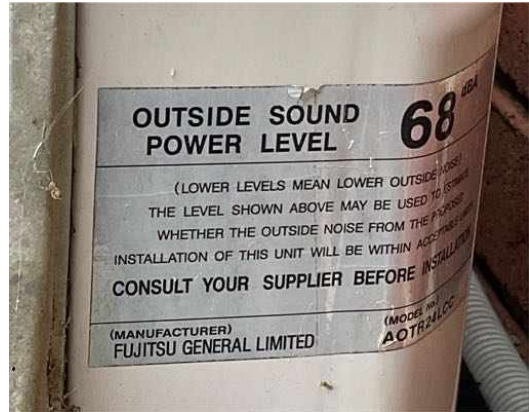
Building: Building 1
 Location: All External Areas
 Finding: Additional Photos
 Information: Additional photos are provided for your general reference

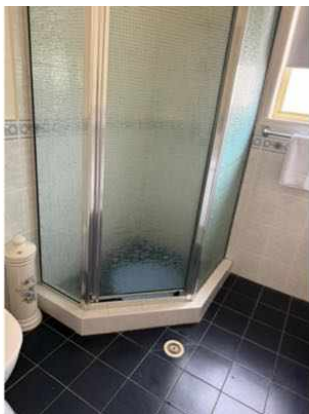
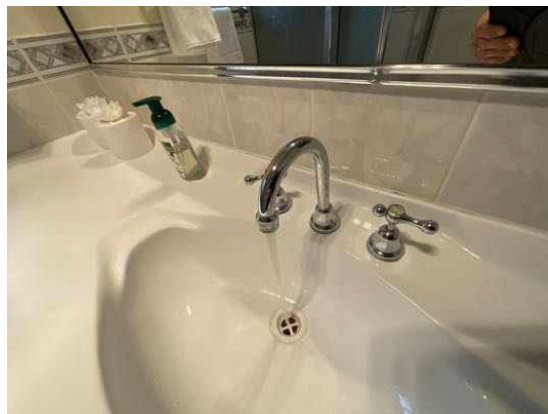
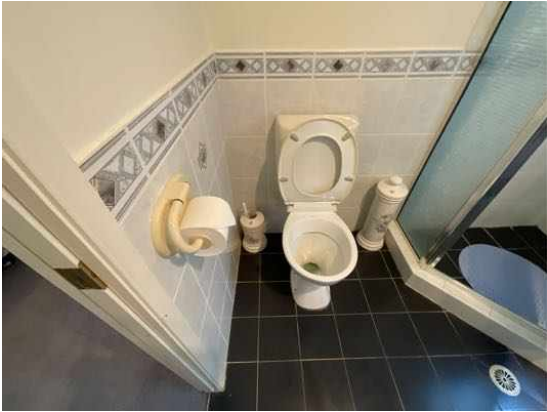
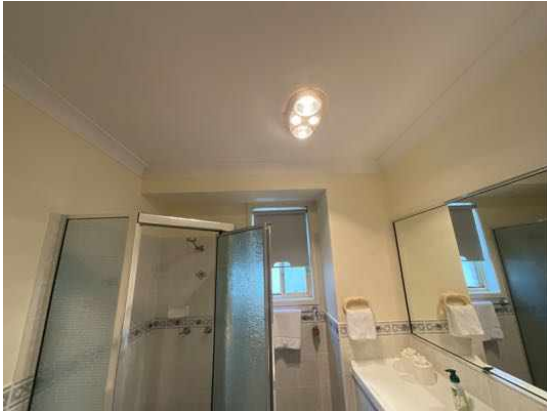
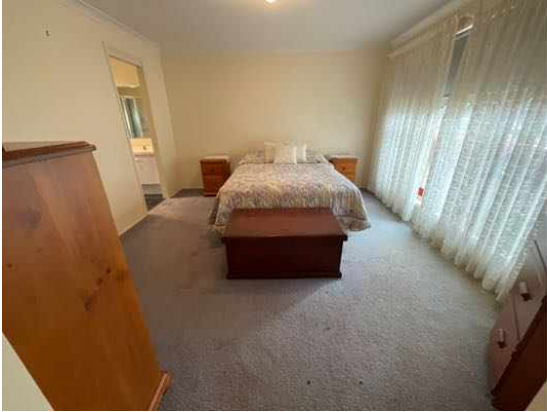
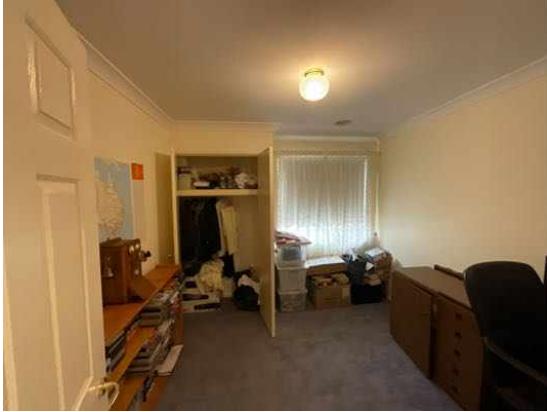
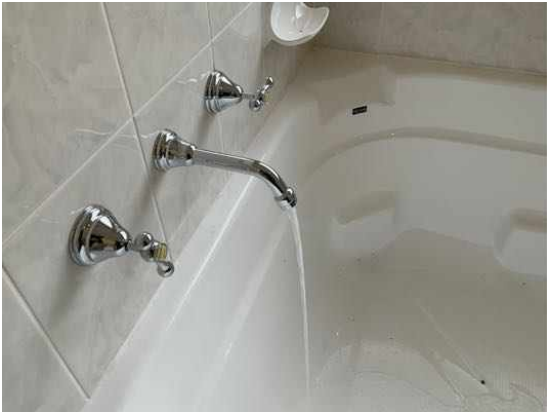
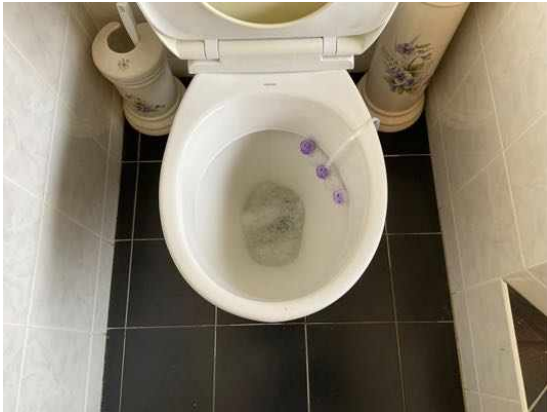
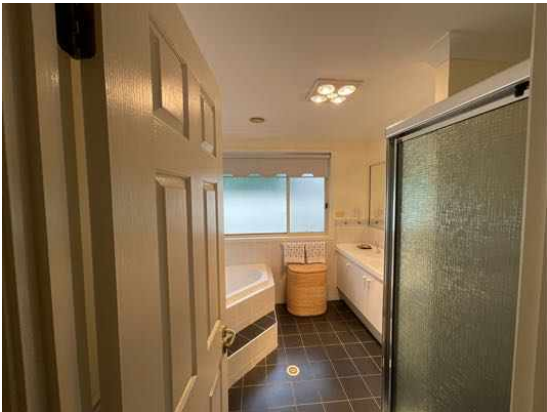
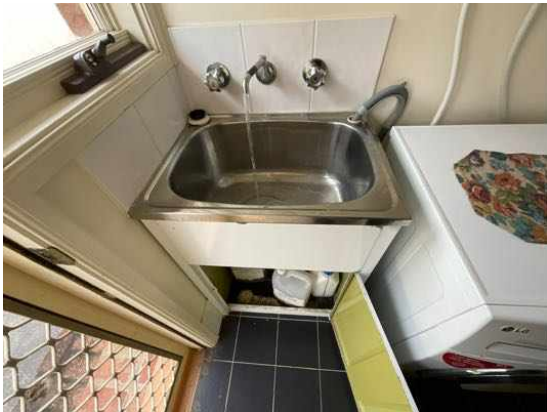
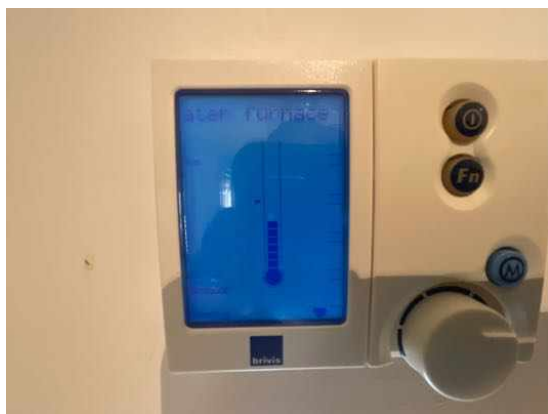
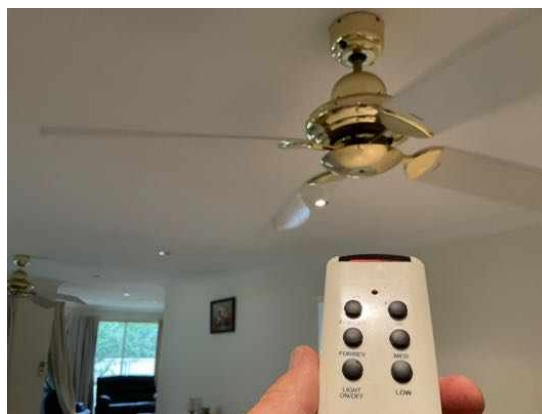
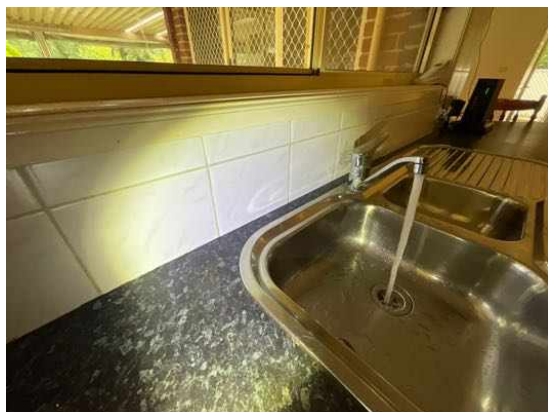
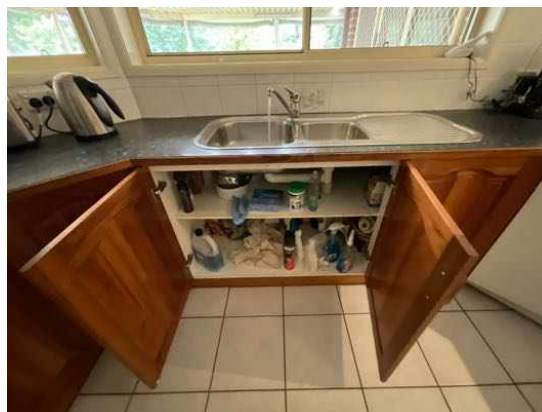
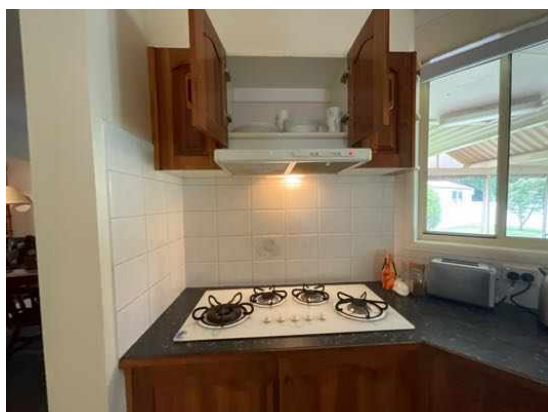
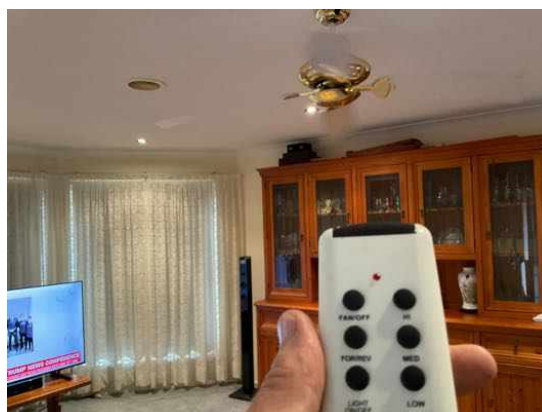
Building: Building 1
Location: All Internal Areas
Finding: Additional Photos
Information: Additional photos are provided for your general reference

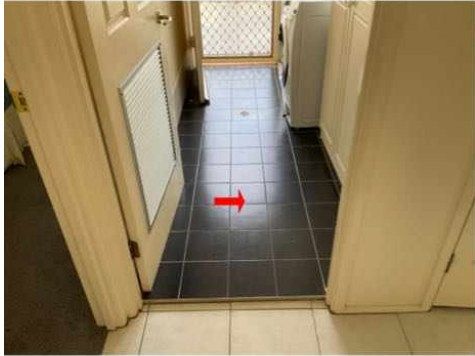
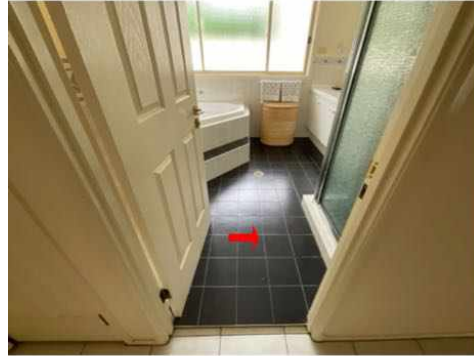
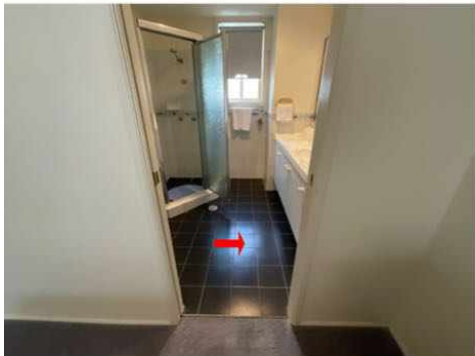
With older property's where this information is unavailable all wet areas should be monitored. If any leaks, water staining, peeling or bubbling of the paint become evident to any adjacent walls or ceilings below a licensed builder or waterproofing specialist is recommended to investigate further.
