# Building and Timber Pest Inspection Report

Inspection Date: Tue, 27 Jan 2026

Property Address: 3 Brushbox Cl, Glenwood NSW 2768,  
Australia

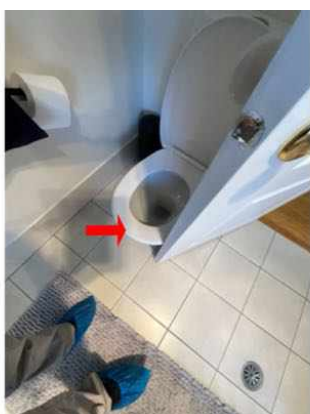
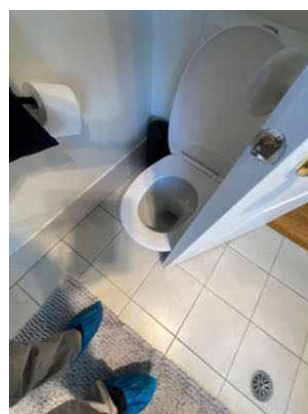
Building: Main Building  
Location: Bathroom  
Finding: Door - Hitting toilet seat  
Information: A safety hazard was identified in the bathroom of the property. The issue pertains to the door, which, when fully opened, makes contact with the adjacent toilet. This situation poses an immediate risk to the safety and well-being of occupants due to the potential for accidents and injuries.

Collision between the door and the toilet can cause injury to individuals using the bathroom.

The repeated contact between the door and the toilet can also result in damage to both fixtures, leading to costly repairs or replacements.

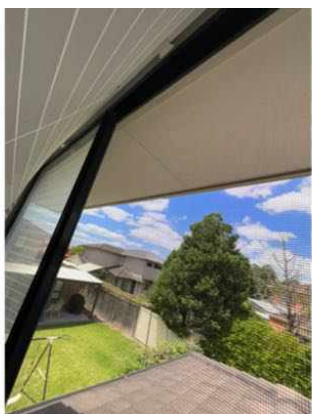
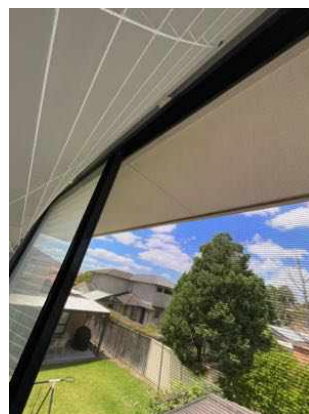
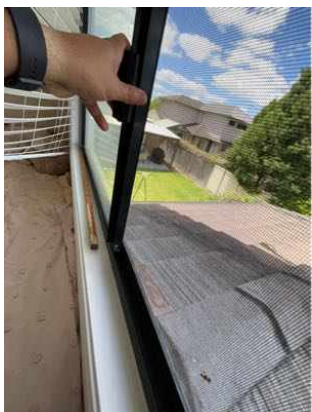
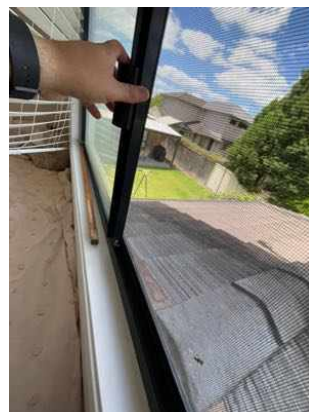
#### Finding 1.02

Building: Main Building  
Location: All Areas  
Finding: Window child lock missing  
Information: The window in question lacks a child lock mechanism, which poses a potential safety risk to young occupants in the premises. As per Australian Standards windows accessible to children should be equipped with appropriate child safety locks to prevent accidental opening, reducing the risk of falls and ensuring compliance with safety regulations.

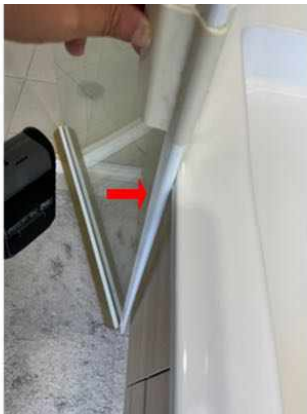
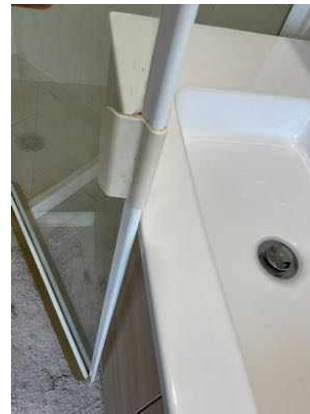
### Finding 1.03

Building: Main Building  
 Location: Ensuite  
 Finding: shower screen door hitting vanity unit  
 Information: The shower screen door makes contact with the edge of the vanity unit when opened. This indicates inadequate clearance between the shower screen and the fixed bathroom fixture. The door's operation is impeded and presents a safety concern.

- Potential for impact damage to the vanity and shower screen.
- Increased risk of glass breakage, posing a personal injury hazard.
- Ongoing stress may lead to hardware failure or misalignment of the door.

This condition does not comply with the intent of AS 4349.1-2007, Appendix C – Significant Items, under “Defects in the condition of secondary and finishing elements,” specifically where normal use may cause failure or injury.

Engage a licensed glazier or shower screen installer to adjust or replace the screen to ensure proper clearance and safe operation. A cabinetmaker may be consulted if modification to the vanity is more feasible.

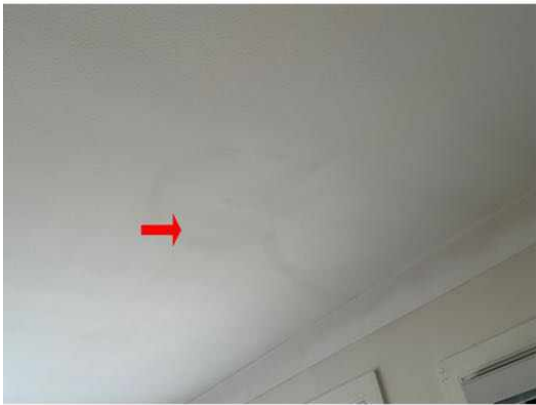
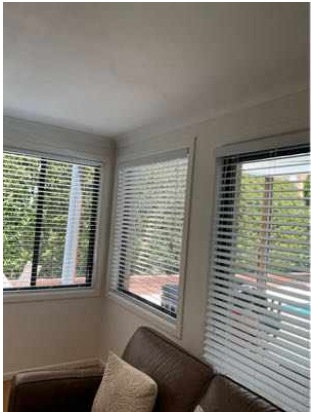
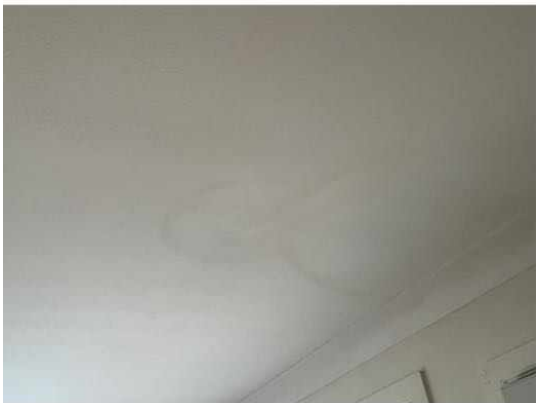
### Finding 2.01

Finding: Water staining

Information: Water staining was evident in this area at the time of inspection. Water staining indicates that surfaces have been exposed to excessive moisture over time. The minerals and other elements in the water lead to staining, which may graduate to corrosion and deterioration if left unmanaged.

water staining can be indicative of more serious defects, which may be currently concealed by other building elements.

Where water staining is active, a licensed plumber must be consulted to identify the cause of the staining and to provide advice on any repair work that may be required. Replacement of any broken or damaged structures is advised.

Conversely, where water staining is old and inactive, affected building materials may be repaired or replaced at client discretion. A qualified carpenter or registered builder may be appointed to perform these works.

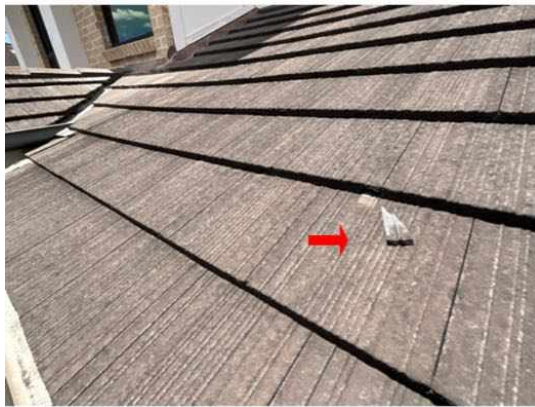
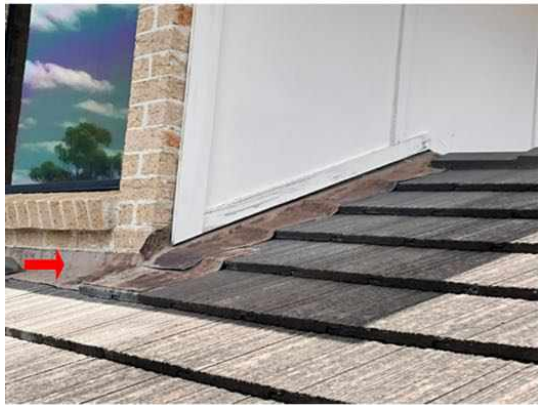
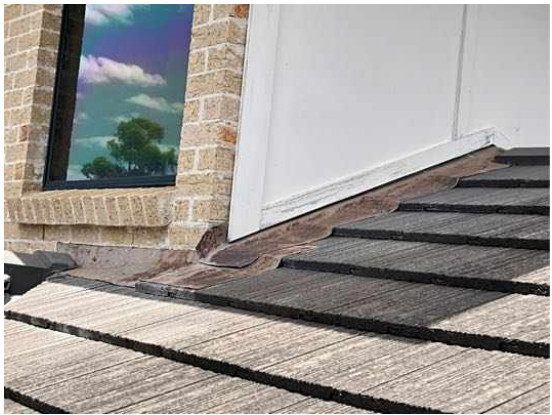
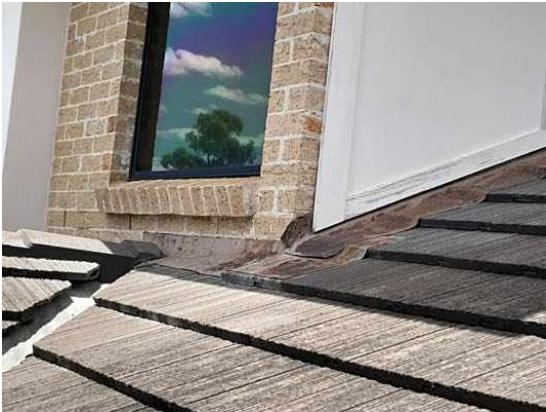
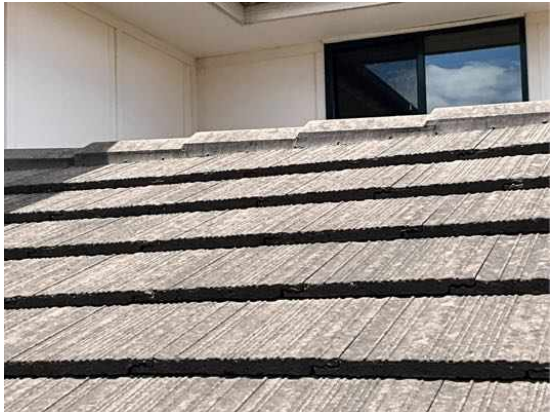
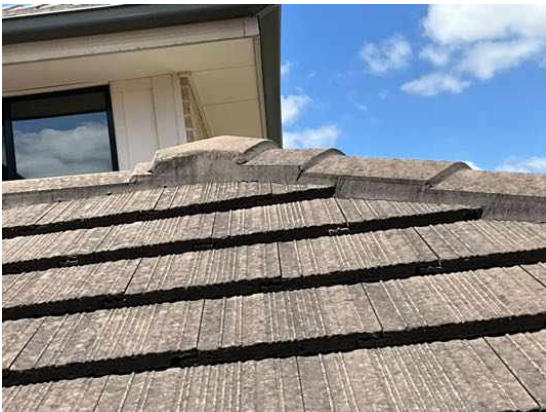
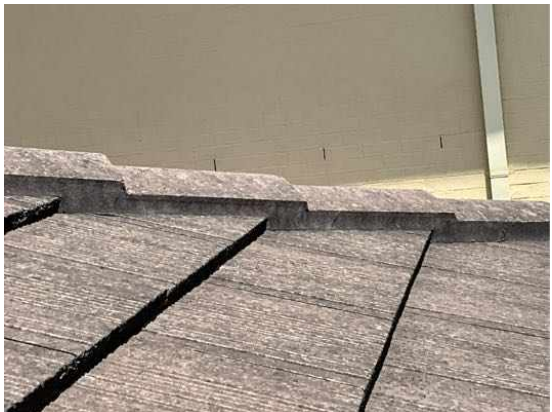
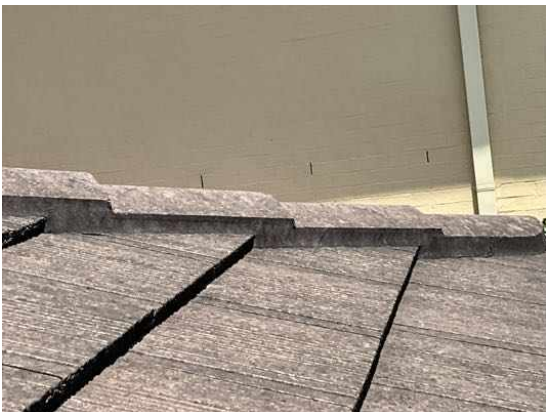
**Finding 3.01**

Building: Main Building  
Location: All Areas  
Finding: Roof Weathered  
Information: Upon inspection of the exterior roofing, the majority of roof was not in a fair condition. While weathering of the roof is consistent with the age of the property, maintenance works are required.

Isolated areas of mortar have come loose in the valleys and minor cracking is also present. Re-pointing and re-sealing the may be considered as an interim solution by the client to help preserve and extend the life span of the tiles.

Where left unmanaged, deteriorating roof are likely to lead to a number of secondary defects, including minor water leaks and weather exposure to internal roofing structures.

Consultation with a roofing contractor is highly advised to gain advice on cost of remedial works that may be required in the short to medium term. Remedial works are likely to increase the longevity of the exterior roofing structure.

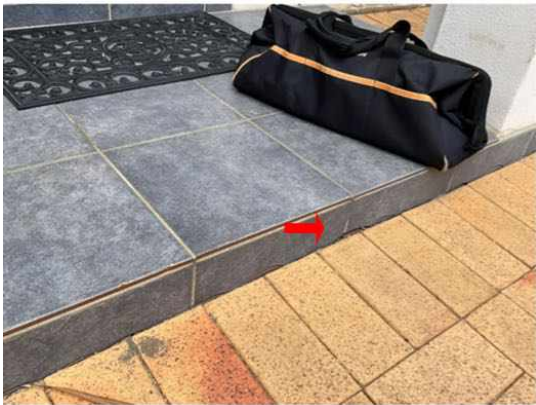
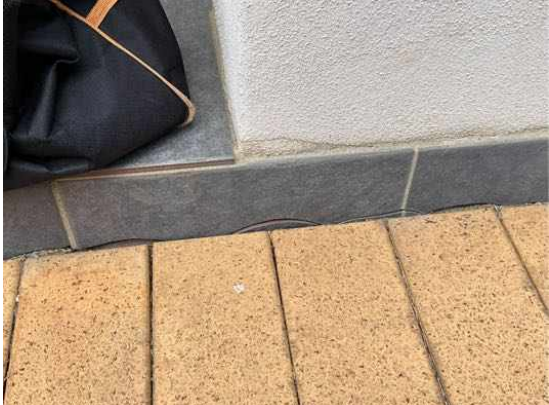
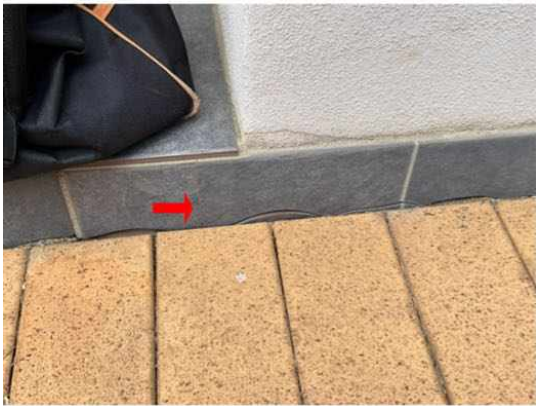
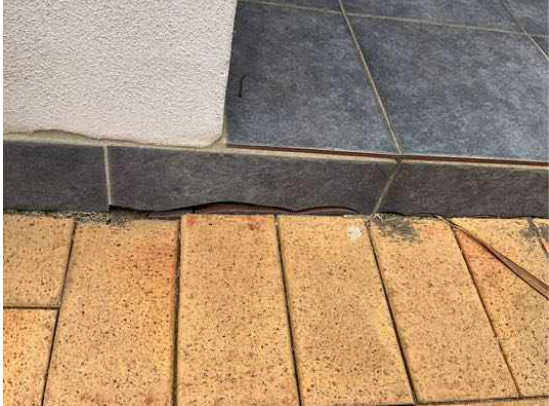
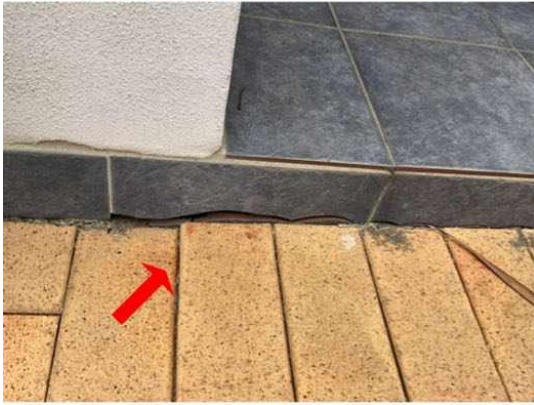
Finding 3.02

Building: Main Building  
Location: Front porch  
Finding: Floor Tile crack  
Information: A floor tile has a visible crack on the surface.

The damaged tile presents a trip hazard, may lead to cuts if stepped on barefoot, and can allow moisture ingress into the substrate, which may cause further deterioration or loosening of adjacent tiles. It also affects the overall appearance of the floor.

A licensed tiler should be engaged to remove the damaged tile and install a matching replacement. If spare tiles are unavailable, additional remedial work may be required to blend the repair with surrounding finishes.

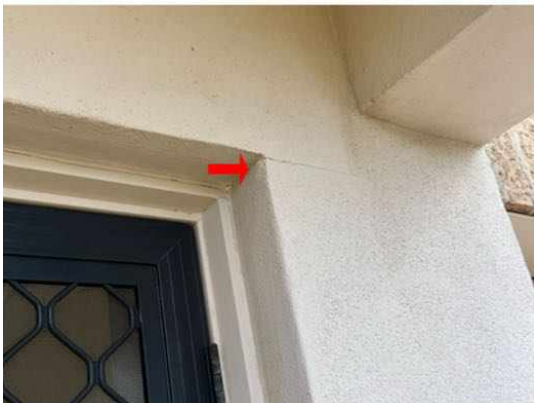
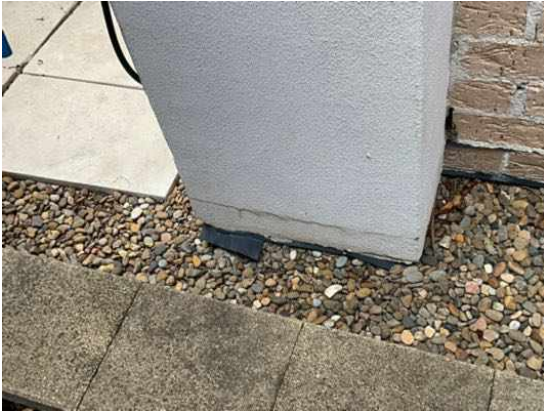
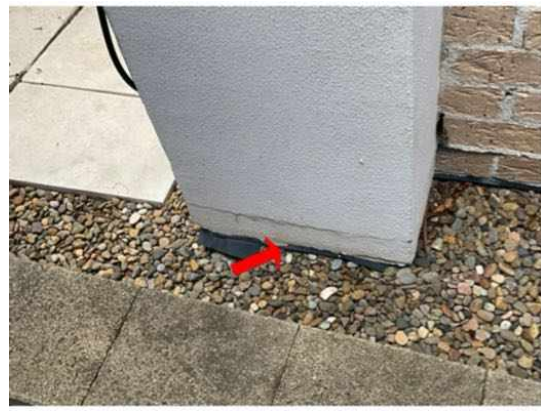
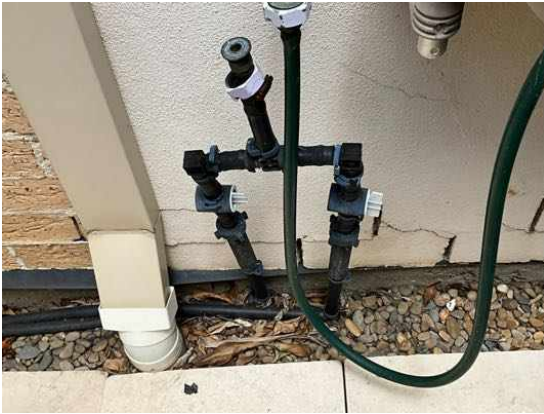
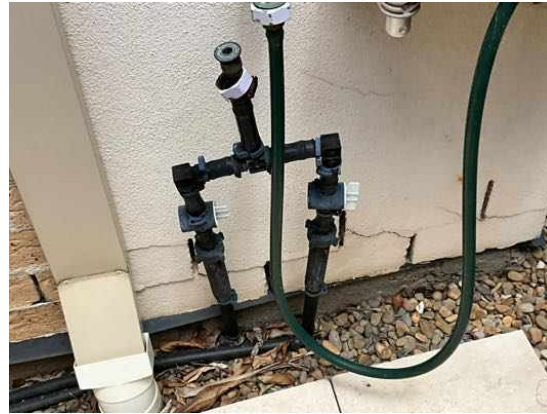
### Finding 3.03

Finding: Brickwork - Cracking [Fine]

Information: Although fine cracks are quite noticeable, they are often only considered to be an appearance defect and usually do not indicate any structural damage. Generally, the cause of a fine crack is indicative of a separation between brickwork and mortar throughout the structure, but single bricks may also show cracks of this nature.

Cracking of this nature can generally be repaired with minor filling and should be conducted by a qualified bricklayer.

Always contact a building inspector should cracks widen lengthen or become more numerous.

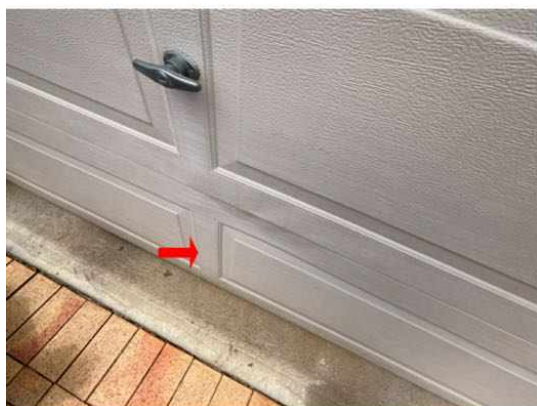
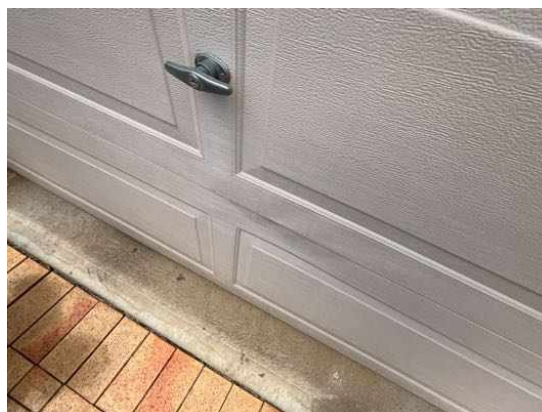
### Finding 3.04

Building: Main Building  
Location: Garage  
Finding: Minor Dent on Garage Door  
Information: A minor dent is visible on the lower section of the garage door. It does not affect how the door works but does impact its appearance.

Risk:  
Low. Mainly cosmetic. Could worsen over time if hit again.

Who Can Fix It:  
A garage door technician or handyman can repair or replace the panel if needed.

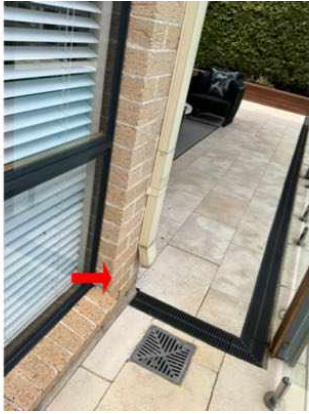
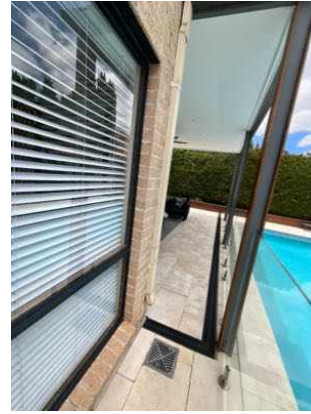
### Finding 3.05

Building:	Main Building
Location:	Exterior walls - right side
Finding:	Disconnected downpipe
Information:	A notable defect with a disconnected downpipe, compromising the efficient drainage of rainwater from the roof. This disconnectivity poses an increased risk of water accumulation, potentially leading to foundation erosion, water damage to the property, and a conducive environment for mold growth.”

1. Foundation Erosion: Accumulated water around the foundation due to the disconnected downpipe can lead to soil erosion, jeopardizing the stability of the property’s foundation.
2. Water Damage: Uncontrolled water runoff can result in water penetrating the building envelope, causing interior water damage to walls, ceilings, and other structural components.
3. Mold Growth: The presence of excess moisture provides an ideal environment for mold growth, posing health risks and necessitating costly remediation.

Engage a qualified and licensed roofing or gutter specialist to address the disconnected downpipe. This professional will reconnect the downpipe to ensure proper water drainage, mitigating the associated risks and preserving the integrity of the property.

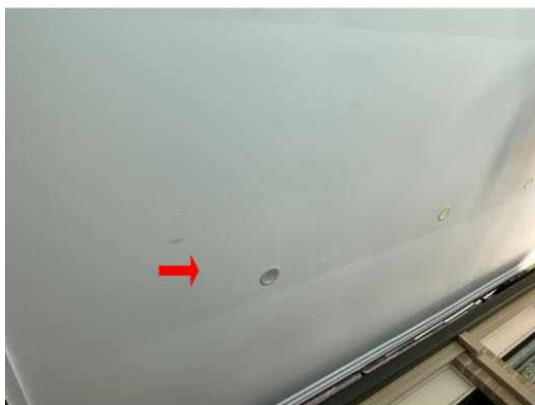
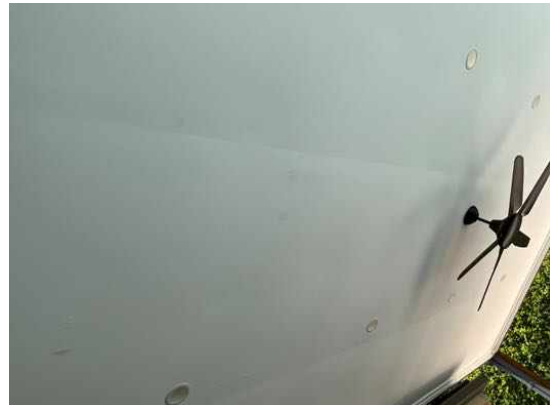
### Finding 3.06

Building:	Main Building
Location:	Pergola
Finding:	Sagging ceiling
Information:	The ceiling exhibits noticeable sagging, characterized by visible dips or bulges in the surface.

Risk: Sagging ceilings pose several risks, including potential collapse or detachment of ceiling materials, which can lead to property damage and serious injuries to occupants. Additionally, sagging ceilings may indicate underlying structural issues, such as water damage or compromised support beams, which could worsen over time if left unaddressed.

A qualified and licensed Builder or structural engineer should be consulted to assess the extent of the sagging and identify the underlying cause. Depending on the severity and cause, repairs may involve reinforcing support structures, addressing water damage, or replacing damaged ceiling materials to ensure safety and structural integrity.

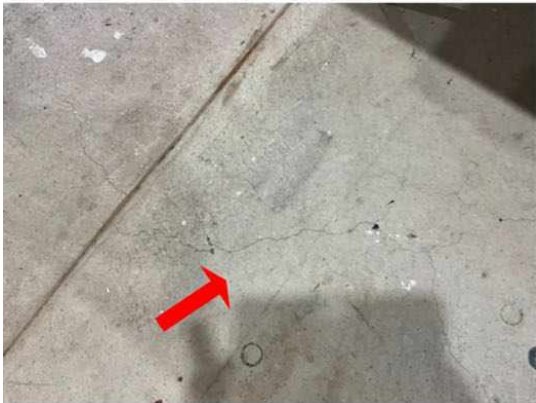
### Finding 3.08

Finding: Crack in concrete slab - Category 0

Information: A crack coded as Category 0 was identified in the slab. A Category 0 crack is described as a hairline crack, representing insignificant movement of slab from level.

The approximate width of the crack to be considered Category 0 is 0.3mm, or change in offset of less than 8mm when a 3m straight edge is placed over the defect.

No rectification is required at this time. However, all cracking should be monitored over a 12 month period to identify any further damage in the area.

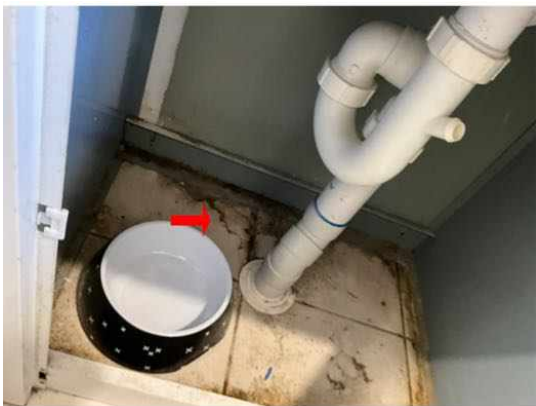
**Finding 3.09**

Building: Main Building  
Location: Laundry  
Finding: Water Stains in Vanity  
Information: "Water stains observed in the vanity area, compromising its appearance and potentially causing damage."

Continued water exposure may lead to material damage, mold growth, and diminished aesthetic appeal.

A licensed plumber or maintenance professional should assess and fix any leaks contributing to the water stains, while a cleaning or restoration service may be needed to address the visible stains and prevent further damage.

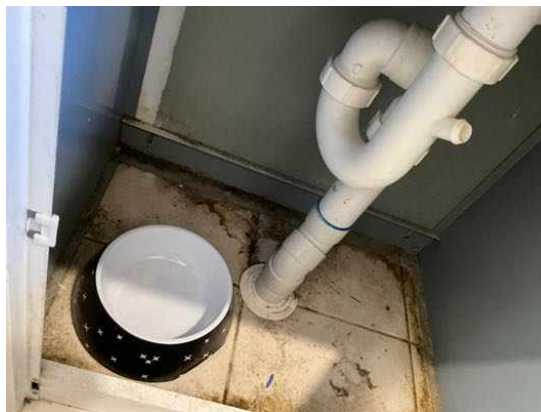
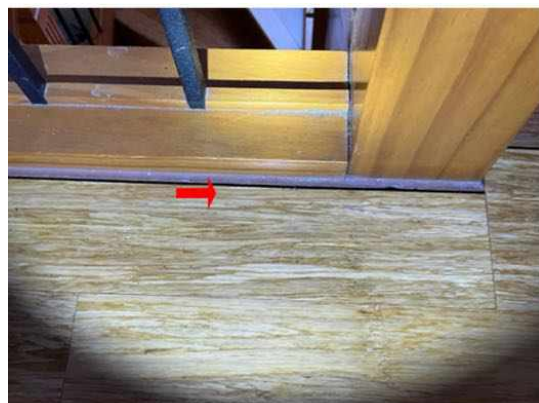
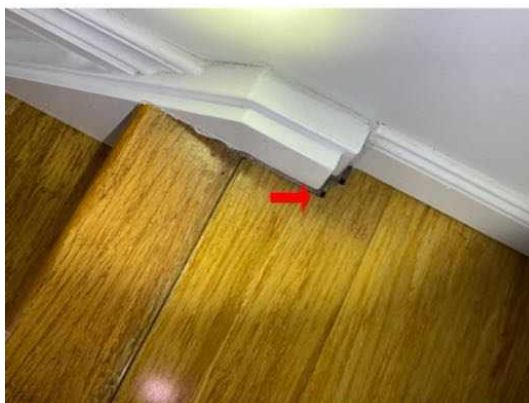
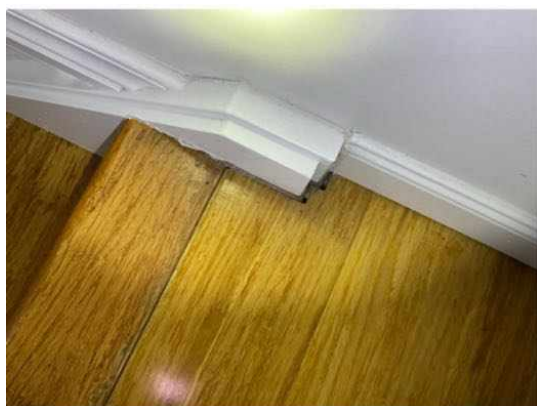
### Finding 3.10

Building: Main Building  
 Location: Upstairs  
 Finding: Timber flooring - Gaps  
 Information: Gaps have developed in the timber flooring, creating spaces between the individual floorboards.

The gaps pose a tripping hazard and can accumulate dirt and debris, affecting the aesthetic appeal of the flooring. Additionally, exposure to moisture or changes in humidity may exacerbate the issue, potentially leading to long-term damage.

A flooring specialist should inspect and address the gaps in the timber flooring. The professional can employ appropriate techniques, such as filling, sealing, or adjusting the floorboards to ensure a safe and aesthetically pleasing floor surface.

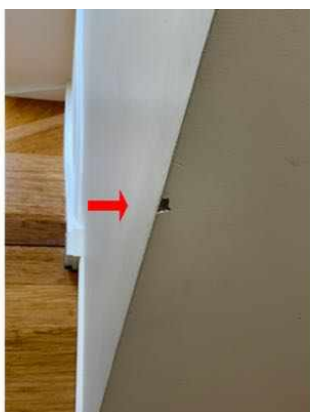
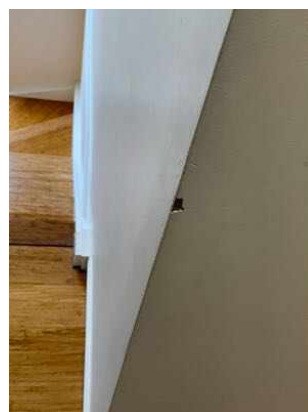
### Finding 3.11

Building:	Main Building
Location:	Upstairs near bathroom
Finding:	Wall Gyprock damaged
Information:	Sections of plaster sheeting in this area appear to be damaged .

The most common causes of plaster failure are physical damage and moisture damage. Moisture causes plaster to swell and shrink as the humidity of the air changes, or as a consequence of leaks.

Plaster generally needs chemical re-adhesion or to be screwed back to the substrate, with minor consequent patching and painting required.

Ensure that the general environment is free from physical damage such as door handles in this instance . Appointment of a qualified plasterer is advised in order to complete remedial works as necessary.

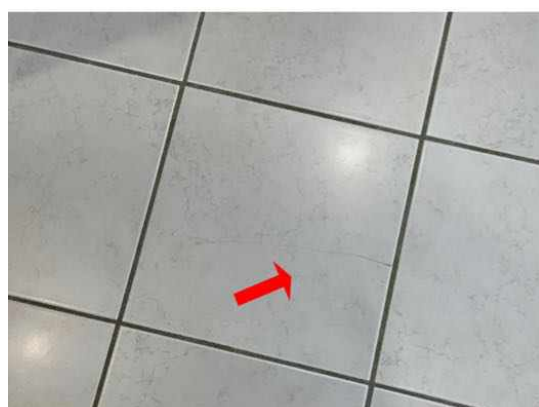
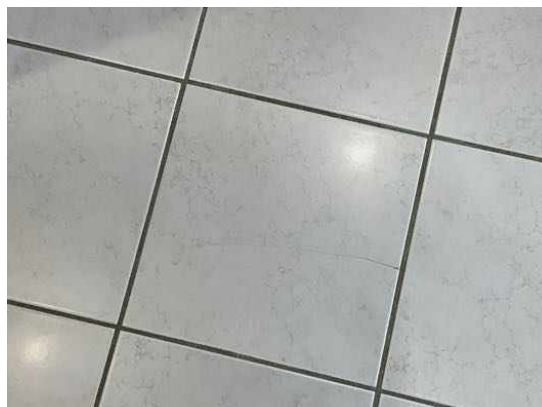
### Finding 3.12

Building:	Main Building
Location:	Bathroom
Finding:	Floor Tile crack
Information:	A floor tile has a visible crack on the surface.

The damaged tile presents a trip hazard, may lead to cuts if stepped on barefoot, and can allow moisture ingress into the substrate, which may cause further deterioration or loosening of adjacent tiles. It also affects the overall appearance of the floor.

A licensed tiler should be engaged to remove the damaged tile and install a matching replacement. If spare tiles are unavailable, additional remedial work may be required to blend the repair with surrounding finishes.

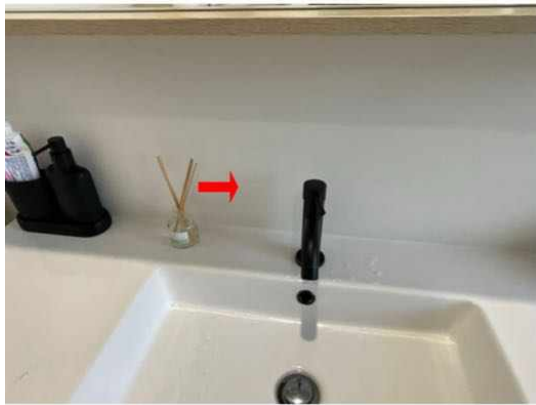
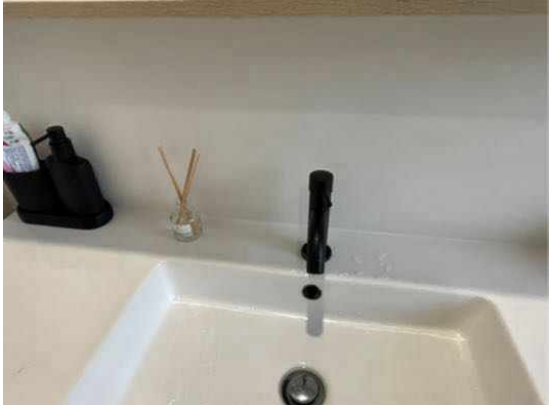
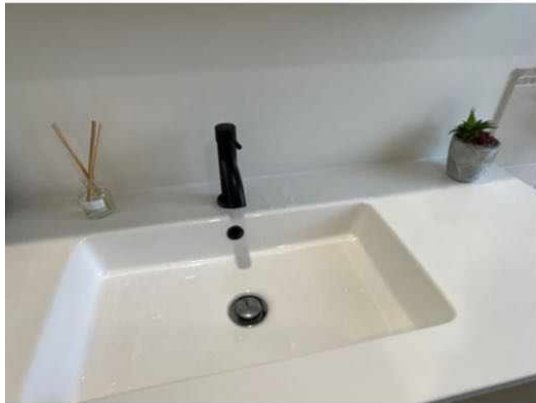
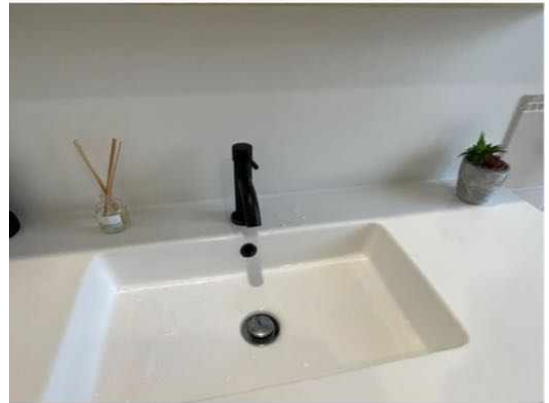
**Finding 3.13**

Building:	Main Building
Location:	Bathroom & en-suite
Finding:	Splashback Missing- Washbasin / Vanity
Information:	No splashback was installed behind the washbasin/vanity. The wall-bench junction is exposed, with painted wall lining (gyprock) directly behind the basin.

Water splash may directly affect the wall lining, leading to moisture penetration, damage to gyprock, deterioration of finishes, and potential mould growth over time.

A suitable splashback and waterproof sealant should be installed by a licensed plumber or bathroom contractor to protect the wall lining from water exposure.

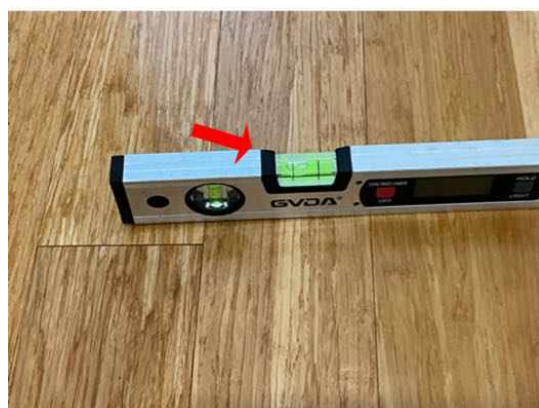
Finding 3.14

Building: Main Building  
 Location: Upstairs  
 Finding: Timber Flooring - Uneven  
 Information: The internal flooring in this area is out of level and uneven. Uneven flooring is likely to indicate minor defects may be caused by friction or impact.

It is advised that the flooring be closely monitored to identify any further movement or changes. If the flooring remains relatively unchanged for an extended period (i.e. several months), the current minor defects can be addressed through surface repair. Should the unevenness worsen, further assessment and corrective actions on the flooring will be necessary to prevent continued damage.

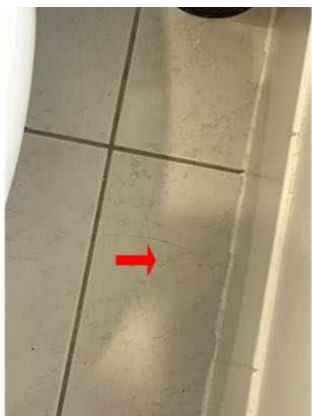
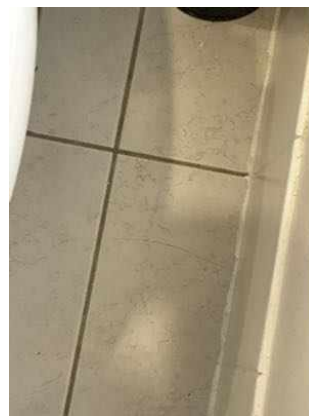
### Finding 3.15

Building: Main Building  
 Location: Ensuite  
 Finding: Floor Tile crack  
 Information: A floor tile has a visible crack on the surface.

The damaged tile presents a trip hazard, may lead to cuts if stepped on barefoot, and can allow moisture ingress into the substrate, which may cause further deterioration or

loosening of adjacent tiles. It also affects the overall appearance of the floor.

A licensed tiler should be engaged to remove the damaged tile and install a matching replacement. If spare tiles are unavailable, additional remedial work may be required to blend the repair with surrounding finishes.

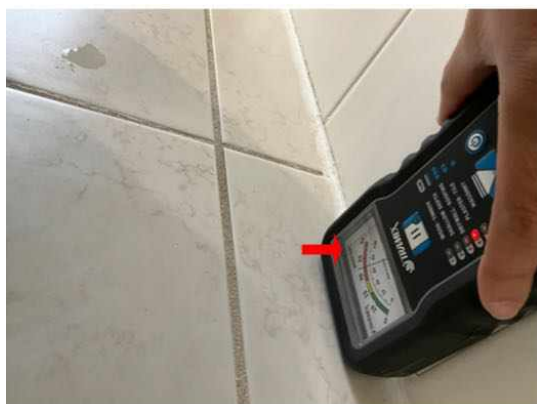
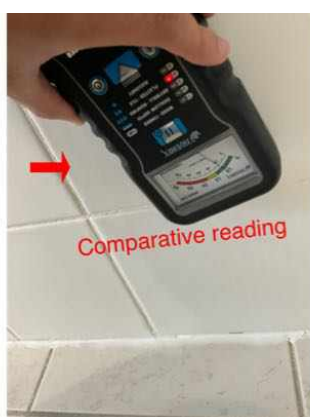
### Finding 3.16

Building:	Main Building
Location:	Ensuite
Finding:	Shower - Damp
Information:	Damp is evident to the lower 300mm of wall to the shower alcove. This defect is quite common, and is suspected to have been caused by moisture permeating through the grouting in this area, which shows evidence of deterioration. Leaking pipes within the adjoining wall is also a possible cause.

Unmanaged damp in the shower recess is likely to facilitate the formation and development of mould and fungi growth, decaying associated building materials and compromising their structural integrity. It is important to address damp conditions, as the World Health Organisation notes that excess moisture leads - on almost all indoor materials - to growth of microbes such as moulds, fungi and bacteria, which subsequently emit spores and other matter into the indoor air. Exposure to these contaminants is associated with a wide range of respiratory and other health-related problems.

Consultation with a qualified plumber or bathroom specialist is advised immediately to identify the cause of damp and to perform remedial works as required. Where excessive mould growth is present, further inspection by a specialist environmental

health inspector should also be considered.

Always ensure that sealant and grout is in good condition to prevent any moisture issues occurring in the future.

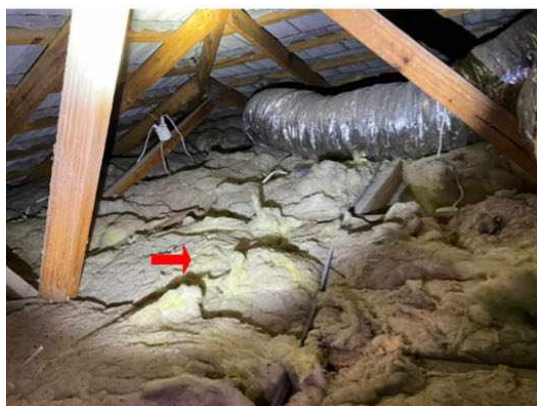
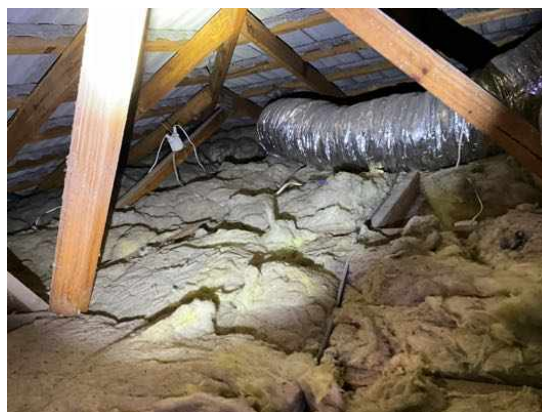
### Finding 3.17

Building:	Main Building
Location:	Roof Void
Finding:	Insulation - Covering downlights
Information:	Sections of insulation in the roof void have been poorly installed or moved from their original position and are covering down light fittings. While the down lights have been fitted with appropriate protective covers, the presence of this insulation creates a potential fire hazard.

Any insulation within the vicinity of down light fixtures should be moved and re-applied to more appropriate sections of the roof void, thus ensuring the area is fire-safe. An insulation contractor should be appointed as soon as possible to perform any necessary works as required.

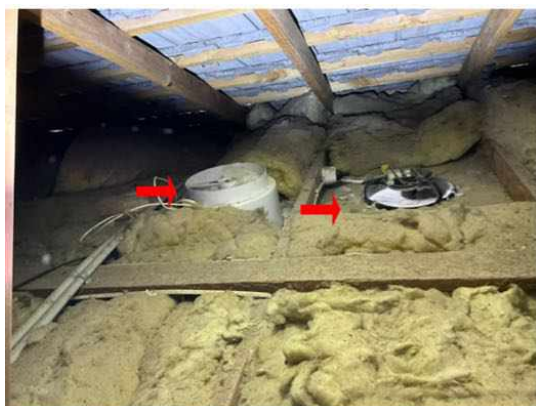
### Finding 3.18

Building:	Main Building
Location:	Roof Void
Finding:	Exhaust fan not vented out
Information:	The exhaust fan located within the roof void is not appropriately ducted to the external atmosphere and is currently discharging moist air directly into the roof space. This is considered a defect under AS 4349.1, as it does not meet the minimum standard of residential building performance expected under normal residential building practices.

This condition may lead to excessive condensation within the roof void, increasing the risk of mould growth, deterioration of insulation, timber decay, and overall reduced durability of building elements. It may also result in poor indoor air quality, potentially affecting occupant health.

It is recommended that the exhaust fan be modified by a licensed HVAC contractor or qualified builder, ensuring it is properly ducted to discharge externally in accordance with manufacturer specifications, the National Construction Code (NCC), and applicable Australian Standards.

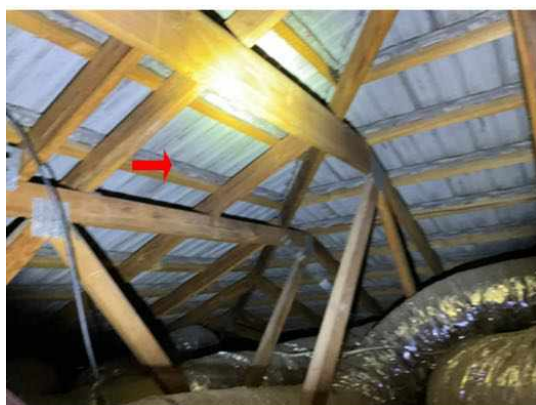
### Finding 3.19

Building:	Main Building
Location:	Roof Void
Finding:	Sarking - Missing
Information:	Sarking is missing under the roof sheeting. Sarking acts as an insulator that helps with noise reduction and protects against water penetration. Sarking plays a key role in the operation and function of the overall roofing structure and its performance.

Although not a requirement at the time of construction, replacement of any missing building element is advisable (although this can be quite expensive to do after the time of construction). Where sarking is missing, regular inspections of the roof tiles for cracking and potential moisture penetration is required.

Sarking may be retrospectively fitted by a registered builder at the discretion of the client.

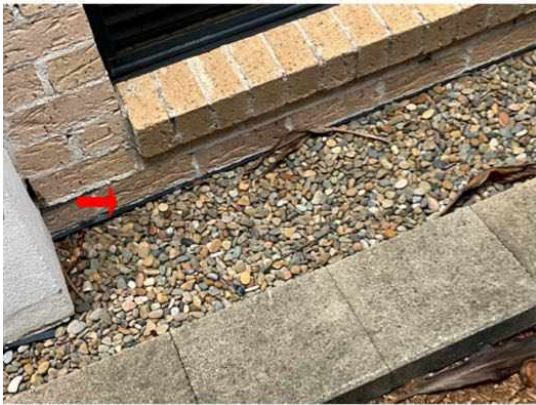
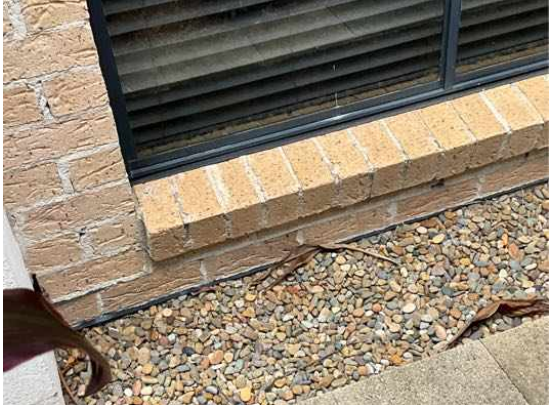
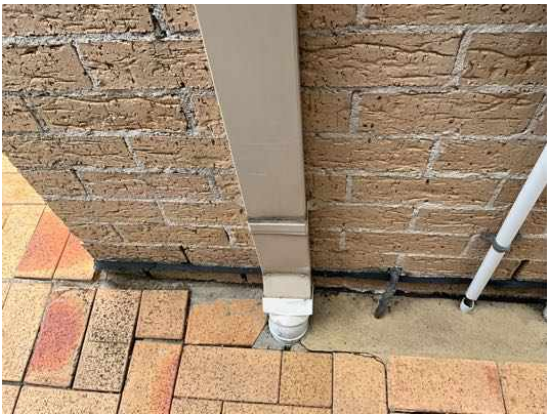
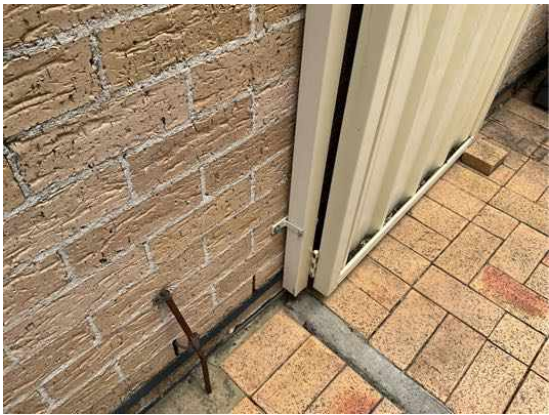
If the slab edge is not properly exposed there is a high risk of termite attack. Sometimes, in order to determine the type of slab, a suitably qualified person such as an architect or builder may be required to consult the construction plans.

Where the slab edge cannot be properly inspected, it is highly recommended that termite or timber pest inspections be carried out every 6-12 months to aid protection of the property against infestation.

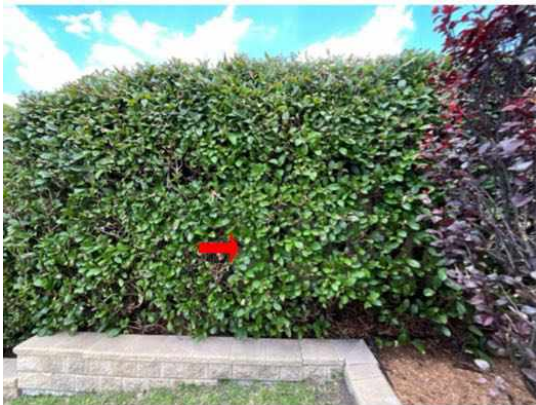
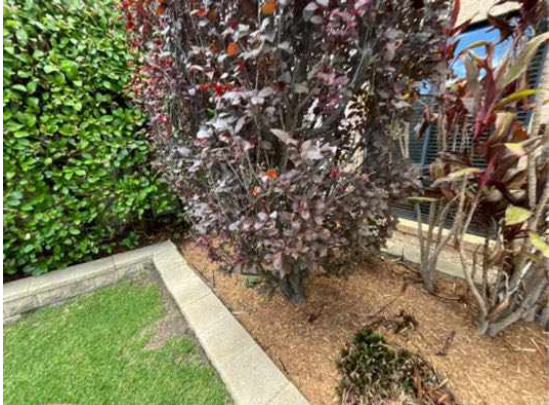
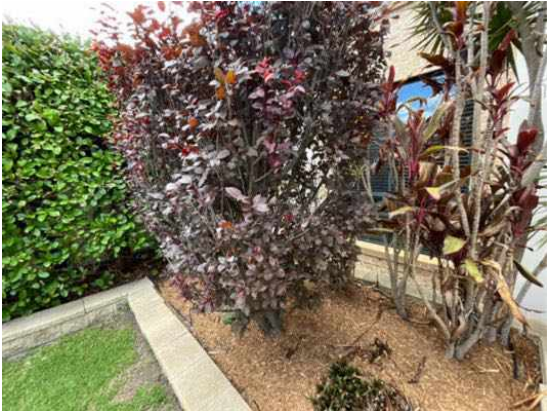
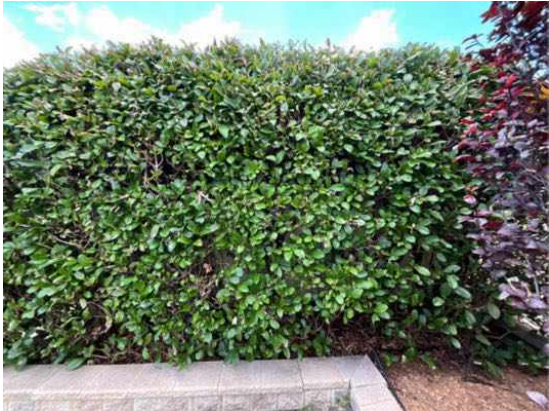
**Finding 6.02**

Finding: Dense vegetation around a property can increase the risk of termite infestation

Information: The presence of dense vegetation around a property can increase the risk of termite infestation, as it provides a conducive environment for them. To address this, consider maintaining a clear space between the vegetation and your home. If you suspect a termite issue, it's advisable to consult with a licensed pest control professional for inspection and treatment.

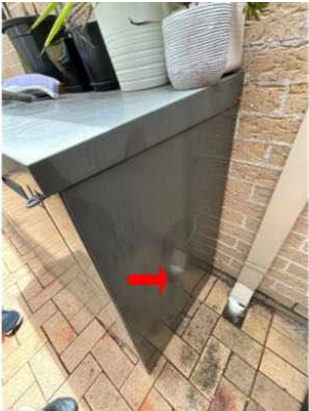
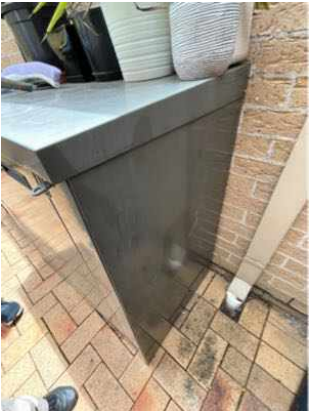
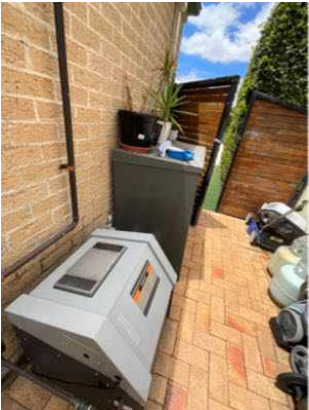
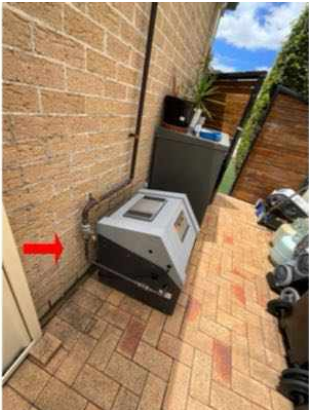
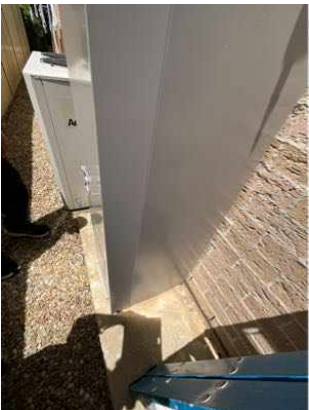
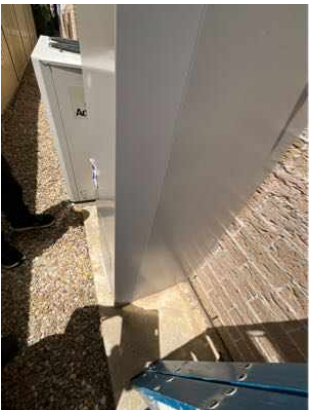
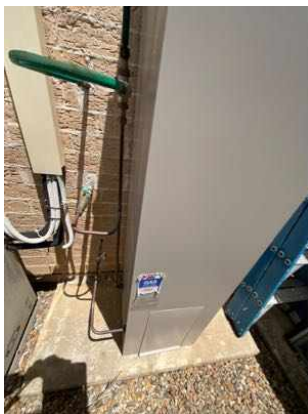
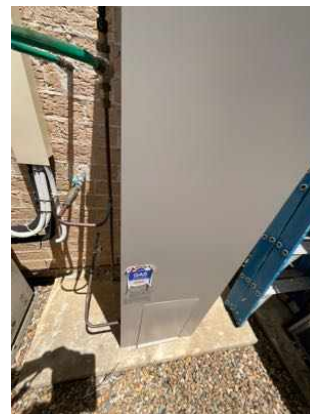
### Finding 6.03

Building: Main Building  
 Location: All Areas  
 Finding: Bridging or Obstruction Conducive environment for Termites  
 Information: Bridging of termite barriers occurs when termites bridge (usually by building a mud tunnel) a termite barrier or inspection zone or where termites have a passage, allowing them to bridge the barrier.

Recommended moving obstructions away from the external walls for further and future inspections.

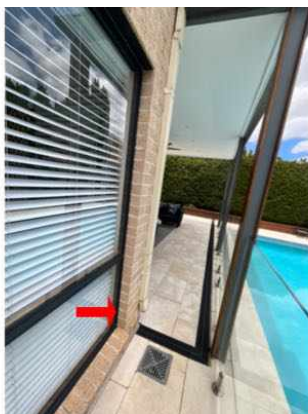
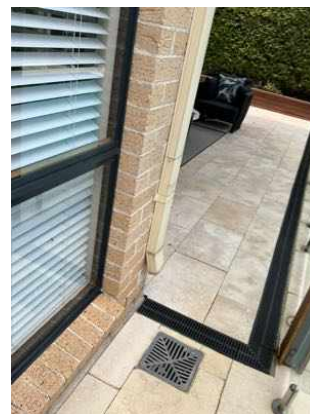
### Finding 6.04

Building:	Main Building
Location:	Exterior walls - right side
Finding:	Downpipes not connected / leaking Downpipes
Information:	Unconnected downpipes can indeed pose a risk for attracting termites, as they provide a source of moisture near a building's foundation. Termites are attracted to moisture and wood, so it's important to address this issue to prevent potential infestations. Connecting downpipes to the stormwater system or ensuring proper drainage away from the building can help mitigate this.

A licensed plumber is the most qualified professional to handle plumbing-related tasks, including connecting downpipes to the stormwater system. They have the necessary expertise and tools to ensure proper installation. Please remember that proper installation is essential to ensure effective drainage and prevent future issues, so it's often best to hire a qualified professional, especially for complex or extensive downpipe installations.

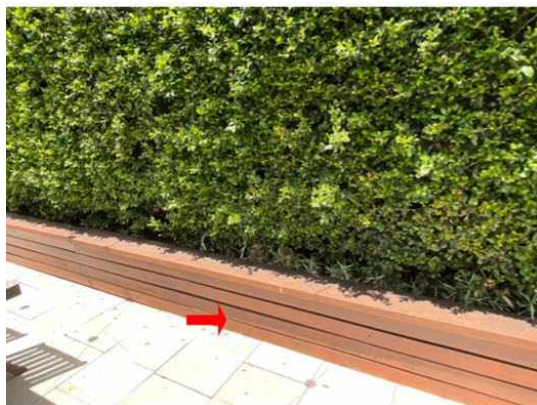
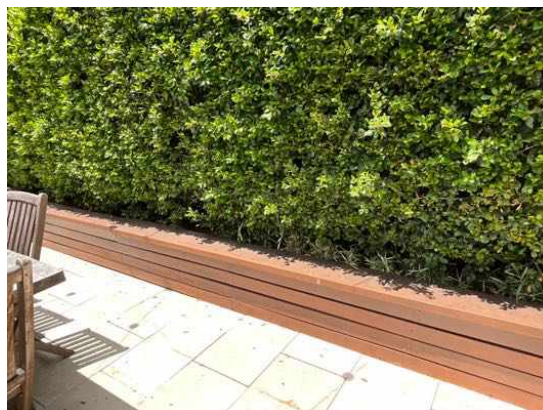
### Finding 6.05

Building:	Main Building
Location:	All Areas
Finding:	Timber on ground / conducive conditions to termite damage

Information: Timber on the ground is indeed conducive to termite damage. Termites are known to thrive in moist environments, and wood in contact with soil or moisture is more susceptible to infestation.

To prevent this, it's important to keep timber elevated and away from direct ground contact. Regular inspections and proper termite control measures are also essential to protect your wooden structures from termite damage.

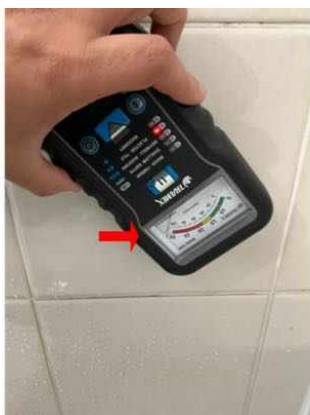
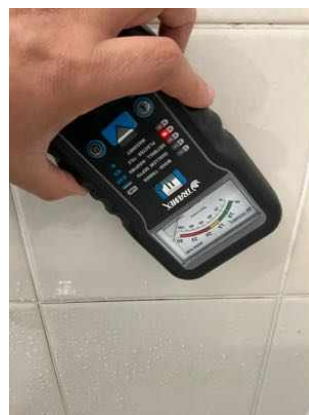
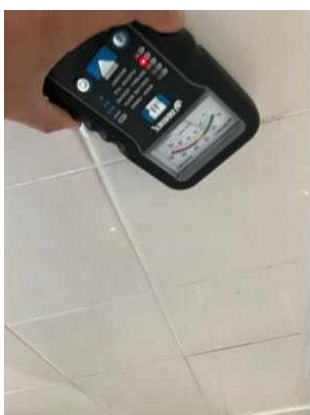
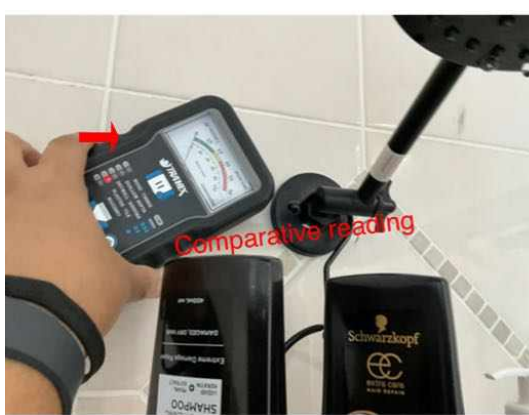
### Finding 6.06

Building: Main Building  
 Location: Bathroom  
 Finding: Evidence of excessive moisture was present at the time of inspection  
 Information: Excessive moisture is present behind the bathroom tiles, indicating a potential water leakage issue within the wall.

The prolonged presence of moisture can lead to mold growth, deteriorate the structure, and create an environment conducive to health hazards. Additionally, it may compromise the adhesive holding the tiles, leading to their detachment.

A licensed plumber or a qualified contractor specializing in water damage remediation should investigate the source of the moisture, fix any leaks, and address the damage. Additionally, replacing affected tiles and ensuring proper waterproofing are crucial to

preventing future issues.

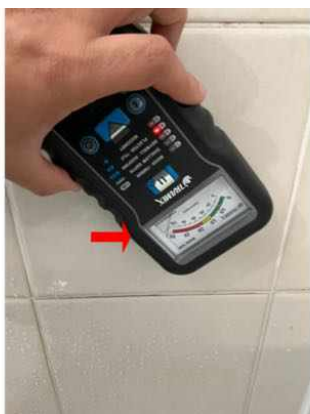
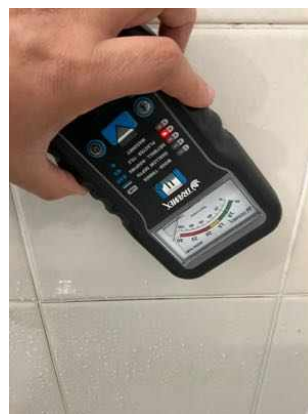
### Finding 6.07

Building:	Main Building
Location:	Bathroom
Finding:	Excessive moisture - Conducive to Timber pest
Information:	Excessive moisture can attract termites and produce conditions that promote fungal growth and wood decay.

Excessive moisture is generally caused by deteriorated inadequate or missing roof drainage leaking plumbing pipes or fixtures poorly plumbed HWS overflows or condenser units and poor site drainage.

If mould growth has been found there may be environmental biological or health issues involved. In these cases an appropriately qualified inspector should also be contacted.

Prior to any remedial works being performed a qualified plumber should be appointed to further inspect the property and to identify the cause of the excessive moisture. Works to remove affected building elements may then be necessary and should be performed by an appropriate tradesperson.

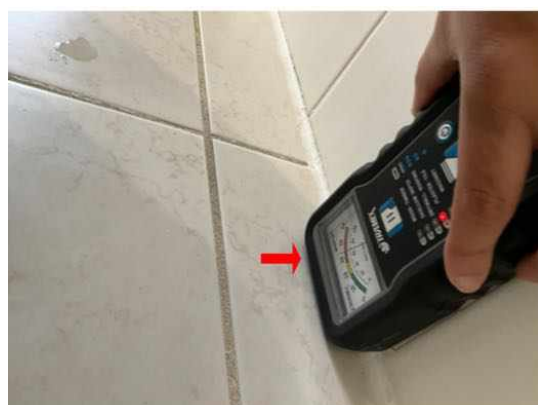
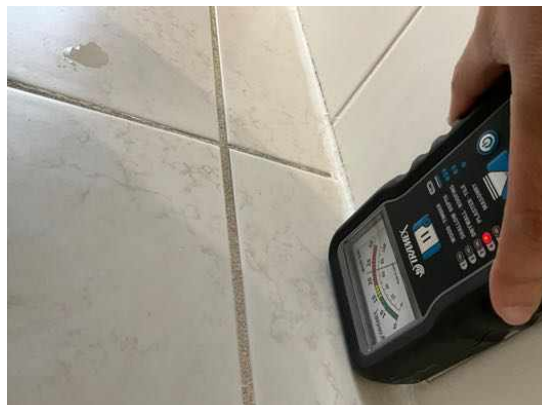
### Finding 6.08

Building:	Main Building
Location:	Ensuite
Finding:	Excessive moisture - Conducive to Timber pest
Information:	Excessive moisture can attract termites and produce conditions that promote fungal growth and wood decay.

Excessive moisture is generally caused by deteriorated inadequate or missing roof drainage leaking plumbing pipes or fixtures poorly plumbed HWS overflows or condenser units and poor site drainage.

If mould growth has been found there may be environmental biological or health issues involved. In these cases an appropriately qualified inspector should also be contacted.

Prior to any remedial works being performed a qualified plumber should be appointed to further inspect the property and to identify the cause of the excessive moisture. Works to remove affected building elements may then be necessary and should be performed by an appropriate tradesperson.
