# Building and Timber Pest Inspection Report

Inspection Date: Tue, 27 Jan 2026

Property Address: 3 Brushbox Cl, Glenwood NSW 2768,  
Australia

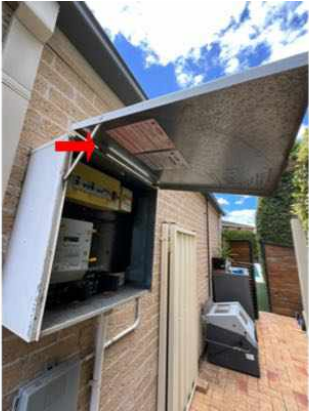
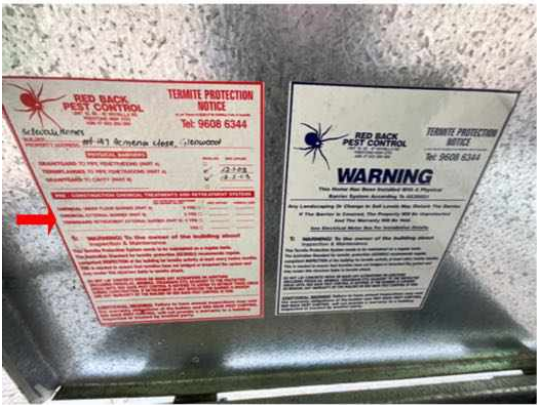
Building:	Main Building
Location:	Exterior walls - right side
Finding:	Evidence of Termite Management System - Durable notice / Legible Sticker - seek further information
Information:	The application of a pre & post-construction chemical termite barrier is highly recommended for all properties. Such barriers are highly effective in preventing termite attack on any timber building elements throughout the property.

A durable notice placed in the switchboard unit to indicate termite barriers at the time of inspection.

Client must seek further information from the vendor or real estate agent if the conditions of termite management systems were maintained as per the label or seek advise from licensed pest controller.
