Building and Timber Pest Inspection Report

Inspection Date: Mon, 5 Jan 2026

Property Address: Villa 5 South Shores, Normanville SA 5204,
Australia

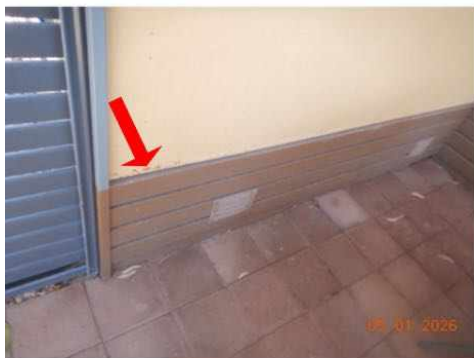
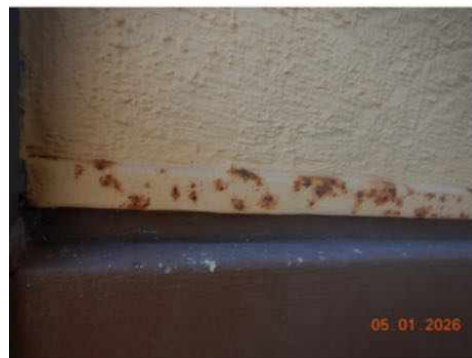
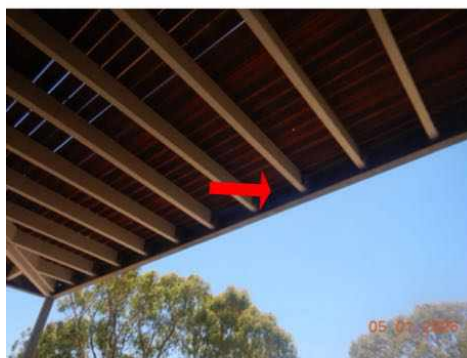
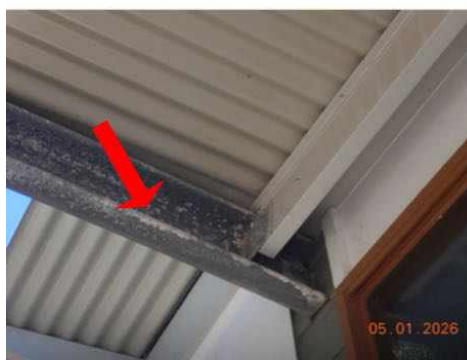
Building: Building 1
Location: Deck
Finding: Building element - Rusted or corroded
Information: Minor surface rust and corrosion appears to be evident to still work around the decking/ veranda and also elements of the exterior cladding, which is likely to have developed as a result of excessive exposure to moisture and the proximity to the ocean.

As surface rust provides no protection to the underlying iron, the deteriorating condition is likely to worsen if not addressed in the short-term future.

Where possible, the use of galvanized (treated) metals or aluminium coated metals aid in rust prevention, as does regular general maintenance. Rust formation can be controlled with coatings, such as paint, that isolate the iron from the environment.

Rusting and corrosion should be managed by ideally removing or limiting the affected surface from exposure to moisture, then treating the rust to slow the deterioration and could be carried out by a licensed painting contractor.

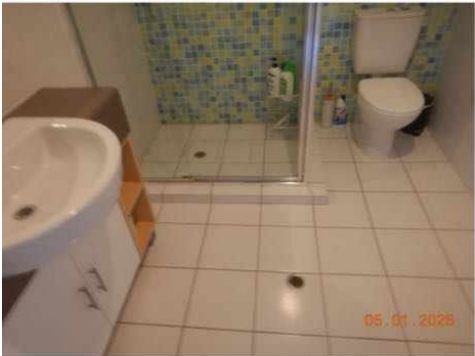
Finding 3.02

Building:	Building 1
Location:	Bathroom
Finding:	Tiles - Cracked or damaged minor
Information:	Cracking was evident to approximately 10 tiles to the bathrooms, in the general floor areas of the home at the time of inspection.

The cracking appears to be minor and is likely due to general movement, settlement of the building.

As the area should not be submerged in water, no secondary defects are likely to be created and as such repairs left to the discretion of the client.

A tiling contractor could be appointed to make repairs to return the ascetics of the property.

Always contact Jims Building Inspections if cracking becomes more extensive.

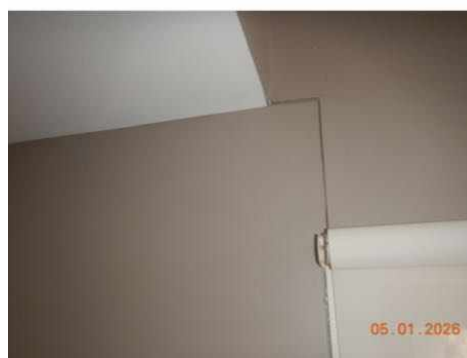
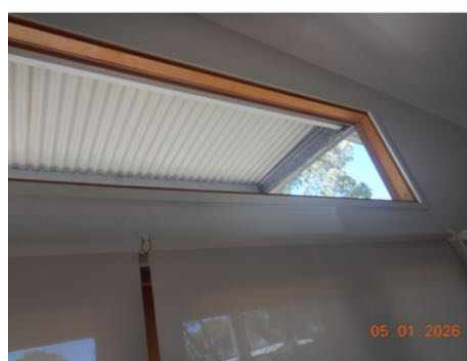
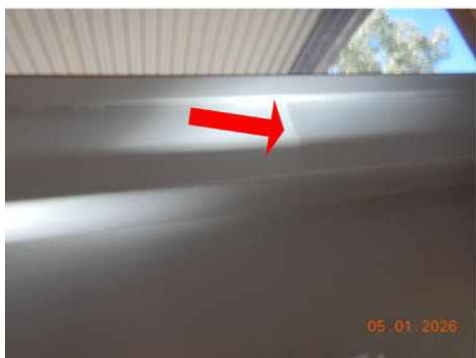
Finding 3.03

Building: Building 1
Location: All Internal Areas
Finding: Cracking - Damage Category 1 - Fine (up to 1mm)
Information: There were fine cracks evident to the walls and ceilings throughout the dwelling at the time of inspection.

Although fine cracks are quite noticeable, they are often only considered to be an appearance defect, and usually do not indicate any structural damage. Generally, the cause of a fine crack is indicative of a separation between building materials and finishes (e.g. paint, plaster, etc.) along joins.

Cracking of this nature can generally be repaired with minor sanding, filling and/or repainting. Such works should be performed by a qualified painter or a general handyman.

Monitoring of all cracking should be conducted frequently. Always contact a building inspector should cracks widen, lengthen, or become more numerous.

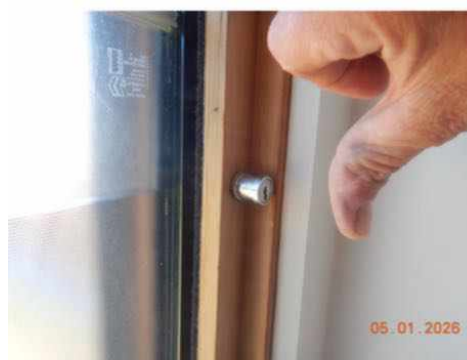
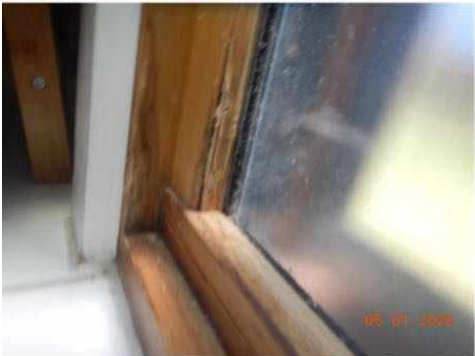
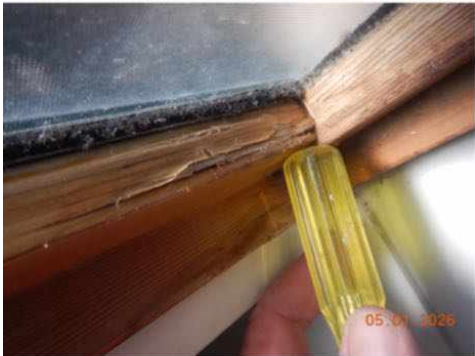
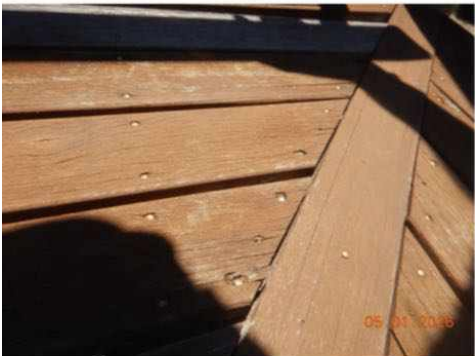
Finding 3.04

Building: Building 1
 Location: All Areas
 Finding: Minor defects present
 Information: There were several age and maintenance related defects evident to the dwelling at the time of inspection. These defects include but are not limited to

- Some window locks difficult to operate, lubricant
- Minor damage to several window stiles
- Several loose deck boards, refix
- Loose flyscreen upstairs.
- Door rubbing on frame
- Solar potentially not operating

Appropriate licensed trades people could be appointed to make repairs at the discretion of the client.

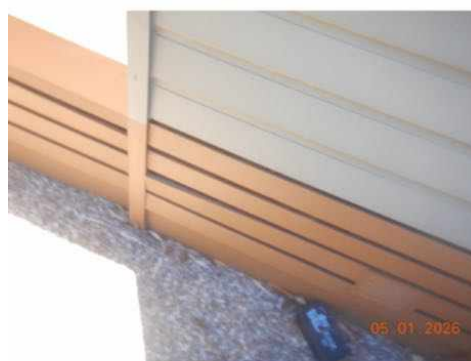
Building: Building 1
 Location: All External Areas
 Finding: Untreated or non-durable timbers in a hazardous environment
 Information: To reduce the risk of timber pest attack it is essential that timber used in a hazardous environment (e.g. in direct contact with the ground or frequently exposed to damp conditions) is of sufficient durability and/or is adequately preservative treated. Additionally any timber lying around or timber stumps should be removed.

Untreated timbers in direct contact with the ground are likely to develop severe wood rot and/or fungal decay if left unattended creating attraction for subterranean termites to infest the timbers from surrounding areas.

If untreated or non-durable timbers are found to be in a hazardous environment it is highly advised that replacement of these building elements be performed as soon as possible to aid the protection of the property against termite / timber pest attack. Failing this close monitoring is recommended in an attempt to identify termite infestation at an early stage.

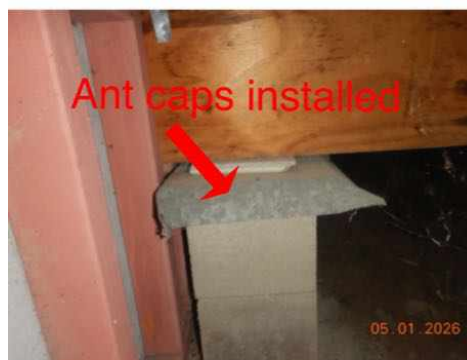
Finding 6.02

Building: Building 1
 Location: All Areas
 Finding: Termite Management System - no evidence of a chemical installation

At the time of inspection, it appeared as though no termite management system has been installed, with no evidence to suggest preventative works taking place.

The client may consider gaining further advice from a pest controller as to the costs and procedures involved with this application. It is recommended that obtaining such advice be a short-term priority.

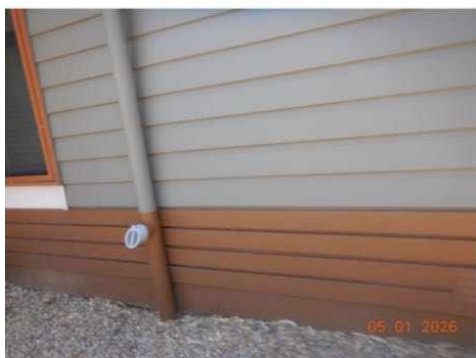
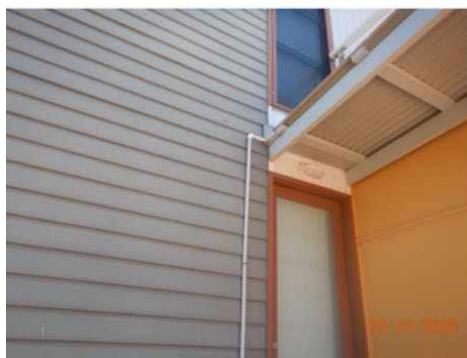
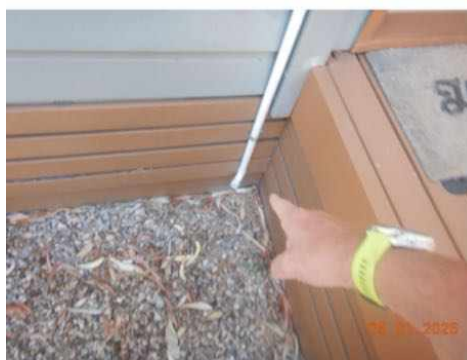
Finding 6.03

Building: Building 1
Location: All External Areas
Finding: Air conditioner and or external tap - No drainage
Information: Moisture around the perimeter of the building should be minimised to ensure that the area is kept dry and stable which in turn reduces the risk of water damage and termite infestation.

There appears to be no drainage points set up to the air conditioning unit, and or the external tap/ stormwater overflows. While this is not a legal requirement it is recommended to reduce the risk of moisture related issues and the creation of an environment conducive to termite activity.

It is recommended that a licensed plumber be appointed to set up drainage in order to prevent such an environment from being created.

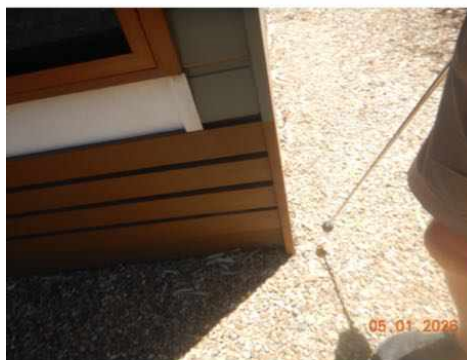
Finding 6.04

Building:	Building 1
Location:	All External Areas
Finding:	Perimeter Paving - Missing/ Insufficient Fall
Information:	The perimeter ground levels around the dwelling, were found to have an inadequate slope away from the adjoining building structure, creating potential for water pooling in this area and allowing moisture to enter the wall.

Not only that but soil has been placed against the wall with no protection to the brickwork to prevent moisture ingress. No high moisture was evident to the brickwork at the time of inspection.

Perimeter paving is required to fall from the building by a minimum of 25mm in the first metre and bare ground should fall away from the house by 50mm in the first meter. This standard ensures that excessive moisture does not pool around the base of building structures, which creates potential for water and structural damage, as well as making the area susceptible to termite and timber pest activity.

Where paving or ground levels do not have adequate fall, a licensed paving contractor should be appointed to install perimeter pavement to ensure a dry environment beneath the house. It is recommended that these works are carried out in the short-term.

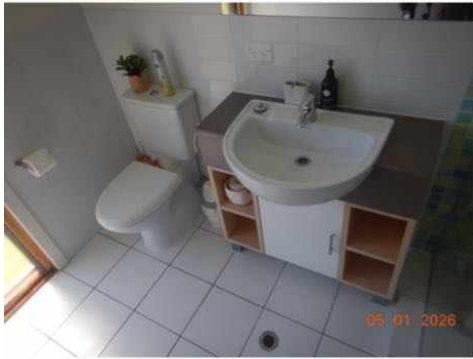
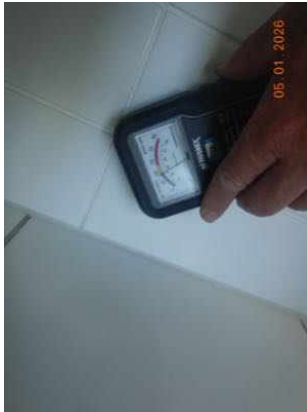
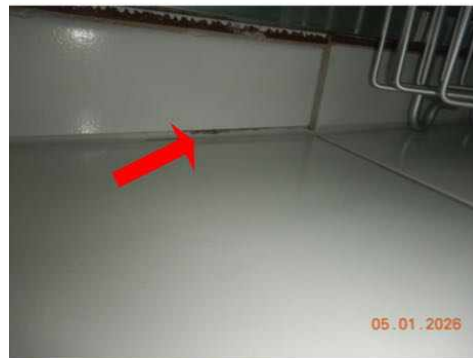
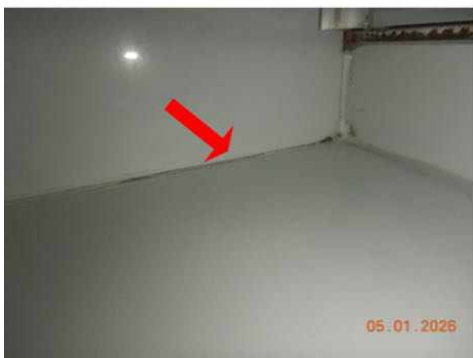
Finding 6.05

Building:	Building 1
Location:	Ensuite - Master
Finding:	Sealant - maintenance required
Information:	It was noted on inspection that sealant is showing signs of deterioration to the main bathroom. There were no abnormally high readings for moisture in the area.

Secondary defects can occur if maintenance is not carried out ranging from moisture in walls to deterioration of adjacent building elements

Flexible and materials should be applied to affected areas to prevent any subsequent water damage that can occur. Regular maintenance and replacement of damaged/ deteriorated sealant and grout is highly recommended as this is a regular wear and tear defect.

Repairs are required and should be carried out by a licensed bathroom sealant specialist immediately.

Silicone and grout generally need repair at least every 5 years and as such close monitoring should be carried out in the future after repairs are carried out.

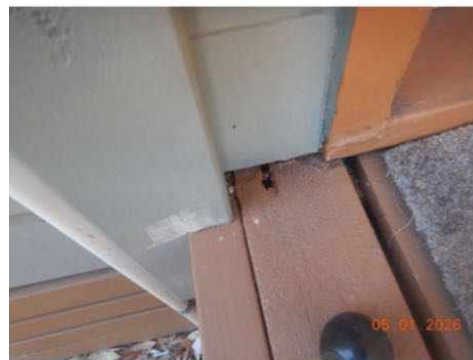
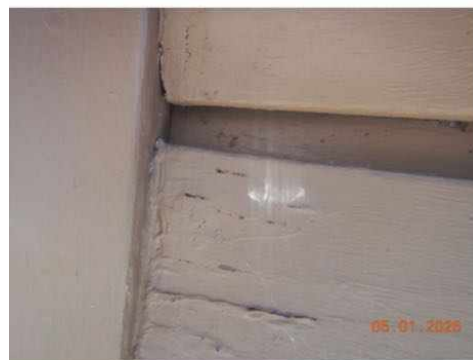
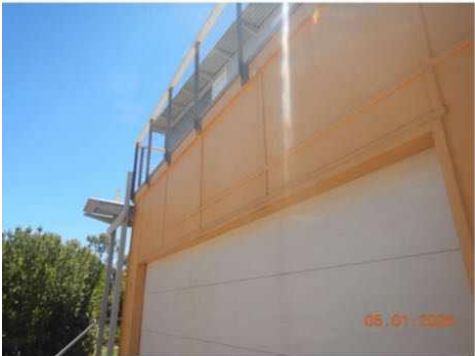
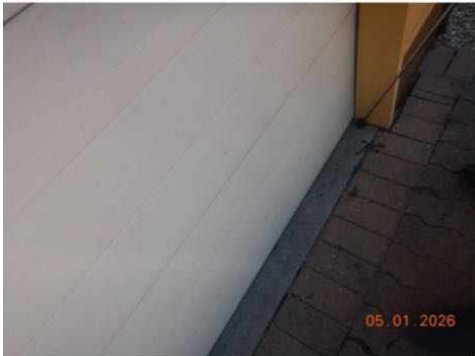
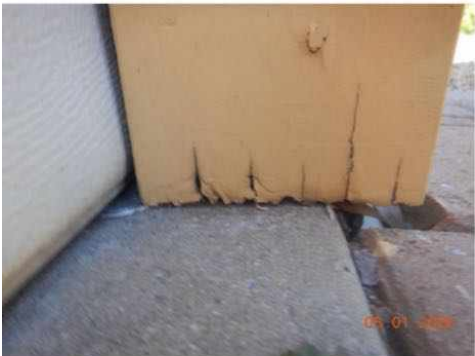
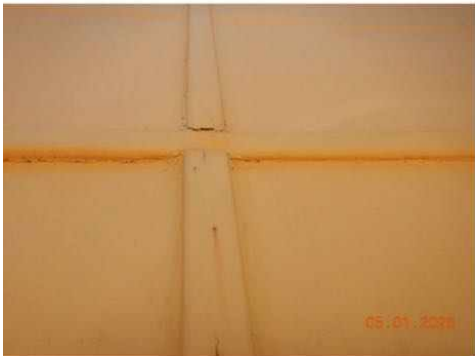
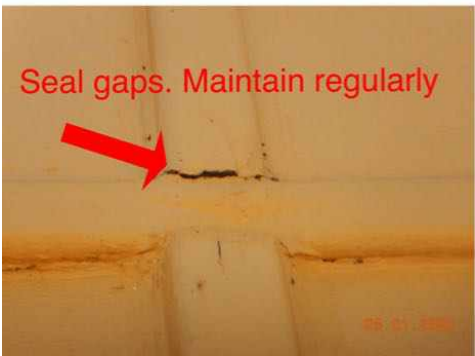
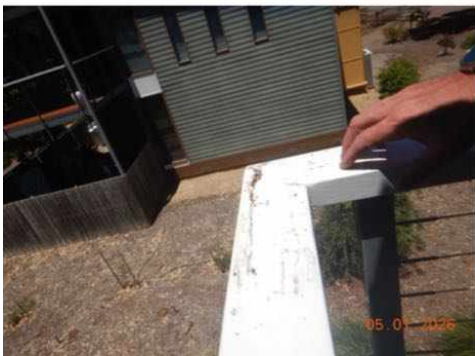
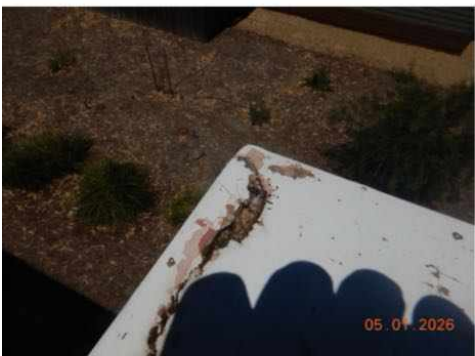
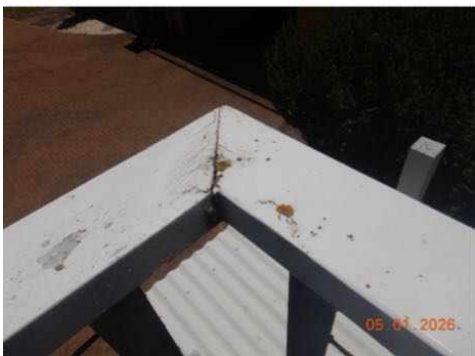
Finding 7.01

Building: Building 1
Location: All External Areas
Finding: Several elements - Wood rot
Information: Wood rot was found to be affecting several elements including small sections of the external cladding and trims at the time of inspection.

Wood rot, also known as Fungal Decay, occurs when timbers and other cellulose

building materials are exposed to damp conditions on an ongoing basis.

It is likely that this wood rot has developed as a result of frequent exposure to rain and other weather conditions however deteriorated guttering or building elements can be a contributing factor also.

It is also suspected that failure to maintain these elements over a prolonged period has resulted in them deteriorating at an accelerated rate, increasing their susceptibility to the development of wood rot.

Early intervention and regular maintenance will prolong the useful life of these building elements.

Repair and/or replacement of affected areas may be a necessary step in protecting surrounding building elements from such deterioration. Remedial works should be performed by a registered builder at the discretion of the client to prevent any further damage.

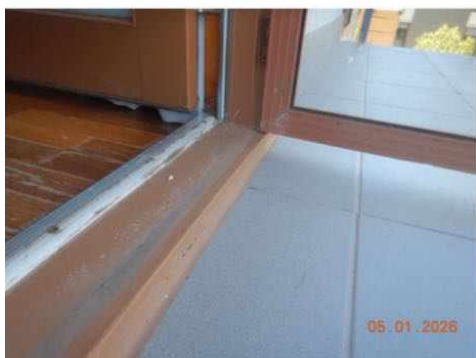
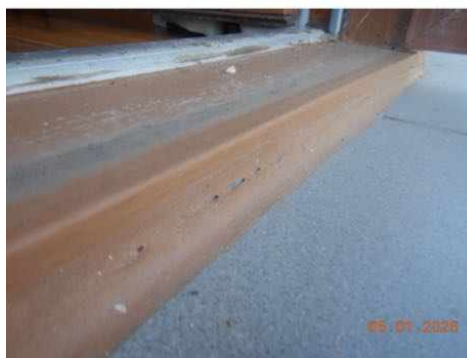
Finding 7.02

Building: Building 1
Location: All Areas
Finding: Building element - Swollen/ leak
Information: There is swelling evident to several internal window/ door frames, architraves and also damage to adjacent flooring evident. Moisture to these areas generally occurs when windows, balconies or other exterior elements leak which is not uncommon where buildings are subject to excessive wind and rain pressures often found in coastal areas.

There were no high readings for moisture to these areas indicating that issues regarding moisture ingress may have been managed and should be monitored closely.

Swollen building elements generally indicate that the building materials have been affected by excessive moisture over a prolonged period of time, and have swollen as a result. The formation and development of mould/fungi or mildew is also a likely consequence of excessive moisture.

Excessive moisture is likely to lead to the development of secondary damage to any associated building elements, which may necessitate major reparation works if prolonged.

Rectification of the cause of the water leak should be addressed prior to any remedial works to the swollen building elements. A licensed plumber should be appointed immediately to identify the cause of the leak and provide advice on remedial works as necessary, Repair and/or replacement of swollen building elements should be conducted as a matter of maintenance by a registered builder or qualified carpenter.

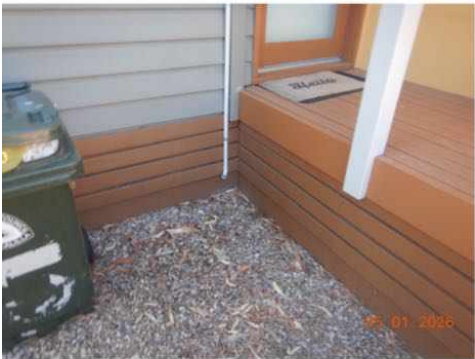
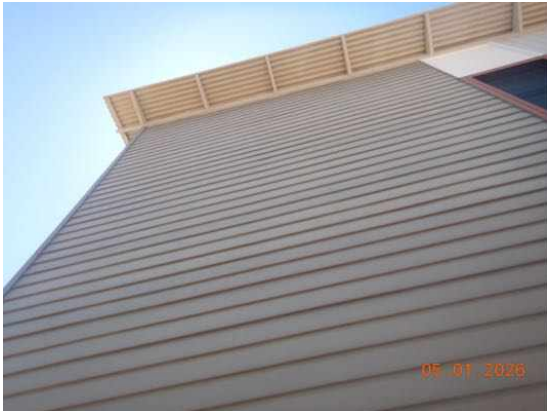
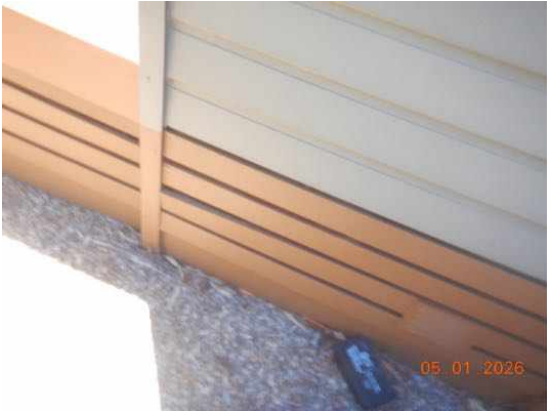
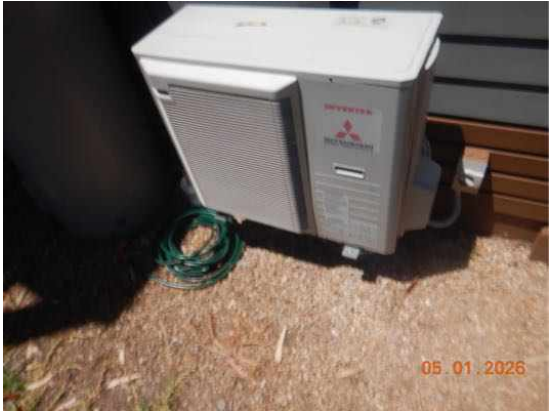
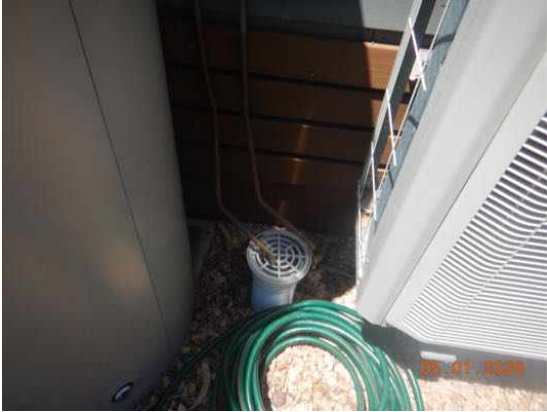
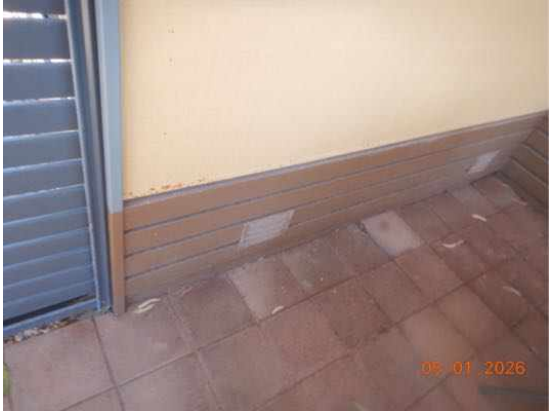
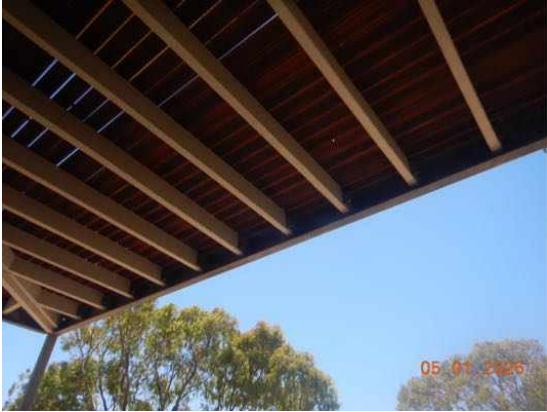
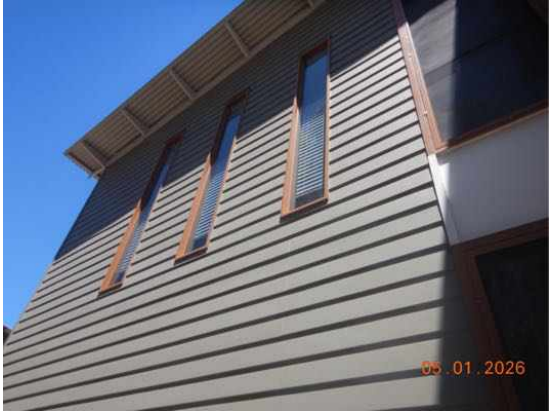
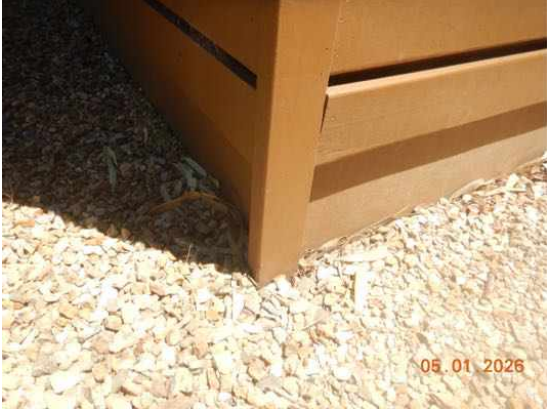
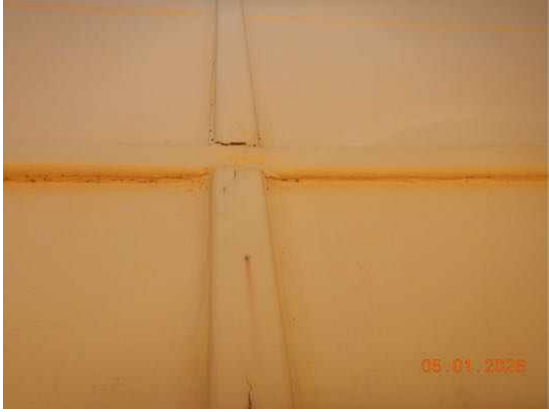
Noted Item

Building: Building 1
Location: All Areas
Finding: Additional Photos - Obstructions and Limitations
Information:

These photographs are an indication of the obstructions and limitations which impeded full inspection of the property at the time of inspection. These obstructions can hide an array of defects and should be removed to allow full inspection to be carried out.
