## Building Inspection Report

Inspection Date: Mon, 23 Feb 2026

Property Address: 35 Prince Charles St, Morphett Vale SA  
5162, Australia

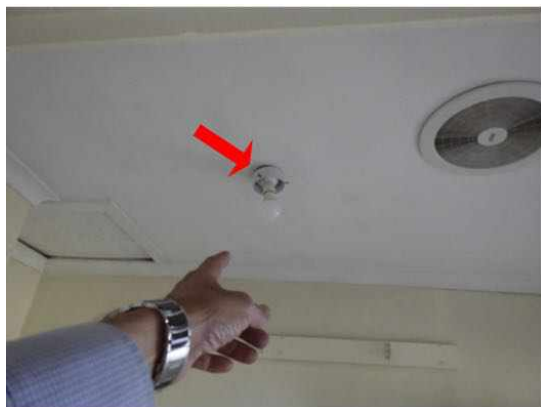
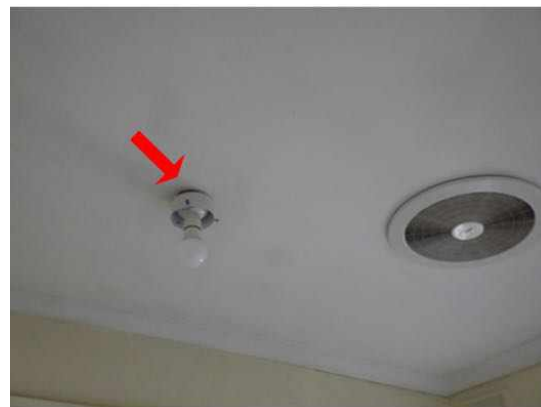
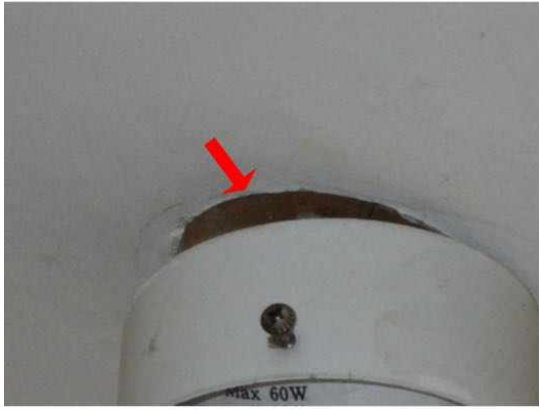
#### Defects 1.01

Building:	Building 1
Location:	All Internal Areas
Finding:	Electrical fitting - Broken/ Loose from its original fixing
Information:	The electrical fitting in this laundry area was found to be broken/ loose from its original fixing at the time of inspection. Breakage occurs generally when the building materials have aged and decayed, but may also be indicative of impact damage to the building element (accidental or deliberate).

Left unmanaged, the fitting is unlikely to cause further damage to surrounding building elements. However, the broken fitting does expose electrical works, and may create a safety hazard if there is potential contact with persons in the area.

Repair and/or replacement of the broken fitting is advised. A Licensed electrician should be appointed to repair/replace the fitting immediately.

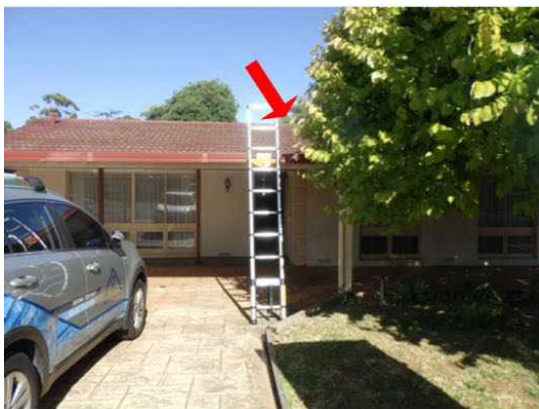
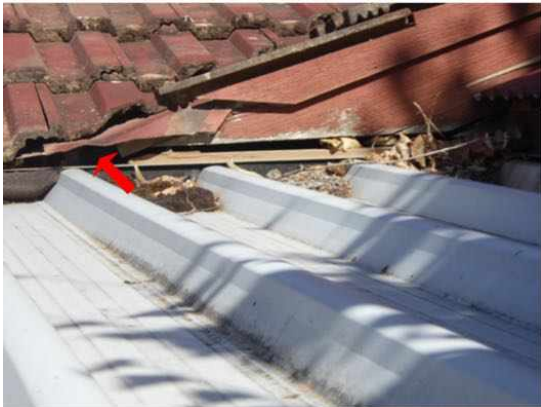
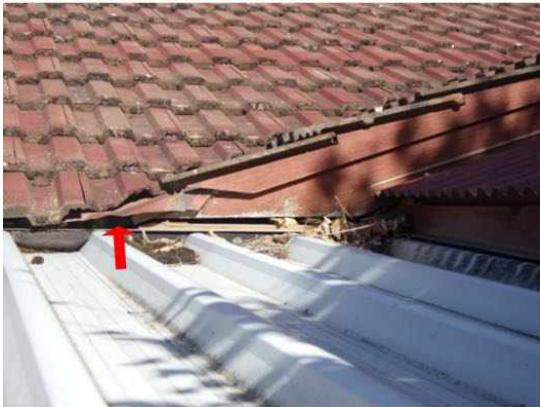
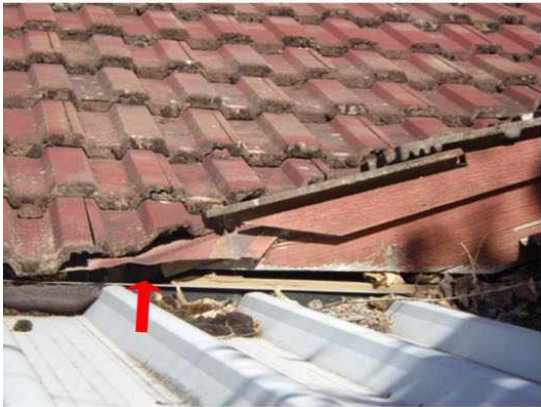
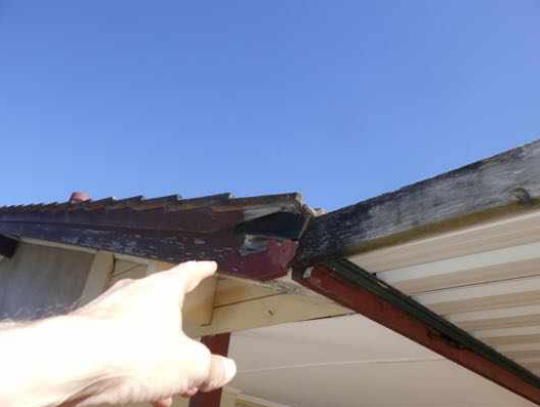
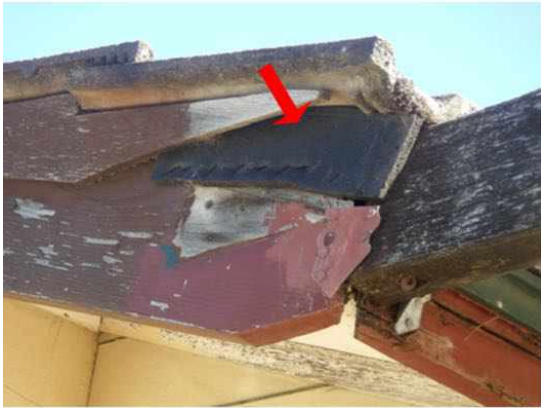
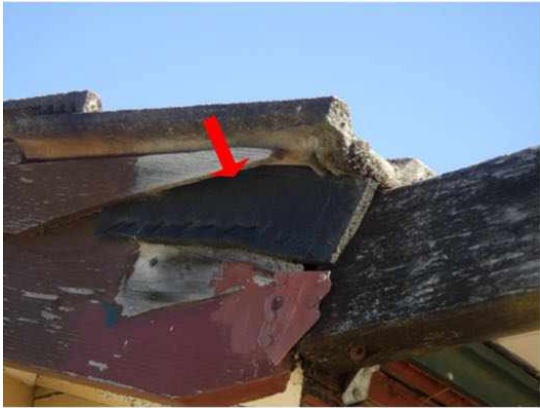
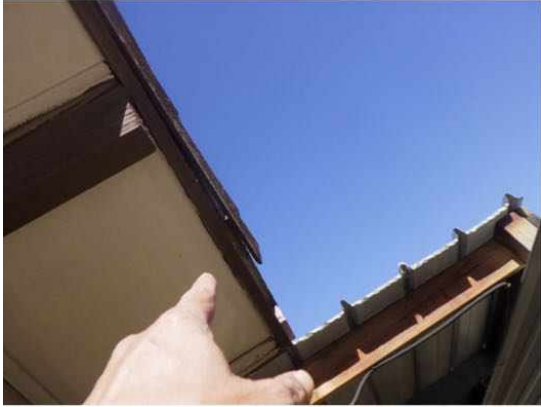
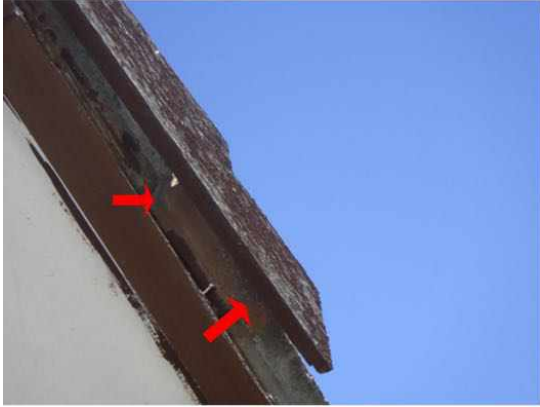
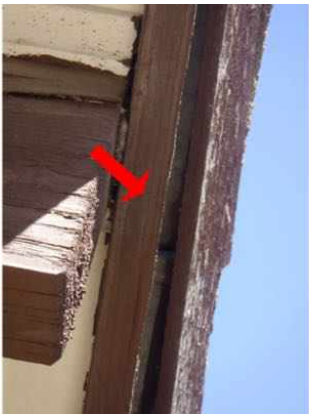
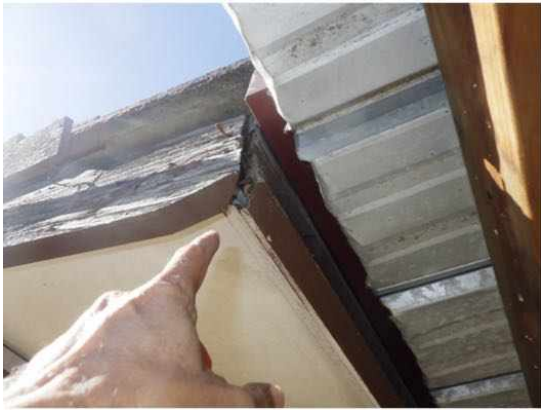
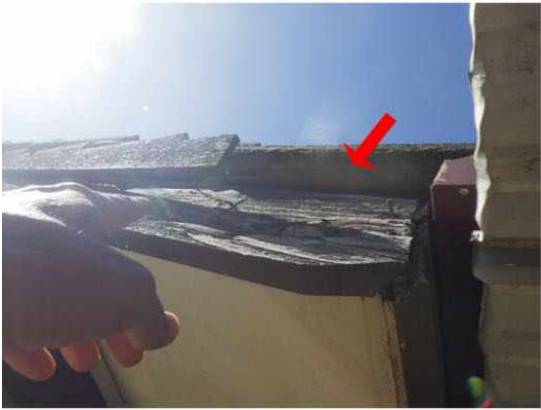
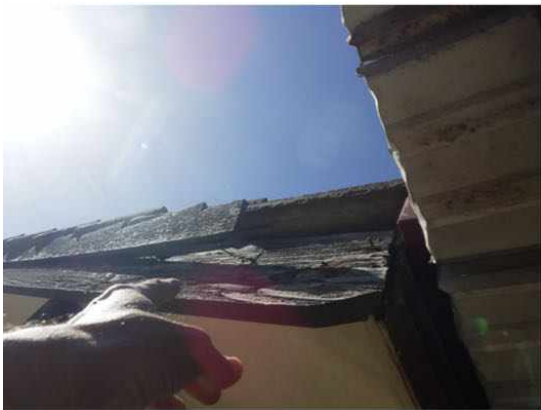
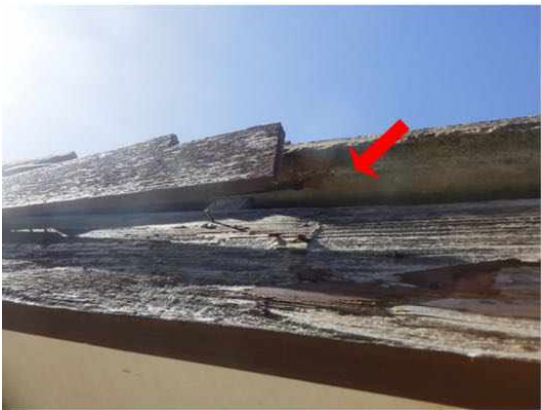
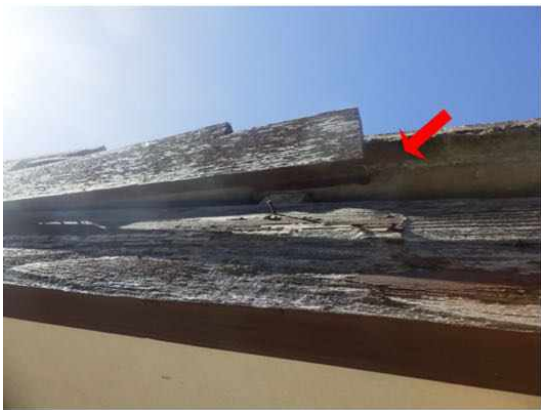
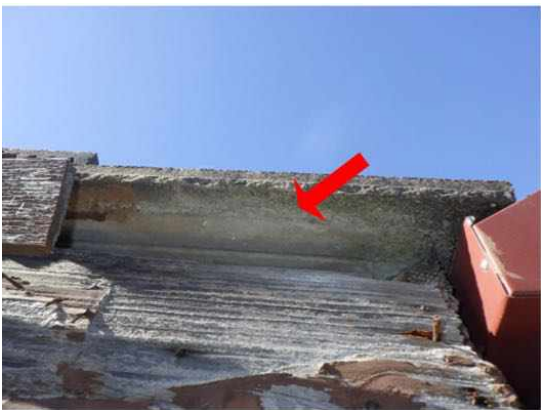
### Defects 2.01

Building:	Building 1
Location:	All External Areas
Finding:	Roof plumbing - Flashing inadequate
Information:	At the time of inspection it was noticed some sections of the roof are missing or have inadequate roof flashings. Flashings are metal and other materials which are applied to seals and intersections between roof coverings and building elements. They are designed to aid in weatherproofing of roof joins.

Flashings that are not installed adequately or are missing are likely to result in water penetration to the interior of the property, as well as creating excessively damp conditions against the exterior surfaces and around the base perimeter of the building.

Premature ageing and secondary building defects are imminent where roof plumbing is missing or inadequately installed. Additionally, water pooling also creates an environment that is susceptible to termite and pest infestation.

A roofing plumber should be appointed as soon as possible to install relevant roof plumbing materials, ensuring that no further damage is sustained.

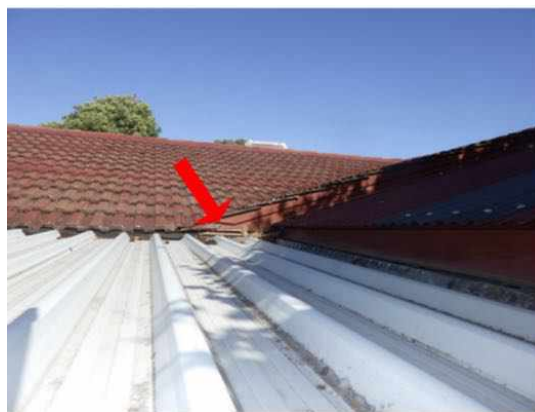
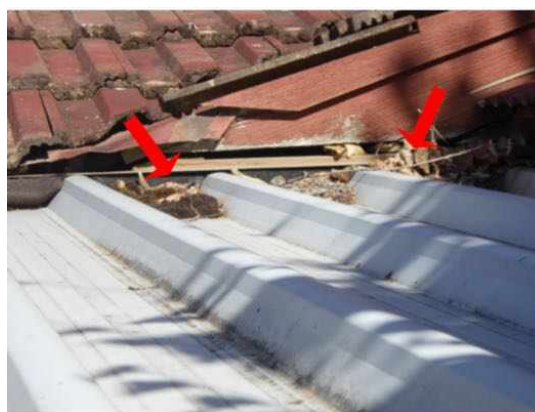
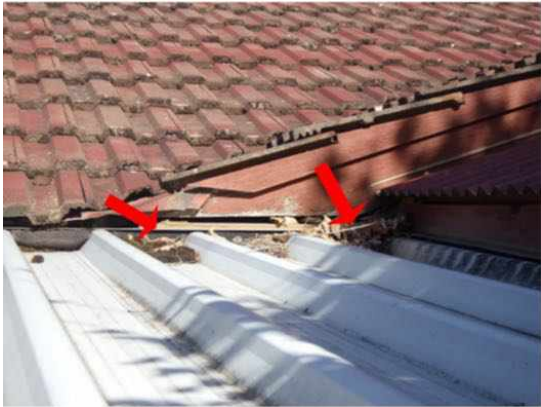
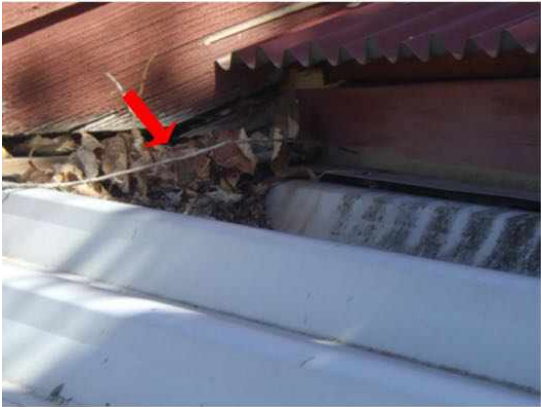
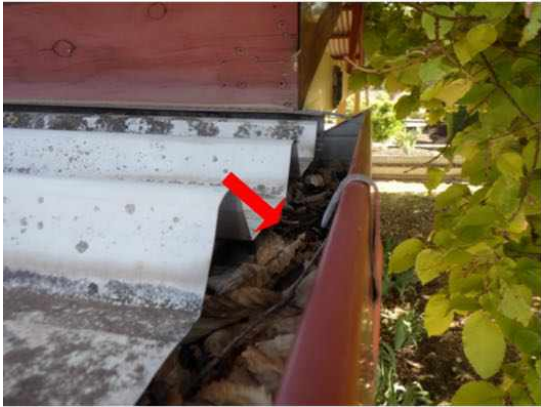
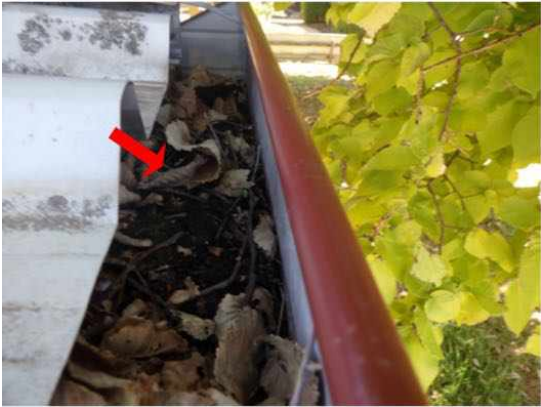
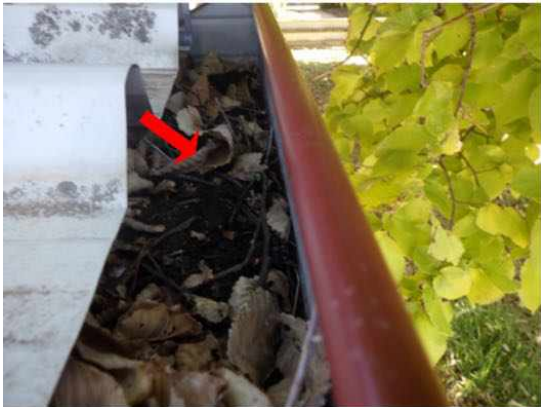
Defects 2.02

Building: Building 1  
Location: All External Areas  
Finding: Gutters - Blocked  
Information: At the time of inspection it was noticed that gutters were blocked in few sections around the property. Gutters have to be cleaned in regular intervals

Blocked gutters are likely to lead to high levels of moisture in the affected areas. Such moisture will not only cause rust and decay of the associated building materials, but can also provide conditions that are conducive to termite and timber pest activity. Blockages in gutters should therefore be removed immediately to ensure dry conditions are maintained.

Consult a Licensed Plumber for further specific advice on remedial works that may be required. In the interim, it is highly advised that blocked gutters be removed by the homeowner or a general handyperson as a matter of urgency.

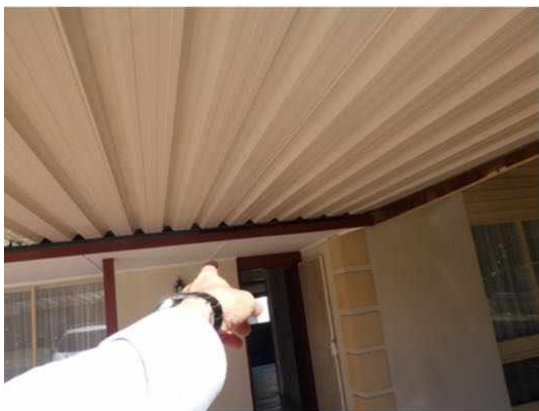
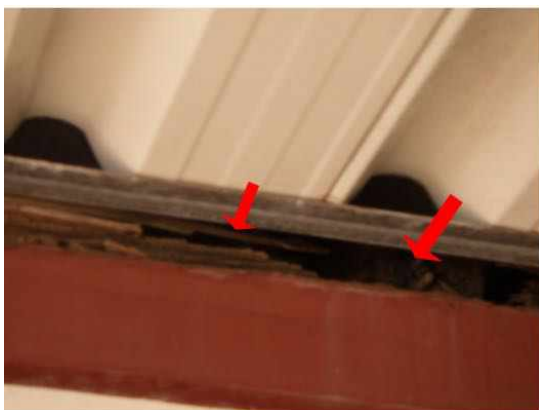
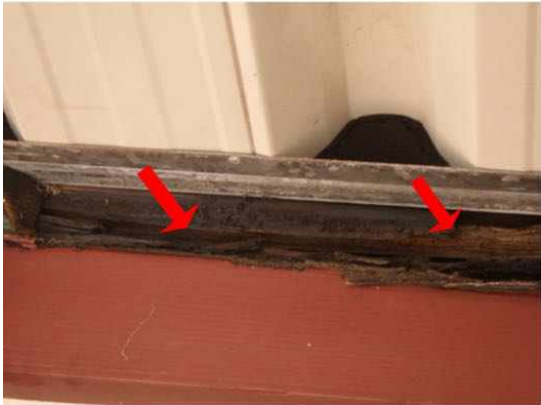
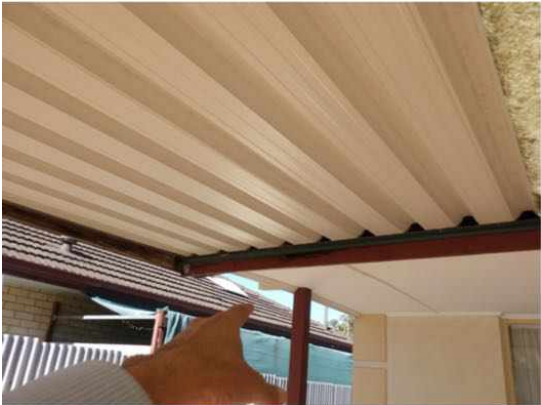
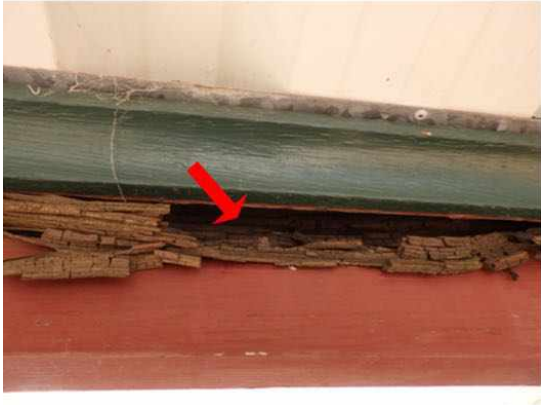
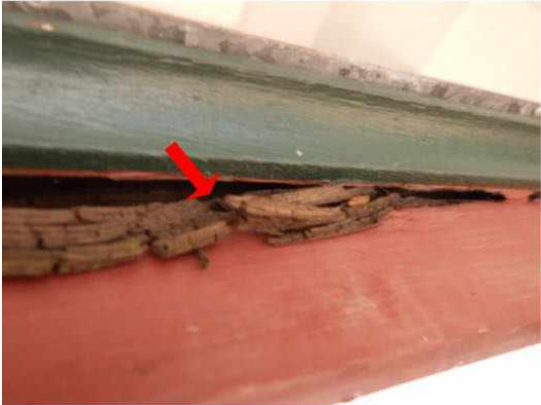
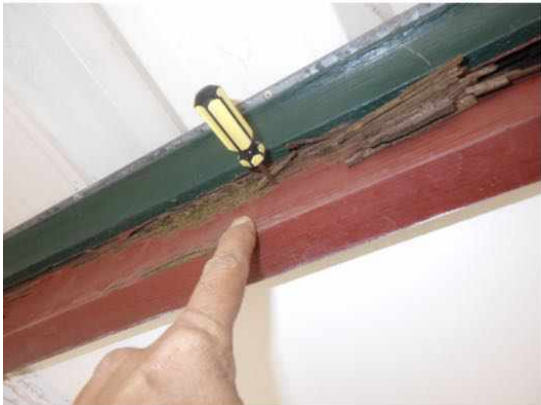
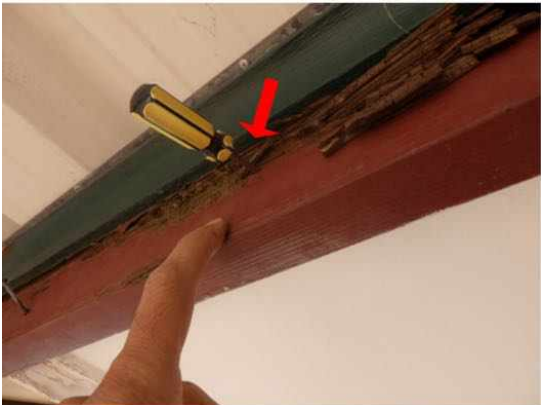
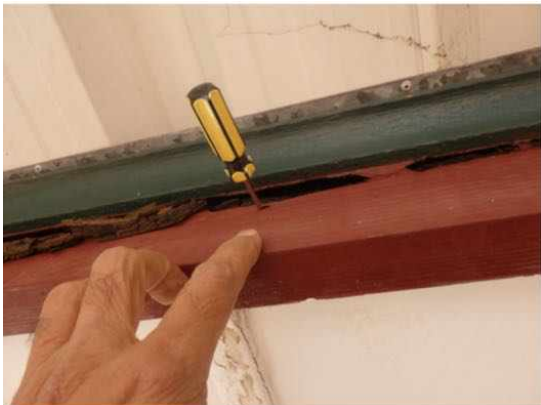
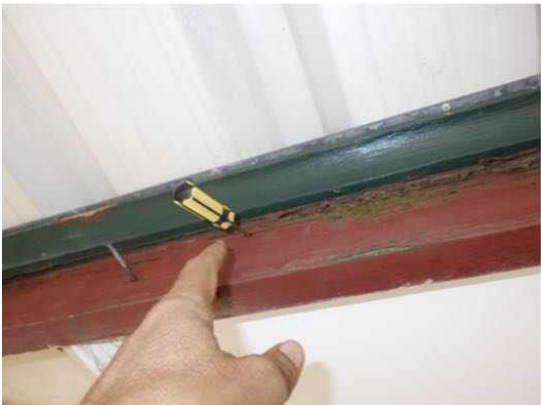
**Defects 2.03**

Building: Building 1  
Location: All External Areas  
Finding: Wood rot  
Information: This building element shows evidence of wood rot. Wood rot, also known as Fungal Decay, occurs when timbers and other cellulose building materials are exposed to damp conditions on an ongoing basis. This could be the result of exposure to weathering over a prolonged period of time, or the attraction of excessive moisture from other abutting building materials. Contributing factors also include poor air ventilation in the area.

Wood rot is often associated with general damp problems and is evidenced by a 'musty' smell or mould and mildew occurring on surfaces. If left unmanaged, damp conditions can lead to further health problems and the decay of timbers will continue.

Early intervention and regular maintenance, particularly of exterior timbers, will prolong the useful life of these building elements. Prior to any works being performed, the cause of the moisture that has created the visible wood rot should be identified and addressed in a suitable manner. Replacement of affected timbers may then be a necessary step in protecting surrounding building elements from such deterioration.

A qualified plumber may be appointed to assess the cause of excessive moisture and to provide advice on any remedial works as required. A qualified carpenter or registered builder may also be required to replace affected building materials.

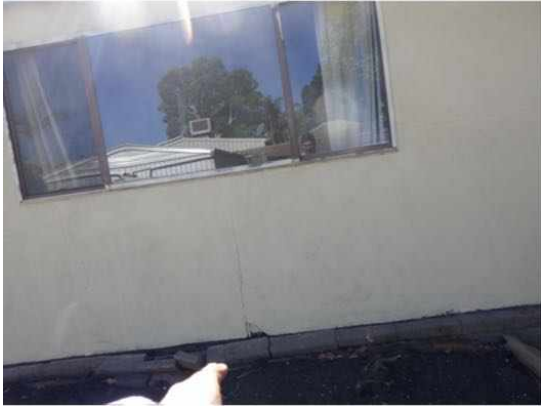
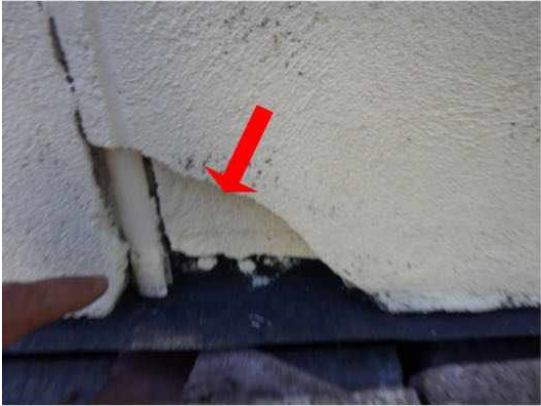
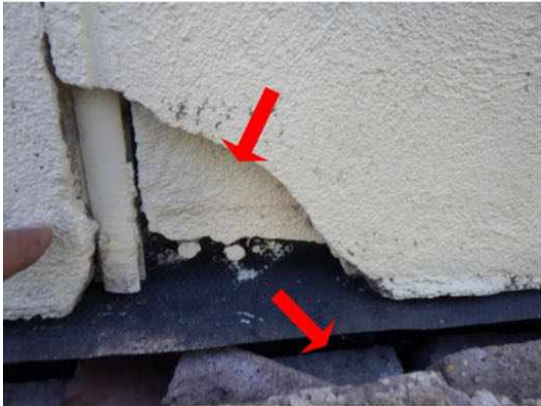
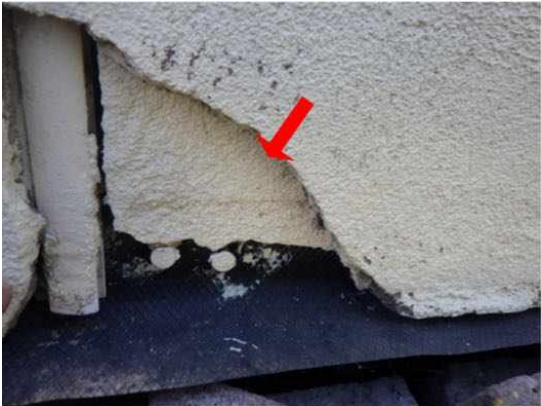
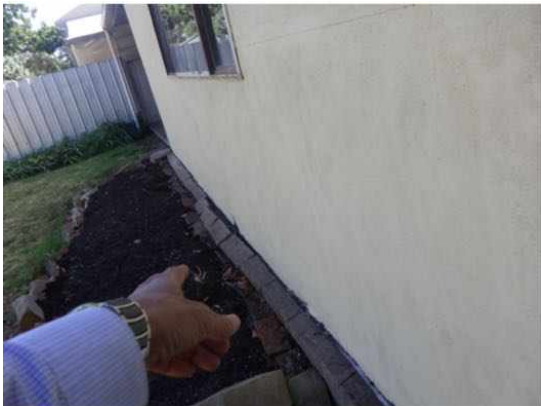
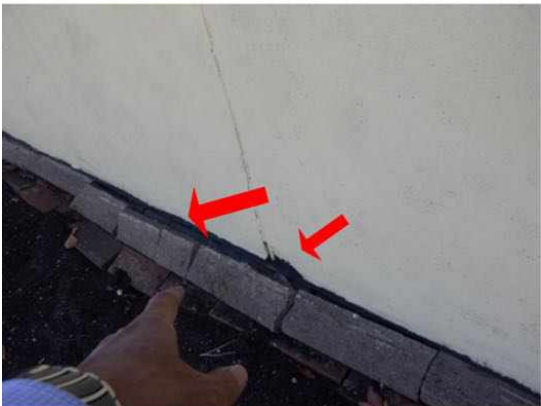
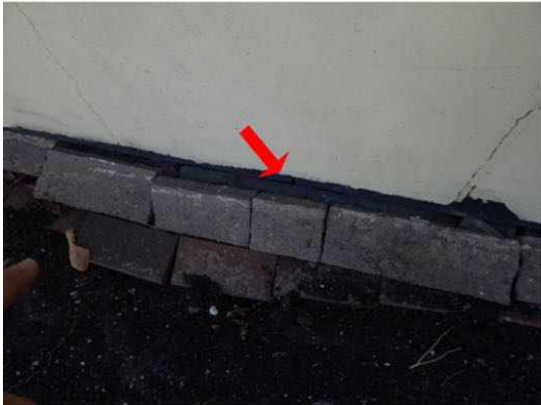
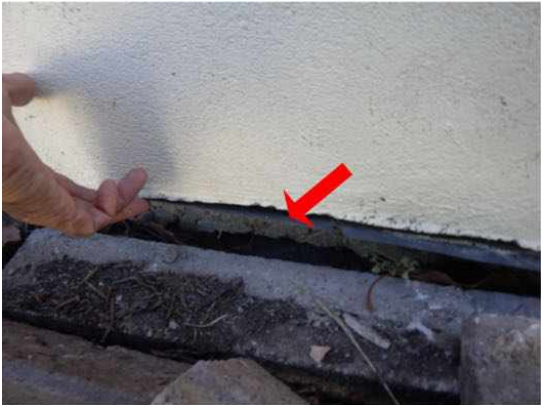
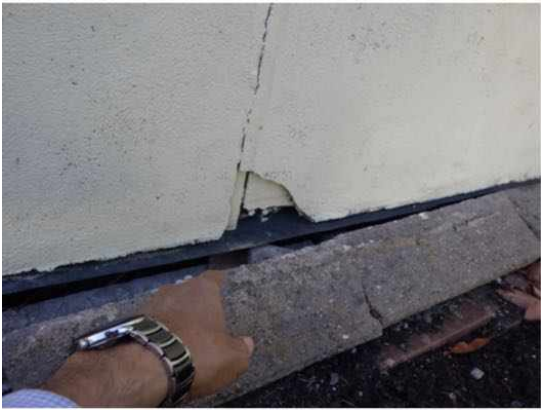
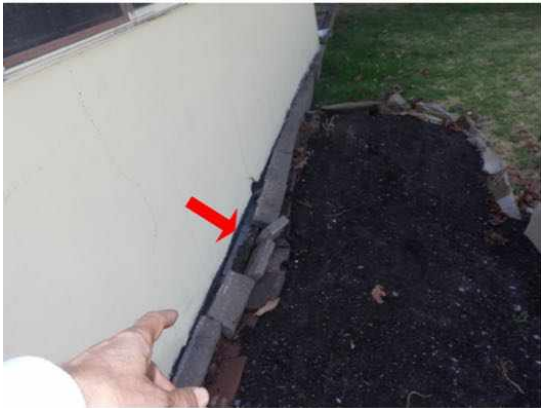
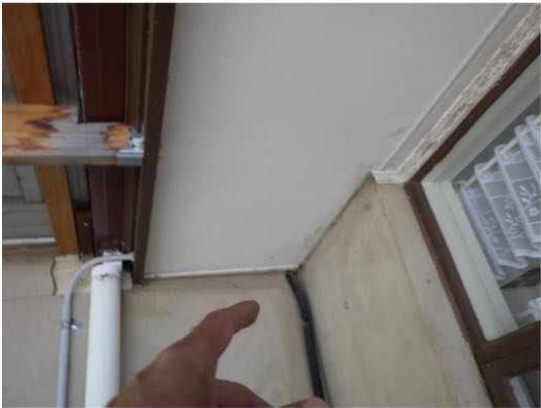
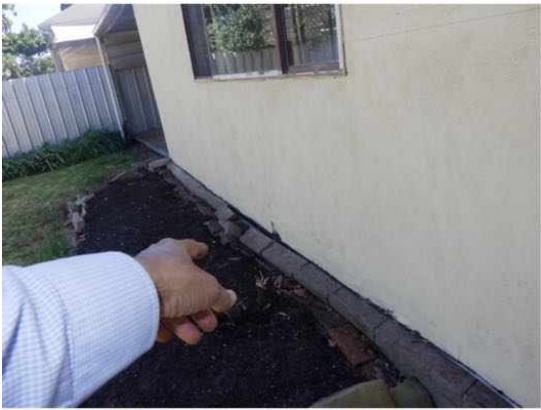
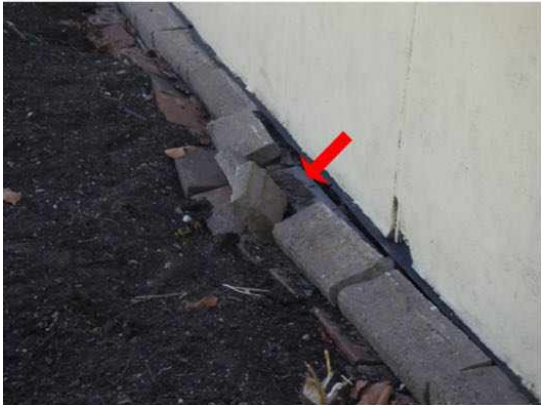
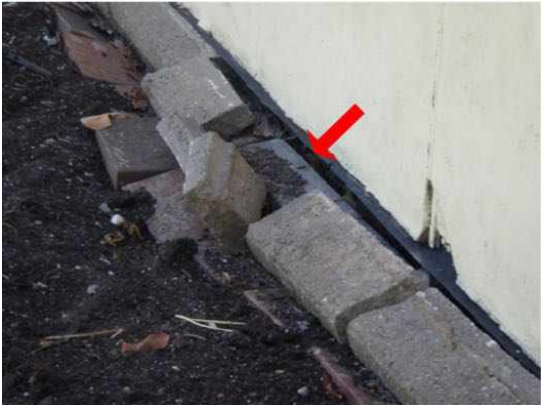
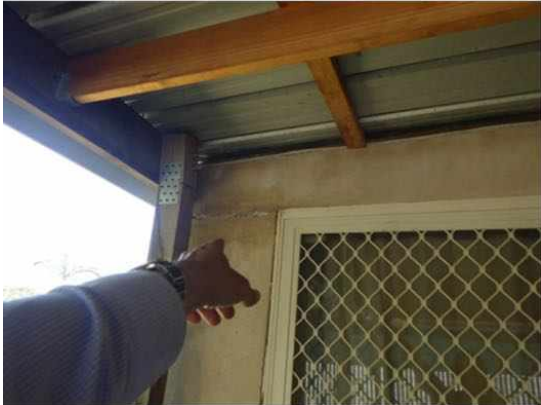
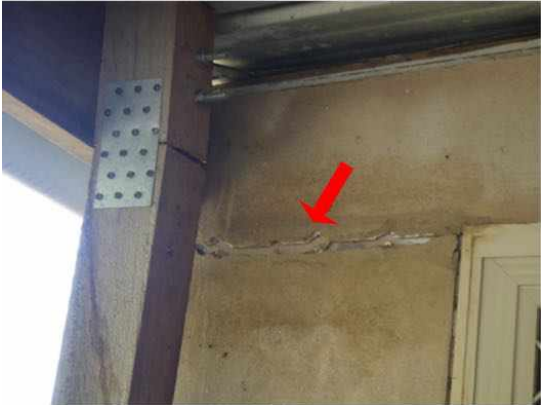
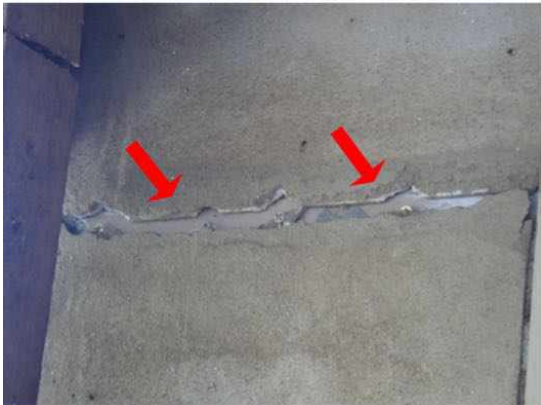
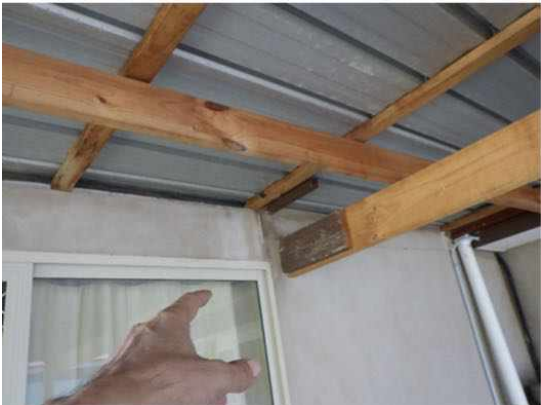
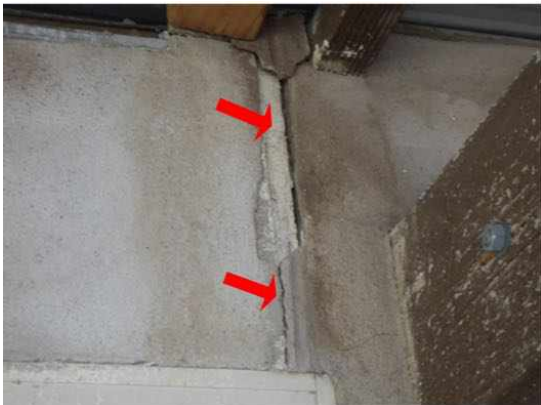
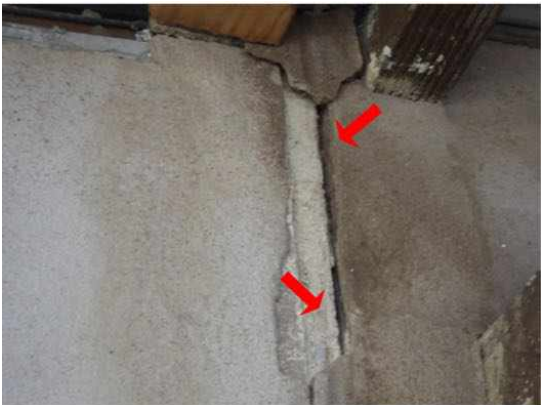
## Defects 2.04

Building:	Building 1
Location:	All External Areas
Finding:	Living area - External walls - Damaged
Information:	At the time of inspection it was noticed that sections of living area external walls were damaged.

Apart from that it was also noticed that paving were loose from its original fixing in this living area external walls.

Breakage occurs generally when the building materials have either aged and decayed, or as a result of damage (accidental or deliberate).

Repair and/or replacement of broken elements is advised to ensure that additional secondary defects do not arise as a consequence. Such works are necessary, as all building elements play a key role in the operation and function of the overall structure and its performance.

A relevant tradesperson should be appointed as soon as possible to repair or replace the affected building element prior to any subsequent damage being caused.

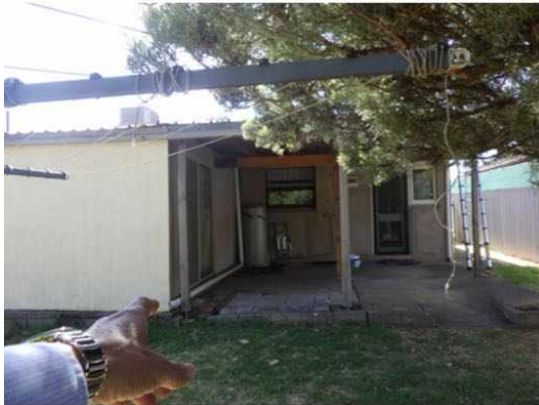
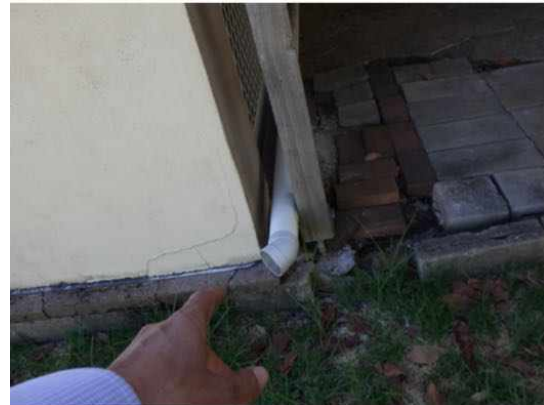
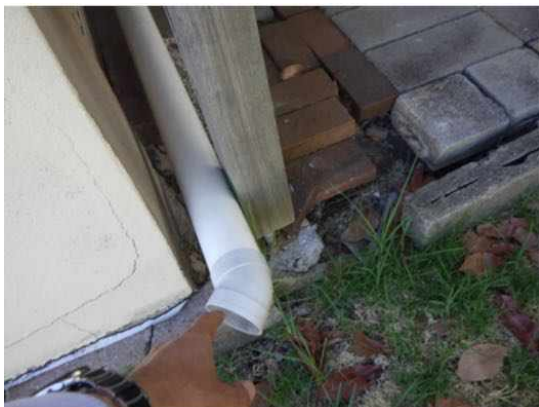
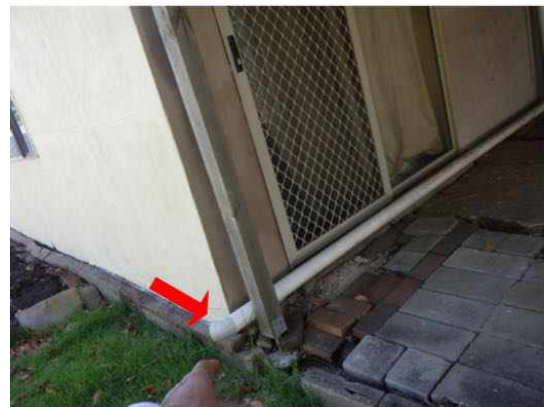
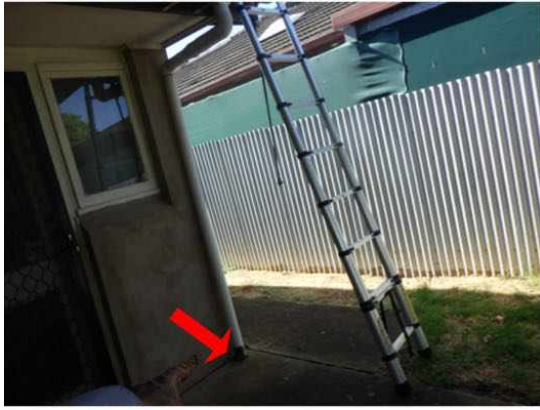
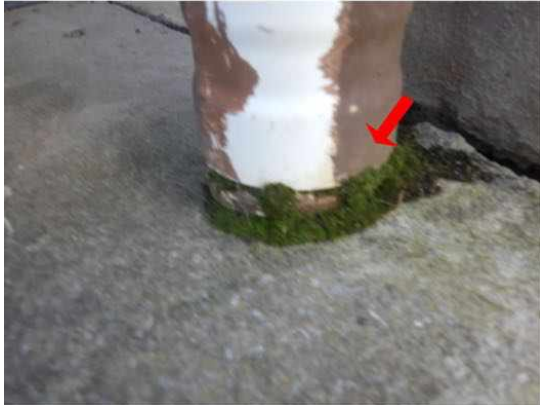
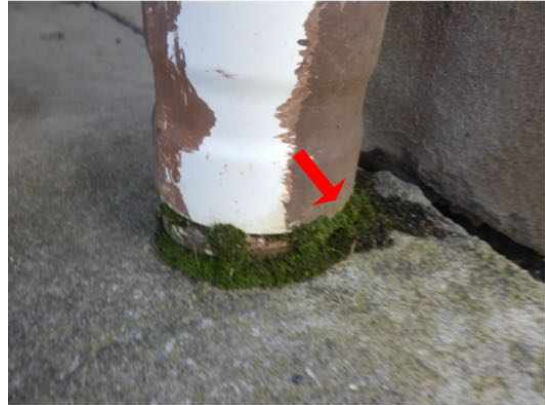
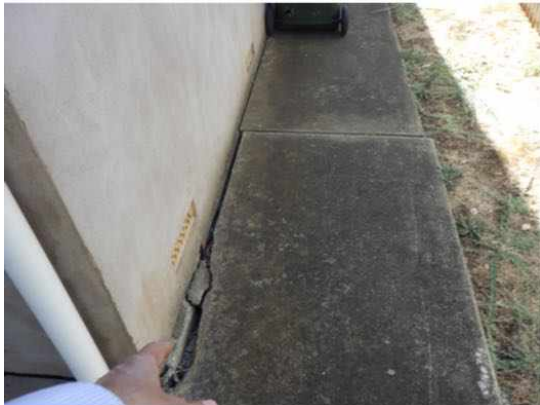
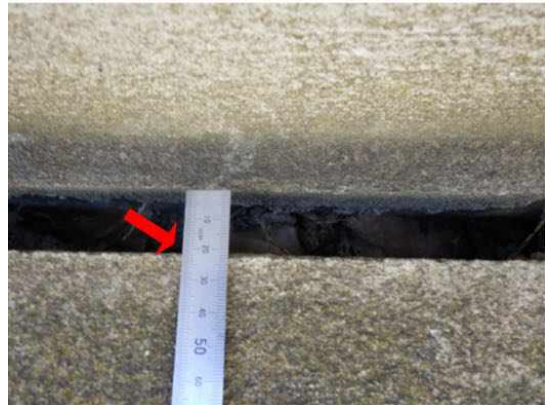
Defects 2.05

Building: Building 1  
Location: All External Areas  
Finding: Site drainage - Inadequate  
Information: The site drainage in this area was found to be inadequate at the time of inspection, creating potential for subsequent water damage to associated building elements.

It is important that water does not lie against the base of walls; surrounding paths and ground levels should be sloped to drain water away from walls. Downpipes should not discharge stormwater onto lower walls or plinths. Stormwater should be carried away by large, regularly cleaned drains. Ground levels may need to be lowered to expose a buried DPC.

Where site drainage is inadequate, installation of an Agricultural (Aggie) Drain may be required. A qualified plumber should be appointed to further inspect the property and perform any remedial works as necessary. Water damage and secondary defects are likely to occur if left unmanaged.

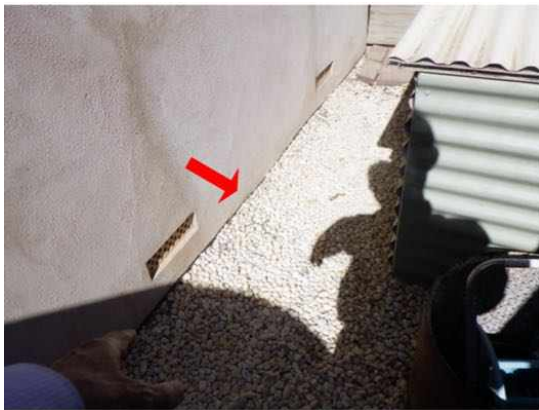
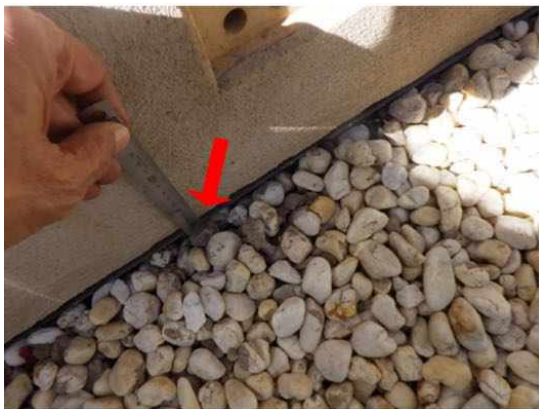
### Defects 3.01

If the slab edge is not properly exposed there is a high risk of termite attack. Sometimes, in order to determine the type of slab, a suitably qualified person such as an architect or builder may be required to consult the construction plans.

Where the slab edge cannot be properly inspected, it is highly recommended that termite or timber pest inspections be carried out every 6-12 months to aid protection of the property against infestation.

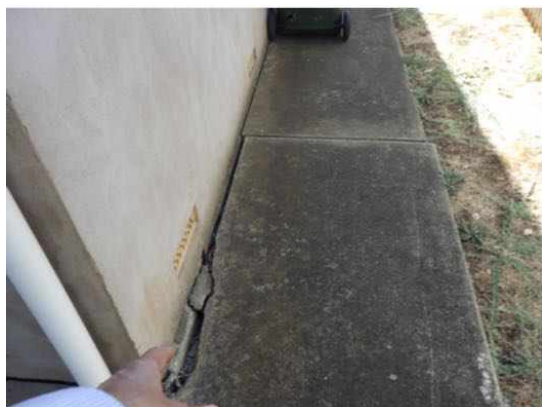
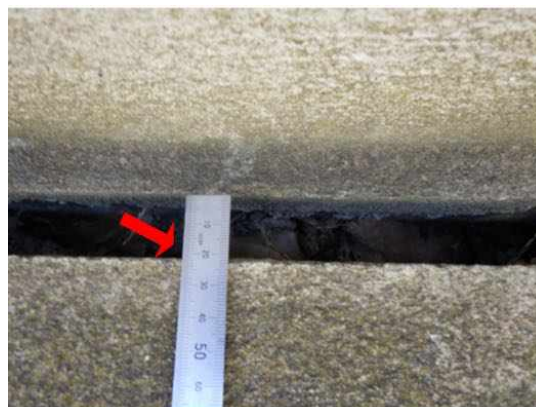
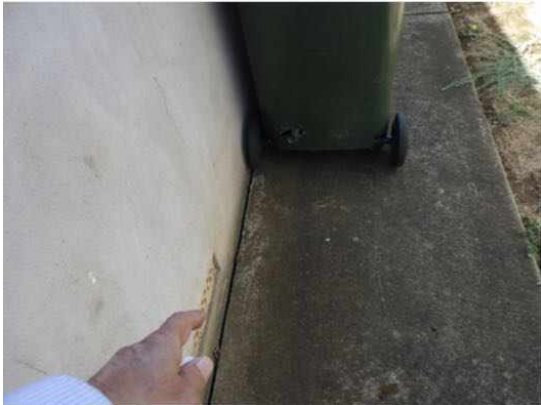
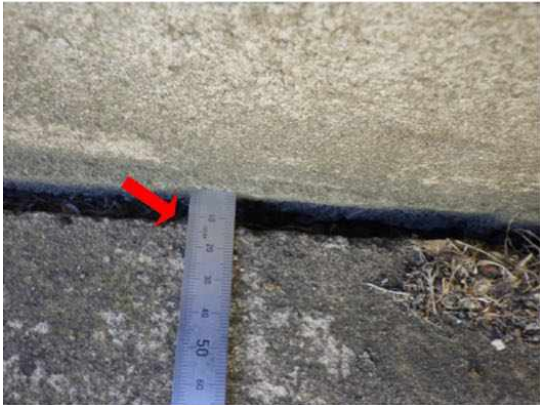
### Defects 3.02

Building:	Building 1
Location:	All External Areas
Finding:	Gaps in perimeter pavement
Information:	Gaps in the external concrete paving were identified at the time of inspection. Gaps in the slab are significant and are likely to lead to the development of secondary defects if left unmanaged, such as the creation of a trip hazard and water entry points.

With reactive clay soils, it is extremely important to ensure that all stormwater flows including roof and ground flows, contained and continually maintained. High moisture also creates an environment that is conducive to termite attack.

A licensed Plumber should be appointed immediately to ensure that the stormwater pipework is intact and adequate, and all gaps to concrete, driveways and paths should be sealed by a licensed builder or a general handy person to keep moisture from entering.

A licensed concretor may be required to replace pavements that are beyond repair.

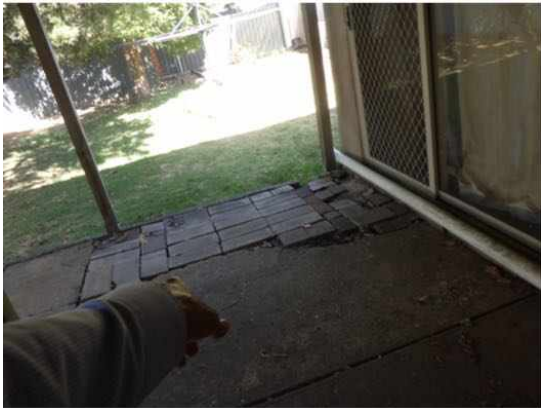
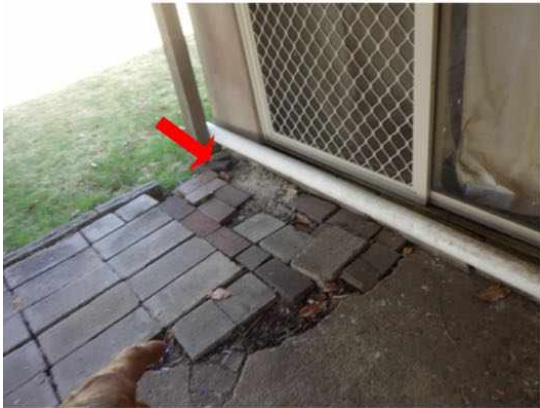
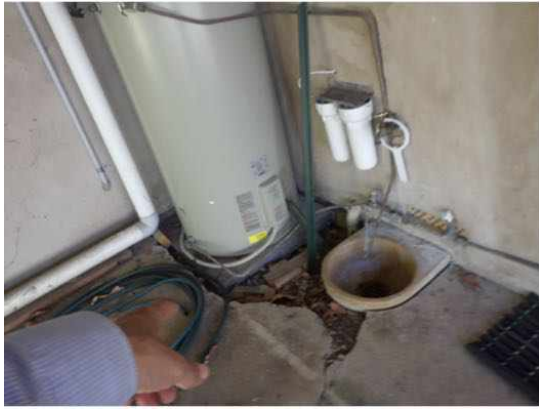
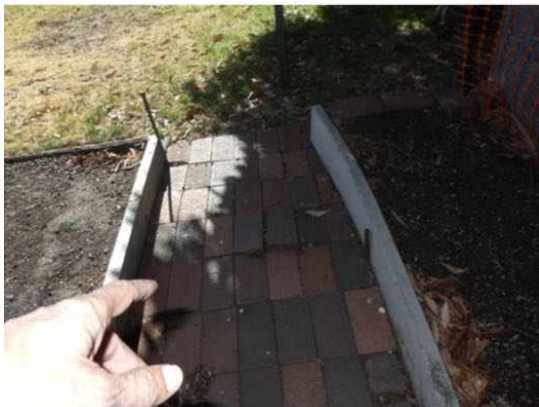
**Defects 3.03**

Building: Building 1  
Location: All External Areas  
Finding: Paving - Uneven/ Damaged  
Information: Sections of the external paved area are uneven/ damaged, creating a potential trip hazard. It appears as though the area has been subject to rough installation, or that paving sections have lifted due to movements in the foundation of the property.

Where paving creates a trip hazard, personal injury may ensue if due caution is not taken by all persons within this area.

Re-paving of the area is required as soon as possible to remedy this situation. Further consultation with a specialist concreter is advised.

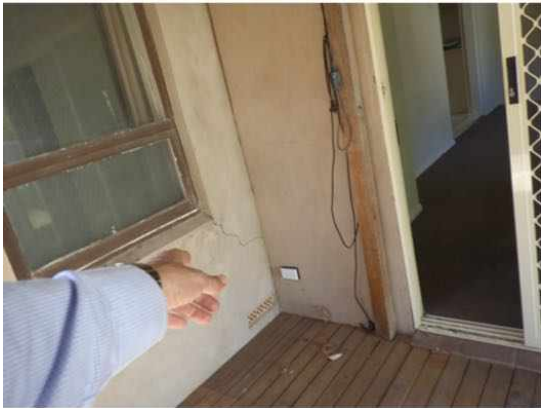
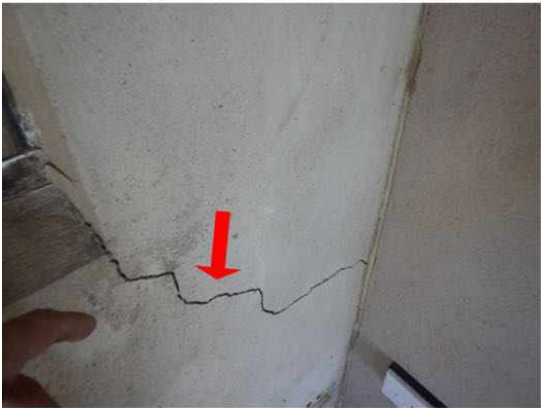
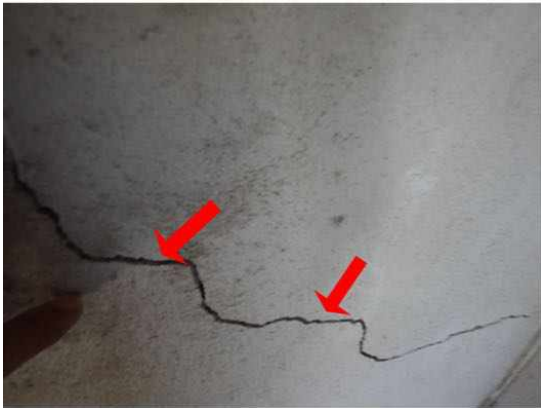
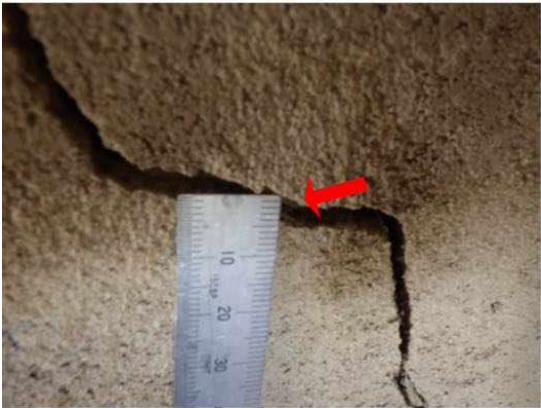
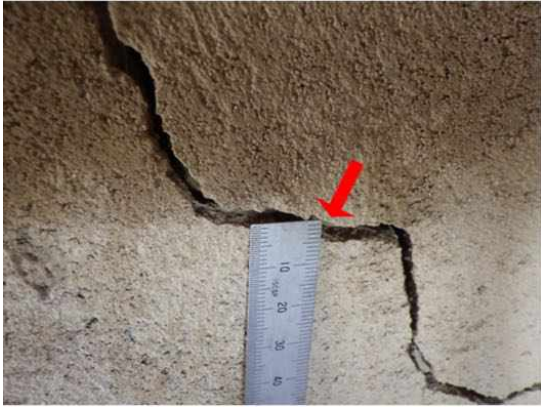
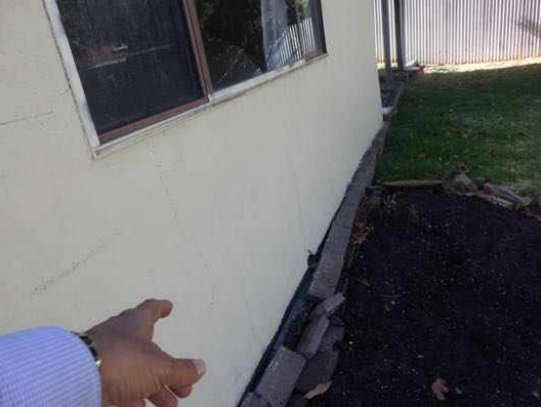
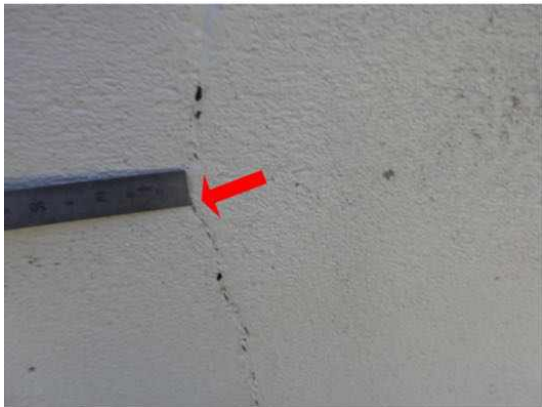
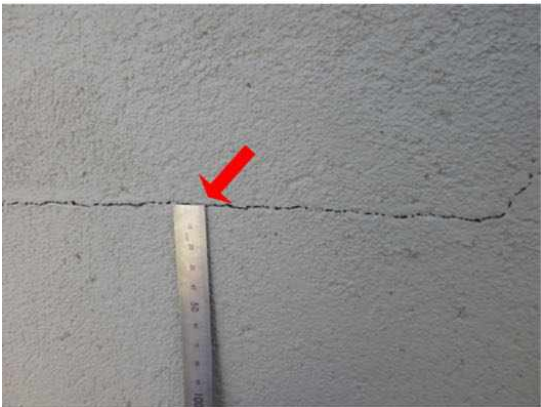
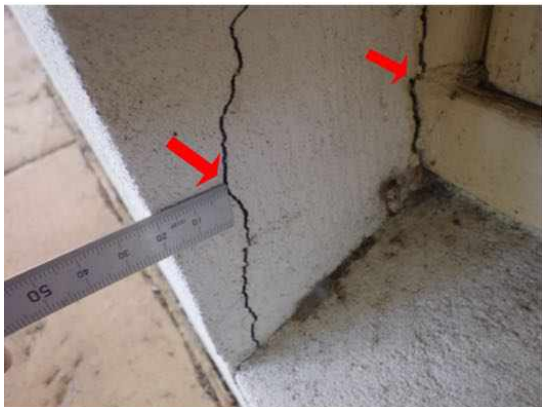
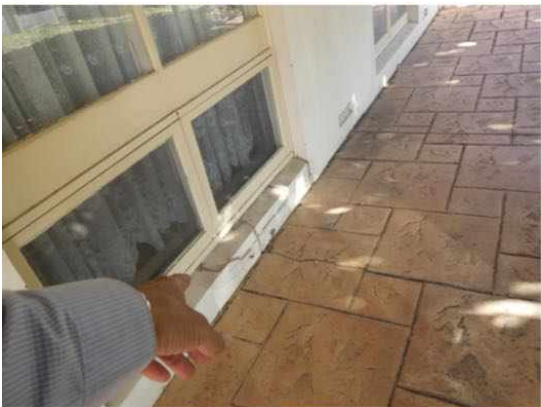
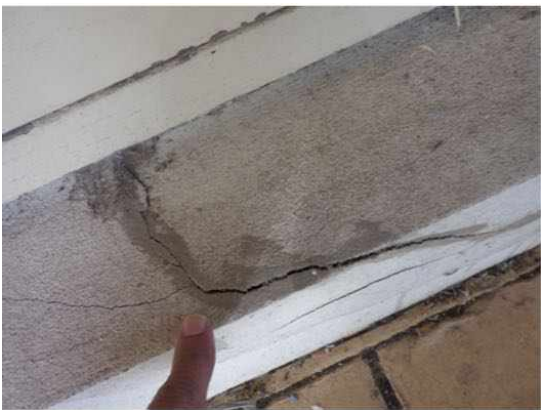
### Defects 3.04

Building:	Building 1
Location:	All External Areas
Finding:	Damage to Masonry Walls (Cracks)- Category 2
Information:	It has been observed that damage to masonry walls caused by movement of slabs, footings, or other causes, has occurred. The degree of damage falls within Category 2, described as noticeable cracks which are easily filled. Such cracking may cause doors and/or windows to stick slightly, and are generally less than 5mm in width.

Damage of this category is required to be monitored for a period of 12 months, after which time a crack rated at Category 2 or above is considered a defect requiring rectification, such as minor repairs and repointing. Always contact your building

inspector should cracks widen, lengthen, or grow more numerous.
