## Building Inspection Report

Inspection Date: Mon, 23 Feb 2026

Property Address: 35 Prince Charles St, Morphett Vale SA  
5162, Australia

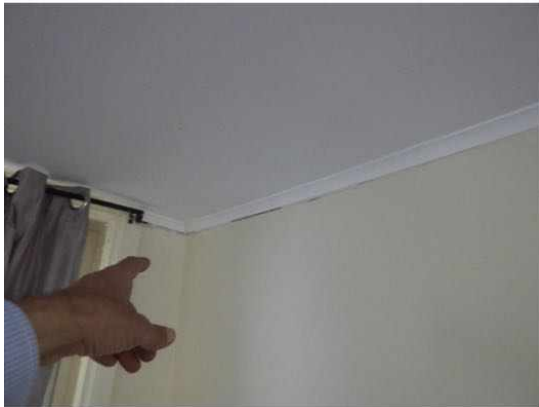
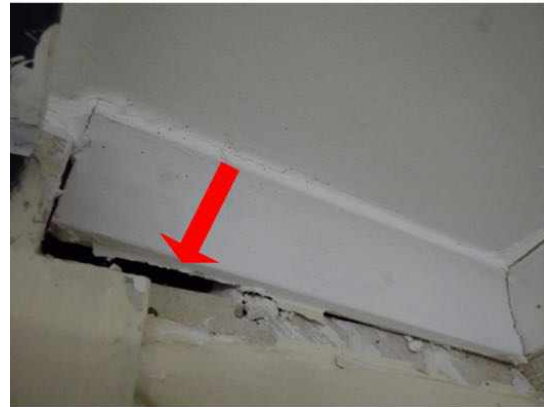
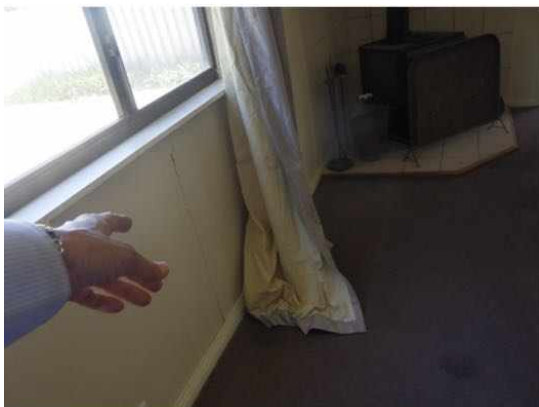
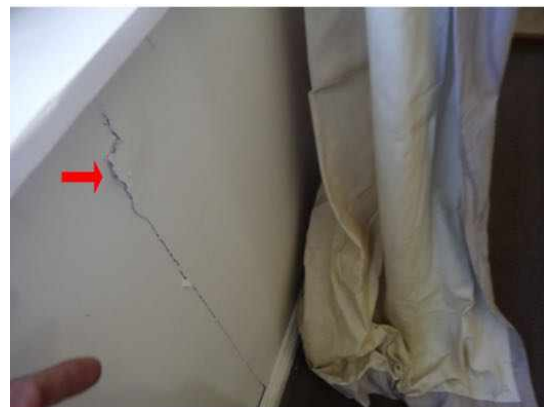
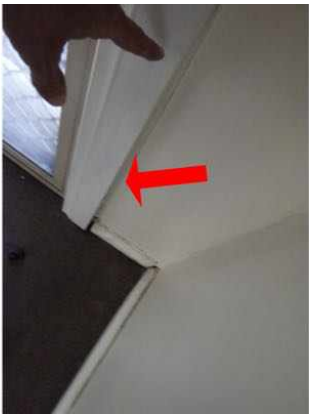
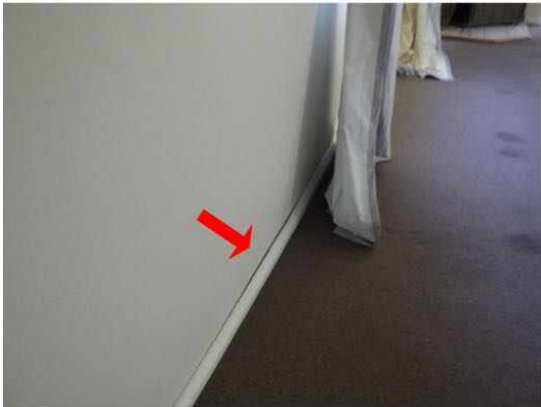
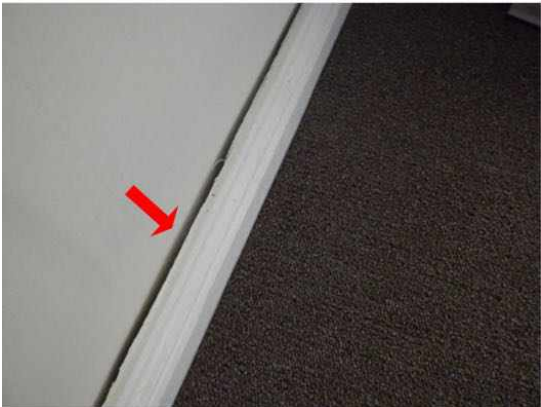
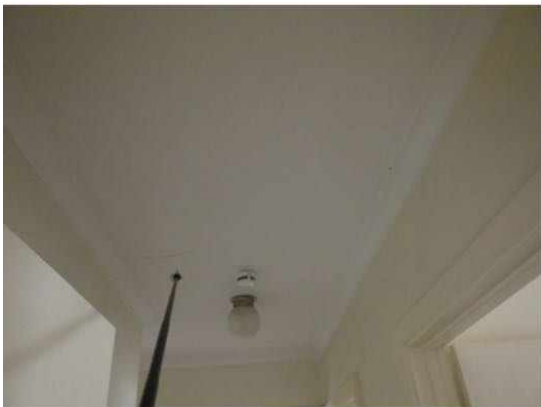
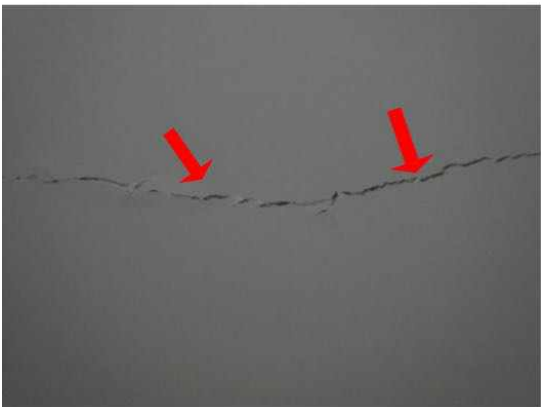
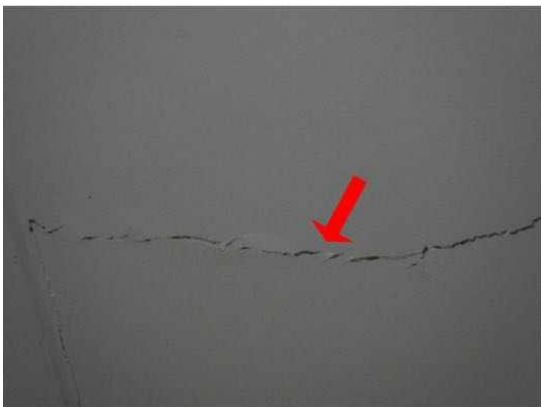
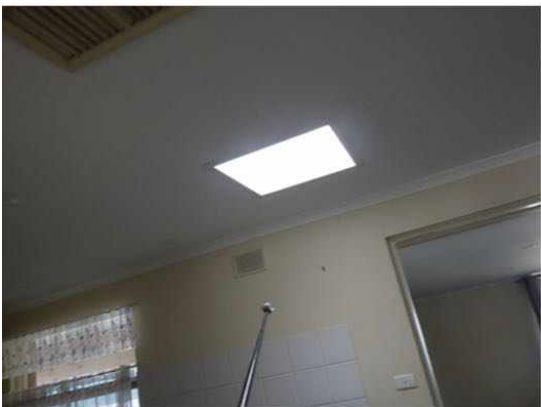
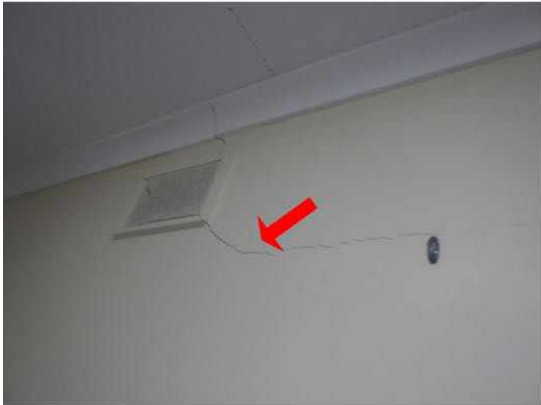
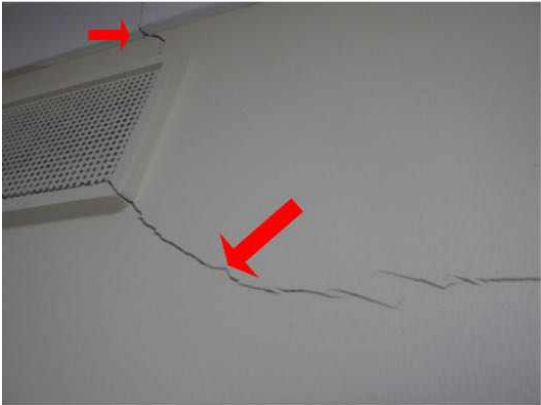
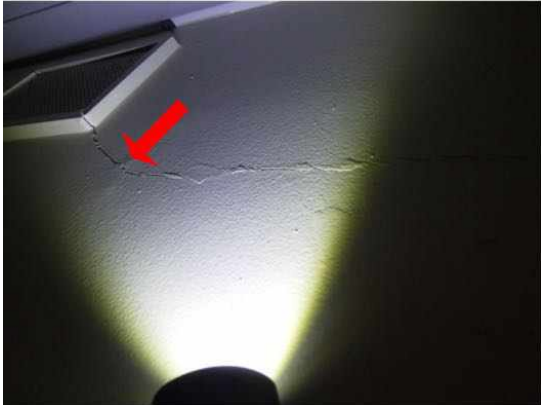
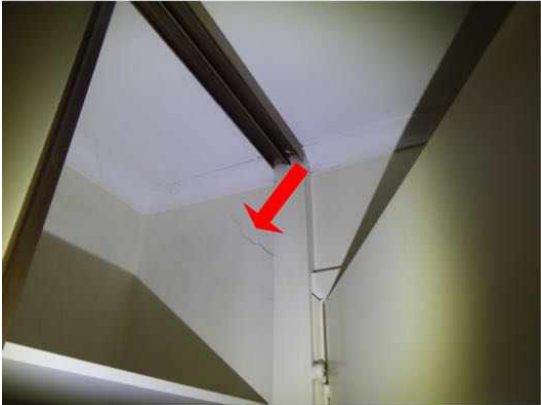
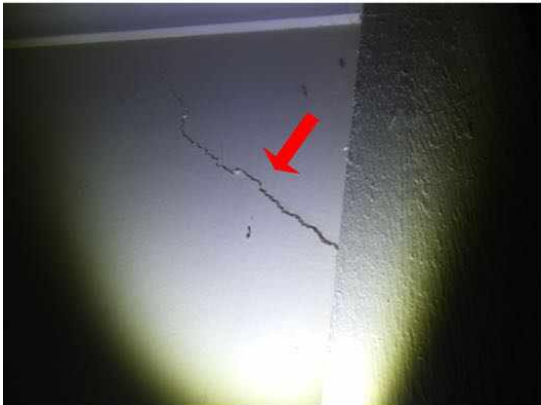
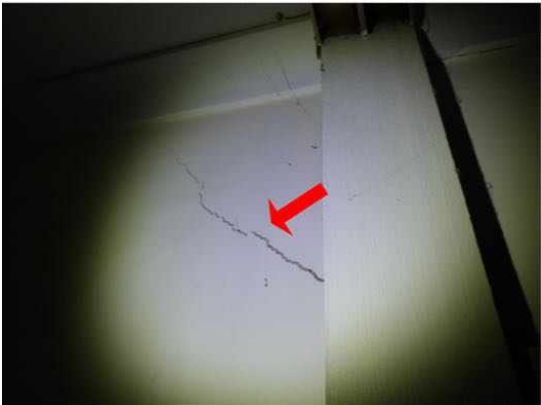
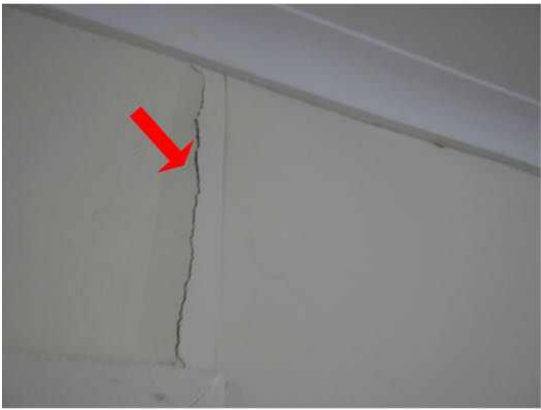
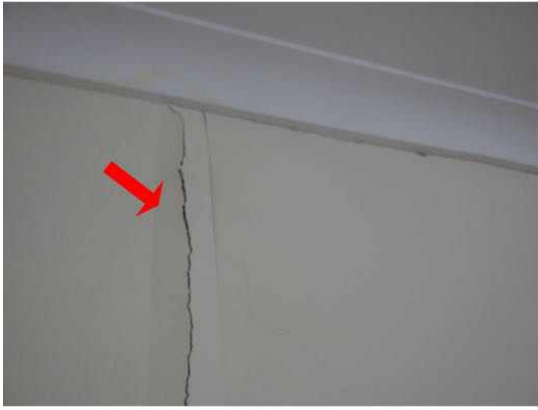
Defects 3.05

Building: Building 1  
Location: All Internal Areas  
Finding: Internal walls & Ceilings - Damaged/ Cracked  
Information: At the time of inspection it was noticed that few sections of internal walls and ceilings were damaged / cracked around the property.

Breakage occurs generally when the building materials have either aged and decayed, or as a result of damage (accidental or deliberate).

Repair and/or replacement of broken elements is advised to ensure that additional secondary defects do not arise as a consequence. Such works are necessary, as all building elements play a key role in the operation and function of the overall structure and its performance.

A relevant tradesperson should be appointed to repair or replace the affected building element prior to any subsequent damage being caused.

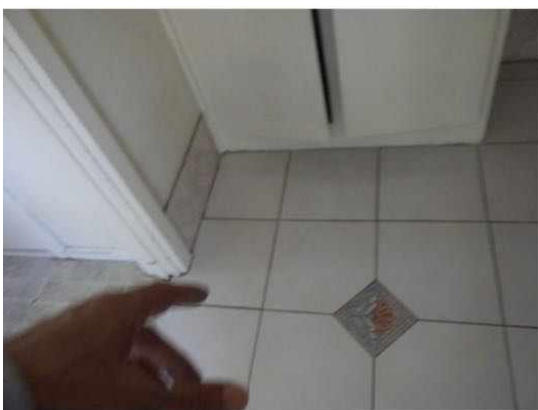
### Defects 3.06

Building:	Building 1
Location:	All Internal Areas
Finding:	Tiles - Cracked or damaged
Information:	Cracking was evident to the tiling in this area at the time of inspection. While the cracking appears to be minor, this area is frequently exposed to water, allowing potential for water penetration into adjoining sections of walls or flooring.

If left unmanaged, water penetration to these areas may lead to subsequent water damage, which is likely necessitate repair work to affected building elements.

A tiling contractor should be appointed to ensure that no further water damage occurs. The re-application of silicone and grouting throughout remaining tile work is also advised, to further protect the area against water penetration.

Where water penetration has led to water damage, appointment of a relevant tradesperson may be required to repair damaged building elements.

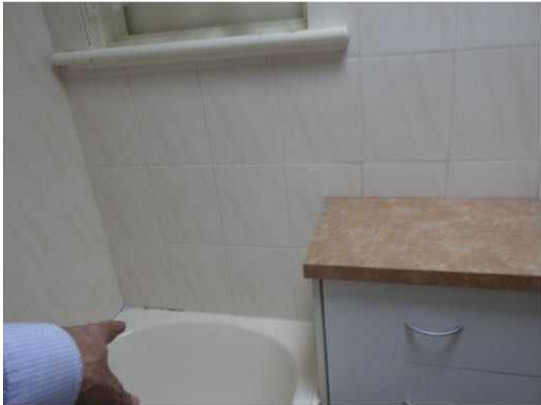
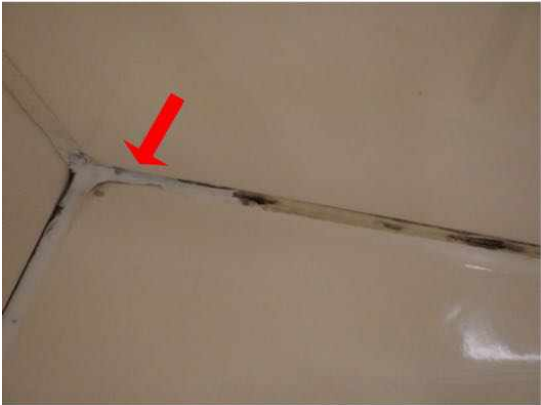
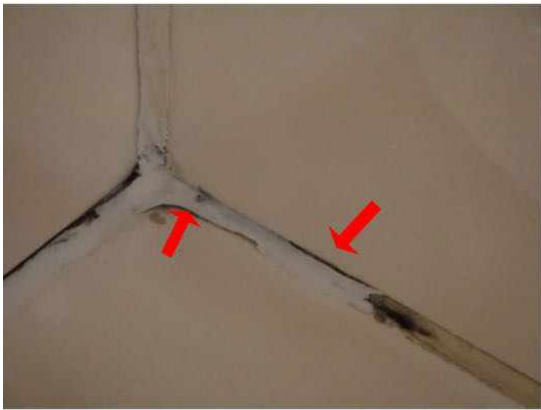
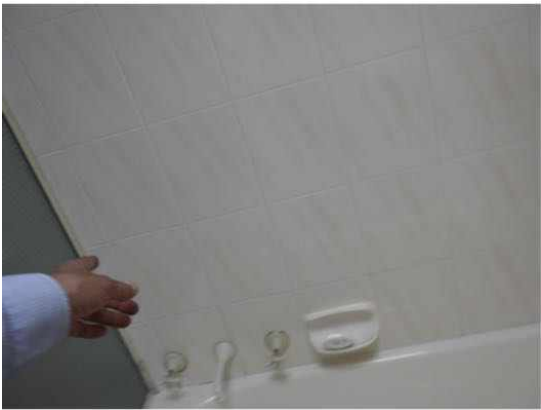
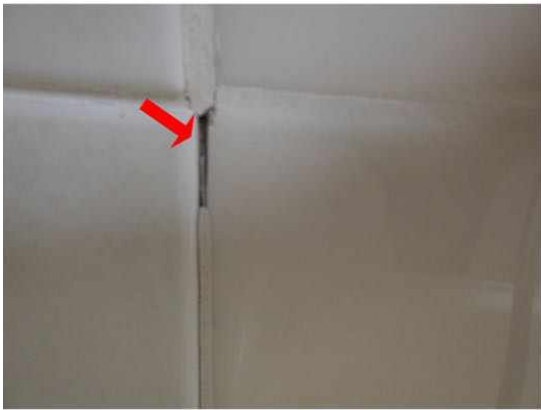
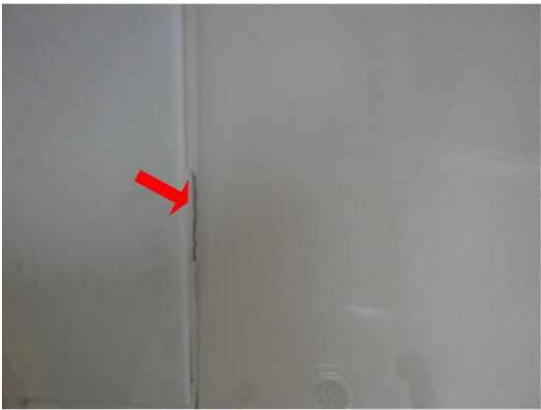
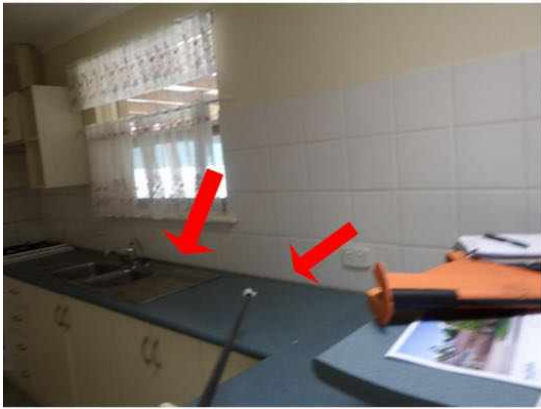
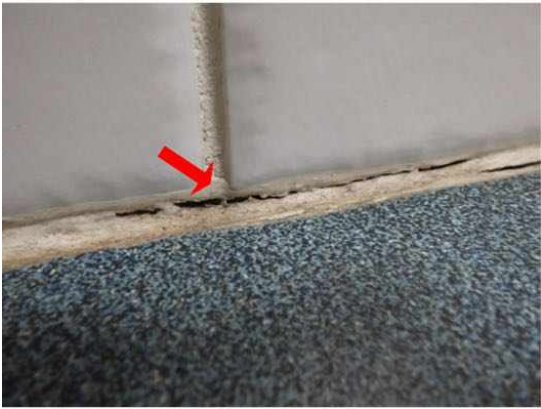
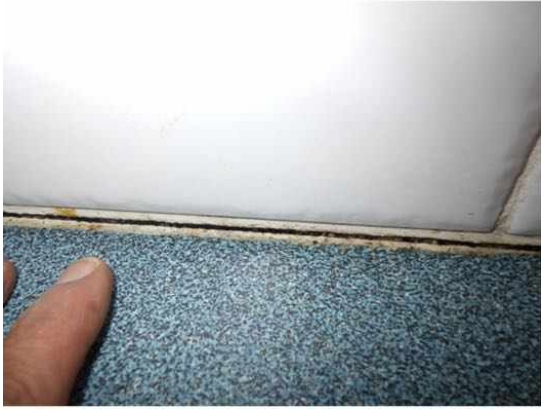
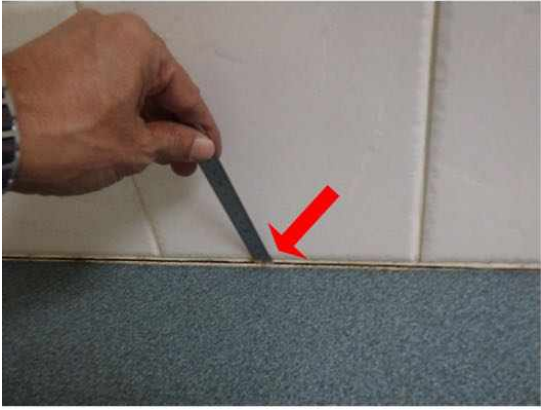
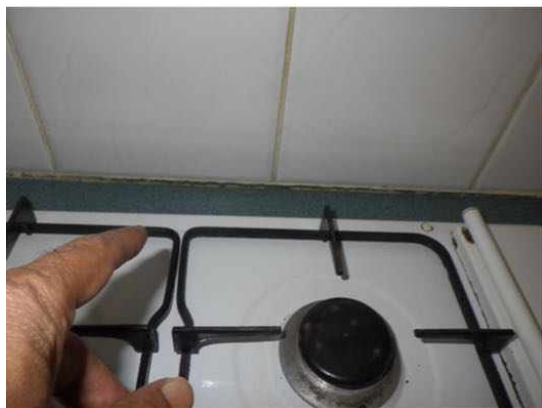
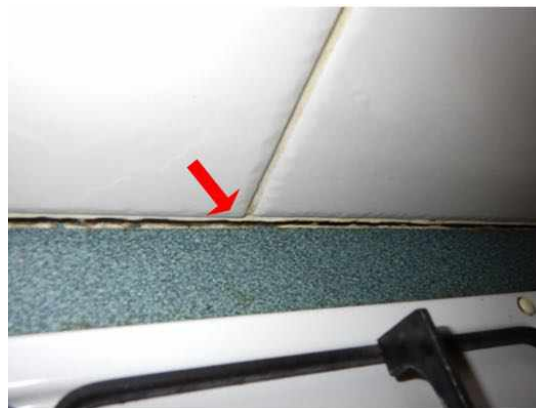
**Defects 3.07**

Building: Building 1  
Location: All Internal Areas  
Finding: Grout - Missing / Deteriorated  
Information: Grout is missing / deteriorating in this kitchen and bathtub area. Grout is used to protect gaps and crevices in building materials to ensure that they are water-tight and prevent water penetration to the associated structures.

Where grout is missing, a tiling contractor should be appointed immediately to apply grout and re-apply any silicone where necessary. Failure to do so is likely to lead to water damage to the surrounding area.

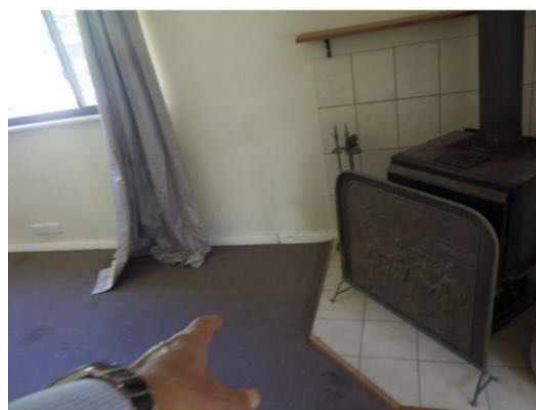
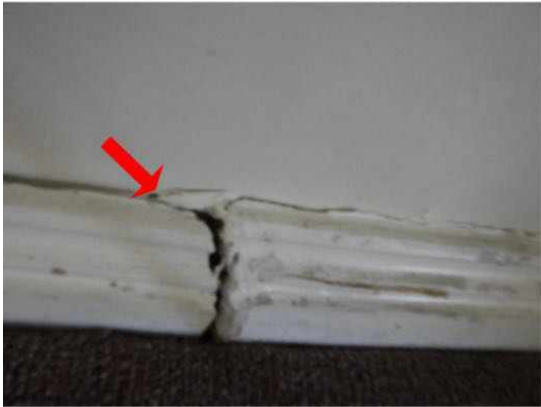
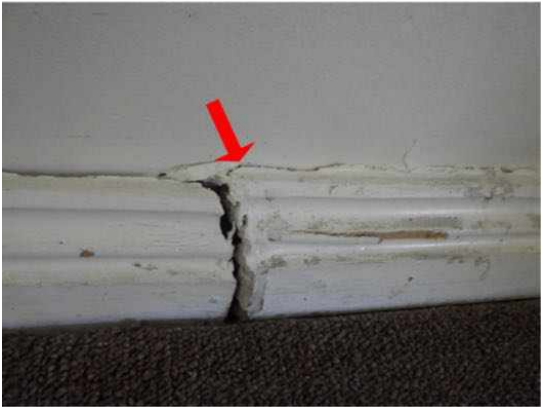
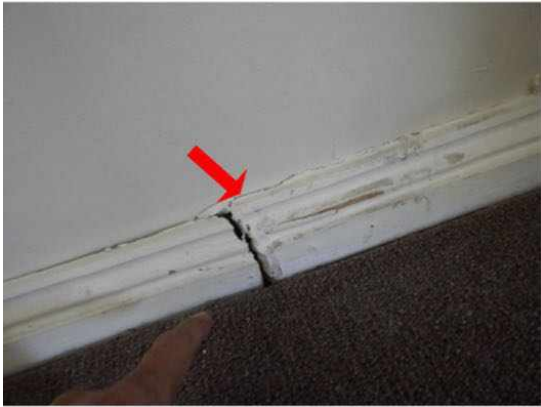
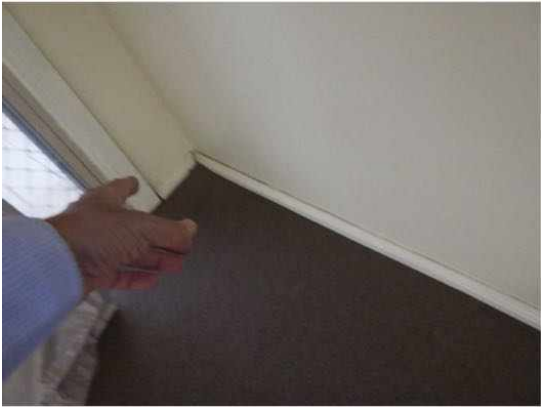
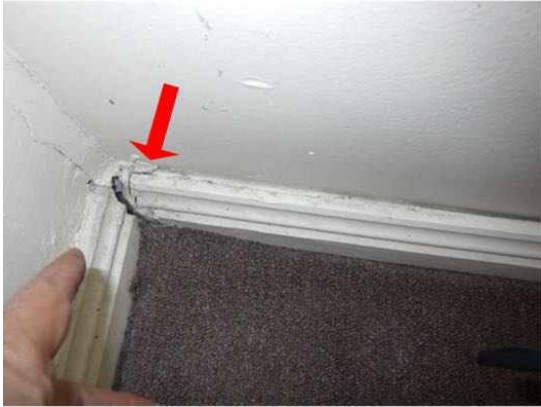
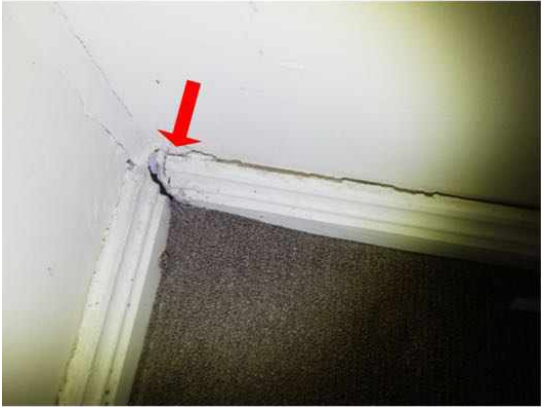
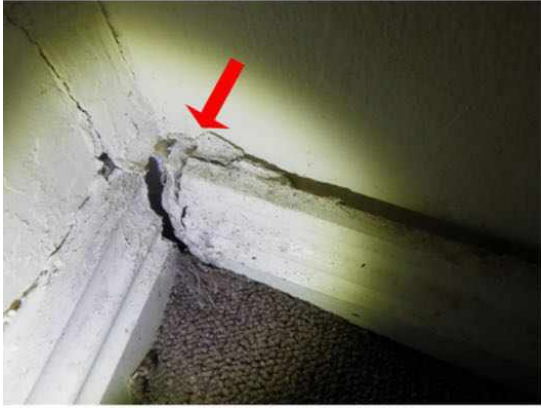
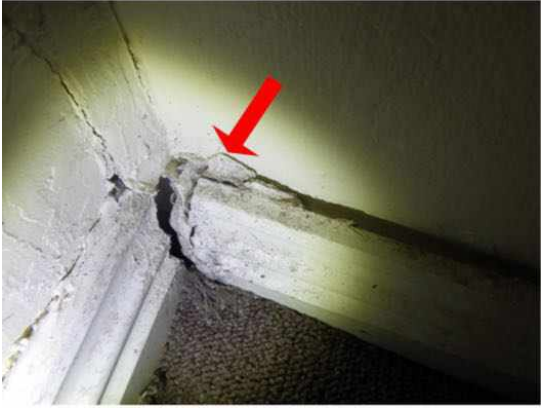
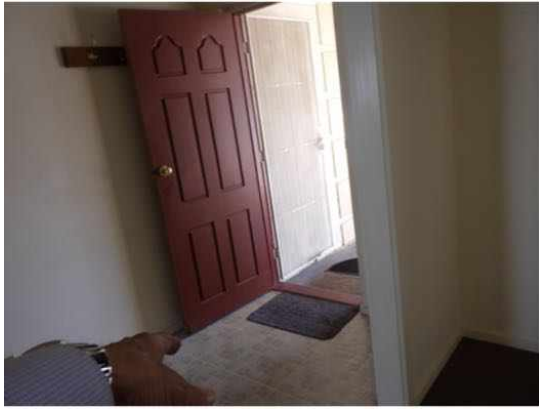
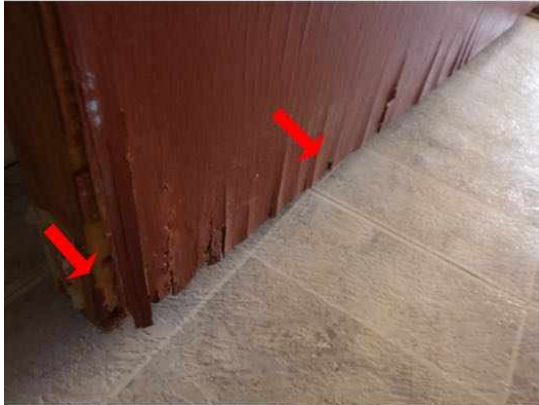
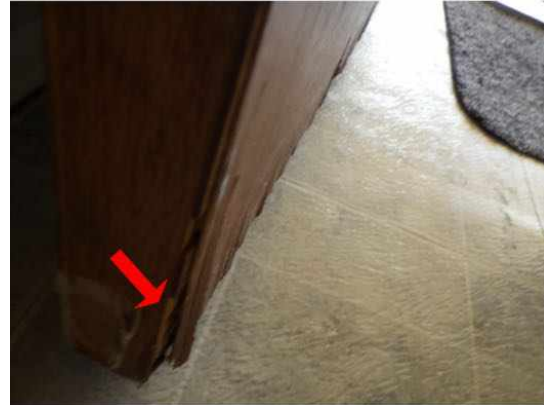
### Defects 3.08

Building:	Building 1
Location:	All Internal Areas
Finding:	Building element - Swollen
Information:	Swollen building elements generally indicate that the building materials have been affected by excessive moisture over a prolonged period of time, and have swollen as a result. The formation and development of mould/fungi or mildew is also a likely consequence of excessive moisture, which may pose major respiratory issues for occupants, particularly the elderly, the very young and those with existing illnesses and could be potential health safety hazards. In these cases an appropriately qualified inspector/tester should also be contacted for advice and/or technical assistance.

The structural integrity of swollen building elements can not be guaranteed, and further damage is likely to develop if left unmanaged. Excessive moisture is likely to lead to the development of secondary damage to any associated building elements, which may necessitate major reparation works if prolonged.

Rectification of the cause of the water leak should be addressed prior to any remedial works to the swollen building elements. A licensed plumber should be appointed immediately to identify the cause of the leak and provide advice on remedial works as necessary, Repair and/or replacement of swollen building elements should be conducted as a matter of urgency by a registered builder or qualified carpenter.

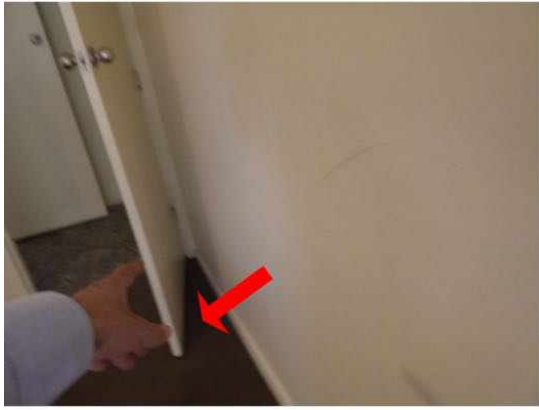
### Defects 3.09

Building:	Building 1
Location:	All Internal Areas
Finding:	Door stop - Missing
Information:	The door stop is missing or is inadequate to stop the door handle from damaging the wall. Although some building elements may seem irrelevant or unnecessary, all building elements play a key role in the operation and function of the overall structure and its performance.

Re-installation or replacement of the door stop is advised as soon as possible to prevent any subsequent damage to the door or associated structures. A general handyman may be appointed to perform these works at client discretion.

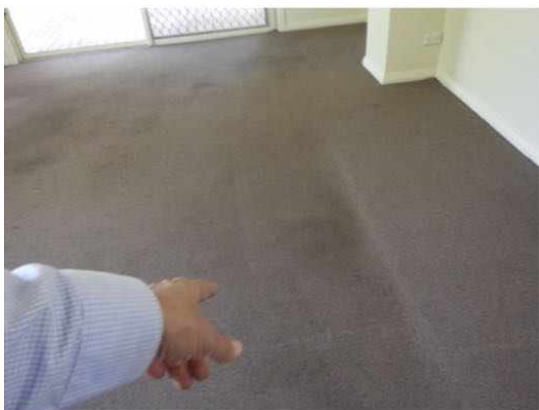
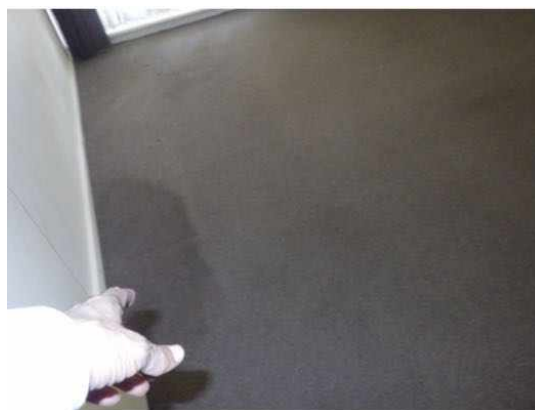
### Defects 3.10

Building:	Building 1
Location:	All Internal Areas
Finding:	Carpet - Deteriorated
Information:	Sections of the carpet floor covering in this area appeared to be mouldy. It is suspected that the presence of excessive moisture, possibly due to an internal water leak, has created an environment conducive to mould/fungi growth.

Mould presents as a health hazard and may create potential for respiratory difficulties.

Prior to any remedial works being completed, it is essential that a licensed plumber further inspect the area and identify the cause of the excessive moisture, as well as identifying any underlying issues that may be associated.

Replacement of the affected carpet is required as a matter of urgency to ensure the safety of the area. Where required, remedial works should be undertaken to any associated walls and flooring showing evidence of mould.

Where mould is excessive, further inspection by an Environmental Health inspector is advisable.

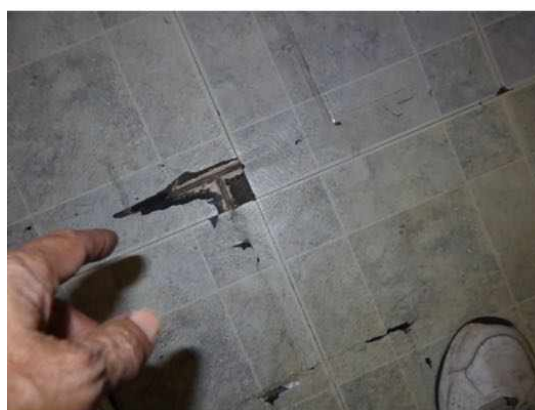
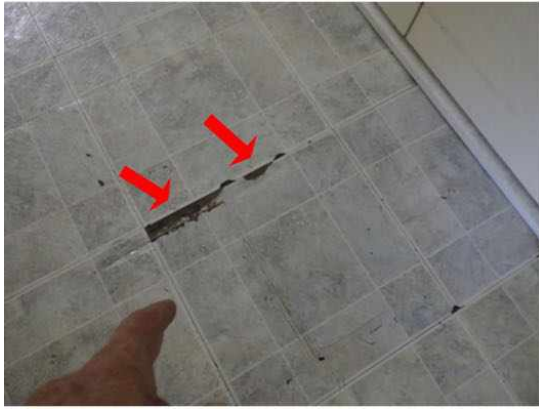
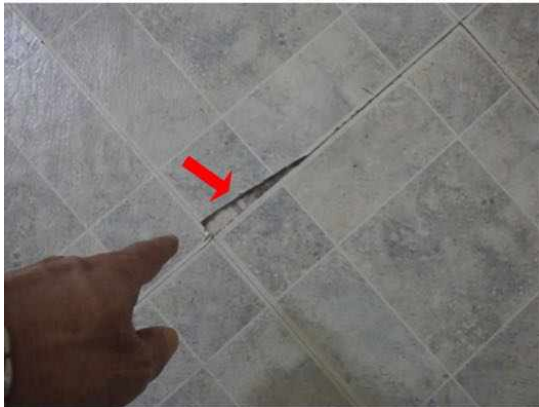
### Defects 3.11

Building:	Building 1
Location:	All Internal Areas
Finding:	Flooring - Damaged
Information:	At the time of inspection it was noticed that few sections of flooring was damaged / deteriorated around the property .

Breakage occurs generally when the building materials have either aged and decayed, or as a result of damage (accidental or deliberate).

Repair and/or replacement of broken elements is advised to ensure that additional secondary defects do not arise as a consequence. Such works are necessary, as all building elements play a key role in the operation and function of the overall structure and its performance.

A relevant tradesperson should be appointed to repair or replace the affected building element prior to any subsequent damage being caused.

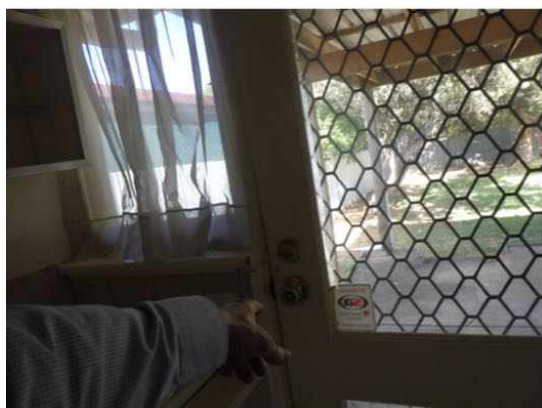
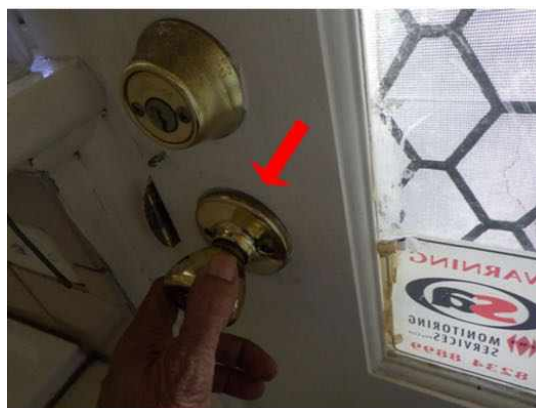
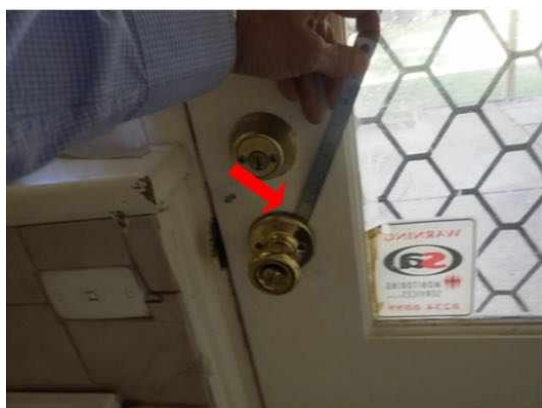
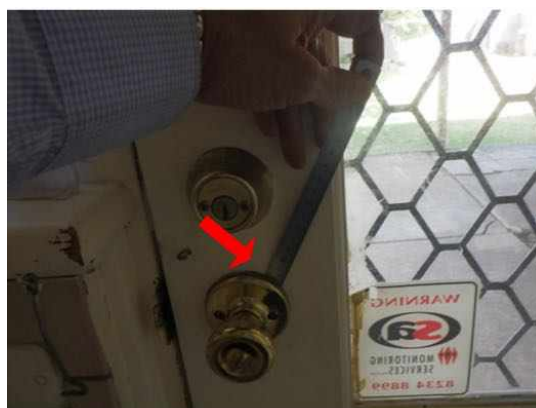
### Defects 3.12

Building:	Building 1
Location:	All Internal Areas
Finding:	Door - Broken handle/ Loose from its original fixing
Information:	The door handle in this laundry area was found to be broken/ loose from its original fixing at the time of inspection. Breakage occurs generally when the building materials have aged and decayed, but may be indicative of impact damage (accidental or deliberate).

Repair and/or replacement of the broken door handle is advised to improve the operational state of the associated door.

A qualified carpenter or general handyman should be appointed to repair/replace the door handle at the client's discretion.

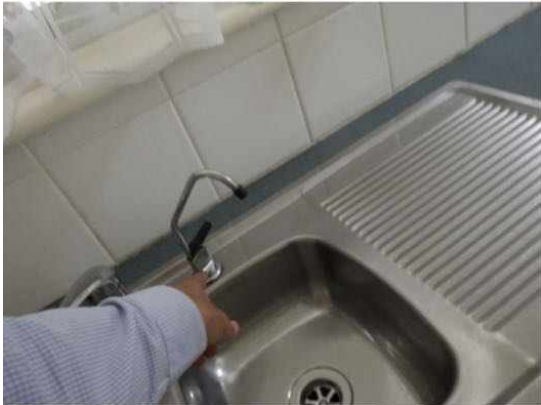
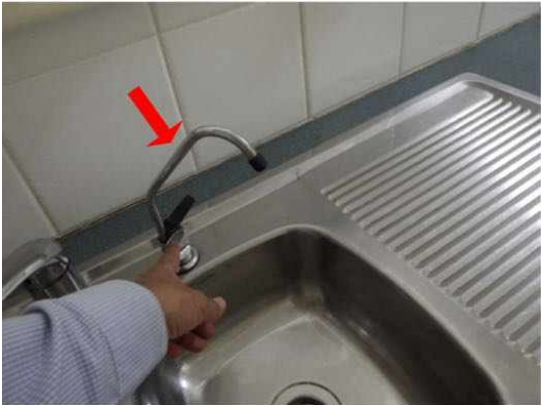
### Defects 3.13

Building:	Building 1
Location:	Kitchen
Finding:	Pura tap - Not operating
Information:	At the time of inspection it was noticed that pura tap was not operational in this kitchen area.

Non-operational items should be addressed to ensure that the full function of the building structure is available. Where some building elements are not operating as intended, it is possible that secondary building defects could arise due to their non-operation.

Repair and/or replacement of the faulty building element is recommended. It is highly recommended that the relevant tradesperson be engaged to perform any necessary works.

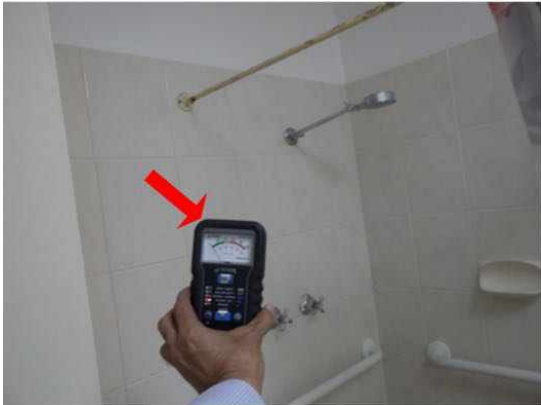
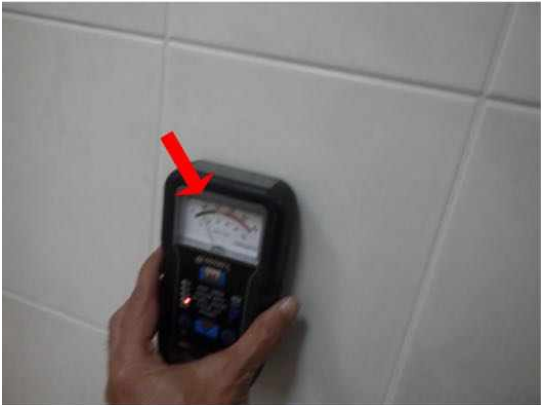
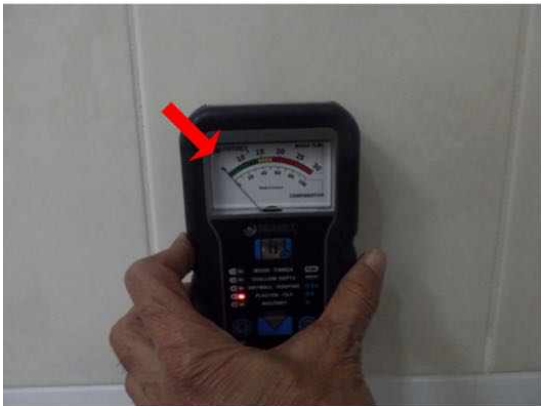
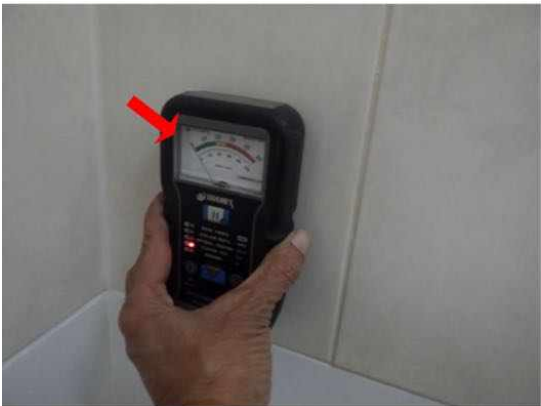
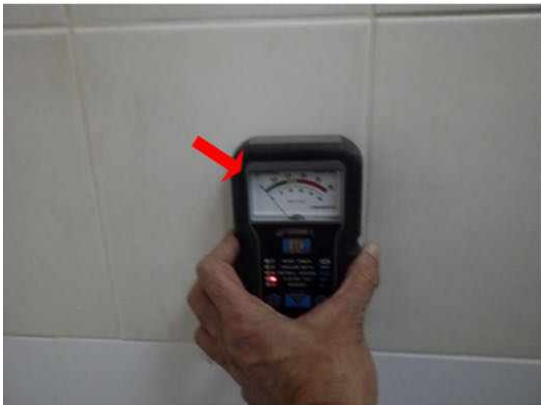
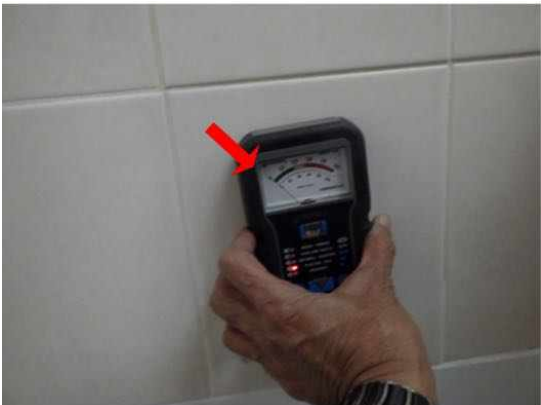
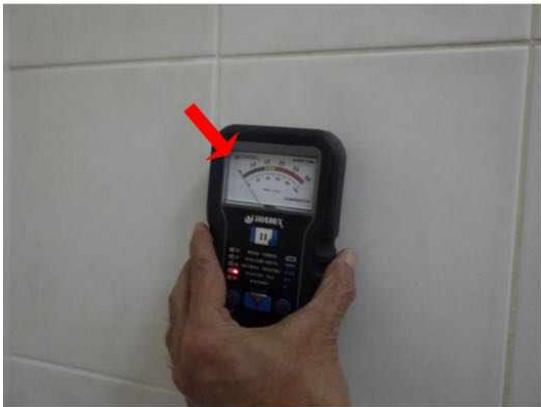
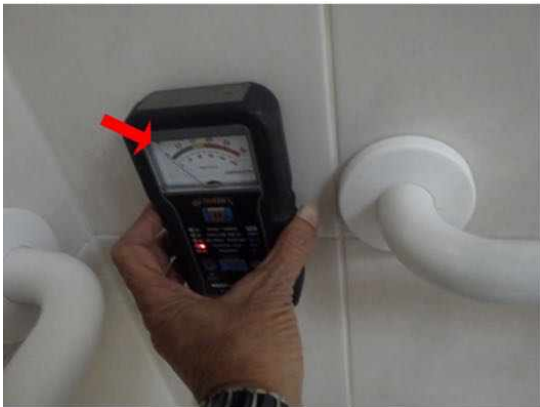
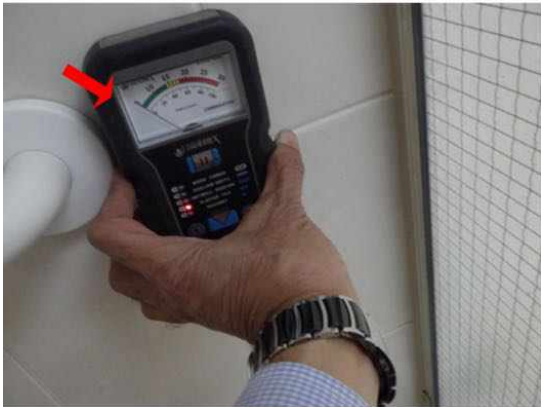
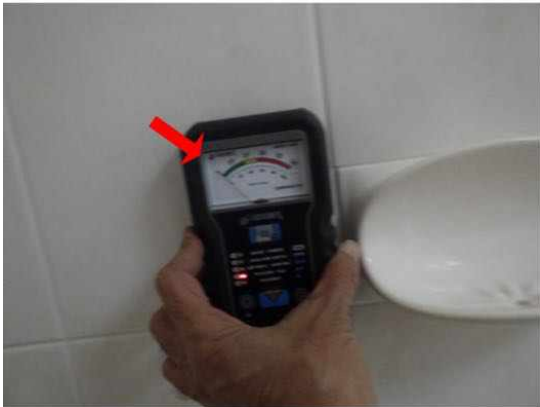
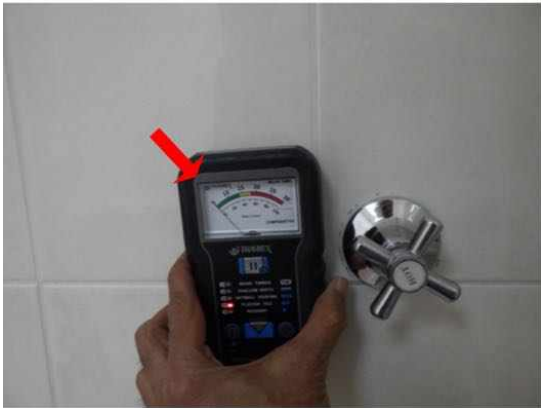
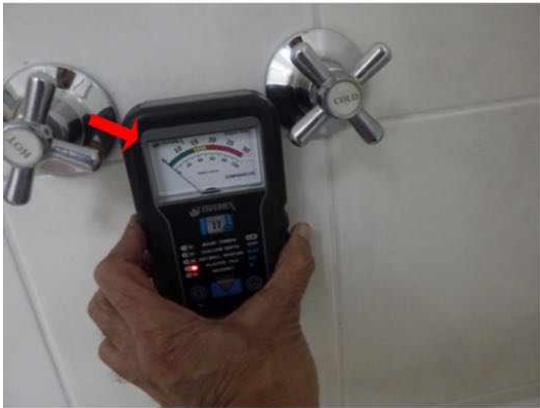
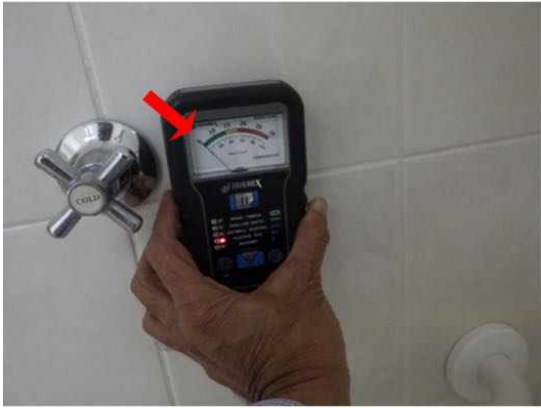
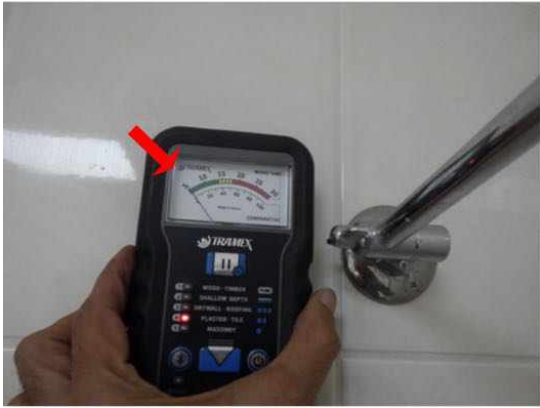
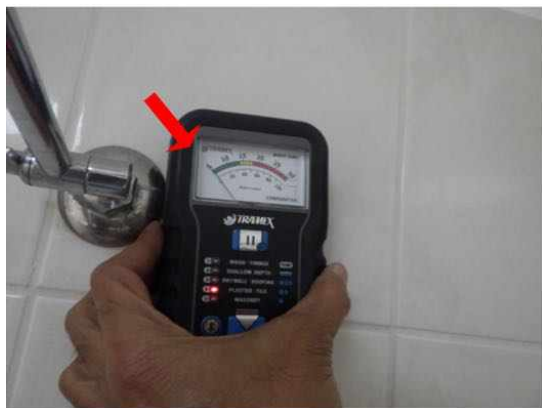
Damp (or structural damp) refers to the presence of unwanted moisture in the structure of a building, either as the result of intrusion from outside, or condensation

from within the structure. In the shower area, internal water leaks or other sources of excessive moisture are generally the cause of damp.

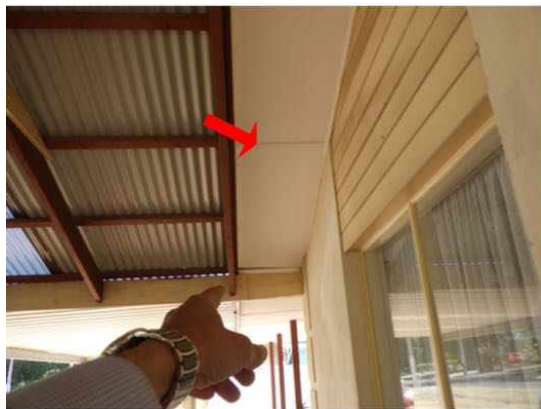
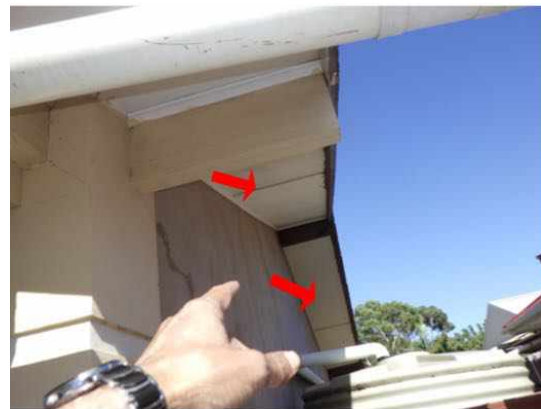
Building: Building 1  
 Location: All Areas  
 Finding: Asbestos - Suspected ACM Identified on Site  
 Information: Reporting on Asbestos is outside the Scope of this Report. This suspected defect is highlighted as a caution only. We suspect, based on our experience in the building industry, that there is a higher risk of the identified building element containing asbestos.

As Asbestos Reporting is outside the scope of this report, we advise that you consider a separate Asbestos Inspection and Condition Audit, which can include the taking of samples for definitive confirmation of the presence of Asbestos.

In the interim, the client is advised to act with caution, especially when considering any damage to building materials general wear and tear renovations extensions demolition and general maintenance activities due to the suspected presence of Asbestos.

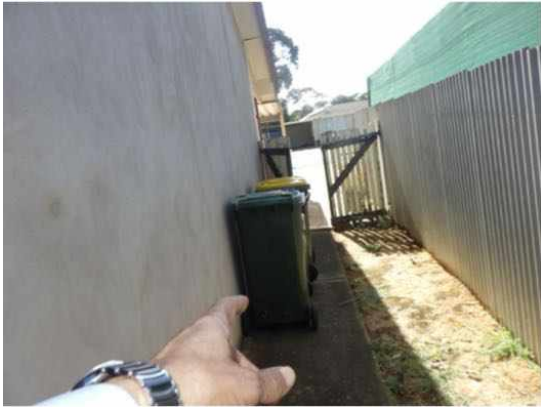
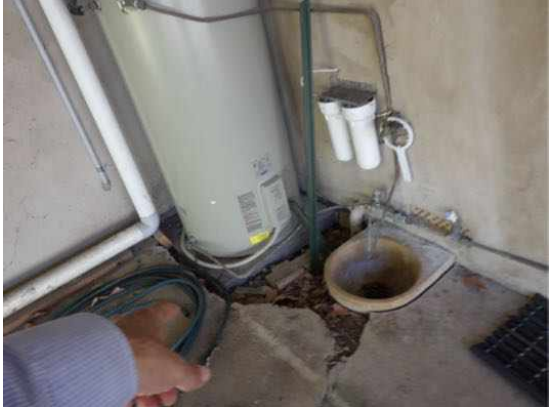
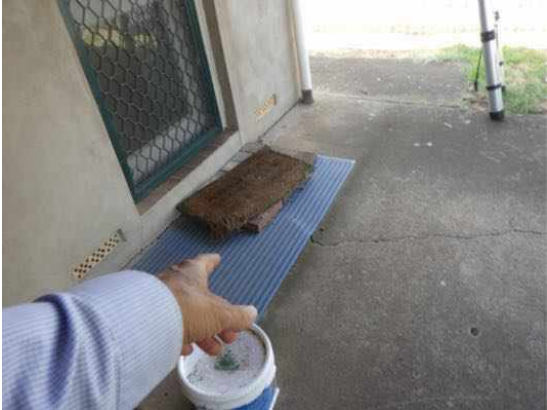
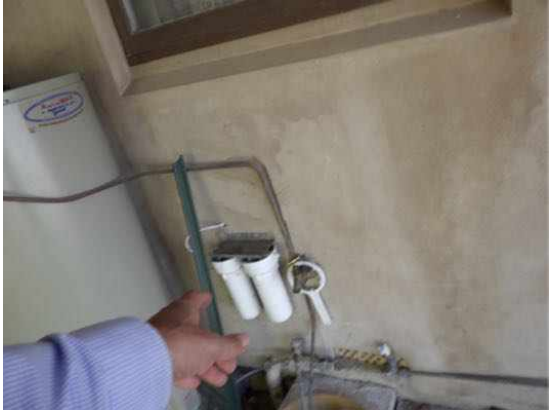
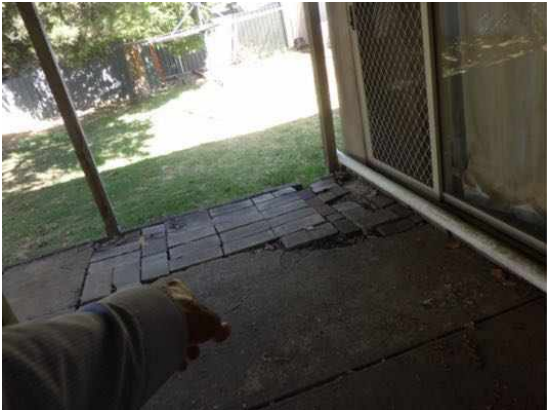
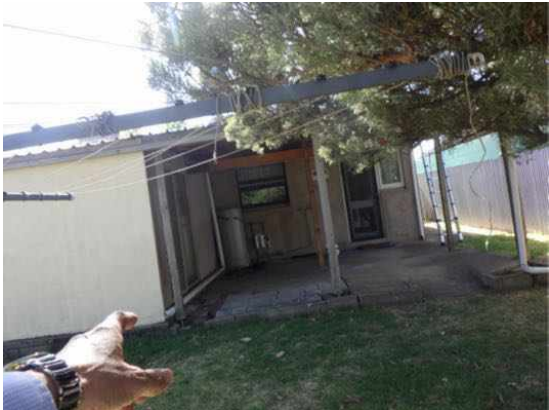
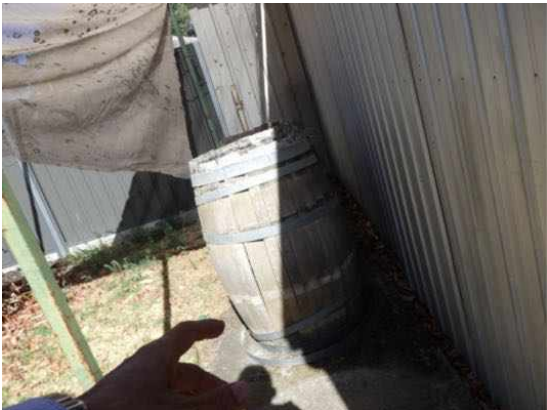
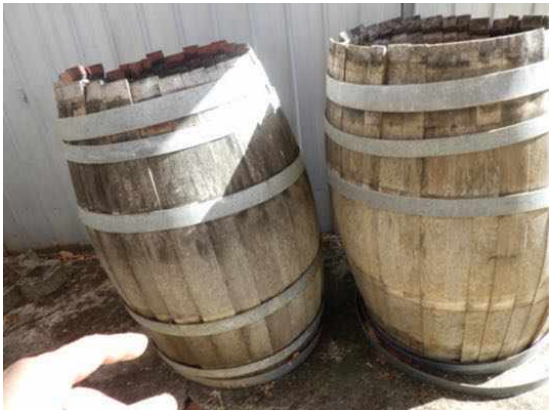
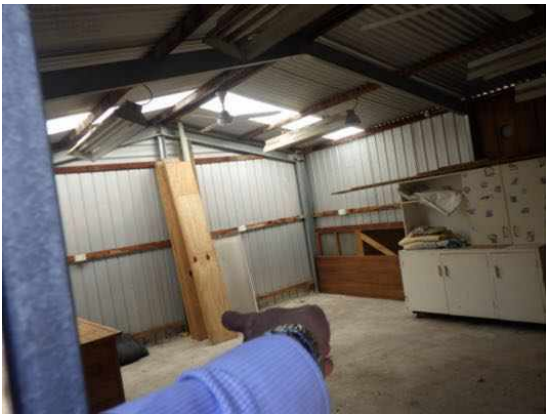
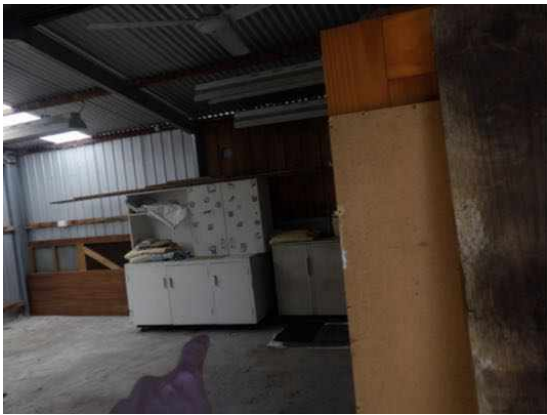
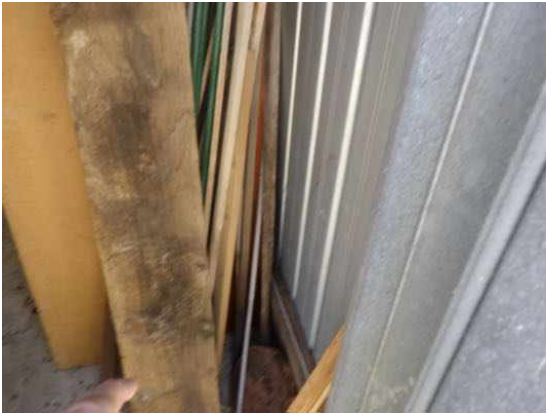
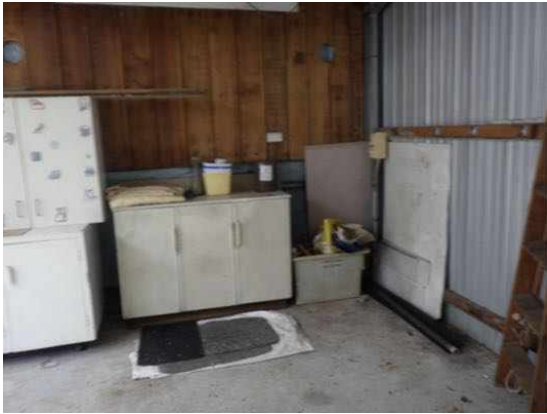
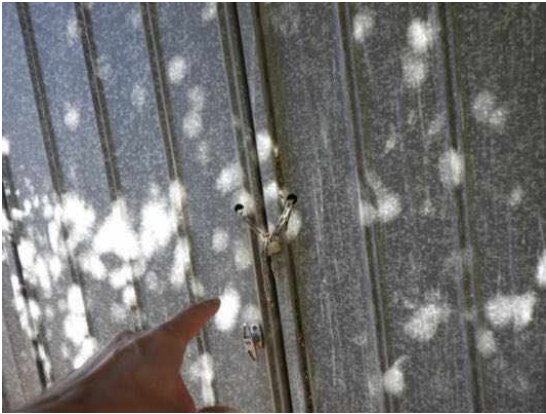
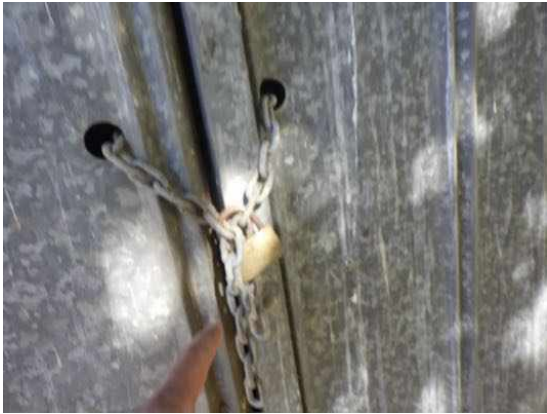
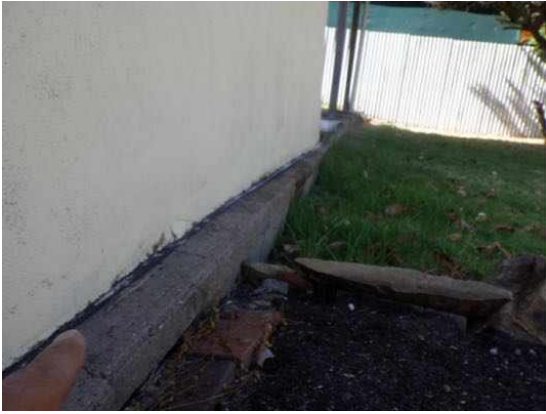
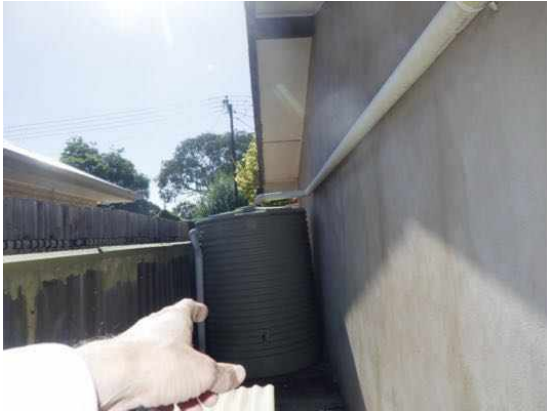
Building: Building 1  
 Location: All Areas  
 Finding: Additional Photos - Obstructions and Limitations  
 Information: These photographs are an indication of the obstructions and limitations which impeded full inspection of the property at the time of inspection. These obstructions can hide an array of defects and should be removed to allow full inspection to be carried out. A re-inspection is recommended once the areas are made accessible.
