## Building Inspection Report

Inspection Date: Mon, 23 Feb 2026

Property Address: 35 Prince Charles St, Morphett Vale SA  
5162, Australia

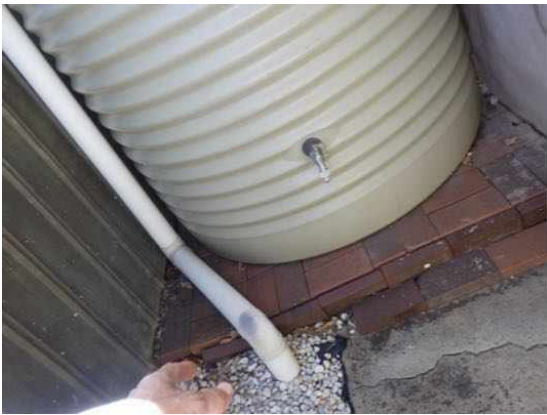
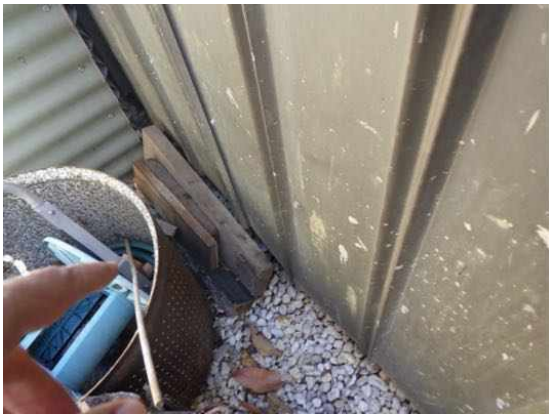
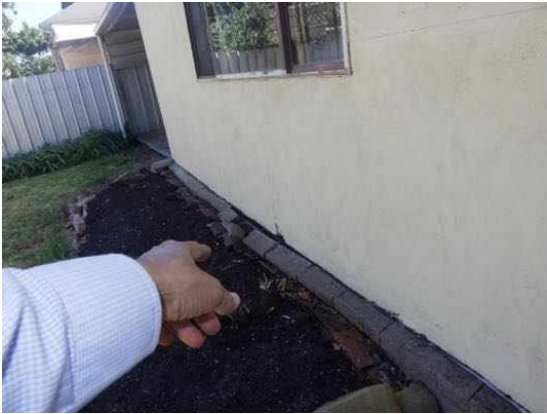
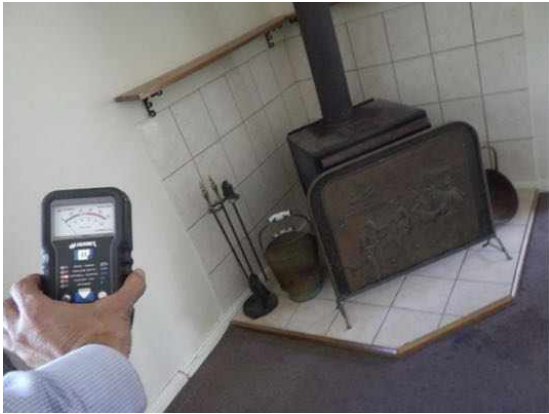
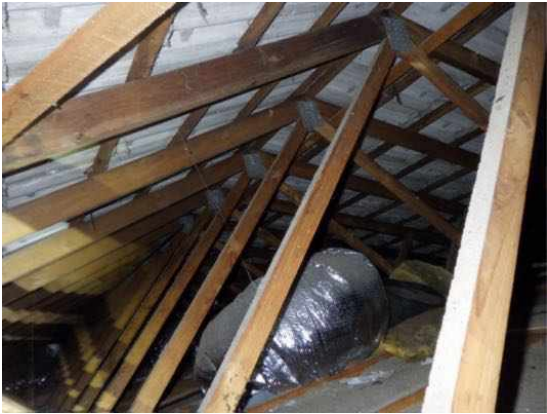
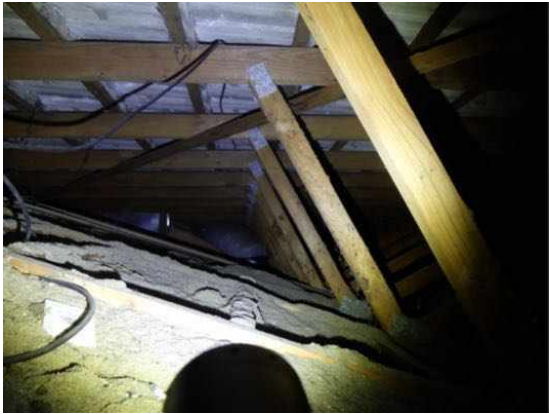
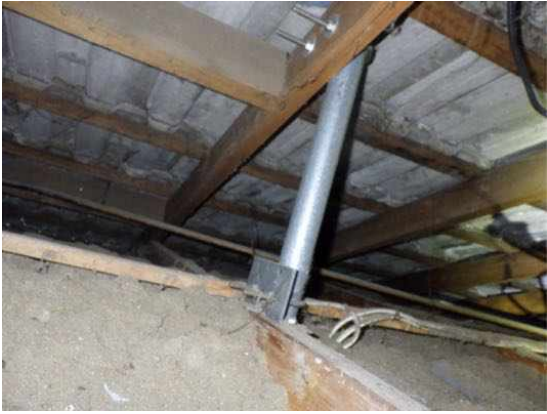
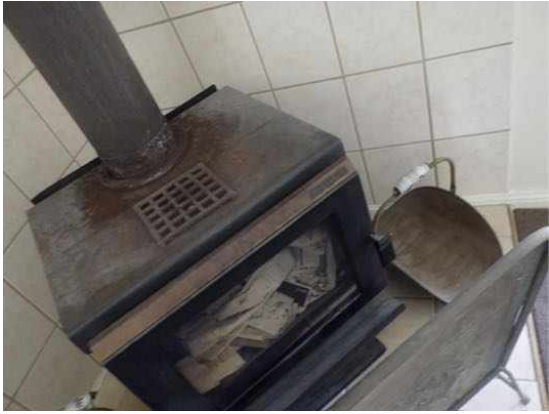
Building: Building 1  
 Location: All Areas  
 Finding: Additional Photos - Obstructions and Limitations  
 Information: These photographs are an indication of the obstructions and limitations which impeded full inspection of the property at the time of inspection. These obstructions can hide an array of defects and should be removed to allow full inspection to be carried out. A re-inspection is recommended once the areas are made accessible.
