Building and Timber Pest Inspection Report

Inspection Date: Mon, 16 Mar 2026

Property Address: 614/2 Studio Dr, Eastgardens NSW 2036,
Australia

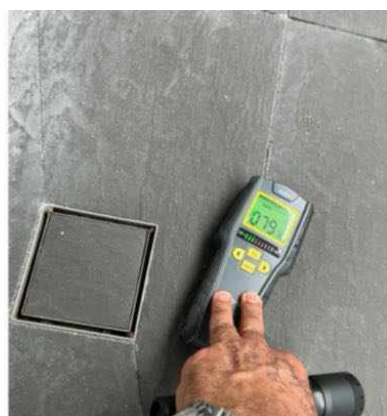
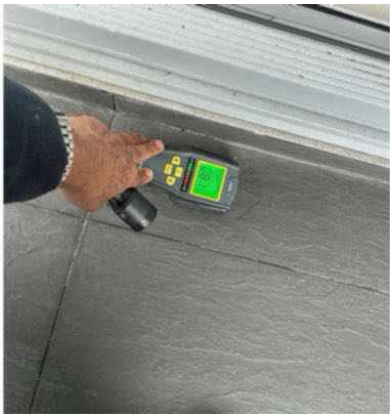
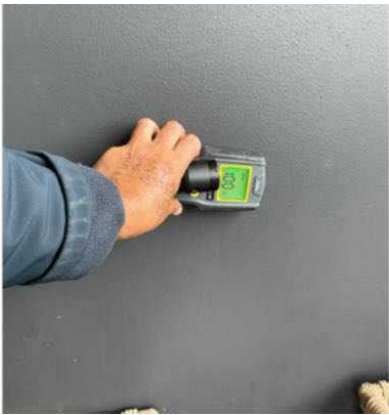
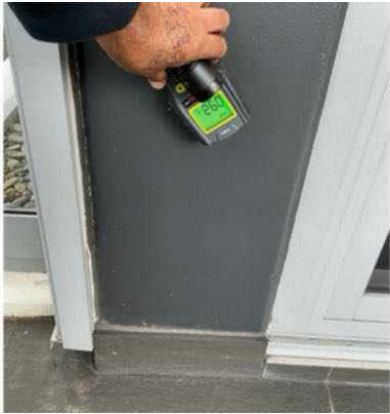
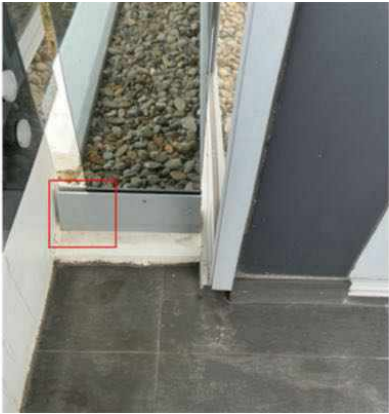
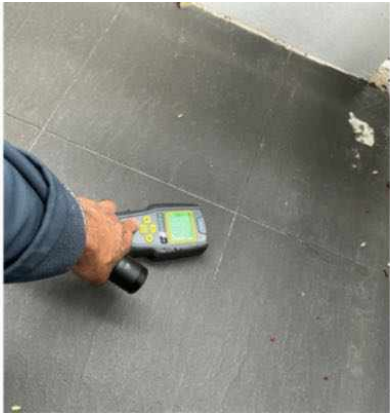
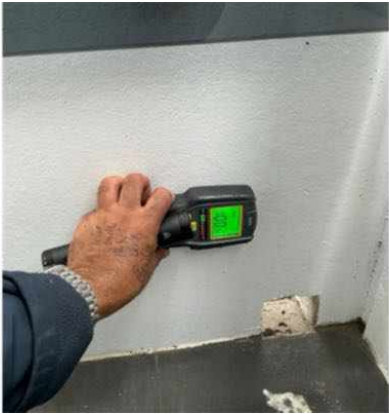
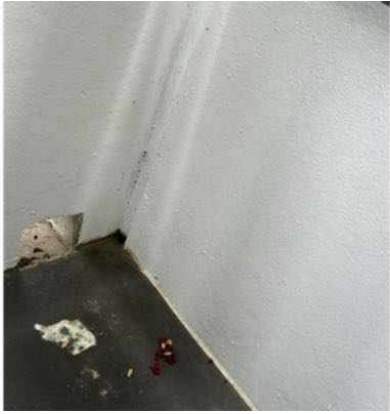
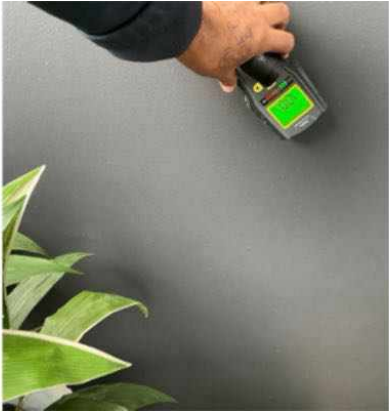
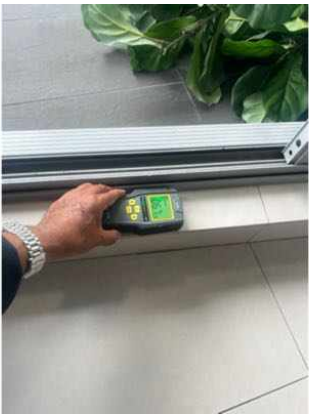
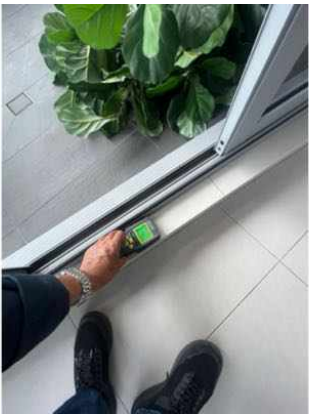
Building: Main Building
Location: Balcony bedroom , Lounge Balcony
Finding: Balcony Elevated Moisture - Strata - Further investigation recommended
Information: Elevated moisture was recorded at the base of the balcony wall and tiles, with associated staining consistent with water exposure including deteriorated grout and efflorescence . While no internal damage was visible at the time of inspection, balconies in multi-unit dwellings are high-risk areas for waterproofing failure, which can lead to leaks into adjoining units and significant rectification costs. Further investigation by a licensed waterproofing contractor is strongly recommended.

Depending on the strata plan, this area may form part of the common property, in which case remedial responsibility may rest with the owners corporation (strata). Purchasers should seek clarification from the strata manager and legal adviser prior to purchase.

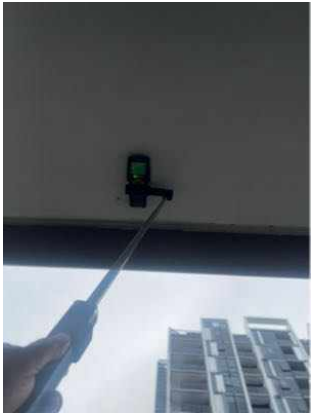
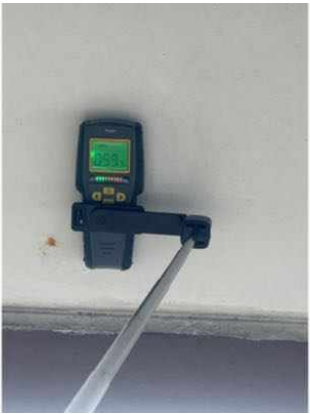
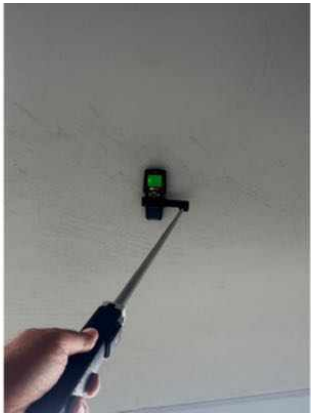
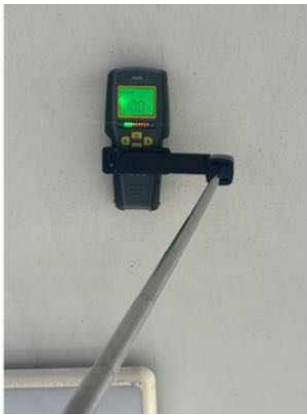
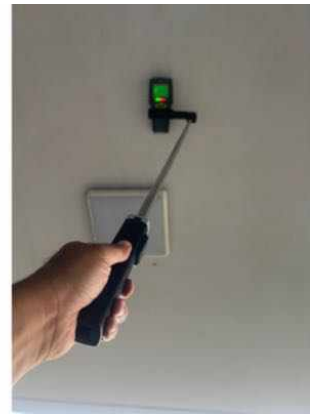
Finding 3.02

Building: Main Building
Location: Balcony x 2
Finding: Rust Staining & Elevated moisture - Requires further investigation
Information: Elevated moisture , minor staining and marks appearing consistent with possible screw penetrations with rust staining through paint was noted at the time of inspection. No symptoms of concrete spalling was observed. Recommend the Owners Corporation engage a painter or remedial contractor to seal any exposed steel and apply an appropriate external-grade coating during routine maintenance.

Further investigation by a remedial engineer or licensed waterproofing contractor is recommended to understand cause of elevated moisture.

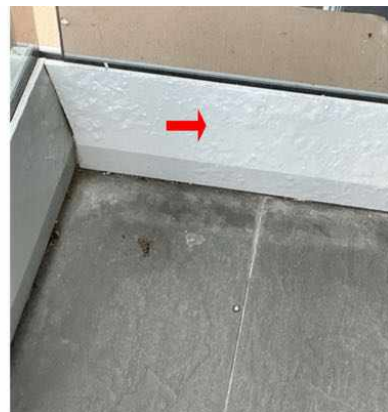
Finding 3.03

Building:	Main Building
Location:	Balcony
Finding:	Painted surface - Bubbling and possible rusting
Information:	Sections of paint in this area was found to have bubbled and deteriorated. Paint bubbling is generally an indication of excessive moisture in the area, that is currently hidden by the painted surface.

The presence of excessive moisture can have major implications on associated building elements if left unattended. While only seemingly minor at this stage, the damage cannot be determined due to the paint obstructing any further inspection of the damage.

It is highly advised that the affected paint be cleaned to allow a further, more invasive inspection by a licensed plumber. Failure to act on this defect may necessitate major works in the future.

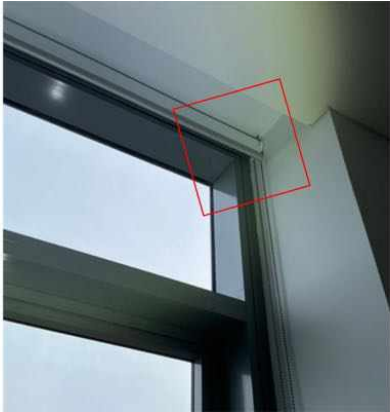
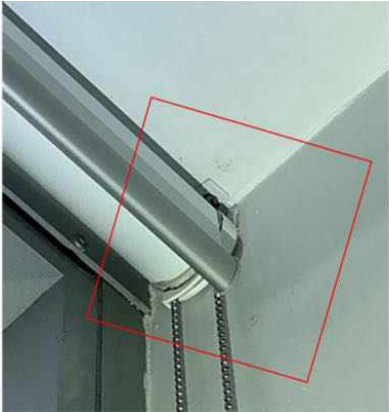
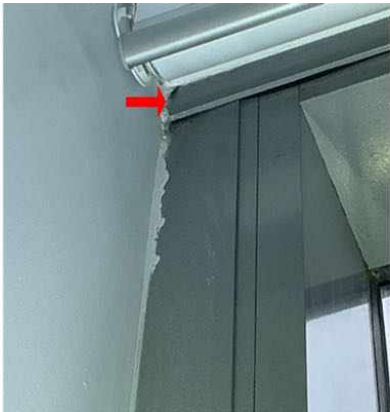
Finding 3.04

Building: Main Building
Location: Kitchen
Finding: Minor Mould Growth – Window
Information: Minor mould growth was observed to the internal window. The extent appears localised and superficial, commonly associated with condensation and limited ventilation rather than active water ingress. No evidence of material deterioration or structural impact was observed at the time of inspection. This condition is classified as a minor defect. Cleaning with an appropriate mould treatment and improving ventilation are recommended to reduce recurrence. It is also recommended for a strata appointed contractor to inspect the window seals for damage or deterioration.

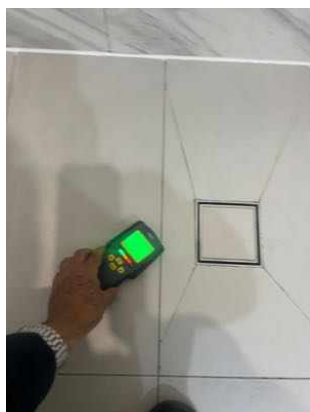
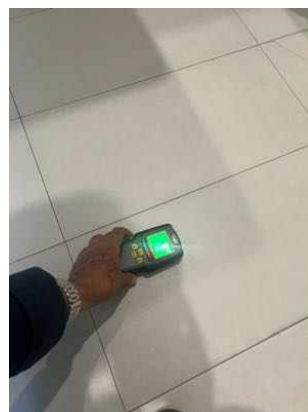
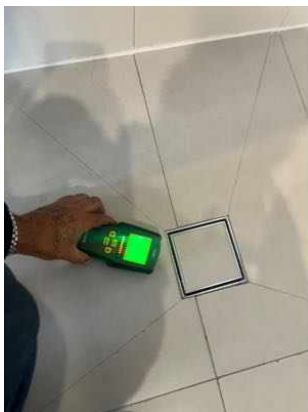
Finding 3.05

Building:	Main Building
Location:	Bathrooms, Laundry
Finding:	Elevated Moisture Bathroom (No visible deterioration noted)
Information:	Elevated moisture levels were detected to tiled surfaces in bathroom/shower areas. Persistent moisture ingress can lead to concealed damage, including timber rot and mould growth.

Elevated moisture readings in tiled wet areas can occur from normal shower use, age/deterioration of waterproofing membranes, plumbing leaks or moisture absorption through grout lines. While no damage was visible, elevated readings may indicate moisture retention behind tiles, which can be a conducive condition for future deterioration if not monitored.

Monitor the area over time for signs of drumming, efflorescence, tile movement, or grout deterioration. A licensed waterproofing specialist can perform further investigation (e.g., pressure testing, membrane assessment) to understand the cause of elevated moisture.

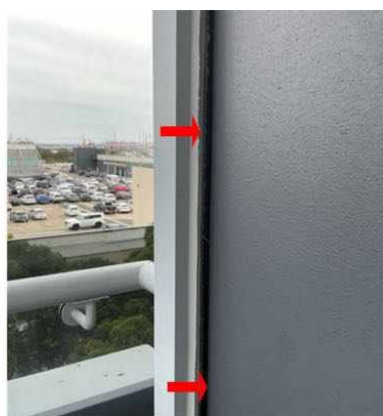
Finding 3.06

Building:	Main Building
Location:	Balcony
Finding:	Building element - Damaged - Gap between window and wall possible moisture ingress
Information:	Breakage occurs generally when the building materials have either aged and decayed, or as a result of damage (accidental or deliberate).

Repair and/or replacement of broken elements is advised to ensure that additional secondary defects do not arise as a consequence. Such works are necessary, as all building elements play a key role in the operation and function of the overall structure and its performance.

A relevant tradesperson should be appointed to repair or replace the affected building element prior to any subsequent damage being caused.

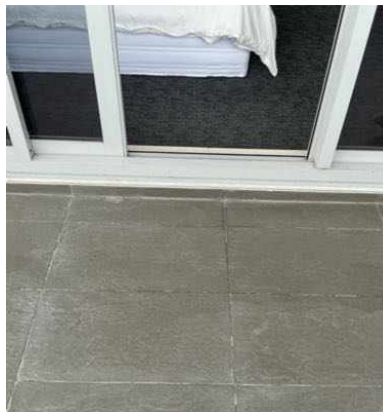
Finding 3.07

Building:	Main Building
Location:	Balcony bedroom & Lounge
Finding:	Balcony Floor Level Differential
Information:	The balcony finished surface appears to be close to, or at the same level as, the

internal floor. Standard construction practice requires a step-down of approximately 50 mm unless a fully engineered threshold drainage system is provided. No such drainage features were visible during inspection. This configuration increases the risk of water ingress, and confirmation of the balcony waterproofing detail through strata/building management is recommended.

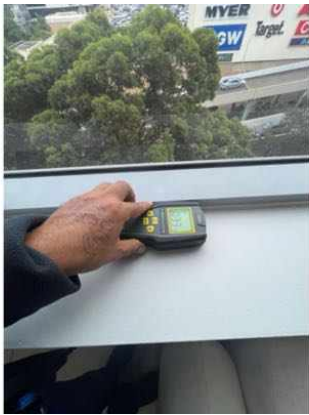
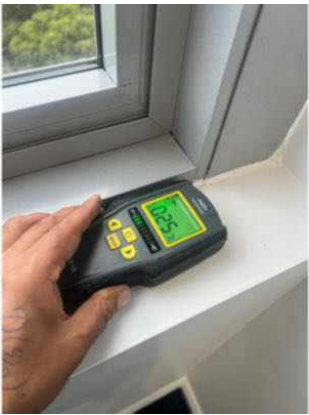
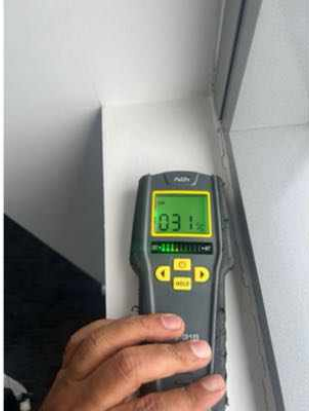
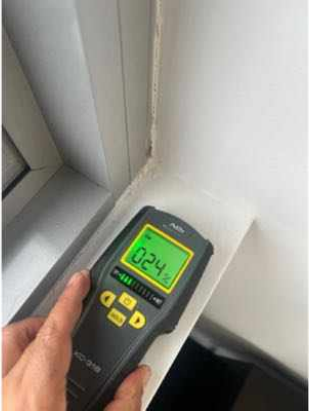
Finding 3.08

Building:	Main Building
Location:	All Internal Areas
Finding:	Elevated Moisture – Further Investigation Recommended - window sills
Information:	Elevated moisture readings were detected in window sill, with some areas also showing signs of dampness while others did not present visible surface issues, although no significant structural damage was evident at the time of inspection, dampness can contribute to deterioration if left unaddressed. Inspector was not able to inspect the external wall or window detailing. A further investigation by a licensed plumber or waterproofing specialist is recommended to confirm the source and ensure no concealed issues are developing.

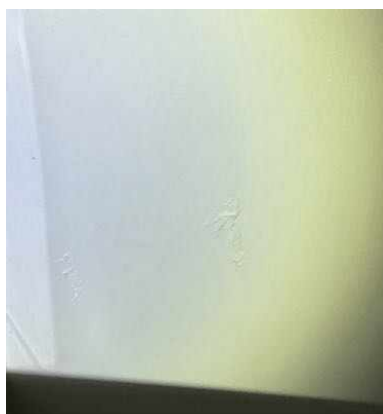
Building:	Main Building
Location:	Ensuite
Finding:	Painted surface - Bubbling
Information:	Sections of paint in this area was found to have bubbled and deteriorated. Paint bubbling is generally an indication of excessive moisture in the area, that is currently hidden by the painted surface.

Paint bubbling typically occurs due to poor adhesion, inadequate surface preparation, or minor humidity exposure during painting. No visible signs of moisture ingress or structural movement were observed at the time of inspection.

The presence of excessive moisture can have major implications on associated building elements if left unattended. While only seemingly minor at this stage, the damage cannot be determined due to the paint obstructing any further inspection of the damage.

It is highly advised that the affected paint be cleaned to allow a further, more invasive inspection by a licensed plumber. Failure to act on this defect may necessitate major works in the future.

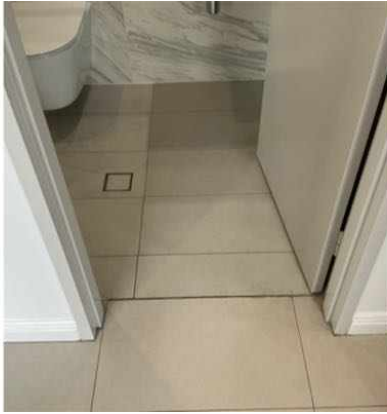
Finding 3.11

Building:	Main Building
Location:	Bathroom
Finding:	Bathroom & external floor threshold
Information:	The bathroom floor is at the same level as the adjoining timber flooring. This configuration is typical in modern apartments and is permitted where compliant waterproofing and floor falls are provided. No evidence of moisture damage was observed at the time of inspection; however, waterproofing performance cannot be confirmed without invasive inspection.

Care should be taken to avoid excessive water migration beyond the bathroom during

use.

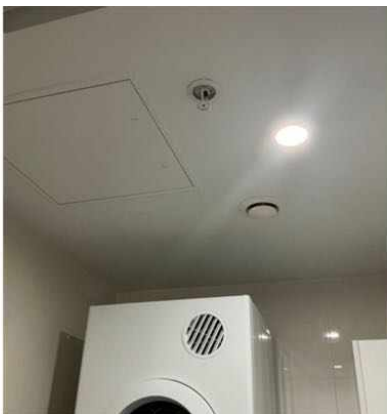
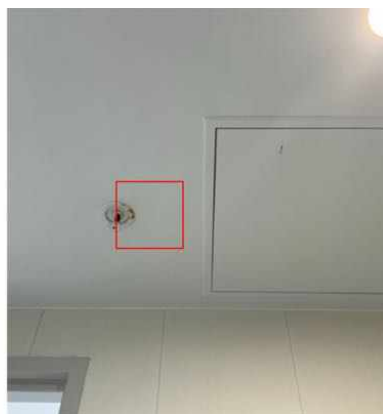
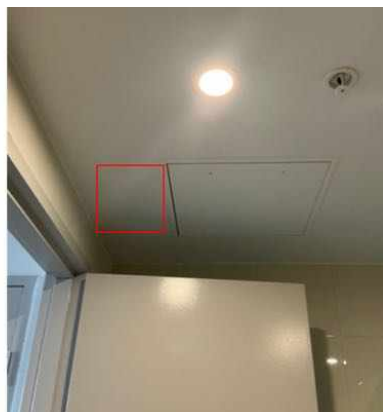
Finding 3.12

Building:	Main Building
Location:	Laundry ,bathroom, ensuite ,
Finding:	Water Staining - Humidity or Ventilation
Information:	The ceiling surface shows peeling paint and water staining on the walls faint commonly consistent with humidity-related staining, often found in bathroom or wet areas with insufficient ventilation. While there is no visible sagging or major water damage, the pattern suggests prolonged moisture exposure, possibly due to steam accumulation or minor condensation issues. According to AS 4349.1–2007 (Appendix C), this would be classified as a minor defect unless further deterioration or active leaks are found. Recommend improving mechanical or natural ventilation, cleaning the surface with mould treatment, and monitoring for recurrence.

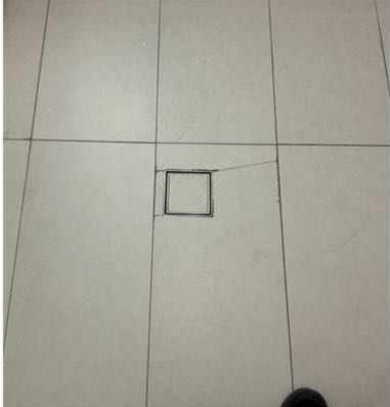
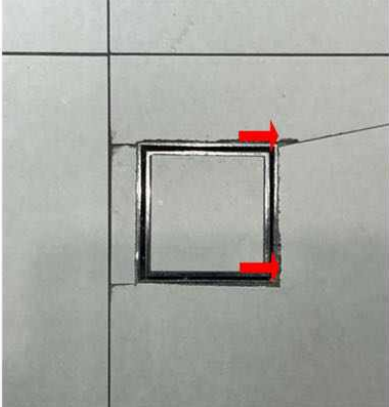
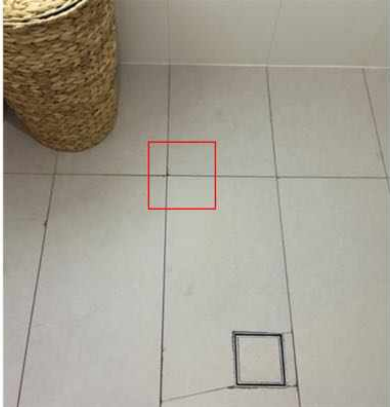
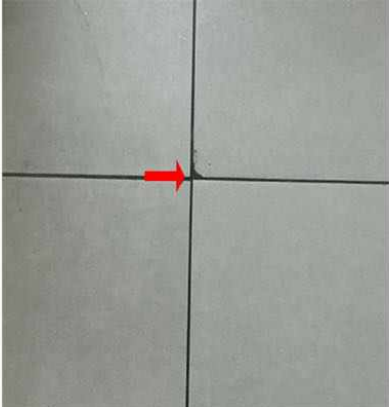
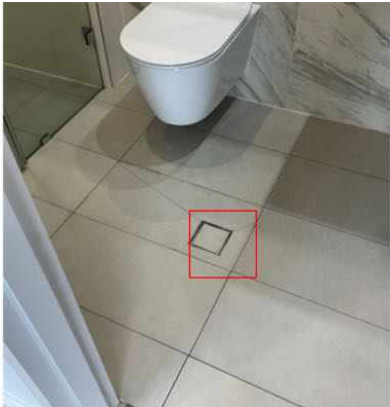
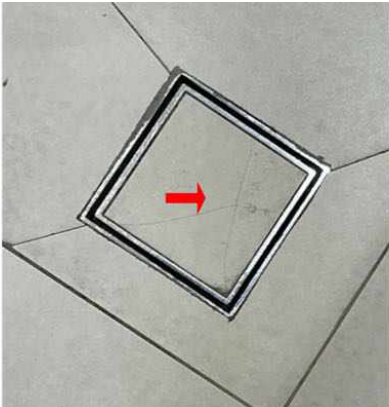
Building: Main Building
 Location: All Internal Areas - Laundry, bathroom ,ensuite, balcony front
 Finding: Tiles - Cracked or damaged
 Information: Cracking was evident to the tiling in this area at the time of inspection. While the cracking appears to be minor, this area is frequently exposed to water, allowing potential for water penetration into adjoining sections of walls or flooring.

If left unmanaged, water penetration to these areas may lead to subsequent water damage, which is likely necessitate repair work to affected building elements.

A tiling contractor should be appointed to ensure that no further water damage

occurs. The re-application of silicone and grouting throughout remaining tile work is also advised, to further protect the area against water penetration.

Where water penetration has led to water damage, appointment of a relevant tradesperson may be required to repair damaged building elements.

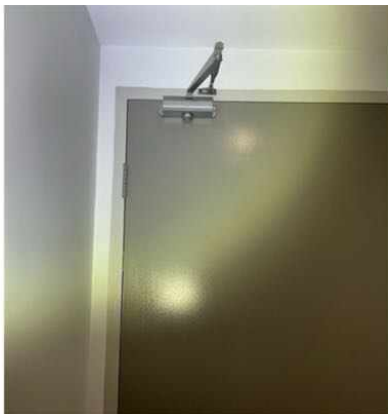
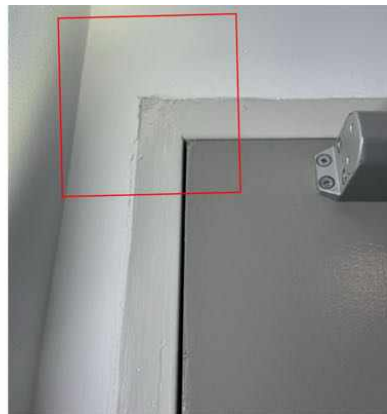
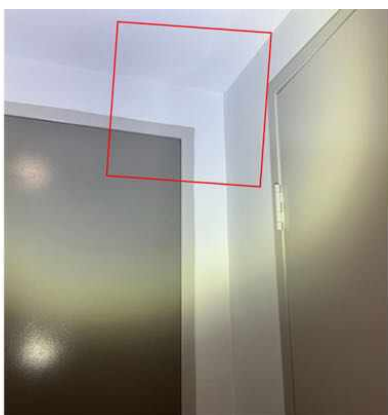
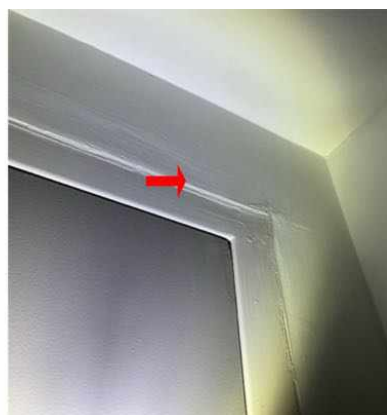
Finding 3.14

Building:	Main Building
Location:	All Internal Areas
Finding:	Paint finish and hairline cracking
Information:	The paint finish in this area was identified as being incomplete at the time of inspection including some hairline minor cracking.

Whilst incomplete or missing paint finish is generally an appearance defect, it can also lead to the development of secondary building defects over time. Incomplete areas of paint finish expose the area to moisture, potentially accelerating the deterioration of underlying building materials.

Incomplete paint finishes should be sanded back, filled, leveled and painted, as applicable. Where inadequate or missing paint protection has led to the deterioration of the associated building element, repair and/or replacement of this building element may be required.

A painting contractor should be appointed as soon as possible to perform necessary works to aid the appearance of the affected area and to ensure the area is protected against further deterioration. Alternatively, the homeowner following manufacturer instructions may perform these works.

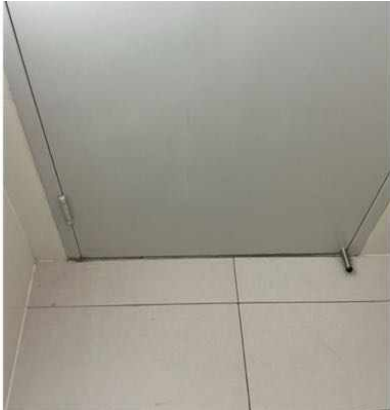
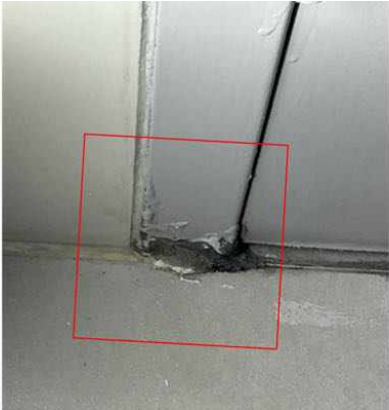
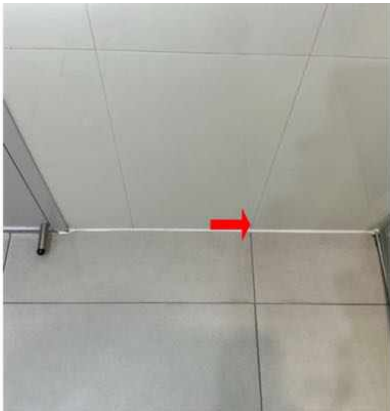
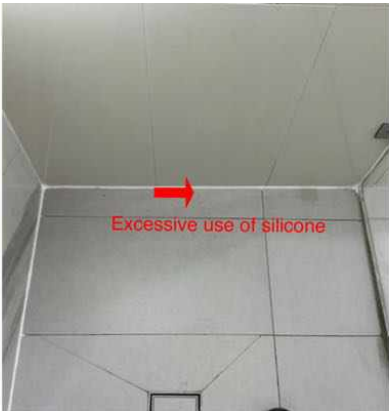
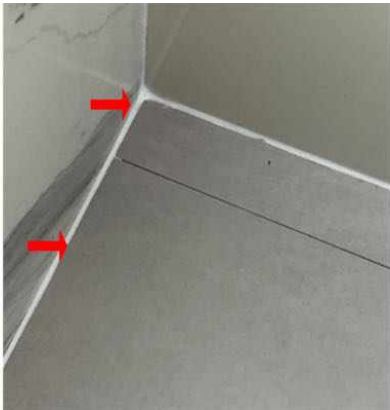
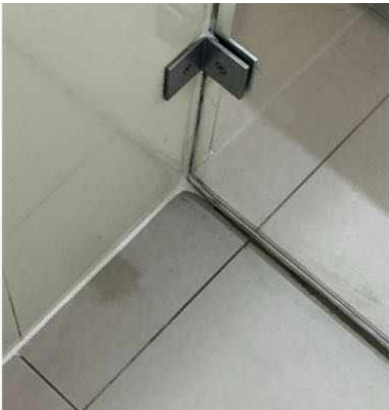
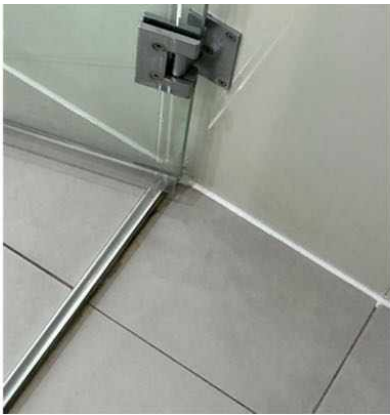
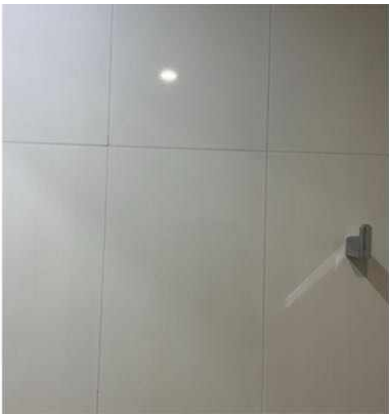
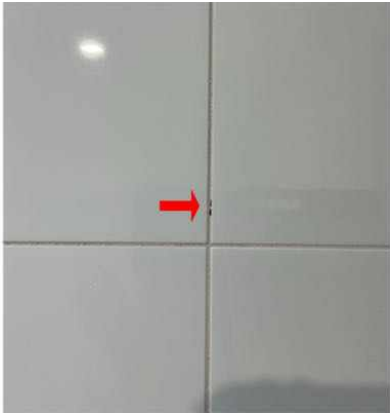
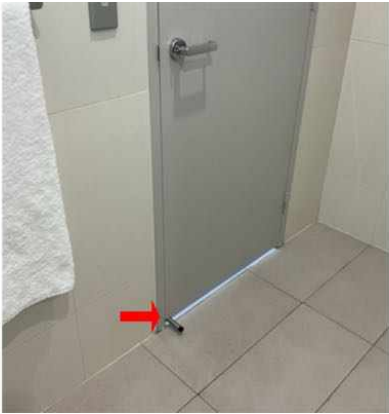
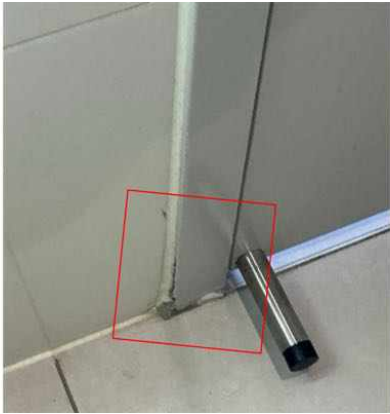
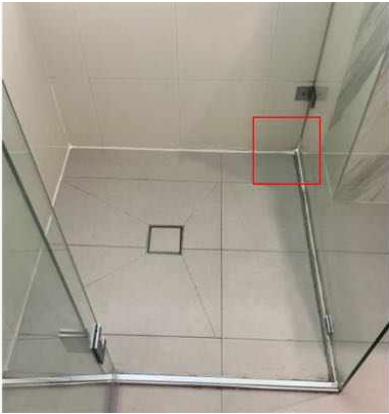
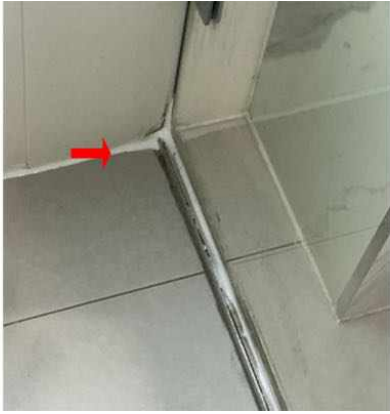
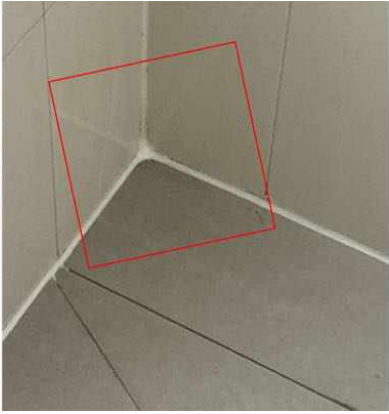
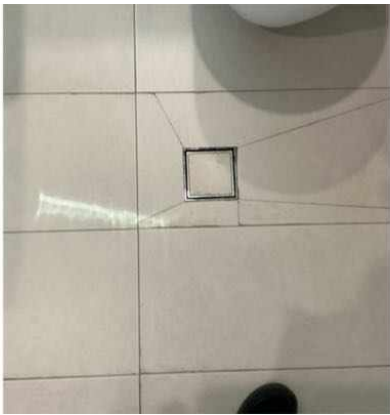
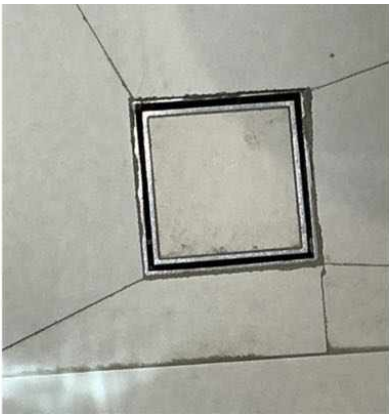
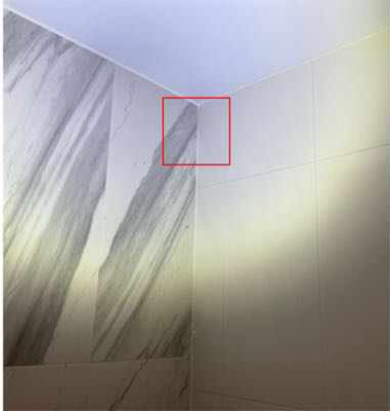
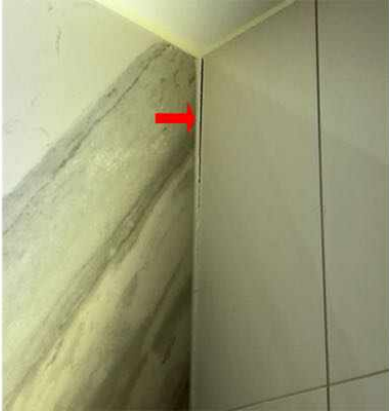
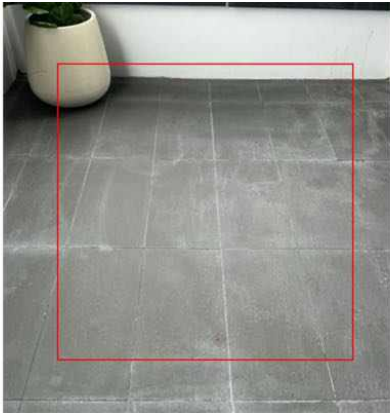
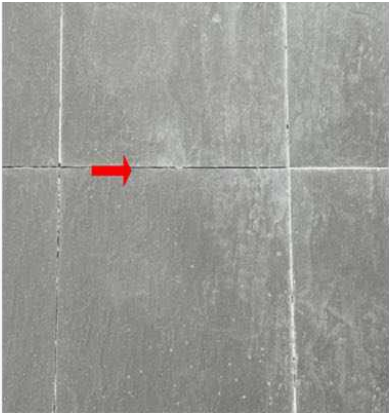
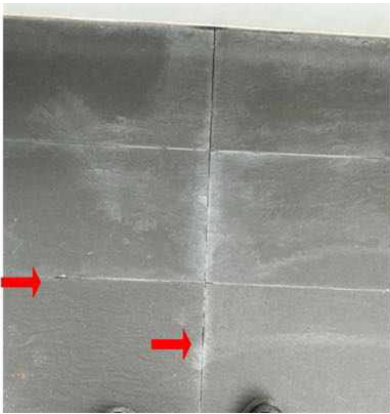
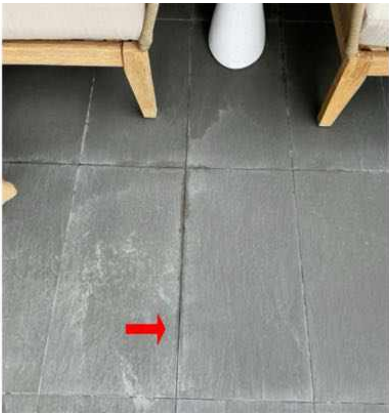
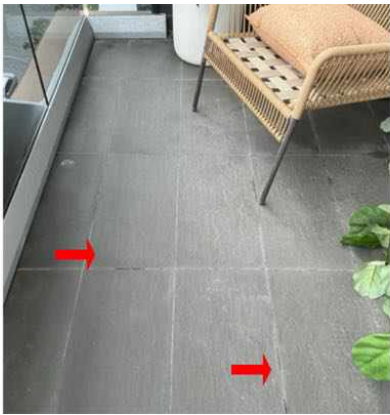
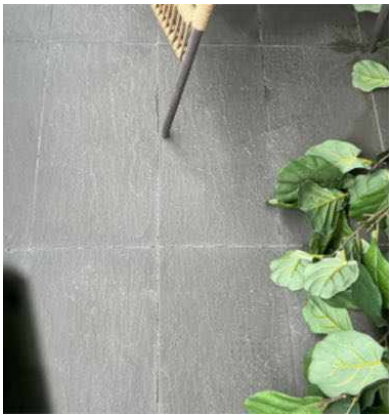
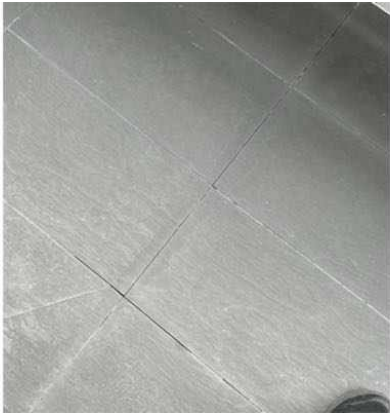
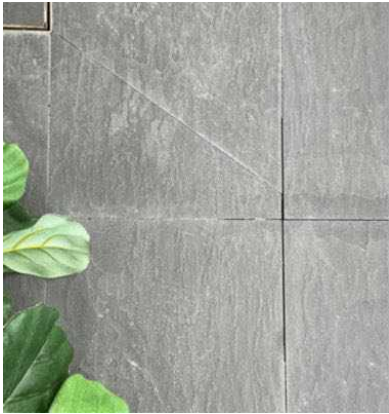
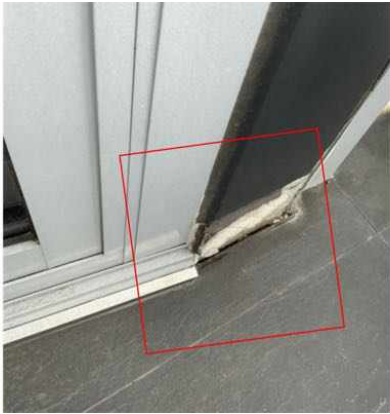
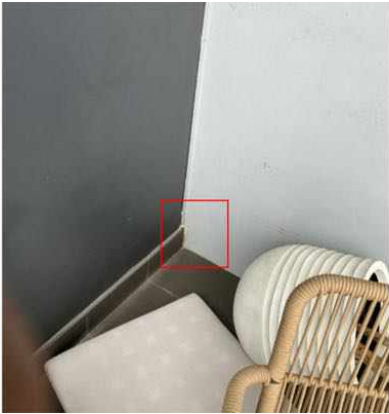
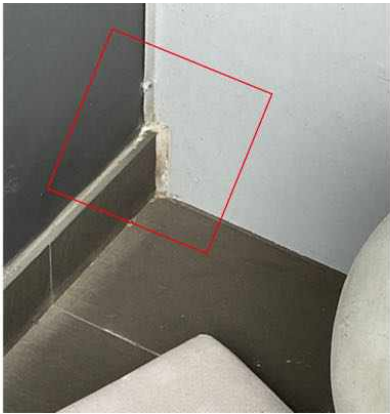
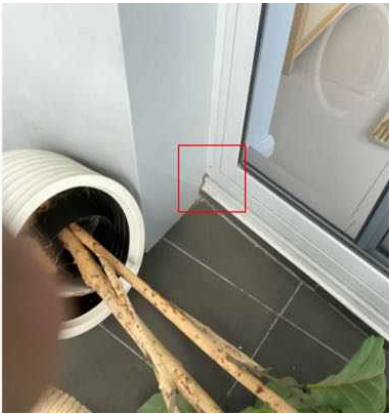
Finding 3.15

Building:	Main Building
Location:	All Internal Areas
Finding:	Sealant and grouting - Missing or degraded
Information:	It was noted on inspection that sealant or grout is degraded. There is also evidence of poor workmanship and excessive use of sealant. Silicone should never be used as a first line of defence against waterproofing. Further inspection by a licensed waterproofing contractor is highly recommended.

Different materials and floor areas move at different rates, generally causing cracking to grout or sealant at this point. A flexible sealant is required to allow for expected expansion and contraction, while keeping the joint water tight and protective of all associated building materials.

There appears to be excessive mould to the sealant and grout which will likely require scraping out and replacement.

Flexible and mould resistant materials should be applied to affected areas to prevent any subsequent water damage that is likely to occur. Regular maintenance and replacement of damage or missing or damaged sealant and grout is highly recommended to the wet areas, as this is a regular wear and tear defect. Sealant and grouting in areas that come into regular contact with water should be maintained for the long term care of your property.

A sealant specialist or tiling contractor should be appointed to complete these works as soon as possible

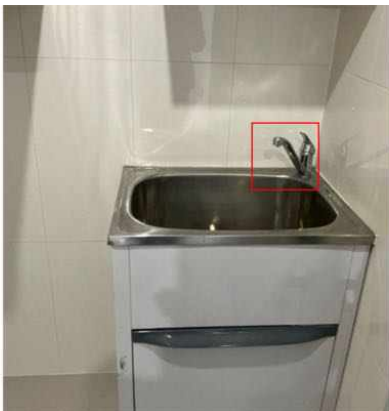
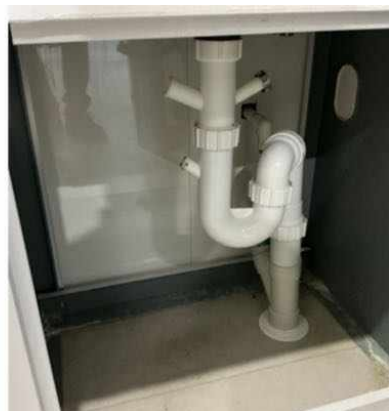
Finding 3.16

Building:	Main Building
Location:	All Internal Areas
Finding:	Building element - Damaged - Laundry no water on tap , minor scratches on kitchen cupboard to some areas , built in seal separation to some areas bedrooms
Information:	Breakage occurs generally when the building materials have either aged and decayed, or as a result of damage (accidental or deliberate).

Repair and/or replacement of broken elements is advised to ensure that additional secondary defects do not arise as a consequence. Such works are necessary, as all building elements play a key role in the operation and function of the overall structure and its performance.

A relevant tradesperson should be appointed to repair or replace the affected building element prior to any subsequent damage being caused.

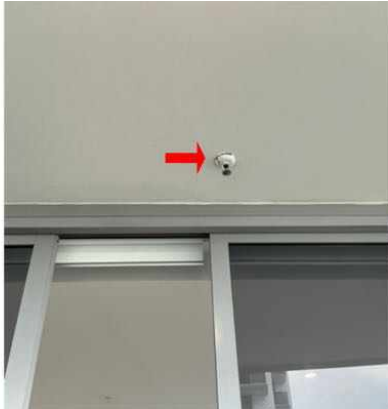
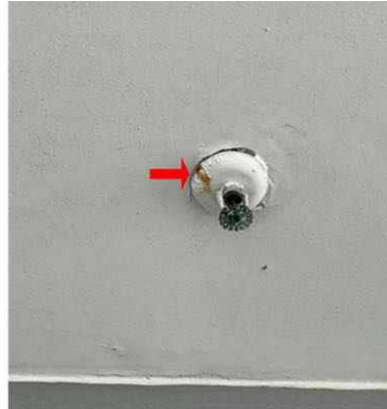
Finding 3.17

Building:	Main Building
Location:	Balcony
Finding:	Building element - Rusted or corroded
Information:	This building element shows evidence of rusting and corrosion, which is likely to have developed as a result of excessive exposure to moisture and or inadequate coatings.

As surface rust provides no protection to the underlying iron, the deteriorating condition is likely to worsen if not addressed in the short-term future.

Where possible, the use of galvanized (treated) metals or aluminium coated metals aid in rust prevention, as does regular general maintenance. Rust formation can be

controlled with coatings, such as paint, that isolate the iron from the environment.

Rusting and corrosion should be managed by ideally removing or limiting the affected surface from exposure to moisture. A registered builder may be appointed to replace any building elements that have been severely affected by rust or water damage.

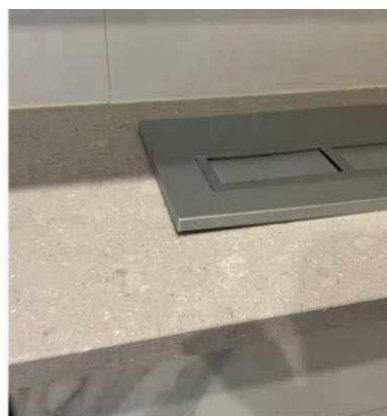
Finding 3.18

Building: Main Building

Information: The installation of this building element appears to have been completed to a substandard level of workmanship or is incomplete. Generally substandard repairs or installation are related to poor workmanship, the use of inappropriate materials, or a failure to complete installation to a suitable standard.

Where installation is substandard and/or incomplete, the client should contact the responsible trade to undertake rectification. Unfinished and substandard building works are likely to degrade more quickly and may create potential for secondary defects to associated building elements.

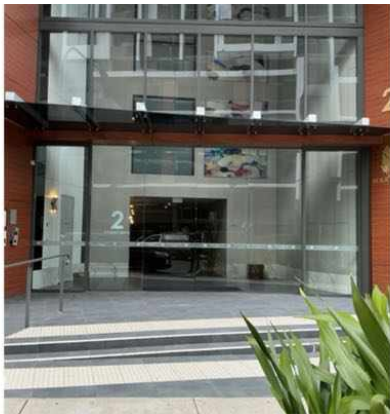
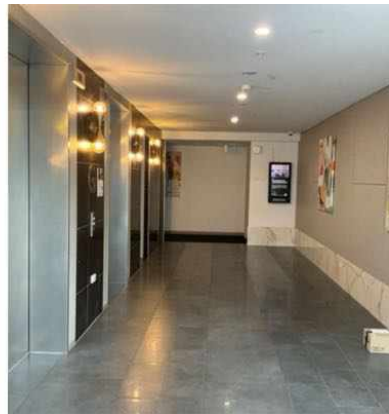
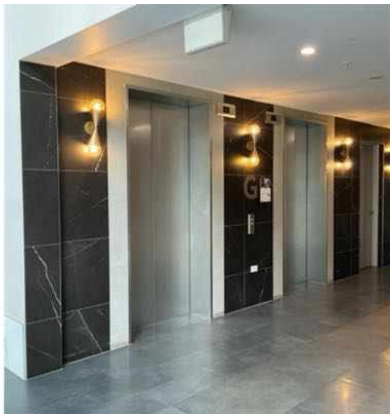
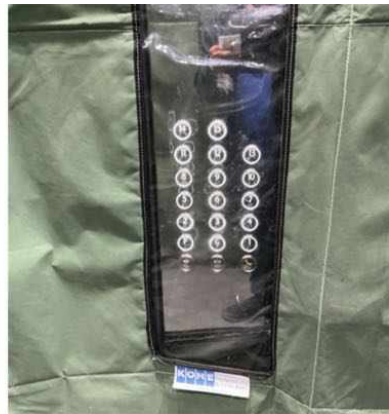
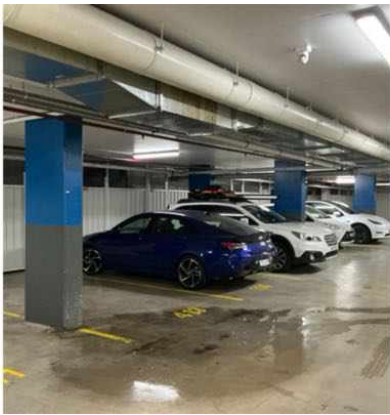
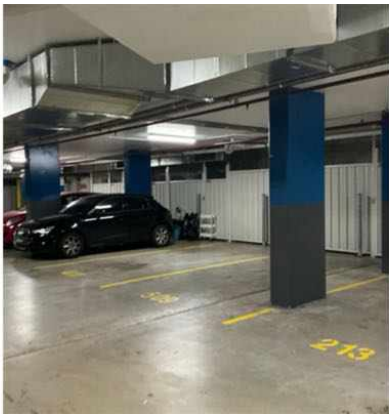
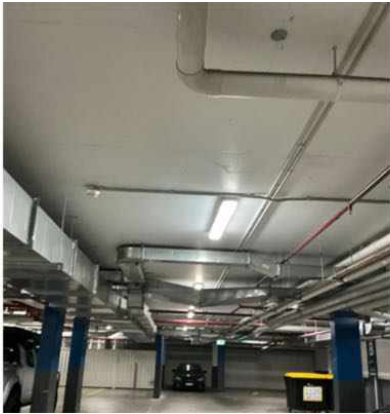
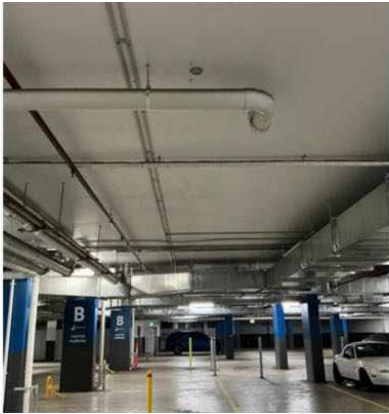
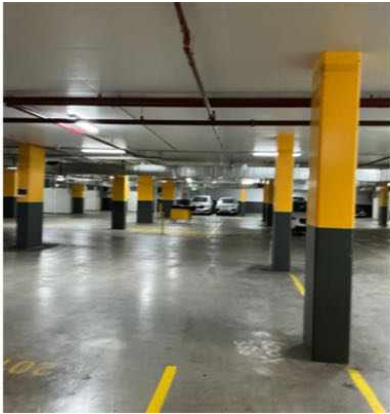
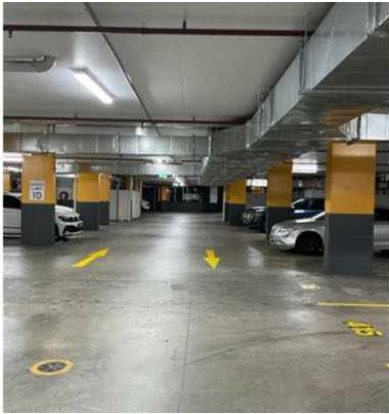
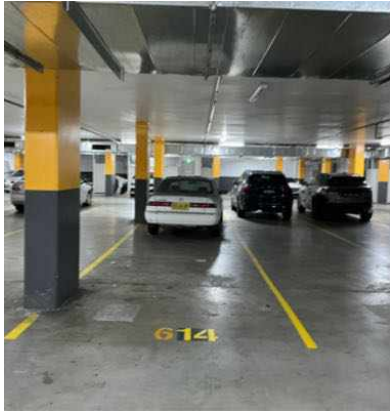
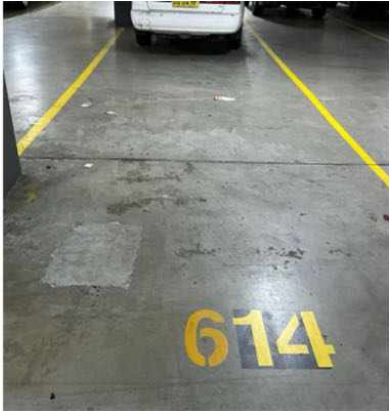
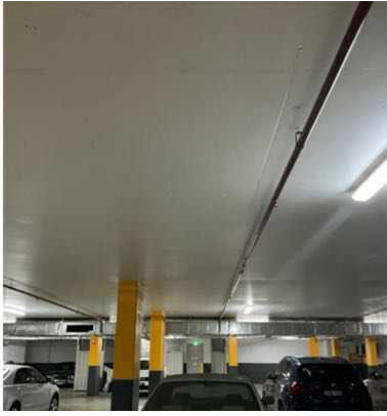
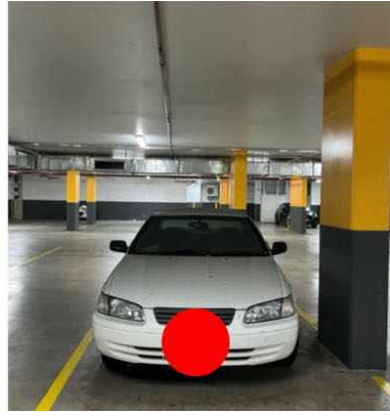
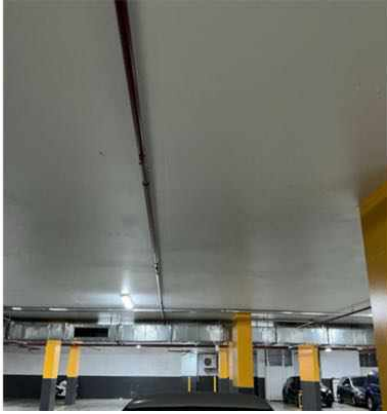
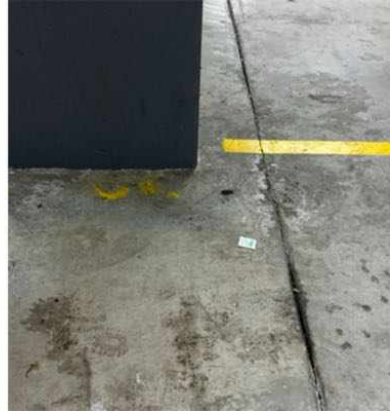
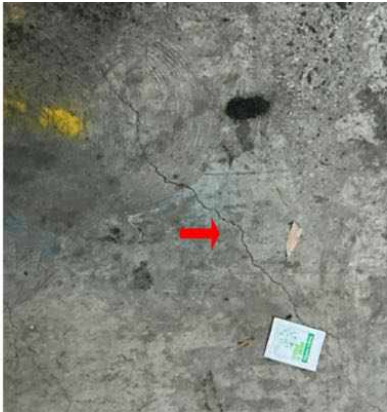
Building: Main Building
Location: All External Areas
Finding: Additional Photos - Obstructions and Limitations
Information: These photographs are an indication of the obstructions and limitations which impeded full inspection of the property at the time of inspection. These obstructions can hide an array of defects and should be removed to allow full inspection to be carried out. A re-inspection is recommended once the areas are made accessible.

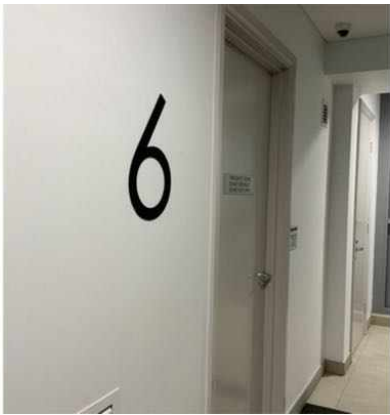
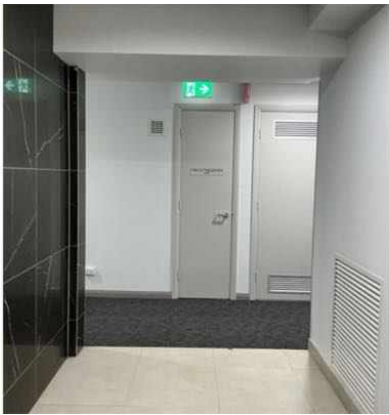
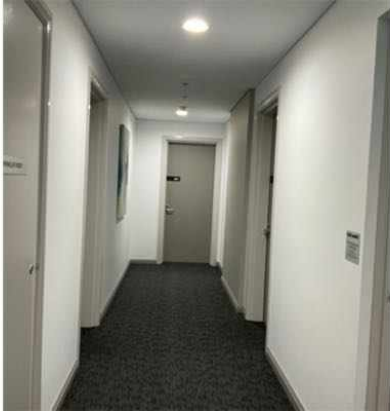
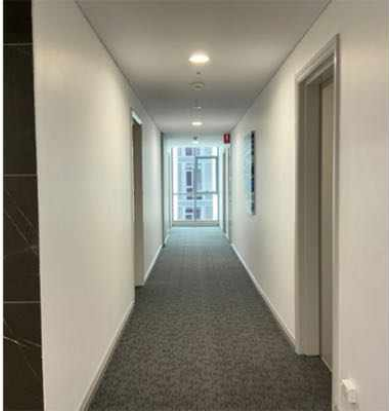
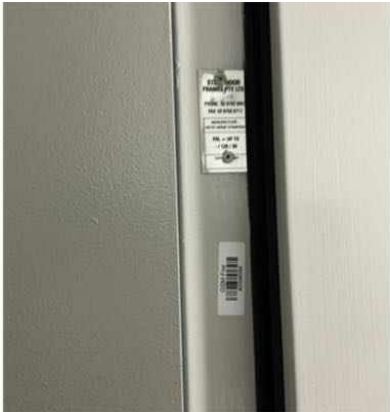
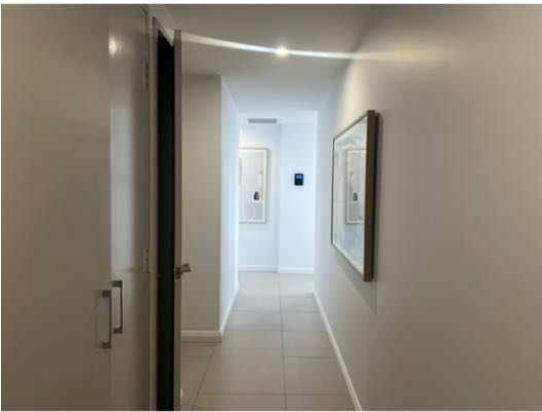
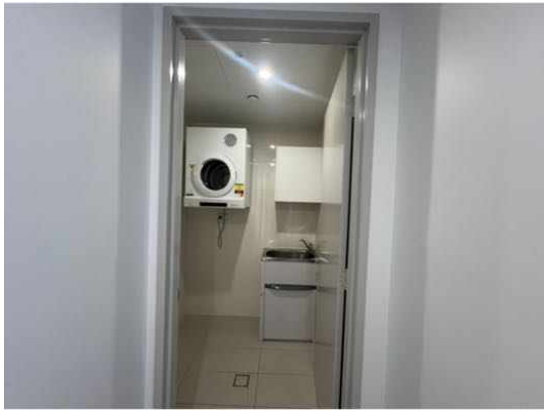
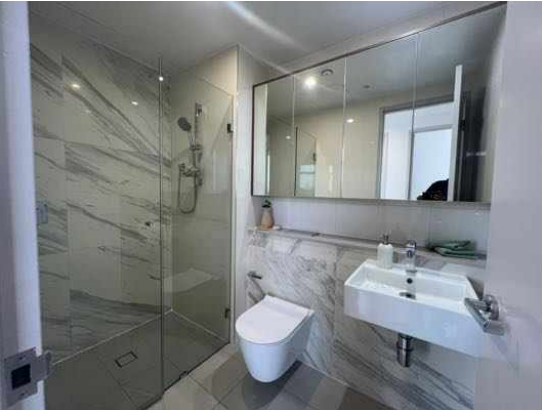
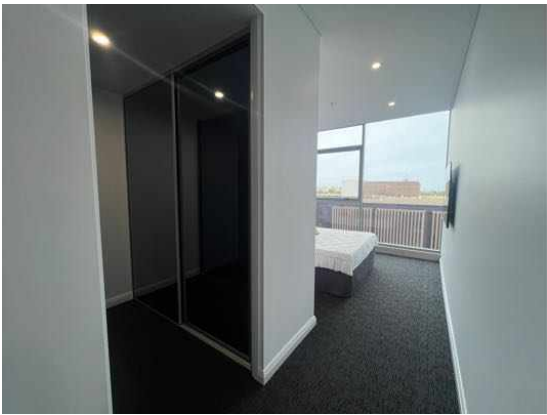
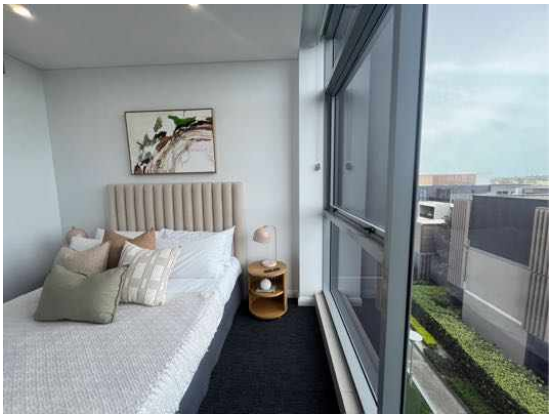
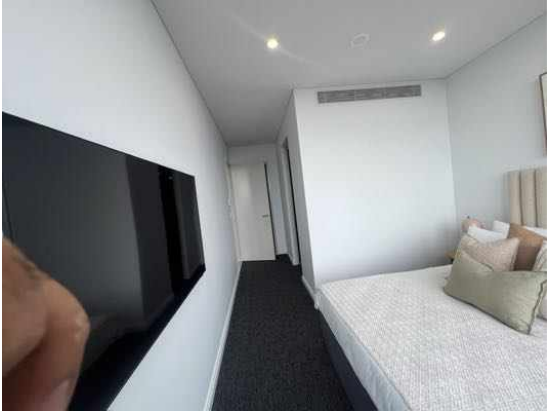
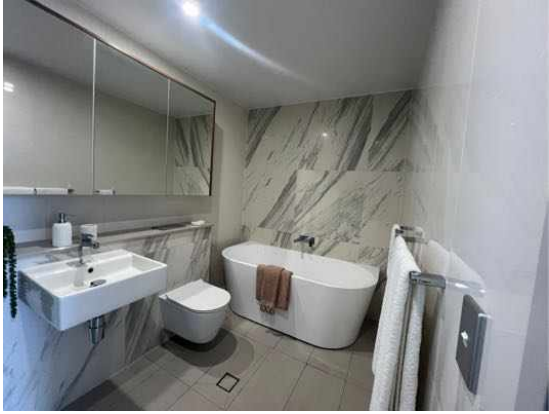
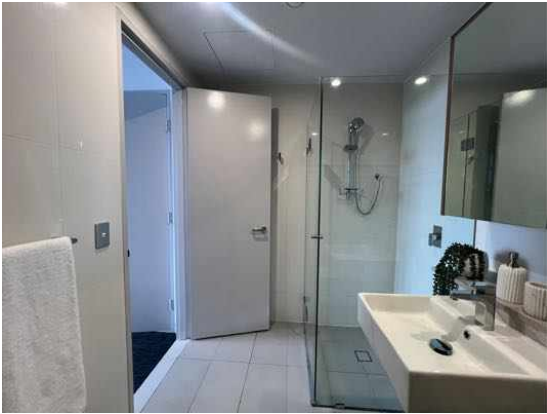
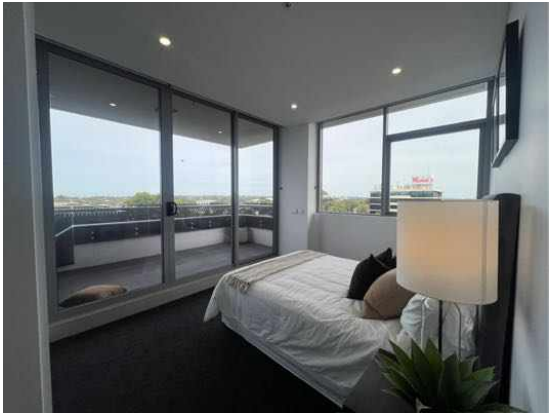
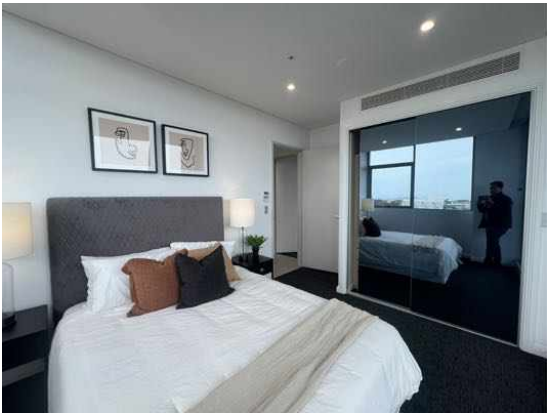
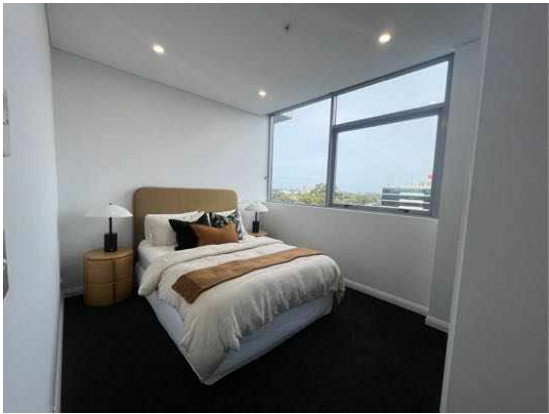
Building:	Main Building
Location:	All Internal Areas
Finding:	Additional Photos - Obstructions and Limitations
Information:	These photographs are an indication of the obstructions and limitations which impeded full inspection of the property at the time of inspection. These obstructions can hide an array of defects and should be removed to allow full inspection to be carried out. A re-inspection is recommended once the areas are made accessible.
