Building and Timber Pest Inspection Report

Inspection Date: Mon, 16 Mar 2026

Property Address: 614/2 Studio Dr, Eastgardens NSW 2036,
Australia

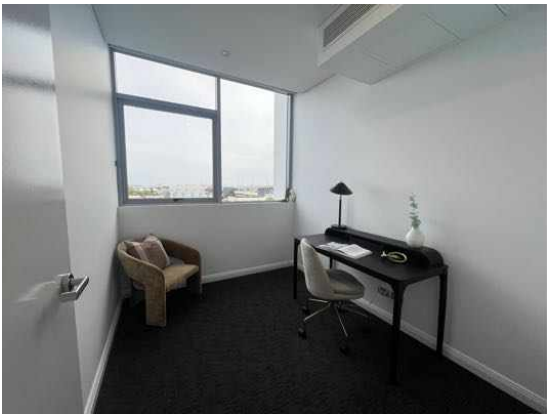
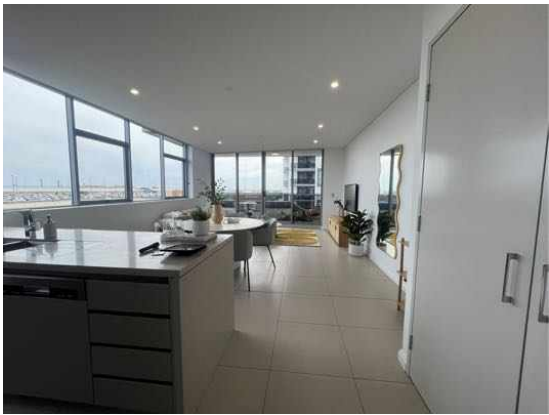
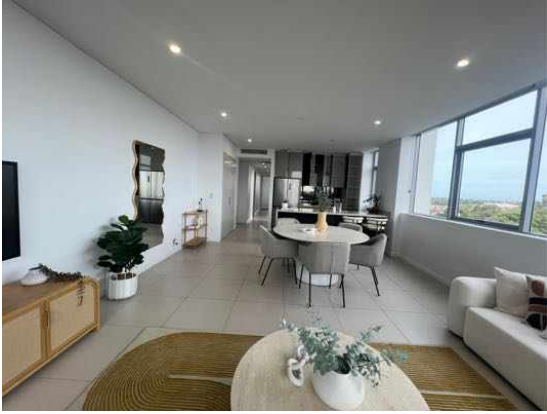
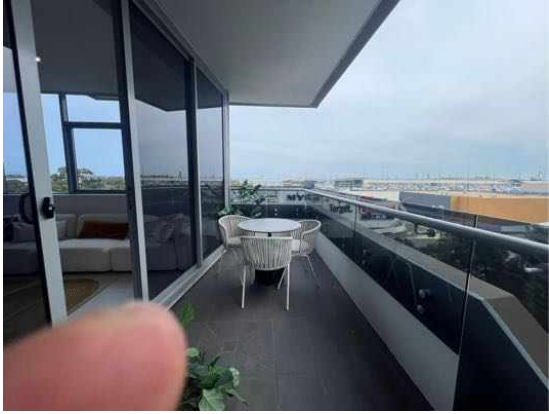
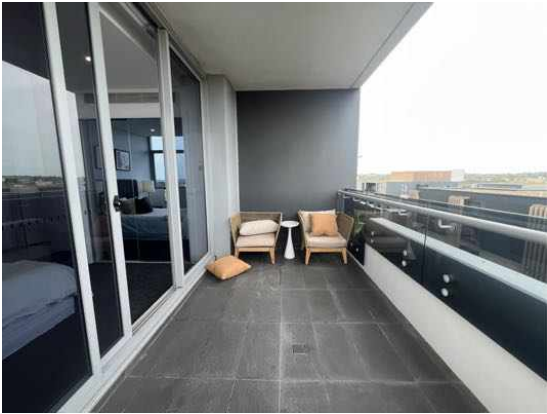
Noted Item

Building:	Main Building
Location:	All Internal Areas
Finding:	Additional Photos - Obstructions and Limitations
Information:	These photographs are an indication of the obstructions and limitations which impeded full inspection of the property at the time of inspection. These obstructions can hide an array of defects and should be removed to allow full inspection to be carried out. A re-inspection is recommended once the areas are made accessible.
