Building and Timber Pest Inspection Report

Inspection Date: Mon, 23 Feb 2026

Property Address: 18 Tanglewood Place, Glenmore Park NSW
2745

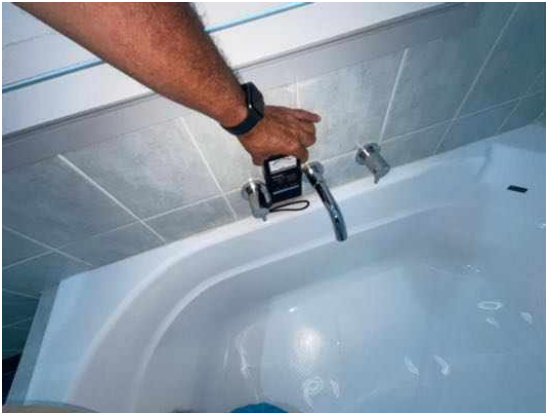
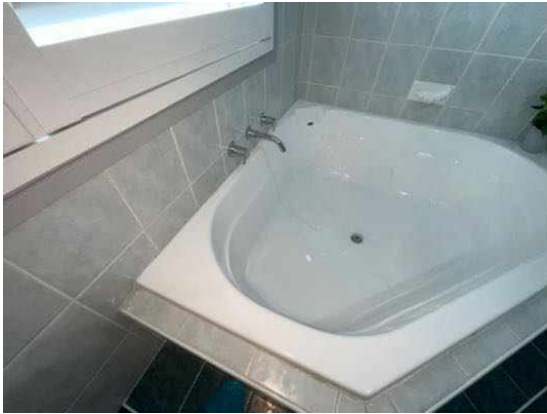
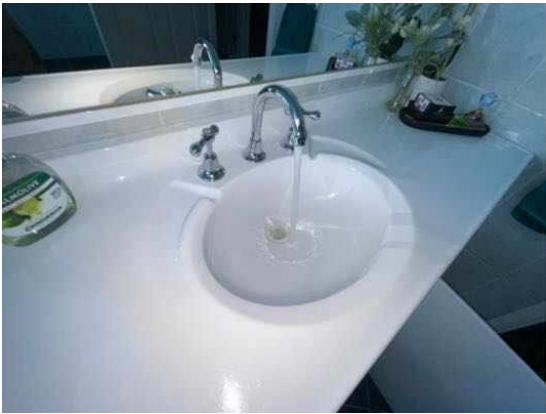
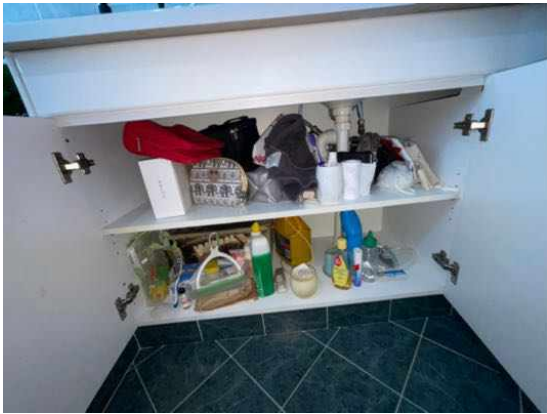
Alternatively, the assumption should be made that leakage may occur, particularly where historical or environmental conditions are conducive. The visual nature of this inspection cannot detect issues concealed behind wall/floor linings or cabinetry, and invasive investigation may be necessary to confirm the true condition of adjacent or hidden structures.

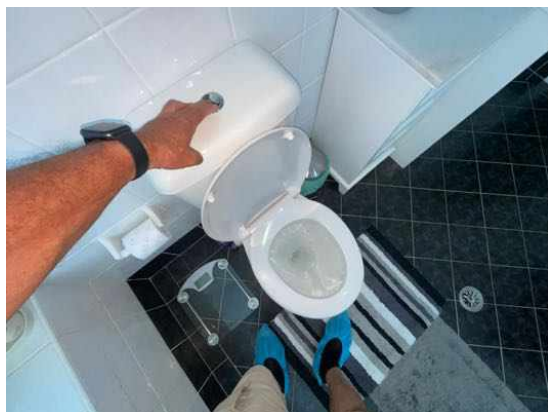
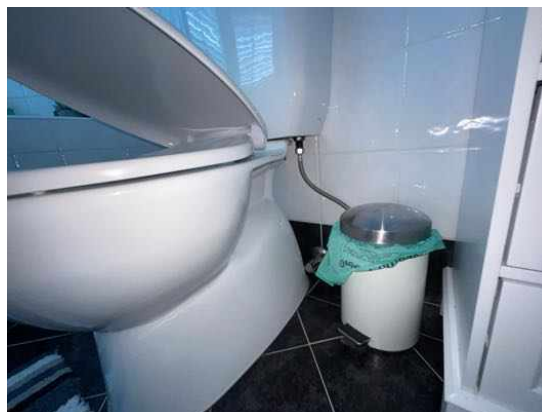
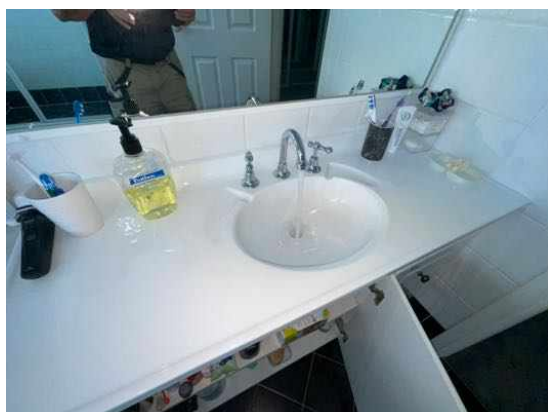
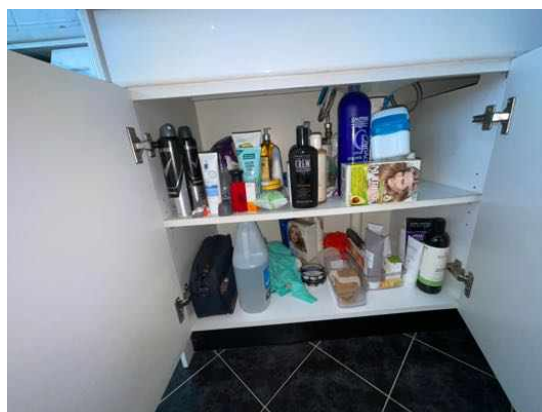
Alternatively, the assumption should be made that leakage may occur, particularly where historical or environmental conditions are conducive. The visual nature of this inspection cannot detect issues concealed behind wall/floor linings or cabinetry, and invasive investigation may be necessary to confirm the true condition of adjacent or hidden structures.

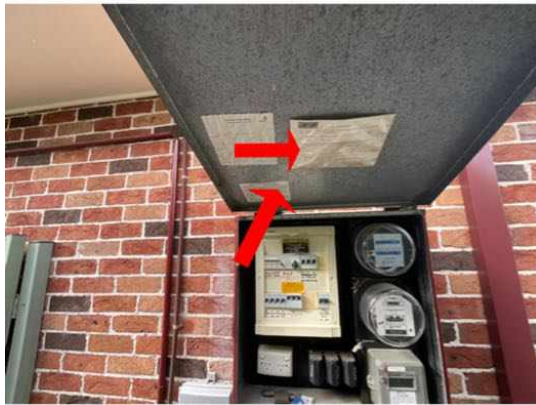
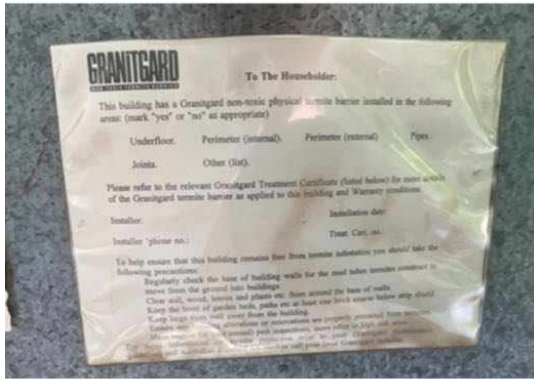
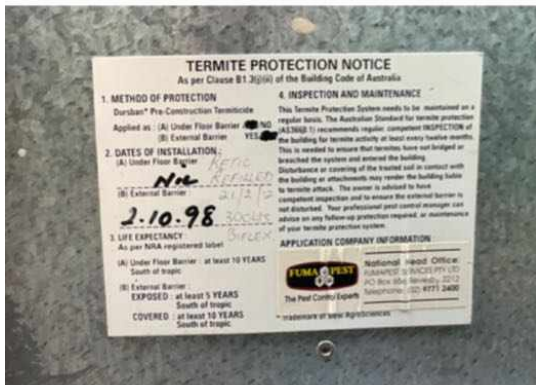
- Confirm the scope and coverage of the treatment
- Determine the current validity or expiry of the barrier as it is suspected that the treatment is outdated
- Arrange for re-treatment if the protection is no longer active or up to standard

Ongoing inspections and maintenance are key to ensuring the termite management system remains effective over time.
