Building and Timber Pest Inspection Report

Inspection Date: Thu, 26 Feb 2026

Property Address: 713 Canterbury Rd, Surrey Hills VIC 3127,
Australia

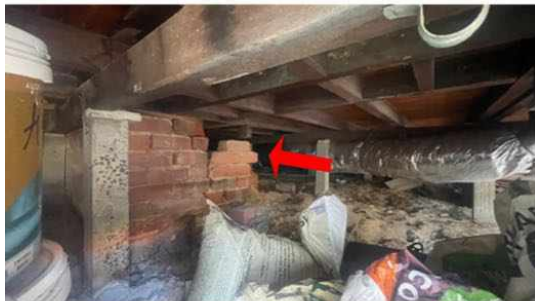
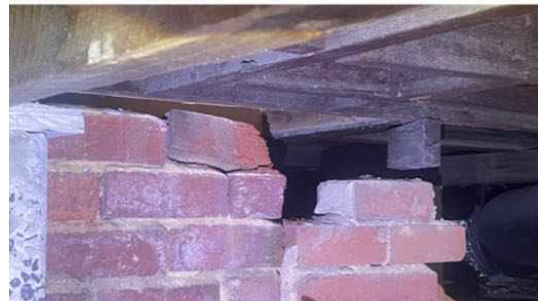
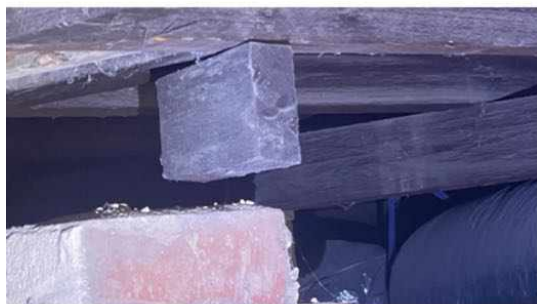
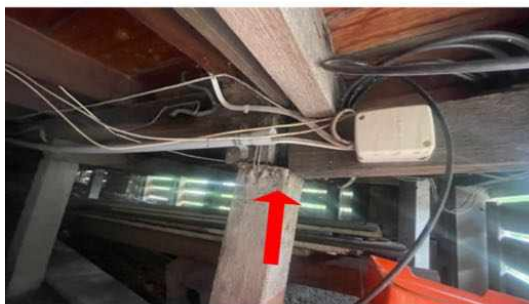
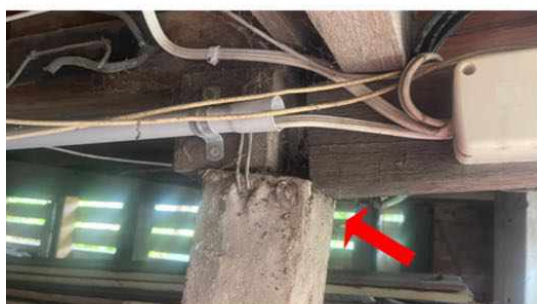
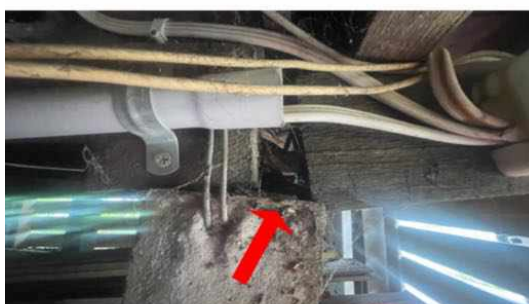
Information: Upon inspection of the subfloor area, it was noted that there are a number of insufficient subfloor structures in place. There appeared to be a number of bearers and joists that did not have sufficient support around them and have the potential to sag.

The absence of adequate subfloor stability potentially indicates non-compliance with contemporary building practices and is likely to result in numerous minor defects, such as uneven and noisy floors. Over time, insufficient subfloor structures are likely to result in structural deterioration, as the structures do not have the capacity to bear the weight of the building.

Please note: it was observed that the flooring above this area was out of level and uneven

The client is advised to seek quotations for required repairs as the potential resolution may range from rebuilding foundation areas to replacement of subfloors framing. Consultation with a structural engineer and a registered builder specialising in re-stumping is advised immediately.

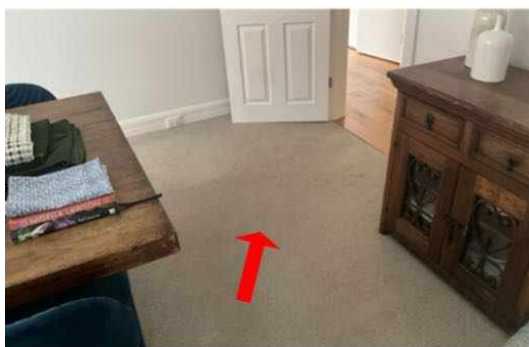
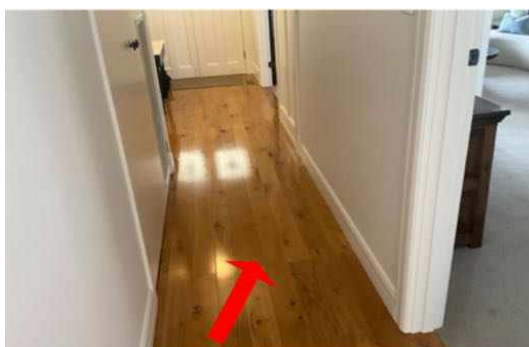
Finding 3.01

Information: The internal flooring in this area is out of level and uneven. Uneven flooring is likely to indicate minor defects such as expected movement of the foundations of the property, but may also indicate subsidence of the associated subfloor stumps.

It is advised that the flooring be closely monitored to identify any further movement. Where flooring remains relatively unchanged for an extended period of time (i.e. several months), it is likely that this defect has been caused by expected movement of the foundations of the property.

However, where flooring is uneven further, potentially invasive inspection of the subfloor structures and stumps in this area is required. In this case, works to repair are likely to be required, and would be carried out by a registered builder specialising in re-stumping.

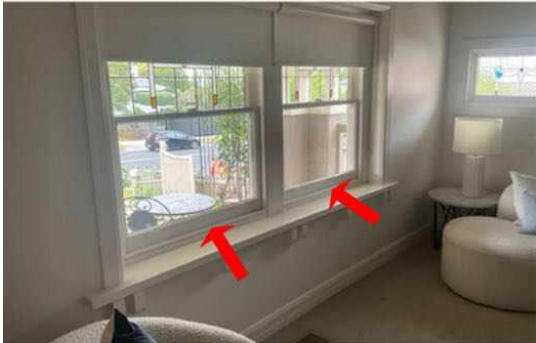
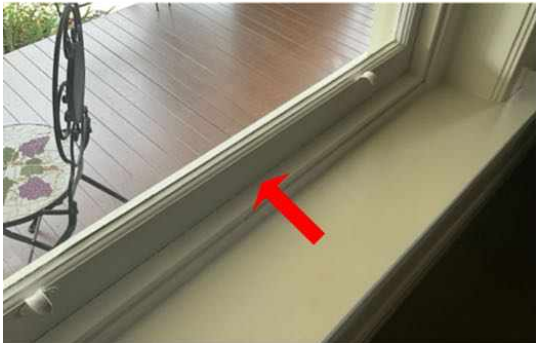
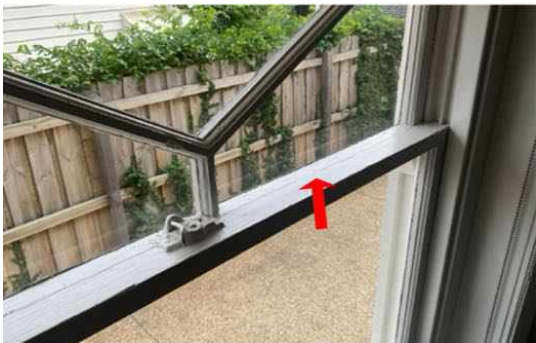
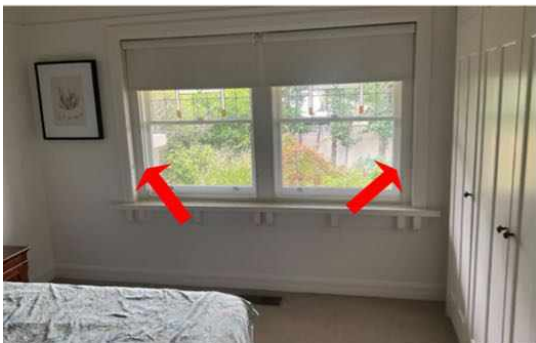
Finding 3.02

Windows provide ventilation to the adjoining area and should be at a fully operational level to ensure user comfort. Restricted function of the window may also pose as a potential safety hazard if required for emergency egress from the building.

Where windows have been painted shut the seal of the paint needs to be broken. This is generally done by breaking the seal of the paint and then maintaining the sash tracks, clearing and lubricating them with silicone. Remedial paint work will likely be required and can be completed along with the rest of the remedial works necessary by a general handyman.

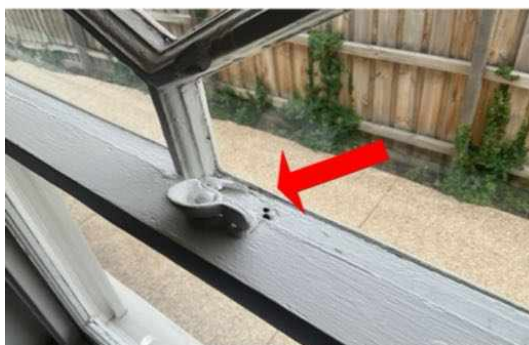
Finding 3.03

Building:
 Location: Dining Room
 Finding: Window missing latches/locks
 Information: At the time of inspection the windows in these areas were missing their latches and were unable to be locked.

This has the potential to pose as a potential safety/security risk .

It is recommended the windows have latches installed as a matter of urgency by a licensed carpenter or suitably competent handyman.

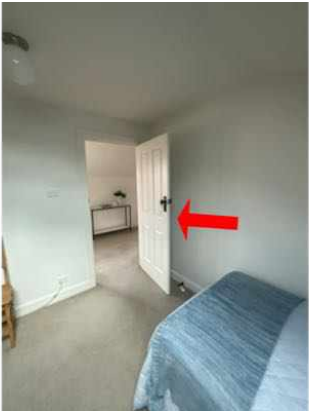
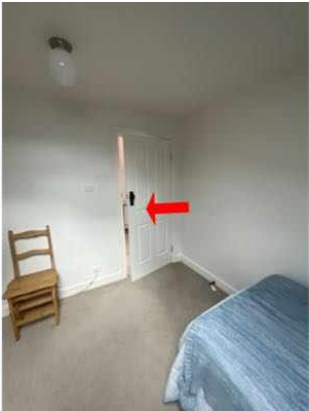
Information: It was noted at the time of inspection that the door to this area would not stay half open and "self closed".

This may be the result of incorrect installation or can be due the framing not being plumb.

A licensed carpenter or registered builder can be engaged to rectify these issues at the discretion of the homeowner.

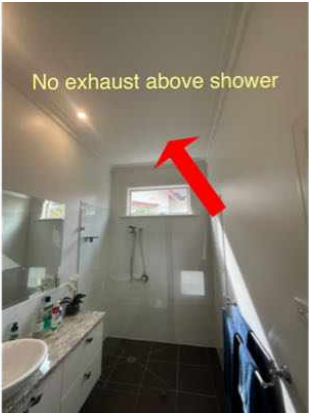
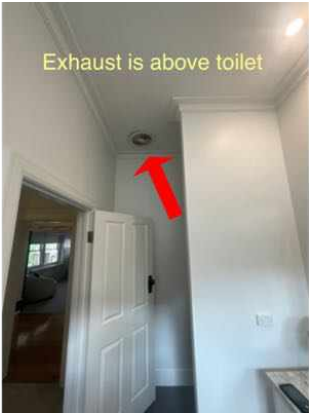
Finding 3.07

Information: The exhaust fan in the ensuite bathroom was not positioned above the shower - it was over above the toilet. This may lead to a build up of condensation above the shower which in turn can result in the development of mould. More significant defects such as moisture damage to surrounding building materials from inadequate ventilation can also occur in extreme cases.

It is recommended that a licensed electrician be appointed to install a second exhaust fan in the area - this time above the shower.

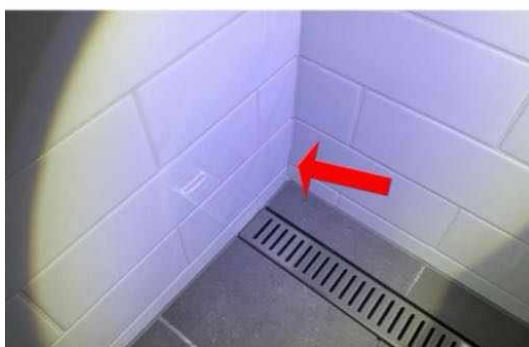
Finding 3.08

Building:
 Location: Bathroom
 Finding: Grout and sealant - Missing or degraded within the bathroom area
 Information: It was noted on inspection that grout or sealant is degraded to areas within the bathroom.

Different materials move at different rates, generally causing cracking to grout at this point. Build up of moisture in the bathroom can also cause grout and sealants to degrade and become mouldy.

Any damaged or degraded materials should be scraped out and flexible and mould resistant materials should be applied to affected areas to prevent any subsequent water damage that may occur. Regular maintenance and replacement of damaged or missing grout/ sealant is highly recommended to the wet areas, as this is a regular wear and tear defect. Both grout and sealant in areas that come into regular contact with water should be maintained for the long term care of your property.

A bathroom specialist or tiling contractor should be appointed to complete these works as soon as possible.

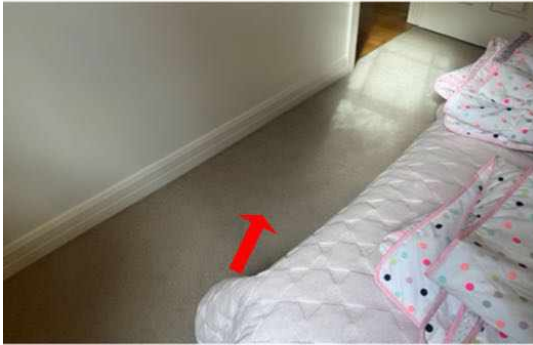
Creaking floors generally indicate that the floorboards or the subfloor structures are coming loose from the supporting structure that they are installed on.

The areas should be monitored for any changes or unevenness. Should this occur, consultation with a registered builder should be undertaken to determine the cause . The potential resolution may involve regluing and screwing the floor down through to replacement of subfloor support structures.

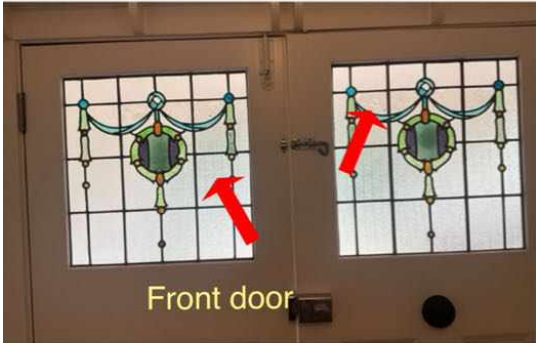
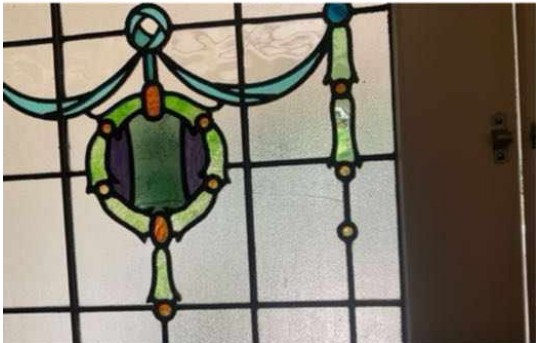
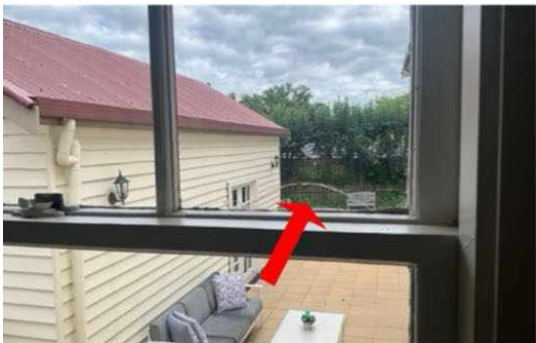
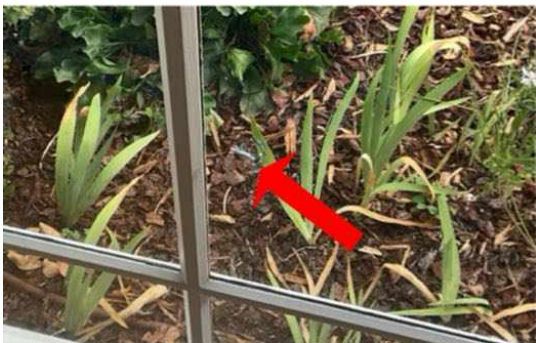
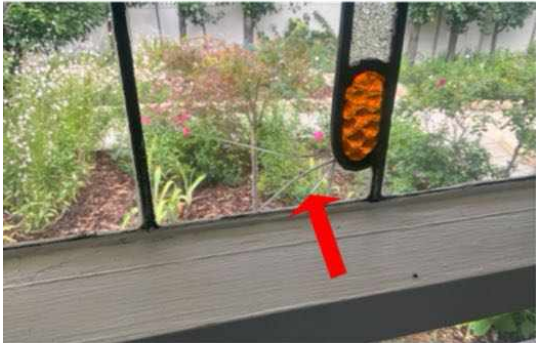
Finding: Window cracked

Information: At the time of inspection the window in this area had some significant cracking. This defect is generally the result of impact damage but may be due to other factors. Refer to photos for further information. Care should be taken in this area. The area should be monitored for further dilapidation.

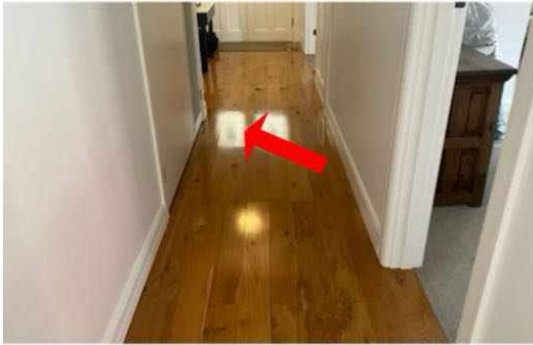
Finding: Floating floorboards - slight lifting and damage to the flooring in this area.

Information: At the time of inspection, there was some evidence of suspected moisture damage to the flooring, as noted where the floor boards were lifted slightly.

The flooring should be monitored for any further damage or changes and should that occur, consultation with a flooring specialist should be sought.

This may require the flooring to be lifted and replaced in severely damaged areas.

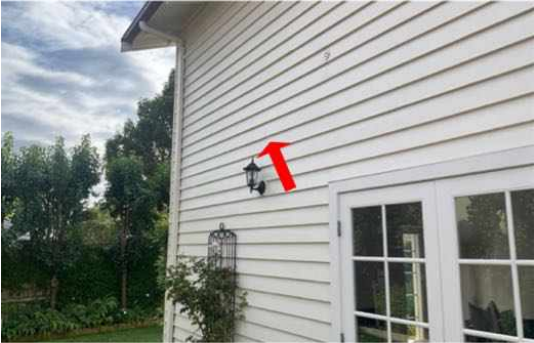
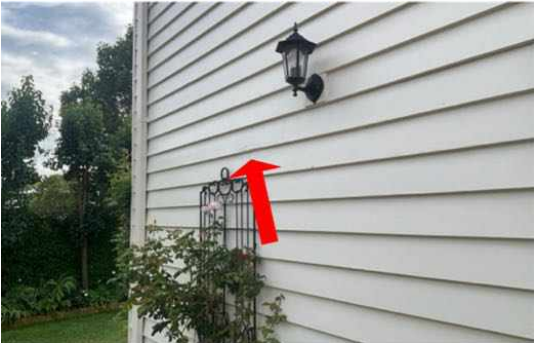
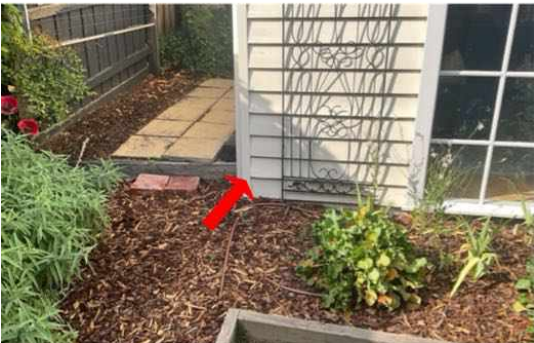
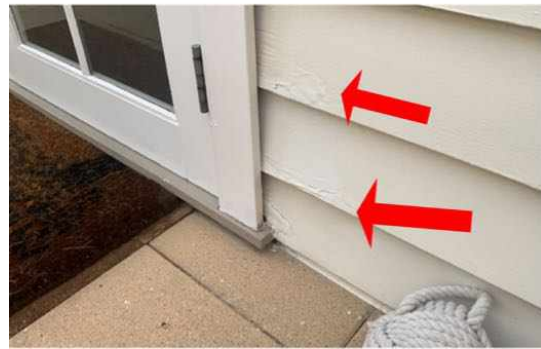
Finding 3.16

necessitating major repair or replacement works in the long-term future.

To maintain the condition of the external wall cladding, any severely affected weatherboards should be substituted as soon as possible with pre-treated replacements. Where weatherboards have rotted due to excessive moisture other than rain penetration, the cause of the moisture should be identified immediately by a licensed plumber. A qualified carpenter should be appointed to repair and replace rotting weatherboards.

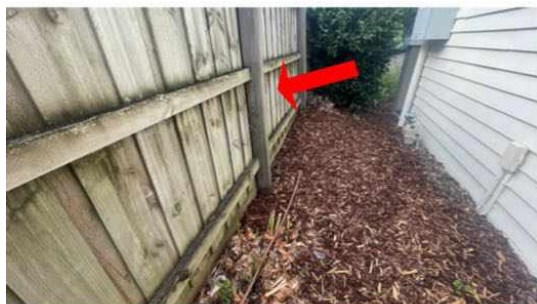
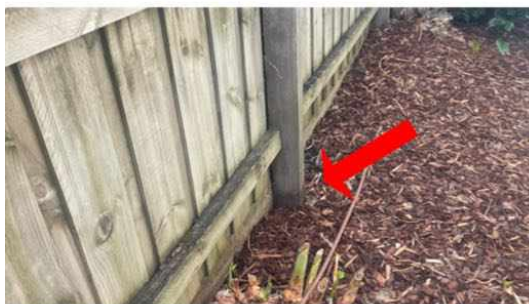
Finding 3.19

Finding: Fencing - leaning with some areas of deterioration

A licensed fencing contractor should be appointed to provide further advice and perform rectification works as necessary.

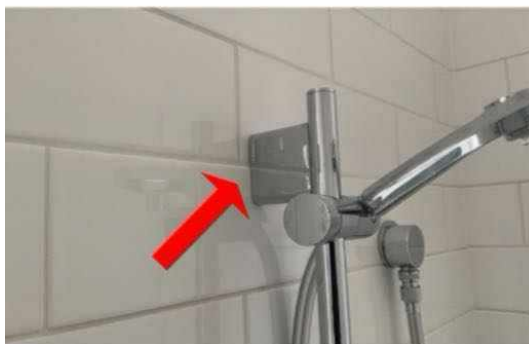
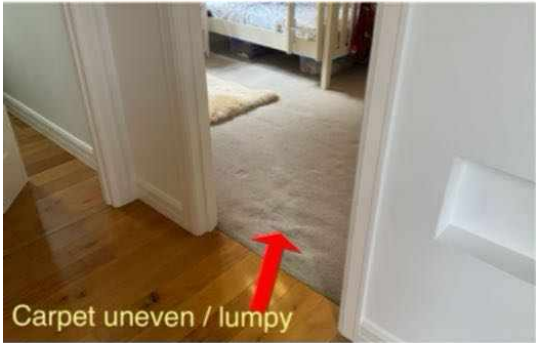
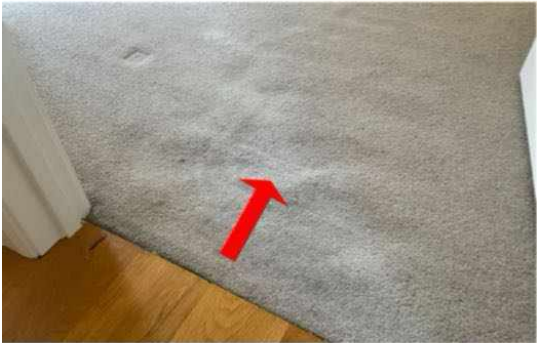
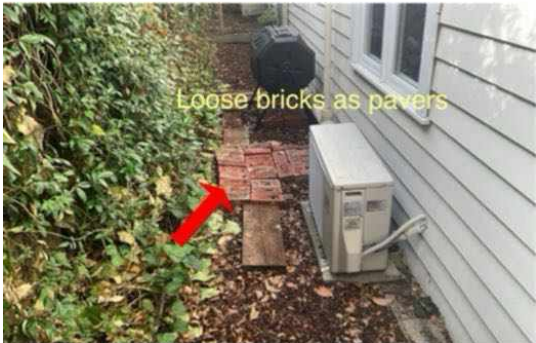
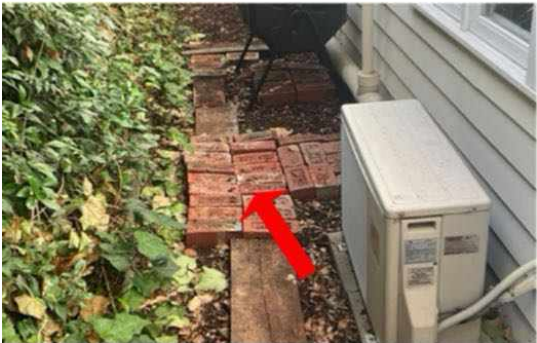
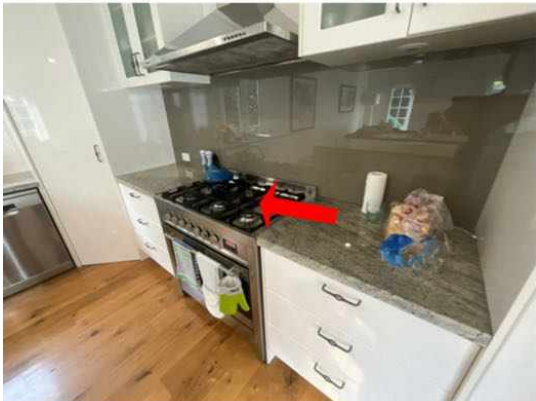
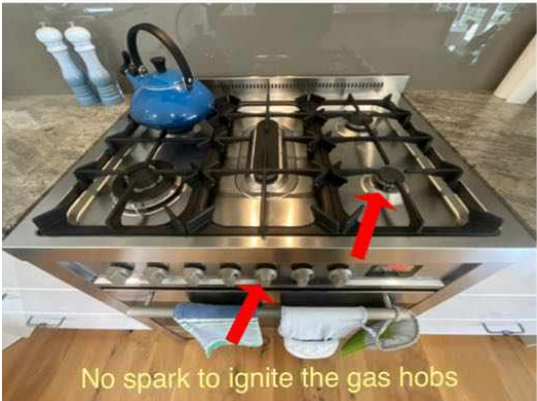
Finding 3.23

Building:
Location: All Areas
Finding: Additional Photos - minor defects
Information: Additional photos are provided for your general reference. Arrows have been included where necessary to highlight areas of importance.

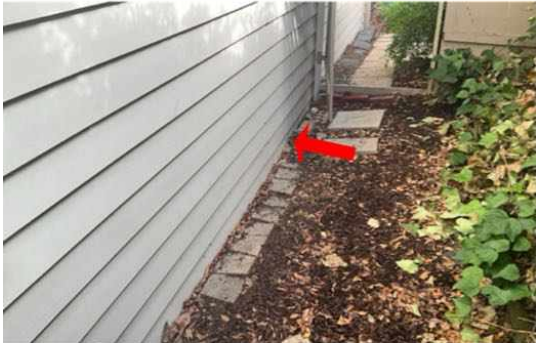
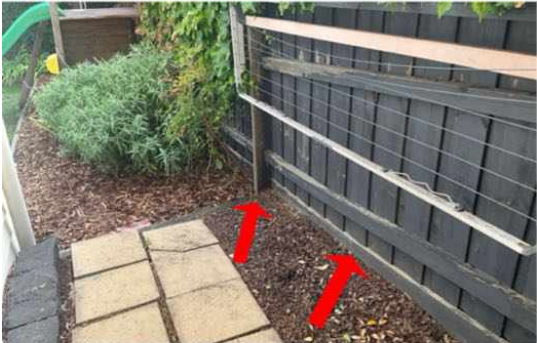
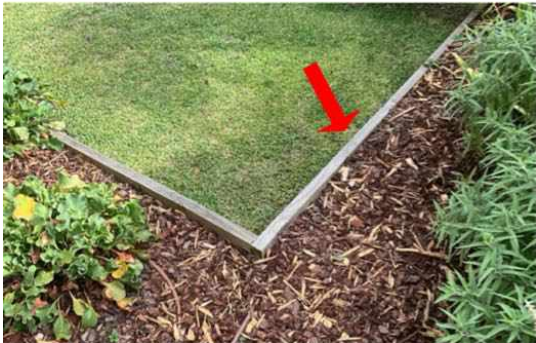
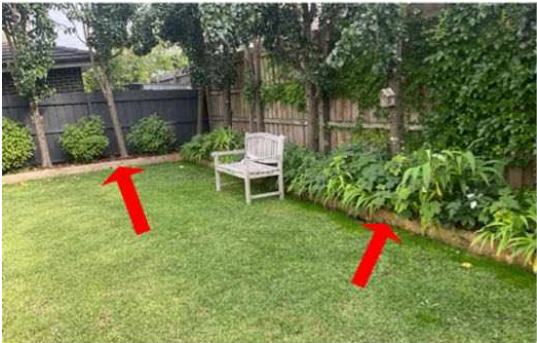
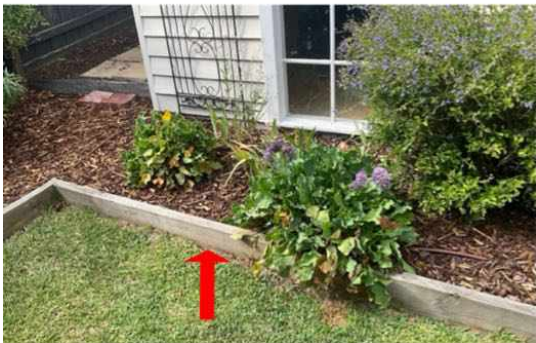
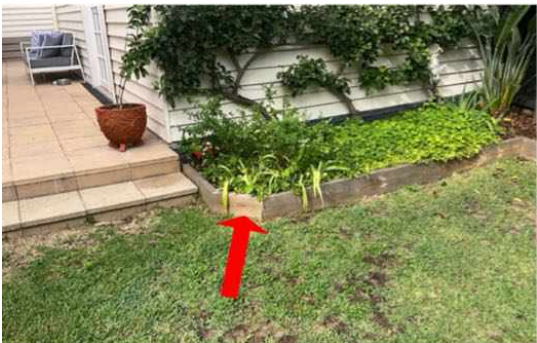
Building:
 Location: All External Areas
 Finding: Building materials in direct ground contact - conducive to termites
 Information: Where timber elements are in direct contact with the ground and consequently moisture or dampness, they become conducive to termite activity. Whether timber is used as a building element, part of a fencing structure or stored as an unused item, they can provide an environment that is attractive to termite infestation.

When met with excessive moisture, timber begins to decay and develop wood rot. Any timbers that are in direct contact with external grounds especially if left untreated or non-durable also provide ingress for subterranean termites into that particular element.

Where possible, the removal of any such materials that may be conducive to termite activity should be carried out as soon as possible to minimise the risk of termite attack. Where not possible or practical, regular monitoring of timber elements is recommended. Replacement of any damaged materials should be carried out where necessary.

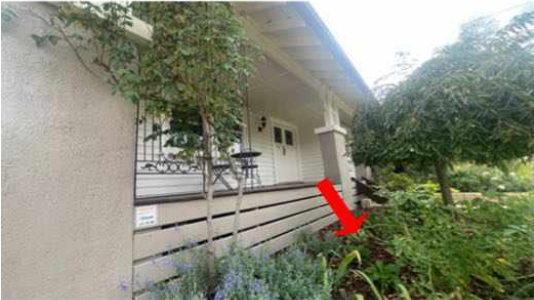
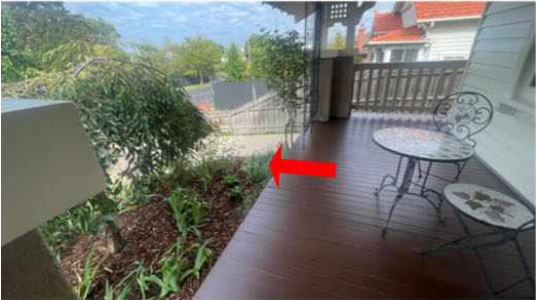
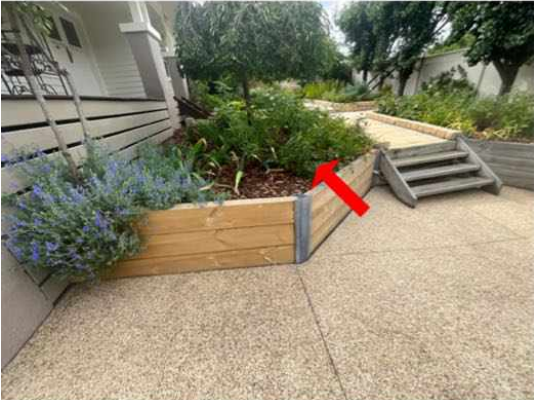
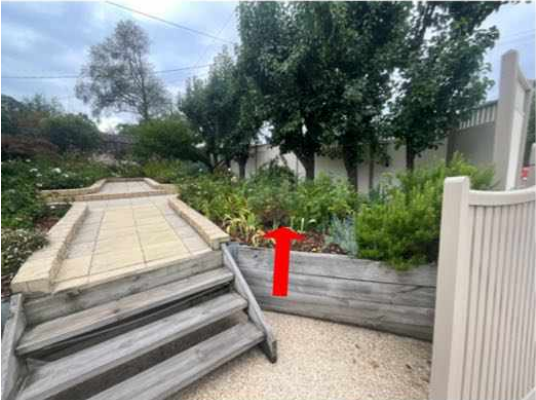
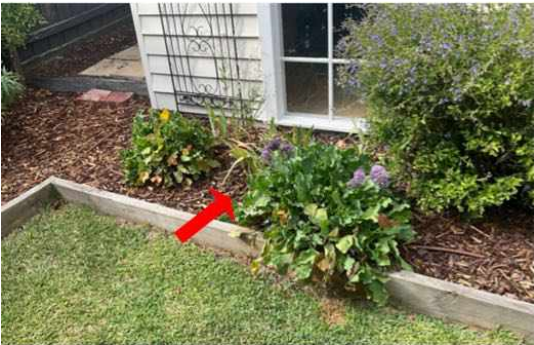
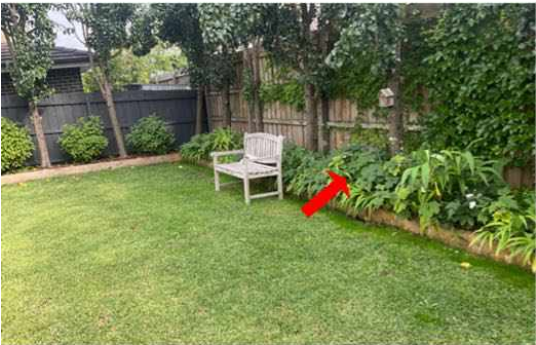
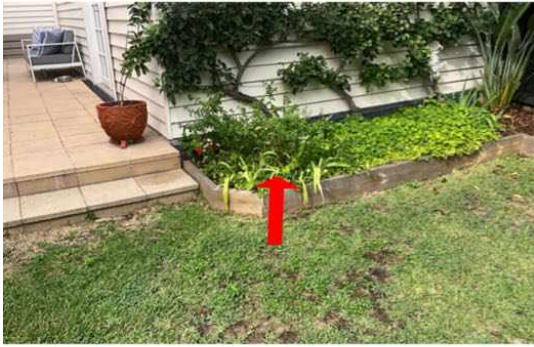
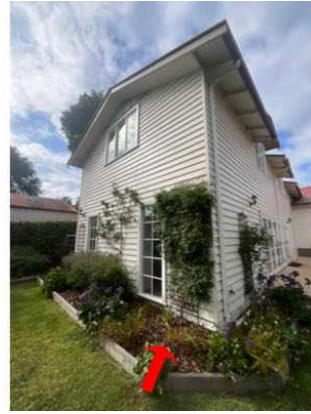
Finding 6.02

Building:
Location: All External Areas
Finding: Garden Beds - Conditions Conducive to Termites
Information: Garden beds were found to be evident around and against the property. These garden beds can include untreated timber, and with a combination of moisture from rainfall and hosing, can make conditions conducive to termite activity and termite ingress.

The removal and replanting of species that do not provide "cover" or cutting back of existing vegetation will assist greatly in preventing this from occurring.

Where removal of any such materials that may be conducive to termite activity is not possible or practical regular monitoring of the areas should be carried out to minimize the risk of potential termite attack.

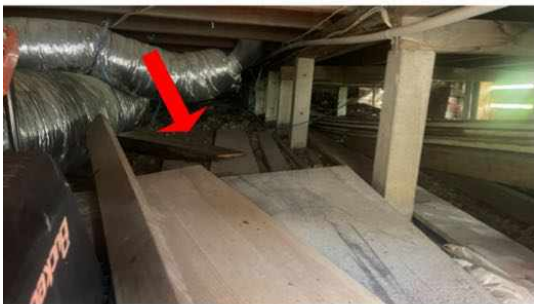
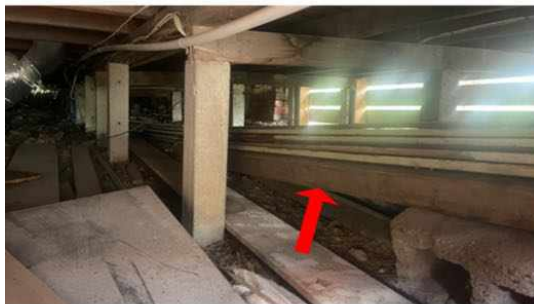
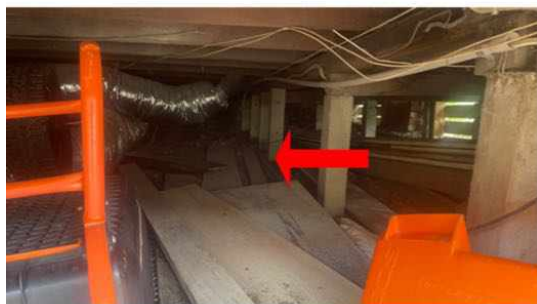
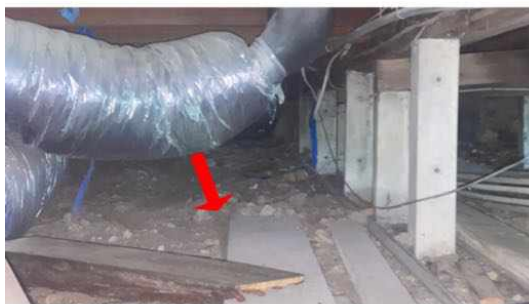
Finding 6.03

Information: The storing of timbers in the subfloor space increases the risk of termite activity being present. As they are likely to come into contact with weather conditions or excessive moisture wood rot is likely to develop on timbers that are not treated.

It is highly recommended that any stored timbers be immediately removed from areas in which they may attract any termite / timber pest attack.

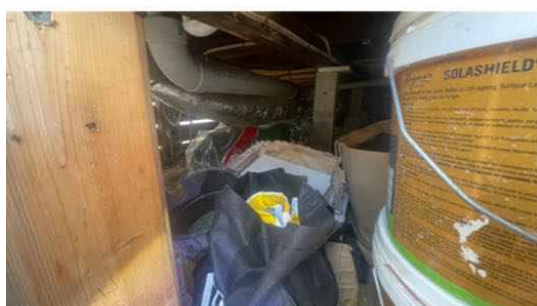
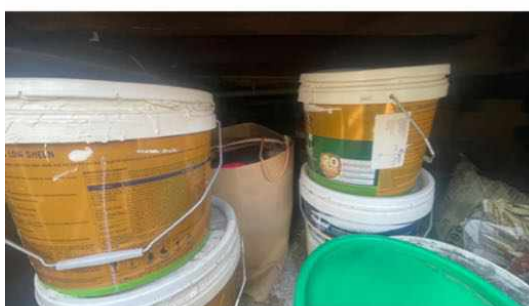
Finding 6.04

Information: An array of stored items and debris were found in the subfloor area at the time of inspection. Stored items and debris in this area restricts subfloor ventilation and creates potential for concealed pest entry. Stored timbers and other materials may also make the area susceptible to termite activity and wood rot.

Please note: stored items and debris prevented full access to the subfloor area to inspect for any pest activity or defects.

A clear and empty subfloor will be better ventilated and easier to maintain in a dry condition. The removal of any timber debris is vital in minimising the risk of termite or wood borer activity.

Any stored items and debris in the subfloor should be removed as soon as possible.

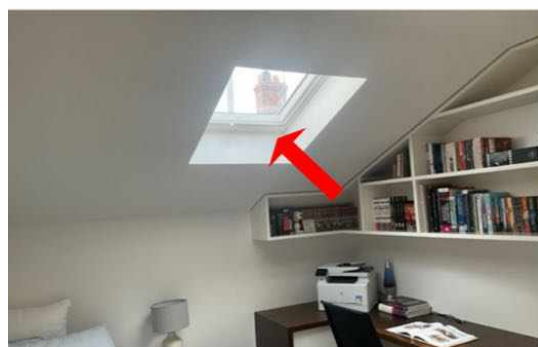
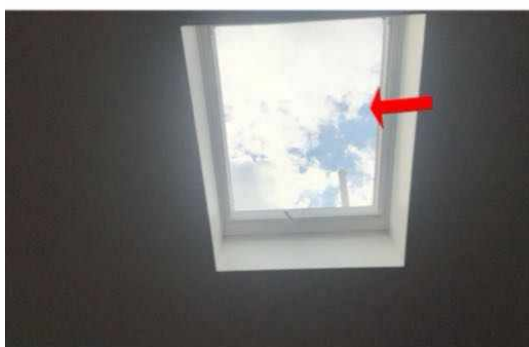
Information: It was noted the property has skylights present.

Whilst no evidence of any moisture leaking was noted during the inspection, skylights are notorious for leaking. The seals and/or flashing around the skylights can deteriorate allowing moisture to enter.

The ceilings around the skylights should be regularly monitored for any evidence of moisture leaking eg staining or bubbling of paint.

Where moisture damage is evident, a plumber should be appointed as soon as possible to identify the leak and perform rectification works as necessary, ensuring the moisture damage is restricted.

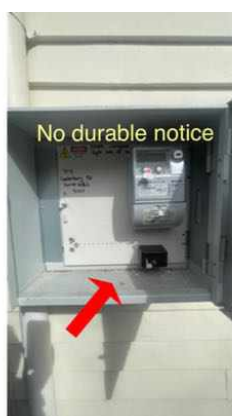
A durable notice should be placed in the switchboard unit to indicate current termite barriers. At the time of inspection, it appeared as though no termite management system has been installed, with no evidence to suggest preventative works taking place.

Information: The application of a post-construction chemical termite barrier is highly recommended for all properties, particularly if live termite activity has been found on the site previously. Such barriers are highly effective in preventing termite attack on any timber building elements throughout the property.

The client may consider gaining further advice from a pest controller as to the costs and procedures involved with this application. It is recommended that obtaining such advice be a short-term priority.

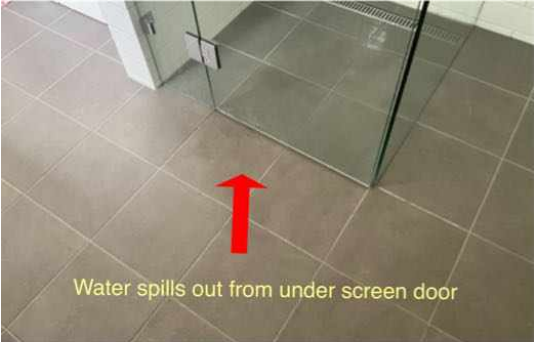
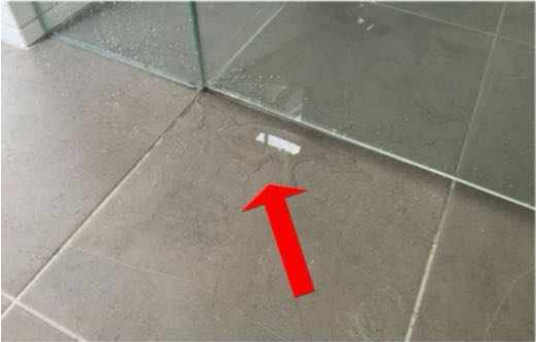
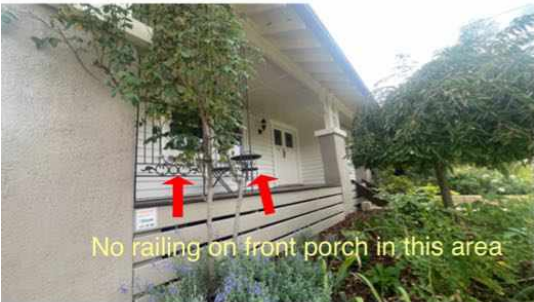
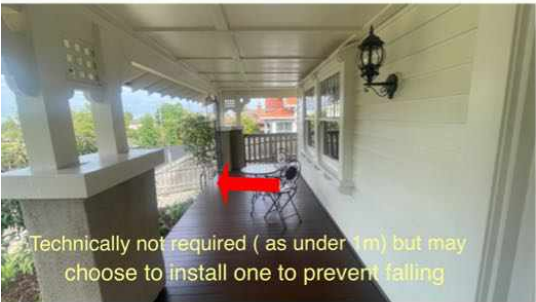
Water escapes under the shower door when the shower was operated in the main bathroom
