Building and Timber Pest Inspection Report

Inspection Date: Fri, 13 Feb 2026

Property Address: 12/12-14 Barker St, St Marys NSW 2760,
Australia

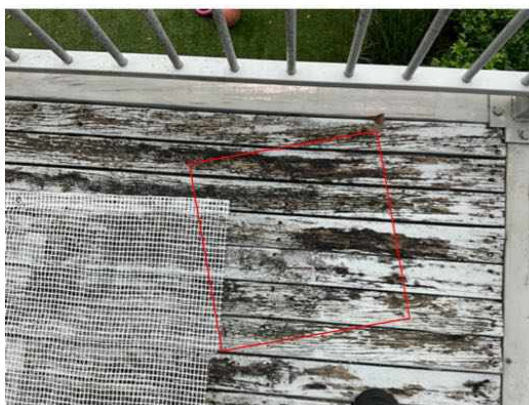
Finding 1.02

Building:	Main Building
Location:	Balcony
Finding:	Loose handrail — Fall from heights
Information:	The handrail was lacking appropriate support and fixing to the adjacent wall or floor at the time of inspection.

The handrail was further loose and moving upon minimal force applied with hand.

These handrails pose a risk and persons coming in contact may fall from heights if these handrails fail, thus causing severe injury.

A licensed builder must be appointed as soon as possible to rectify any non-compliance.

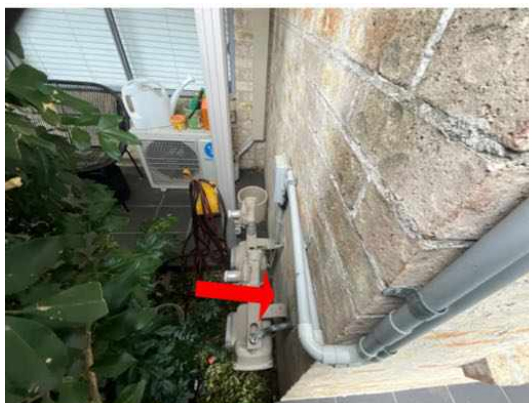
Finding 6.03

Building:	Main Building
Location:	Slab penetrations
Finding:	Service penetrations
Information:	Services into home can allow for concealed termite entry without additional or adequate termite protection.

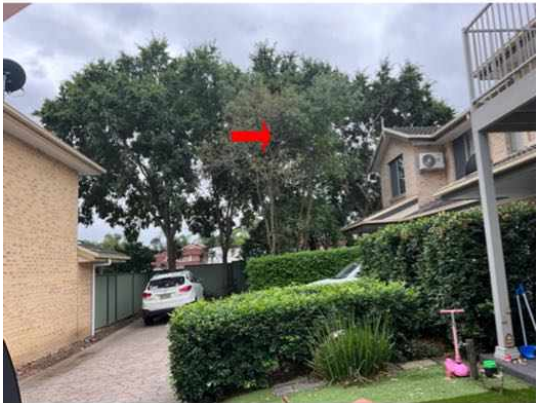
Finding 6.06

Building: Main Building
 Location: Garden beds

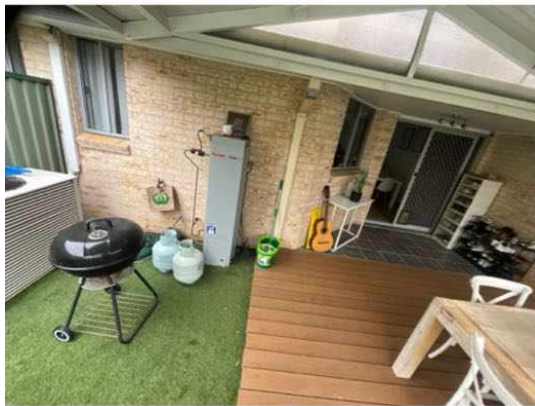
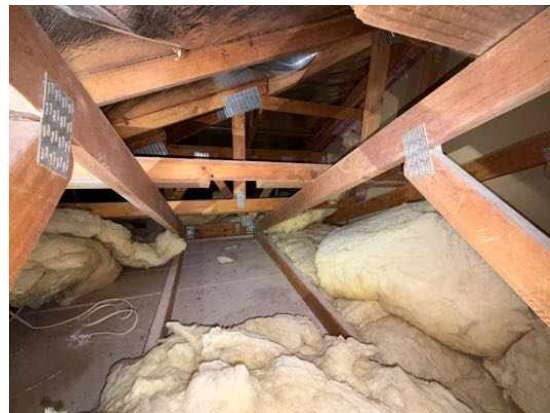
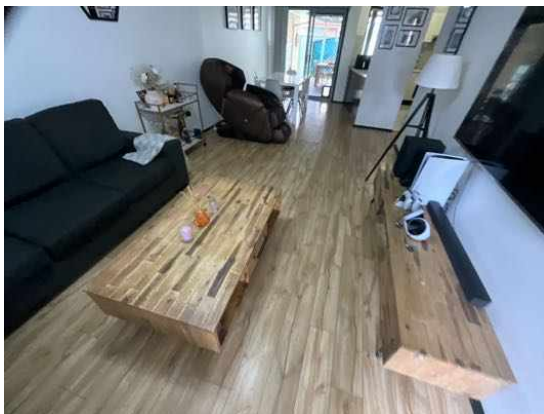
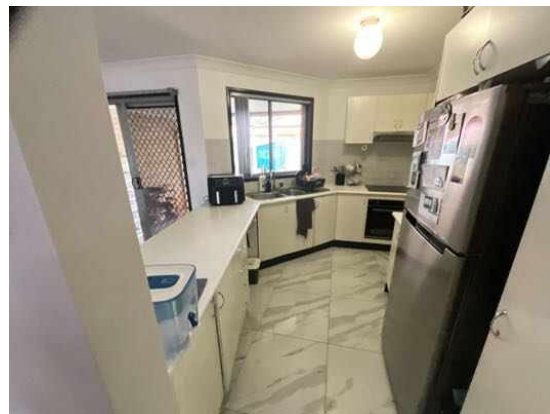
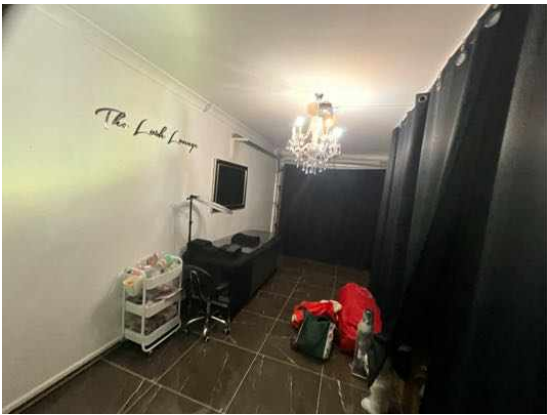
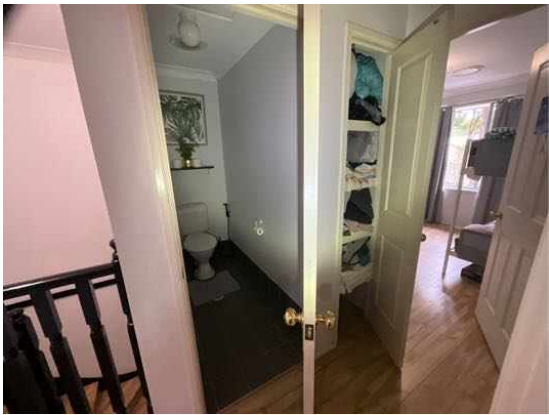
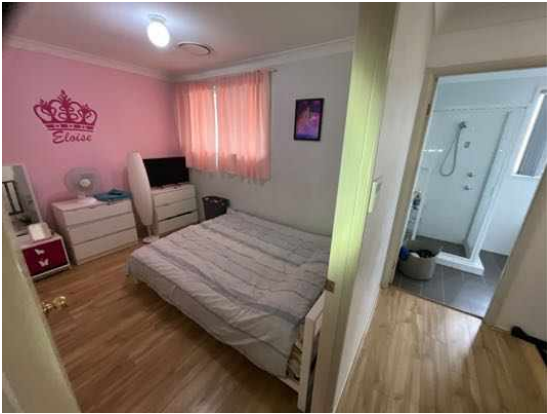
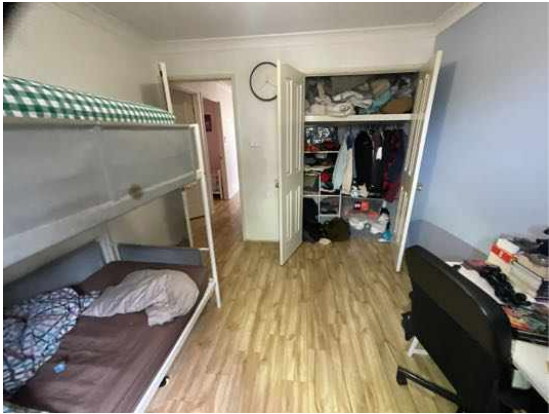
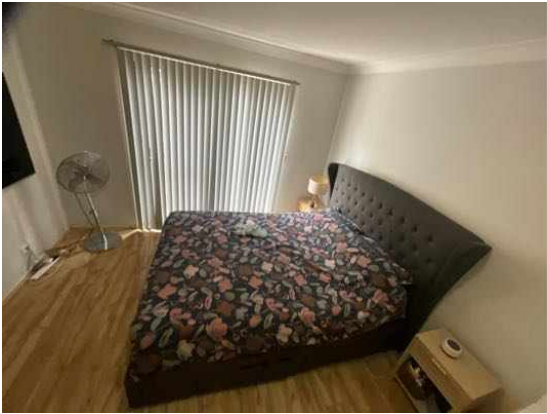
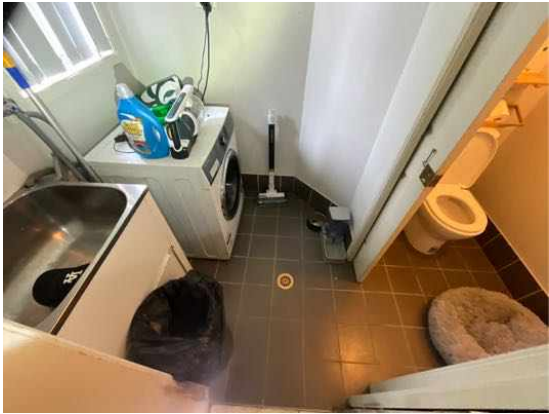
Building: Main Building
 Location: All Areas
 Finding: Additional Photos - Obstructions and Limitations
 Information:

These photographs are an indication of the obstructions and limitations which impeded full inspection of the property at the time of inspection. These obstructions can hide an array of defects and should be removed to allow full inspection to be carried out. A re-inspection is recommended once the areas are made accessible.
