Building Inspection Report

Inspection Date: Thu, 12 Feb 2026

Property Address: 9 Temple-Wood Ct, Berwick VIC 3806,
Australia

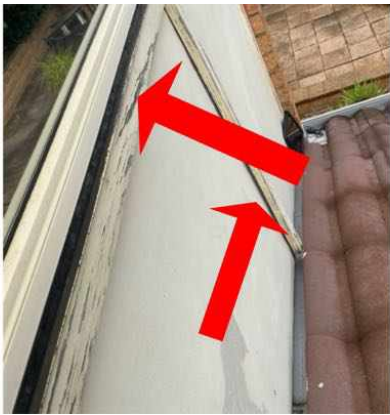
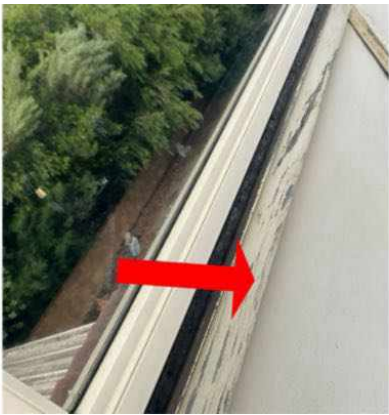
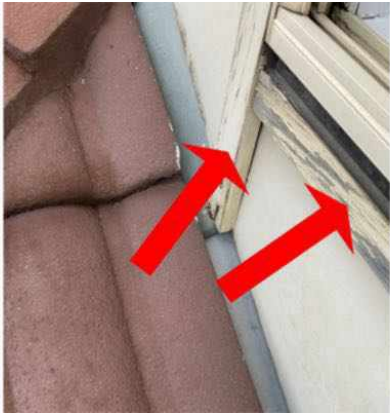
Defects 3.02

Building:	Main Building
Location:	Exterior walls - rear
Finding:	Deterioration and Cracking to External Cladding – Rear Elevation
Information:

The rear elevation of the dwelling incorporates a section of lightweight external cladding, while the remainder of the dwelling is constructed of brickwork. The cladded section was observed to exhibit multiple defects, including vertical and irregular cracking to the sheet joints, localised timber deterioration, and areas of paint breakdown. The lower flashing adjacent to the tiled roof surface shows significant surface corrosion and staining. In addition, sections of timber trim and window framing display advanced paint failure and early-stage decay, particularly at joints and exposed edges.

Cracking to cladding sheets may be associated with differential movement, inadequate joint detailing, moisture exposure, or ageing of the material. The presence of timber deterioration suggests prolonged exposure to moisture, likely due to weathering, inadequate sealing, or flashing performance. Corroded flashings may reduce effective weatherproofing and can contribute to moisture ingress behind the cladding system. If left unaddressed, continued deterioration may lead to progressive timber decay, potential water penetration into the wall cavity, and structural damage to framing elements.

A registered builder should be engaged to further assess the condition of the cladding system, including removal of affected sections if required to inspect the underlying framing. Damaged or deteriorated cladding sheets and timber components should be replaced as necessary, corroded flashings renewed with appropriate corrosion-resistant materials, and all joints properly sealed. All exposed timber should be repaired or replaced, primed, and repainted using suitable external-grade coatings to restore weather resistance and durability.

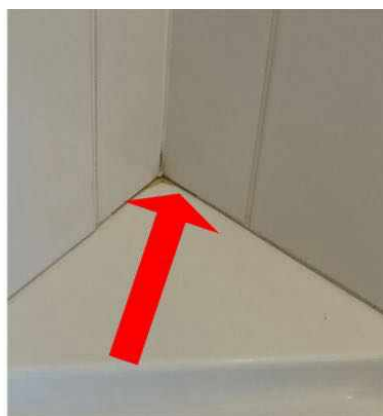
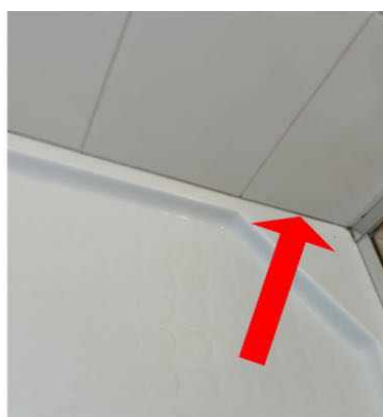
Defects 3.03

Building: Main Building
Location: Bathroom 2
Finding: Sealant and grouting - deteriorated
Information: It was noted on inspection that sealant or grout is degraded to the tiled shower alcove and or other areas of the bathroom.

Different materials and floor areas move at different rates, generally causing cracking to grout or sealant at this point. A flexible sealant is required to allow for expected expansion and contraction, while keeping the joint water tight and protective of all associated building materials.

Flexible and mould resistant materials should be applied to affected areas to prevent any subsequent water damage that is likely to occur. Regular maintenance and replacement of damage or missing or damaged sealant and grout is highly recommended to the wet areas, as this is a regular wear and tear defect. Sealant and grouting in areas that come into regular contact with water should be maintained for the long term care of your property.

A sealant specialist or tiling contractor should be appointed to complete these works as soon as possible

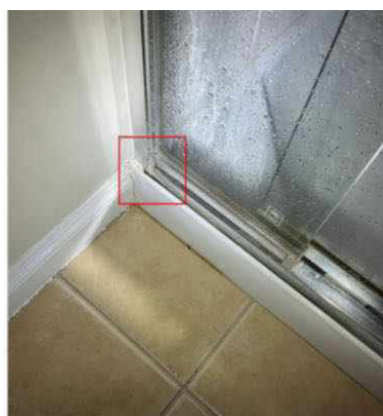
Defects 3.04

Building: Main Building
 Location: Bathroom 2
 Finding: Shower screen - Leaking
 Information: Leaking was evident to the 2nd bathroom's shower screen at the time of inspection. It is suspected that the leaking has occurred as a result of deteriorated or missing caulking to the shower or general ageing of the building elements.

Leaking from the shower where left unattended, is likely to lead to water damage to adjoining flooring and walls. Such damage can lead to water damage and necessitate extensive remedial works being required. Active water leaks may also create an environment that is susceptible to the formation and development of mould.

Appointment of a caulking contractor is required to repair or replace the caulking to the shower area. Such works should be performed as soon as possible to ensure that no further damage occurs.

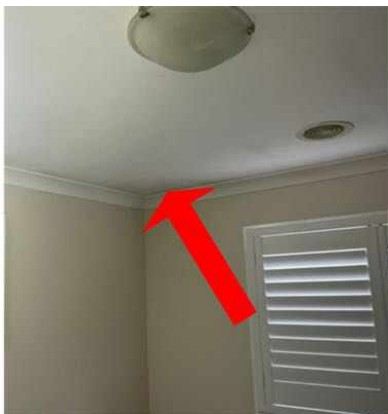
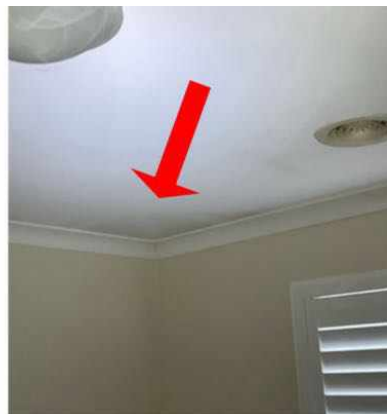
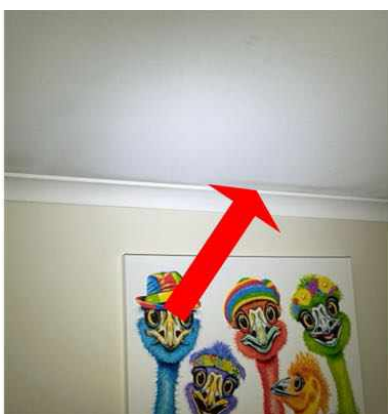
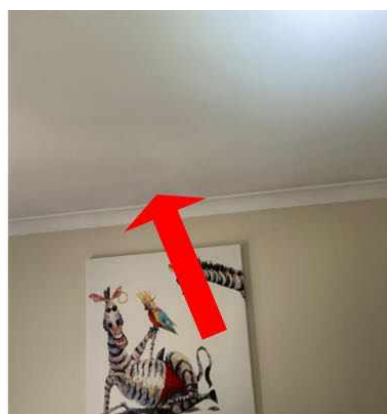
Defects 3.05

Building: Main Building
 Location: Bedroom 3 and 4
 Finding: Ceiling Discolouration – Bedrooms 3 and 4
 Information: Darkened spots and minor staining were observed to the ceiling linings within

Bedrooms 3 and 4. The staining appeared localised and cosmetic in nature, with no visible distortion, or deterioration of the plasterboard noted at the time of inspection. Thermal imaging was conducted during the assessment and did not identify any abnormal temperature differentials suggestive of active moisture intrusion. Non-invasive moisture meter testing was also undertaken, with readings recorded within normal ambient ranges.

Based on the testing carried out at the time of inspection, there was no evidence of active water ingress. The staining may be historical in nature, potentially associated with a previous minor leak that has since been rectified, or may be related to painting defects, ageing of finishes, or minor condensation-related marking. However, as building inspections are limited to the visible and accessible areas only, concealed defects cannot be entirely ruled out.

It is recommended that the affected areas be monitored for any changes, particularly during or after significant rainfall events. If staining worsens, spreads, or moisture readings increase, a licensed plumber or roofing contractor should be engaged to further investigate the roof space and external roof covering above these rooms. If confirmed as cosmetic only, preparation and repainting by a qualified painter would be appropriate.

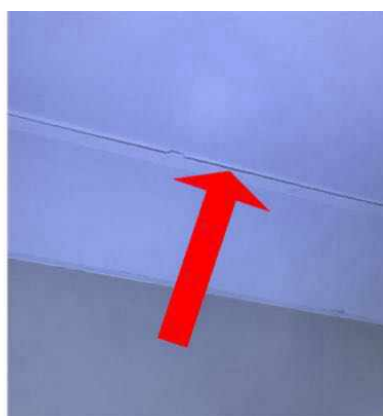
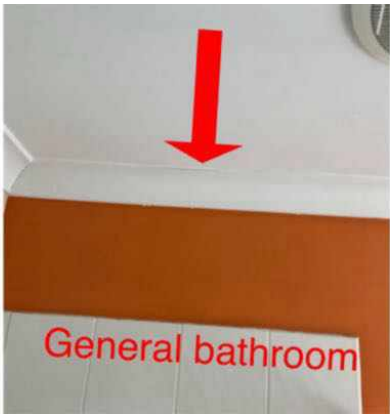
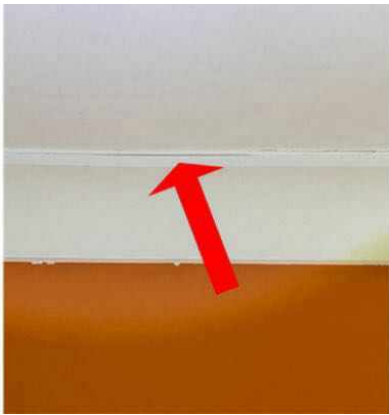
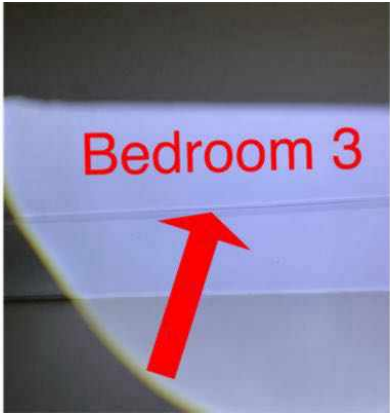
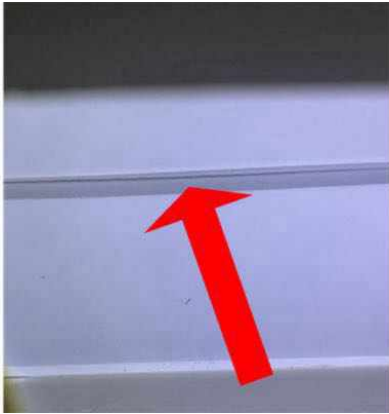
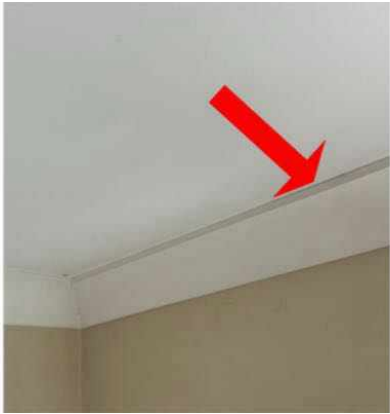
Defects 3.06

Separation gaps were observed between the plaster cornices and the ceiling lining at multiple locations throughout the upper level, including bedrooms and wet areas (ensuite and bathroom). The gaps appear as linear cracking and joint separation along the cornice-to-ceiling junction, with localised areas of visible movement. The condition appears widespread to Level 1, while the ground floor ceilings were noted to be unaffected at the time of inspection.

Moisture testing to the affected areas returned readings within normal ambient ranges, and thermal imaging did not indicate active moisture ingress. A visual inspection within the accessible roof space did not identify obvious structural displacement or significant fixing failure to the ceiling framing. Based on the observations, the condition is more consistent with differential movement, minor structural settlement, seasonal timber shrinkage/expansion, or inadequate original fixing of ceiling sheets and/or cornices, rather than active water penetration.

Although this does not presently appear to be a major structural defect, ongoing movement may result in progressive cracking and aesthetic deterioration. A qualified plasterer should be engaged to assess the extent of movement and determine whether additional mechanical fixing of ceiling sheets is required prior to repairs. Subject to confirmation that no structural or moisture-related cause exists, rectification would typically involve re-securing any loose sections, applying flexible joint compound or sealant to accommodate minor movement, followed by preparation and repainting to restore a uniform finish. Continuous monitoring is recommended to ensure the separation does not worsen over time.

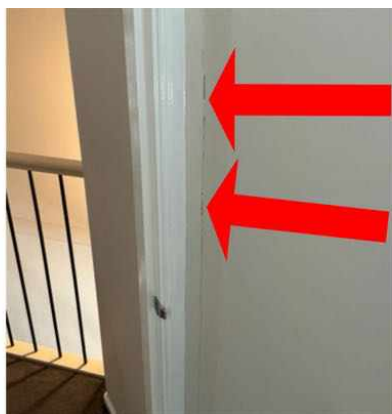
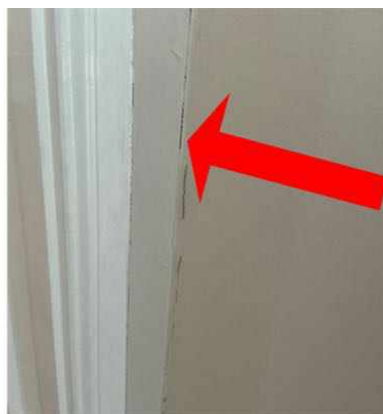
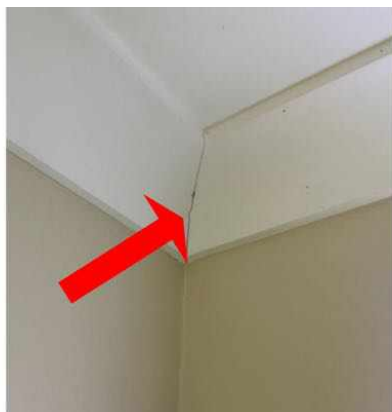
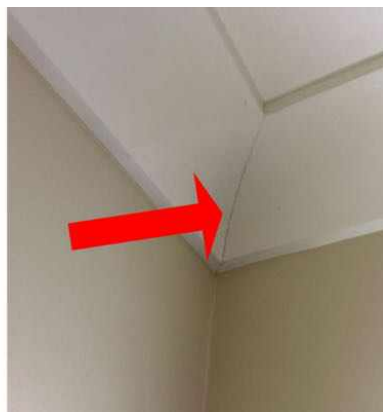
Defects 3.07

Building:	Main Building
Location:	All Internal Areas
Finding:	Minor Internal Movement Cracking and Joint Separation – General
Information:	Minor separation gaps and hairline cracking were observed internally around cornice joints, ceiling-to-wall junctions, internal door frames, architraves, and wall junctions throughout the dwelling. The cracking appears consistent with typical building movement, settlement, and seasonal expansion and contraction of materials. No significant distortion, structural displacement, or moisture-related damage was identified in the affected areas at the time of inspection.

Such conditions are common in residential dwellings, particularly in double-storey construction where differential movement between levels may occur over time. Minor shrinkage of timber framing, normal settlement, and drying of plaster compounds can contribute to joint separation at cornices and architraves. Based on visual inspection, the condition appears cosmetic in nature rather than structural.

Rectification, if desired for aesthetic reasons, would involve raking out loose material where required, applying a suitable flexible joint compound or paintable sealant to accommodate minor movement, followed by preparation and repainting. A qualified plasterer or painter may be engaged to carry out these works. Ongoing minor cracking may reoccur due to normal building movement and should be considered part of routine maintenance.

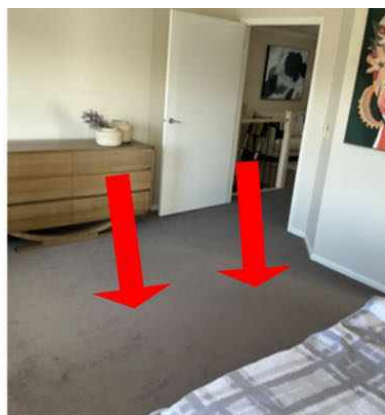
Defects 3.08

Building:	Main Building
Location:	Bedroom - Master
Finding:	Squeaking Subfloor Beneath Carpet – Master Bedroom (Upper Level)
Information:	The floor to the master bedroom at the upper level, which is finished with carpet, was observed to produce noticeable squeaking sounds under normal foot traffic in multiple areas, particularly upon entry to the room. Although the visible surface finish is carpet, the noise is originating from movement within the underlying structural floor system (timber floor sheeting fixed to timber joists).

Squeaking typically occurs where the floor substrate (such as particleboard or plywood sheeting) has loosened from the supporting joists, where fixings have withdrawn over time, or where inadequate fixing was provided at the time of construction. This results in minor vertical movement and friction between components when load is applied. While this condition does not necessarily indicate structural failure, continued movement may lead to further loosening of fixings and ongoing nuisance noise, affecting occupant comfort and amenity.

If the client finds the condition unacceptable, a qualified carpenter should be engaged to investigate and rectify. Rectification generally involves carefully lifting the carpet and underlay in the affected areas, re-securing the floor substrate to the supporting joists using appropriate screws (rather than nails) to minimise future movement, and then reinstating the carpet finish. Works should be carried out using proper carpentry

methods to ensure long-term stability of the floor system.

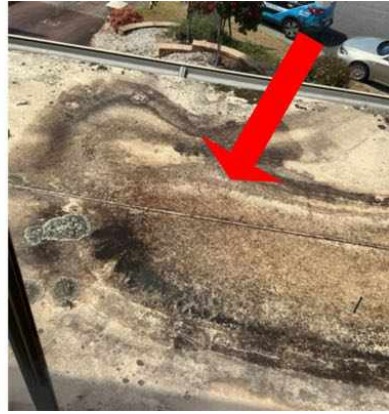
Defects 3.09

Building: Main Building
 Location: Roof Exterior
 Finding: Inadequate Falls and Ponding to Porch Roof Surface
 Information:

The flat roof surface located above the porch entrance was observed to be holding significant ponded water and accumulated debris staining. Visual evidence indicates inadequate falls towards the perimeter gutter, resulting in water pooling across the membrane surface rather than discharging efficiently into the gutter system. The extent and pattern of staining suggest this is an ongoing condition rather than a temporary occurrence.

Persistent ponding on low-slope roofing surfaces can accelerate membrane deterioration, increase the risk of water ingress, and place unnecessary dead load on the roof structure. Over time, this may lead to membrane failure, joint breakdown, internal moisture ingress, ceiling damage to the porch area below, and potential concealed structural decay. Inadequate drainage also promotes debris accumulation, which can further obstruct water flow and exacerbate the issue.

A qualified roofing contractor should be engaged to assess the roof falls and drainage configuration without delay. Rectification may involve regrading the substrate to provide compliant falls towards the gutter, installation of a tapered screed system, or modification of drainage outlets to ensure effective discharge of stormwater. All works should be carried out in accordance with the NCC and relevant Australian Standards to ensure proper long-term performance.

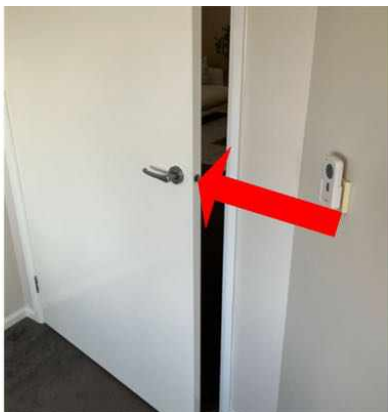
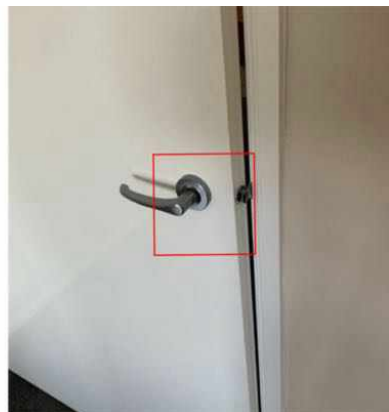
Defects 3.10

Building: Main Building
 Location: Bedroom - Master
 Finding: Door handle - Not latching
 Information: It was noted that the door in master bedroom was not latching during operation at the time of inspection. Whilst detracting from the functionality of this building element, this minor defect may also be a security risk, and may therefore have serious implications if left unattended.

It is suspected that this defect has occurred due to minor issues with the associated hinges. Such damage is identified as general wear and tear, which is expected for building elements of this age.

A qualified carpenter or general handyperson may be appointed to perform rectification works as necessary, at client discretion. If left unattended, further functional impairment is likely to occur.

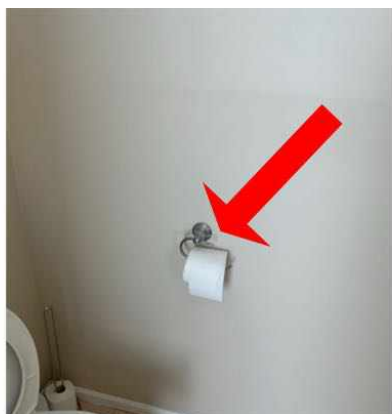
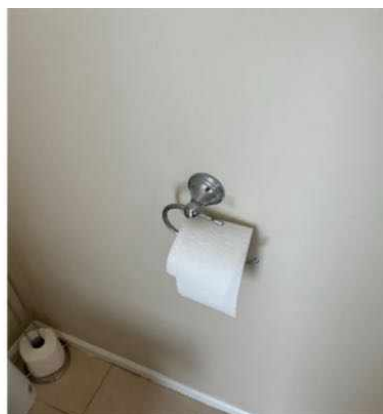
Defects 3.11

Building: Main Building
 Location: Ensuite - Master
 Finding: Toilet roll holder - Loose

Information: The toilet roll holder was found to be loose at the time of inspection. While not a major operational defect, function can deteriorate if the problem is left unmanaged.

It is advised that the homeowner performs remedial works to re-attach the toilet roll holder to its original fixing. A general handyperson may be required to perform these works.

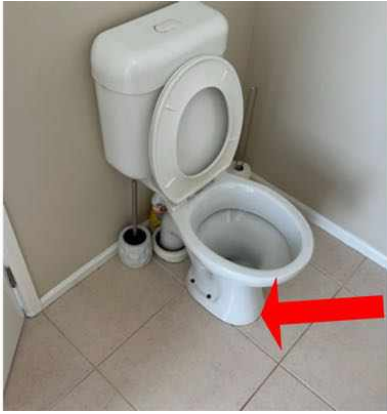
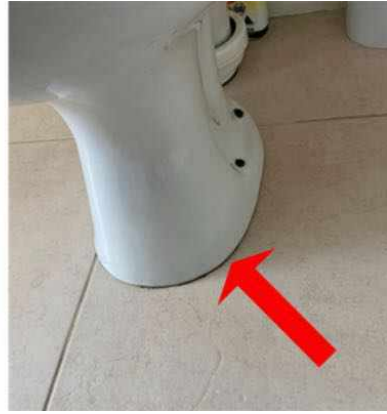
Defects 3.12

Building: Main Building
 Location: Ensuite - Master
 Finding: Unstable Master Ensuite Toilet and Inadequate Perimeter Sealing
 Information:

The toilet suite located within the master ensuite was observed to be inadequately secured to the floor substrate. The fixture exhibited slight movement when lateral pressure was applied, indicating insufficient anchorage or potential loosening of the fixing bolts. Additionally, the base of the toilet pan was not sealed to the finished floor surface with an appropriate flexible waterproof sealant.

Movement of the toilet pan can compromise the integrity of the pan collar seal and may lead to water leakage at the waste connection over time. Continued movement increases the risk of concealed moisture damage to the subfloor and surrounding finishes, and may result in odour escape or hygiene concerns. The absence of perimeter sealing also allows water intrusion beneath the pan during cleaning or minor overflow events, which can contribute to deterioration of floor finishes and potential microbial growth.

A licensed plumber should be engaged to remove and reset the toilet suite, ensuring it is properly secured to the floor with appropriate fixings and that the pan collar seal is inspected and replaced if required. Upon reinstallation, the base of the toilet pan should be sealed with a high-quality flexible waterproof sanitary-grade sealant in accordance with best plumbing practice.

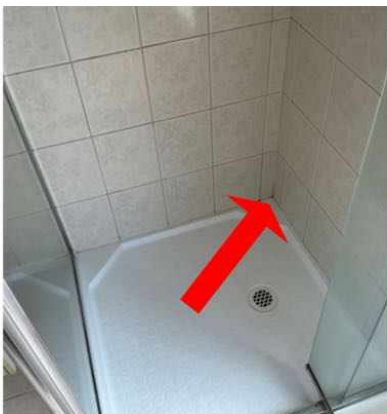
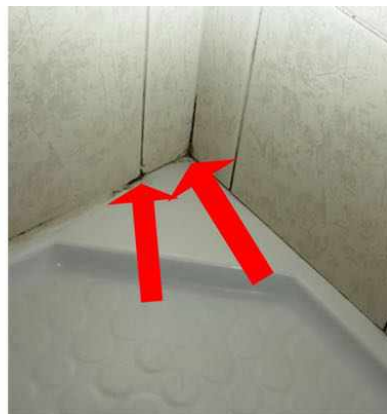
Defects 3.13

Building:	Main Building
Location:	Ensuite - Master
Finding:	Sealant and grouting - Deteriorated
Information:	It was noted on inspection that sealant or grout is degraded to the tiled shower alcove and or other areas of the bathroom.

Different materials and floor areas move at different rates, generally causing cracking to grout or sealant at this point. A flexible sealant is required to allow for expected expansion and contraction, while keeping the joint water tight and protective of all associated building materials.

Flexible and mould resistant materials should be applied to affected areas to prevent any subsequent water damage that is likely to occur. Regular maintenance and replacement of damage or missing or damaged sealant and grout is highly recommended to the wet areas, as this is a regular wear and tear defect. Sealant and grouting in areas that come into regular contact with water should be maintained for the long term care of your property.

A sealant specialist or tiling contractor should be appointed to complete these works as soon as possible

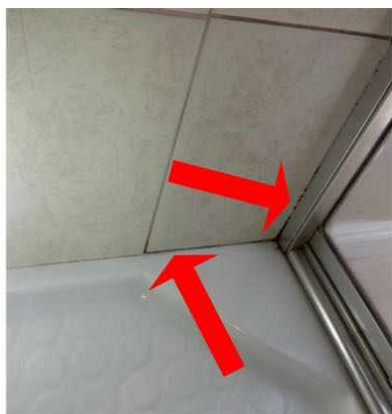
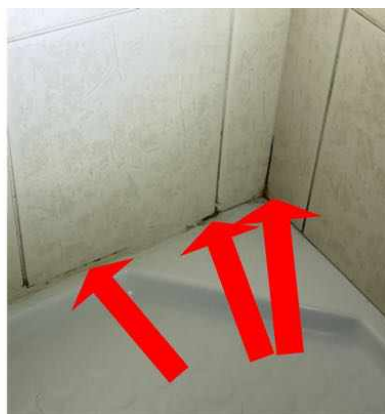
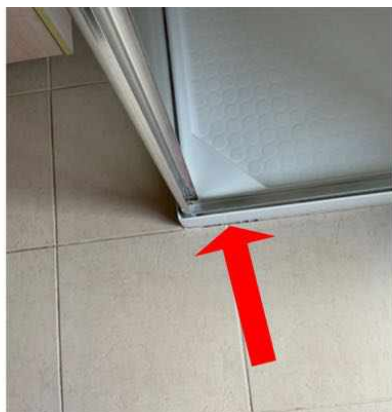
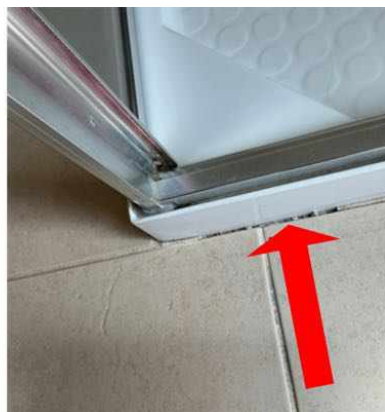
Defects 3.14

Building:	Main Building
Location:	Ensuite
Finding:	Shower - Damp
Information:	Damp is evident to the lower 300mm of wall to the shower alcove. This defect is quite common, and is suspected to have been caused by moisture permeating through the grouting in this area, which shows evidence of deterioration. Leaking pipes within the adjoining wall is also a possible cause.

Damp (or structural damp) refers to the presence of unwanted moisture in the structure of a building, either as the result of intrusion from outside, or condensation from within the structure. In the shower area, internal water leaks or other sources of excessive moisture are generally the cause of damp.

Unmanaged damp in the shower recess is likely to facilitate the formation and development of mould and fungi growth, decaying associated building materials and compromising their structural integrity. It is important to address damp conditions, as the World Health Organisation notes that excess moisture leads - on almost all indoor materials - to growth of microbes such as moulds, fungi and bacteria, which subsequently emit spores and other matter into the indoor air. Exposure to these contaminants is associated with a wide range of respiratory and other health-related problems.

Consultation with a qualified plumber or bathroom specialist is advised immediately to identify the cause of damp and to perform remedial works as required. Where excessive mould growth is present, further inspection by a specialist environmental health inspector should also be considered.

Always ensure that sealant and grout is in good condition to prevent any moisture issues occurring in the future.

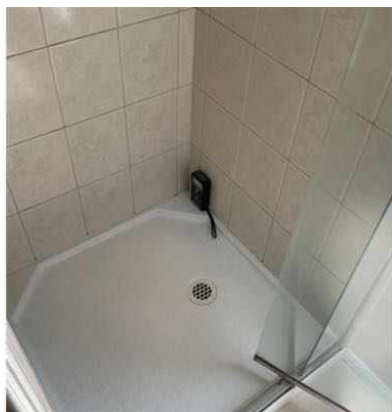
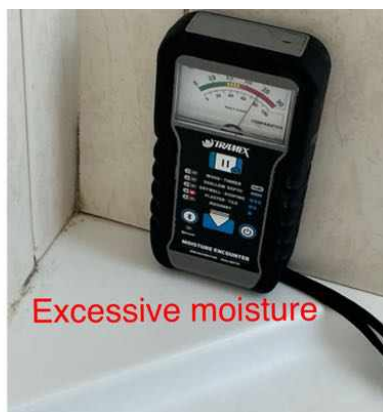
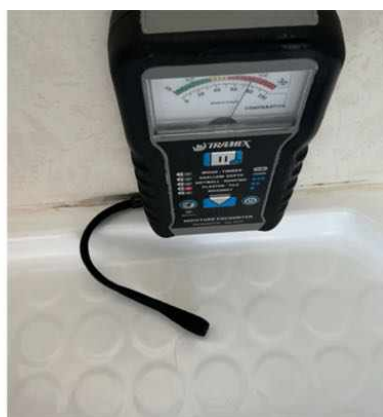
Defects 3.15

Building:	Main Building
Location:	Bedroom - Master
Finding:	Shower screen - Leaking
Information:	Leaking was evident to the master ensuite's shower screen at the time of inspection. It is suspected that the leaking has occurred as a result of deteriorated or missing caulking to the shower or general ageing of the building elements.

Leaking from the shower where left unattended, is likely to lead to water damage to adjoining flooring and walls. Such damage can lead to water damage and necessitate extensive remedial works being required. Active water leaks may also create an environment that is susceptible to the formation and development of mould.

Appointment of a caulking contractor is required to repair or replace the caulking to

the shower area. Such works should be performed as soon as possible to ensure that no further damage occurs.
