Building and Timber Pest Inspection Report

Inspection Date: Wed, 25 Mar 2026

Property Address: 17 Brunel St, Malvern East VIC 3145,
Australia

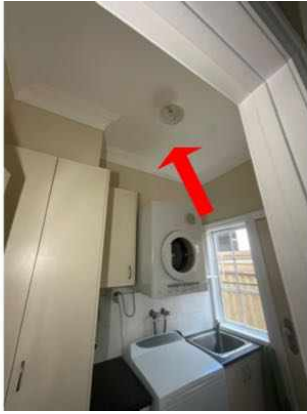
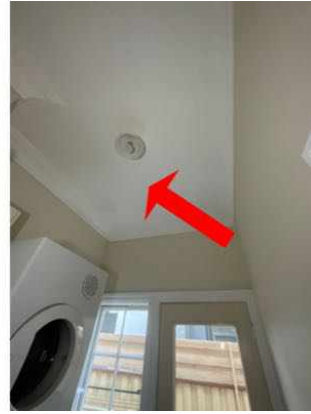
Finding 3.09

Building:	
Location:	All Areas
Finding:	Cracking - fine
Information:	Some fine cracking was noted throughout the property.

Note: photos included are indicative of fine cracking noted at the the time of inspection. Other fine cracks may be present but not recorded here.

Monitoring of all cracking should be conducted frequently. Always contact a building inspector should cracks widen, lengthen, or become more numerous.

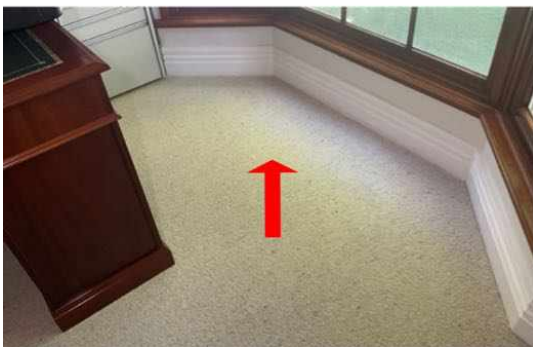
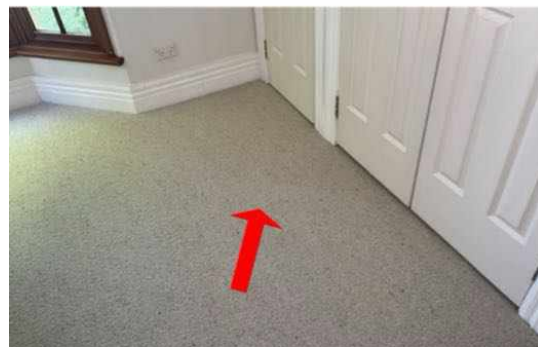
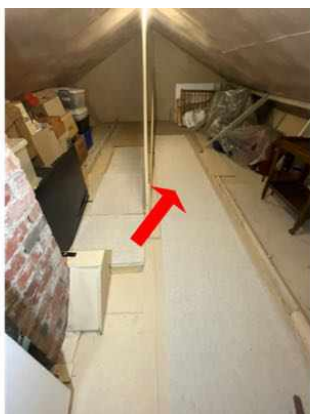
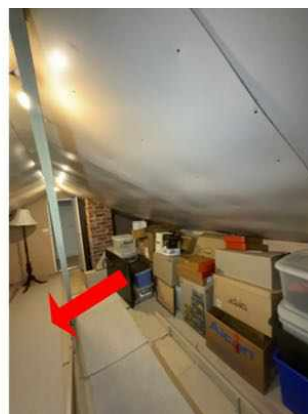
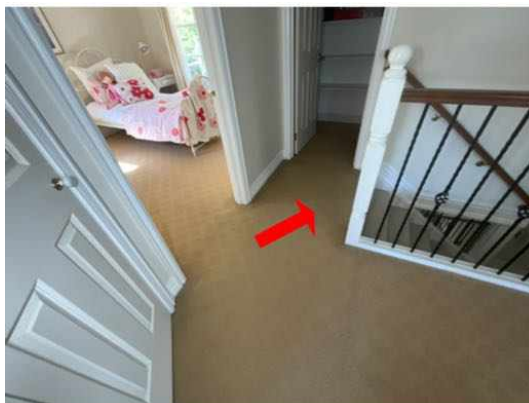
Creaking floors generally indicate that the floorboards or the subfloor structures are coming loose from the supporting structure that they are installed on.

The areas should be monitored for any changes or unevenness. Should this occur, consultation with a registered builder should be undertaken to determine the cause . The potential resolution may involve regluing and screwing the floor down through to replacement of subfloor support structures.

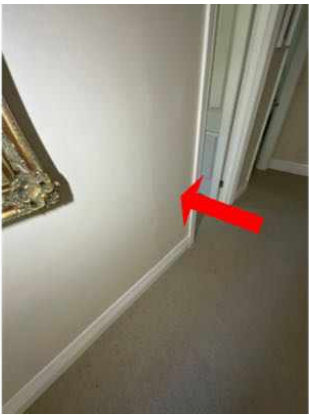
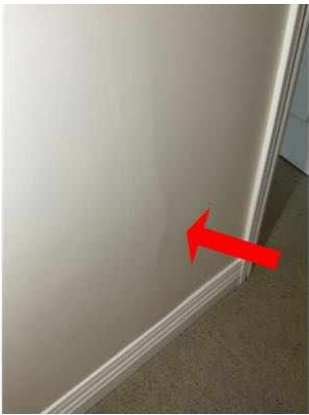
Finding 3.12

Building:	
Location:	Hallway
Finding:	Cracks and crack repairs noted to internal solid plaster surfaces
Information:	Cracking and previous patching of cracks was noted to areas of the internal solid plaster surfaces. Generally these cracks are the result of movement in the foundations of the property and occur quite easily.

It is recommended that the cracks be monitored for a period of time to determine any ongoing cracking. After the monitoring period, should the crack not have changed, in repaired can be filled.

Consultation with a solid plasterer or painting contractor should be sought .

Always contact your building inspector should cracks widen, lengthen, or become more numerous.

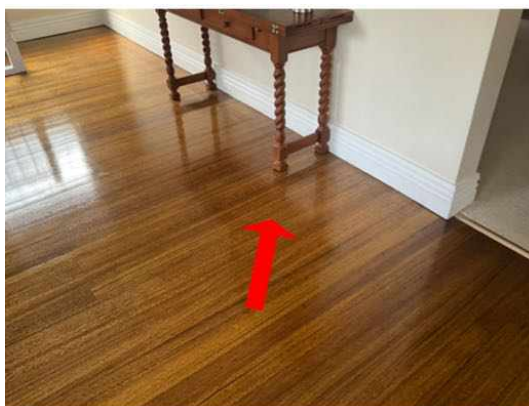
Bouncy floors generally indicate that the floorboards or the subfloor structures are coming loose from the joists that they are installed on. Bouncy flooring may also be the result of gaps between flooring and stumps or joist structures, which require packing.

Where necessary, the client is advised to seek quotations for required repairs from a Registered Builder specialising in re-stumping. The potential resolution may range from packing gaps in subfloor structures through to replacement of subfloors stumps and refixing of flooring.

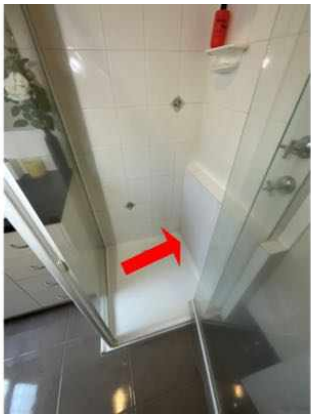
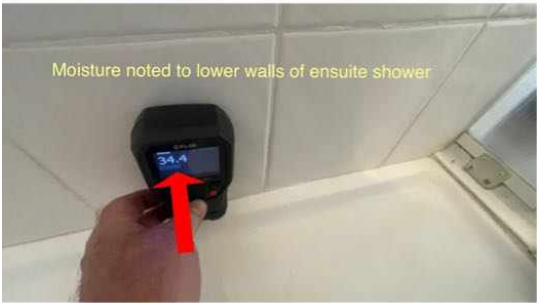
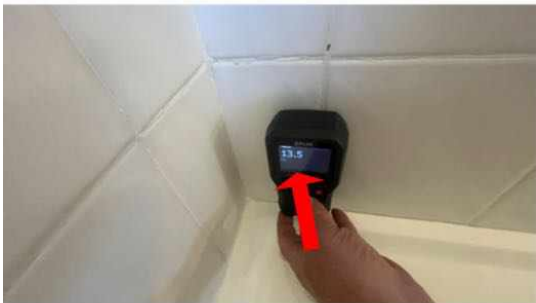
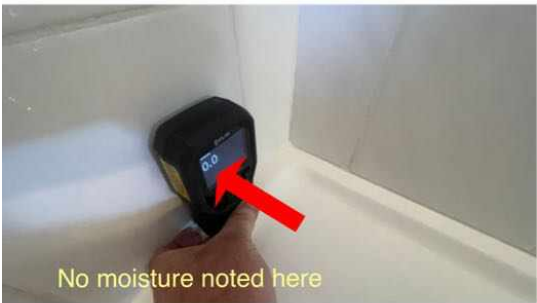
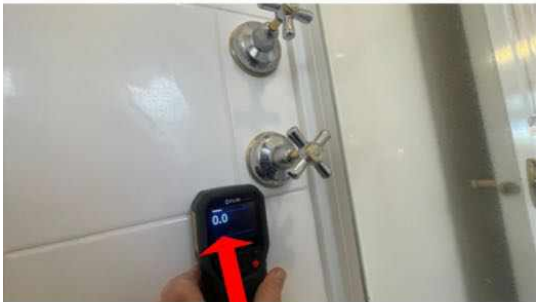
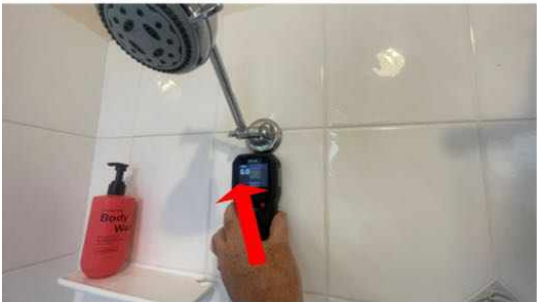
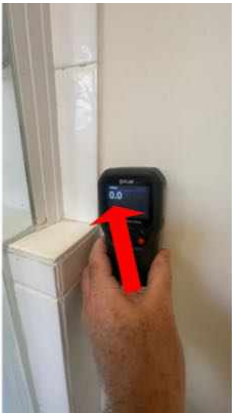
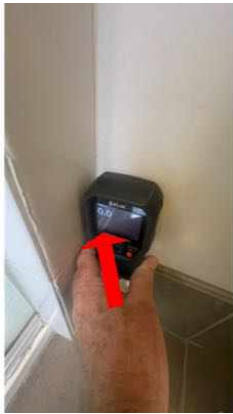
Finding 3.14

Finding: Shower - Damp noted within wall of shower

Information: Damp was evident to the lower part of one of the tiled walls within the ensuite shower when tested with a moisture meter. This defect is quite common, and is suspected to have been caused by moisture permeating through the grouting in this area, which shows evidence of deterioration. Leaking pipes within the adjoining wall is also a possible cause. (Note there was no moisture noted to the wall immediately behind the shower - which is under the stairs.)

Damp (or structural damp) refers to the presence of unwanted moisture in the structure of a building, either as the result of intrusion from outside, or condensation from within the structure. In the shower area, internal water leaks or other sources of excessive moisture are generally the cause of damp.

Unmanaged damp in the shower recess may facilitate the formation and development of mould and fungi growth. It is important to address damp conditions, as the World Health Organisation notes that excess moisture leads - on almost all indoor materials - to growth of microbes such as moulds, fungi and bacteria, which subsequently emit spores and other matter into the indoor air. Exposure to these contaminants is associated with a wide range of respiratory and other health-related problems.

Please note: the shower appeared to have recently been used which can affect the readings of the meter.

Should staining to the wall behind the bathroom occur, consultation with a qualified plumber or bathroom specialist would be advised immediately to identify the cause of damp and to perform remedial works as required.

Always ensure that sealant and grout is in good condition to prevent any moisture issues occurring in the future.

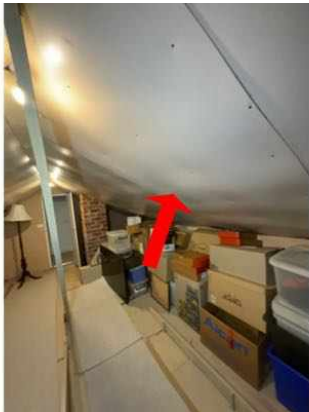
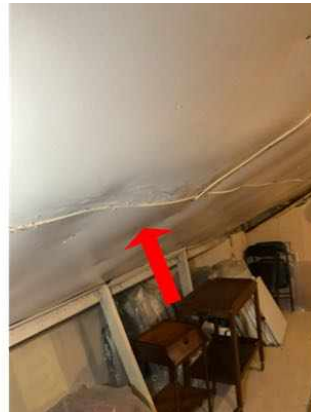
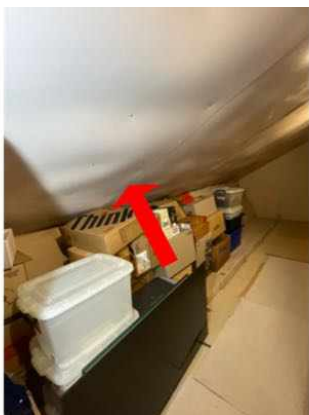
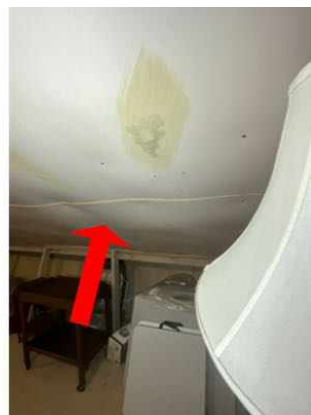
At the time of inspection, the ceiling linings within the roof void were sagging slightly in some areas. No evidence of any leaking was observed.

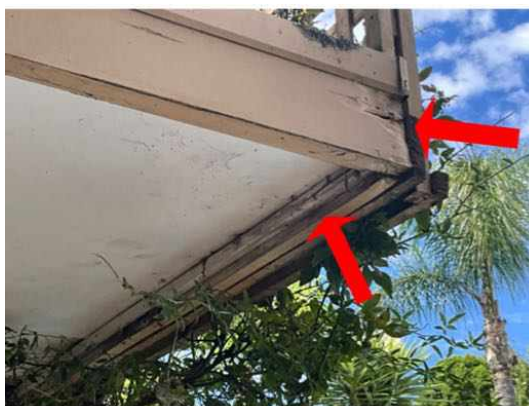
Finding 3.17

Building:
Location: All External Areas
Finding: Fascia and rafters - Wood rot noted
Information: Wood rot was found to be affecting the fascia and rafters in these areas. Wood rot, also known as Fungal Decay, occurs when timbers and other cellulose building materials are exposed to damp conditions on an ongoing basis.

It is likely that this wood rot has developed as a result of faults in the roof cover or plumbing, creating excessive moisture in this areas. Frequent exposure to rain and other weather conditions also make fascias and rafters susceptible to accelerated deterioration.

Early intervention and regular maintenance will prolong the useful life of these building elements. Prior to any works being performed, the cause of the moisture that has created the visible wood rot should be identified and addressed in a suitable manner.

It is advised that a roof plumber be appointed to inspect all roof plumbing and subsequently identify the cause of the wood rot. Replacement of affected fascias and barges may then be a necessary step in protecting surrounding building elements from such deterioration.

A qualified plumber may be appointed to assess the cause of excessive moisture and to provide advice on any remedial works as required. A qualified carpenter or registered builder may also be required to replace affected building materials.

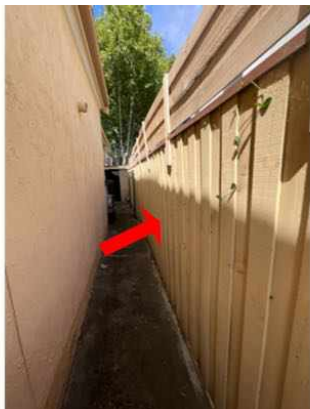
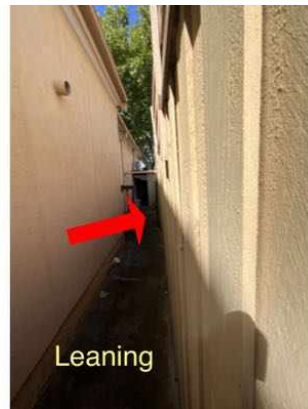
Finding 3.18

Building:
Location: Yard - Back
Finding: Fencing - leaning with some areas of deterioration
Information: It was noted at the time of inspection that sections of the side fencing either side of the property were leaning slightly. Some areas of deterioration were also noted.

Typically fencing deteriorates due to age and or wear, rot and or rust which is generally expected for a structure of this age, due to prolonged exposure to weather conditions. Sometimes inadequate installation or maintenance can be to blame.

Should further damage occur, repair of several elements of the fencing may be required. Replacement may also be a consideration.

A licensed fencing contractor should be appointed to provide further advice and perform rectification works as necessary.

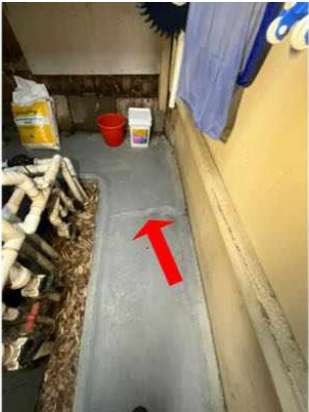
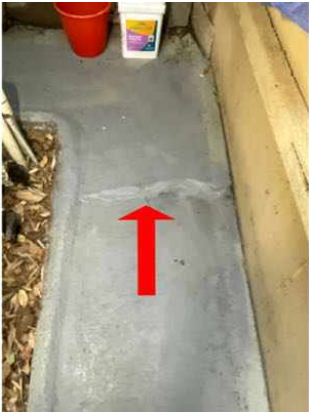
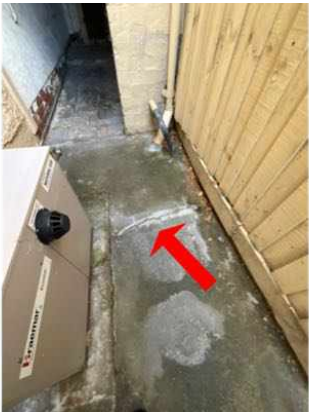
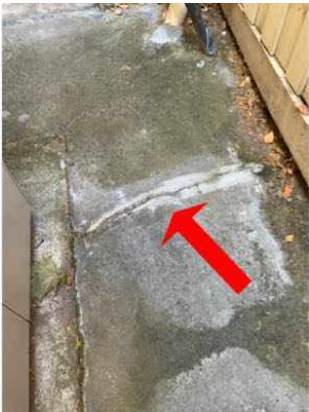
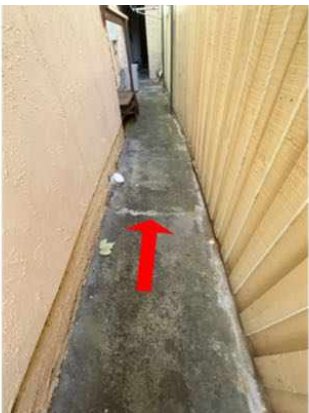
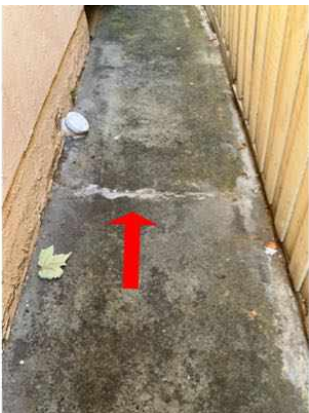
Building:
Location: All External Areas
Finding: Noticeable Cracking - External Concrete Paving
Information: Noticeable cracks were identified in the concrete paving around the property.

General age and expected deterioration of the paved areas is a common cause of this type of cracking. However, expansion and contraction of the driveway may also have occurred due to environmental factors. Such factors include variable moisture and weather conditions, the presence of trees and their roots having a settling or lifting affect on the soil, or the effect of load bearing, e.g. heavy vehicles over a sustained period of time.

Cracking to this degree may also be due to poor original installation of the driveway. Factors such as poor compaction of the sub surface and/or inadequate reinforcing of the slab may create cracking and other secondary defects. Noticeable cracks may also be due to subsidence of soils.

The area should be monitored for any changes that may occur and potentially cause tripping hazards. Should this occur, repair and likely replacement of the concrete paving may be necessary.

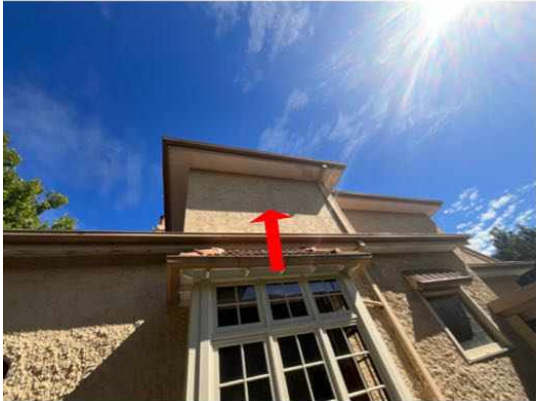
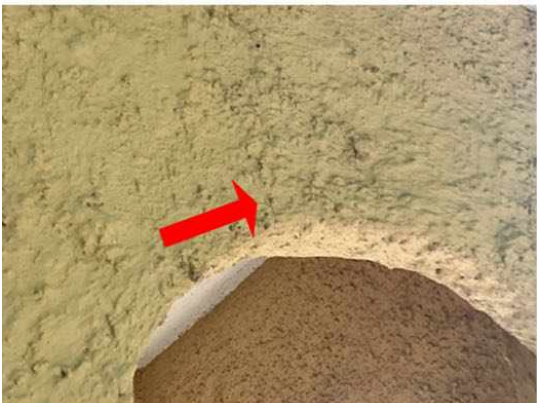
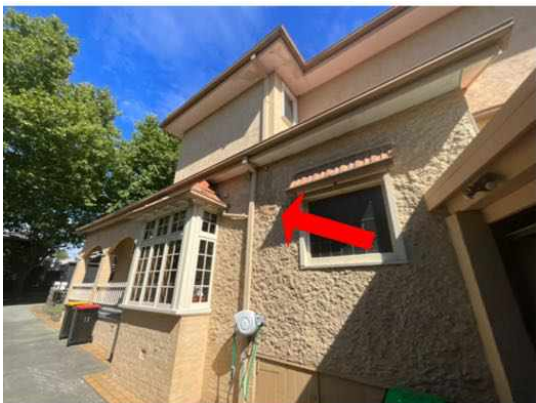
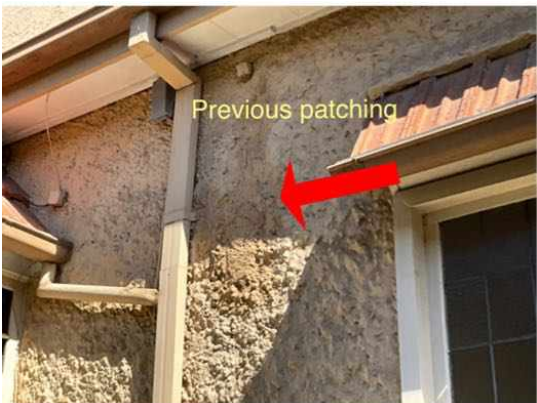
Finding 3.24

Building:
Location: All External Areas
Finding: Exterior rendered wall - minor but noticeable cracking
Information: Minor but noticeable cracking was noted to the exterior rendered walls at the time of inspection.

Consultation with a suitably qualified renderer should be sought to determine costs involved with any repairs necessary.

The areas should be monitored for any further changes. Should cracks increase in size or number, or the joins become further exposed, speak with your building inspector for further advice.

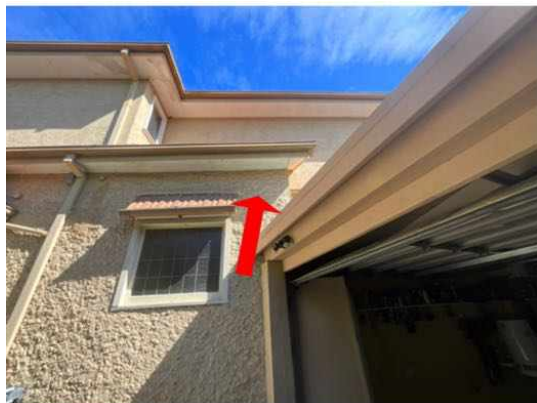
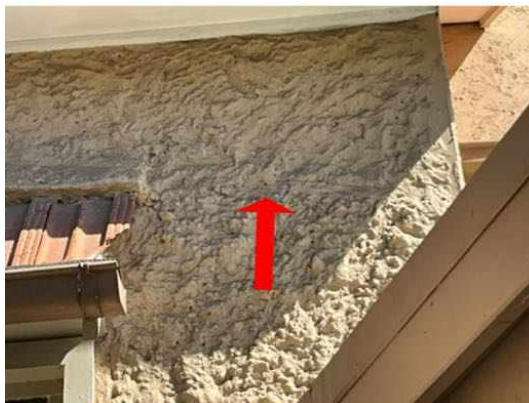
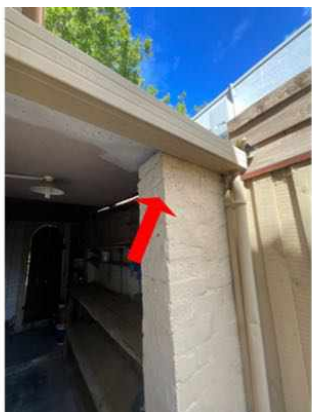
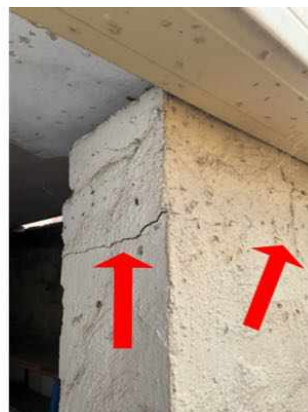
This type of defect is often consistent with general movement of the foundations of the property and is not considered a major structural defect.

Whilst it is more of an appearance issue, repairs may be required as failure to act may allow moisture to enter any cracks and cause secondary damage to other building elements.

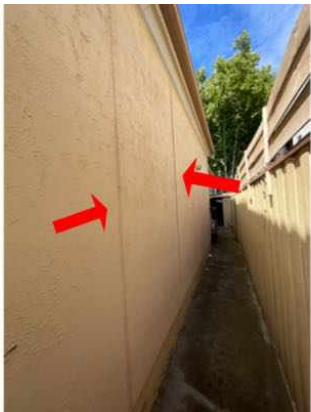
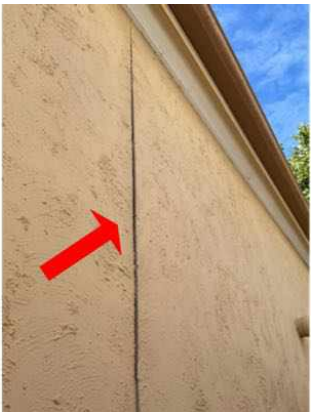
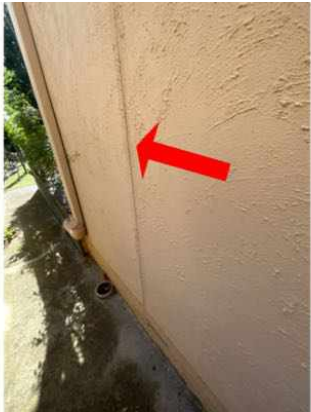
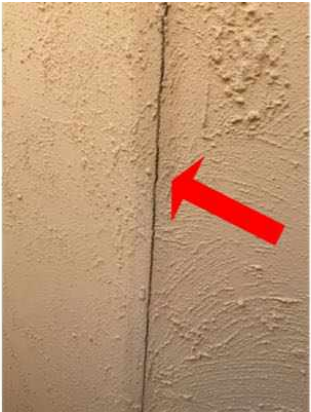
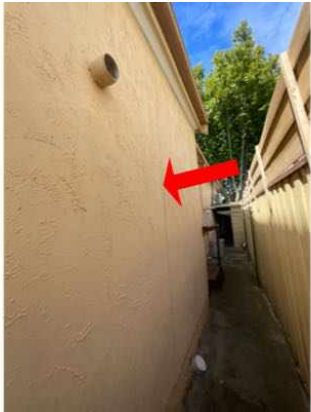
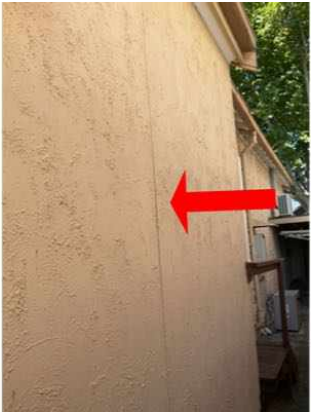
Finding 3.25

Building:	
Location:	Exterior walls - left side
Finding:	Rendered wall - noticeable joins and minor cracking
Information:	Minor cracking and noticeable joins within the rendered wall was identified at the time of inspection.

This type of defect is often consistent with general movement of the foundations of the property and is not considered a major structural defect.

Whilst it is more of an appearance issue, repairs may be required as failure to act may allow moisture to enter any cracks and cause secondary damage to other building elements.

Consultation with a suitably qualified renderer should be sought to determine costs involved with any repairs necessary.

The areas should be monitored for any further changes. Should cracks increase in size or number, or the joins become further exposed, speak with your building inspector for further advice.

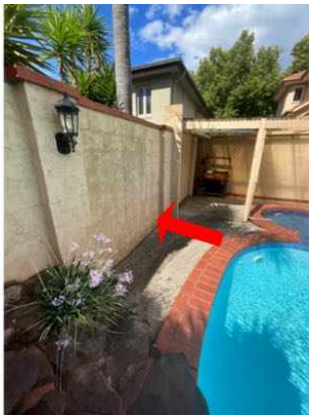
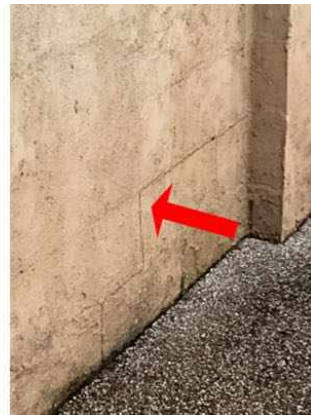
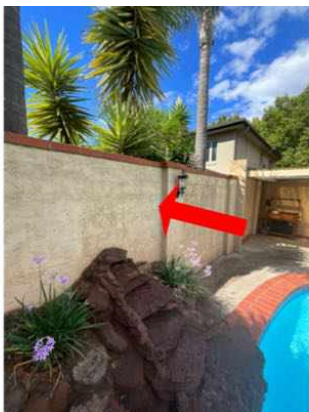
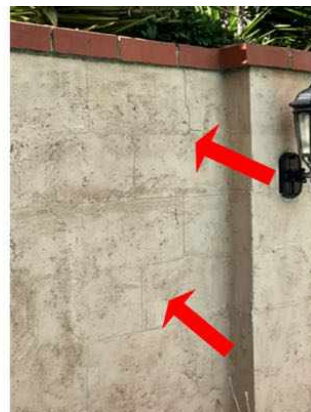
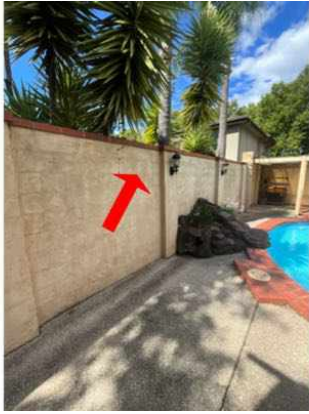
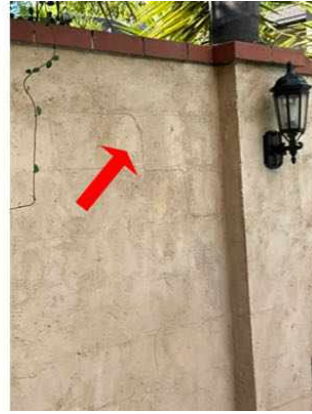
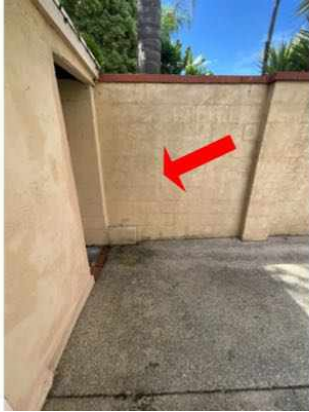
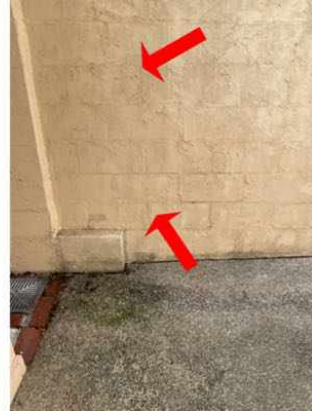
Finding 3.26

Building:
Location: Pool Area
Finding: Block wall - Step cracking
Information: Step cracking was identified to the concrete block boundary wall in the pool area at the time of inspection. Step cracking, which is similar to other forms of cracking, has a variety of possible causes. However, the most common is the subsidence of adjacent footings.

Step cracking is a relatively common defect. Mortar failure in the gaps between affected blocks or bricks indicates the stresses and tensions affecting the wall.

Minor step cracking can be used as a warning sign to address factors causing stress to the wall, which can include the effect of surrounding trees, water leaks, soil erosion, or even the presence of reactive soils in the surrounding area.

Where step cracking is extensive or severe or is coupled with other forms of cracking, the client is advised to consult a structural engineer.

It is highly recommended that the cracking be monitored for a period of time e.g. six months, to determine if there is any further cracking or active movement within the wall. Should no further cracking or movement occur, the wall may be patched by a qualified bricklayer or renderer.

Should cracking increase, a structural engineer should be engaged. In that instance, underpinning of the foundations may be required to stabilise the area and reduce the cracking.

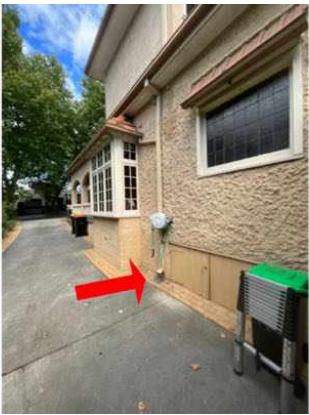
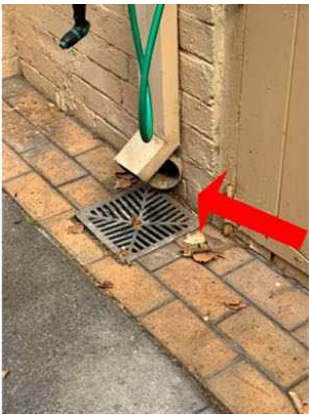
Finding 3.27

Information: Some sections of the roof are not adequately drained via downpipes. Downpipes that are not installed adequately or plumbed directly into the stormwater drainage may result in excessively damp conditions against the exterior surfaces and around the base perimeter of the building.

Excessive moisture creates an environment which accelerates the deterioration of building elements in the area, as well as being conducive to termite and pest infestation. Such an environment may necessitate repair and/or replacement of building elements.

It is highly recommended a roofing plumber be appointed to inspect the area and determine the best course of action, ideally installing plumbing from the downpipe to the drain below.

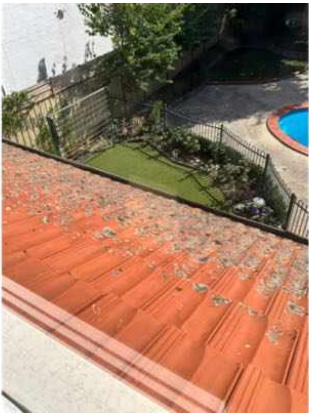
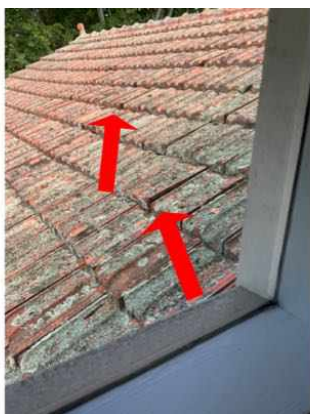
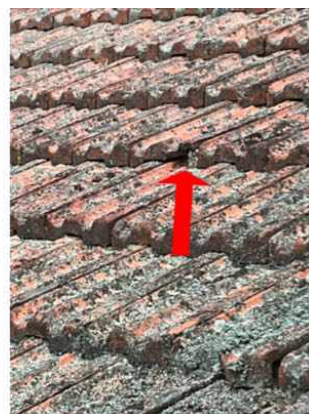
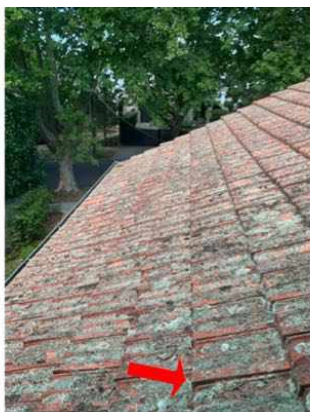
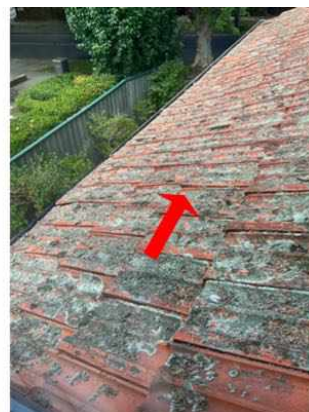
Finding 3.28

Building: Roof Exterior
 Location: Roof Exterior
 Finding: Roof tiles - fair condition but with some maintenance required
 Information: Upon inspection of the exterior roofing, the majority of roof tiles were considered to be in a fair condition. While weathering of the tiles is consistent with the age of the property, some minor maintenance works are required.

Areas of fine cracking of the mortar around the ridge and hip capping was noted. Some tiles had also shifted slightly from their original fixings.

Repairs to damaged tiles is required. Any gaps between tiles should also be attended to.

Consultation with a roofing contractor is advised to gain advice on remedial works that will be required . Where left unmanaged, damage can lead to a number of secondary defects, including water leaks and weather exposure to internal roofing structures.

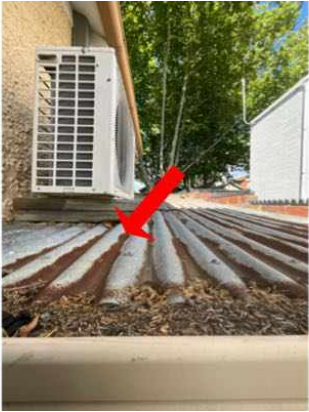
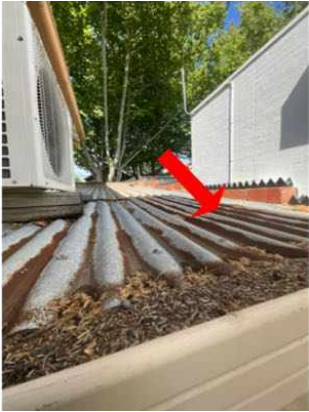
Finding 3.29

Finding: Metal Roofing - Rusted

Information: Metal roofs generally comprise numerous individual sheets, which join and overlap. These are particularly prone to rusting and lifting at the edges.

Upon inspection of the exterior roofing structure at the side and rear of the property , evidence of surface rust was identified. If left unmanaged, this can develop further and allow water ingress to the internal roofing structures, potentially leading to secondary damage of building elements. Accelerated deterioration of the roofing sheets and any associated building elements is also likely to occur.

A roofing contractor should be appointed immediately to assess the condition of the roofing sheets and capping and to perform remedial works as necessary.

Works may include replacement of severely affected areas or minor works such as the application of rust-retardant surface protectors.

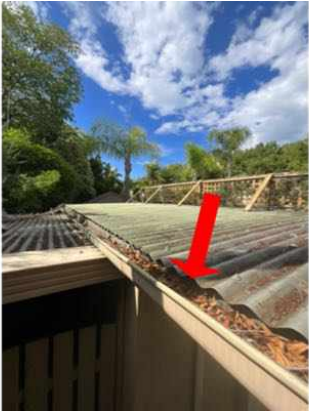
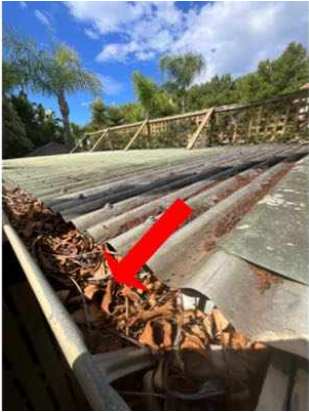
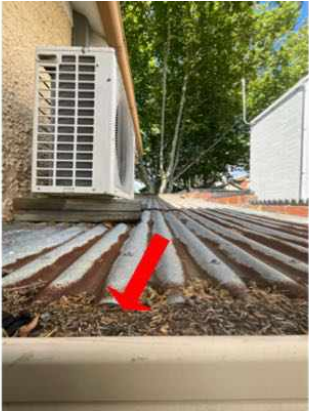
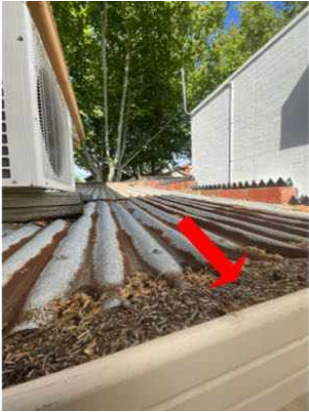
Finding 3.30

Building:
Location: Roof Exterior
Finding: Gutters - require cleaning of debris
Information: Roof plumbing structures, such as guttering and downpipes, should be free of all debris to prevent blockages and potential future damage.

Debris including nails and screws can also cause rusting and decay of the associated building materials. Any blockages or debris in gutters should therefore be removed immediately to ensure the effective operation of the roof plumbing system is maintained.

It is highly advised that blocked gutters be cleared by a gutter cleaning specialist or a general handyperson as a priority. Failure to do so may result in secondary damage to the property.

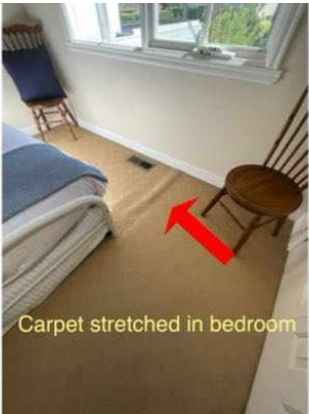
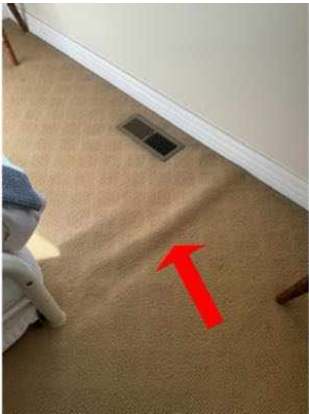
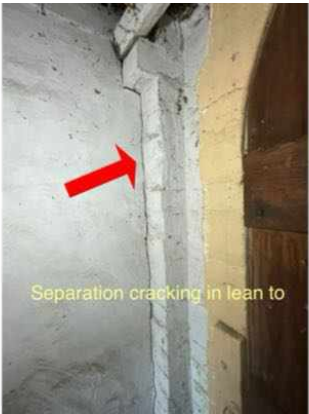
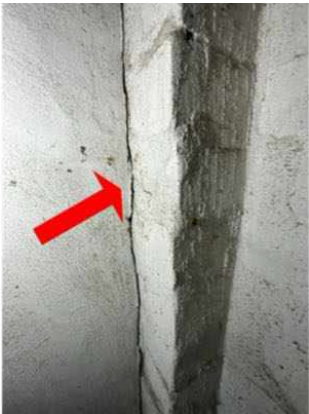
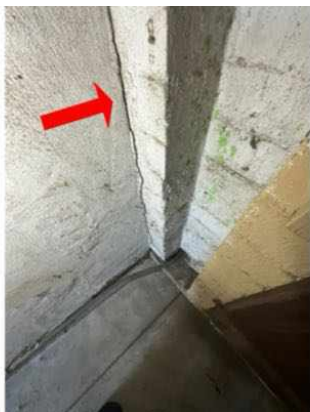
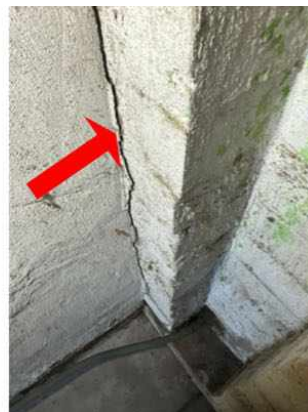
Finding 3.31

Building:
Location: All Areas
Finding: Additional Photos - minor defects
Information: Additional photos are provided for your general reference. Arrows have been included where necessary to highlight areas of importance.

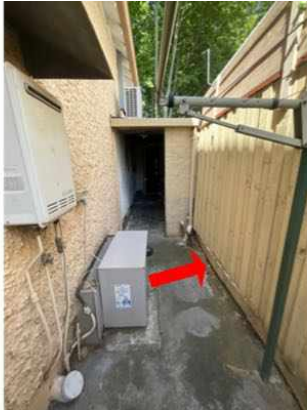
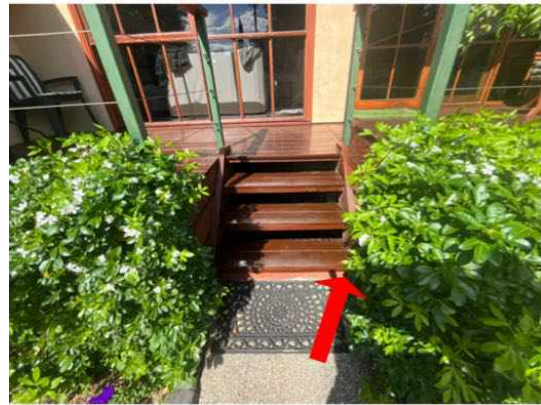
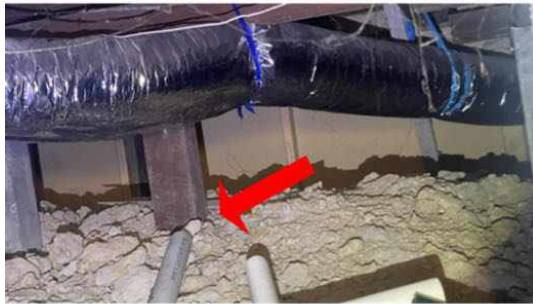
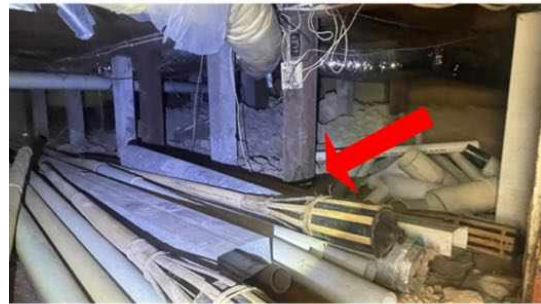
or non-durable also provide ingress for subterranean termites into that particular element.

Where possible, the removal of any such materials that may be conducive to termite activity should be carried out as soon as possible to minimise the risk of termite attack. Where not possible or practical, regular monitoring of timber elements is recommended. Replacement of any damaged materials should be carried out where necessary.

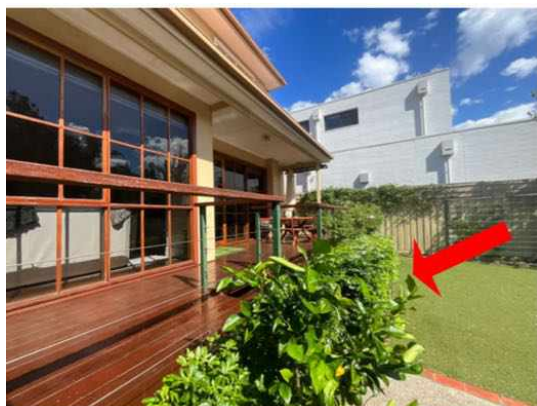
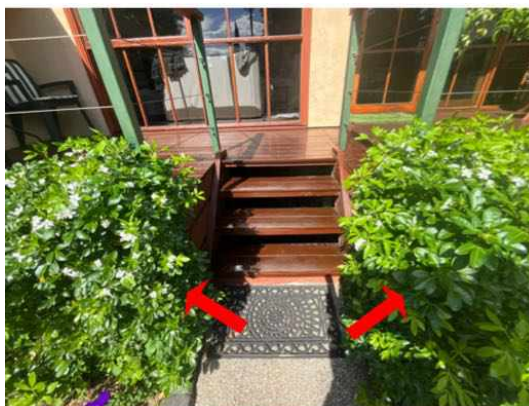
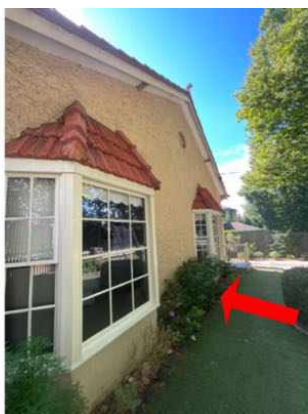
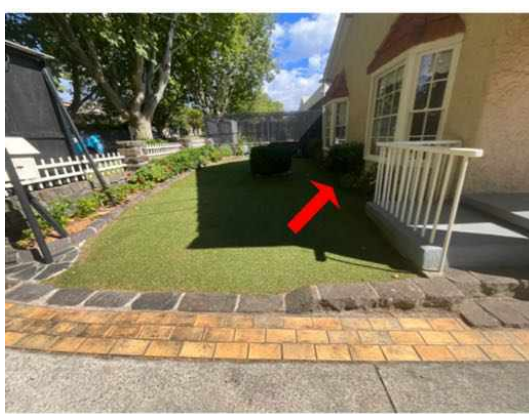
Finding 6.02

Finding: Garden Beds - Conditions Conducive to Termites

Information: Garden beds were found to be evident around and against the property. These garden beds can include untreated timber, and with a combination of moisture from rainfall and hosing, can make conditions conducive to termite activity and termite ingress.

The removal and replanting of species that do not provide "cover" or cutting back of existing vegetation will assist greatly in preventing this from occurring.

Where removal of any such materials that may be conducive to termite activity is not possible or practical regular monitoring of the areas should be carried out to minimize the risk of potential termite attack.

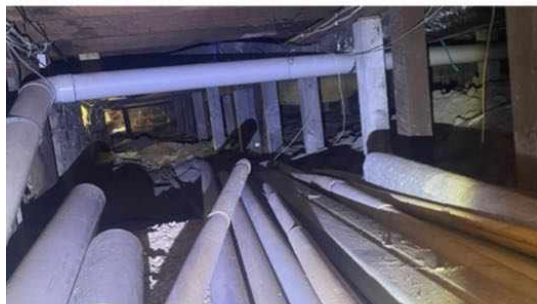
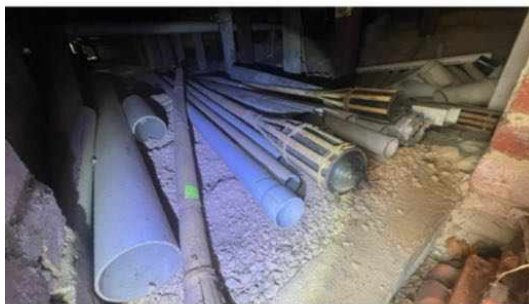
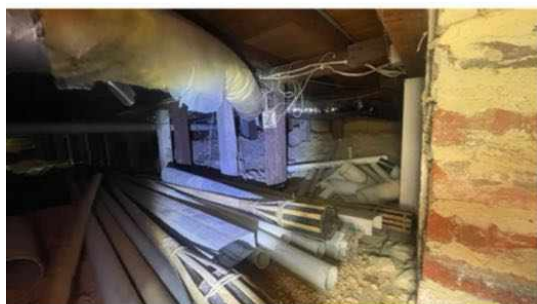
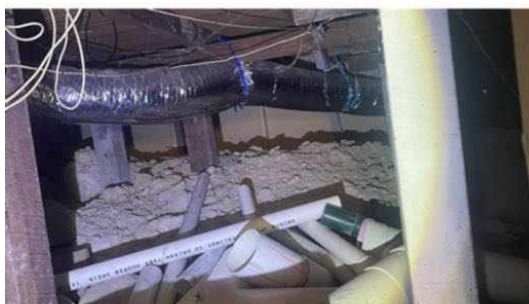
Finding 6.03

Information: An array of stored items and debris were found in the subfloor area at the time of inspection. Stored items and debris in this area restricts subfloor ventilation and creates potential for concealed pest entry. Stored timbers and other materials may also make the area susceptible to termite activity and wood rot.

A clear and empty subfloor will be better ventilated and easier to maintain in a dry condition. The removal of any timber debris is vital in minimising the risk of termite or wood borer activity.

Please note: stored items and debris prevented full access to the subfloor area to inspect for any pest activity or defects.

Any stored items and debris in the subfloor should be removed as soon as possible.

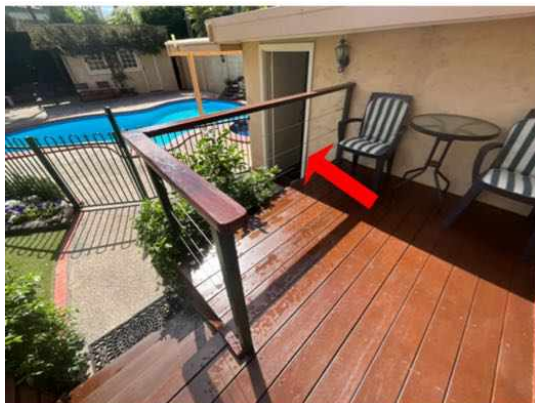
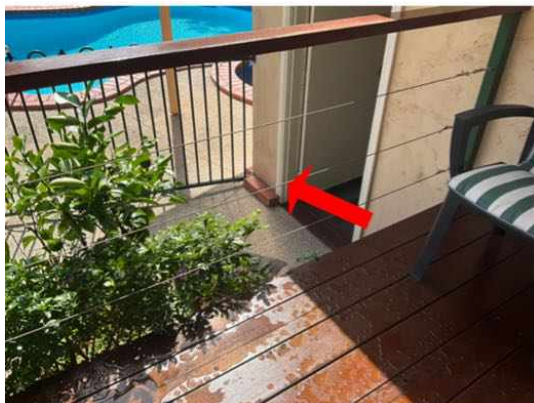
Building:
Location: Deck
Finding: Additional Photos for your information - deck barrier
Information: Additional photos are provided for your general reference.

It was noted that the deck railings were spaced wide apart and horizontal . This may not comply with current safety regulations for elevated balconies.

Caution should be taken in the area, particularly if young children are present.

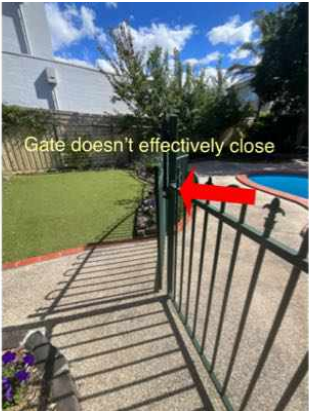
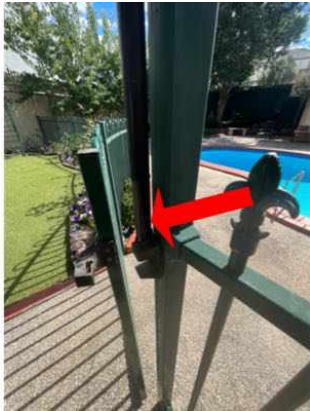
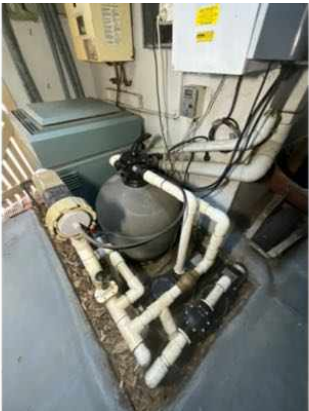
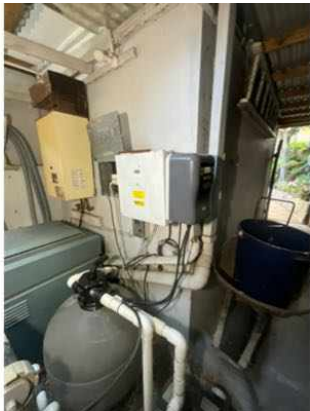
Please note: it was observed at the time of inspection that the pool gate did not fully close which can become a safety hazard. Urgent action should be carried out to ensure the fence complies with minimum standards for safety.

It is highly advised that a pool specialist be appointed to inspect the pool and associated equipment and provide advice on compliance and any rectification works that may be required.

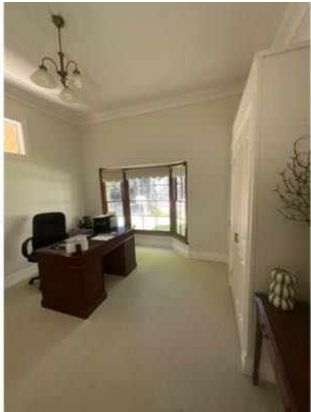
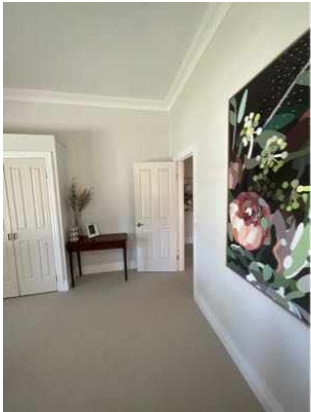
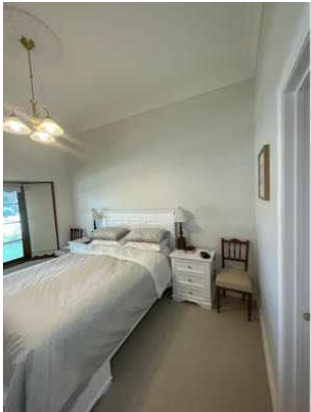
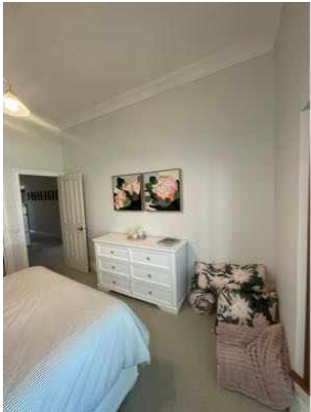
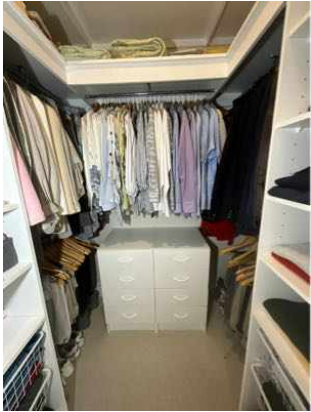
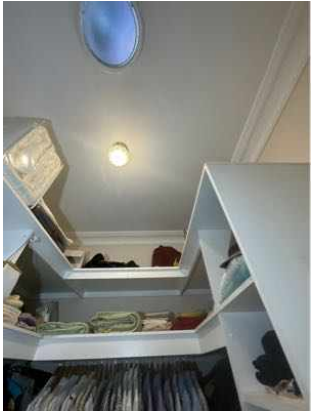
Building:
Location: All Areas
Finding: Additional Photos - Obstructions and Limitations
Information: These photographs are an indication of the obstructions and limitations which impeded full inspection of the property at the time of inspection. These obstructions can hide an array of defects and should be removed to allow full inspection to be carried out. A re-inspection is recommended once the areas are made accessible.
