# Building and Timber Pest Inspection Report

Inspection Date: Mon, 9 Feb 2026

Property Address: 23 Nurla Ave, Little Bay NSW 2036,  
Australia

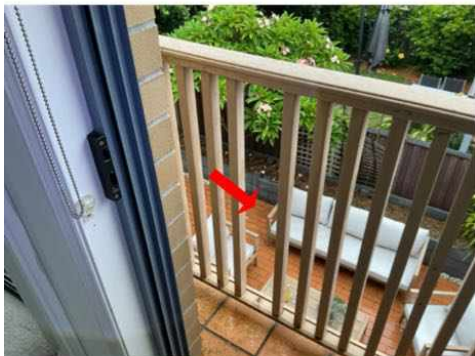
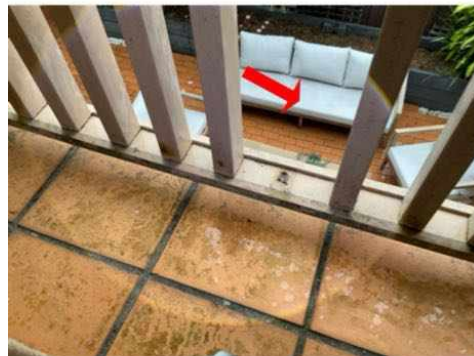
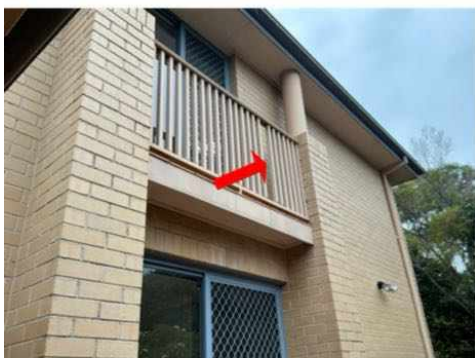
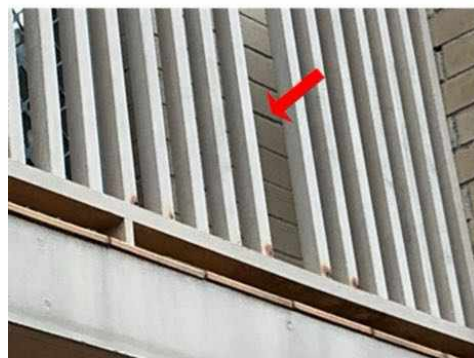
Replacement of any missing building element should be conducted as soon as possible to ensure that no damage or functional issues occur to associated building materials.

The appropriate tradesperson should be appointed as soon as possible to replace the missing building element.

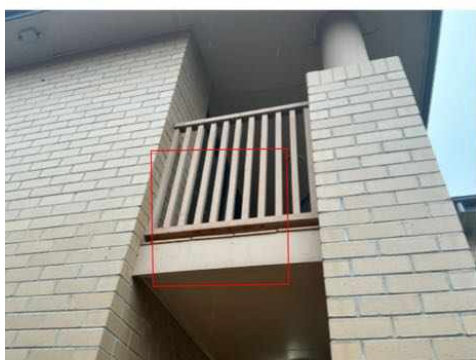
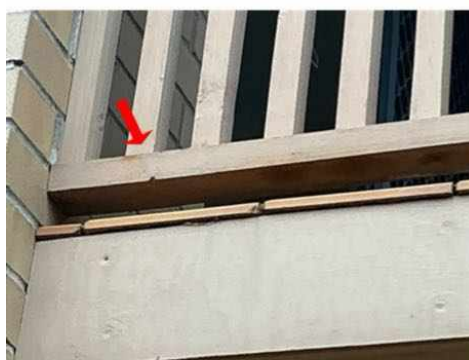
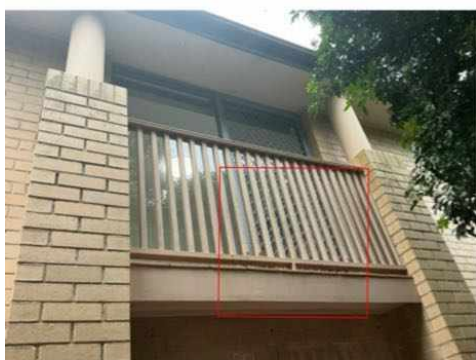
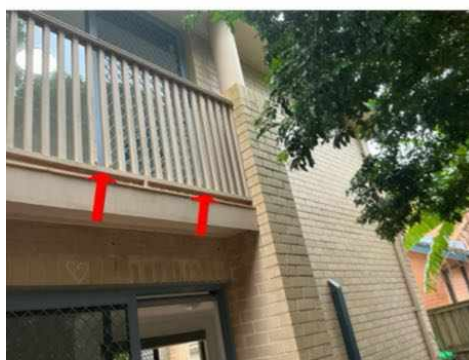
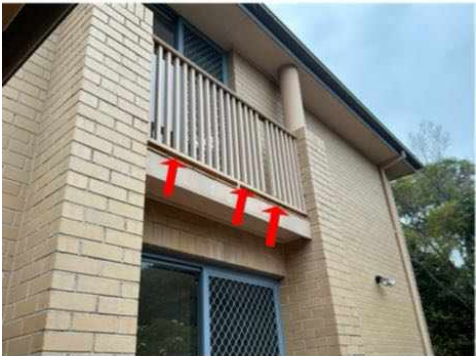
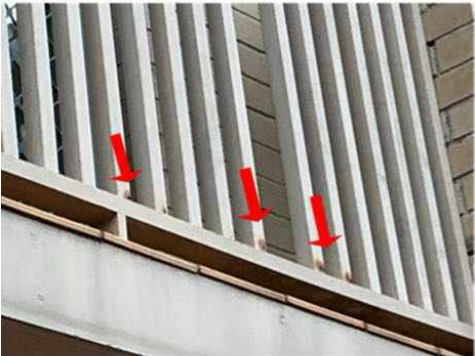
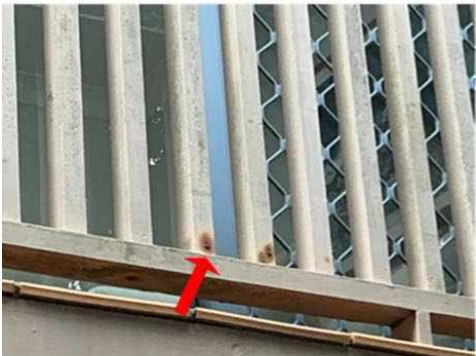
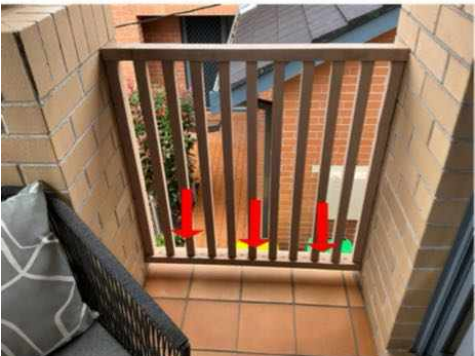
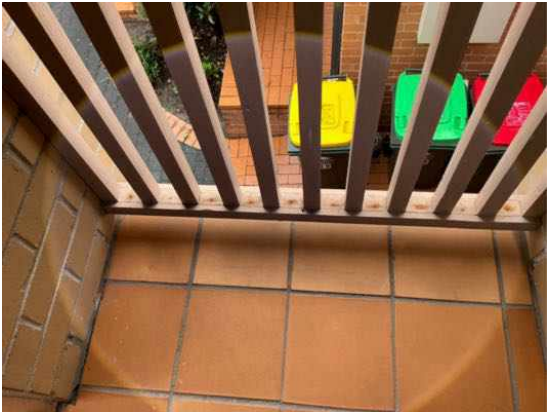
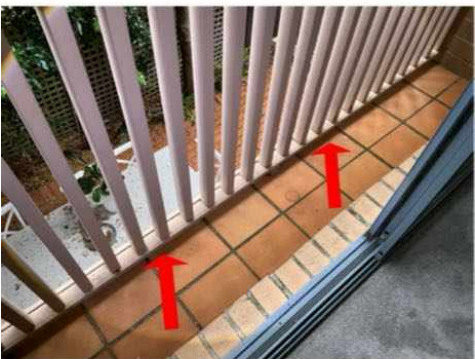
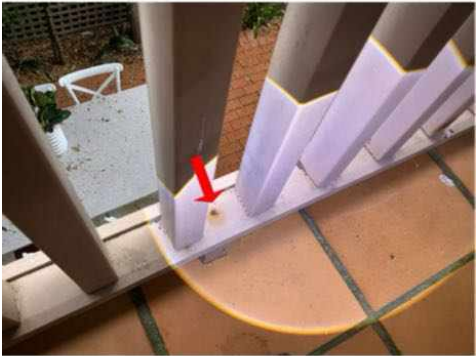
#### Finding 1.02

Building:	Main Building
-----------	---------------

Where possible, the use of galvanized (treated) metals or aluminium coated metals aid in rust prevention, as does regular general maintenance. Rust formation can be controlled with coatings, such as paint, that isolate the iron from the environment.

Rusting and corrosion should be managed by ideally removing or limiting the affected surface from exposure to moisture. A registered builder may be appointed to replace any building elements that have been severely affected by rust or water damage.

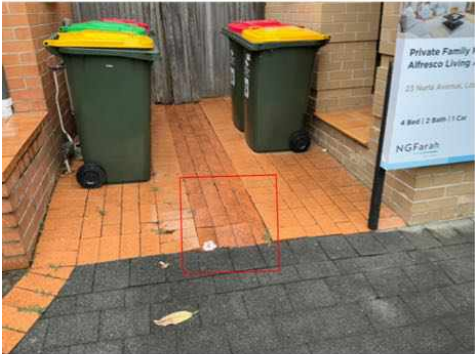
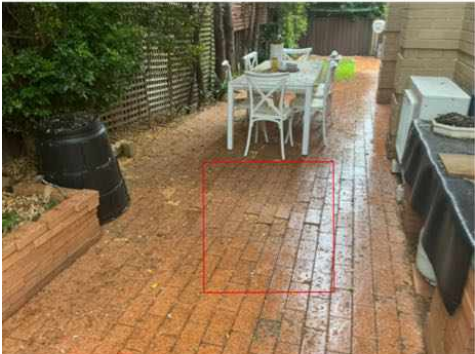
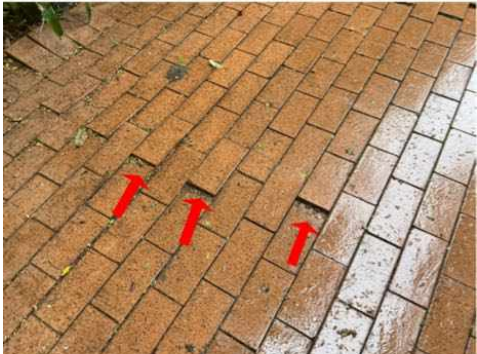
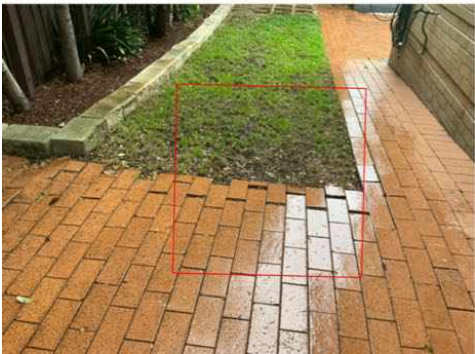
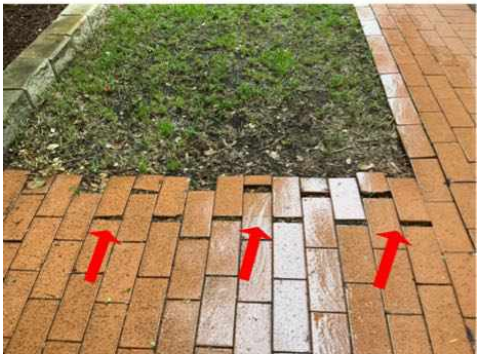
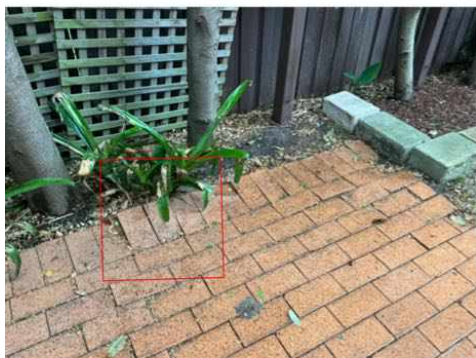
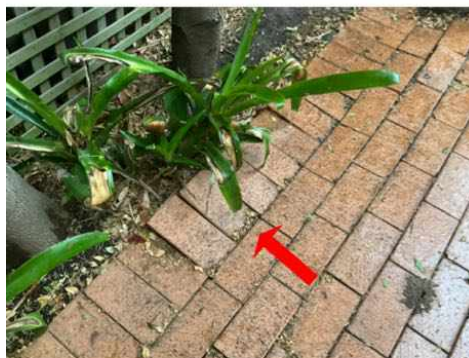
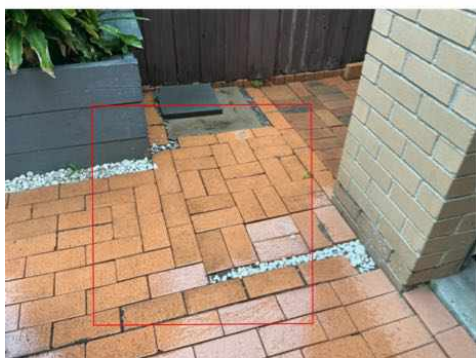
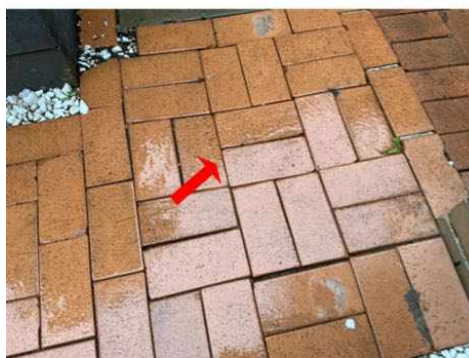
Finding 1.03

Building: Main Building  
Location: External paving- back yard and side passages  
Finding: Paving uneven  
Information: Sections of the external paved area are uneven, creating a potential trip hazard. It appears as though the area has been subject to rough installation, or that paving sections have lifted due to movements in the foundation of the property.

Where paving creates a trip hazard, personal injury may ensue if due caution is not taken by all persons within this area.

Re-paving of the area is required as soon as possible to remedy this situation. Further consultation with a specialist concreter is advised.

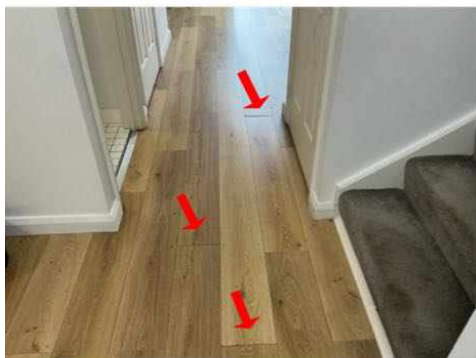
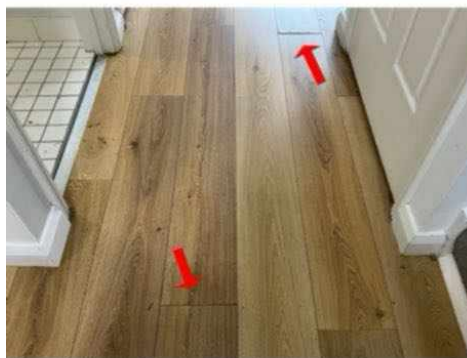
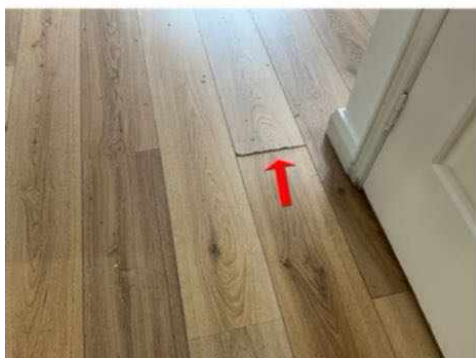
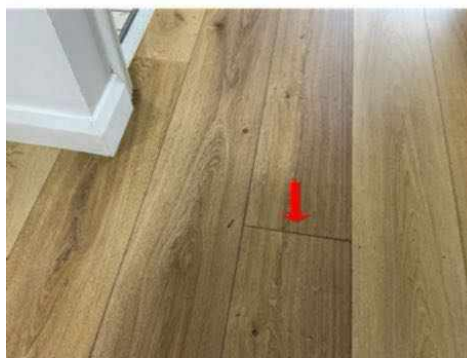
### Finding 1.04

Building:	Main Building
Location:	Downstairs hallway
Finding:	Building element - Damaged- flooring lifting
Information:	Breakage occurs generally when the building materials have either aged and decayed, or as a result of damage (accidental or deliberate).

Repair and/or replacement of broken elements is advised to ensure that additional secondary defects do not arise as a consequence. Such works are necessary, as all building elements play a key role in the operation and function of the overall structure and its performance.

A relevant tradesperson should be appointed to repair or replace the affected building element prior to any subsequent damage being caused.

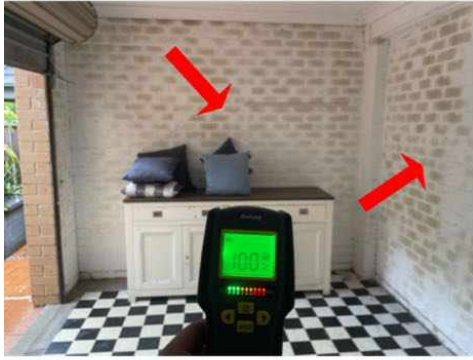
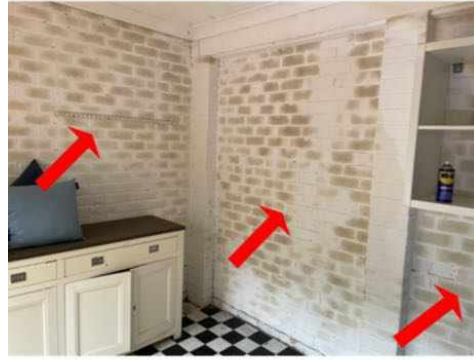
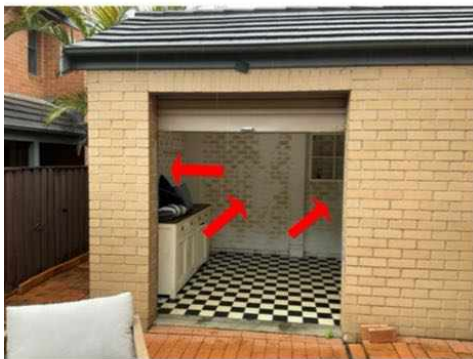
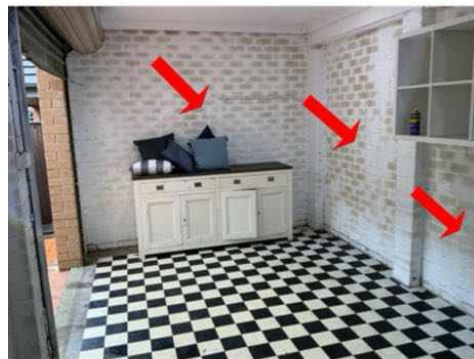
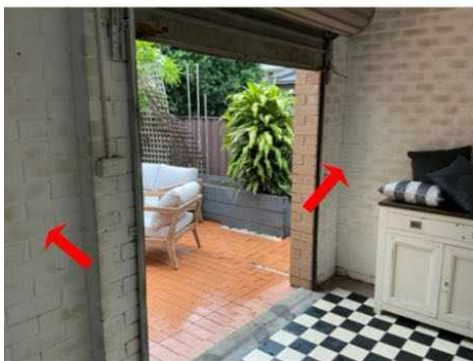
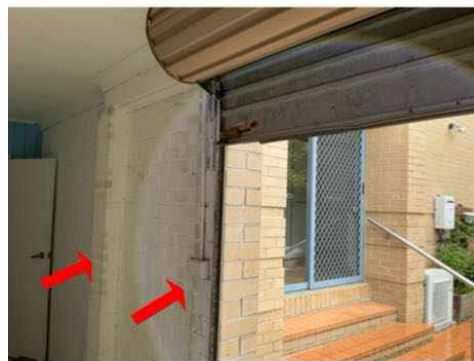
### Finding 2.01

If mould growth has been found there may be environmental biological or health issues involved. In these cases an appropriately qualified inspector should also be contacted.

Prior to any remedial works being performed a qualified plumber should be appointed to further inspect the property and to identify the cause of the excessive moisture. Works to remove affected building elements may then be necessary and should be performed by an appropriate tradesperson.

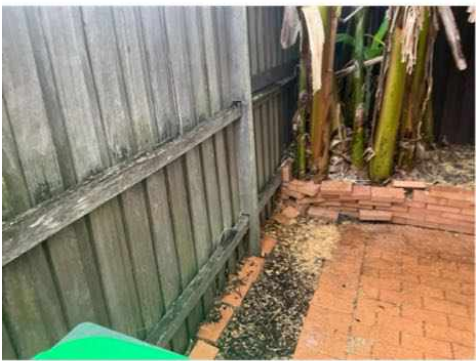
### Finding 3.01

Works that have not been completed to a satisfactory level create potential for the development of building defects and may impede on the safety and integrity of the overall structure.

It is highly recommended that the relevant trades be appointed to complete these works and ensure the safety of the area and the longevity of all associated building elements.

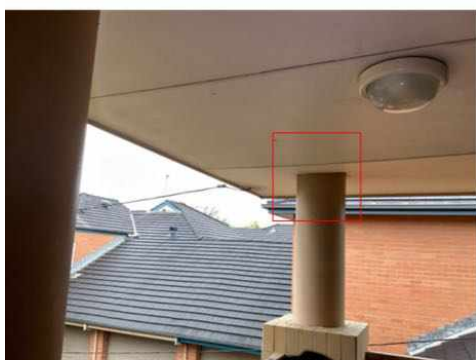
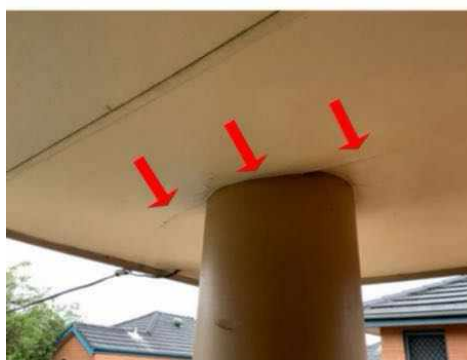
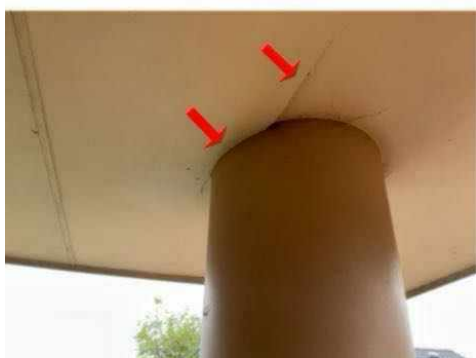
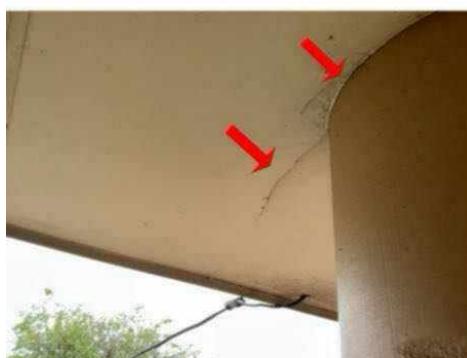
Finding: Building element - Broken or Damaged  
 Information: Breakage occurs generally when the building materials have either aged and decayed, or as a result of damage (accidental or deliberate).

Repair and/or replacement of broken elements is advised to ensure that additional secondary defects do not arise as a consequence. Such works are necessary, as all building elements play a key role in the operation and function of the overall structure and its performance.

A relevant tradesperson should be appointed to repair or replace the affected building element prior to any subsequent damage being caused.

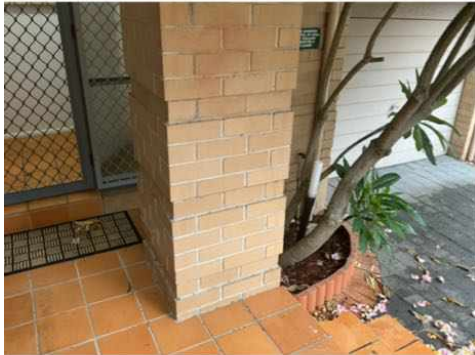
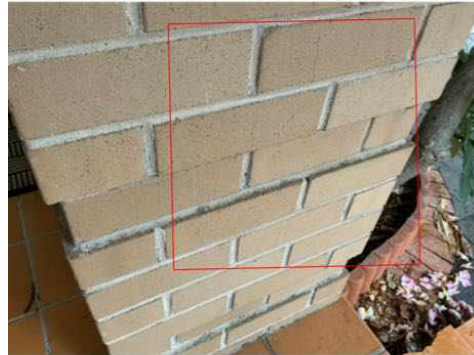
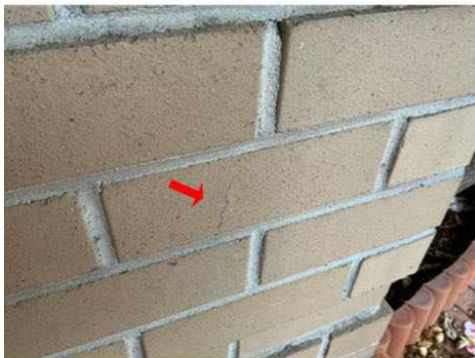
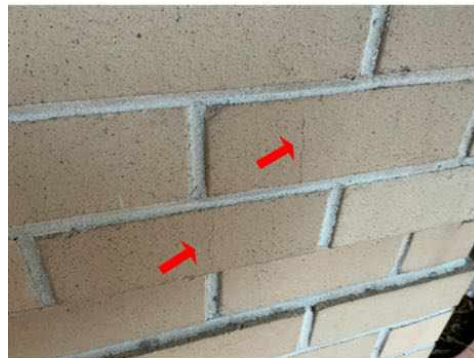
### Finding 3.03

Building: Main Building  
 Location: Front entrance  
 Finding: Brickwork - Cracking [Fine]  
 Information: Although fine cracks are quite noticeable, they are often only considered to be an appearance defect and usually do not indicate any structural damage. Generally, the cause of a fine crack is indicative of a separation between brickwork and mortar throughout the structure, but single bricks may also show cracks of this nature.

Cracking of this nature can generally be repaired with minor filling and should be

conducted by a qualified bricklayer.

Always contact a building inspector should cracks widen lengthen or become more numerous.

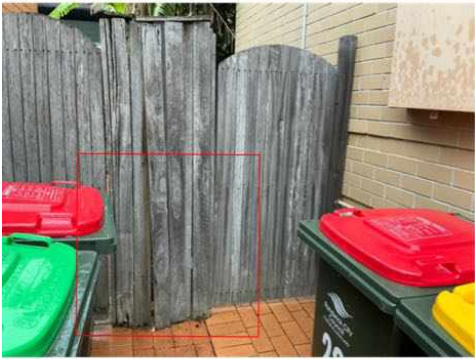
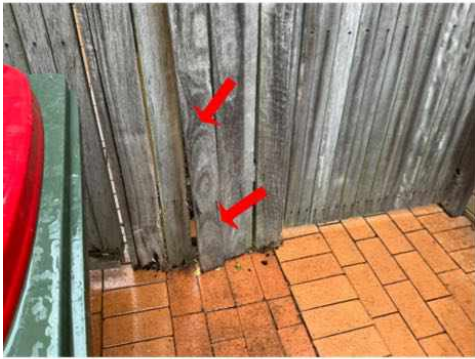
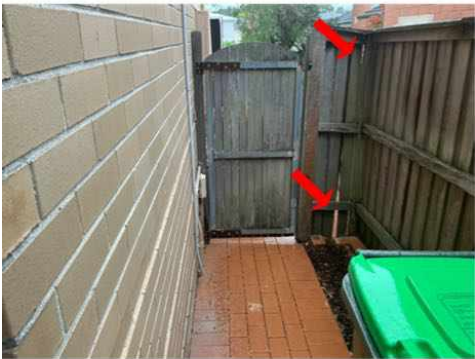
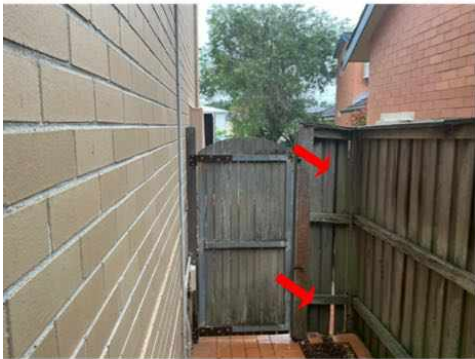
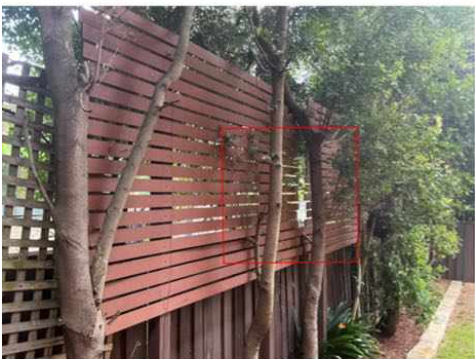
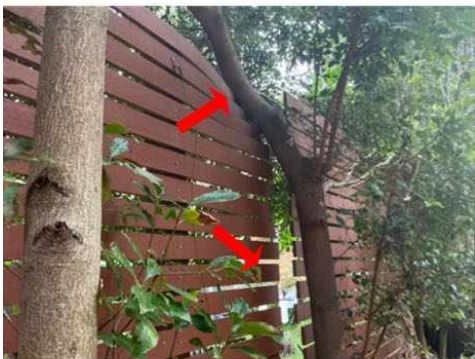
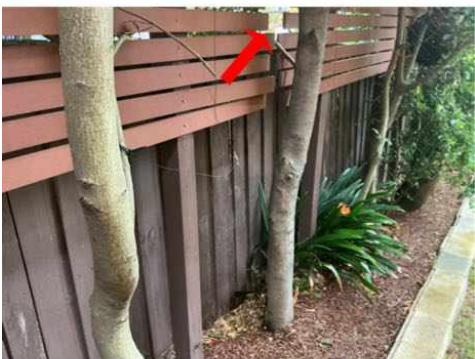
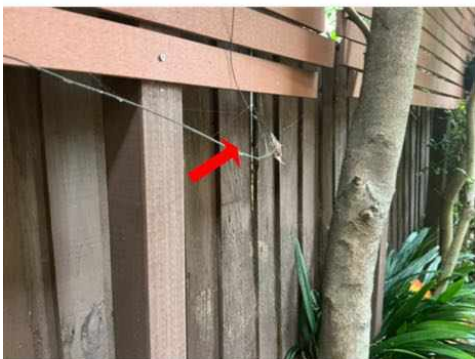
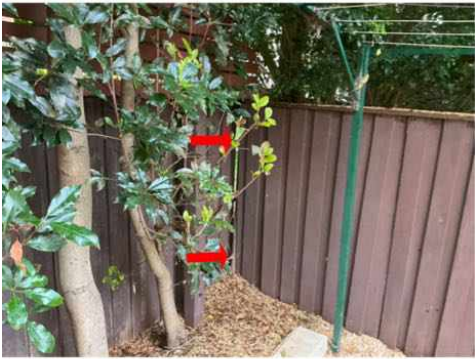
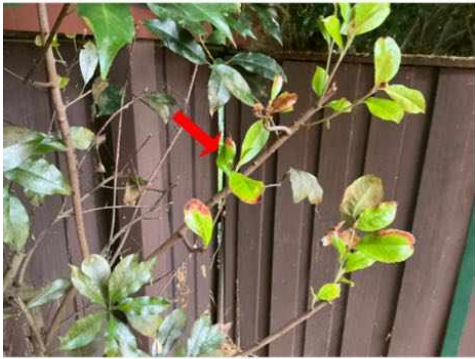
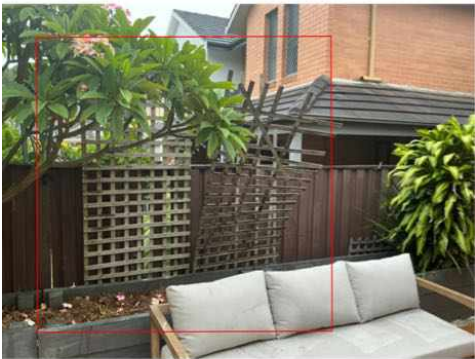
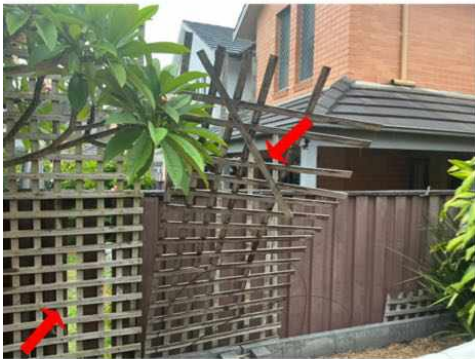
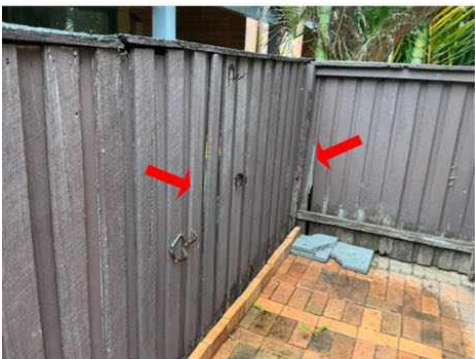
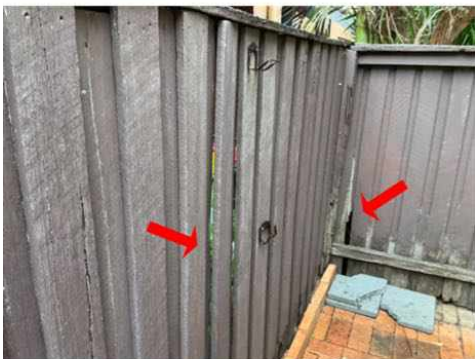
### Finding 3.04

Building:	Main Building
Location:	Back and side- all fences
Finding:	Fencing - Deteriorated
Information:	It was noted at the time of inspection that sections of the fencing throughout the property have deteriorated. Typically fencing deteriorates due to age and or wear, rot and or rust which is generally expected for a structure of this age, due to prolonged exposure to weather conditions. Sometimes inadequate installation or maintenance can be to blame.

If left unattended, it is likely that further damage will occur. It is suspected that repair of several elements of the fencing may be required however replacement may be a consideration of the client also.

A licensed fencing contractor should be appointed to provide further advice and perform rectification works as necessary.

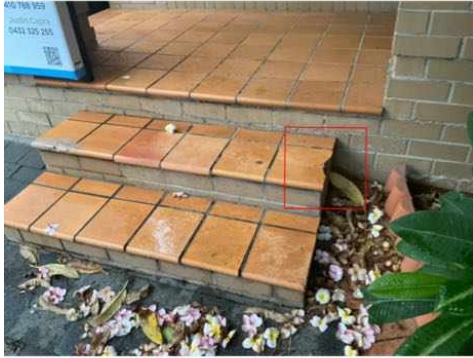
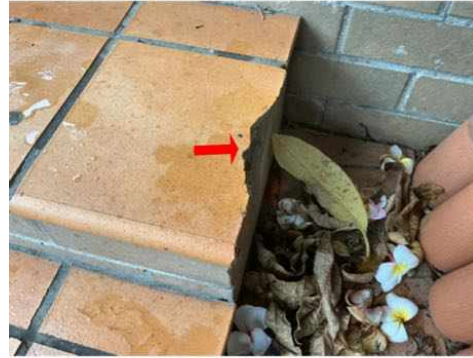
**Finding 3.05**

Building: Main Building  
Location: Front entrance  
Finding: Surface - Chipped- paver  
Information: The surface of this building element appears to have chipped as a result of general wear and tear. While being an appearance defect, such damage is expected of a property of this age and condition.

Chipped surfaces rarely impede on the structure or functionality of the affected building element and generally only create a blemish on its appearance. Chipped surfaces may be left in situ at client discretion, as no repairs or replacement are necessarily required. However, the client may wish to seek quotations for the cost of

refurbishment or replacement of the identified building element.

A qualified carpenter or cabinet maker should be appointed to repair chipped surfaces and replace building elements where major damage has occurred.

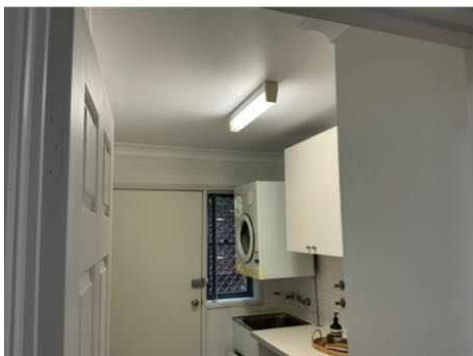
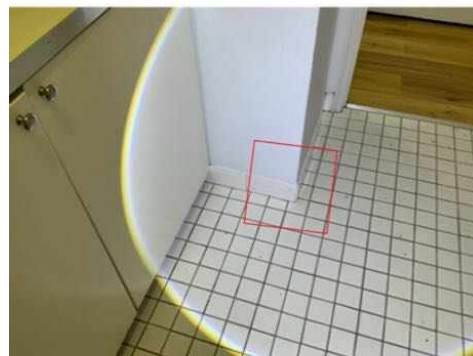
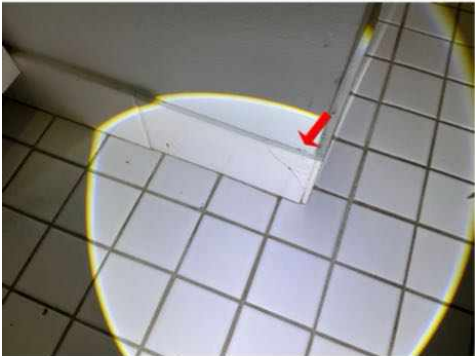
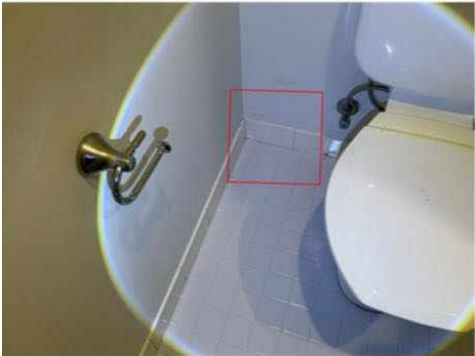
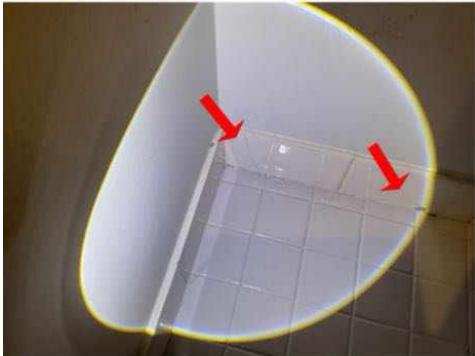
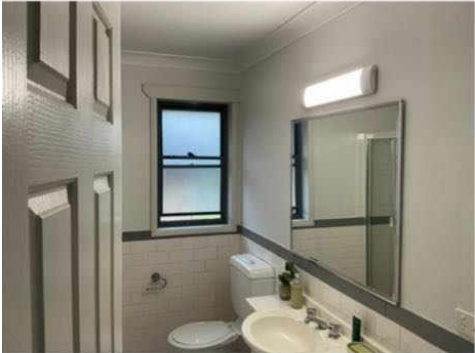
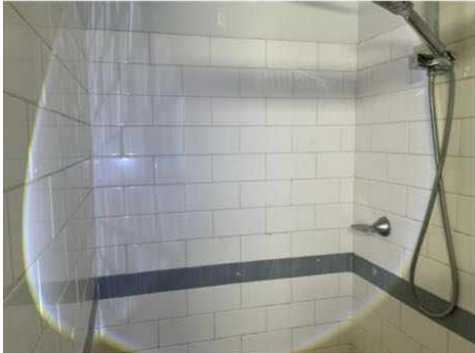
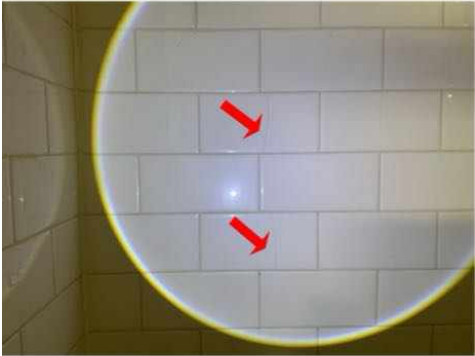
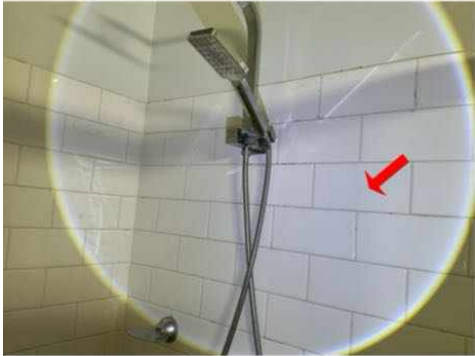
### Finding 3.06

Building:	Main Building
Location:	All wet Areas- Laundry, bathrooms, toilets- up and downstairs
Finding:	Tiles cracked or damaged- (wet areas)
Information:	Cracking was evident to the tiling in this area at the time of inspection. While the cracking appears to be minor, this area is frequently exposed to water, allowing potential for water penetration into adjoining sections of walls or flooring.

If left unmanaged, water penetration to these areas may lead to subsequent water damage, which is likely necessitate repair work to affected building elements.

A tiling contractor should be appointed to ensure that no further water damage occurs. The re-application of silicone and grouting throughout remaining tile work is also advised, to further protect the area against water penetration.

Where water penetration has led to water damage, appointment of a relevant tradesperson may be required to repair damaged building elements.

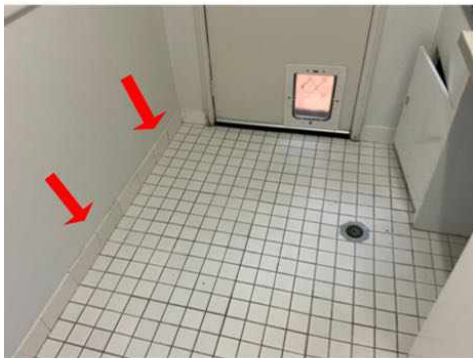
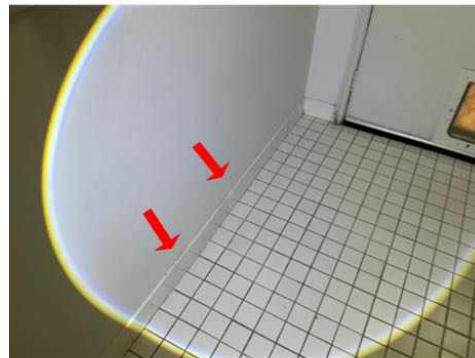
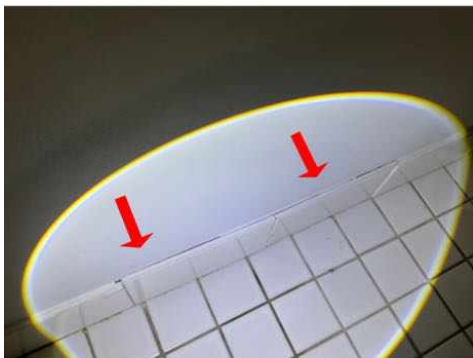
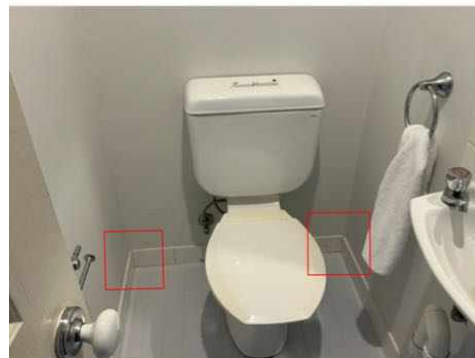
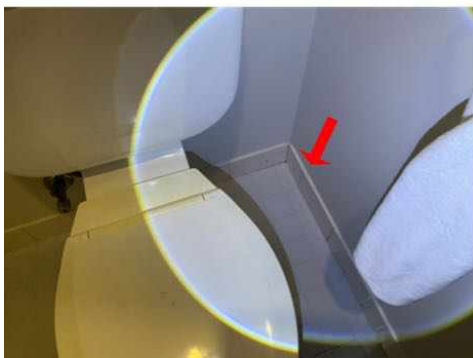
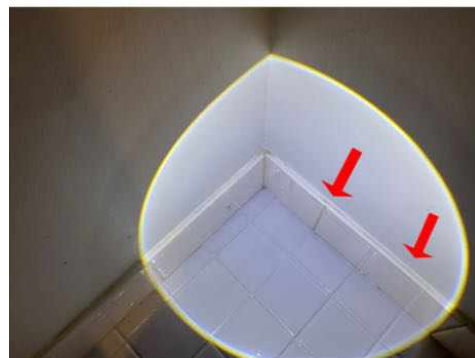
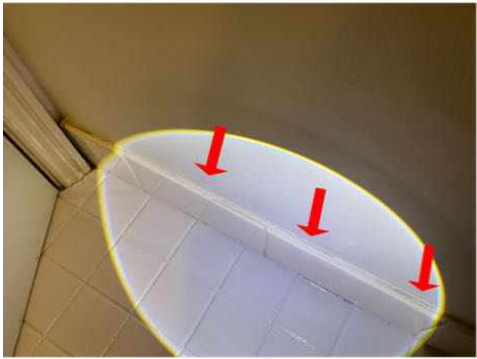
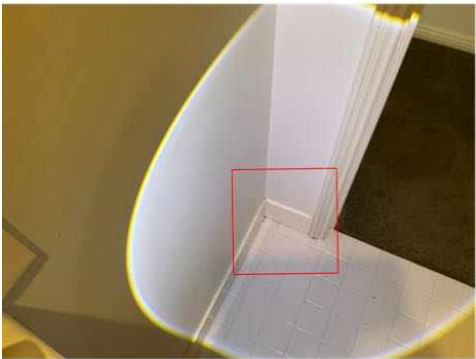
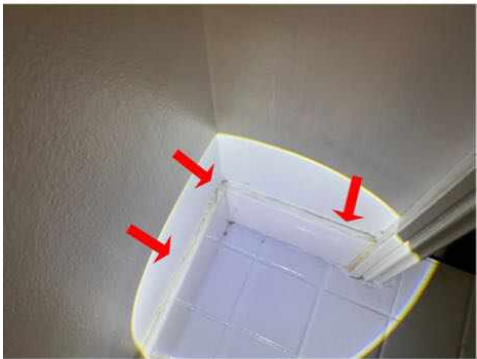
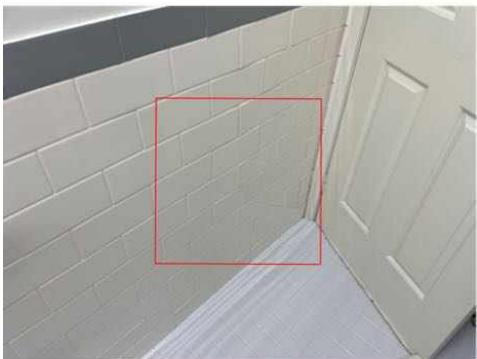
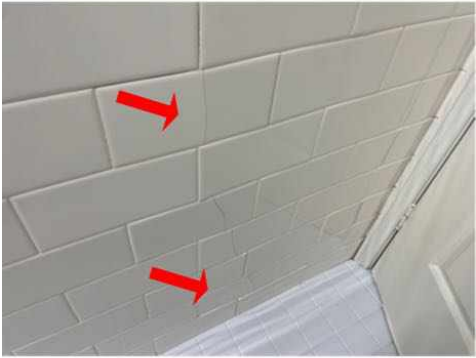
### Finding 3.07

Building:	Main Building
Location:	Downstairs toilet, bathroom, laundry- upstairs bathroom, toilet- All wet areas throughout
Finding:	Tiles - Drummy
Information:	Drummy tiled areas were identified at the time of inspection. The term 'drummy' refers to tiles that have become detached from their fixing, despite otherwise being in relatively good condition. Such defects are generally caused by physical or moisture damage to the area. Drummy tiled areas may also be a direct result of poor workmanship during the construction process.

Tiled areas may swell and shrink with changes in air humidity if the area has sustained

moisture damage. Any exposure to moisture is capable of causing tiled areas to become drummy and/or cracked over a prolonged period of time. Drummy tiled areas generally require removal and replacement of affected tiles, with adequate sealant and grouting.

Specialist trades are available for these types of services. A registered builder may be required to undertake works if damage is extensive or if secondary building defects have resulted. Otherwise, it is advised that a tiling contractor be appointed to perform works as necessary. Immediate action is recommended to ensure that no further damage is sustained in the affected area.

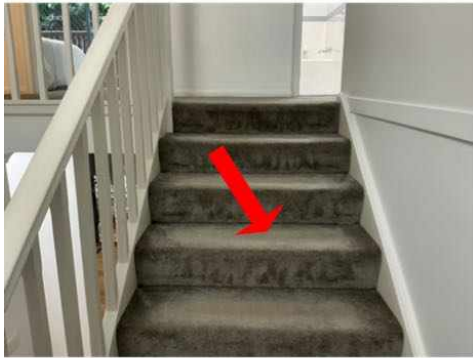
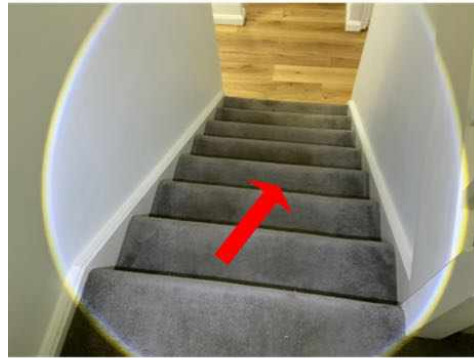
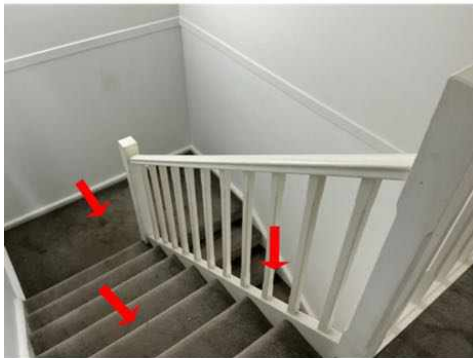
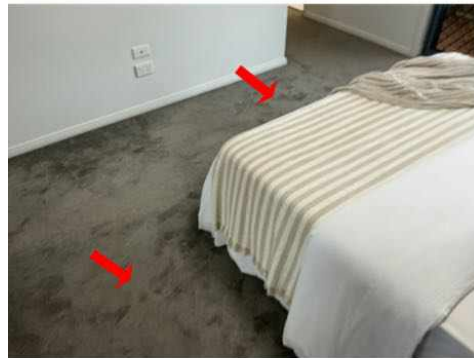
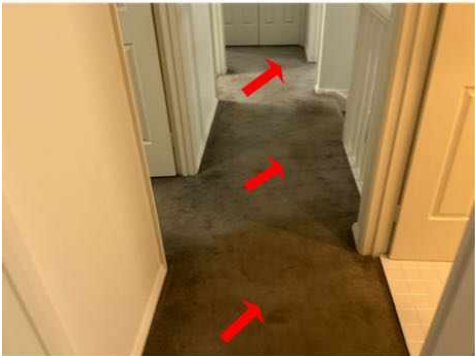
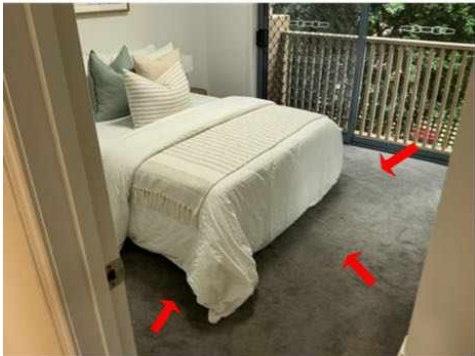
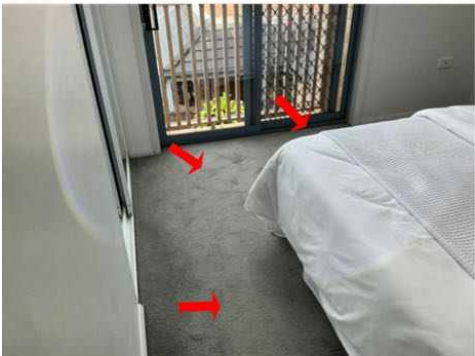
Finding 3.08

Building: Main Building  
Location: All upstairs areas  
Finding: Floors - bouncy- All upstairs areas  
Information: The internal flooring in this area was identified as being bouncy at the time of inspection. A bouncy floor surface generally presents as a discernible change in level as they are walked across, in noisy or creaking flooring, or in consequent movement of surrounding furniture and fixtures.

Bouncy floors generally indicate that the floorboards or the subfloor structures are coming loose from the joists that they are installed on. Bouncy flooring may also be the result of gaps between flooring and stumps or joist structures, which require packing.

The client is advised to seek quotations for required repairs from a Registered Builder specialising in re-stumping. The potential resolution may range from packing gaps in subfloor structures through to replacement of subfloors stumps and refixing of flooring.

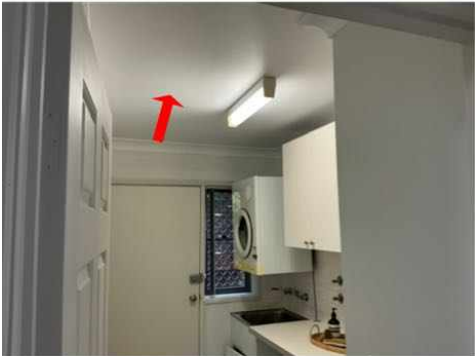
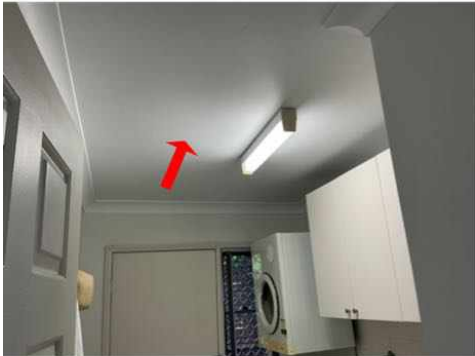
**Finding 3.09**

Building: Main Building  
Location: Laundry  
Finding: Exhaust fan - Missing  
Information: An exhaust fan has not been installed in this area. Missing exhaust fans may lead to the development of more significant defects such as moisture damage to surrounding building materials from inadequate ventilation. Inadequate ventilation in internal areas creates an environment that is conducive to the formation and development of mould and other respiratory hazards. It is highly advised that a licensed electrician be appointed to retrospectively install an exhaust fan. Failure to perform works to aid the ventilation of the area may lead to the development of these secondary defects.

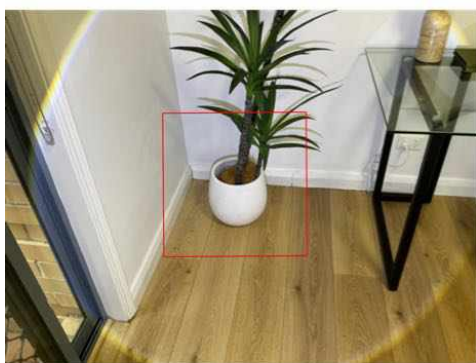
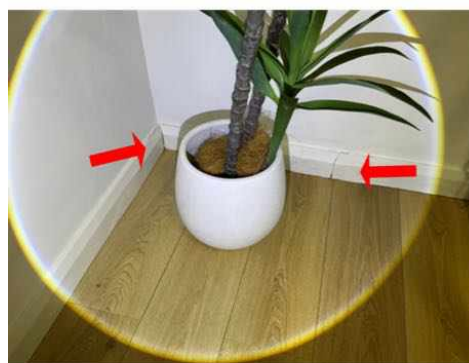
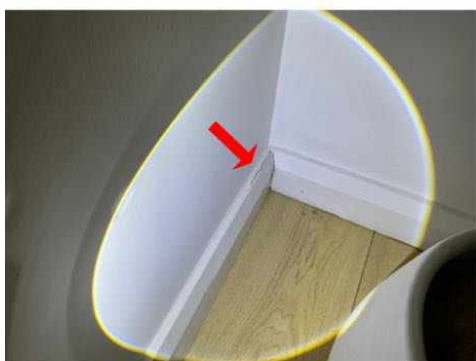
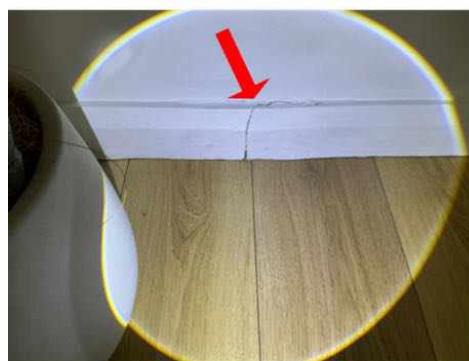
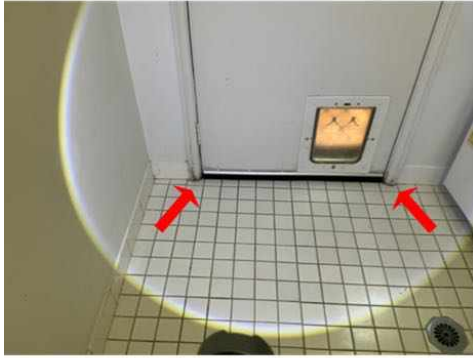
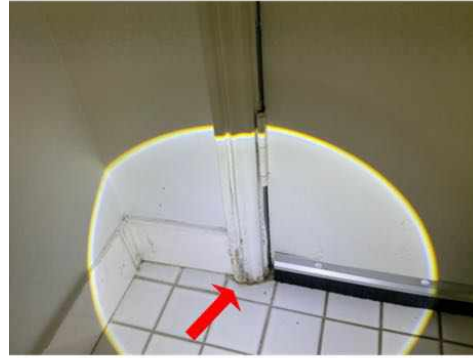
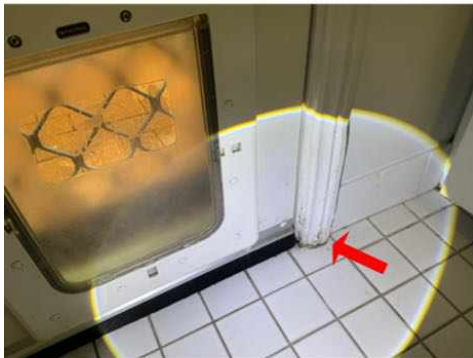
### Finding 3.10

Building:	Main Building
Location:	Lounge room , Laundry
Finding:	Paint finish - Substandard
Information:	The paint finish in this area was found to have been completed to a substandard level. Substandard painting is generally classified as an appearance defect. However, the substandard appearance may also be indicative of poor surface preparation and substandard workmanship.

If this applies, further areas of poor and incomplete finishes could develop over time. Furthermore, substandard paint finishes in areas exposed to moisture, e.g. external areas or wet areas, could lead to deterioration of underlying building materials.

Substandard paint finishes should be sanded back, filled, leveled and repainted, as applicable. Where inadequate paint protection has led to the deterioration of the associated building element, repair and/or replacement of this building element may be required.

A painting contractor should be appointed as soon as possible to perform necessary works to aid the appearance of the affected area and to ensure that the area is protected against further deterioration. Alternatively, the homeowner following manufacturer instructions may be able to provide this service.

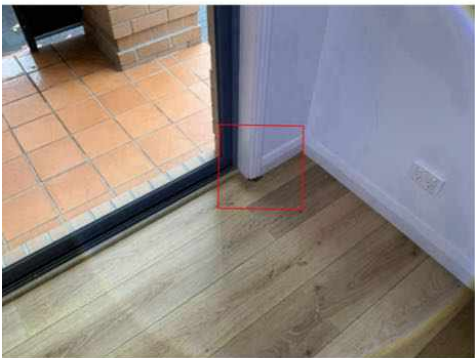
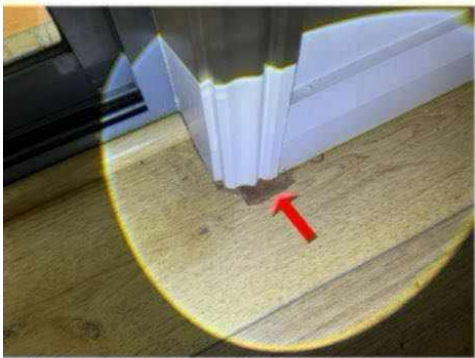
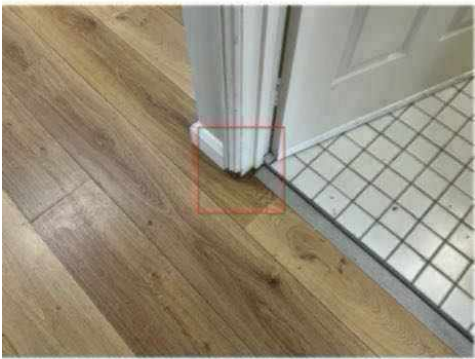
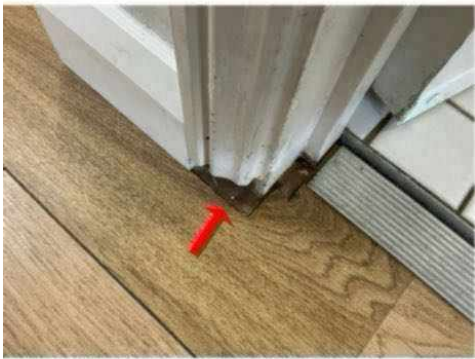
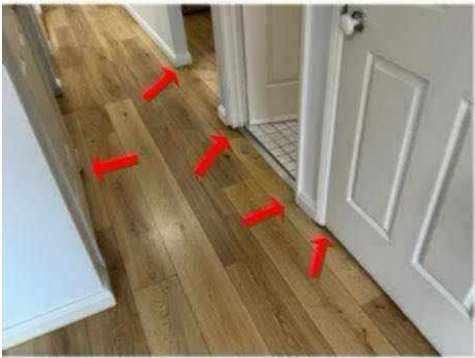
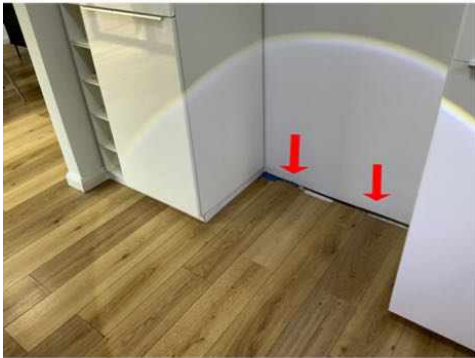
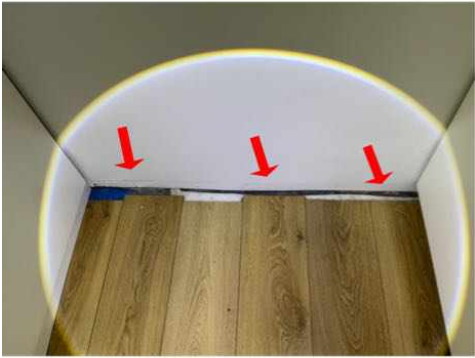
### Finding 3.11

Building:	Main Building
Location:	Bottom hallway, kitchen fridge recess
Finding:	Incomplete or substandard works- flooring not joined to walls
Information:	The works to this area appear to be incomplete or have been completed to a substandard level.

Works that have not been completed to a satisfactory level create potential for the development of building defects and may impede on the safety and integrity of the overall structure.

It is highly recommended that the relevant trades be appointed to complete these works and ensure the safety of the area and the longevity of all associated building elements.

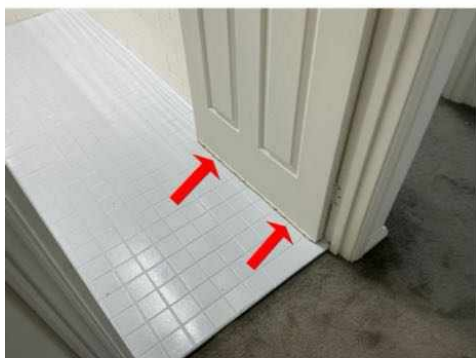
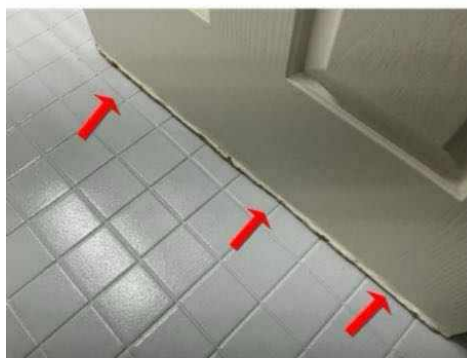
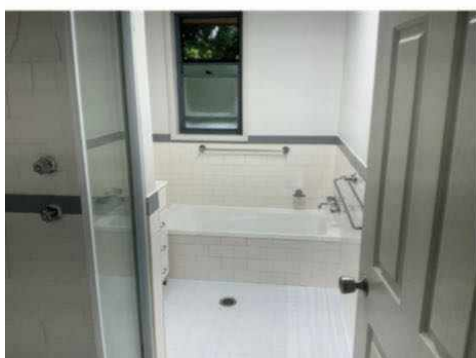
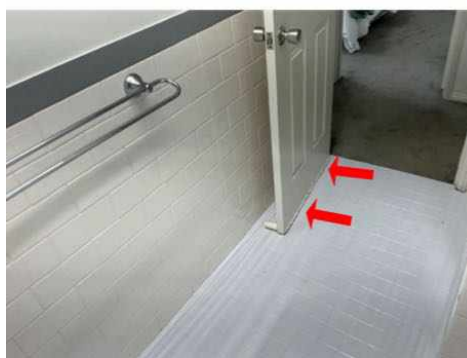
Finding 3.12

Building:	Main Building
Location:	Bathroom, laundry, toilet doors to wet areas.
Finding:	Doors, swollen- delaminated with moisture
Information:	Delamination is one means by which composite materials (e.g. layered timber composites) may fail over time. In laminated materials, repeated cyclic stresses may lead to the formation of mini-structures of separate layers, with significant loss of mechanical toughness. Water penetration or the presence of excessive moisture also generally contributes to delamination.

Where building materials have become delaminated, they lose their structural strength, and are likely to have a variety of appearance and serviceability defects as a result.

Delamination of timbers may be repaired where the area affected is minor and/or easily accessible, by gluing and screwing layers back together. However, this is an interim repair, and where delamination has occurred, the client should plan for the replacement of affected timbers sooner than would otherwise be expected.

All timber structures affected by delamination should be replaced as soon as possible to avoid any further damage. Repair and replacement estimates should be sought from a registered builder or qualified carpenter.
